**STORM WATER CHANNEL  
MAINTENANCE PROGRAM PRIORITIZATION**  
September 13, 2016

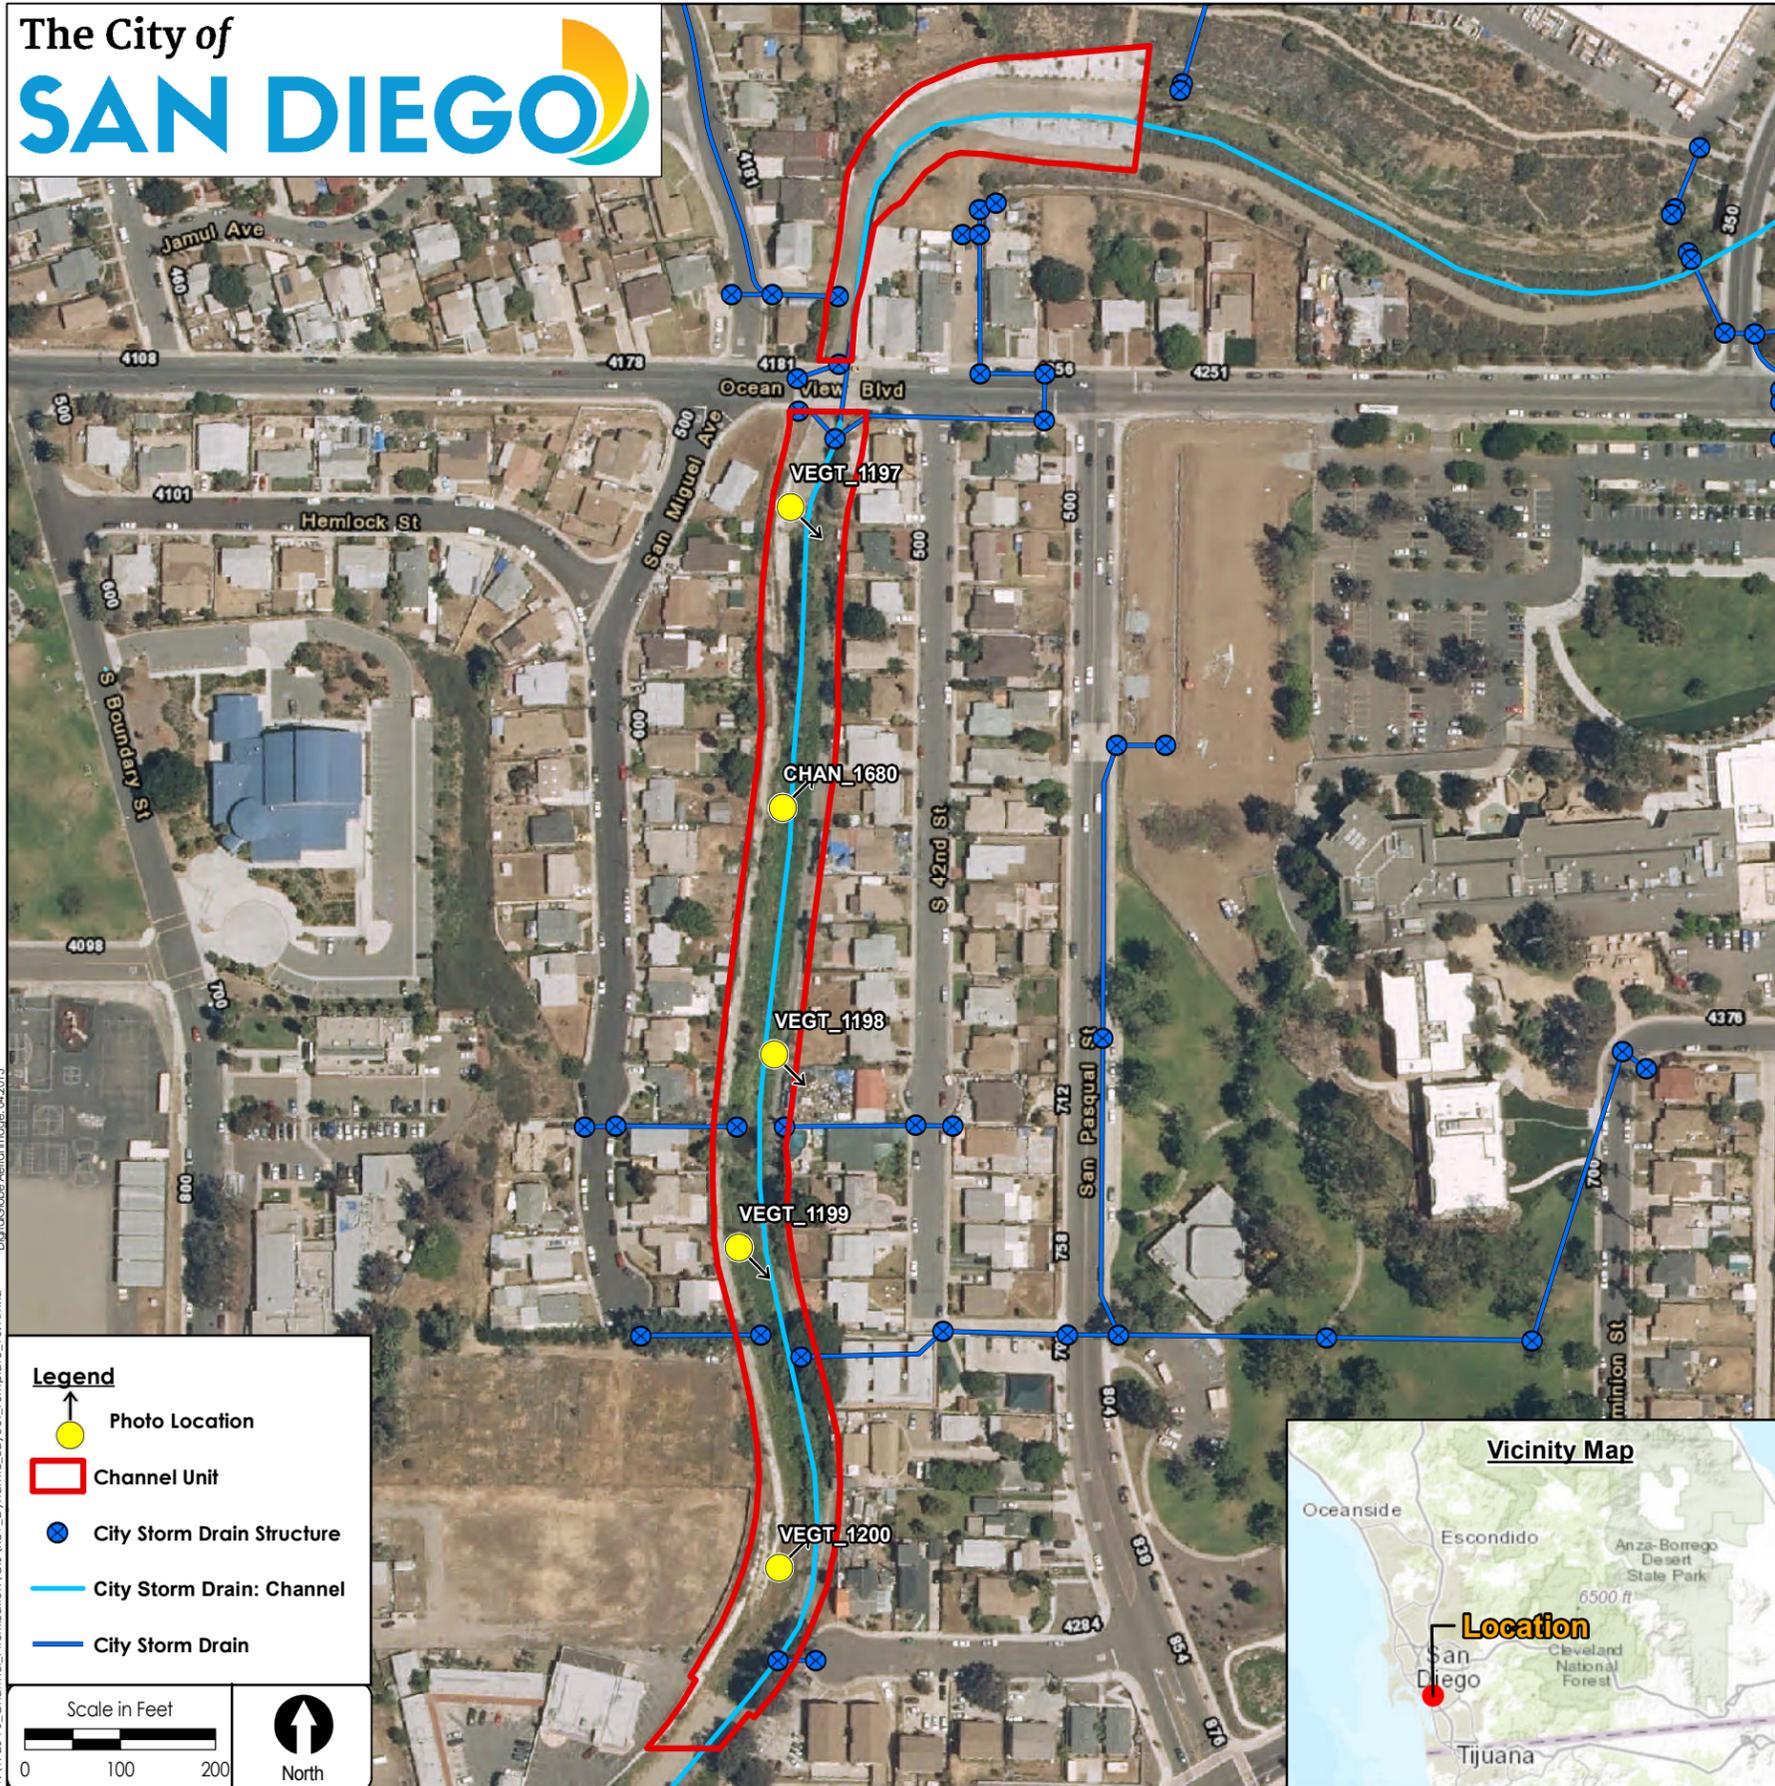
- Maintenance Priority: **HIGH**
- Channel Prioritization Score: **89.1 out of 100**
- Capacity Prior to Maintenance: **less than 2-year storm event**
- Capacity After Maintenance (As-built Capacity): **10-year storm event**
- Clogging Potential: **HIGH**
- Approximate Invasive Vegetation Coverage: **LOW**
- Approximate Native Vegetation Coverage: **HIGH**
- Surrounding Area: **Residential**
- Infrastructure Failures: **NONE**
- Site Evaluation Date: **April 13, 2016**
- Notes/Comments: **Channel has dense vegetation and large deposits of sediment. Channel is near residential housing.**

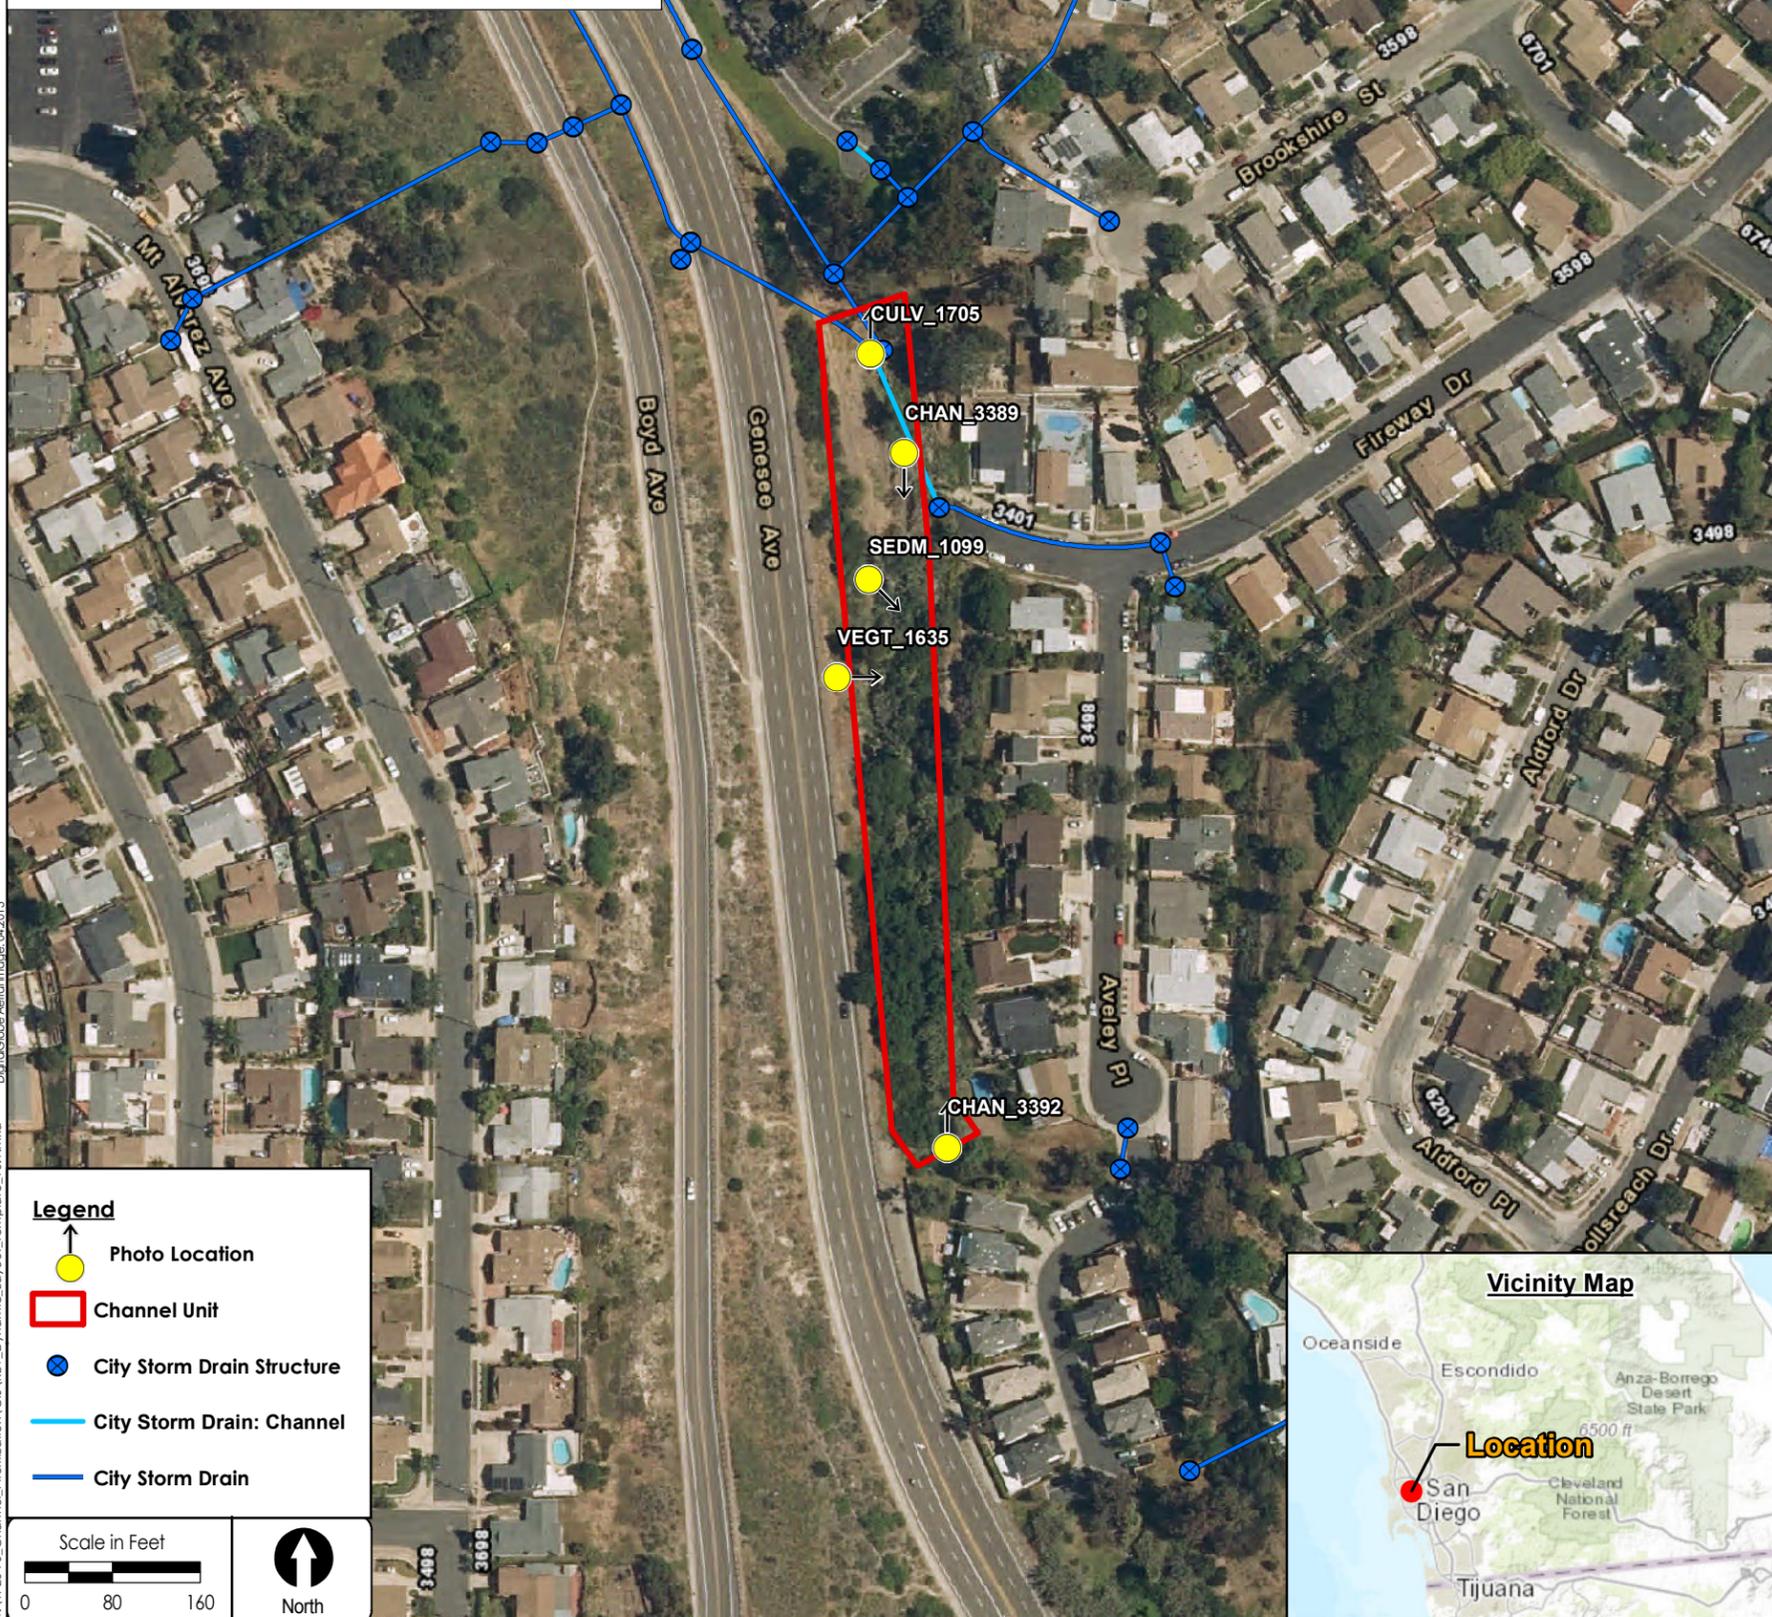
- Maintenance Priority: **HIGH**
- Channel Prioritization Score: **88.8 out of 100**
- Capacity Prior to Maintenance: **less than 2-year storm event**
- Capacity After Maintenance (As-built Capacity) : **25-year storm event**
- Clogging Potential: **MEDIUM**
- Approximate Invasive Vegetation Coverage: **HIGH**
- Approximate Native Vegetation Coverage: **LOW**
- Surrounding Area: **Residential**
- Infrastructure Failures: **NONE**
- Site Evaluation Date: **May 15, 2016**
- Notes/Comments: **Channel has dense arundo growing near downstream culvert. Arundo and channel are right next to residential houses and fencing.**

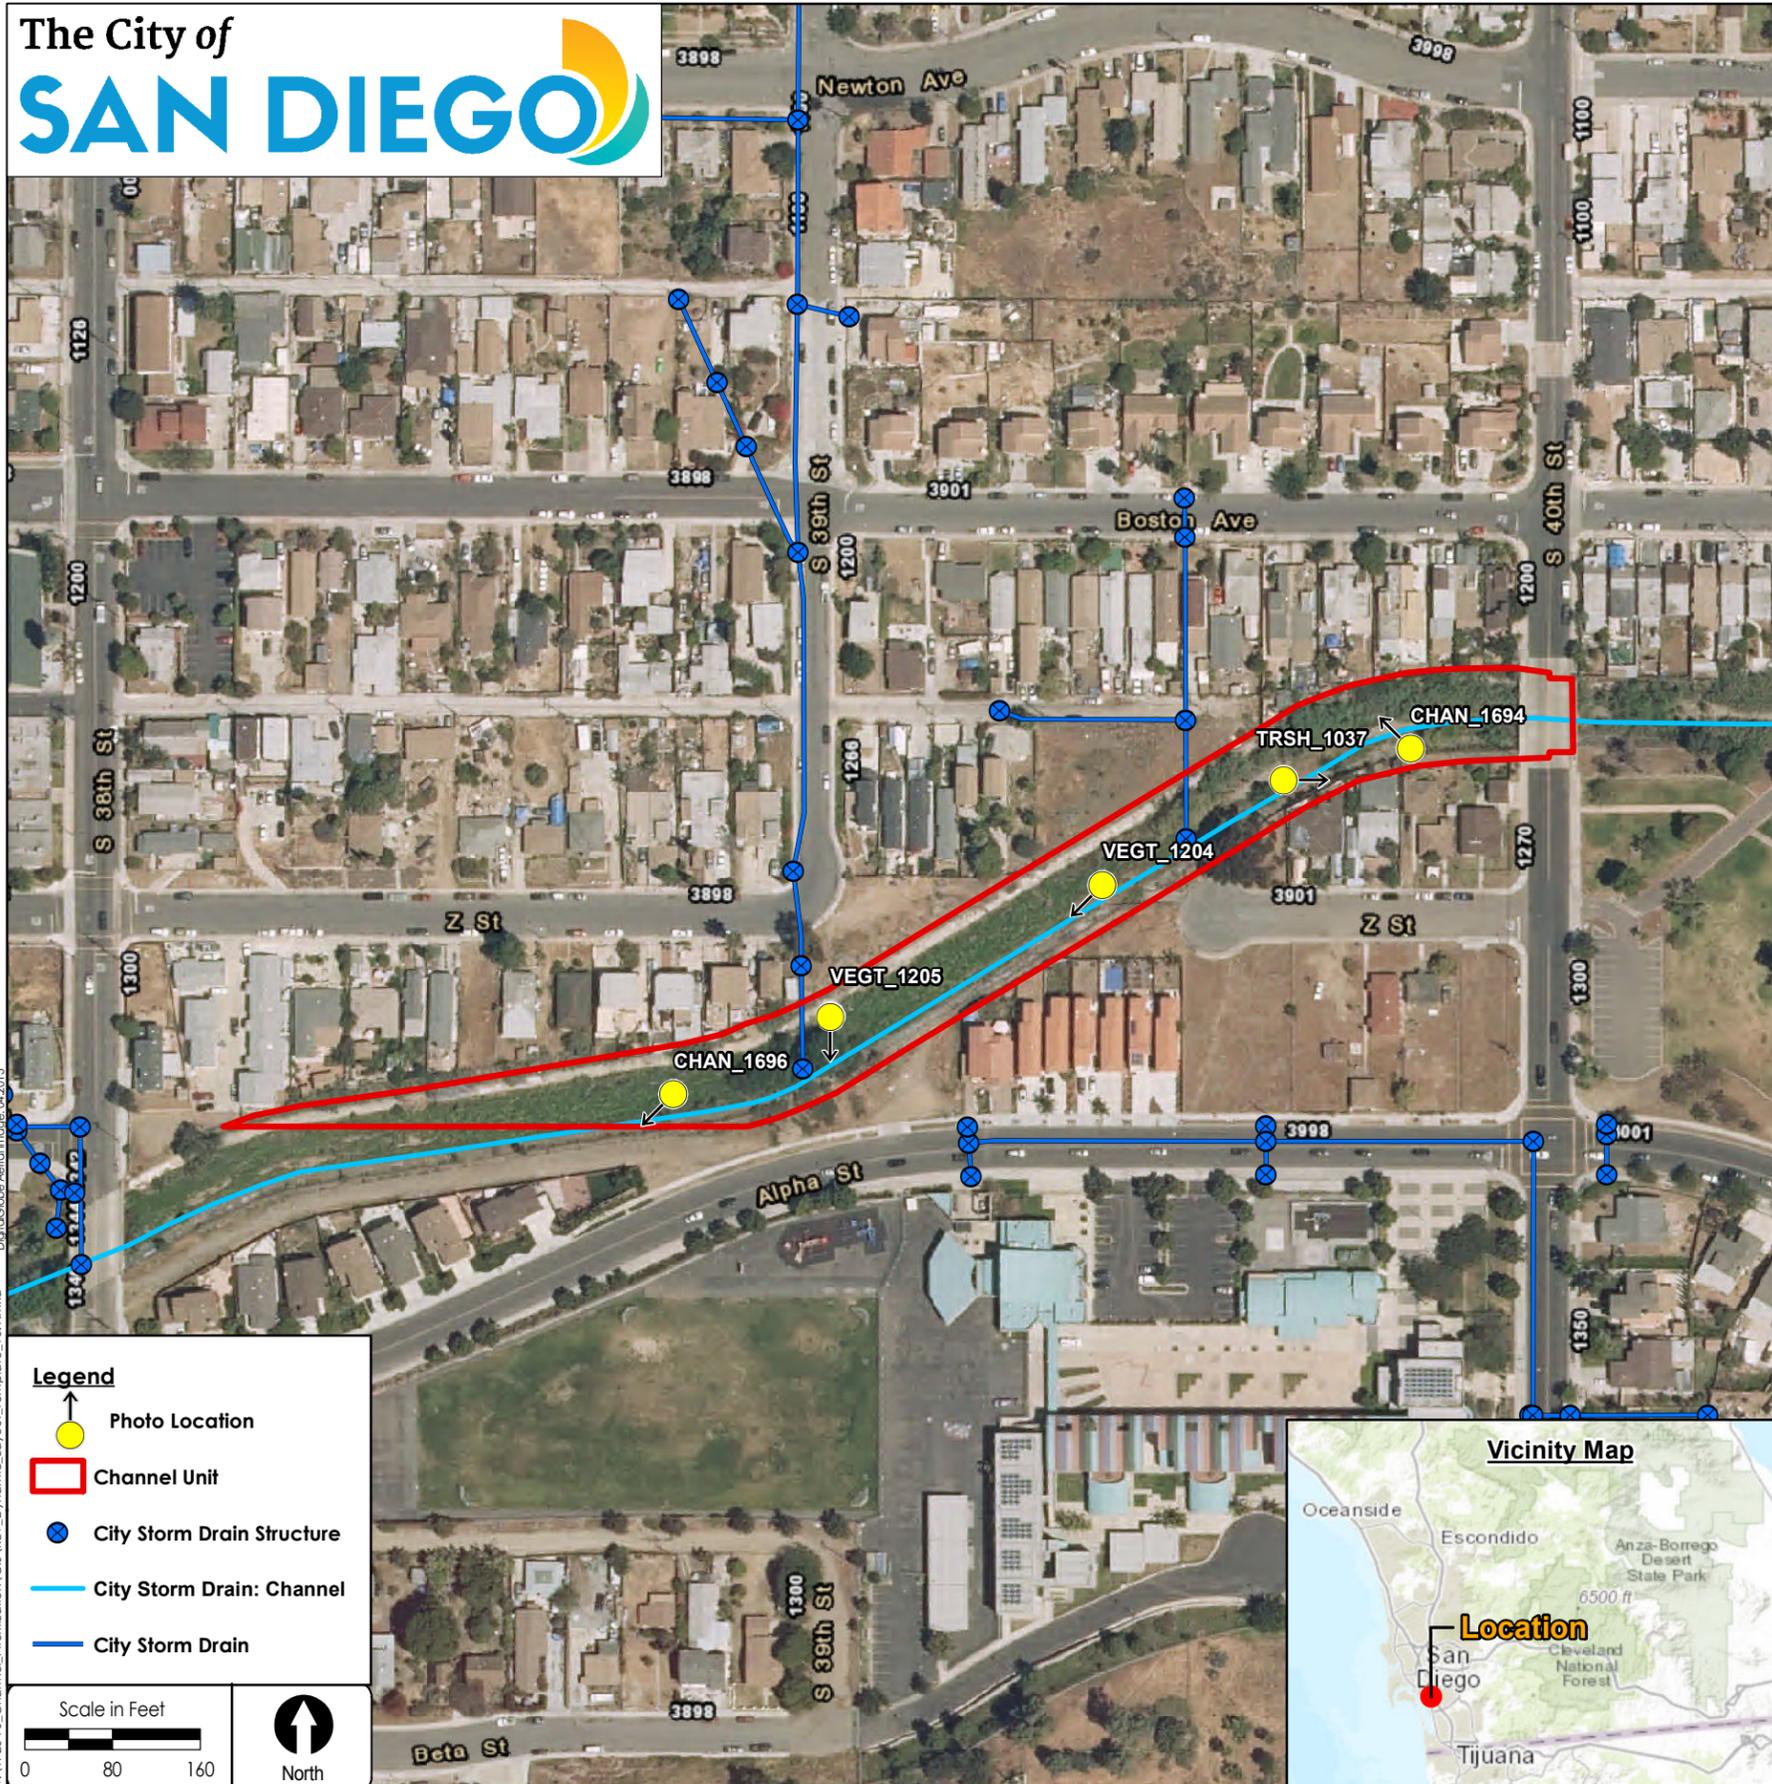
- Maintenance Priority: **HIGH**
- Channel Prioritization Score: **88.0 out of 100**
- Capacity Prior to Maintenance: **5-year storm event**
- Capacity After Maintenance (As-built Capacity): **100-year storm event**
- Clogging Potential: **MEDIUM**
- Approximate Invasive Vegetation Coverage: **LOW**
- Approximate Native Vegetation Coverage: **HIGH**
- Surrounding Area: **Residential**
- Infrastructure Failures: **NONE**
- Site Evaluation Date: **April 14, 2016**
- Notes/Comments: **Channel has high density of vegetation and is in close proximity to residential housing.**

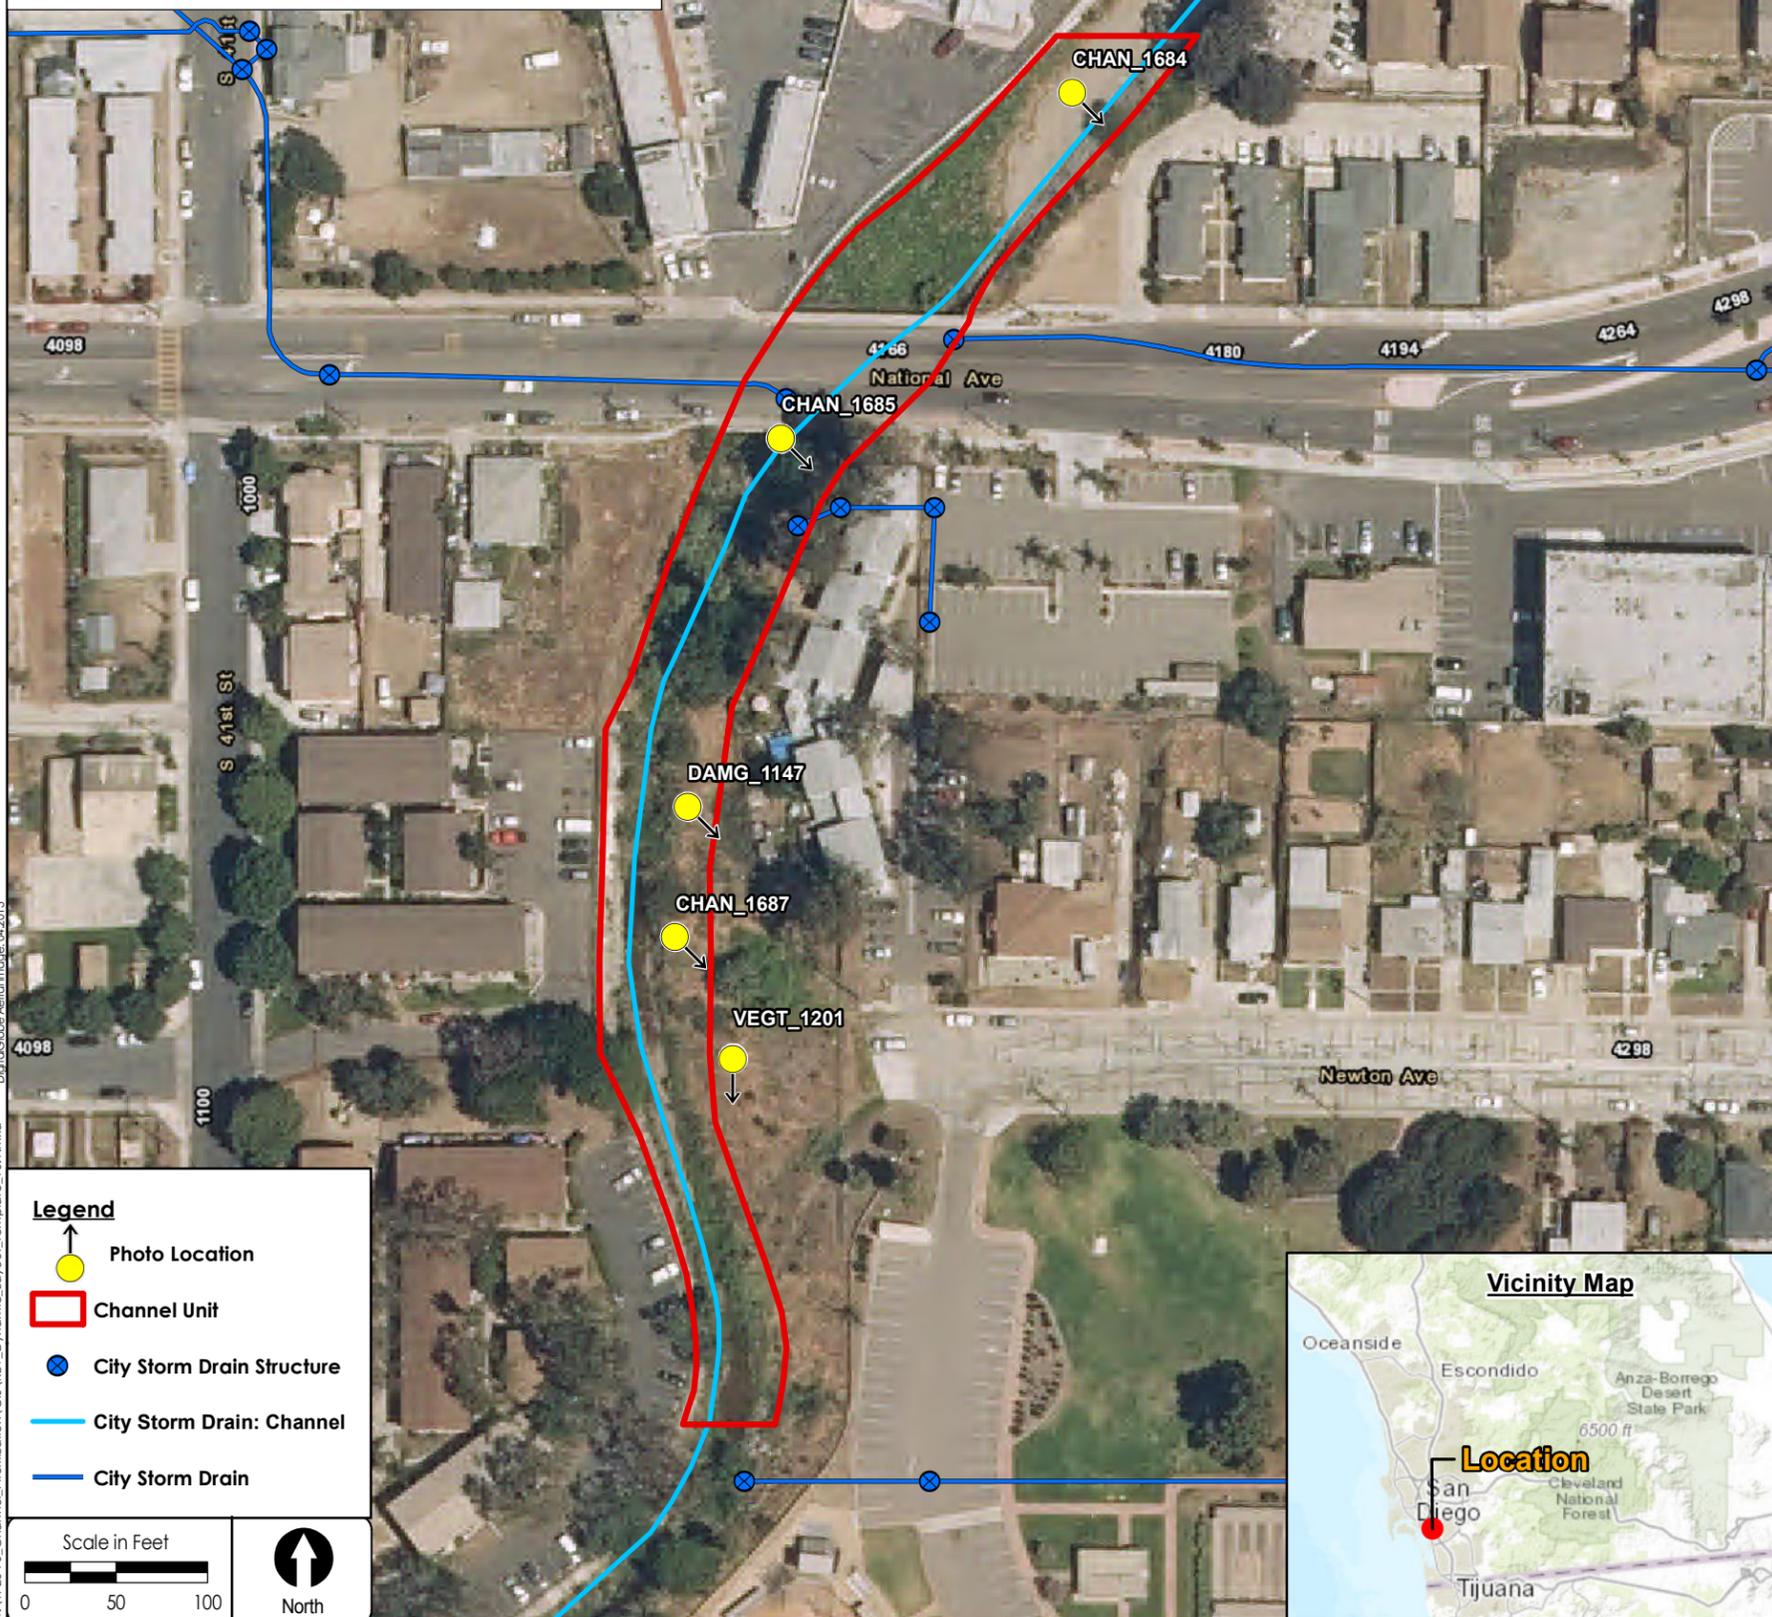
- Maintenance Priority: **HIGH**
- Channel Prioritization Score: **87.1 out of 100**
- Capacity Prior to Maintenance: **less than 2-year storm event**
- Capacity After Maintenance (As-built Capacity): **10-year storm event**
- Clogging Potential: **MEDIUM**
- Approximate Invasive Vegetation Coverage: **LOW**
- Approximate Native Vegetation Coverage: **HIGH**
- Surrounding Area: **Residential**
- Infrastructure Failures: **Broken Concrete**
- Site Evaluation Date: **April 13, 2016**
- Notes/Comments: **Channel has dense vegetation and sediment deposition. Portions of the concrete side slope have been broken/cracked.**

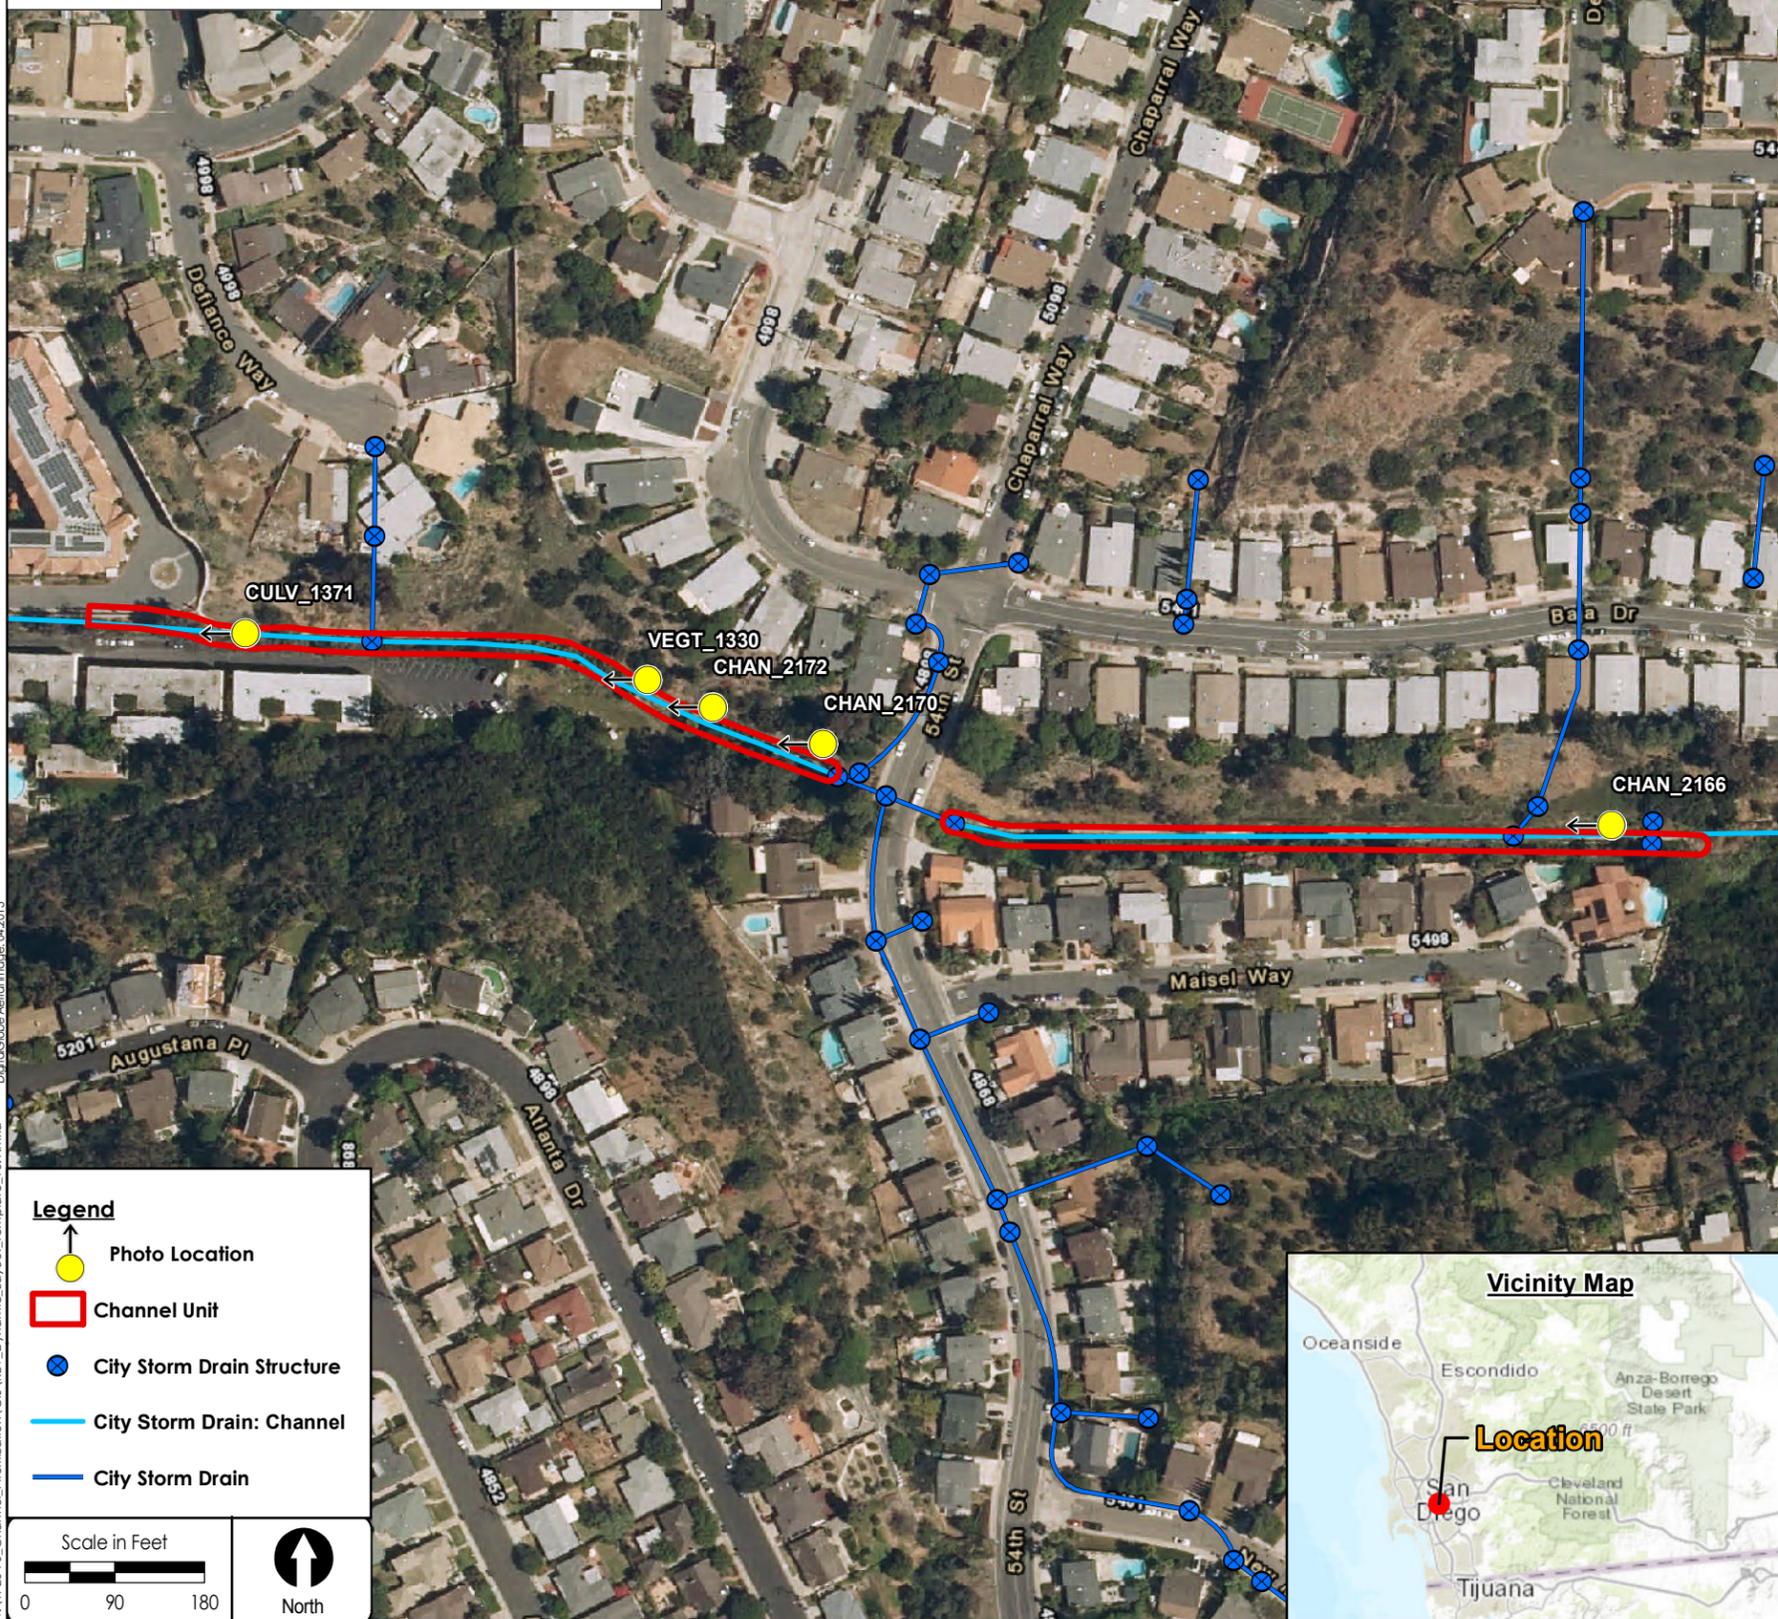
- Maintenance Priority: **HIGH**
- Channel Prioritization Score: **83.8 out of 100**
- Capacity Prior to Maintenance: **less than 2-year storm event**
- Capacity After Maintenance (As-built Capacity): **25-year storm event**
- Clogging Potential: **HIGH**
- Approximate Invasive Vegetation Coverage: **MEDIUM**
- Approximate Native Vegetation Coverage: **MEDIUM**
- Surrounding Area: **Residential**
- Infrastructure Failures: **Broken concrete**
- Site Evaluation Date: **April 23, 2016**
- Notes/Comments: **Large Palm trees have fallen down within the channel. Downstream culvert is small and susceptible to clogging. Channel has portions of broken/damaged concrete throughout the reach.**

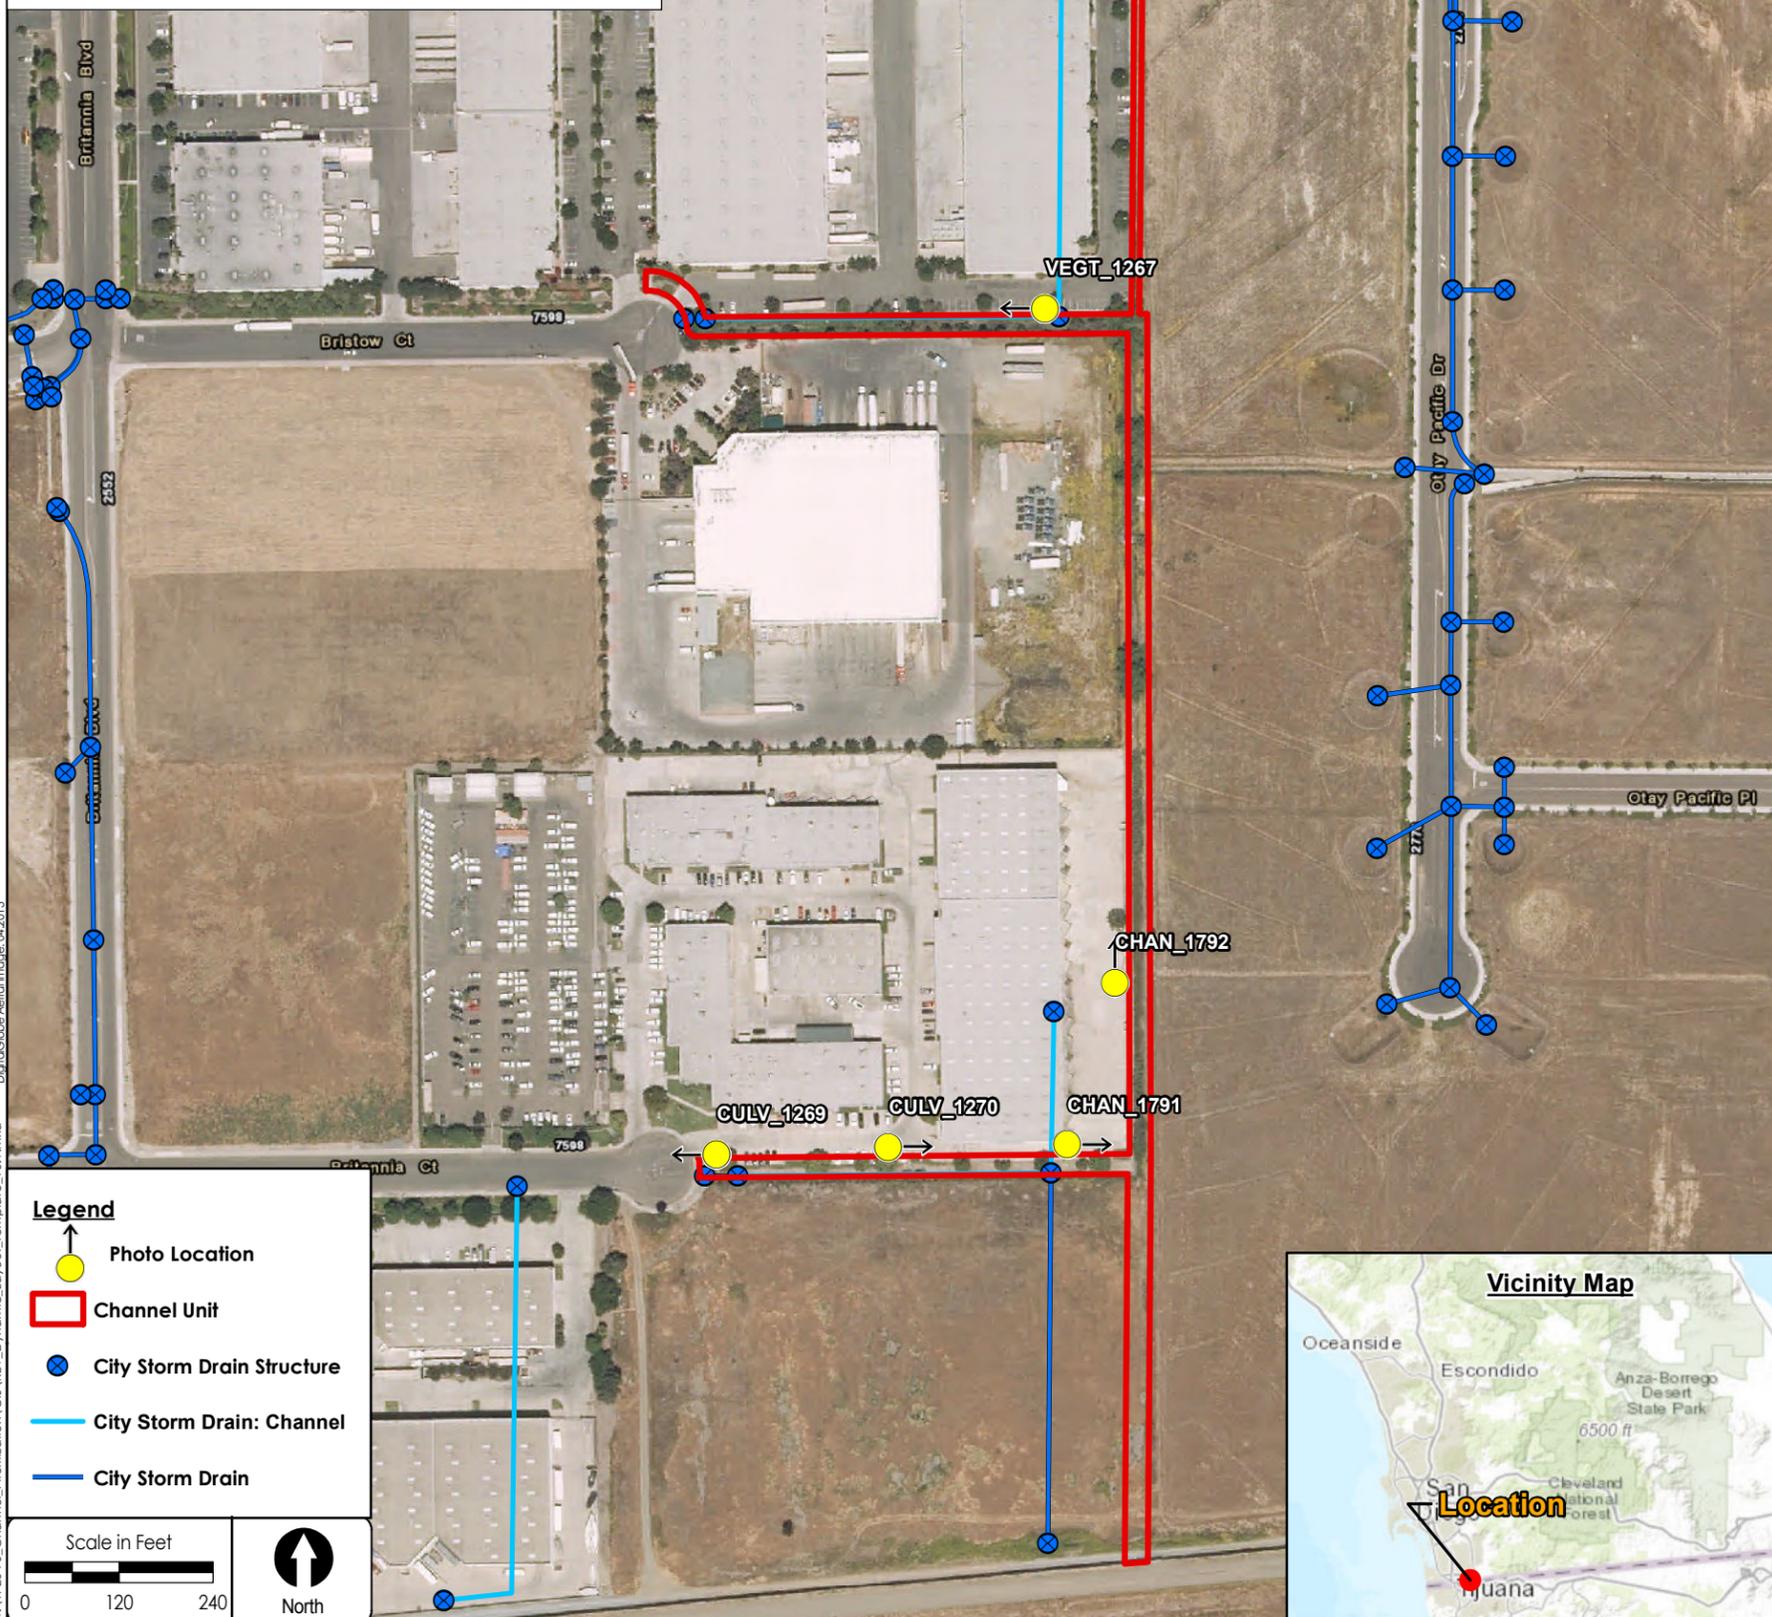
- Maintenance Priority: **HIGH**
- Channel Prioritization Score: **82.8 out of 100**
- Capacity Prior to Maintenance: **less than 2-year storm event**
- Capacity After Maintenance (As-built Capacity): **100-year storm event**
- Clogging Potential: **MEDIUM**
- Approximate Invasive Vegetation Coverage: **LOW**
- Approximate Native Vegetation Coverage: **HIGH**
- Surrounding Area: **Commercial**
- Infrastructure Failures: **Curb Inlet Damage**
- Site Evaluation Date: **April 18, 2016**
- Notes/Comments: **Channel has dense vegetation and sediment deposition. Channel is in close proximity to commercial buildings.**

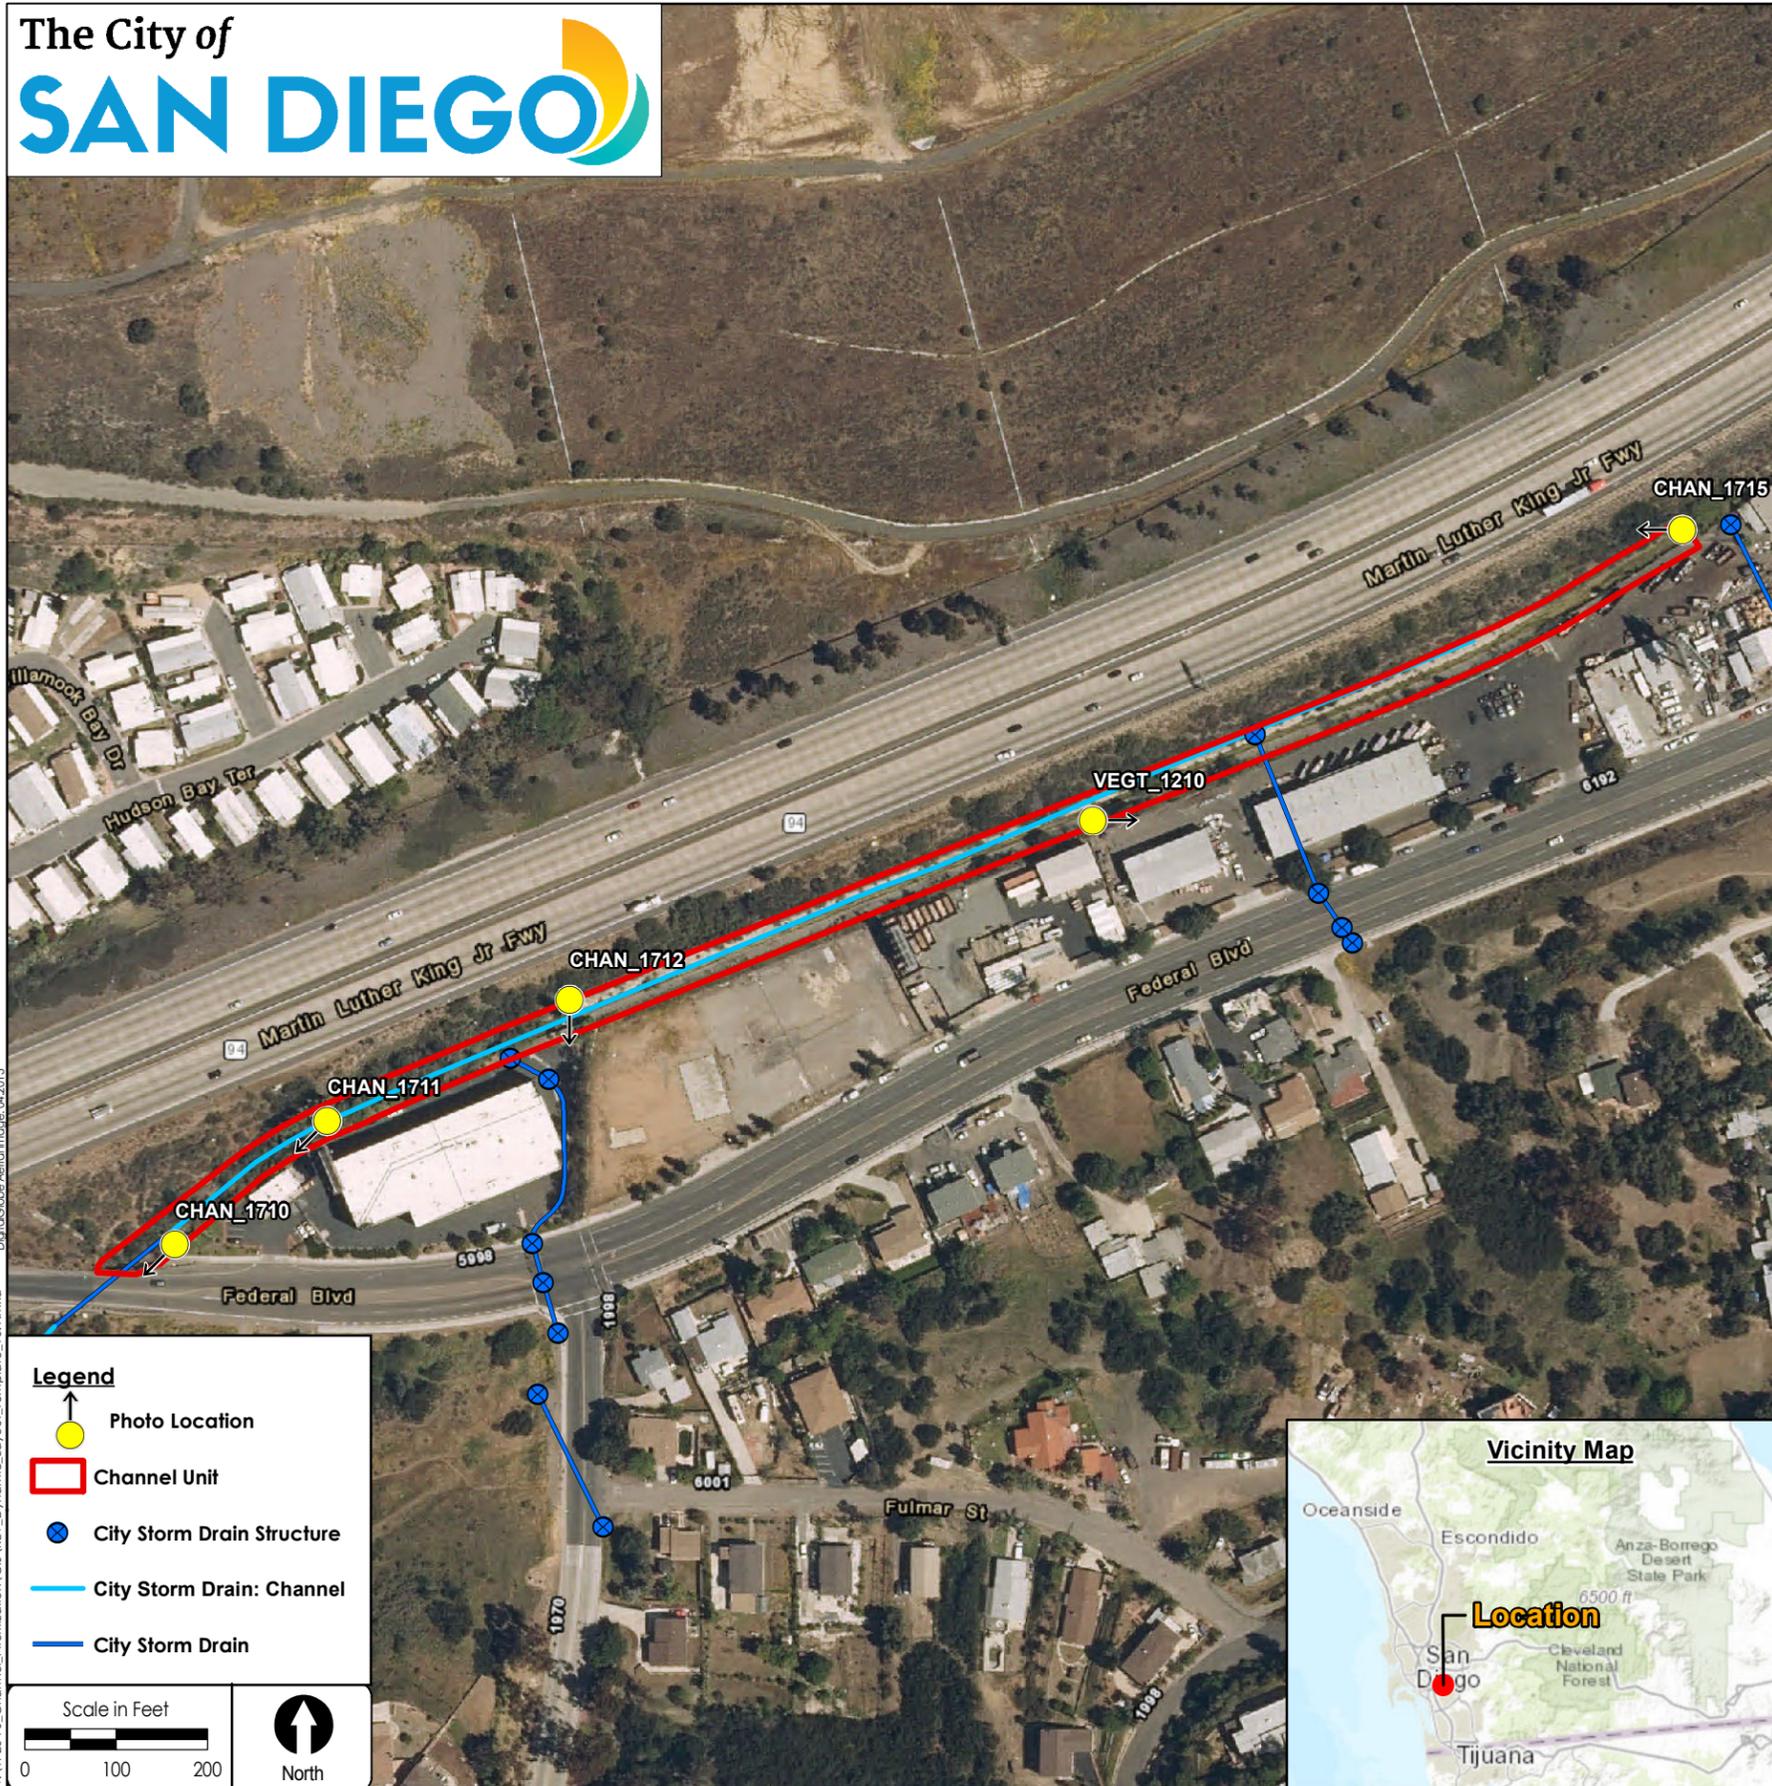
- Maintenance Priority: **HIGH**
- Channel Prioritization Score: **82.0 out of 100**
- Capacity Prior to Maintenance: **2-year storm event**
- Capacity After Maintenance (As-built Capacity): **10-year storm event**
- Clogging Potential: **MEDIUM**
- Approximate Invasive Vegetation Coverage: **HIGH**
- Approximate Native Vegetation Coverage: **LOW**
- Surrounding Area: **Commercial**
- Infrastructure Failures: **Slope failure**
- Site Evaluation Date: **April 15, 2016**
- Notes/Comments: **Potential side slope failure in earthen portion of channel.**
