**STORM WATER CHANNEL  
MAINTENANCE PROGRAM PRIORITIZATION**  
September 13, 2016

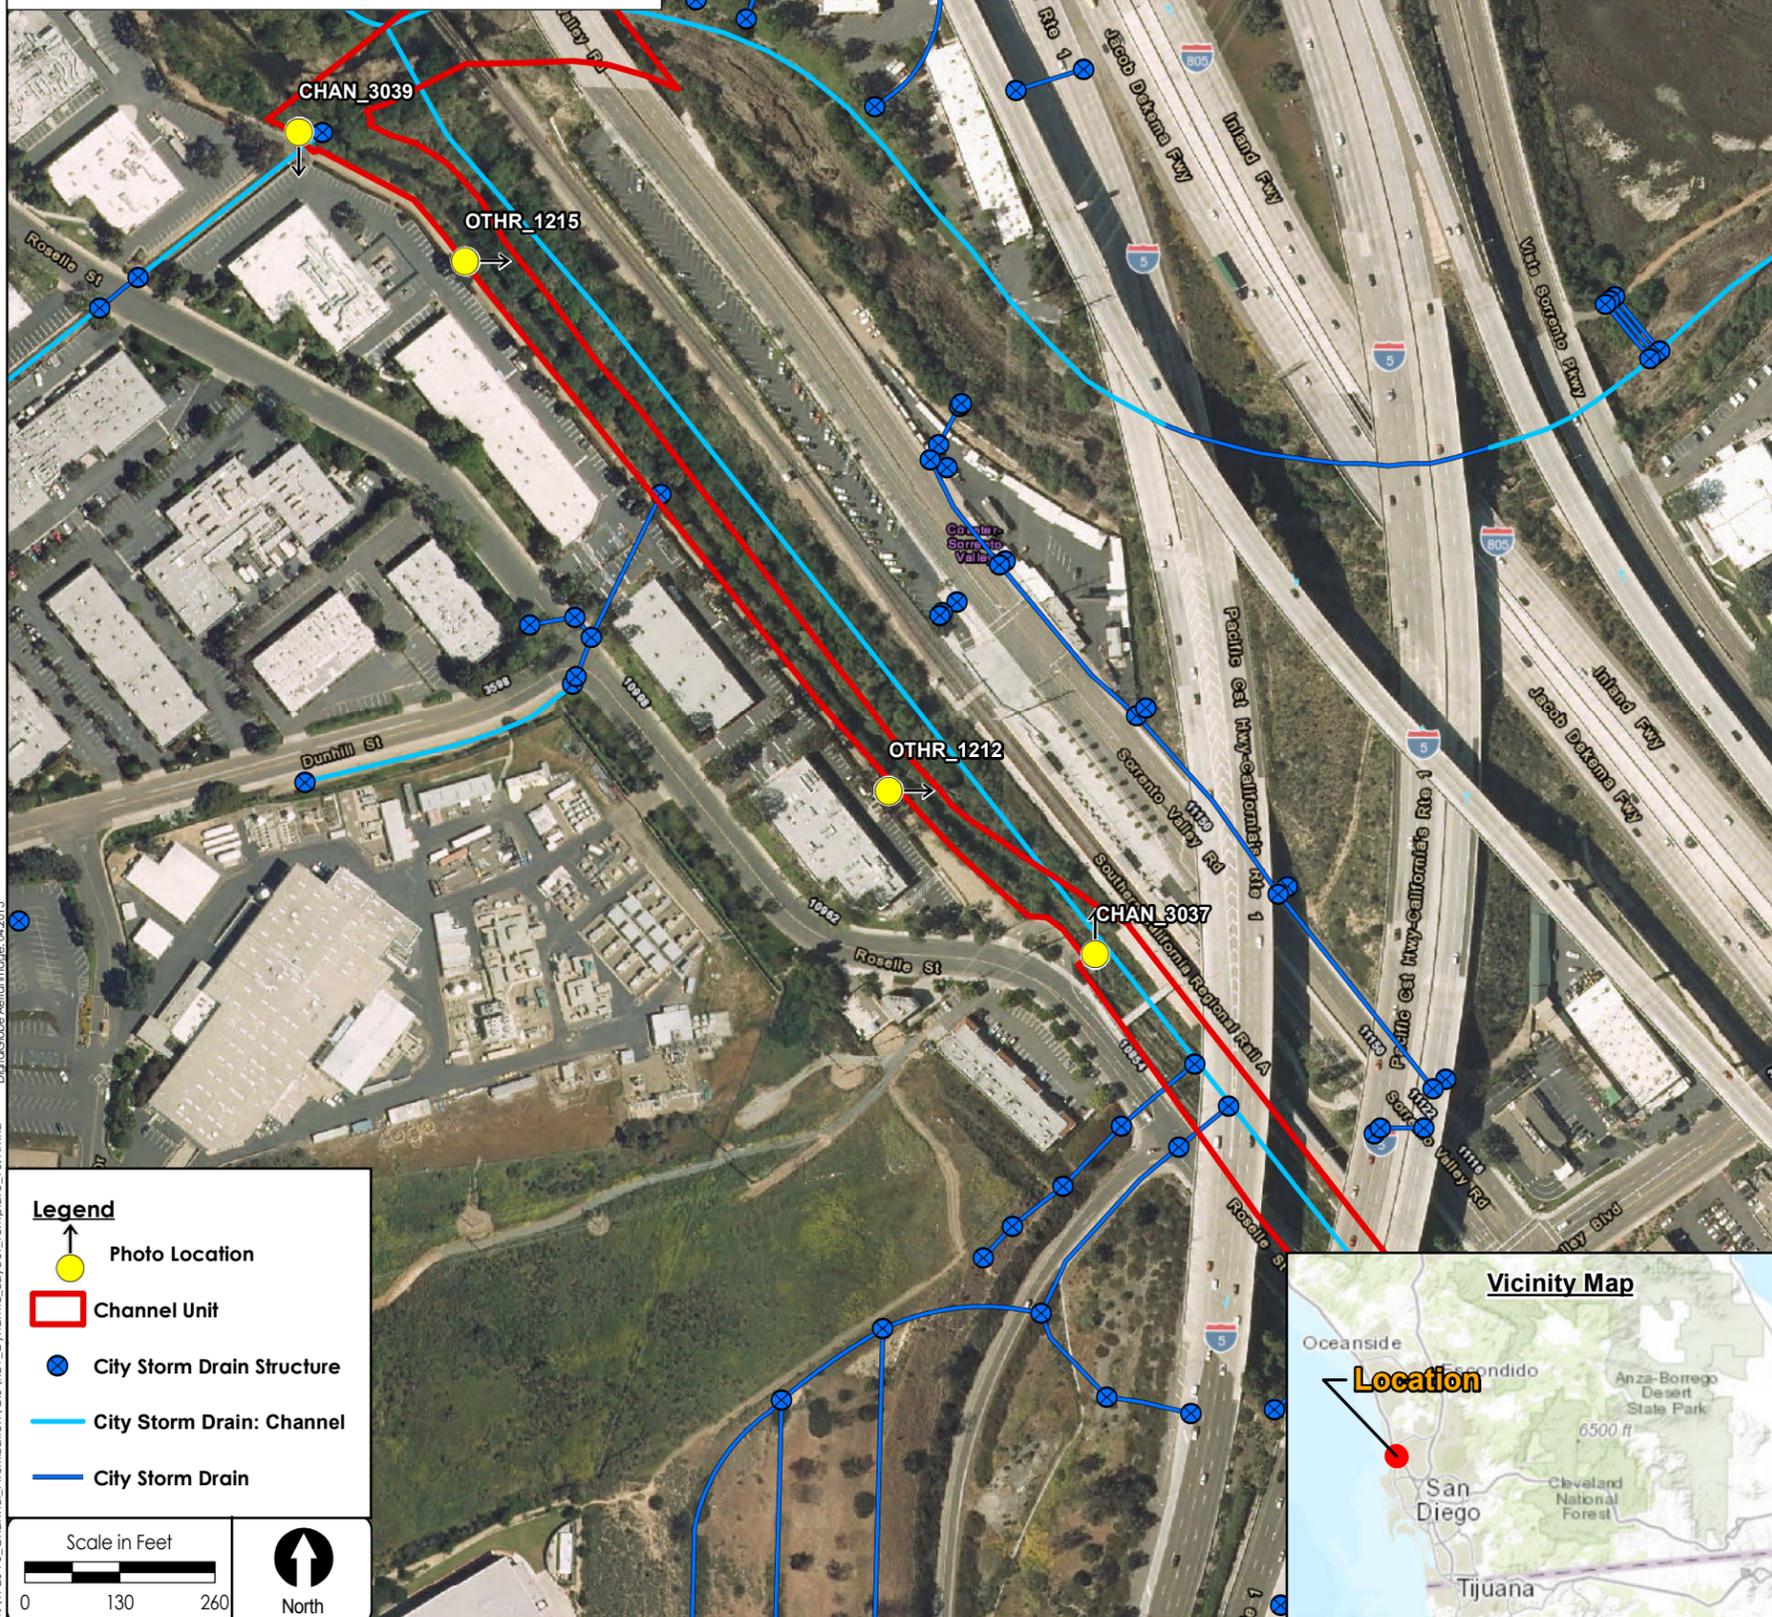
- Maintenance Priority: **MEDIUM**
- Channel Prioritization Score: **81.8 out of 100**
- Capacity Prior to Maintenance: **2-year storm event**
- Capacity After Maintenance (As-built Capacity): **5-year storm event**
- Clogging Potential: **MEDIUM**
- Approximate Invasive Vegetation Coverage: **LOW**
- Approximate Native Vegetation Coverage: **HIGH**
- Surrounding Area: **Commercial**
- Infrastructure Failures: **NONE**
- Site Evaluation Date: **April 26, 2016**
- Notes/Comments: **Downstream portion of channel has large deposits of sediment and vegetation causing ponding upstream.**

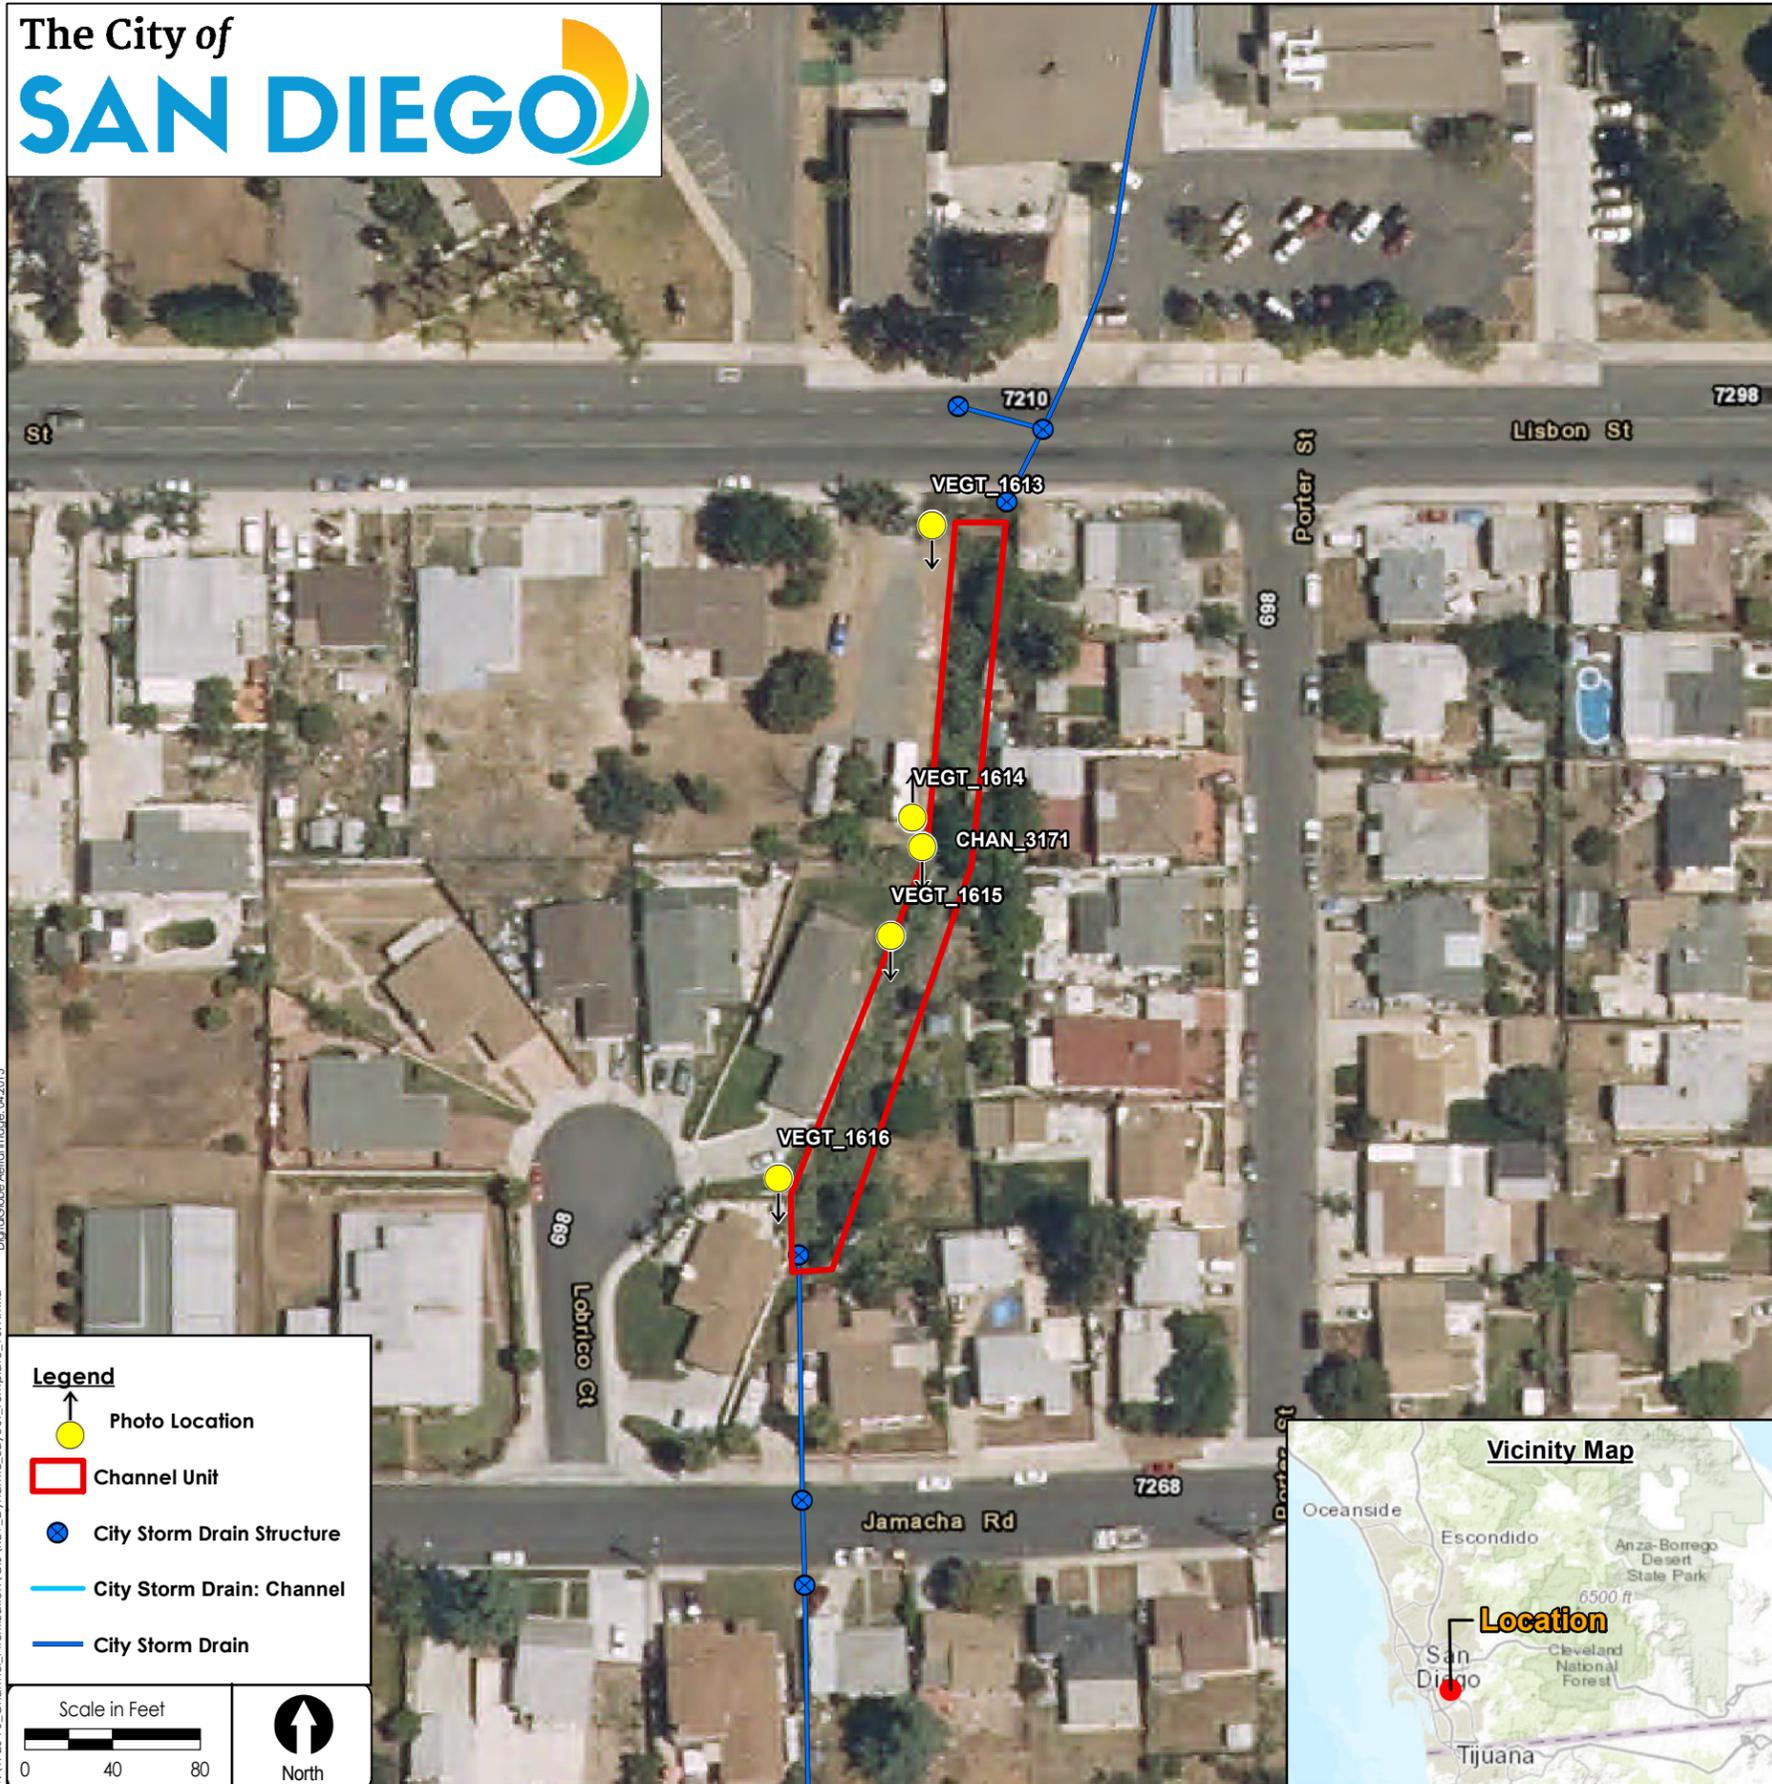
- Maintenance Priority: **HIGH**
- Channel Prioritization Score: **80.6 out of 100**
- Capacity Prior to Maintenance: **less than 2-year storm event**
- Capacity After Maintenance (As-built Capacity): **50-year storm event**
- Clogging Potential: **MEDIUM**
- Approximate Invasive Vegetation Coverage: **HIGH**
- Approximate Native Vegetation Coverage: **LOW**
- Surrounding Area: **Residential**
- Infrastructure Failures: **NONE**
- Site Evaluation Date: **May 11, 2016**
- Notes/Comments: **Channel is adjacent to residential houses. Channel inlet and outlet could not be found due to dense vegetation and sediment deposition.**

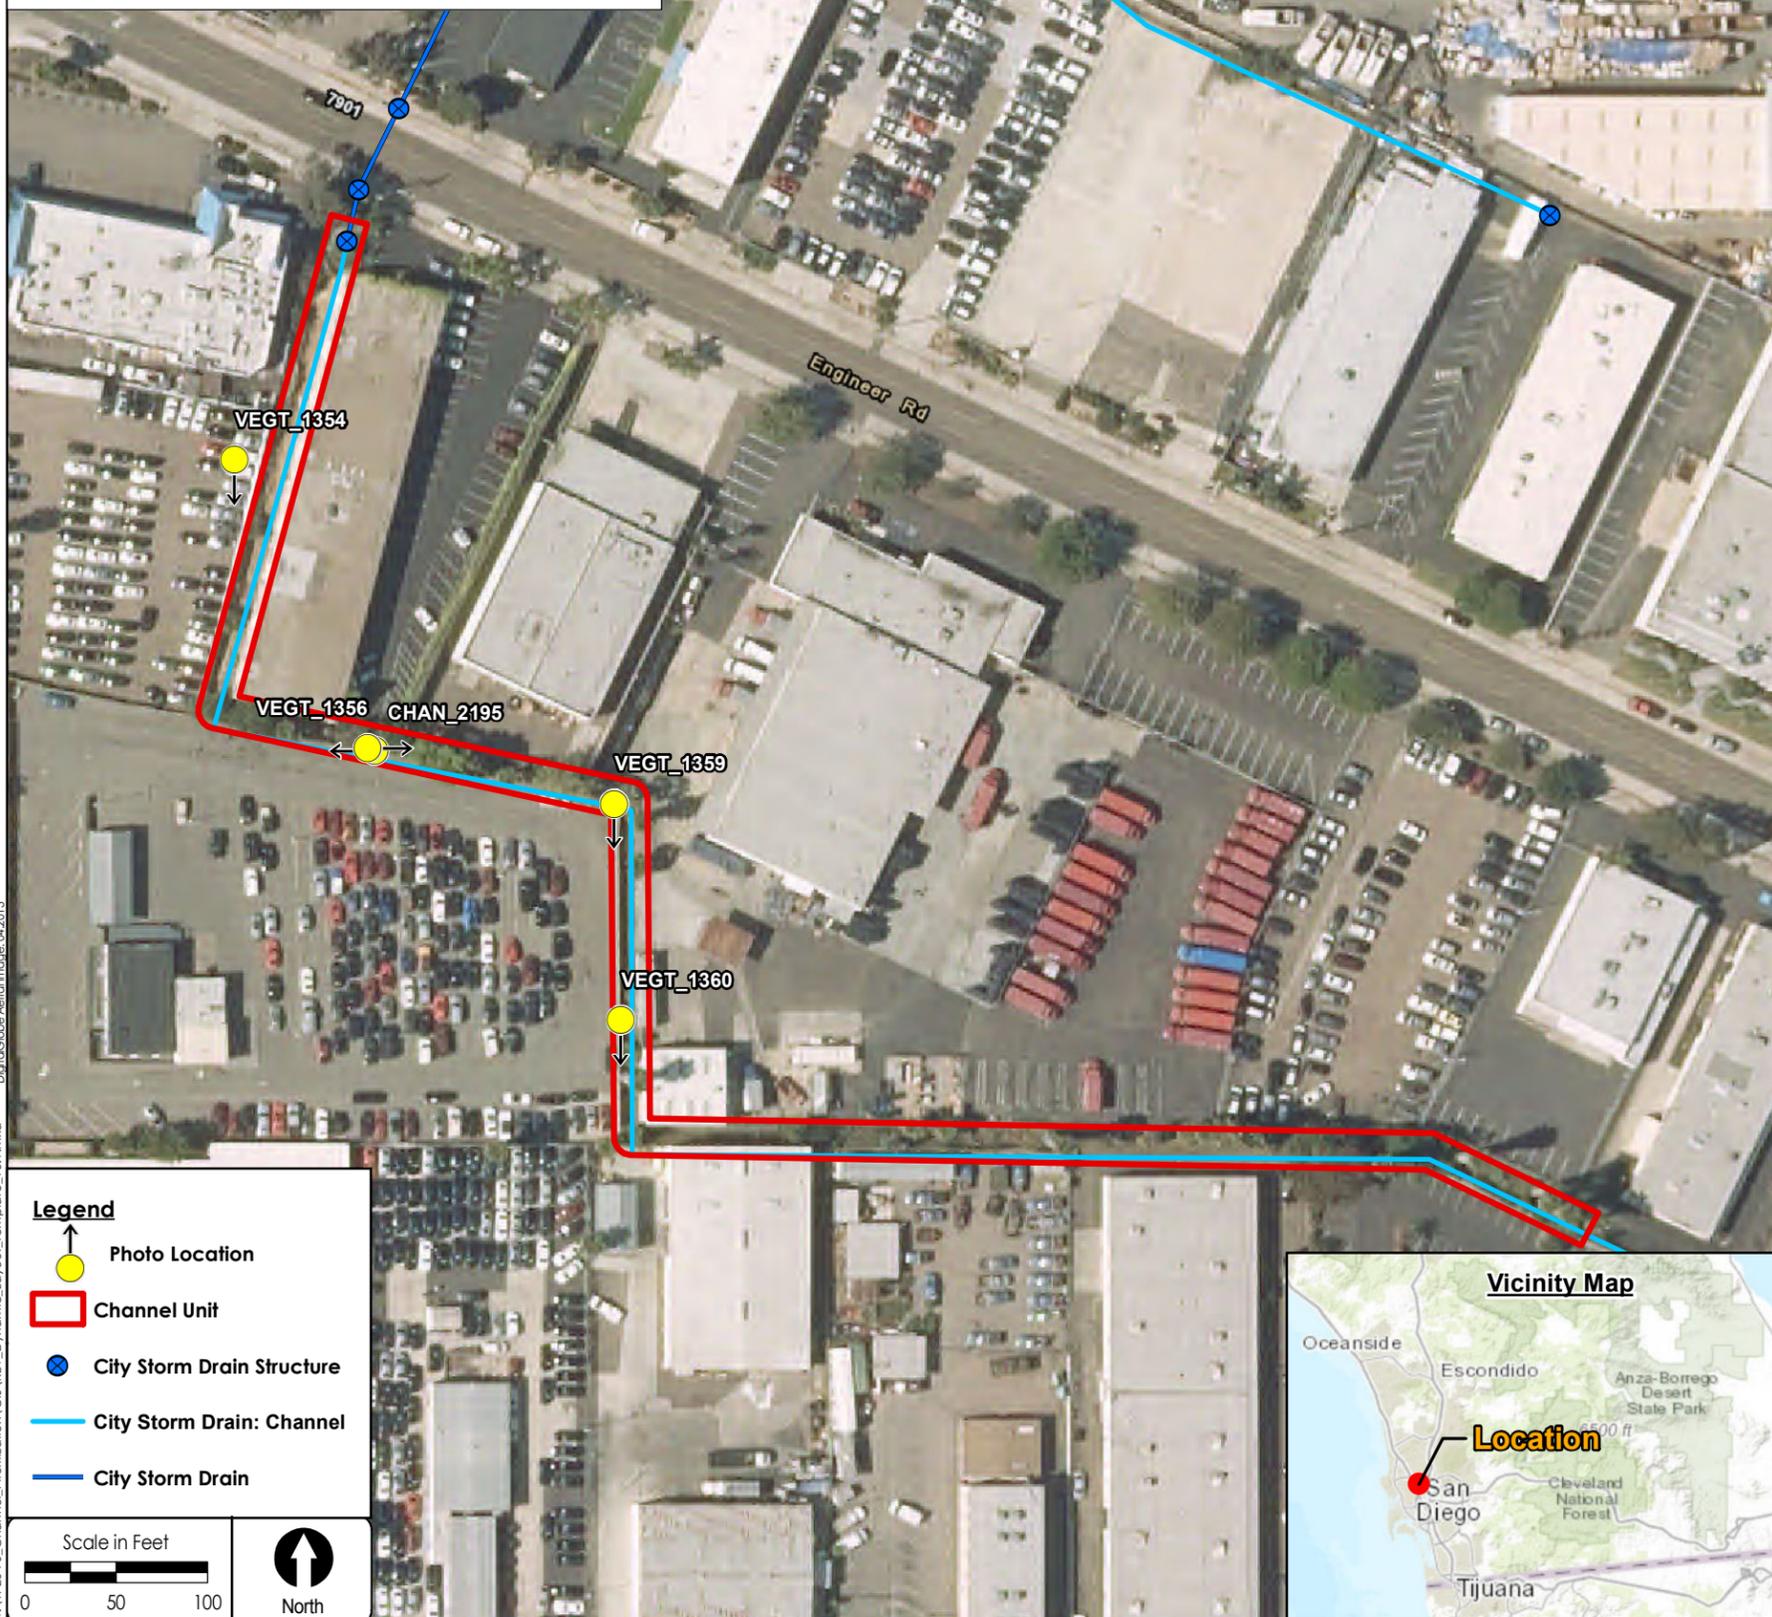
- Maintenance Priority: **MEDIUM**
- Channel Prioritization Score: **80.3 out of 100**
- Capacity Prior to Maintenance: **Less than 2-year storm event**
- Capacity After Maintenance (As-built Capacity): **2-year storm event**
- Clogging Potential: **HIGH**
- Approximate Invasive Vegetation Coverage: **MEDIUM**
- Approximate Native Vegetation Coverage: **MEDIUM**
- Surrounding Area: **Industrial**
- Infrastructure Failures: **Broken Concrete**
- Site Evaluation Date: **April 25, 2016**
- Notes/Comments: **Trash and debris in the channel. Channel has dense vegetation and sediment established within it.**

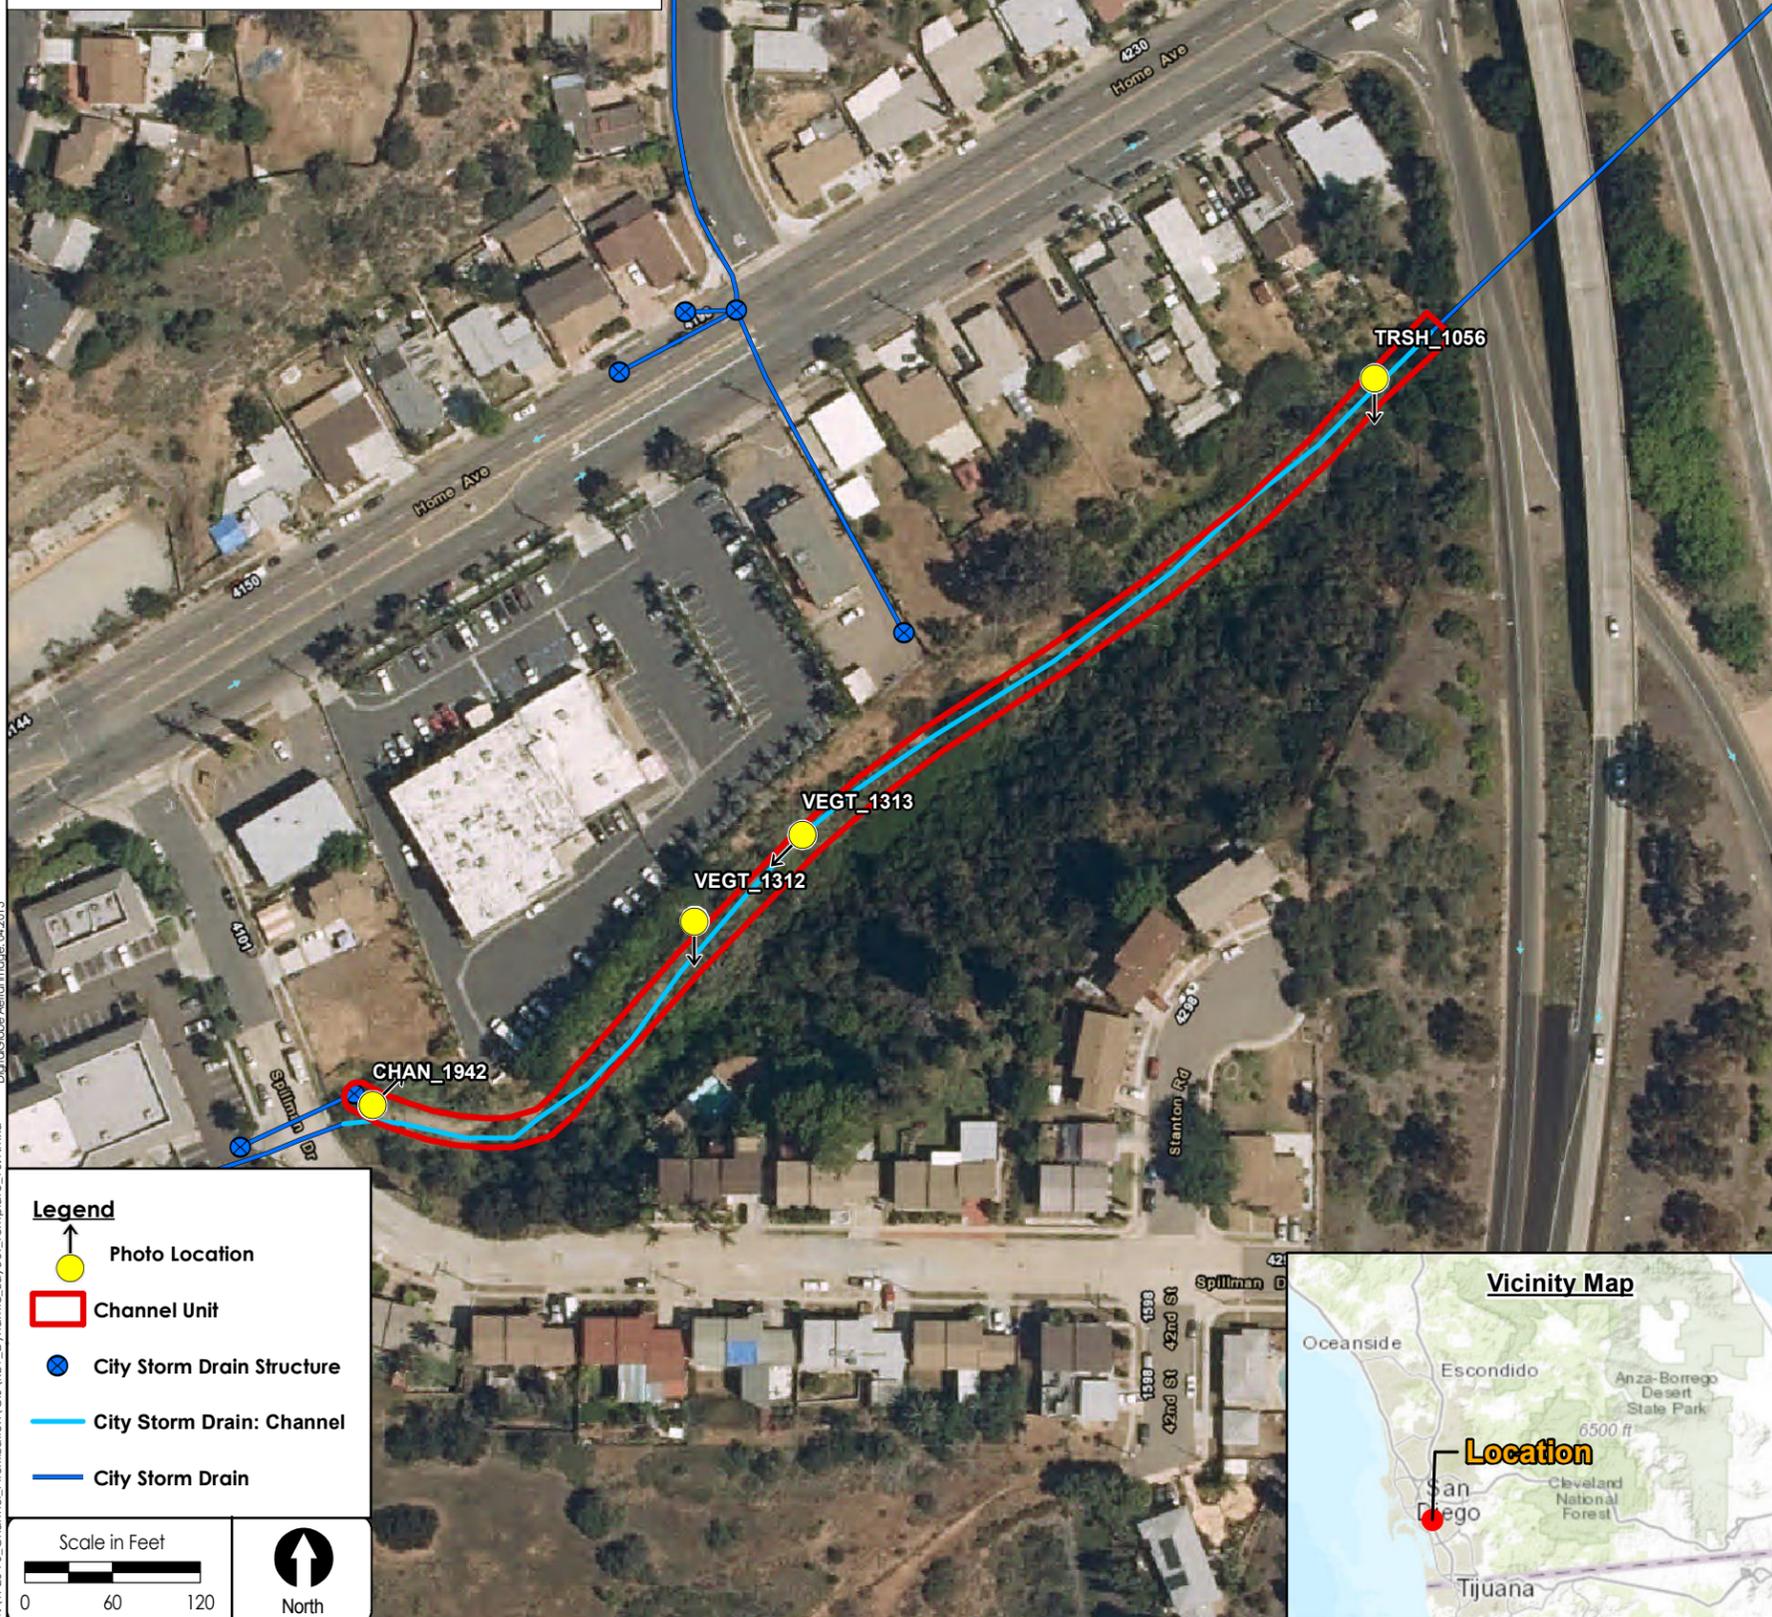
- Maintenance Priority: **MEDIUM**
- Channel Prioritization Score: **79.5 out of 100**
- Capacity Prior to Maintenance: **10-year storm event**
- Capacity After Maintenance (As-built Capacity): **100-year storm event**
- Clogging Potential: **HIGH**
- Approximate Invasive Vegetation Coverage: **MEDIUM**
- Approximate Native Vegetation Coverage: **MEDIUM**
- Surrounding Area: **Residential**
- Infrastructure Failures: **NONE**
- Site Evaluation Date: **April 21, 2016**
- Notes/Comments: **Channel has lots of vegetation and side slopes have built up sediment. The channel has a potential to flood but commercial developments are approximately 10 feet above channel side slope.**

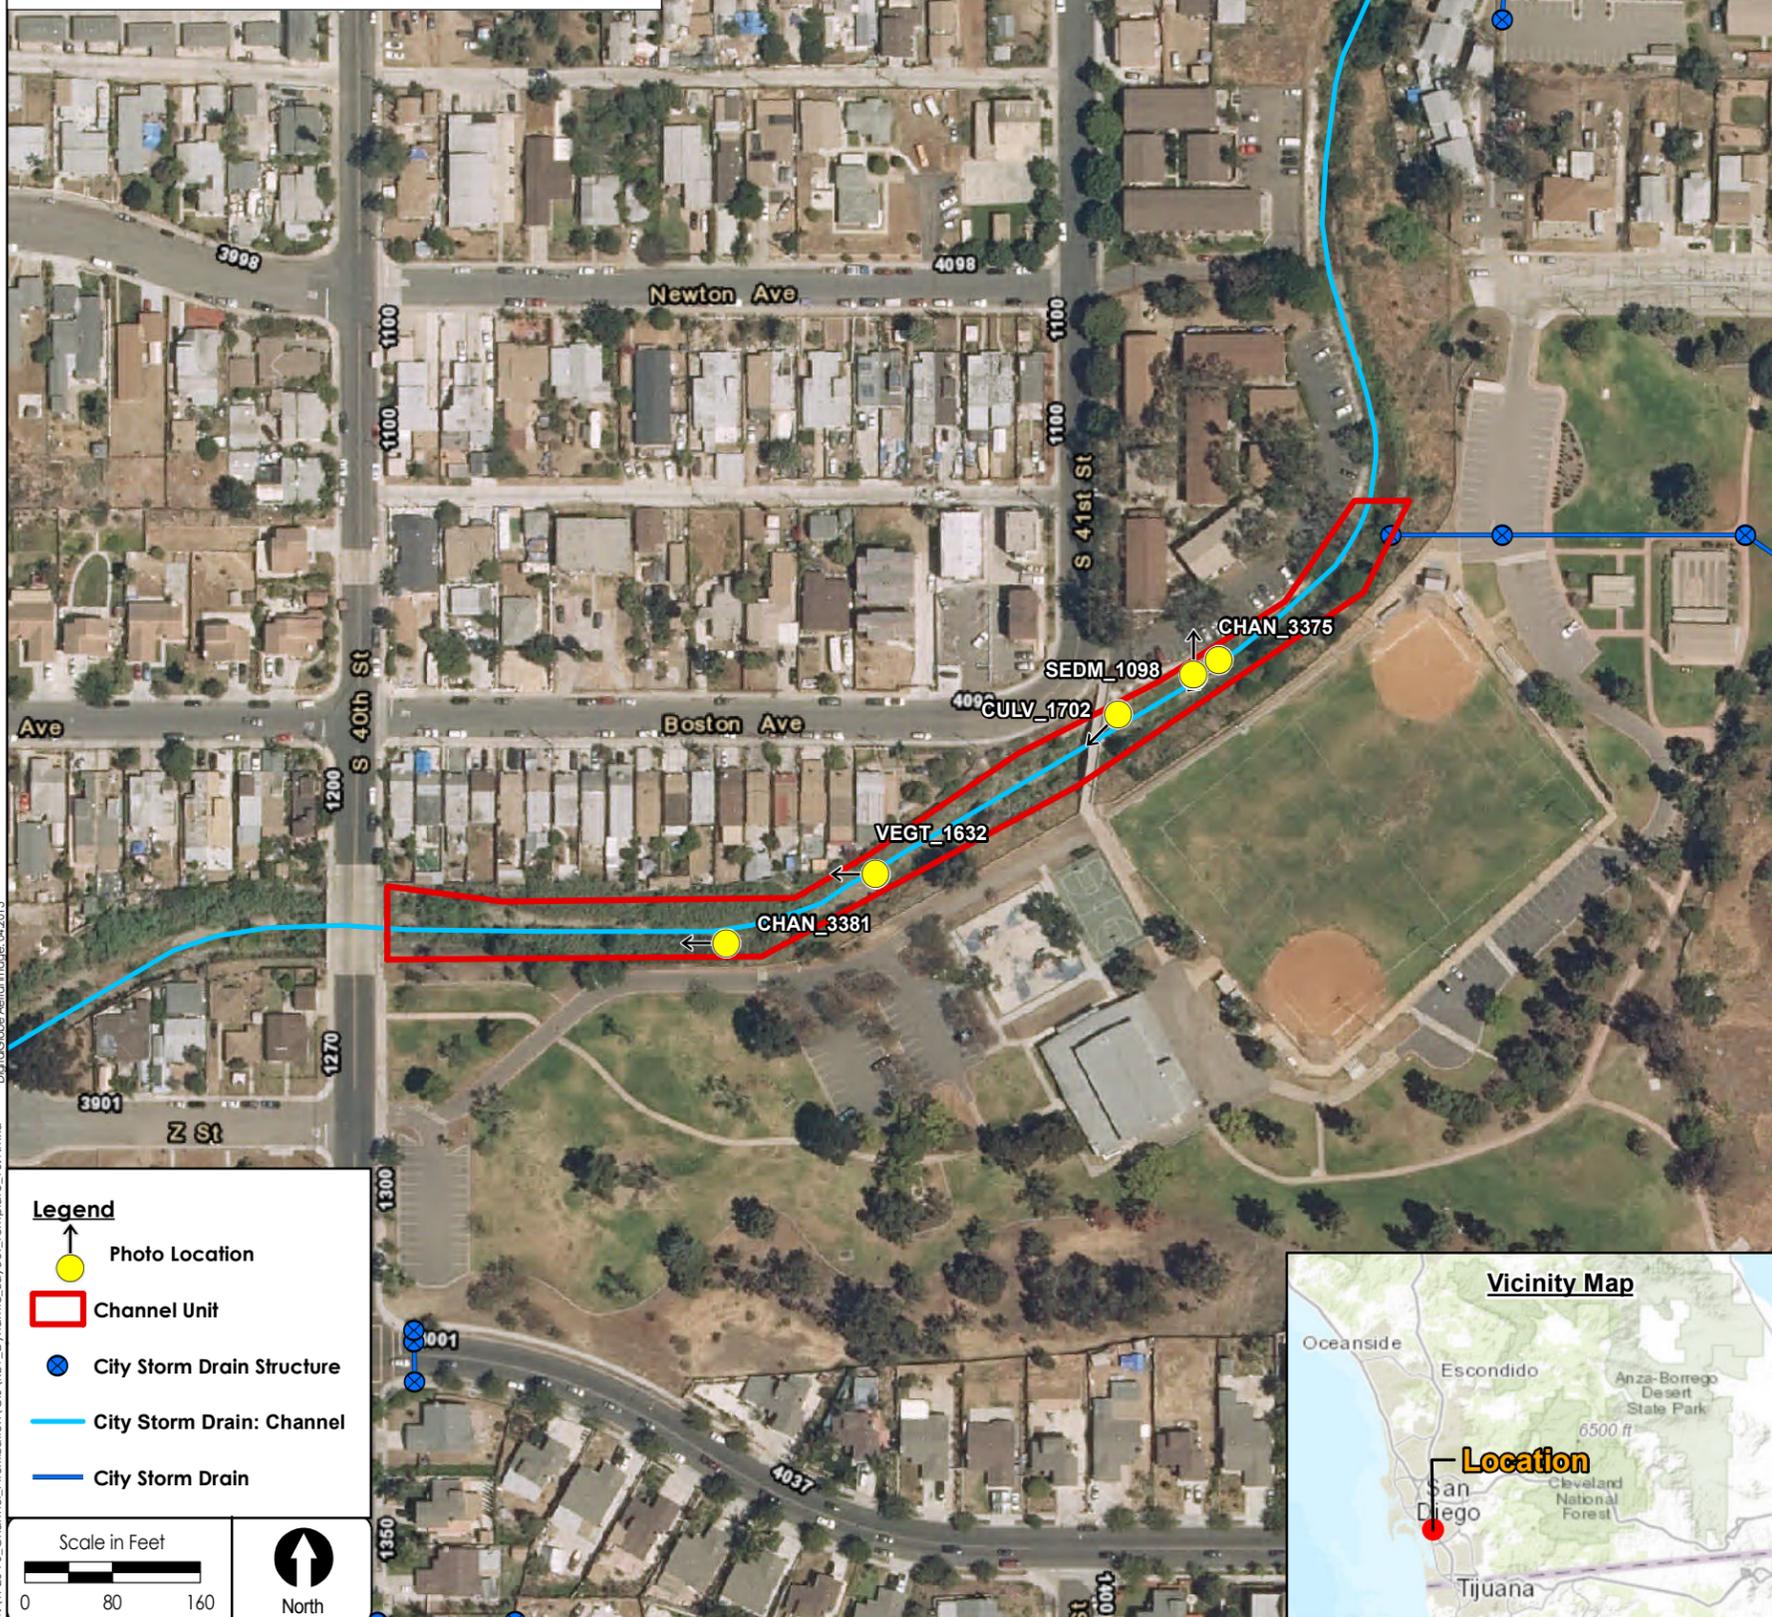
- Maintenance Priority: **MEDIUM**
- Channel Prioritization Score: **78.6 out of 100**
- Capacity Prior to Maintenance: **less than 2-year storm event**
- Capacity After Maintenance (As-built Capacity): **5-year storm event**
- Clogging Potential: **MEDIUM**
- Approximate Invasive Vegetation Coverage: **HIGH**
- Approximate Native Vegetation Coverage: **LOW**
- Surrounding Area: **Residential**
- Infrastructure Failures: **NONE**
- Site Evaluation Date: **June 2, 2016**
- Notes/Comments: **Channel has dense vegetation and sediment deposited within the channel. Channel has invasive vegetation (palm trees and arundo) growing in it.**

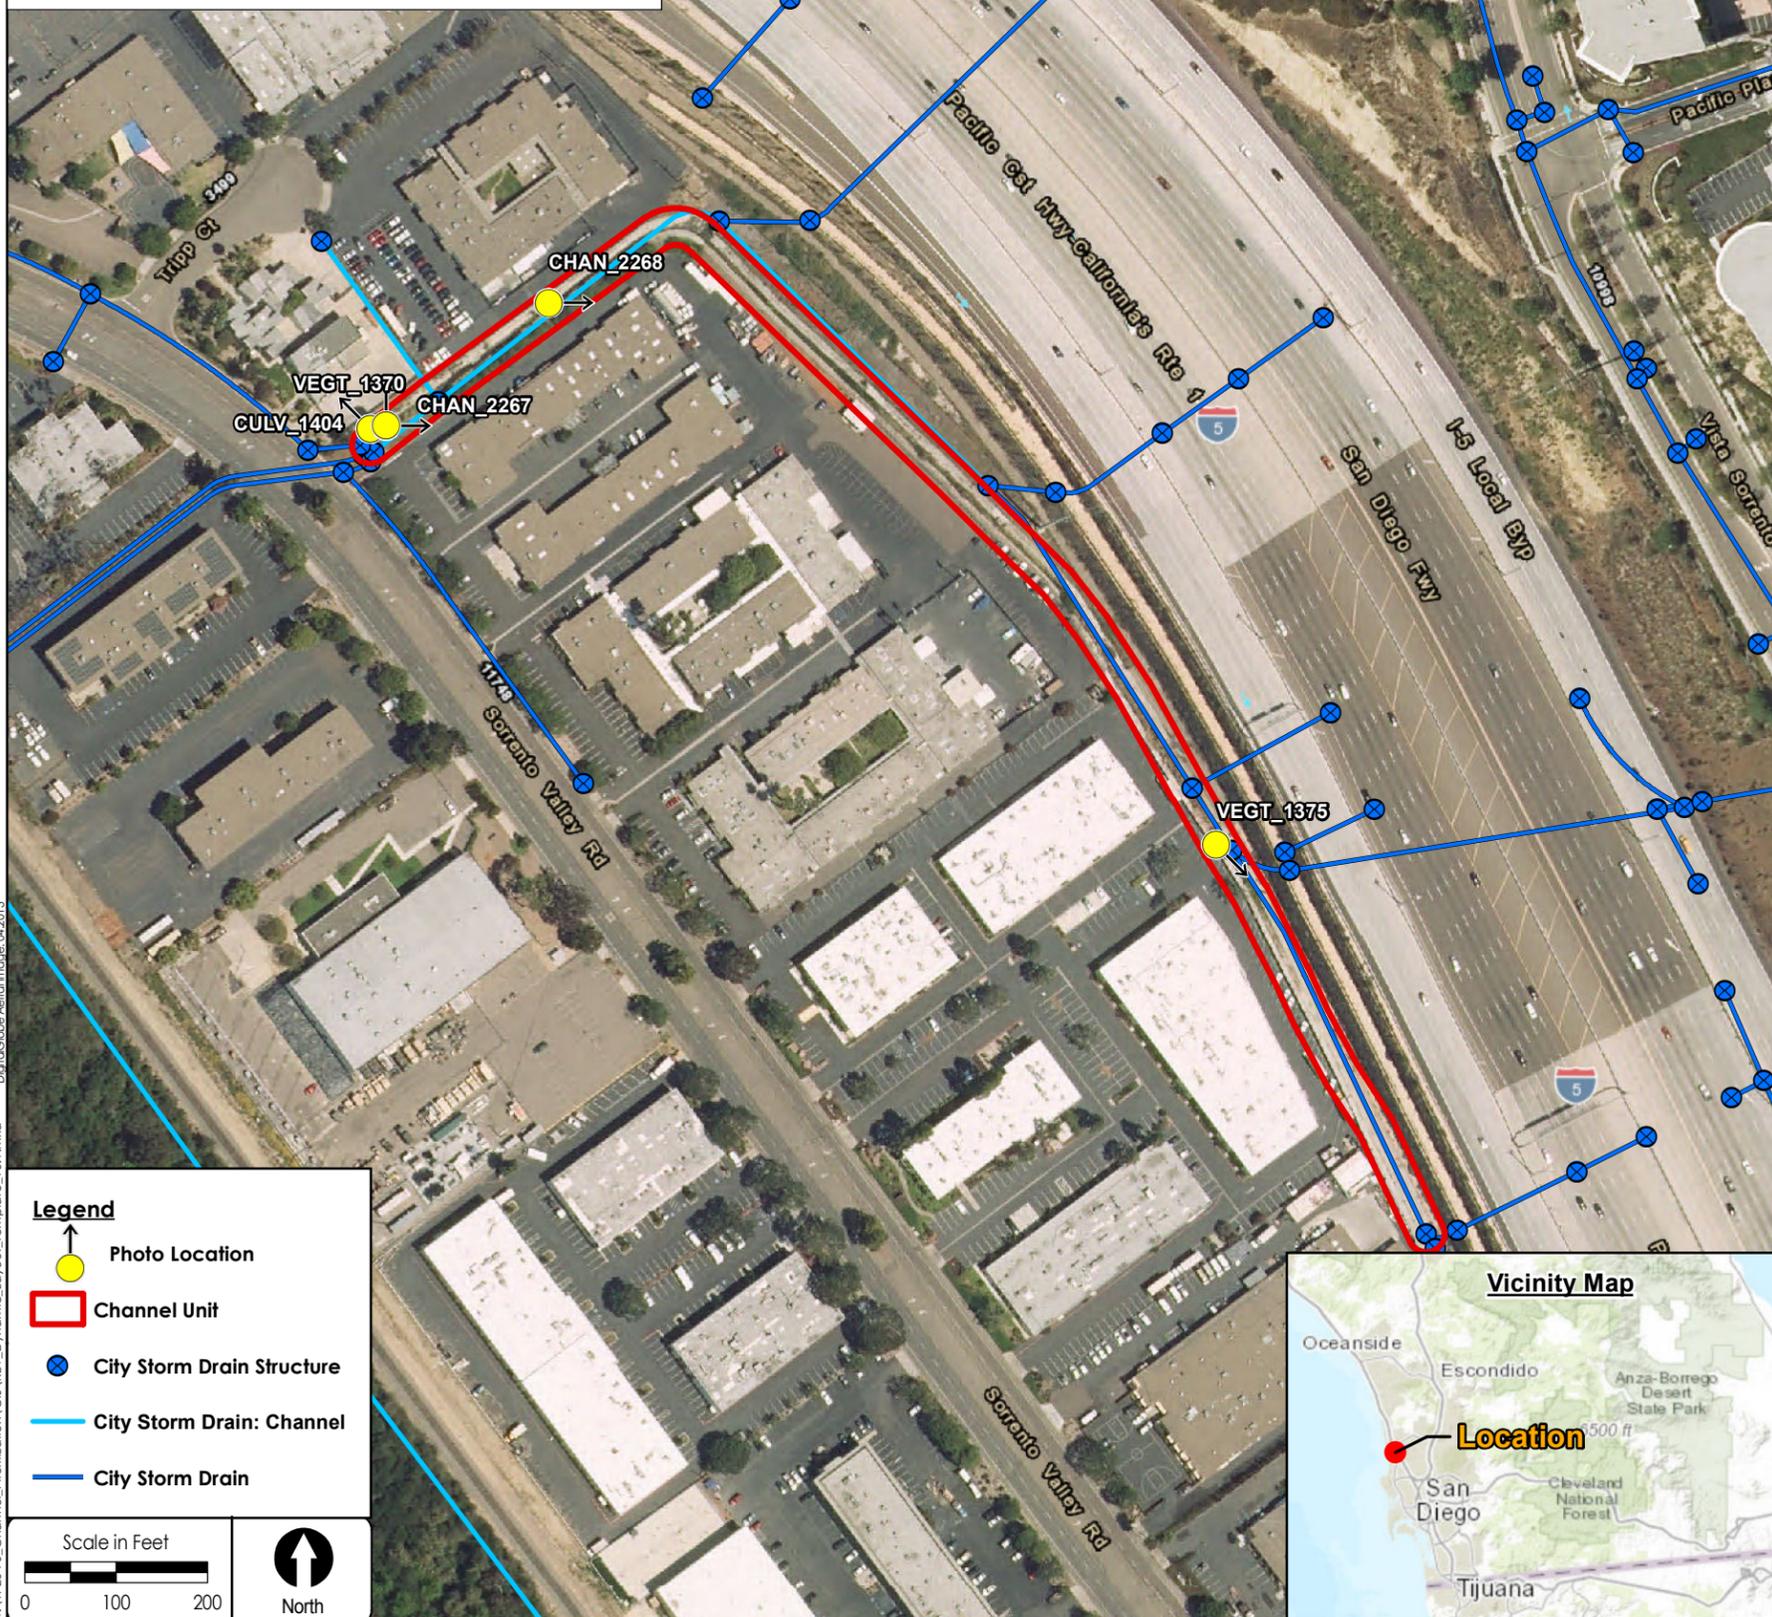
- Maintenance Priority: **MEDIUM**
- Channel Prioritization Score: **78.0 out of 100**
- Capacity Prior to Maintenance: **2-5-year storm event**
- Capacity After Maintenance (As-built Capacity): **2-5-year storm event**
- Clogging Potential: **HIGH**
- Approximate Invasive Vegetation Coverage: **LOW**
- Approximate Native Vegetation Coverage: **HIGH**
- Surrounding Area: **Commercial**
- Infrastructure Failures: **Broken flapper valve**
- Site Evaluation Date: **April 25, 2016**
- Notes/Comments: **Downstream portion of channel has dense vegetation and sediment. The downstream culvert is susceptible to clogging due to the dense vegetation.**

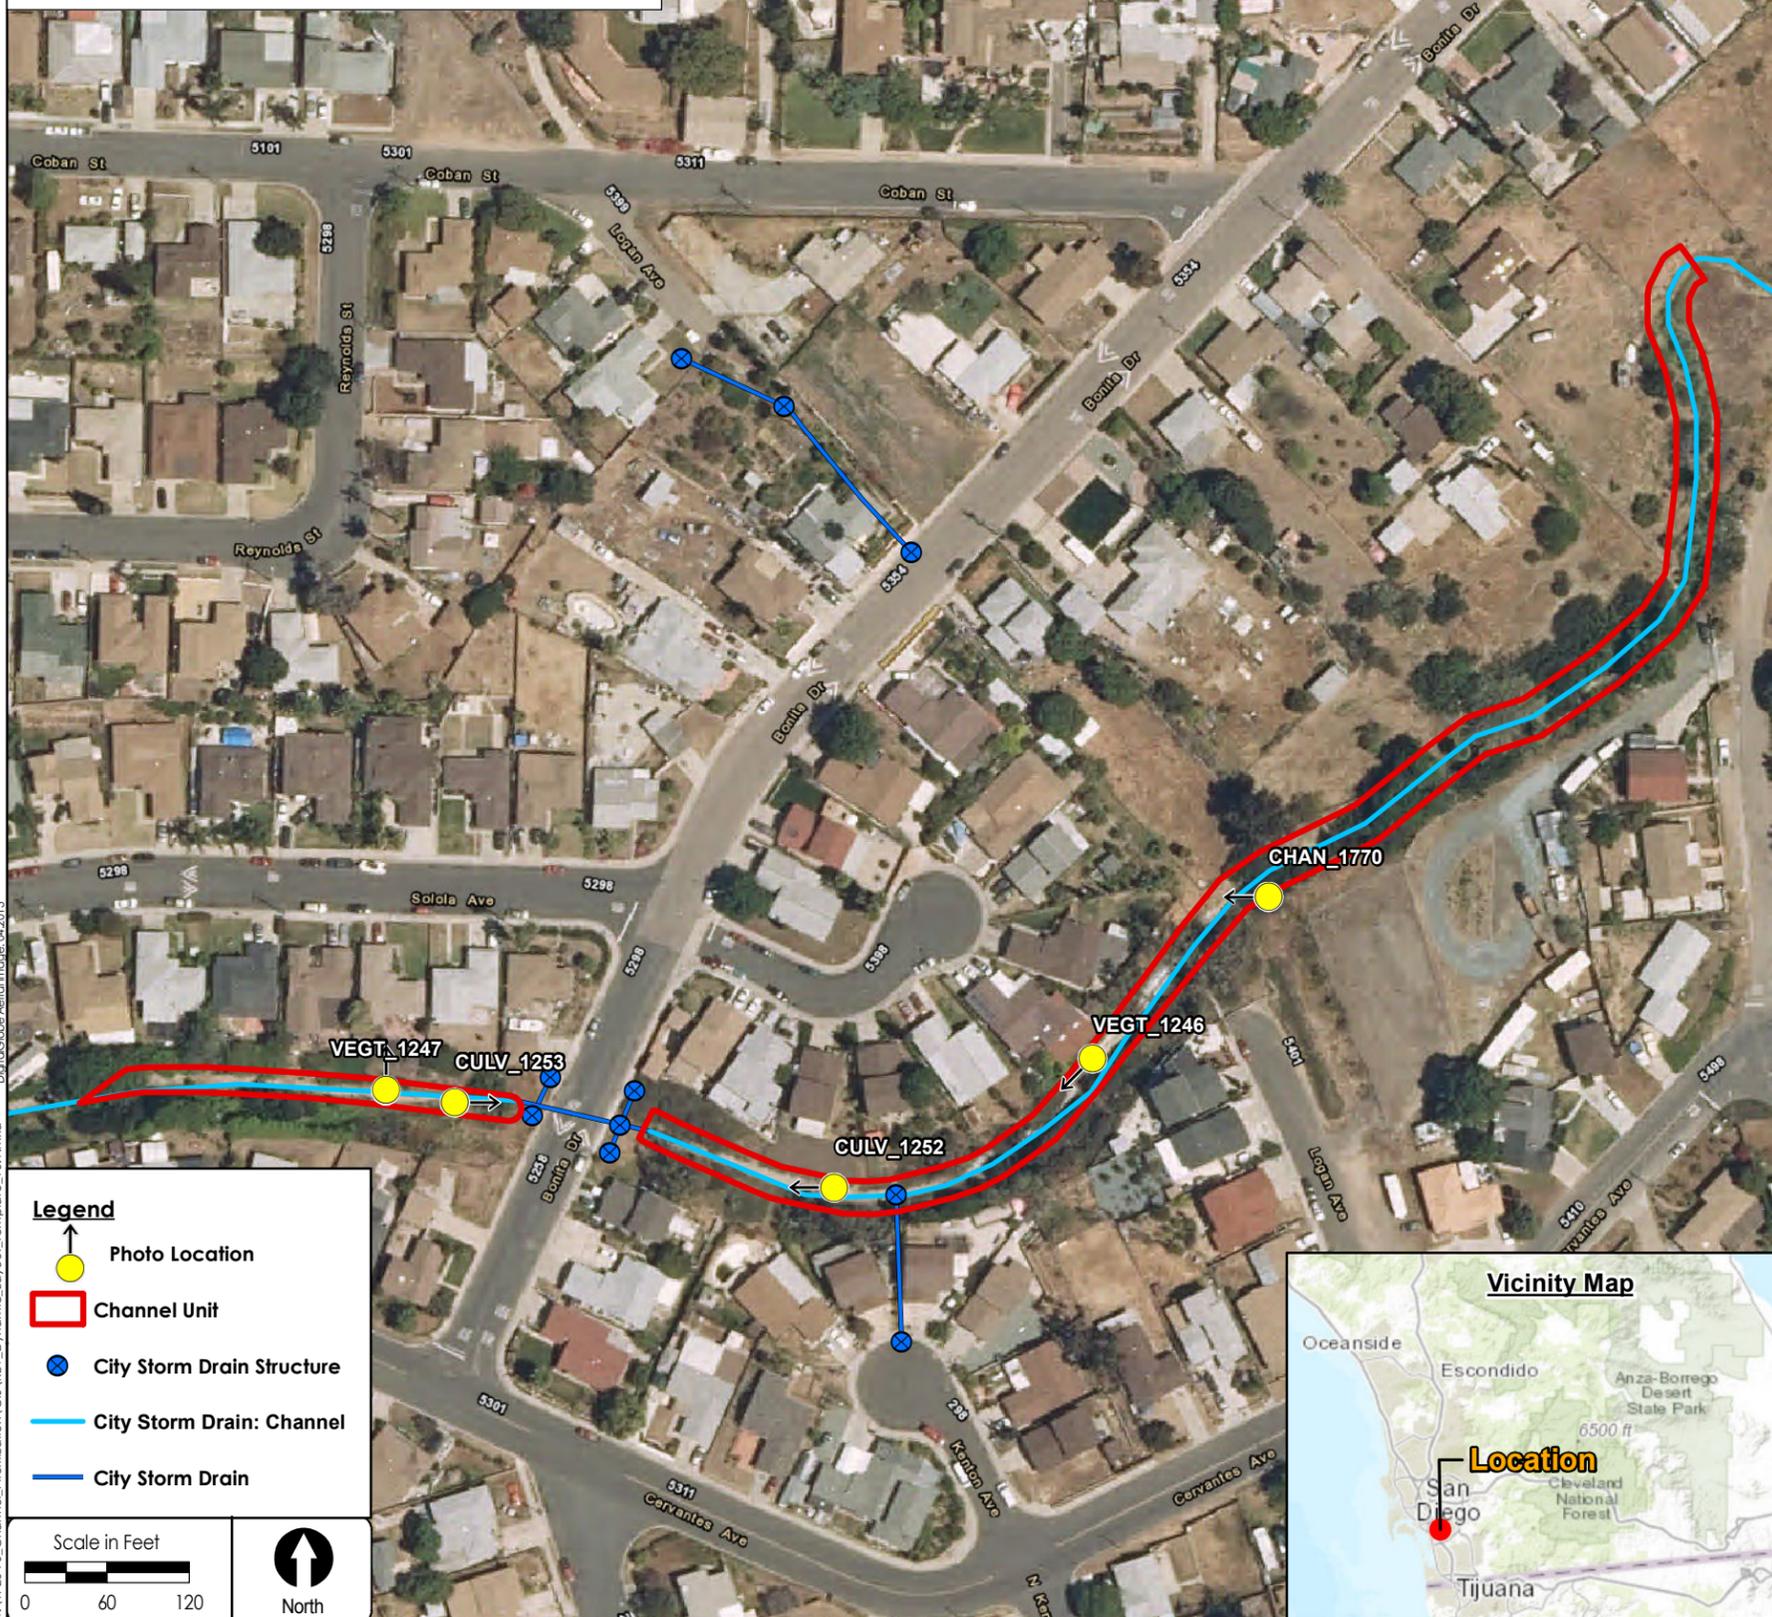
- Maintenance Priority: **MEDIUM**
- Channel Prioritization Score: **76.8 out of 100**
- Capacity Prior to Maintenance: **less than 2-year storm event**
- Capacity After Maintenance (As-built Capacity): **less than 2-year storm event**
- Clogging Potential: **HIGH**
- Approximate Invasive Vegetation Coverage: **HIGH**
- Approximate Native Vegetation Coverage: **LOW**
- Surrounding Area: **Residential**
- Infrastructure Failures: **Concrete damage**
- Site Evaluation Date: **April 17, 2016**
- Notes/Comments: **Channel has large portions of broken concrete and dense vegetation.**
