**STORM WATER CHANNEL  
MAINTENANCE PROGRAM PRIORITIZATION**  
September 13, 2016

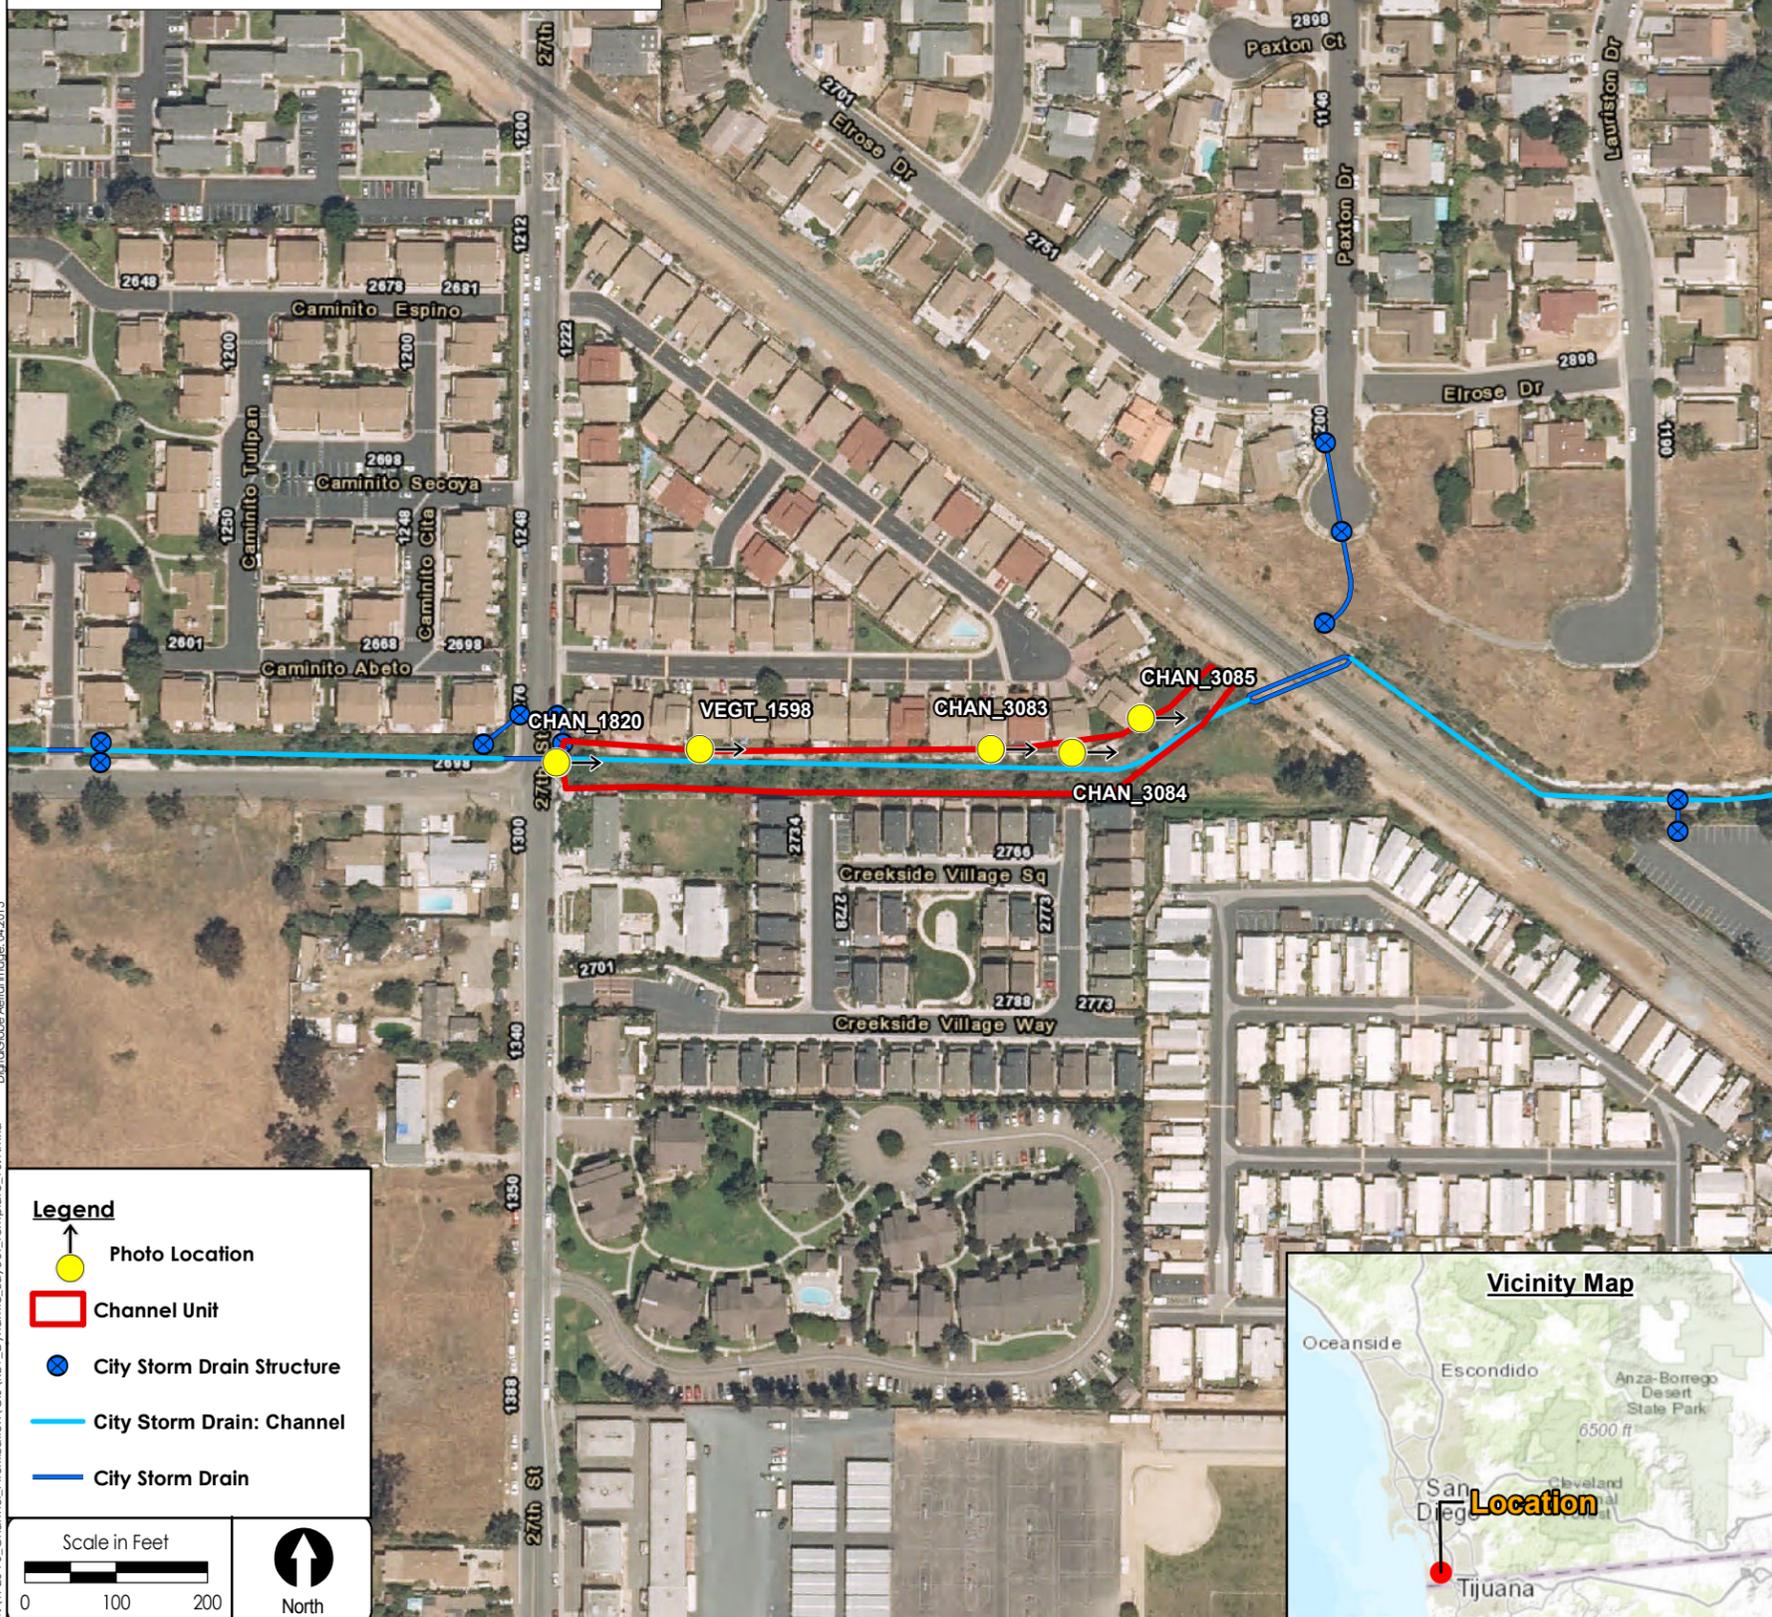
- Maintenance Priority: **MEDIUM**
- Channel Prioritization Score: **76.6 out of 100**
- Capacity Prior to Maintenance: **10-year storm event**
- Capacity After Maintenance (As-built Capacity): **50-year storm event**
- Clogging Potential: **MEDIUM**
- Approximate Invasive Vegetation Coverage: **LOW**
- Approximate Native Vegetation Coverage: **HIGH**
- Surrounding Area: **Residential**
- Infrastructure Failures: **NONE**
- Site Evaluation Date: **May 5, 2016**
- Notes/Comments: **Channel has dense vegetation on the upstream portion. Properties are in close proximity to the upstream portion of channel and could easily flood if the channel overtops.**

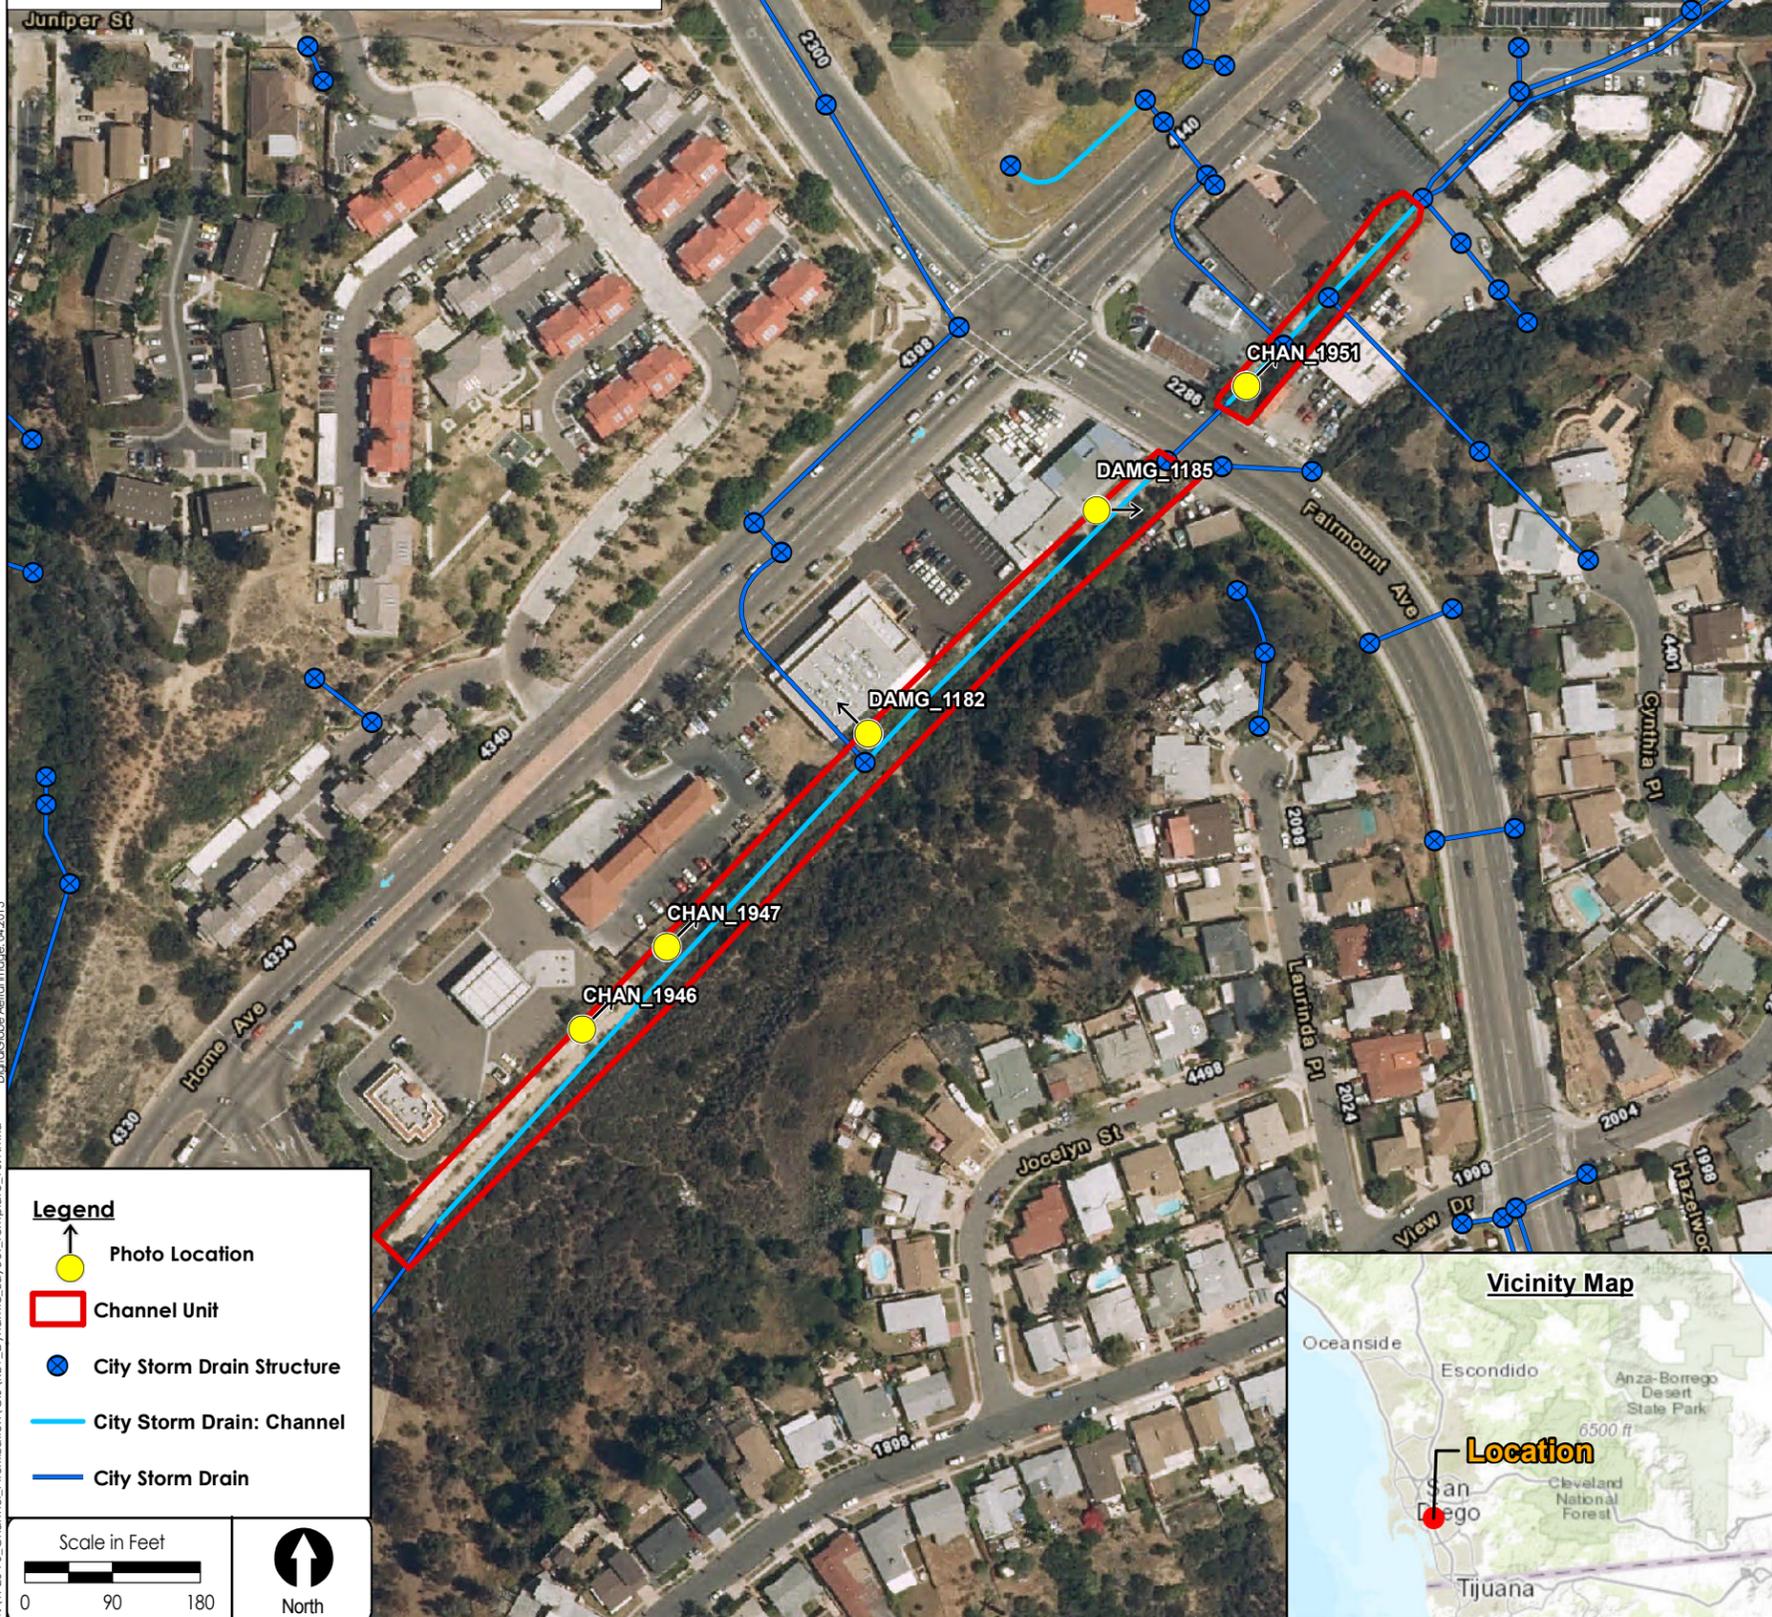
- Assessment Results**
- Maintenance Priority: **MEDIUM**
  - Channel Prioritization Score: **76.0 out of 100**
  - Capacity Prior to Maintenance: **25-year storm event**
  - Capacity After Maintenance (As-built Capacity): **50-year storm event**
  - Clogging Potential: **MEDIUM**
  - Approximate Invasive Vegetation Coverage: **HIGH**
  - Approximate Native Vegetation Coverage: **LOW**
  - Surrounding Area: **Commercial**
  - Infrastructure Failures: **Broken concrete and slope failure**
  - Site Evaluation Date: **April 21, 2016**
  - Notes/Comments: **Downstream section of reach has broken concrete due to arduo. Some earthen side slopes have vertical erosion.**

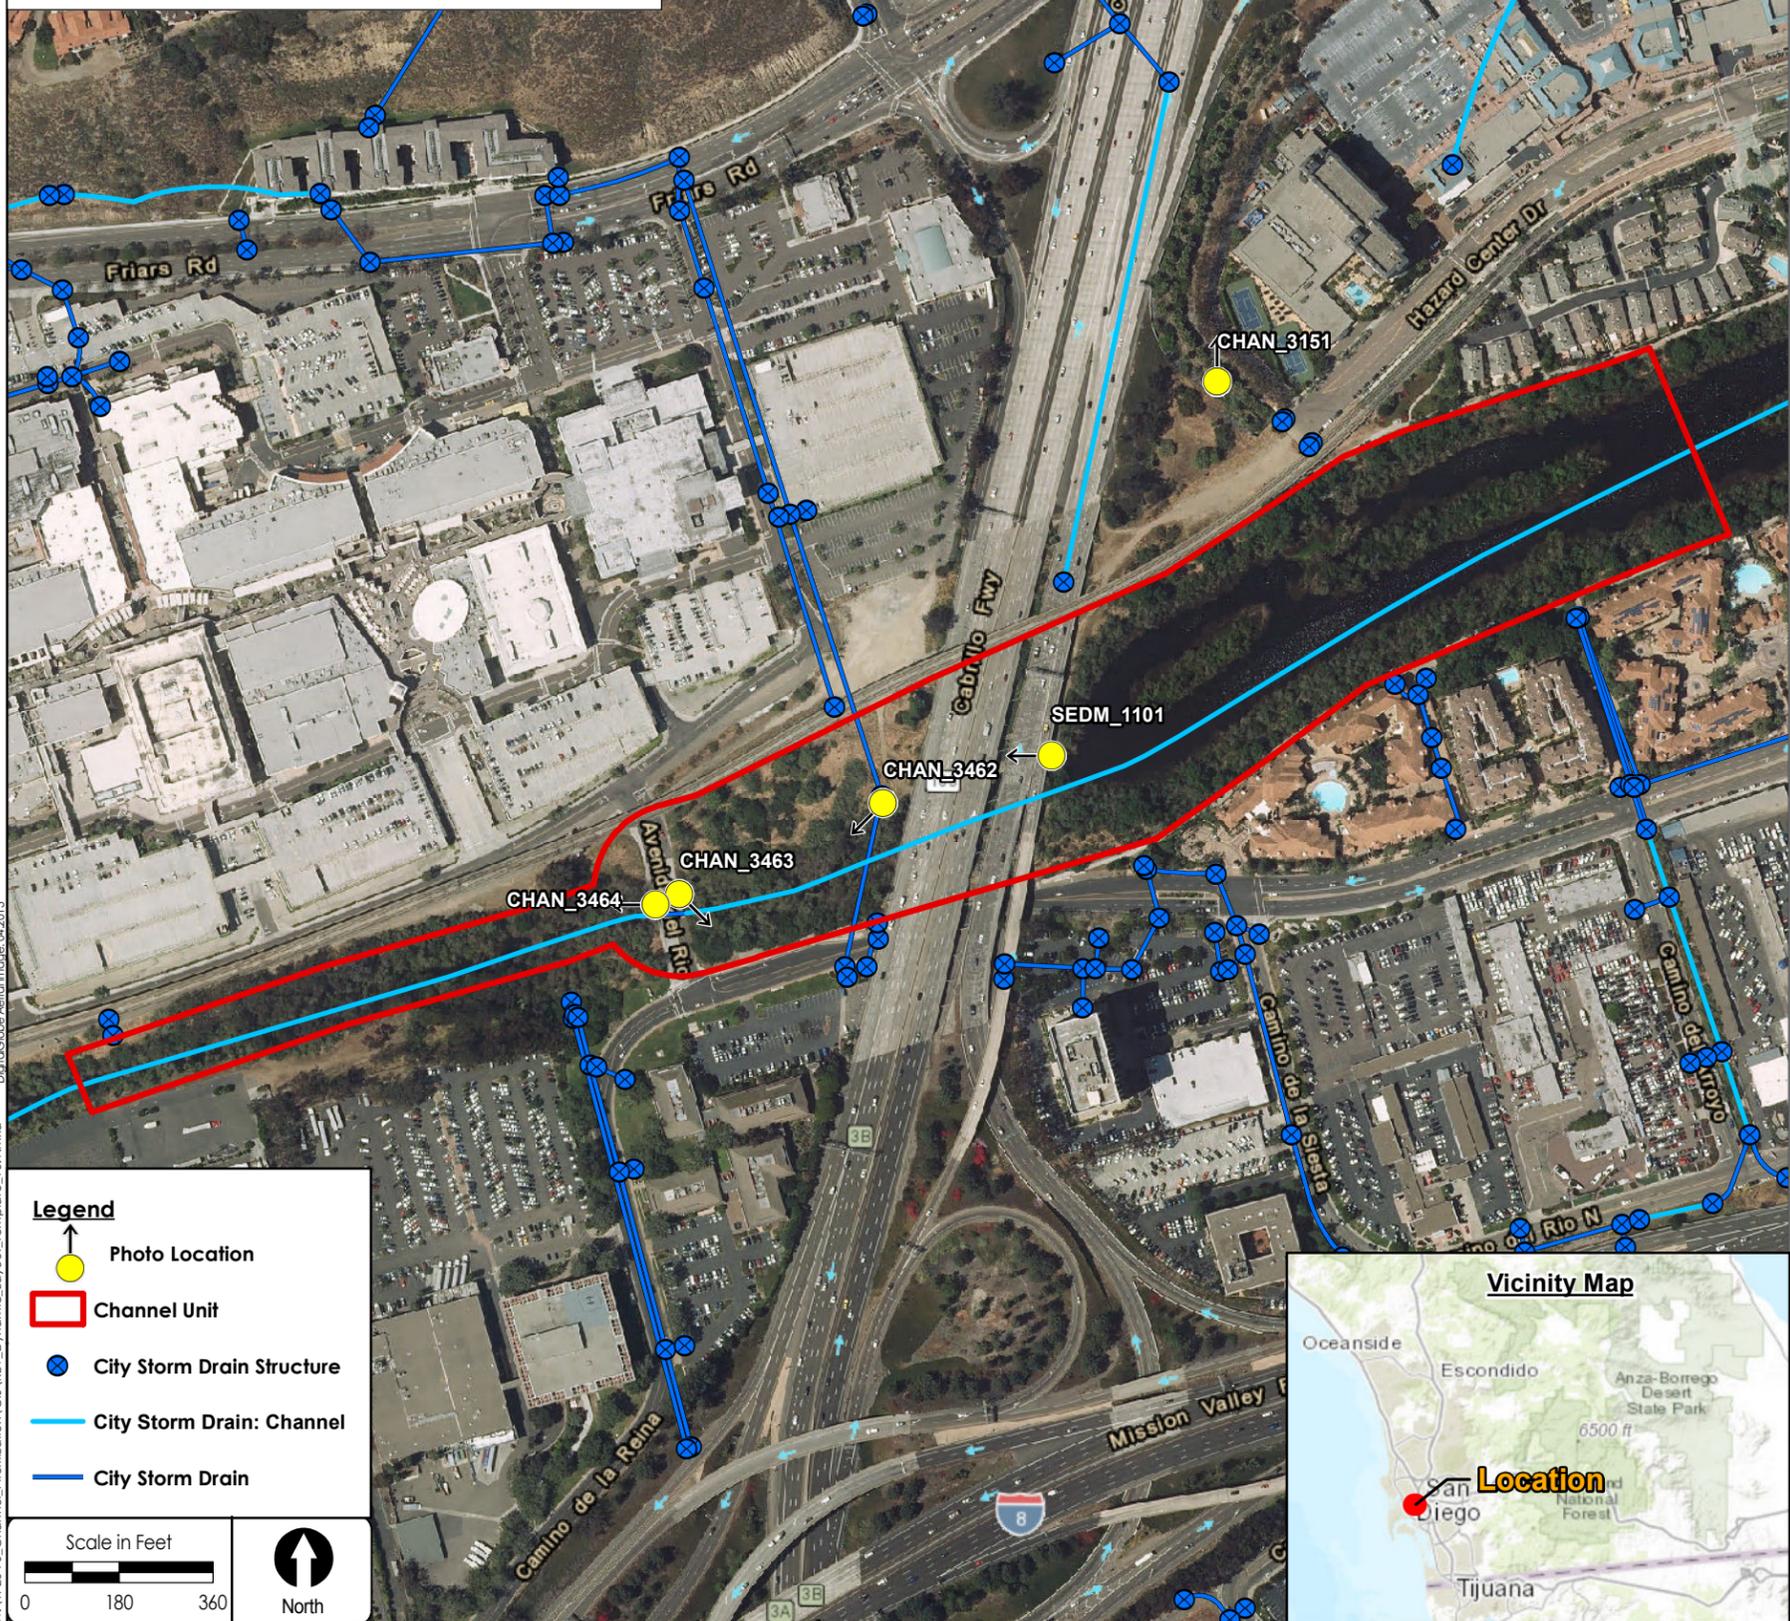
- Maintenance Priority: **MEDIUM**
- Channel Prioritization Score: **75.3 out of 100**
- Capacity Prior to Maintenance: **2-year storm event**
- Capacity After Maintenance (As-built Capacity) : **2-year storm event**
- Clogging Potential: **MEDIUM**
- Approximate Invasive Vegetation Coverage: **LOW**
- Approximate Native Vegetation Coverage: **HIGH**
- Surrounding Area: **Commercial**
- Infrastructure Failures: **NONE**
- Site Evaluation Date: **June 16, 2016**
- Notes/Comments: **Channel narrows drastically once it goes underneath Avenida Del Rio. Channel has high potential to flood Fashion Valley parking structure due to structure being so low and channel being narrow in this area.**

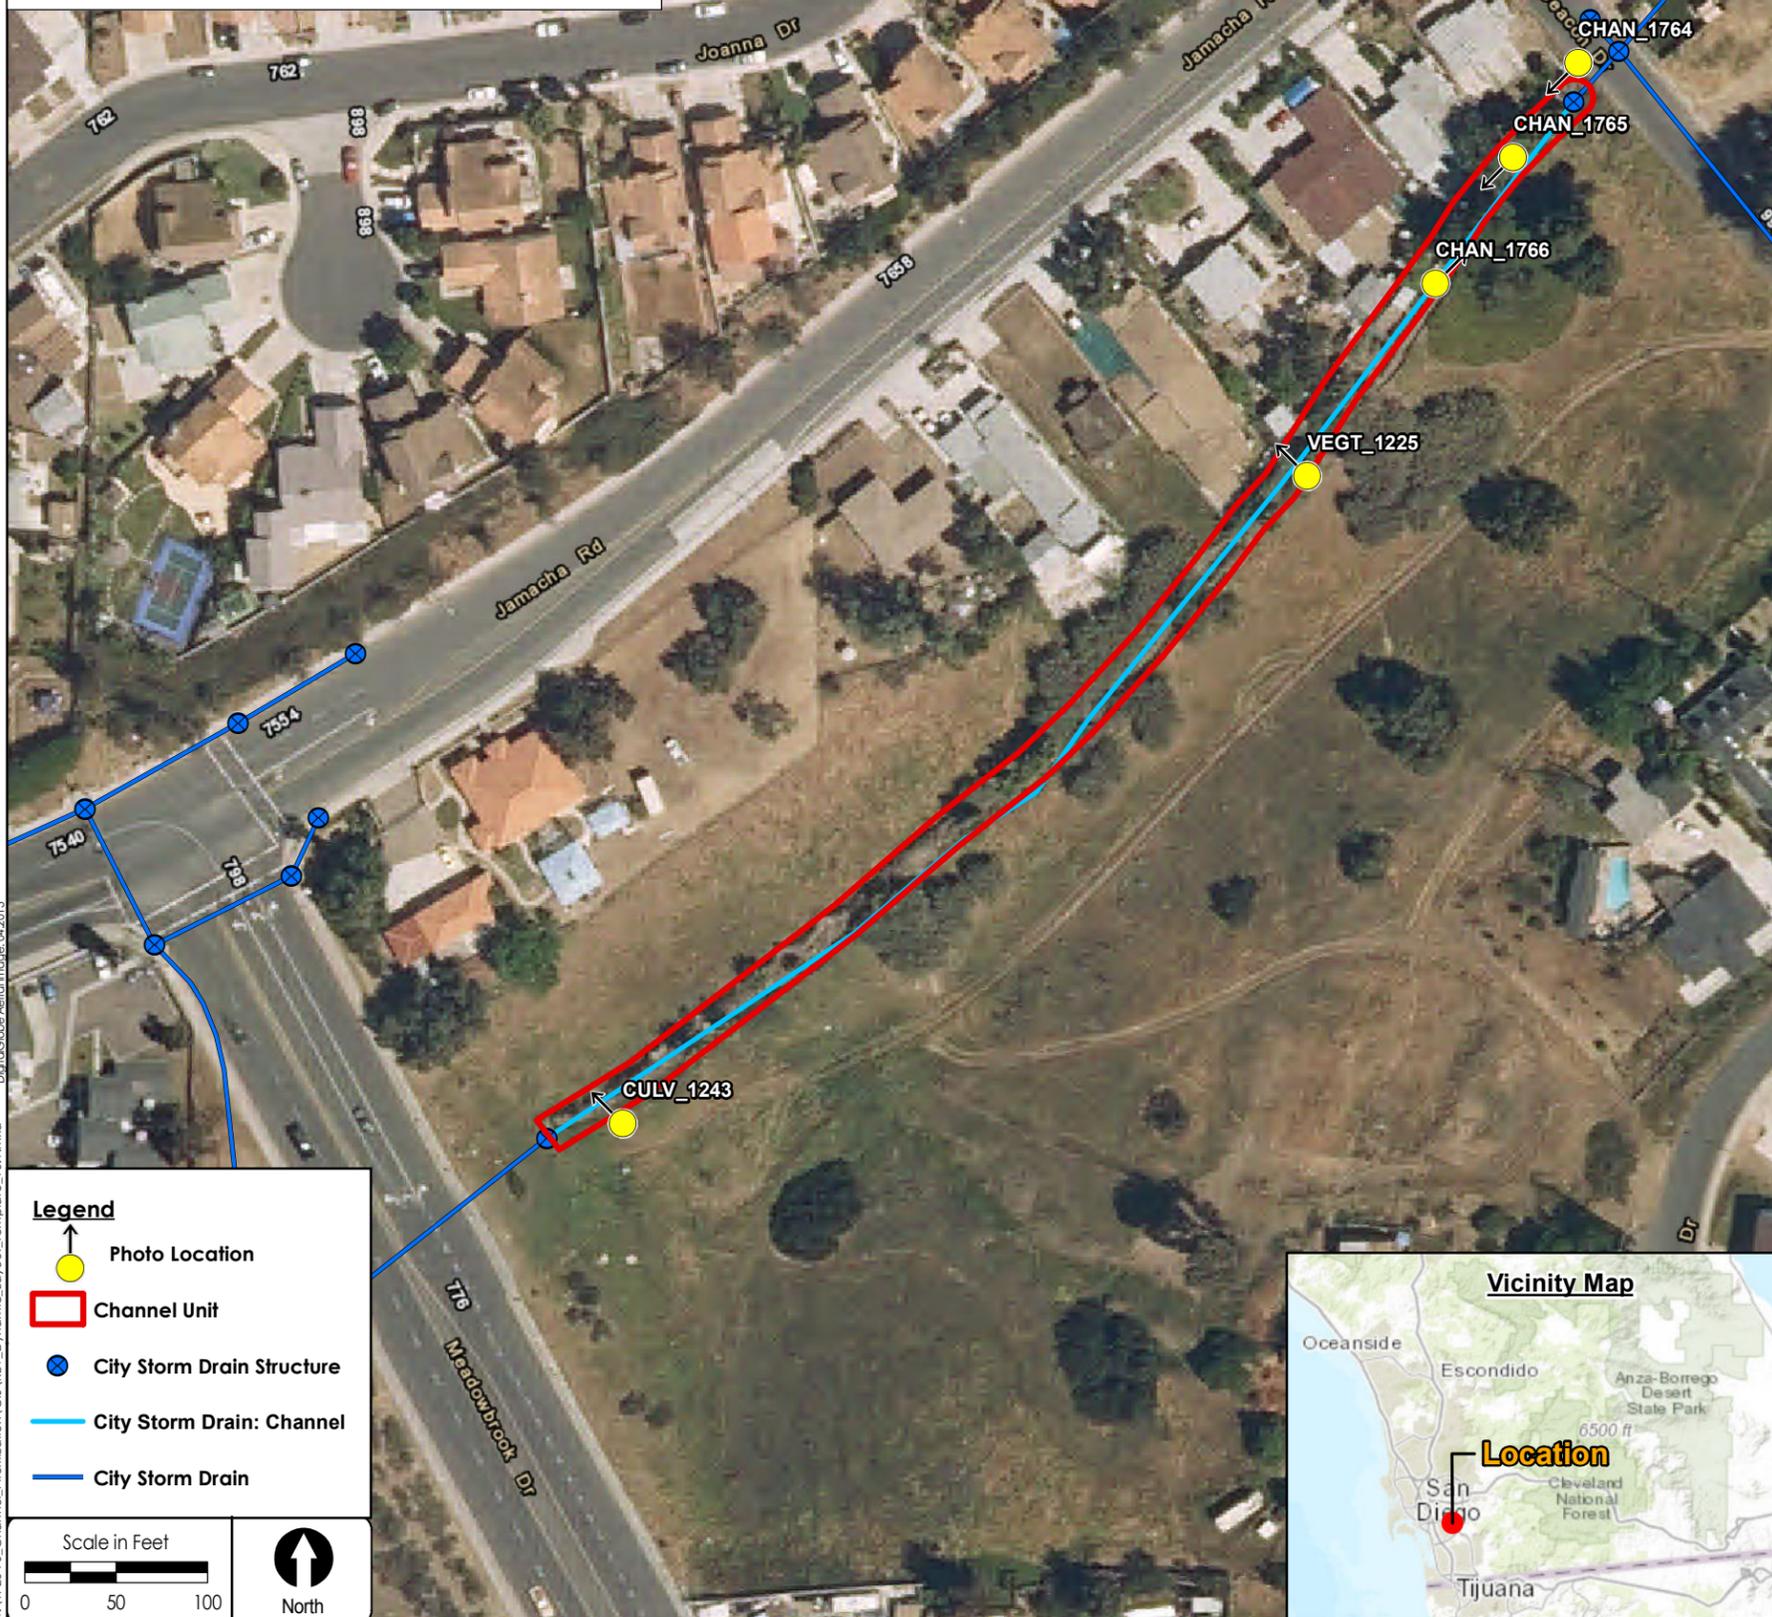
- Maintenance Priority: **MEDIUM**
- Channel Prioritization Score: **75.1 out of 100**
- Capacity Prior to Maintenance: **25-year storm event**
- Capacity After Maintenance (As-built Capacity): **100-year storm event**
- Clogging Potential: **HIGH**
- Approximate Invasive Vegetation Coverage: **HIGH**
- Approximate Native Vegetation Coverage: **LOW**
- Surrounding Area: **Residential**
- Infrastructure Failures: **NONE**
- Site Evaluation Date: **April 16, 2016**
- Notes/Comments: **Channel is full of arundo and palm trees. Channel is in a residential neighborhood and has a high chance of flooding due to high density of vegetation and sediment. Additionally erosion was noticed on portions of the side slopes**

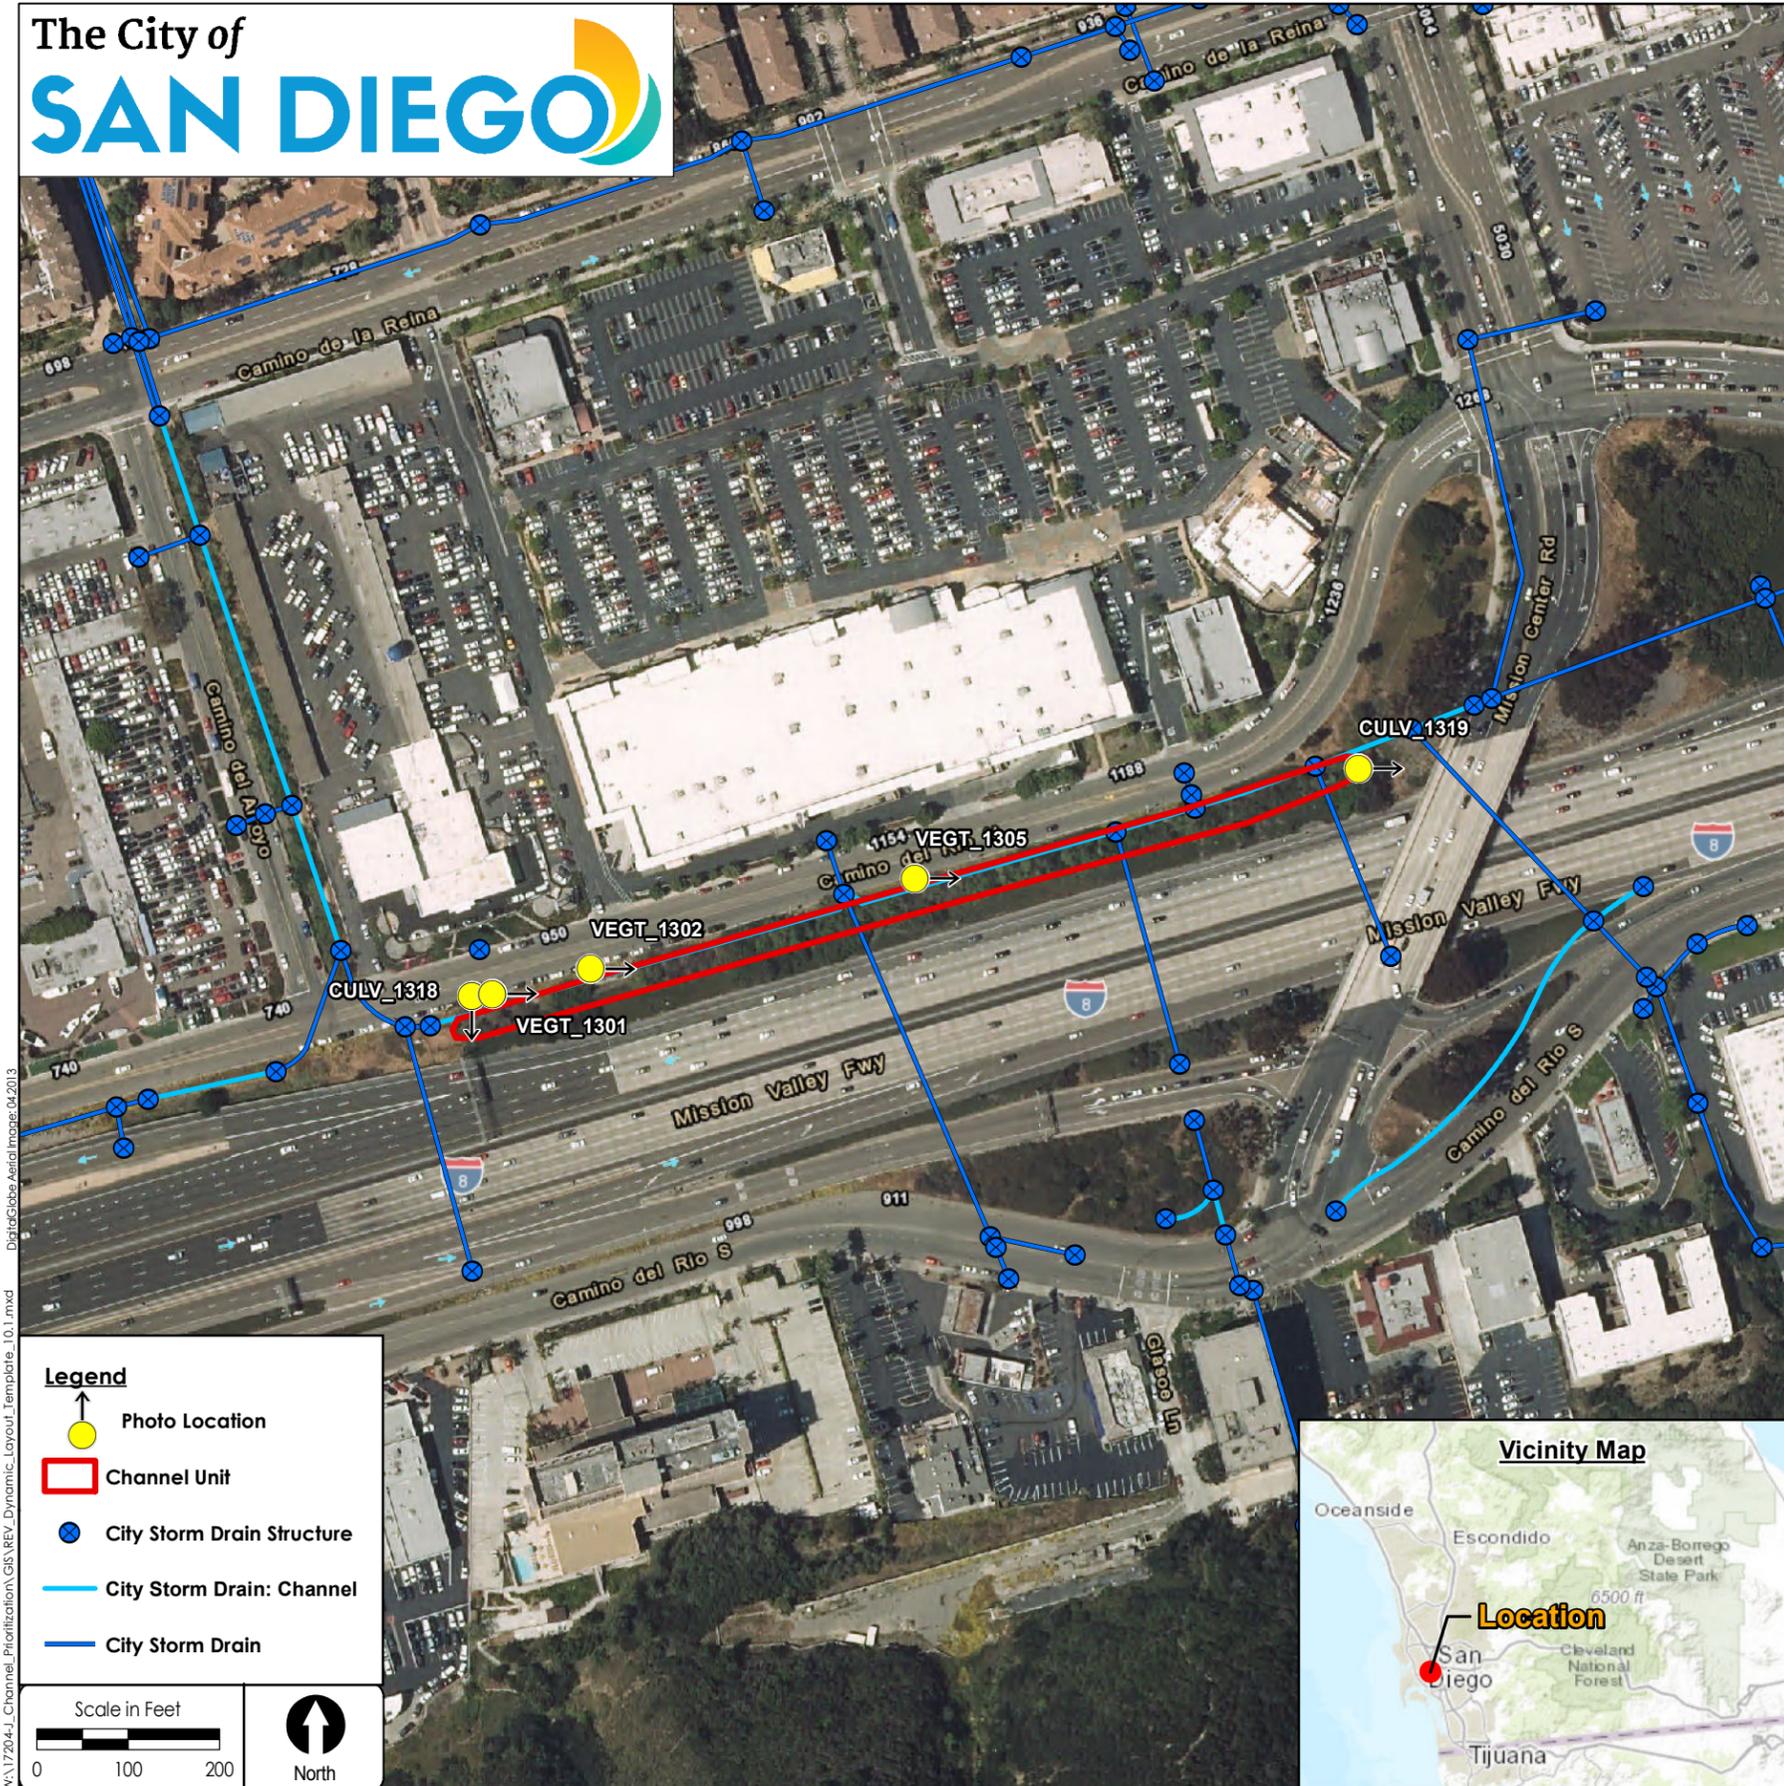
- Maintenance Priority: **MEDIUM**
- Channel Prioritization Score: **71.3 out of 100**
- Capacity Prior to Maintenance: **less than 2-year storm event**
- Capacity After Maintenance (As-built Capacity): **100-year storm event**
- Clogging Potential: **HIGH**
- Approximate Invasive Vegetation Coverage: **LOW**
- Approximate Native Vegetation Coverage: **HIGH**
- Surrounding Area: **Commercial**
- Infrastructure Failures: **NONE**
- Site Evaluation Date: **April 20, 2016**
- Notes/Comments: **Channel has sediment deposition with vegetation. Channel is near a road and a freeway.**

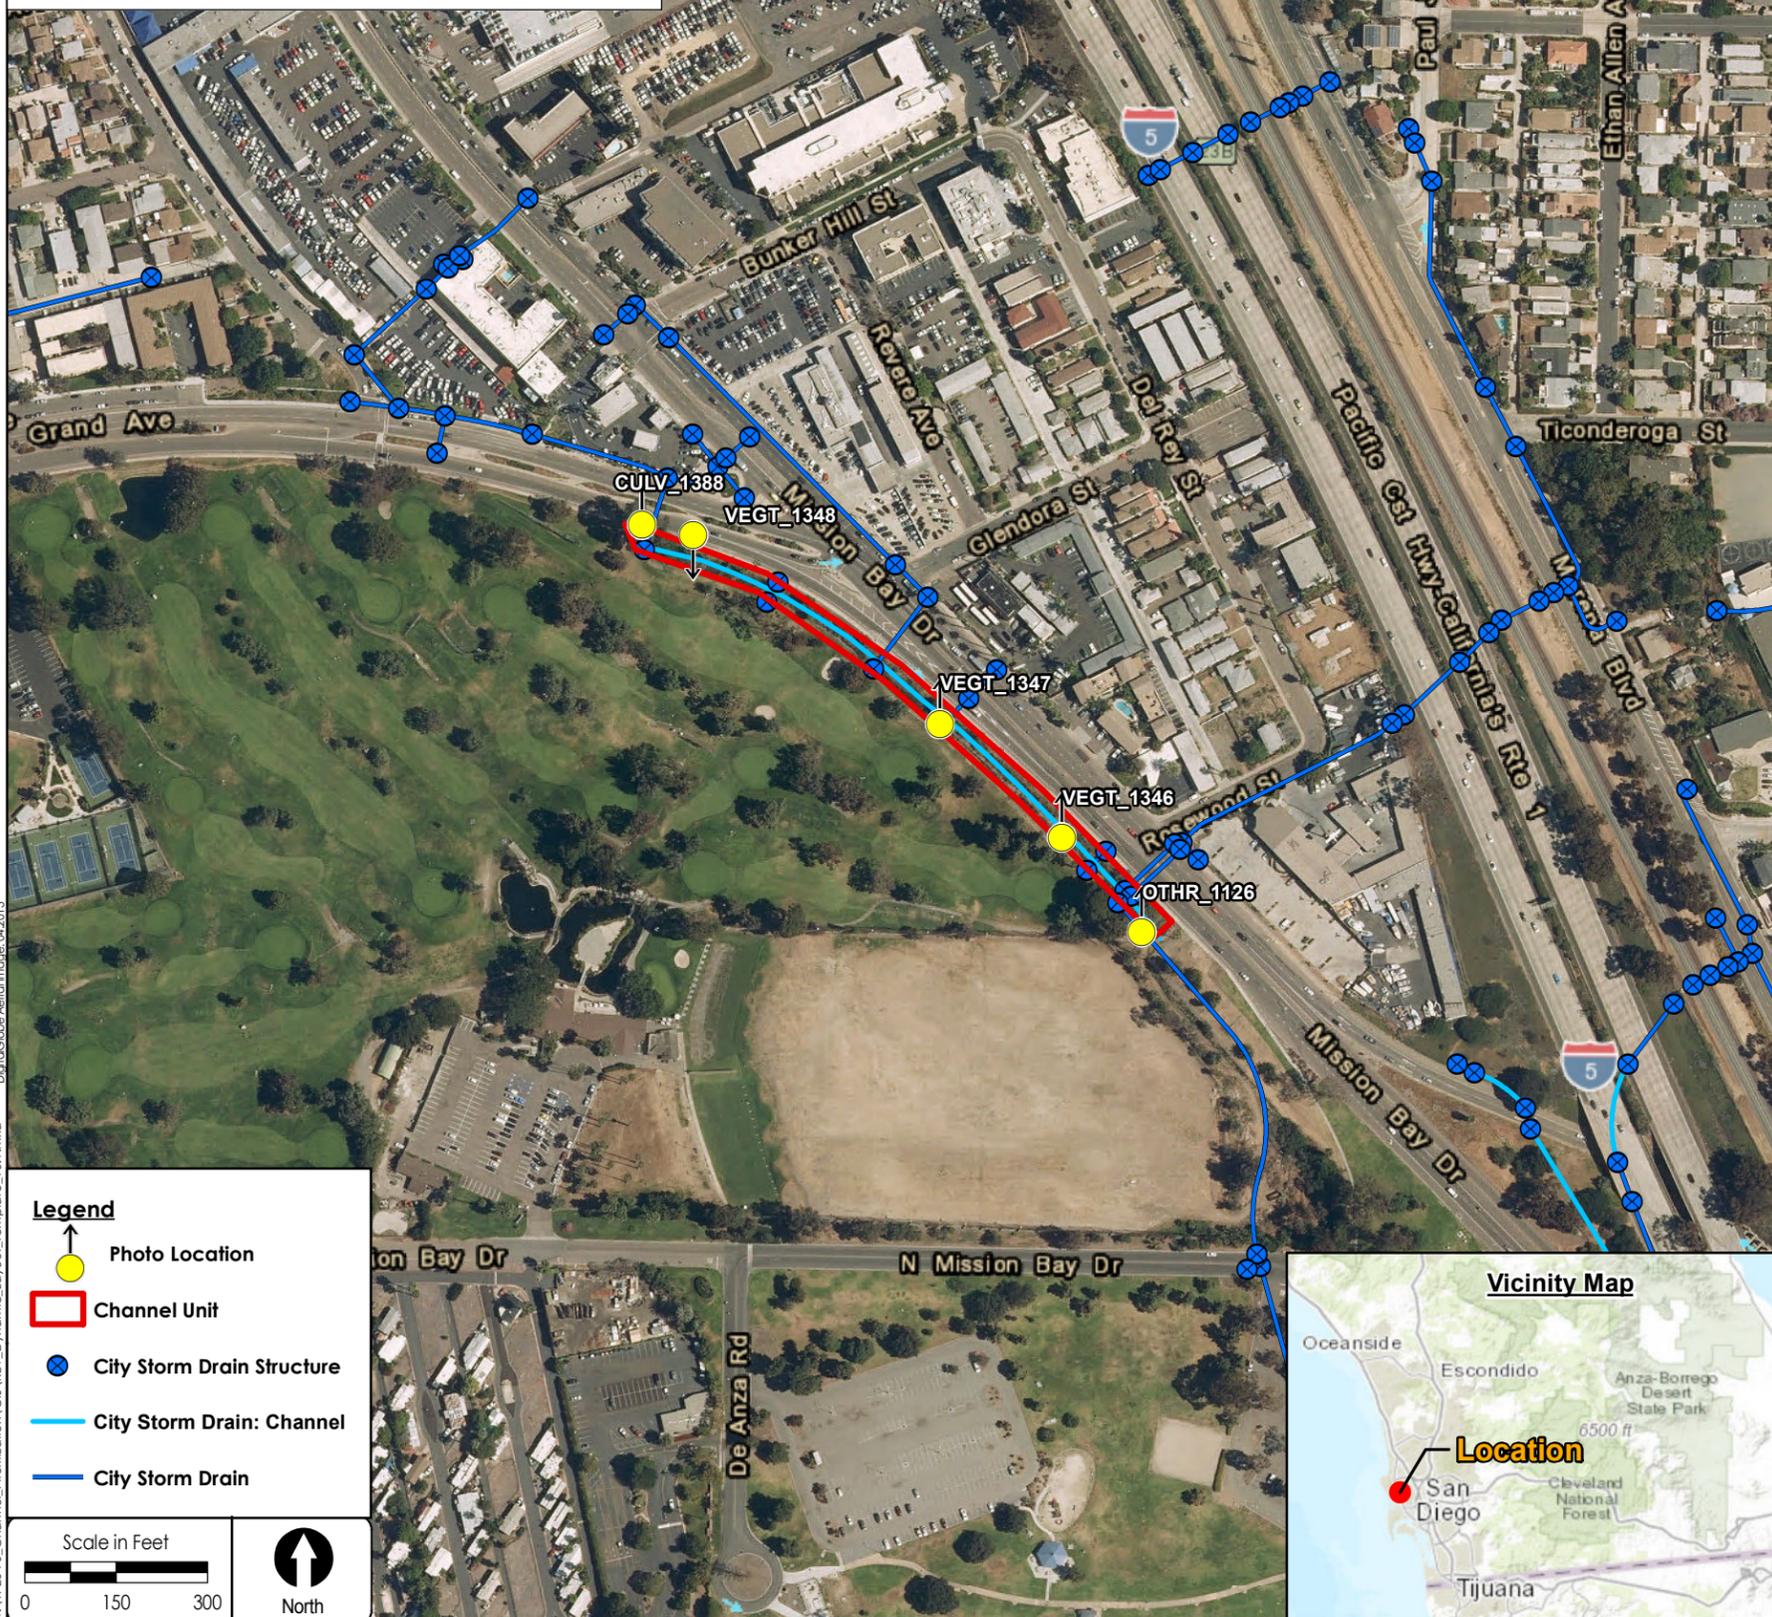
- Maintenance Priority: **MEDIUM**
- Channel Prioritization Score: **70.6 out of 100**
- Capacity Prior to Maintenance: **less than 2-year storm event**
- Capacity After Maintenance (As-built Capacity): **100-year storm event**
- Clogging Potential: **MEDIUM**
- Approximate Invasive Vegetation Coverage: **HIGH**
- Approximate Native Vegetation Coverage: **LOW**
- Surrounding Area: **Commercial**
- Infrastructure Failures: **NONE**
- Site Evaluation Date: **April 24, 2016**
- Notes/Comments: **Channel is full of vegetation and has a high potential to flood nearby streets. However there are no insurable structures near the channel**

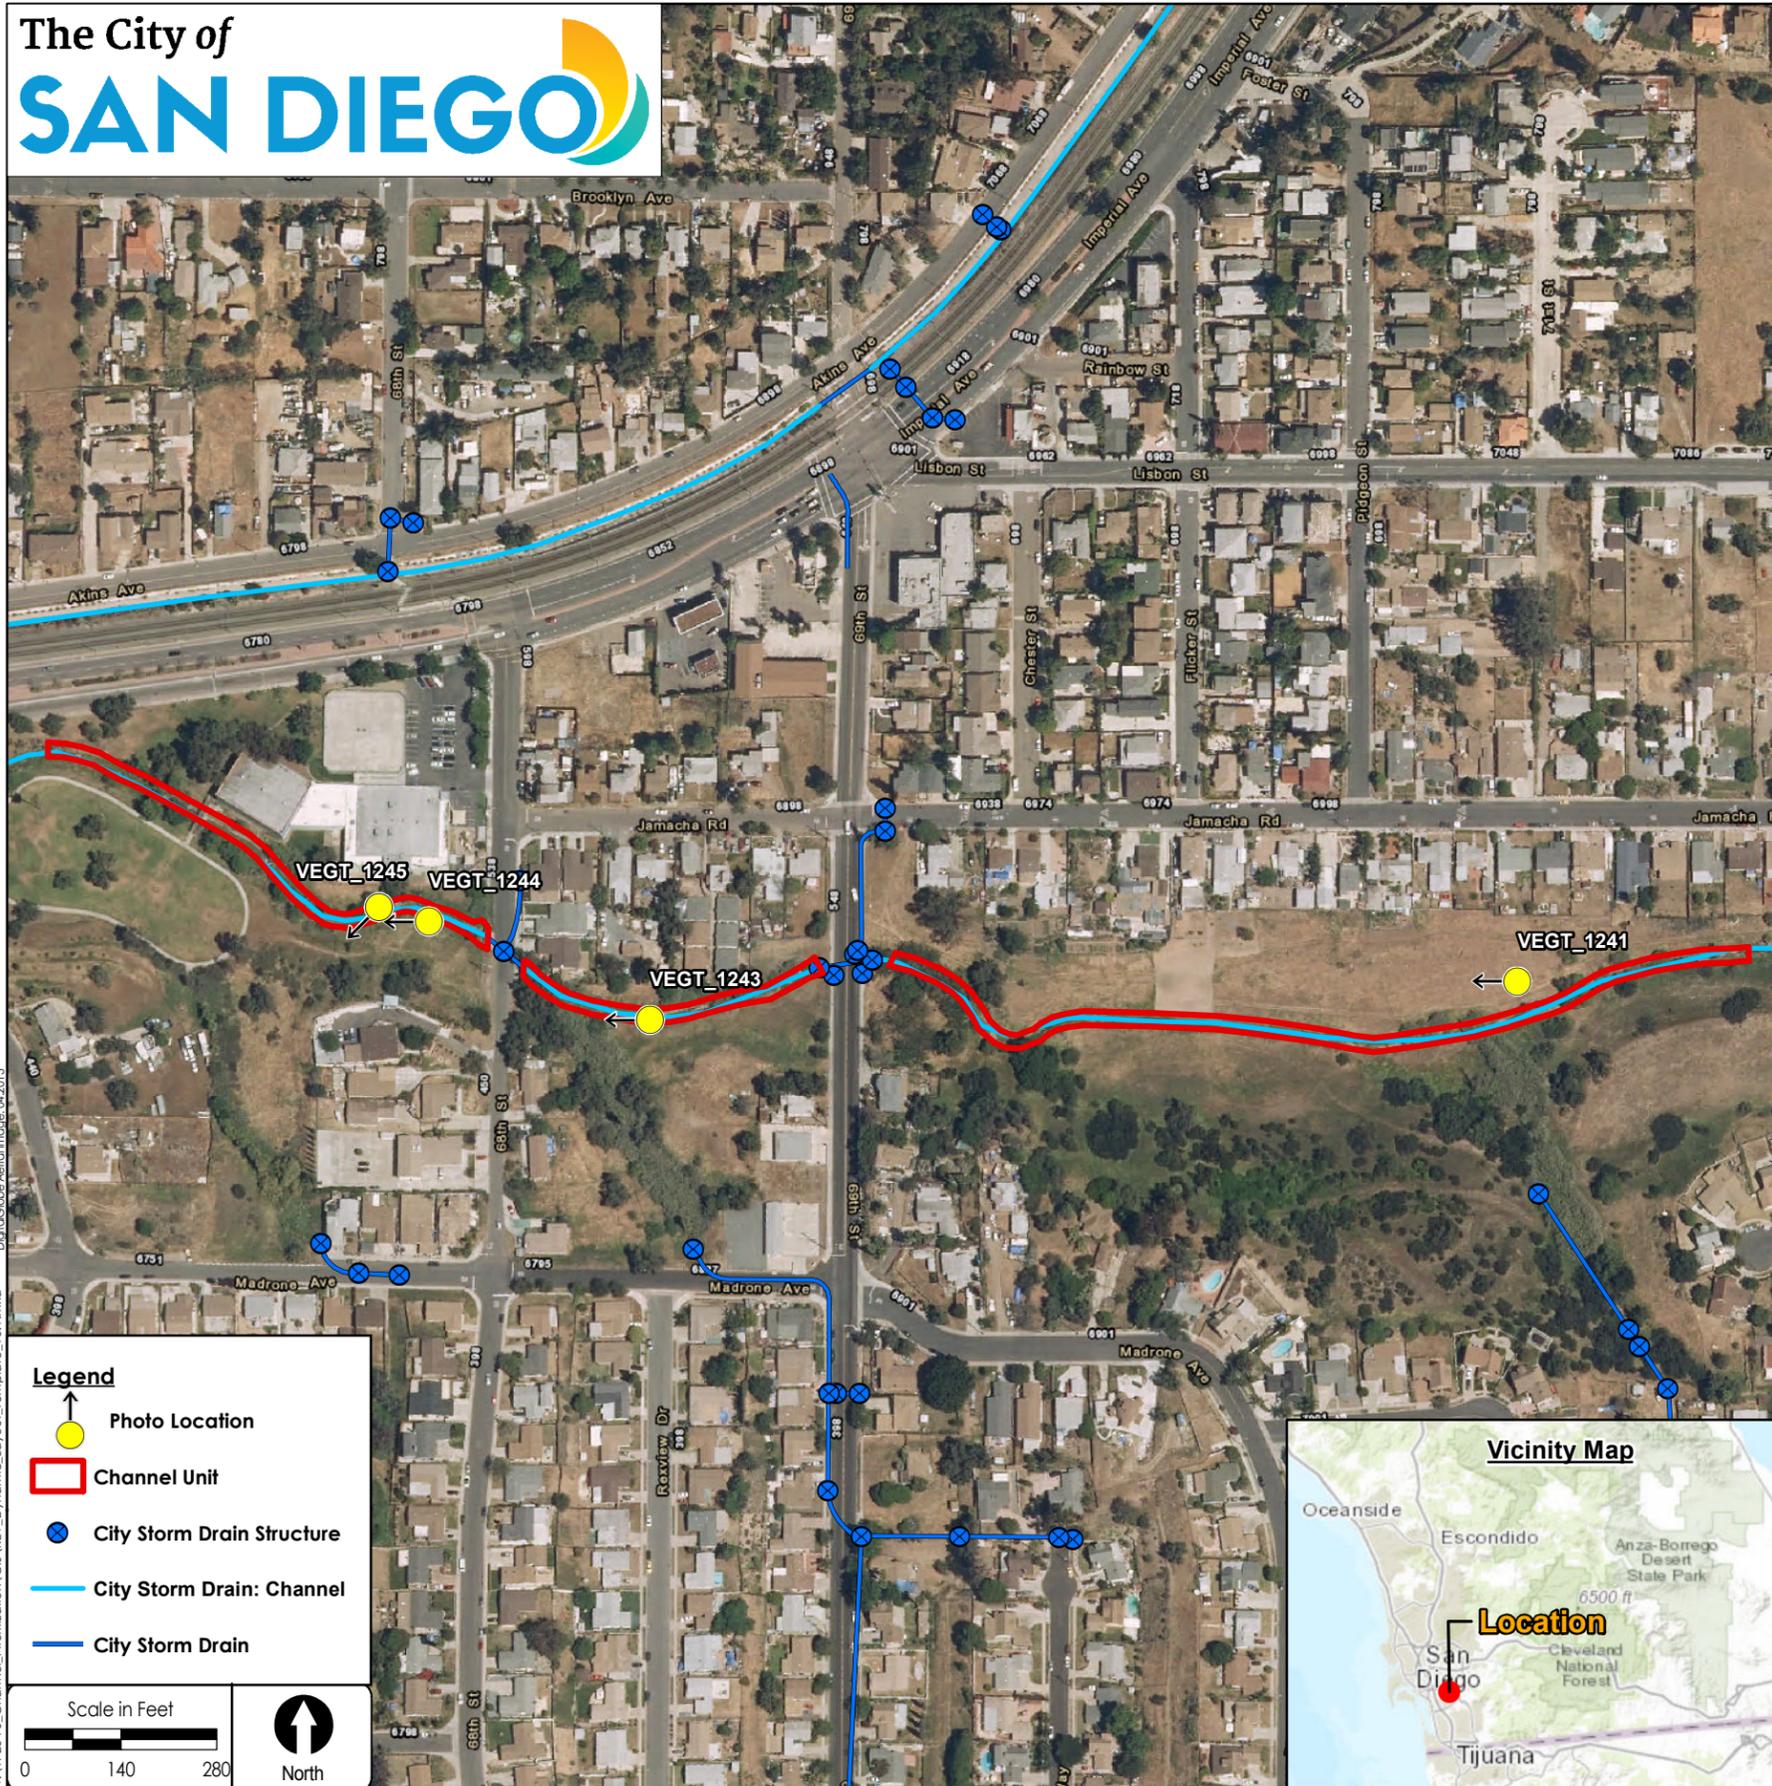
- Maintenance Priority: **MEDIUM**
- Channel Prioritization Score: **68.9 out of 100**
- Capacity Prior to Maintenance: **less than 2-year storm event**
- Capacity After Maintenance (As-built Capacity): **2-year storm event**
- Clogging Potential: **MEDIUM**
- Approximate Invasive Vegetation Coverage: **HIGH**
- Approximate Native Vegetation Coverage: **LOW**
- Surrounding Area: **Residential**
- Infrastructure Failures: **NONE**
- Site Evaluation Date: **April 17, 2016**
- Notes/Comments: **Channel has dense vegetation established however the land surrounding the channel is open space.**
