**STORM WATER CHANNEL  
MAINTENANCE PROGRAM PRIORITIZATION**  
September 13, 2016

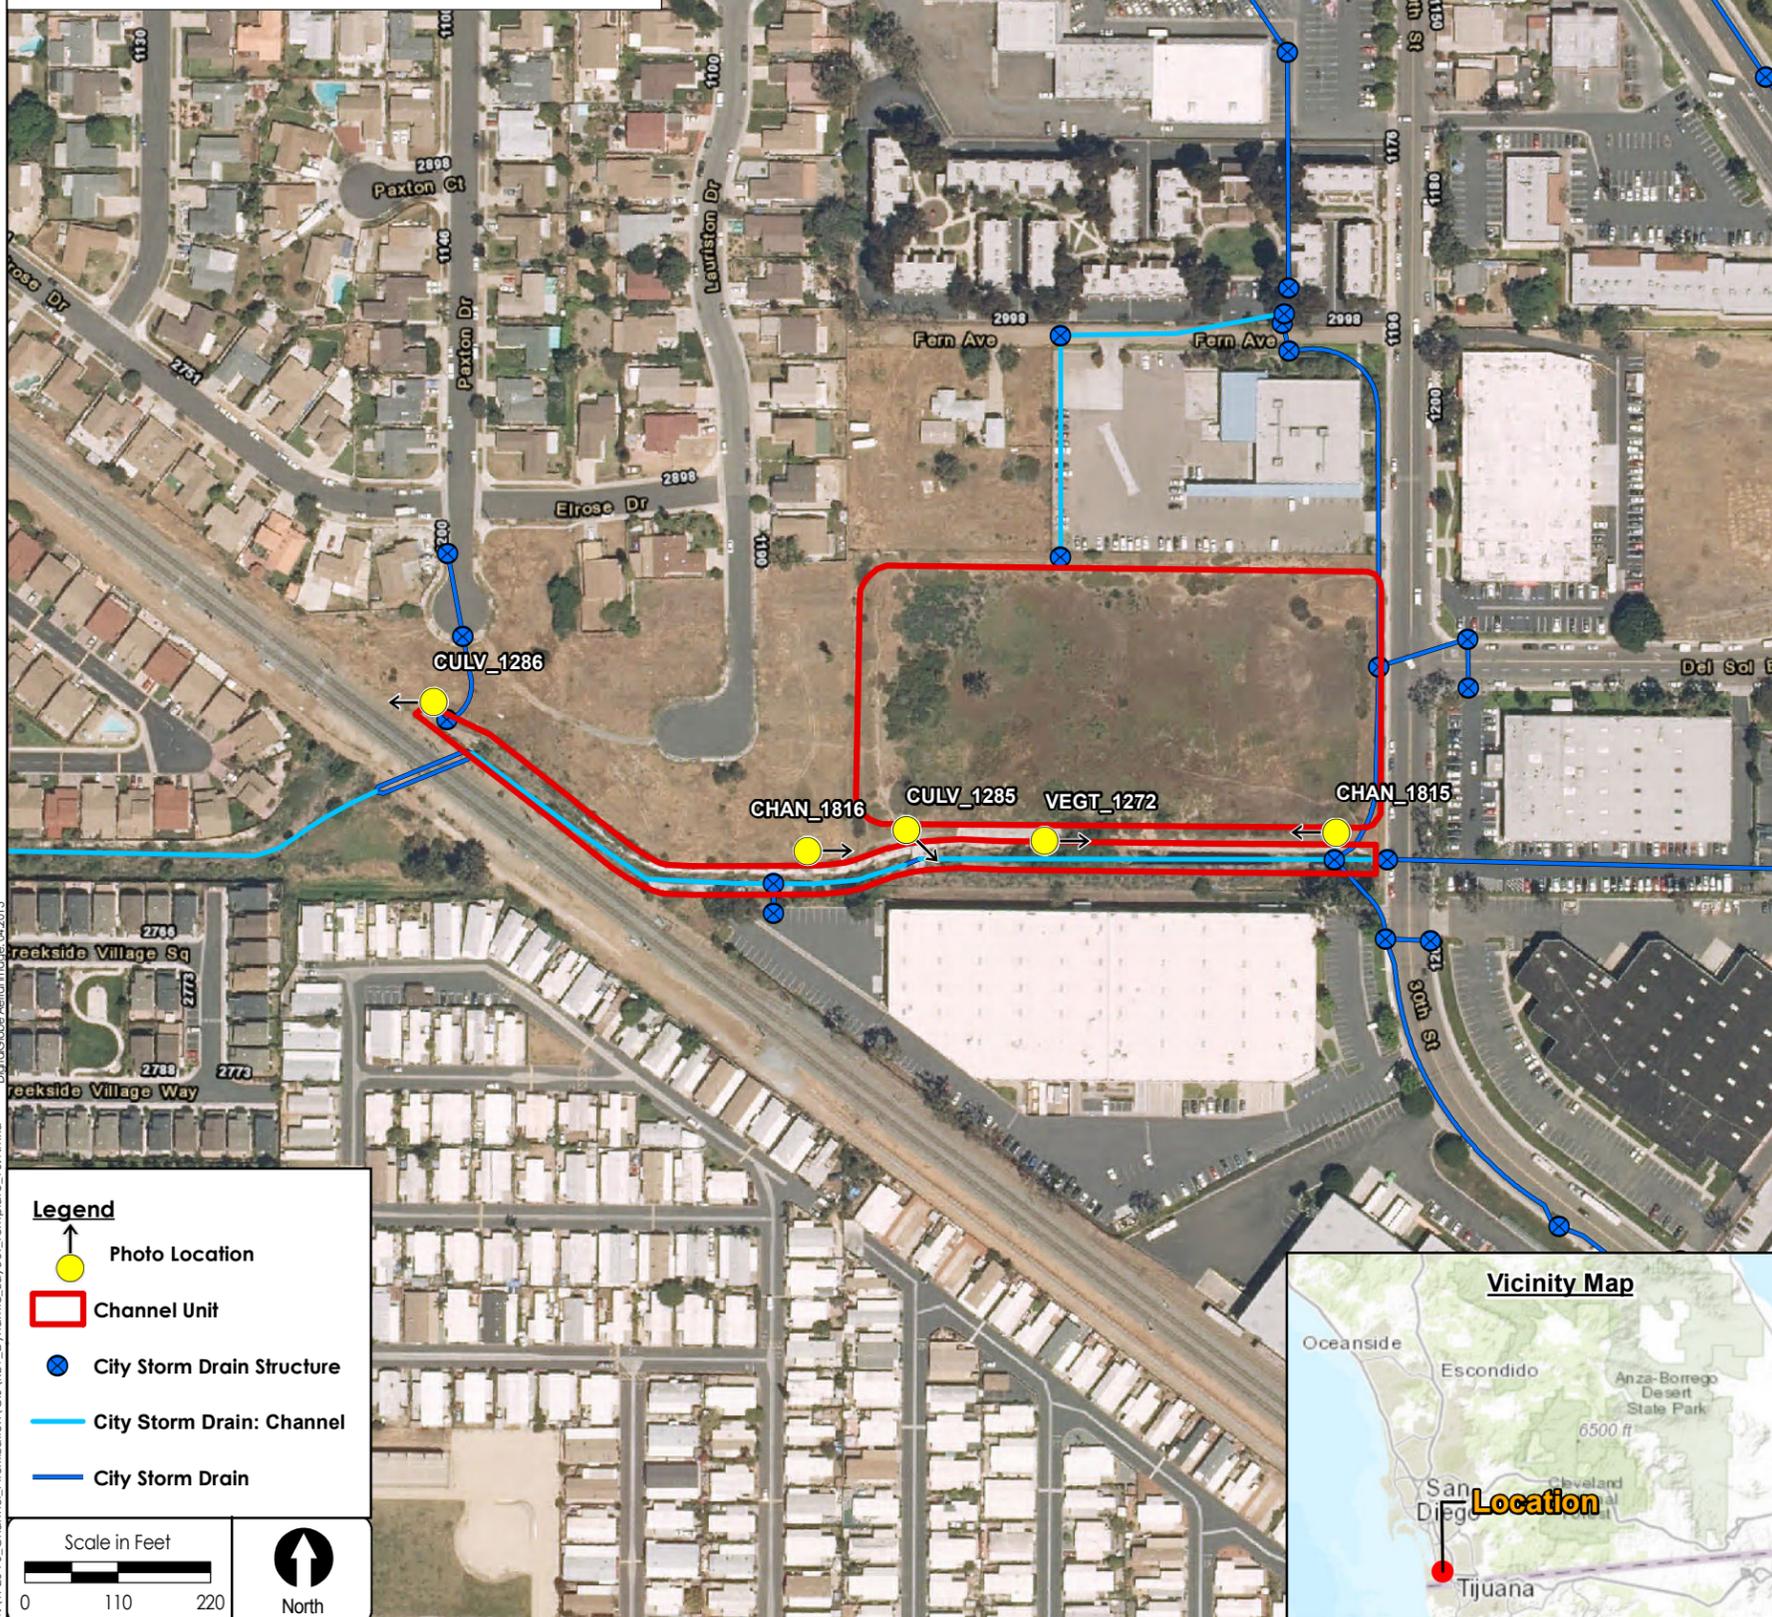
- Maintenance Priority: **MEDIUM**
- Channel Prioritization Score: **68.7 out of 100**
- Capacity Prior to Maintenance: **5-year storm event**
- Capacity After Maintenance (As-built Capacity): **5-year storm event**
- Clogging Potential: **HIGH**
- Approximate Invasive Vegetation Coverage: **LOW**
- Approximate Native Vegetation Coverage: **HIGH**
- Surrounding Area: **Residential**
- Infrastructure Failures: **NONE**
- Site Evaluation Date: **April 19, 2016**
- Notes/Comments: **Portion from behind of the right concrete over bank has been eroded approximately 5 feet deep due to water coming out of channel.**

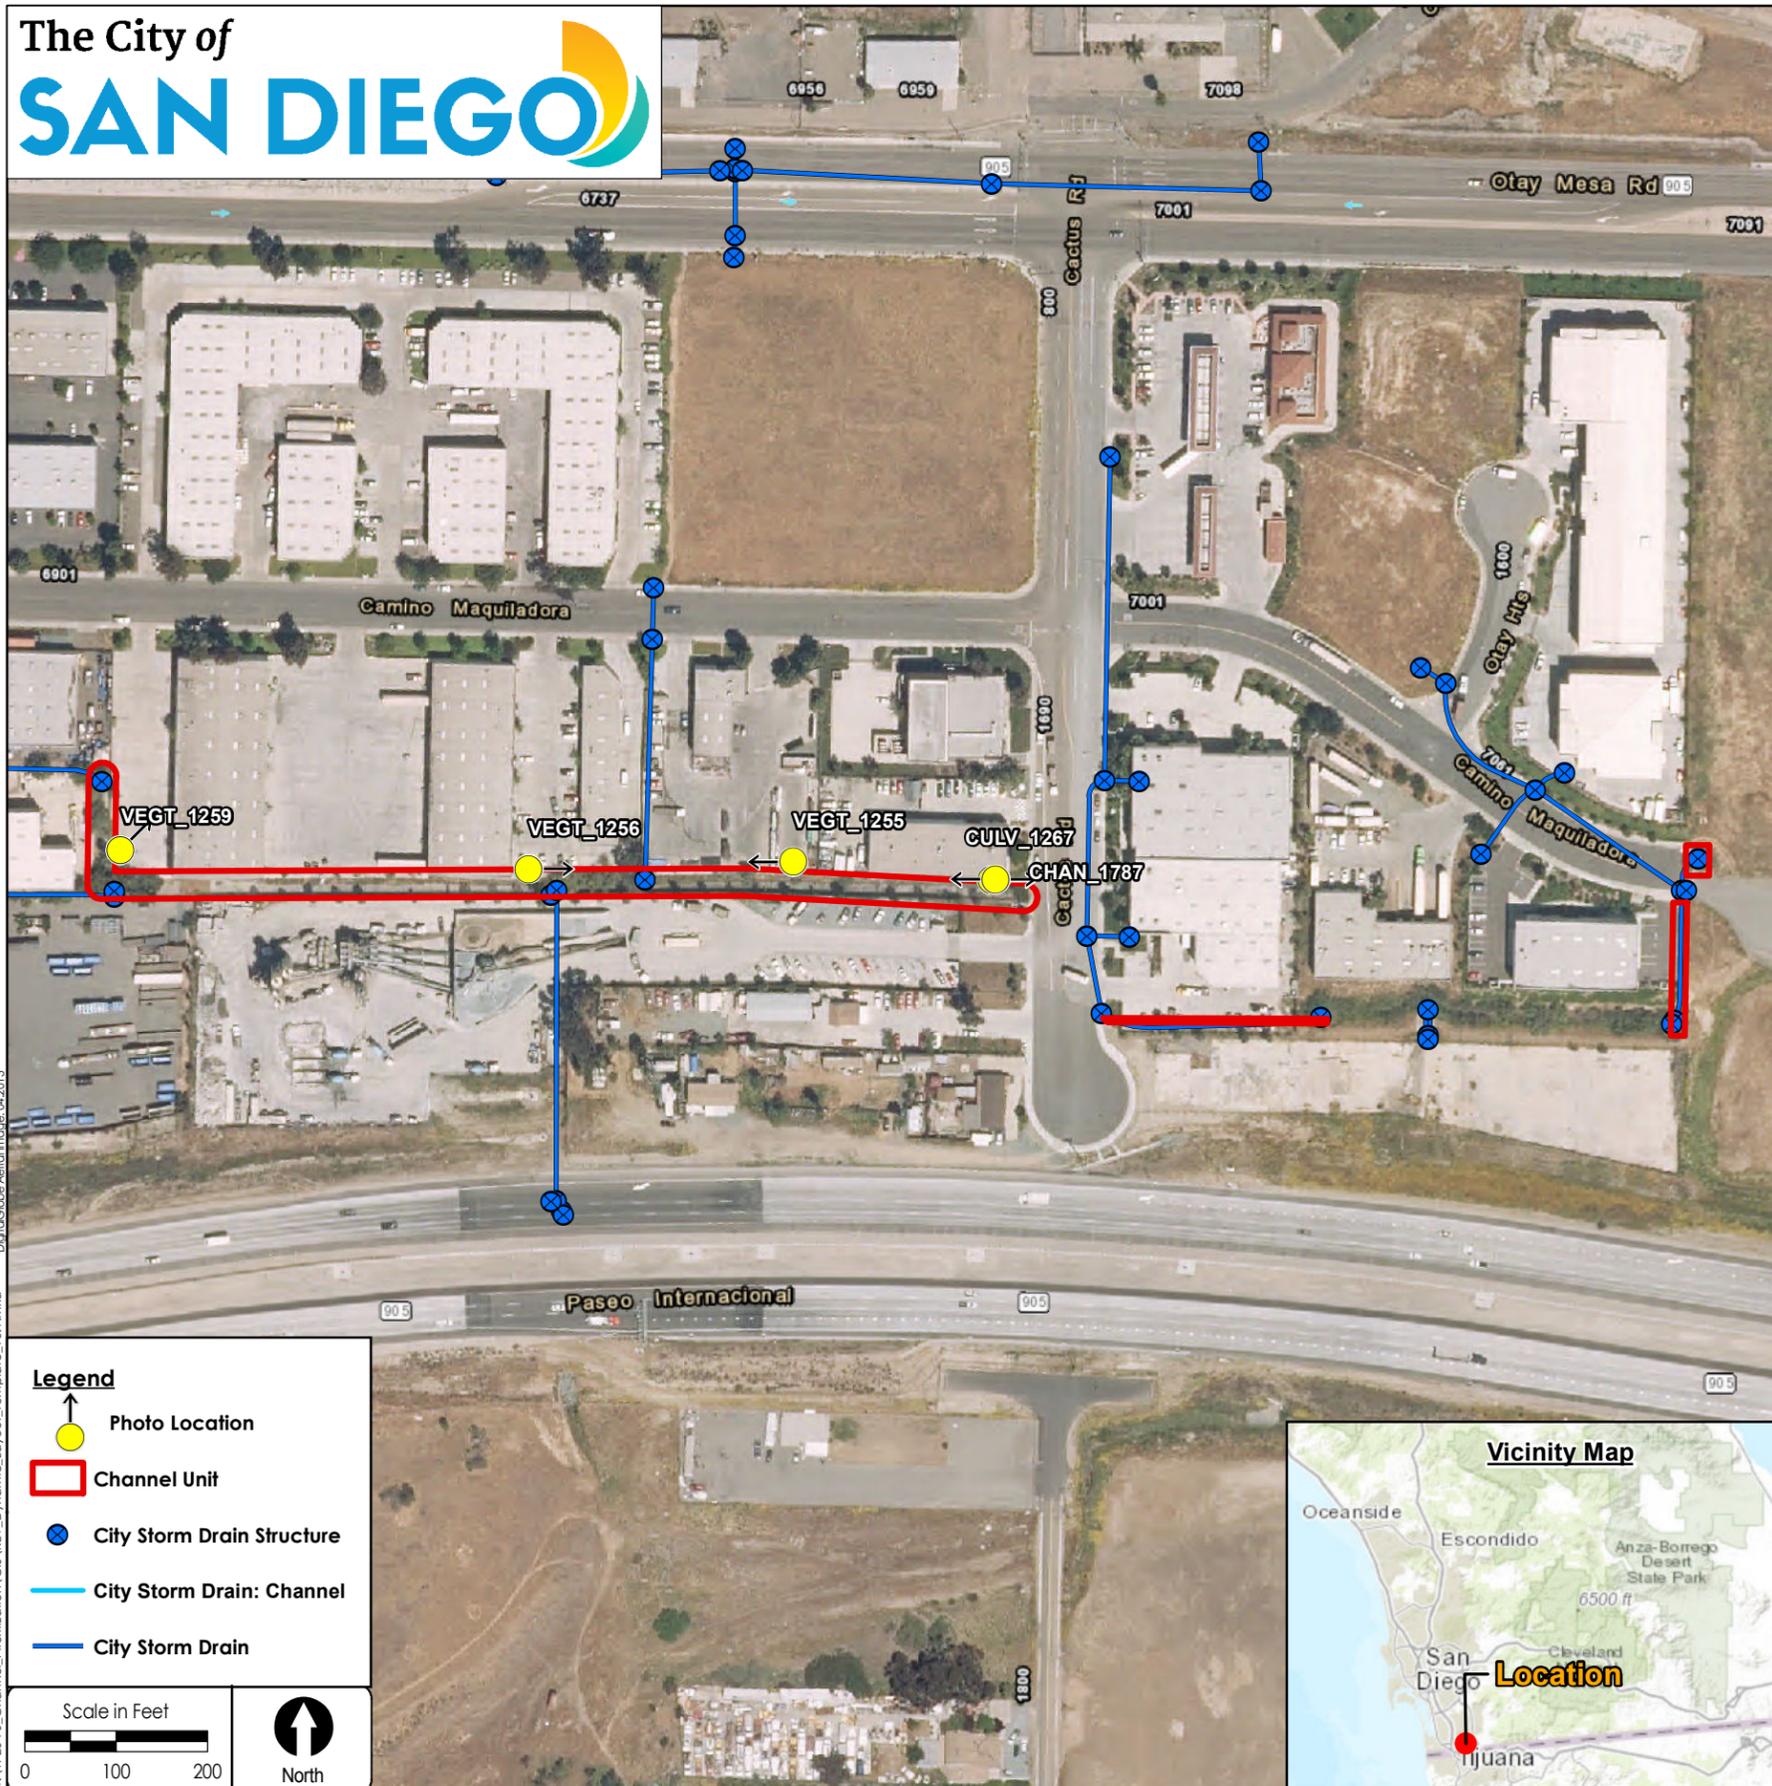
- Maintenance Priority: **MEDIUM**
- Channel Prioritization Score: **68.1 out of 100**
- Capacity Prior to Maintenance: **5-year storm event**
- Capacity After Maintenance (As-built Capacity): **25-year storm event**
- Clogging Potential: **HIGH**
- Approximate Invasive Vegetation Coverage: **HIGH**
- Approximate Native Vegetation Coverage: **LOW**
- Surrounding Area: **Commercial**
- Infrastructure Failures: **NONE**
- Site Evaluation Date: **April 18, 2016**
- Notes/Comments: **This detention basin is concrete lined and has vegetation and sediment established near the outlet.**

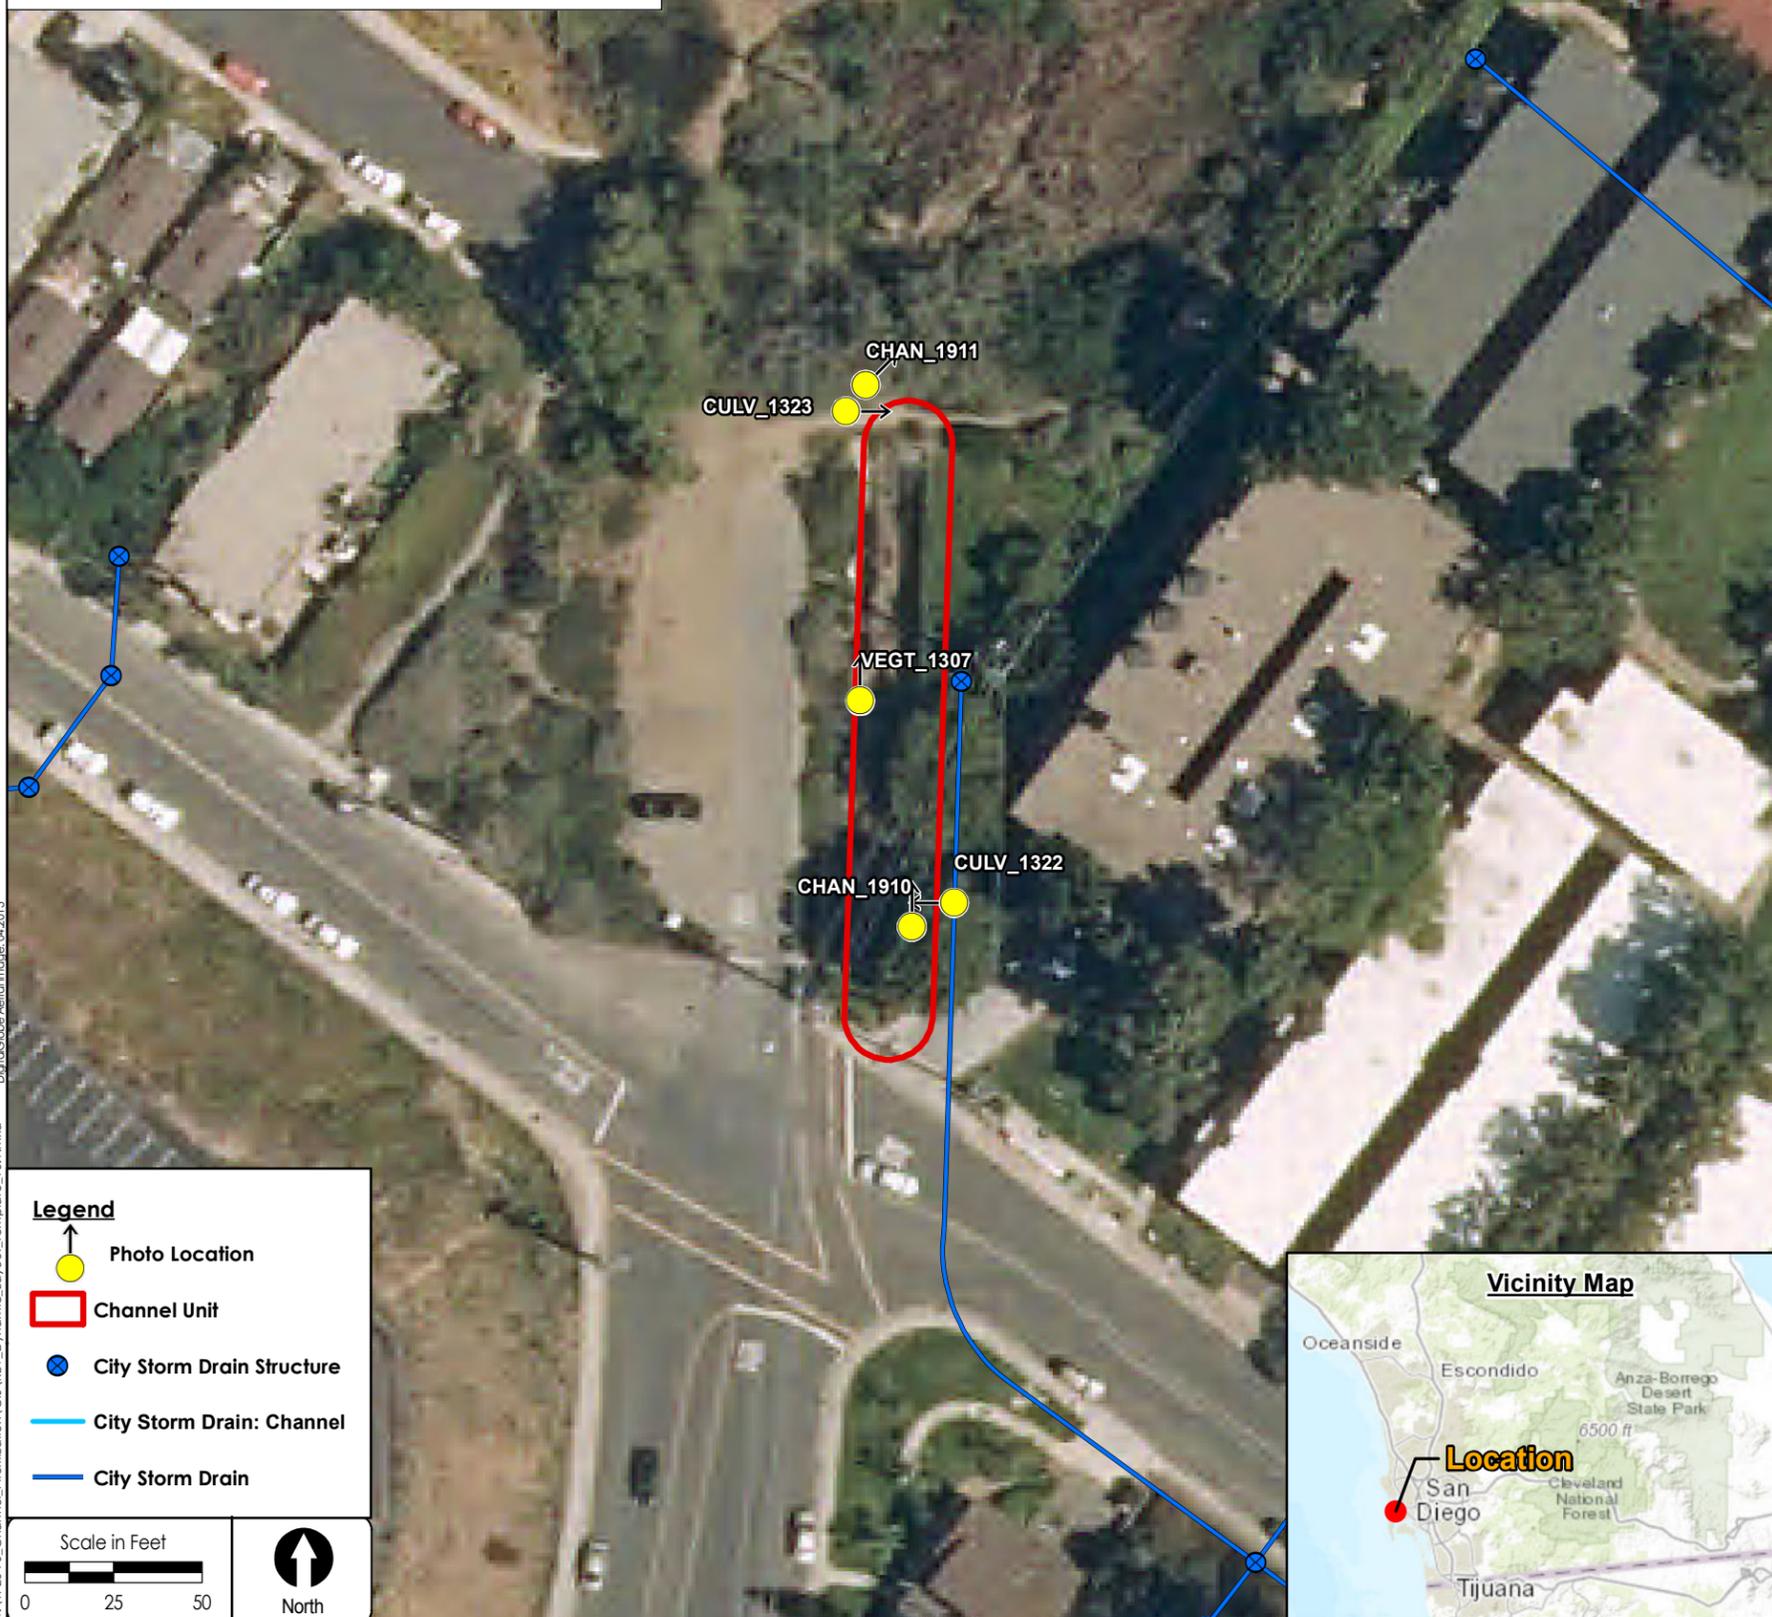
- Maintenance Priority: **MEDIUM**
- Channel Prioritization Score: **67.1 out of 100**
- Capacity Prior to Maintenance: **Less than 2-year storm event**
- Capacity After Maintenance (As-built Capacity): **10-year storm event**
- Clogging Potential: **HIGH**
- Approximate Invasive Vegetation Coverage: **LOW**
- Approximate Native Vegetation Coverage: **HIGH**
- Surrounding Area: **Residential**
- Infrastructure Failures: **NONE**
- Site Evaluation Date: **April 21, 2016**
- Notes/Comments: **Culverts at upstream and downstream ends are half clogged with sediment and vegetation. This channel is in close proximity to an apartment complex and has a high potential of flooding.**

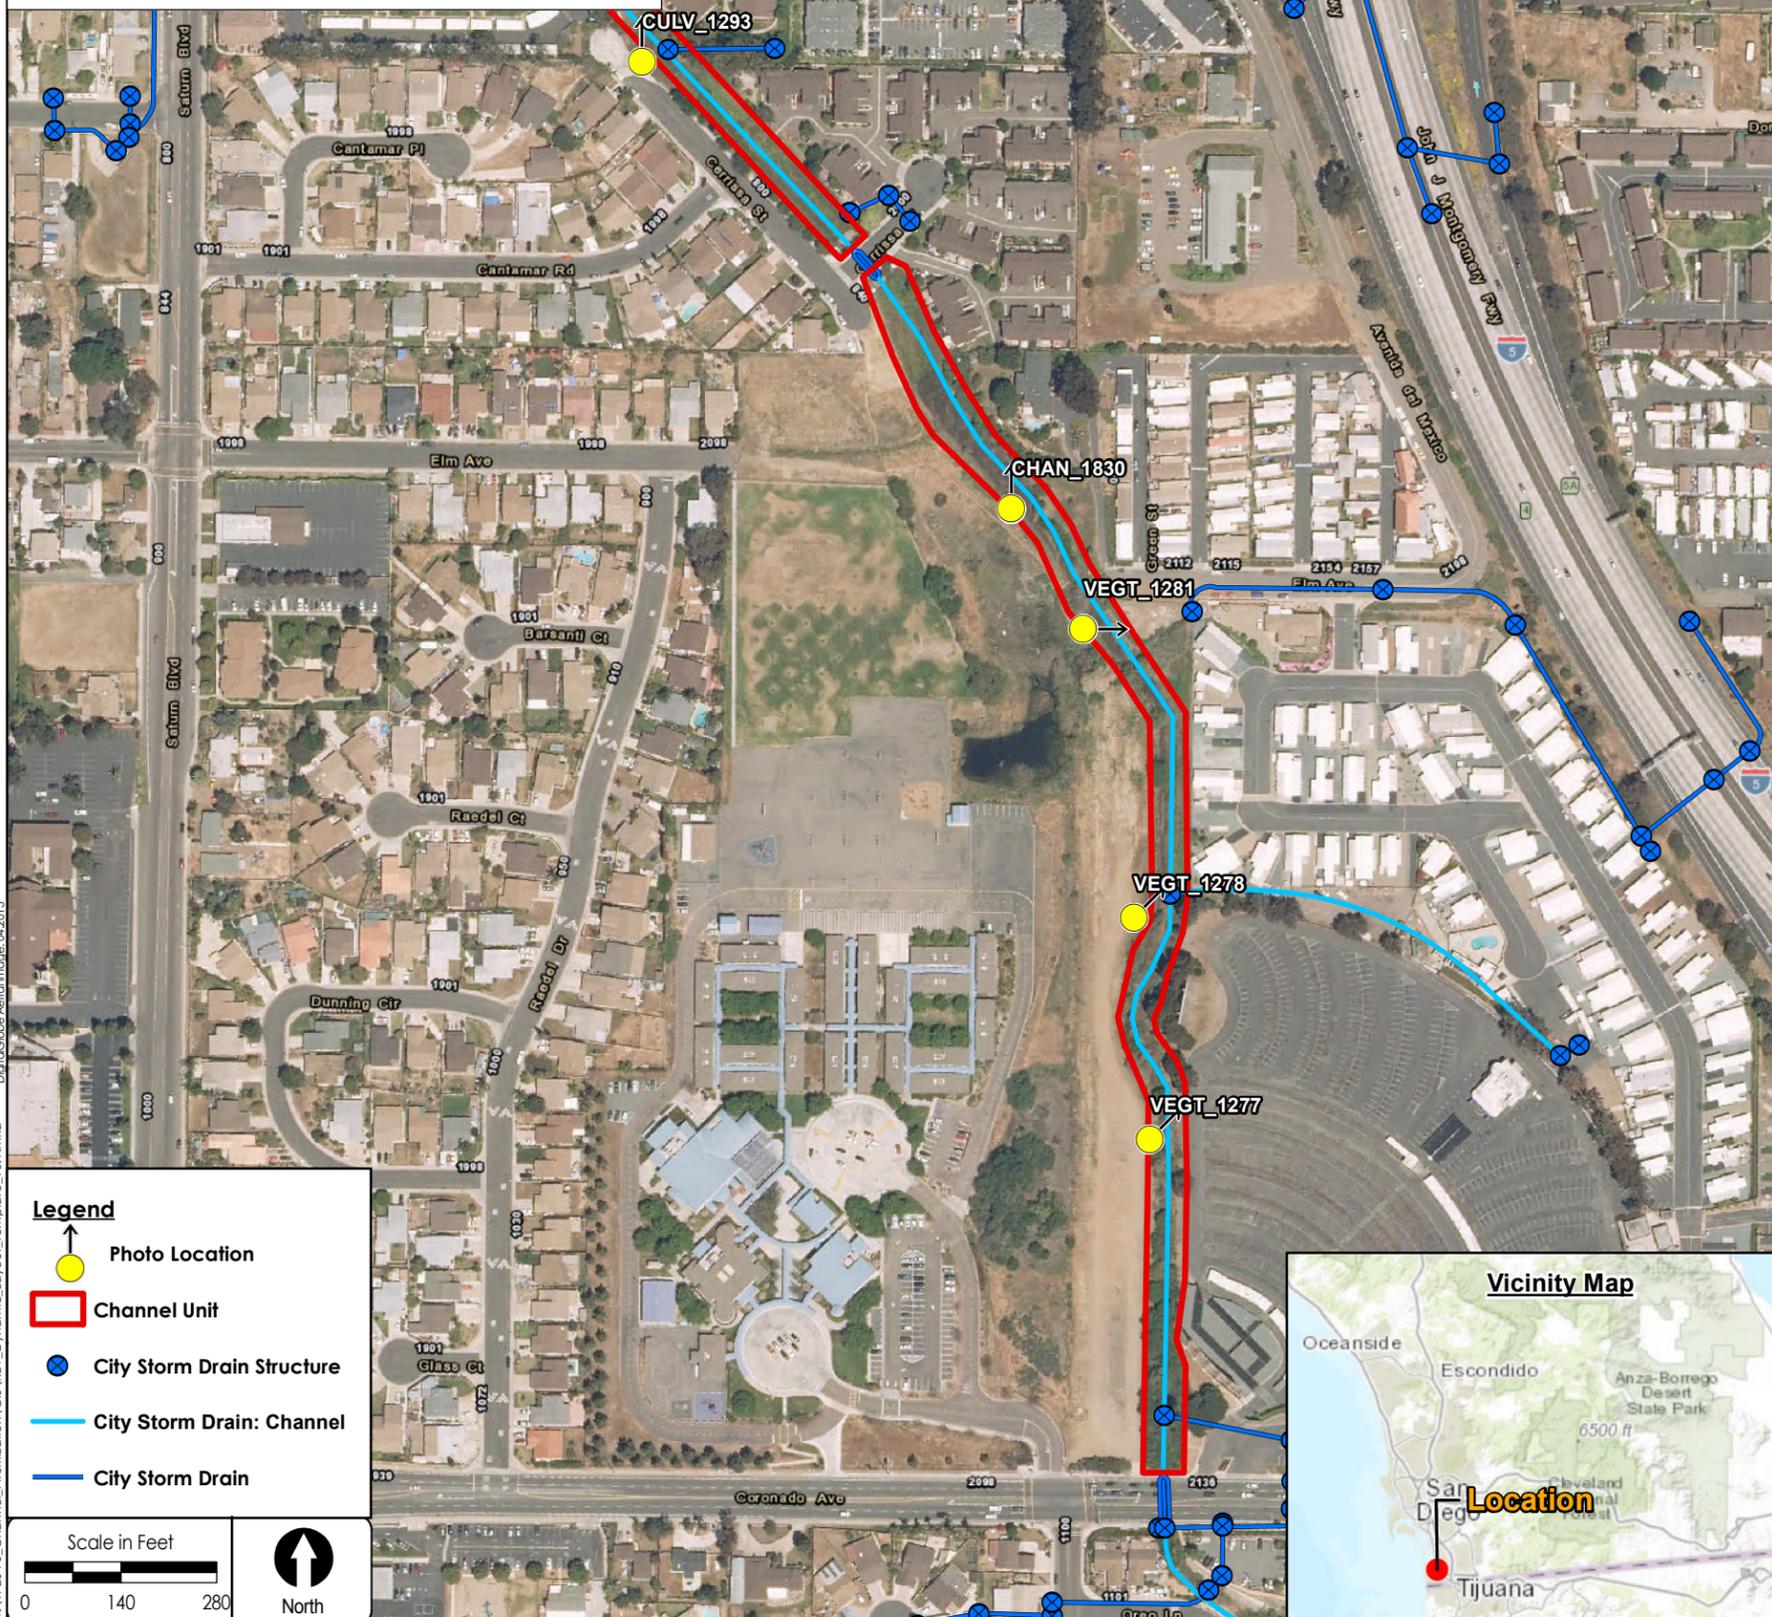
- Maintenance Priority: **MEDIUM**
- Channel Prioritization Score: **65.7 out of 100**
- Capacity Prior to Maintenance: **10-year storm event**
- Capacity After Maintenance (As-built Capacity): **25-year storm event**
- Clogging Potential: **HIGH**
- Approximate Invasive Vegetation Coverage: **LOW**
- Approximate Native Vegetation Coverage: **HIGH**
- Surrounding Area: **Residential**
- Infrastructure Failures: **NONE**
- Site Evaluation Date: **April 19, 2016**
- Notes/Comments: **Channel has dense vegetation in terms of willows, tules and arundo. Houses are in close proximity to the channel and have a potential to flood.**

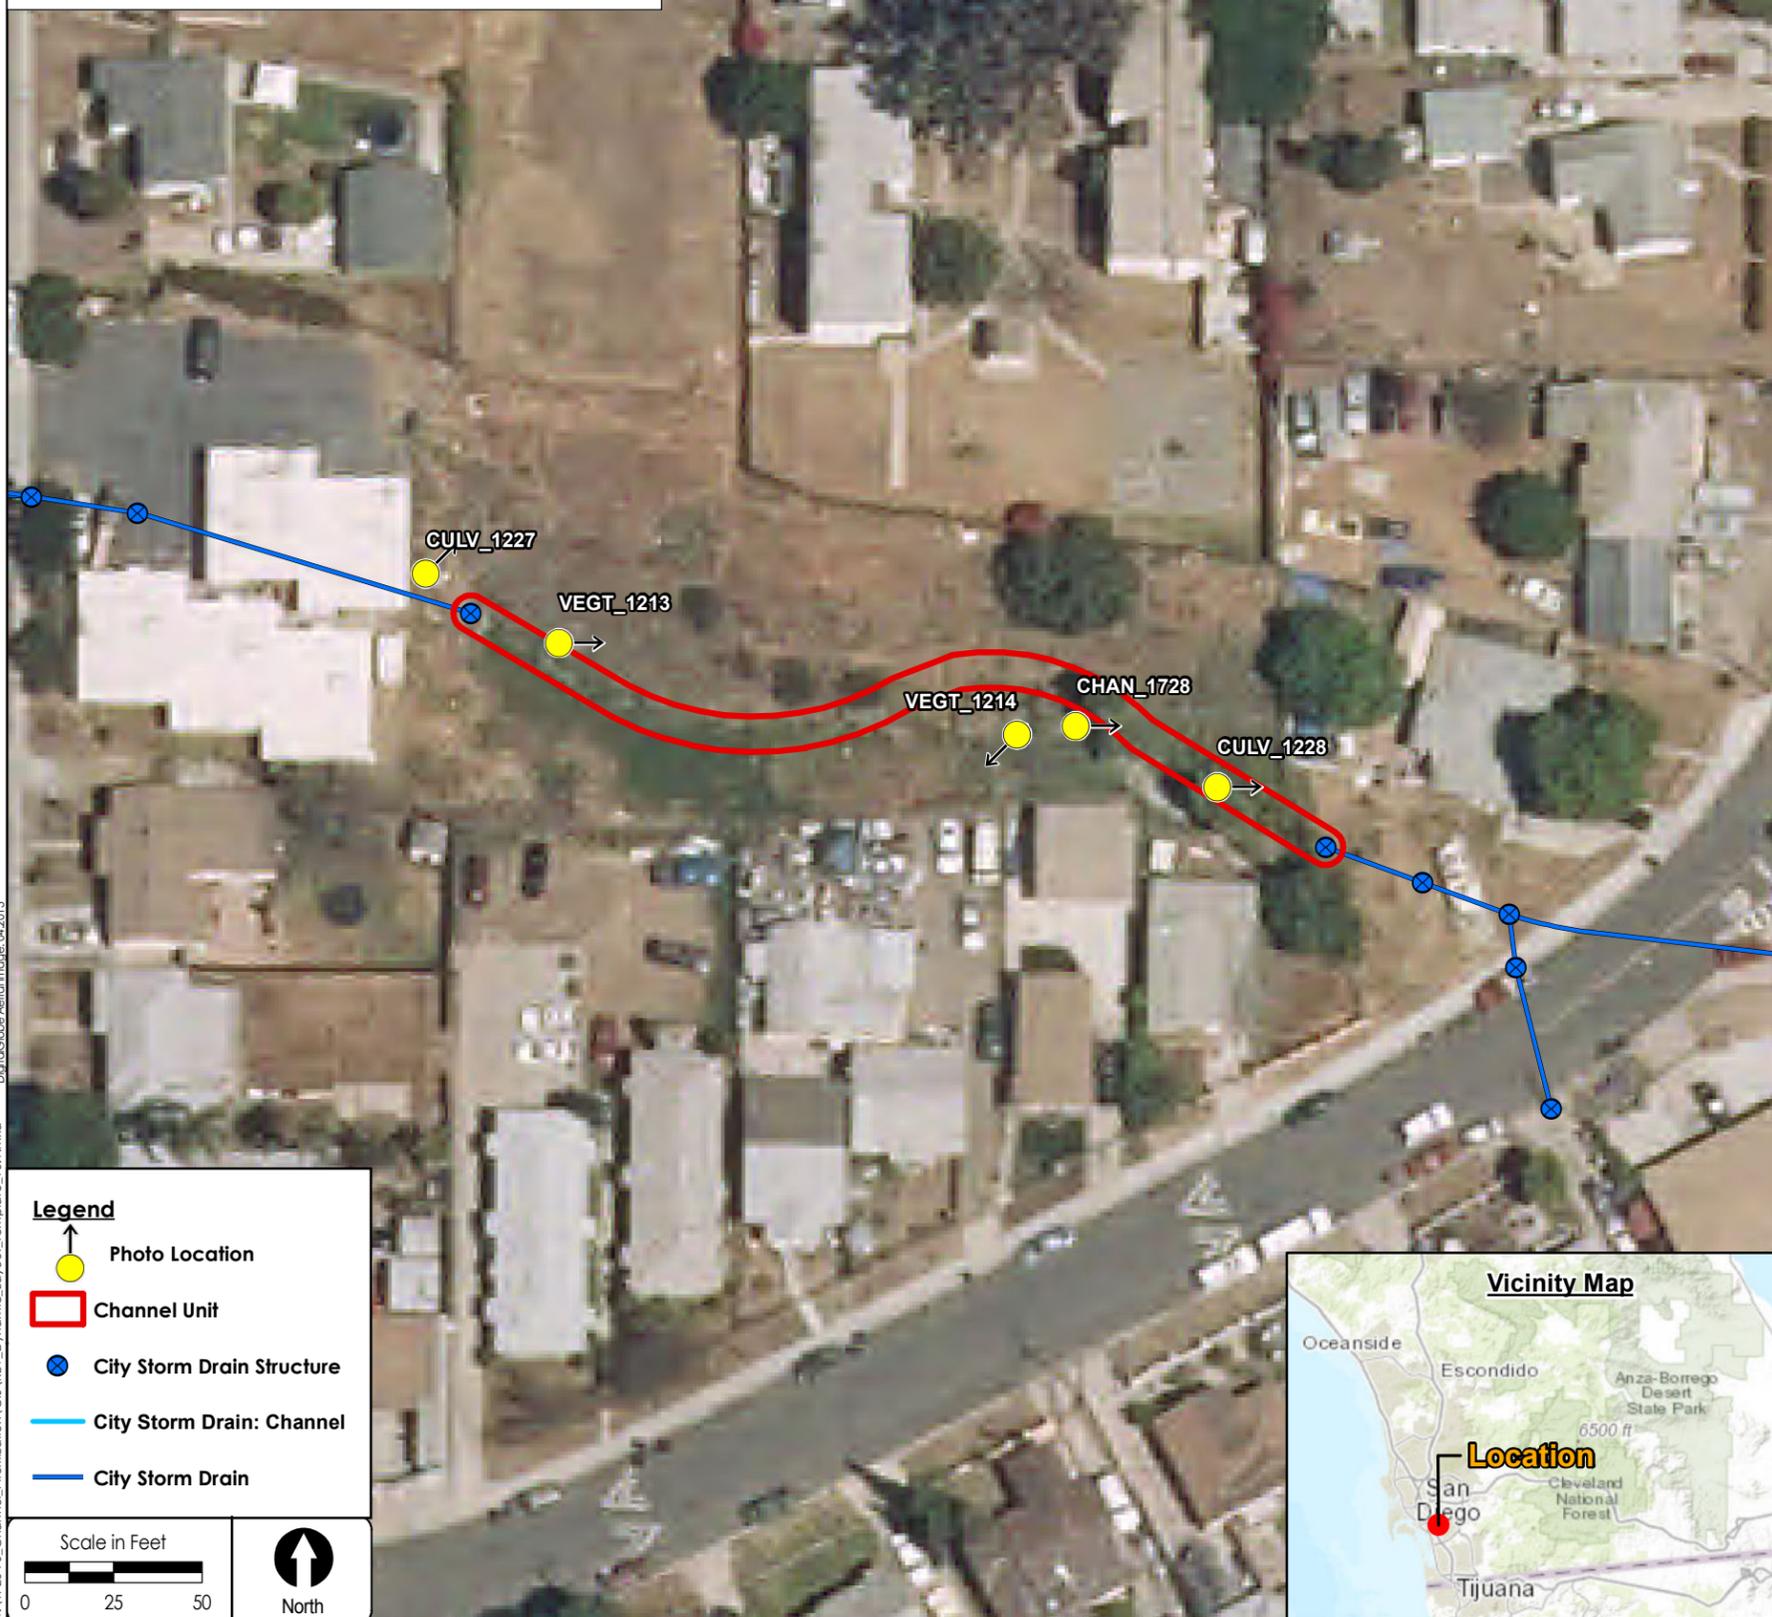
- Maintenance Priority: **LOW**
- Channel Prioritization Score: **63.6 out of 100**
- Capacity Prior to Maintenance: **less than 2-year storm event**
- Capacity After Maintenance (As-built Capacity) : **less than 2-year storm event**
- Clogging Potential: **HIGH**
- Approximate Invasive Vegetation Coverage: **MEDIUM**
- Approximate Native Vegetation Coverage: **MEDIUM**
- Surrounding Area: **Residential**
- Infrastructure Failures: **NONE**
- Site Evaluation Date: **June 17, 2016**
- Notes/Comments: **Inlet to desilting basin is 75% clogged with tullies. The trash fence around the outlet is full of dead vegetation and sediment deposition.**
