TEXT CLARIFICATION
COASTAL EROSION ASSESSMENT AND
CAVE SOLUTION FEASIBILITY ANALYSIS
COAST BOULEVARD AND COOK'S CRACK SEA CAVE
SAN DIEGO, CALIFORNIA

COASTAL EROSION ASSESSMENT AND
CAVE SOLUTION FEASIBILITY ANALYSIS
**COAST BOULEVARD AND
COOK'S CRACK SEA CAVE**
SAN DIEGO, CALIFORNIA

Project No. 2086B
June 17, 2019

GEOTECHNICAL SURVEY & EVALUATION
COOK'S CRACK SEA CAVE
SAN DIEGO, CALIFORNIA

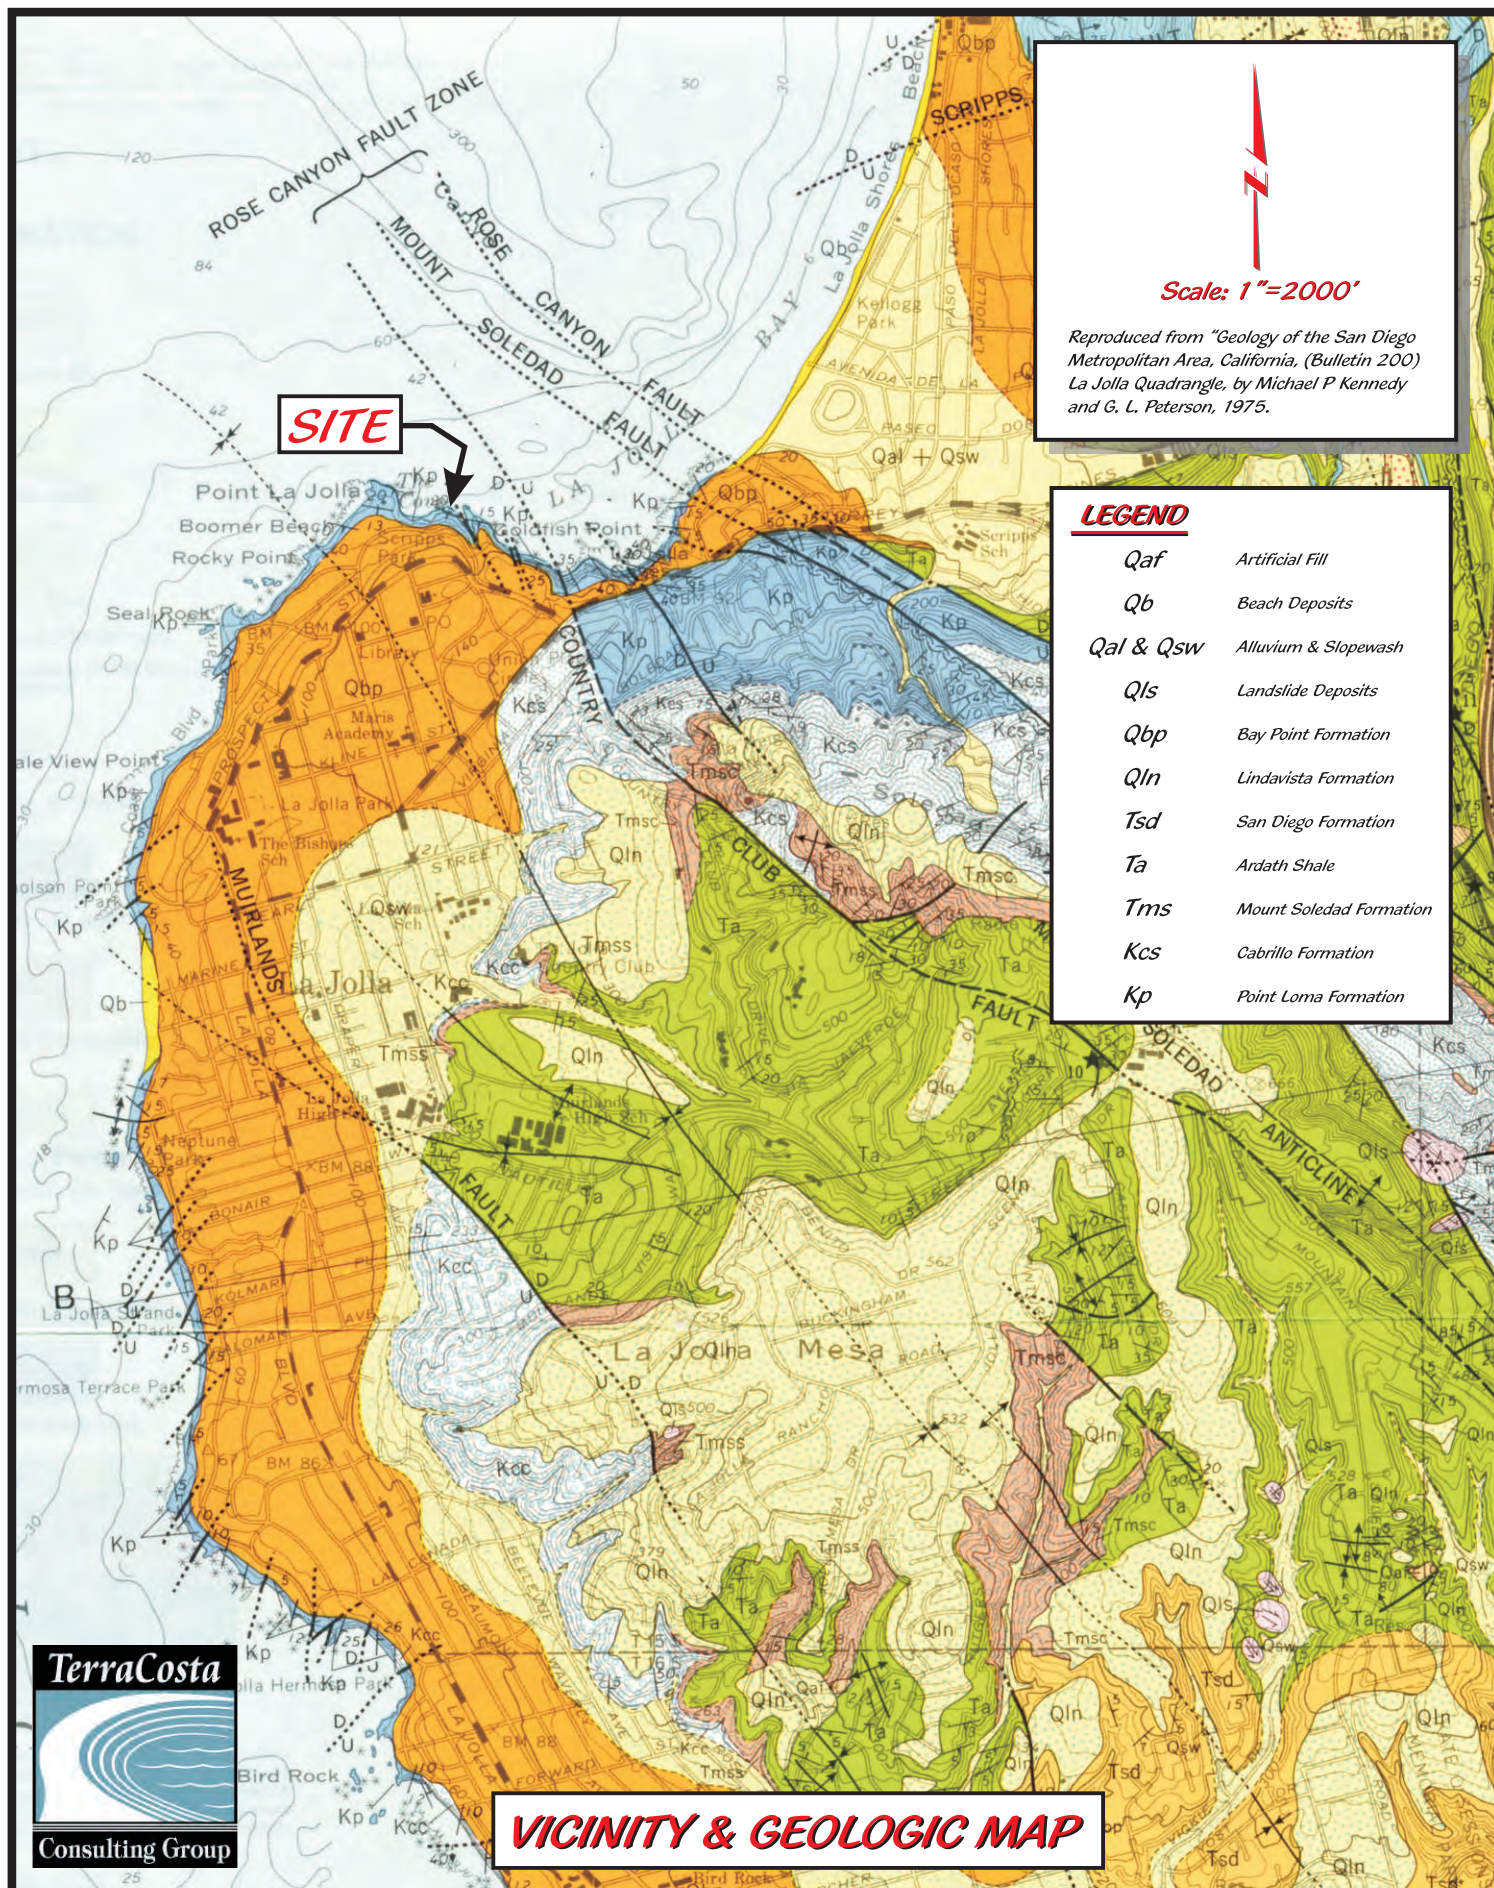
PHOTO NO.:
4

As indicated on Figure 4, the face of the concrete plug would coincide with the approximate back of the depressed area along the sea cliff, as shown on Photo 4, with the actual completed plug not even visible from the perspective of Photo 2. We propose that the plug be filled utilizing concrete-filled 2 cubic yard geobags, for which we are recommending GT1000MB geobags (product literature provided in Appendix B). The front face of the geobags would be positioned to coalign with the back of the indentation within the coastline, then backfilled with a non-reinforced erodible concrete mix consisting of two sacks of cement with 200 pounds of fly ash per cubic yard of erodible concrete. We have utilized this mix design to fill-in several sea caves, and the mix provides both a pumpable and low strength mix that should roughly approximate the strength of the Point Loma formational shelf rock.

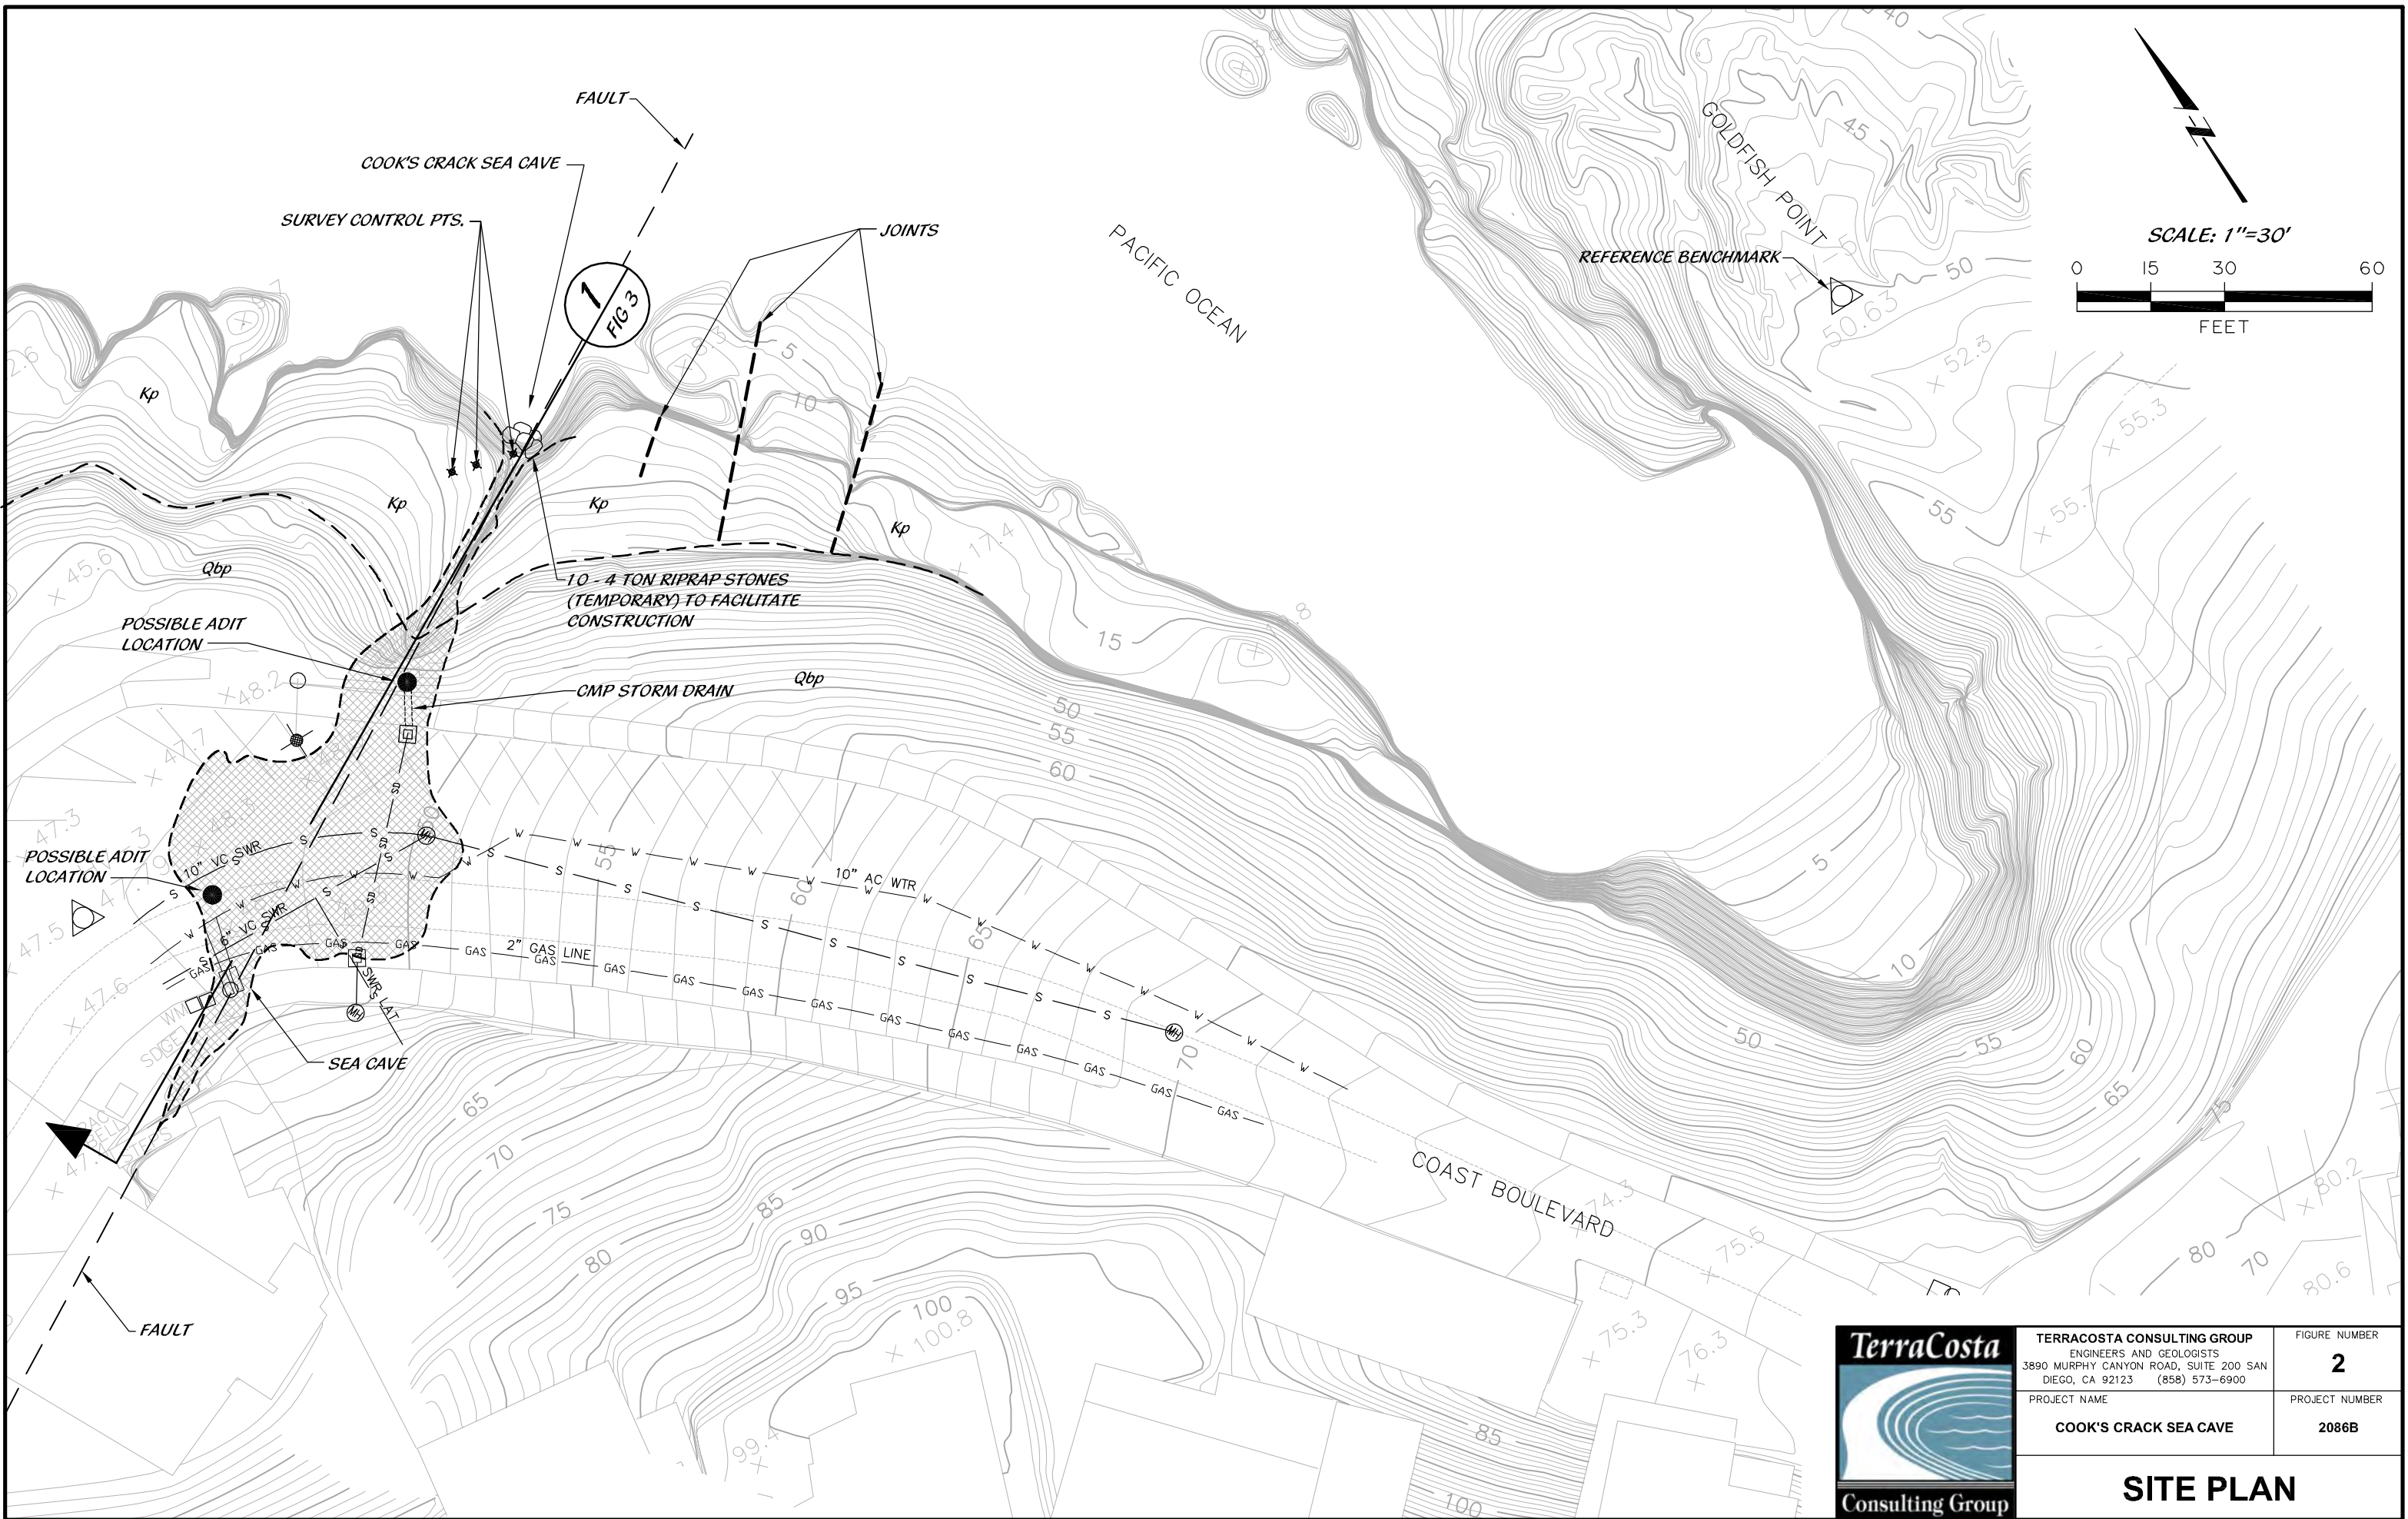
SITE PLAN

Our current survey indicates that as expected, the sea cave has widened approximately 6 to 8 feet (Figure 3) and continues to advance southerly under the sidewalk on the southerly side of Coast Boulevard, as shown on Figure 2. Figures 2 through 8 illustrate the current limits of the sea cave. Photos 2 through 8 are of the interior of the sea cave. It should also be noted that there is evidence of the widening of the fault, allowing the down-dropping of a smaller block, as illustrated on Figure 8 and discussed below in Section 5.

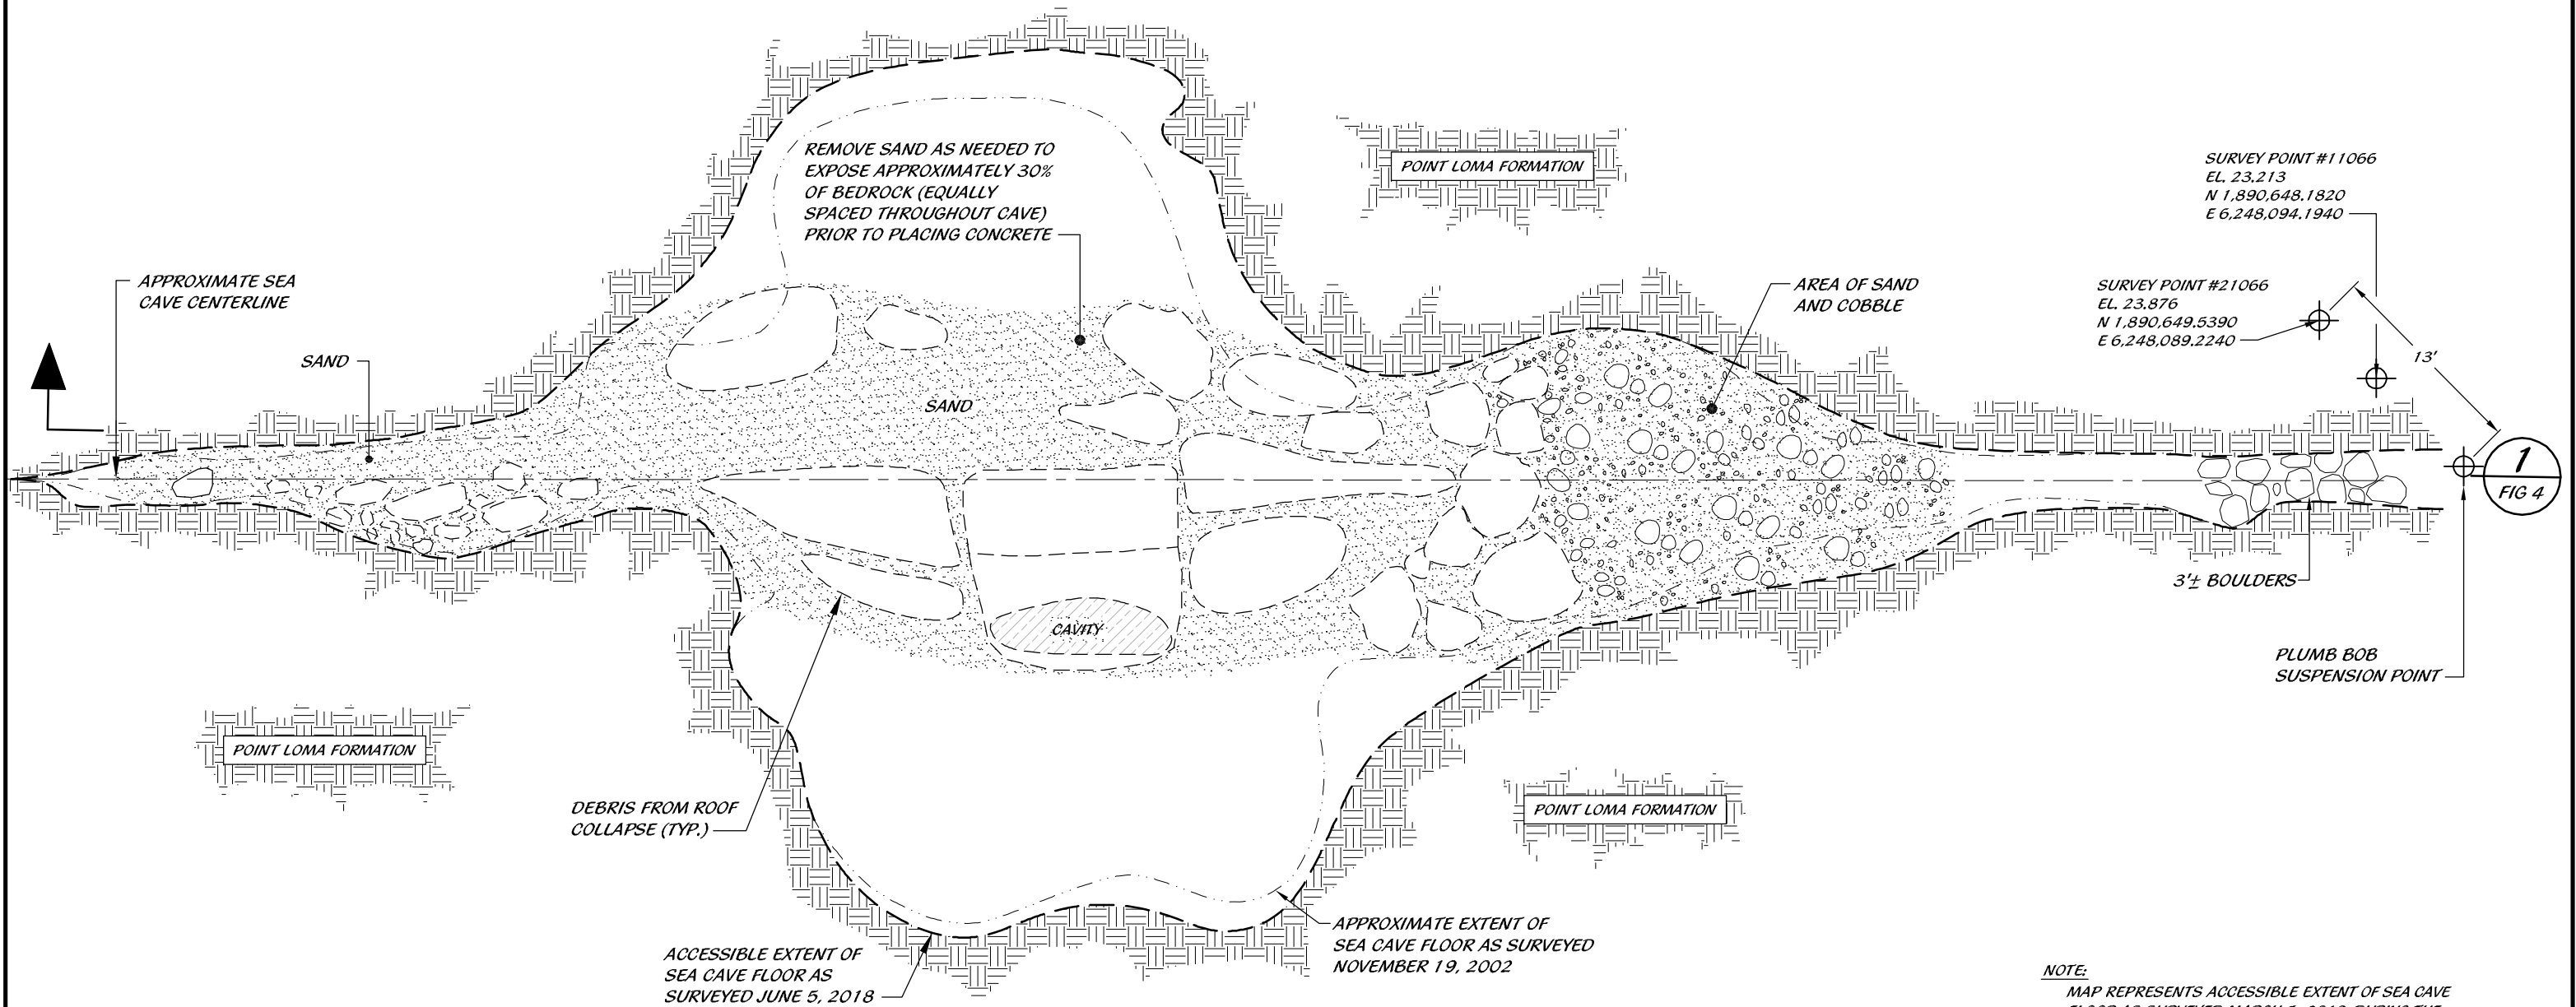
PLAN VIEW
SCALE: 1"=10'

NOTE:
MAP REPRESENTS ACCESSIBLE EXTENT OF SEA CAVE FLOOR AS SURVEYED MARCH 5, 2019, DURING THE TIDAL LOW OF -0.4 MLLW (APPROX. 3:00 p.m.)

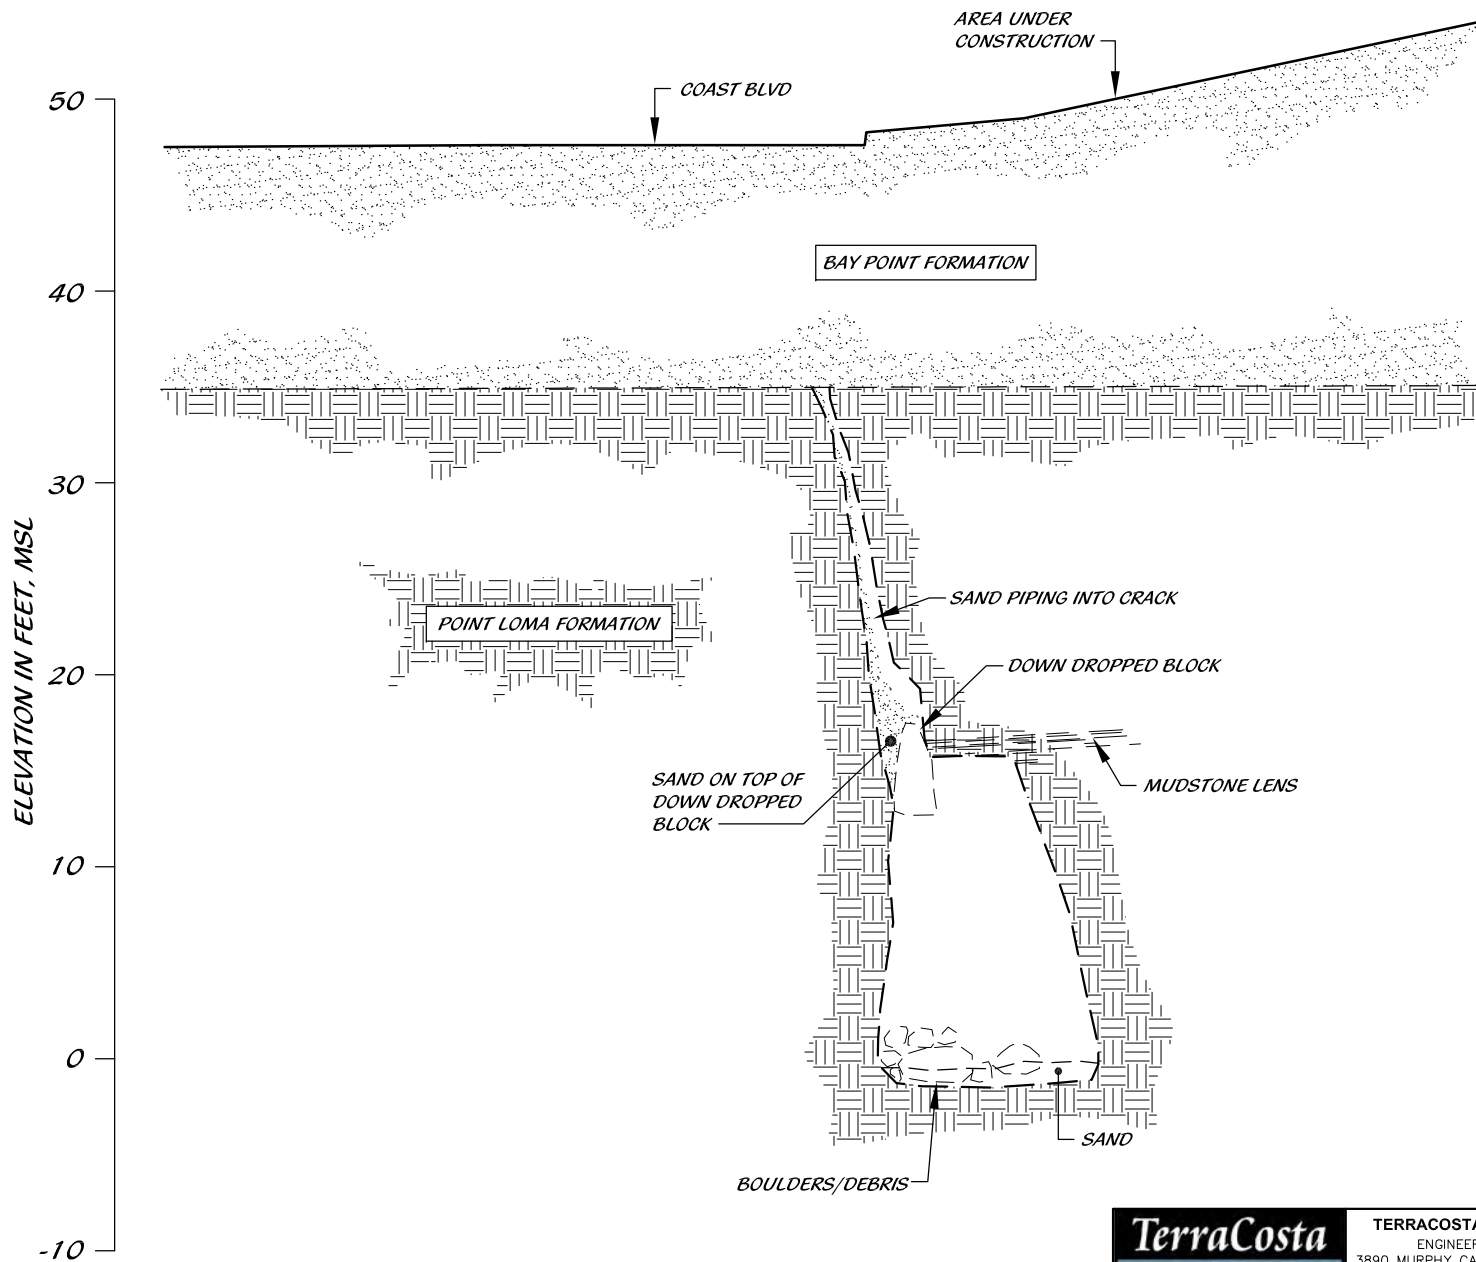
CROSS SECTION 61B-4

Formation soils through widening fractures into the sea cave. This mechanism is exhibited in Figure 8, with sands from the overlying terrace deposits now migrating through this underlying fracture. This lost ground will progressively worsen with time. Based on our recent observations, we recommend that the roadway over the sea cave be closely monitored for signs of settlement, and that the sea cave be inspected again in the next five years. It is also our opinion that a structural solution is necessary to prevent a future catastrophic failure.
