REPORT OF PRELIMINARY GEOTECHNICAL INVESTIGATION

DESSY RESIDENCE 8470 EL PASEO GRANDE LA JOLLA, CALIFORNIA

WAVE RUNUP / SEA LEVEL RISE STUDY Prepared by TerraCosta Consulting Group, Inc. Dated March 21, 2017

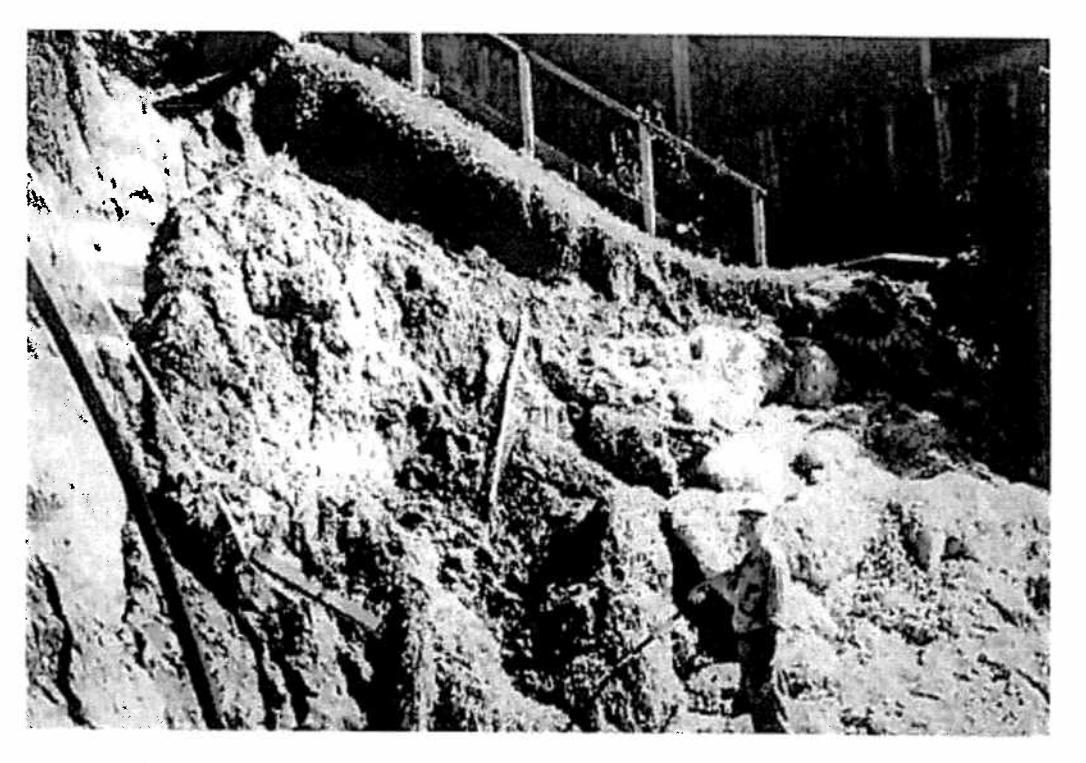
BACKFILL: Retaining wall backfill soils should be compacted to at least 90 percent relative compaction. Expansive or clayey soils should not be used for backfill material. The wall should not be backfilled until the masonry has reached an adequate strength.
