# **Biological Technical Report Addendum**

## **Maple Canyon—Restoration Phase 1 (H176828) Site Development Permit**

**Development Services Department  
Project Number 517439**

**Prepared for  
City of San Diego  
Department of Public Works**

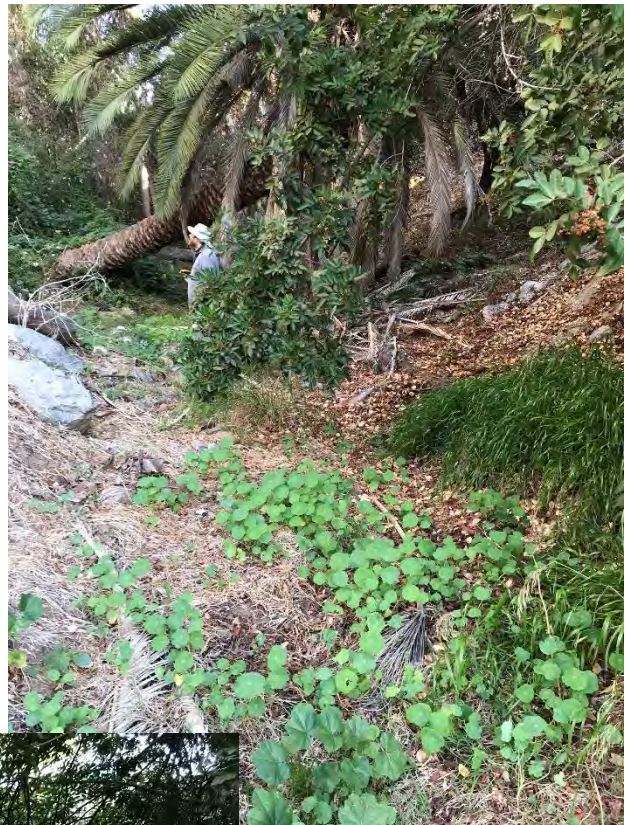
**Photo 1.1:** The head of the canyon looking north with no evidence of a channel, hydrology, or features that would be an OHWM.

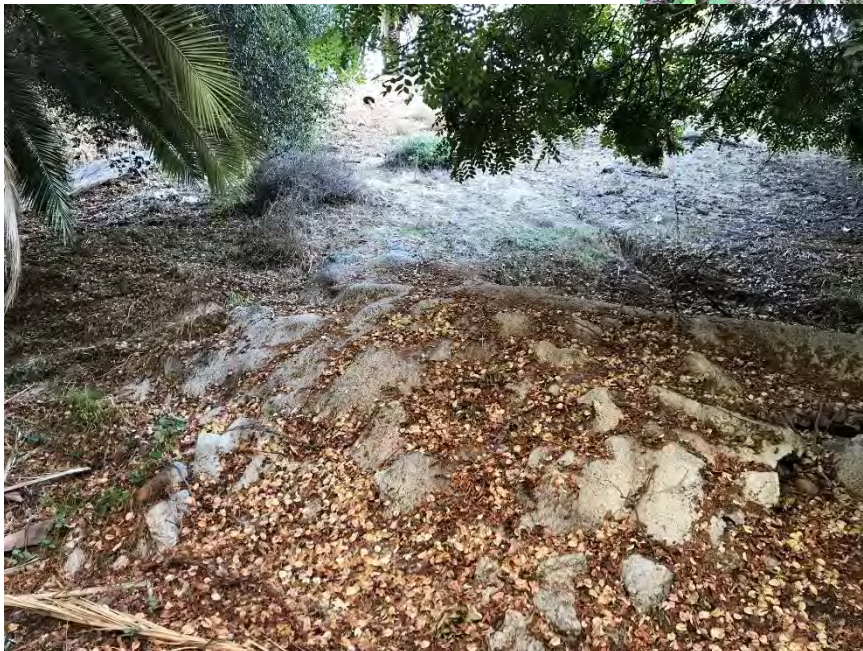
**Photo 1.2.** The existing SD pipe from Fourth Ave comes down this slope and turns right in the middle of the photo. The pipes are mostly covered in concrete that has been applied to prevent erosion.

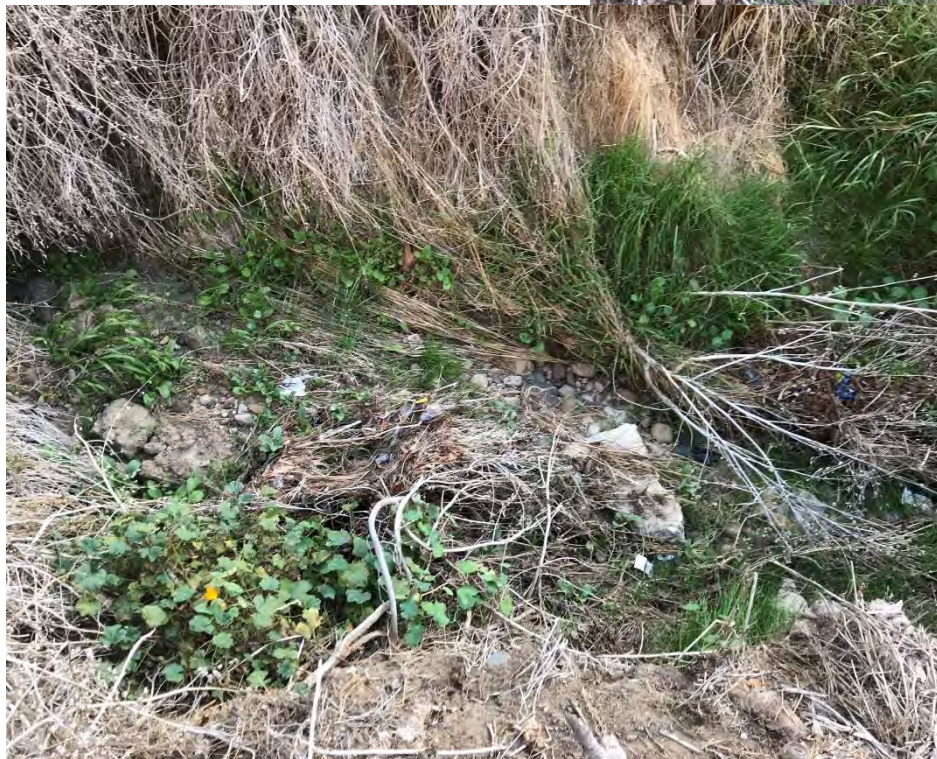
**Photo 1.6:** The first location where signs of an OHWM were present: flow stabilized, a defined bed and bank occurred, vegetation was bent, and some sorting of material was occurring.

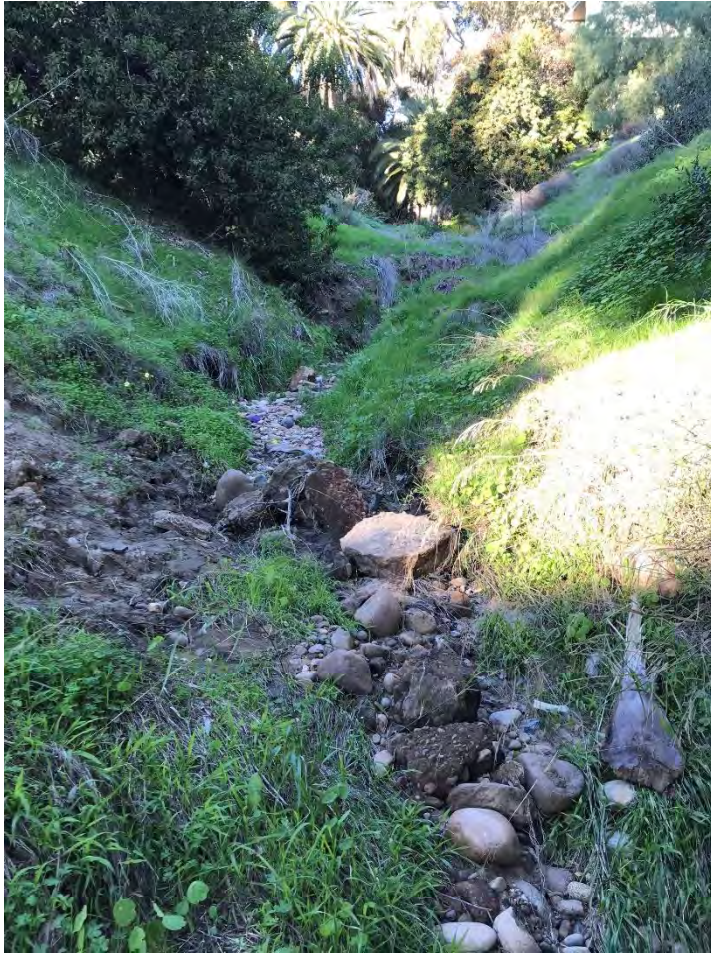
**Photo 1.7:** Looking from south towards upper end of the canyon. Drainage is confined within a bed and bank though some concrete and asphalt debris is present.

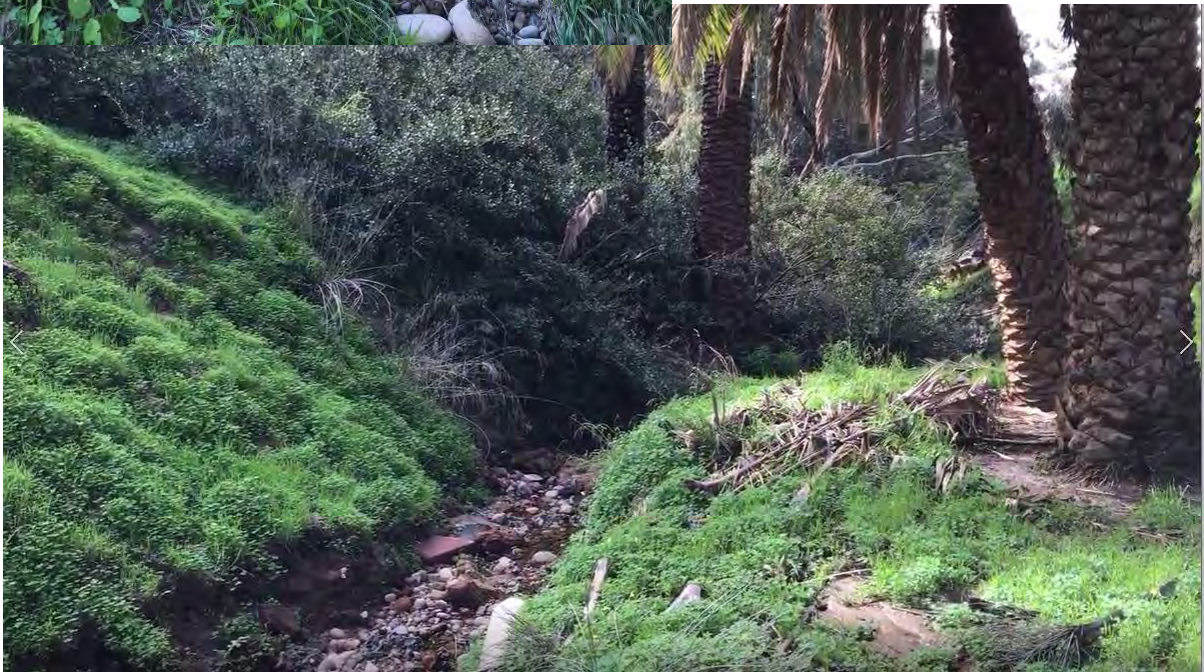
Between the Quince Street and 1<sup>st</sup> Avenue bridges, the creek passes among bluegum trees (*Eucalyptus globulus*; upland [UPL]) and Canary Island Palms (*Phoenix canariensis*; not listed [UPL]) (Photo 1.8 through 1.12) and in one place the bank has eroded threatening the trail (Photos 1.9). A recently installed storm drained outlet was not installed per specifications and needs to be corrected (Photo 1.11). Storms have damaged or toppled eucalyptus trees and their broken branches and fallen trunks are evident in several places along the creek affecting water flow (Photos 1.10 through 1.14). Severe erosion has occurred in places creating high, vertical banks (Photo 1.13), and eroding away soil that contained utility pipes (Photo 1.14).

**Photo 1.9:** Looking north up canyon past the Canary Island palms in Photo 1.8, with the Quince Street Pedestrian Bridge in the background. The drainage is undermining the soil beside the trail and will soon cause the collapse of the trail in this section.

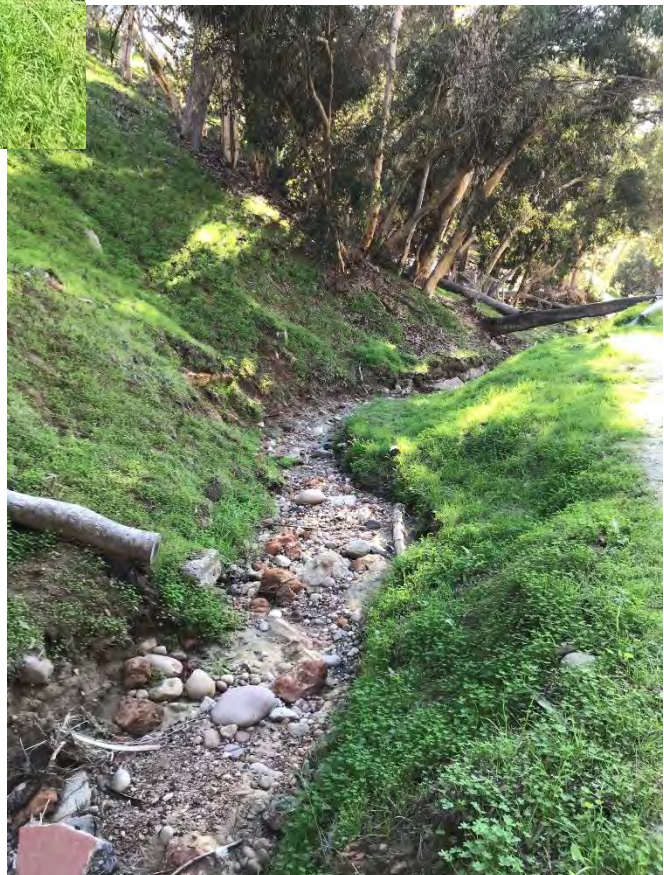
**Photo 1.11:** Existing outfall that will be replaced.

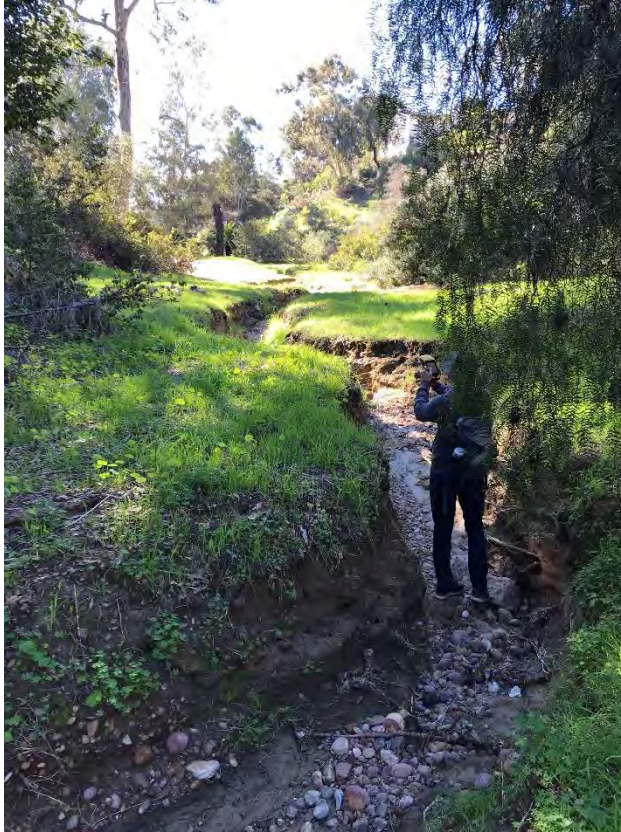
**Photo 1.15:** the creek's gradient decreases and the flow stabilizes south of the erosive section in Photos 1.11 through 1.14. The trail crosses Drainage 1 in the distance.

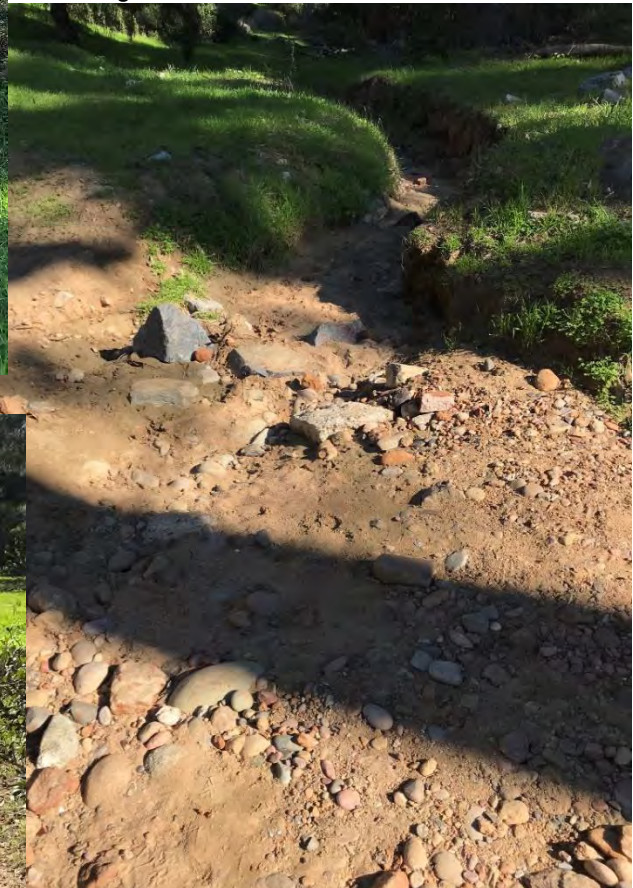
**Photo 1.16:** Drainage 1 spills across the trail which is likely maintained to allow vehicle crossing.

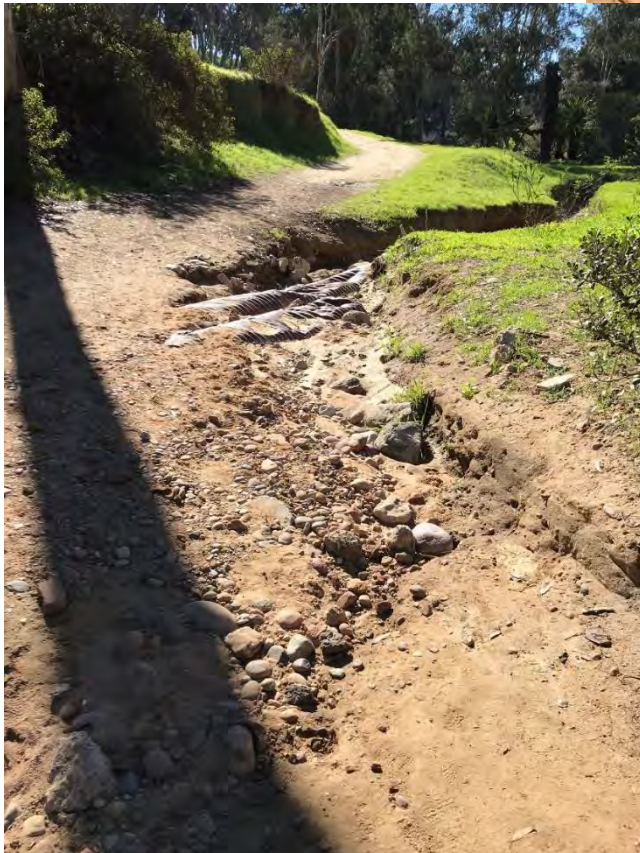
**Photo 1.17:** Looking south where Drainage 1 crosses the trail. The ends of two CMPs are visible but where they start is unknown. The drainage quickly reforms a bed and bank after crossing the trail.

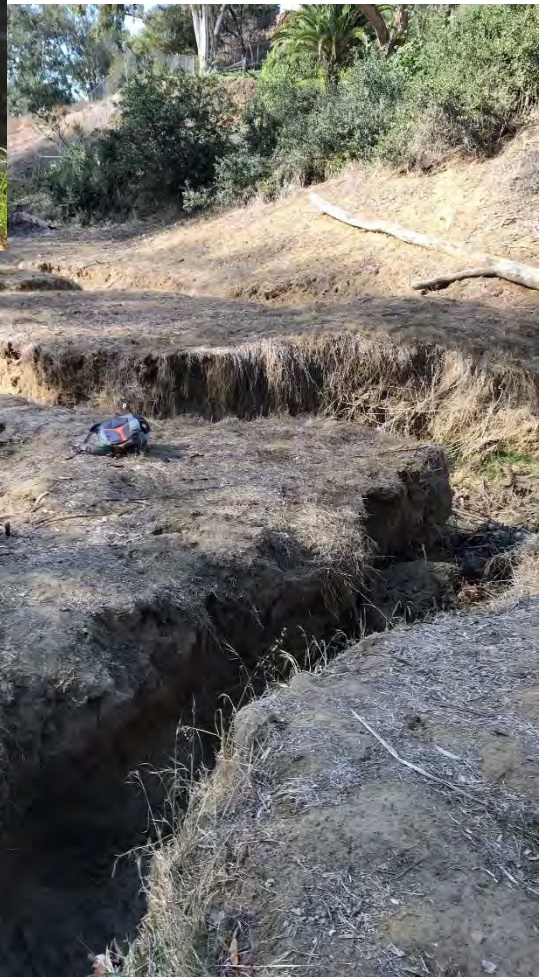
**Photo 1.19:** Drainage 2 (foreground) enters Drainage 1 (Photo taken 11/16/18).

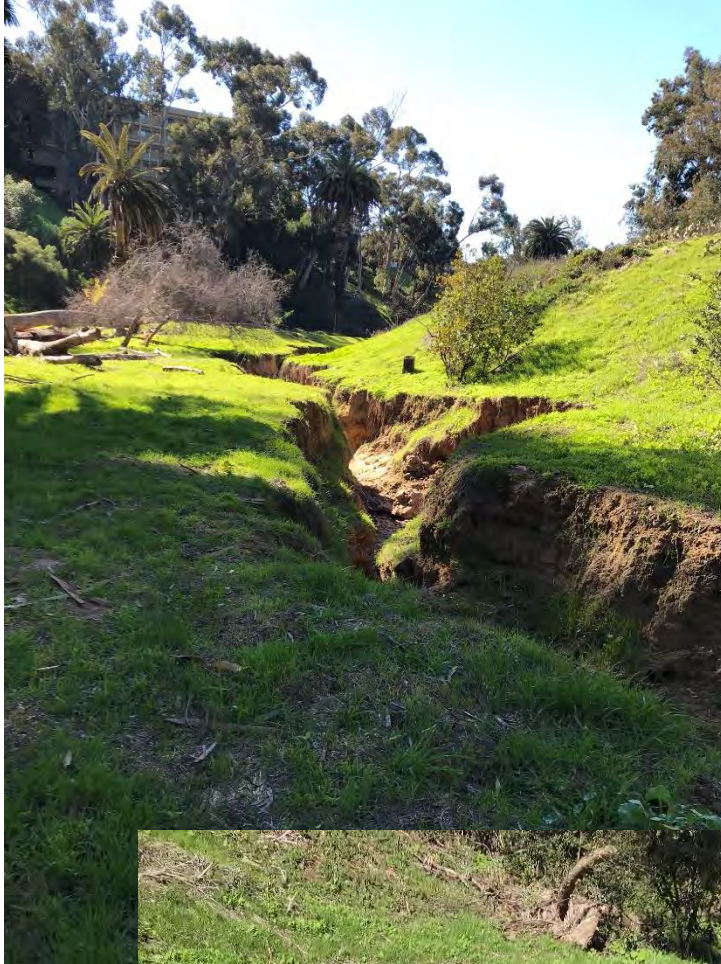
**Photo 1.20:** After Drainage 2 joins with Drainage 1, the creek enters into highly erosive soil with evidence of extensive erosion.

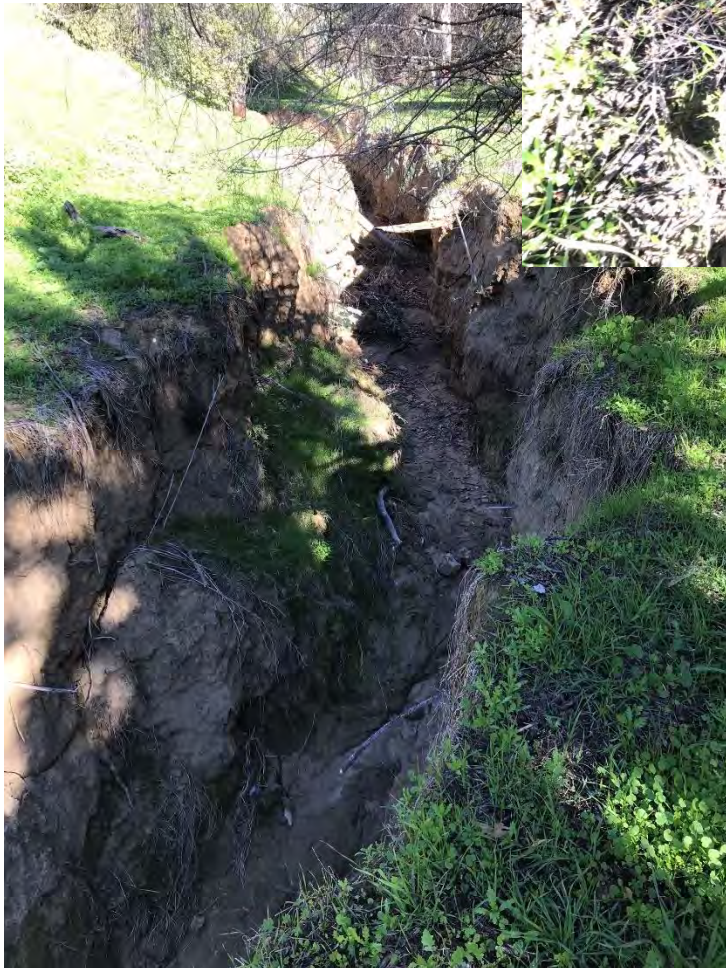
**Photo 1.23:** looking north and upstream, towards the “slot canyon.”

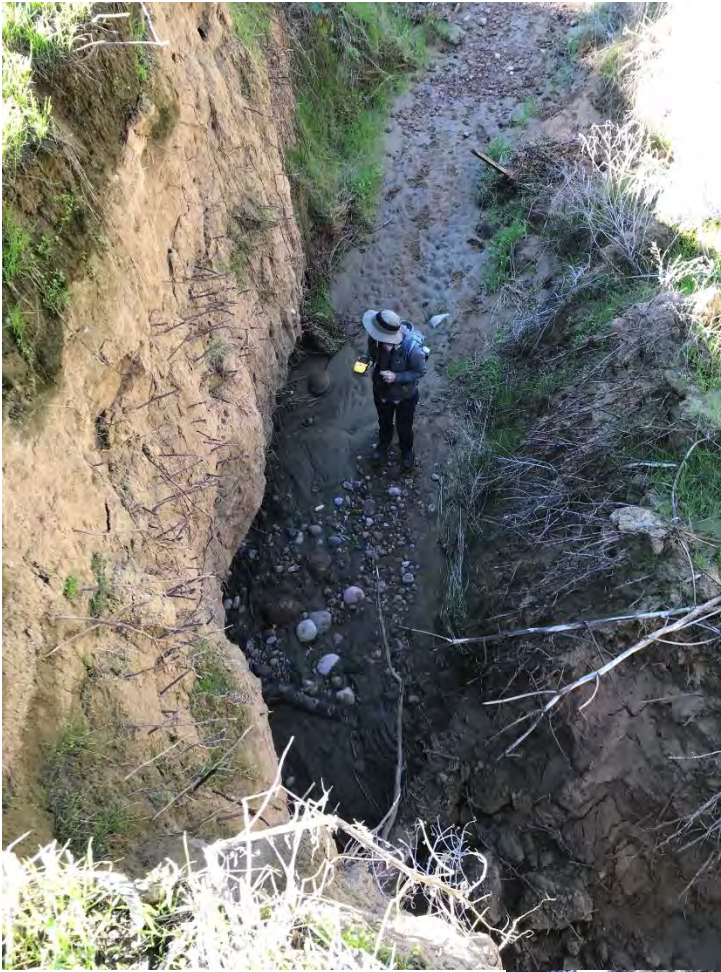
**Photo 1.24:** looking south into the canyon as the channel widens.

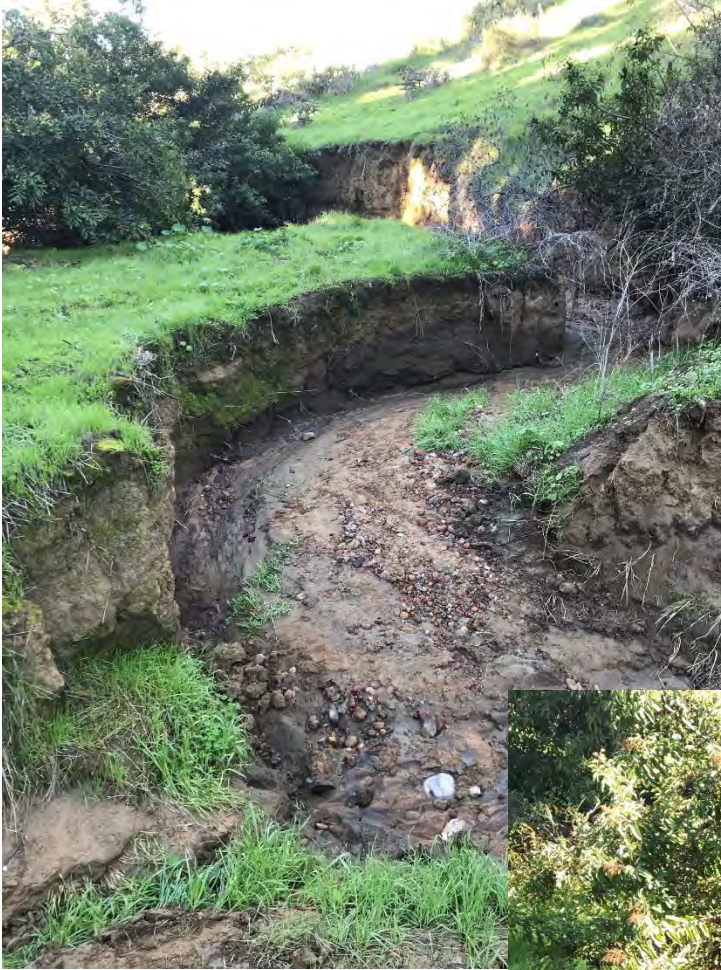
**Photo 1.26:** At the end of the wider section, the creek passes where Drainage 3 enters (bottom left) and passes through curves before reaching the final reach and the terminus at the canyon bottom.

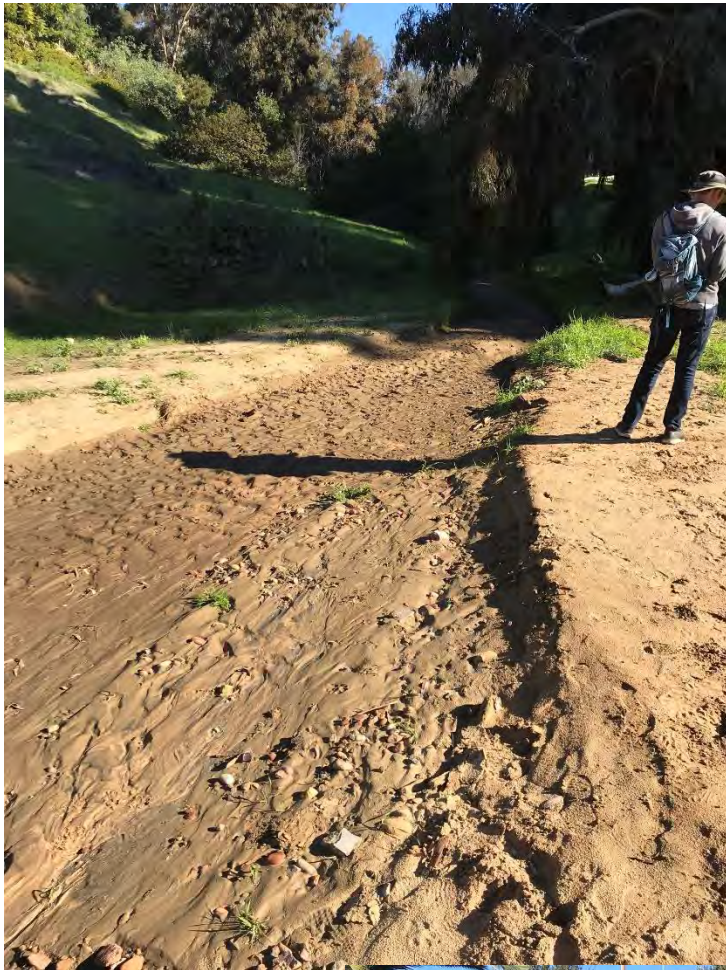
**Photo 1.28:** Drainage 1 enters the filled detention basin with banks of less than 1 foot.

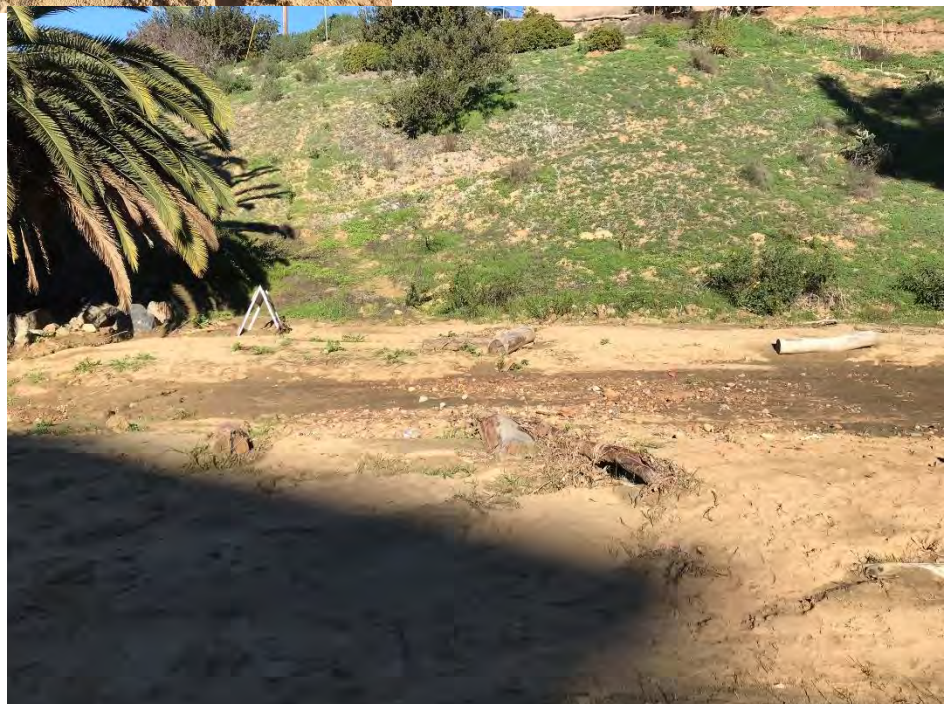
**Photo 1.30:** at the western end of the detention basin the water has overtopped and undermined the riprap.

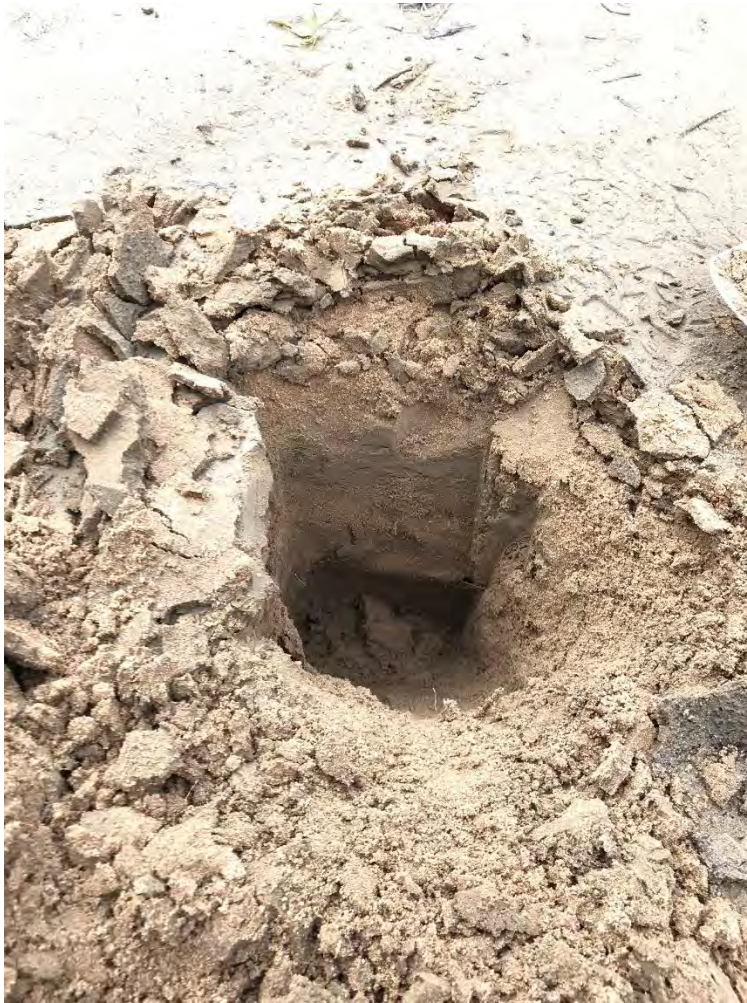
A Soil Pit was dug in the detention basin to assess if it supported wetland indicators (Photo 1.32). This was the only location along the canyon where water had been observed accumulating in the past and where hydrophytic vegetation could potentially grow. The vegetation was determined to not be hydrophytic, the soils were not hydric, and hydrological indicators away from the channel were not evident. The lack of soil saturation despite the wetter than average rain season up to when the soil pit was dug suggested that conditions for supporting hydrophytic vegetation had deteriorated since the detention basin was built in 2007/2008 as the basin filled with sediment. It is unlikely that hydrophytic vegetation grew before the detention basin was constructed.

**Photo 1.32:** Soil Pit 1 in the detention basin showing deposition layers of sand and sandy loam.

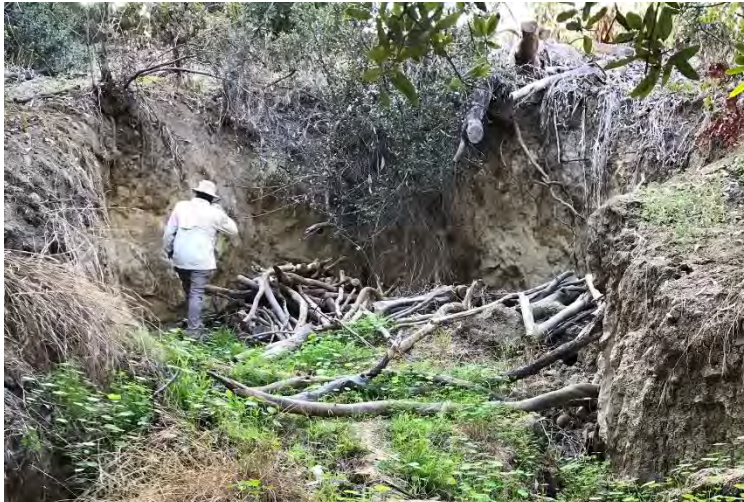
**Photo 2.1:** Slumped area above the start of OHWM in Drainage 2.

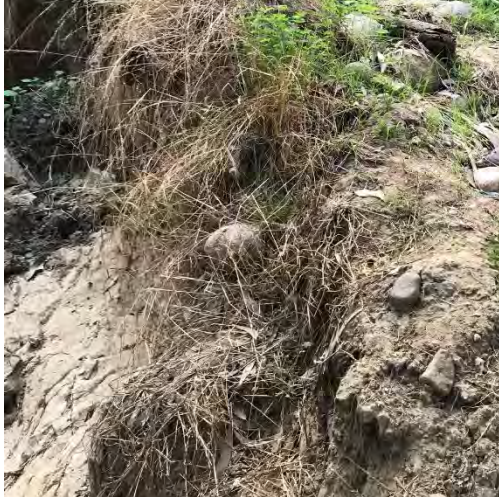
**Photo 2.2:** Start of organized flow at confluence of erosional channel on left and slumped area shown in Photo 2.6 below.

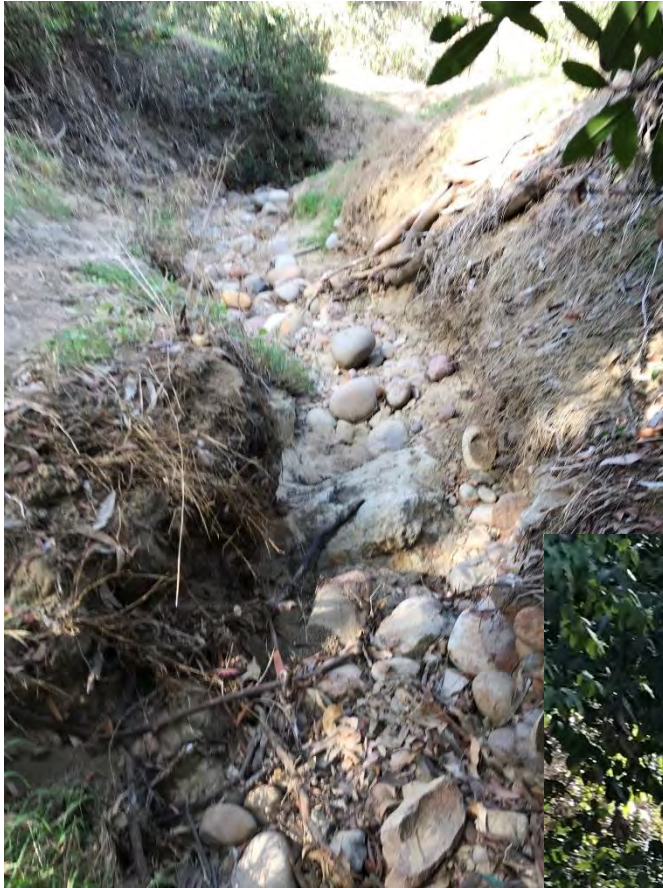
**Photo 2.3:** Clear bed and bank of Drainage 2  
downslope of Photo 2.2.

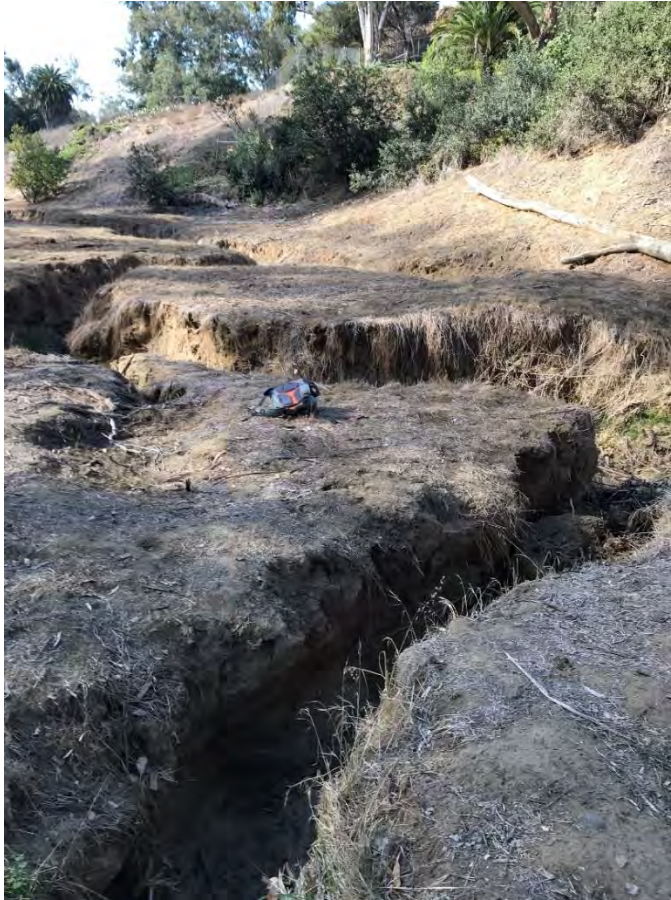
**Photo 2.5:** Looking south to where Drainage 2 merges with Drainage 1

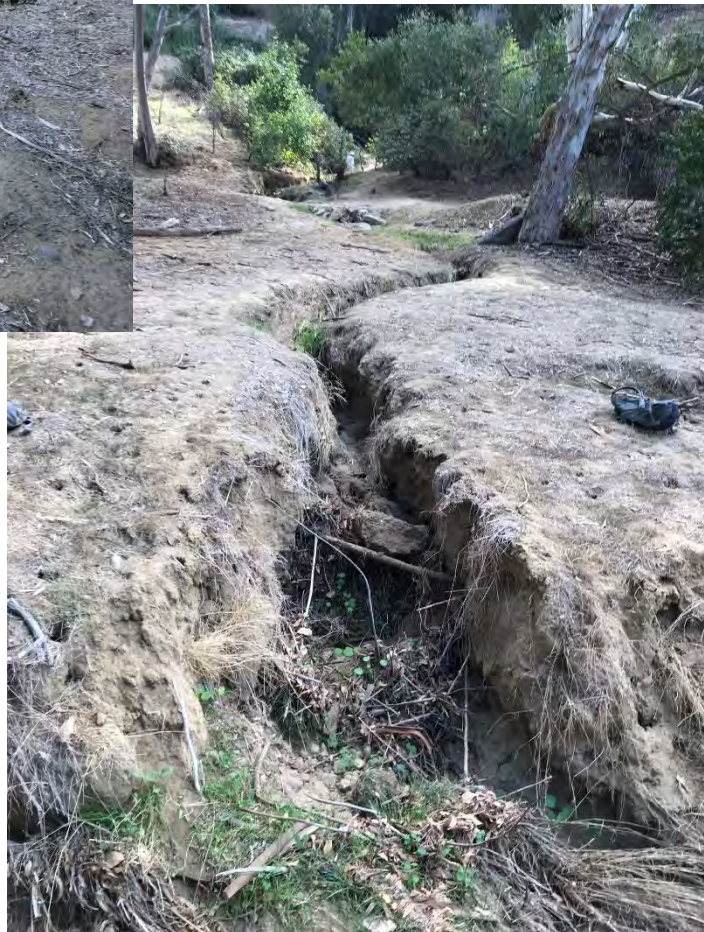
**Photo 2.6:** Looking south up Drainage 2 from the confluence with Drainage 1. The tributary crosses the trail between the two trees. The drainage is in a pipe under the trail.

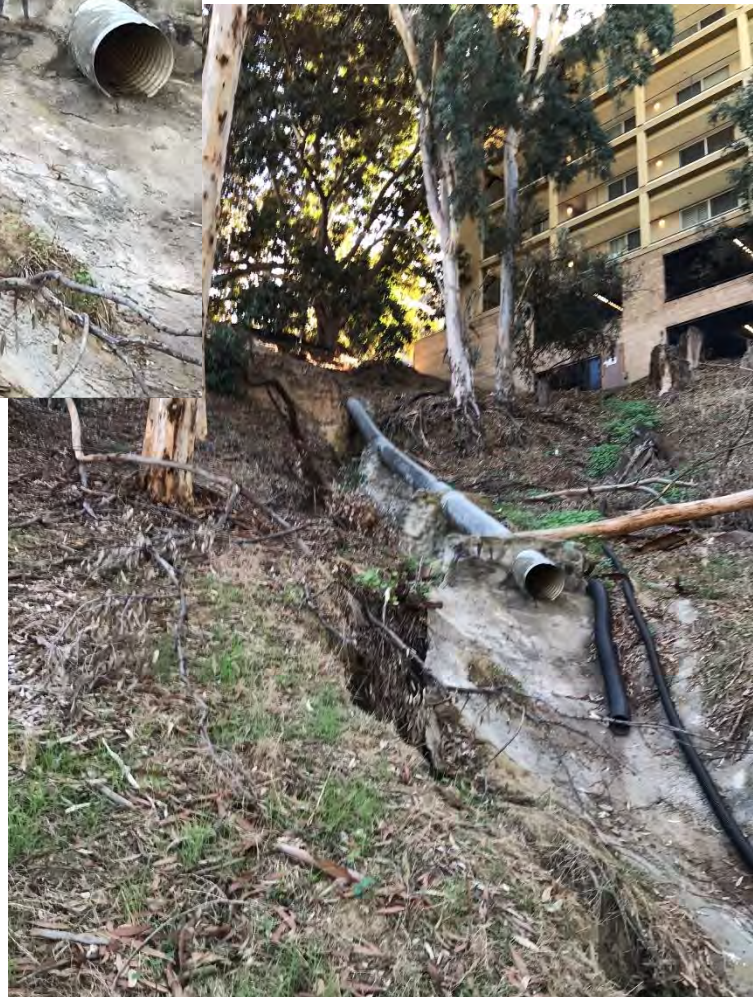
**Photo 3.1:** Close up of outfall of a CMP that is likely from street SD inlet above. Note erosion below where pipe emerges from bank indicating it is broken. As a result, most of the water bypasses the end of the pipe and the concrete that has been poured to carry the water. Cut-off walls have kept the pipe in place, but the pipe is compromised.

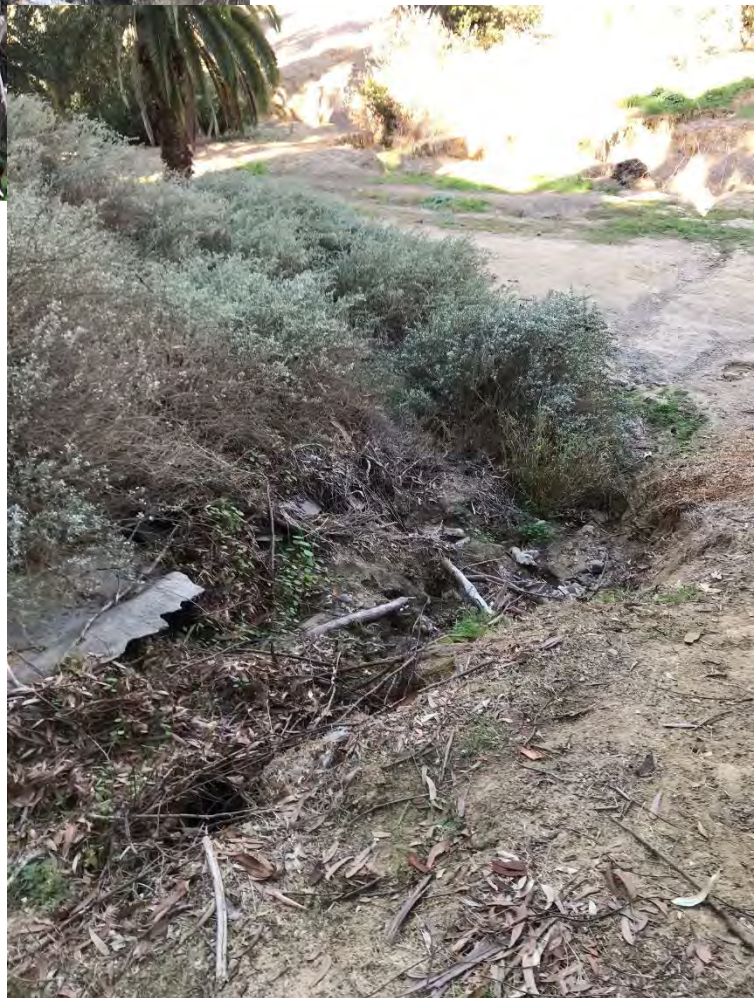
**Photo 3.3:** The end of the concrete which obviously does not carry the majority of the water from above. Water descends down in a chaotic manner beside it.

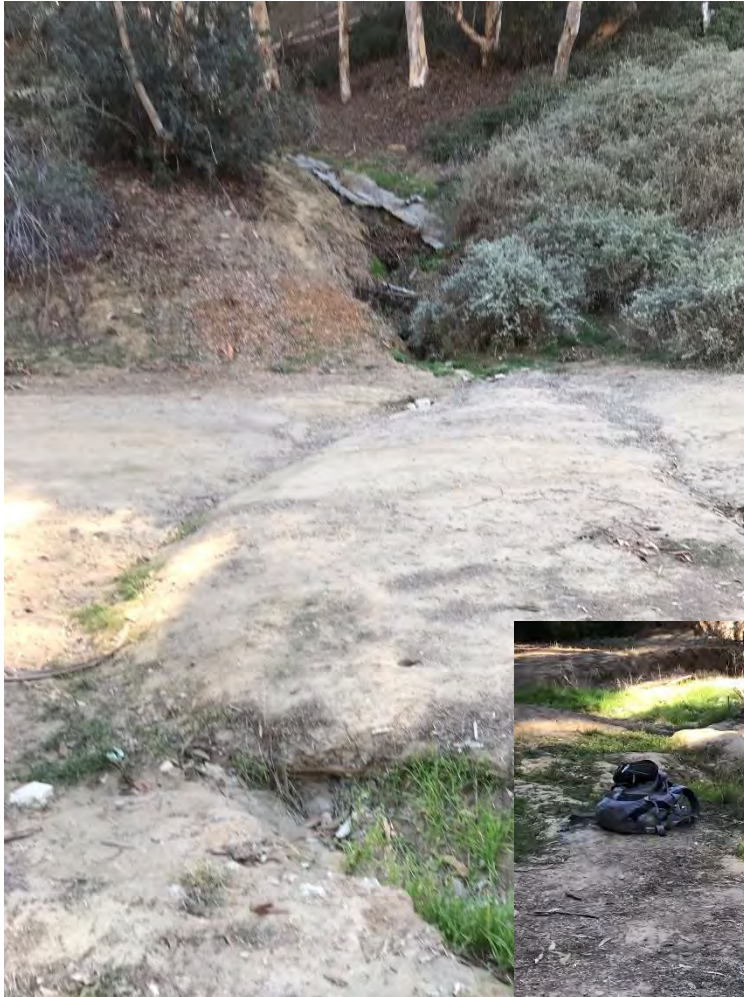
**Photo 3.4:** End of concrete is on left, and the feature shows no organization as water tumbles down the hillside.

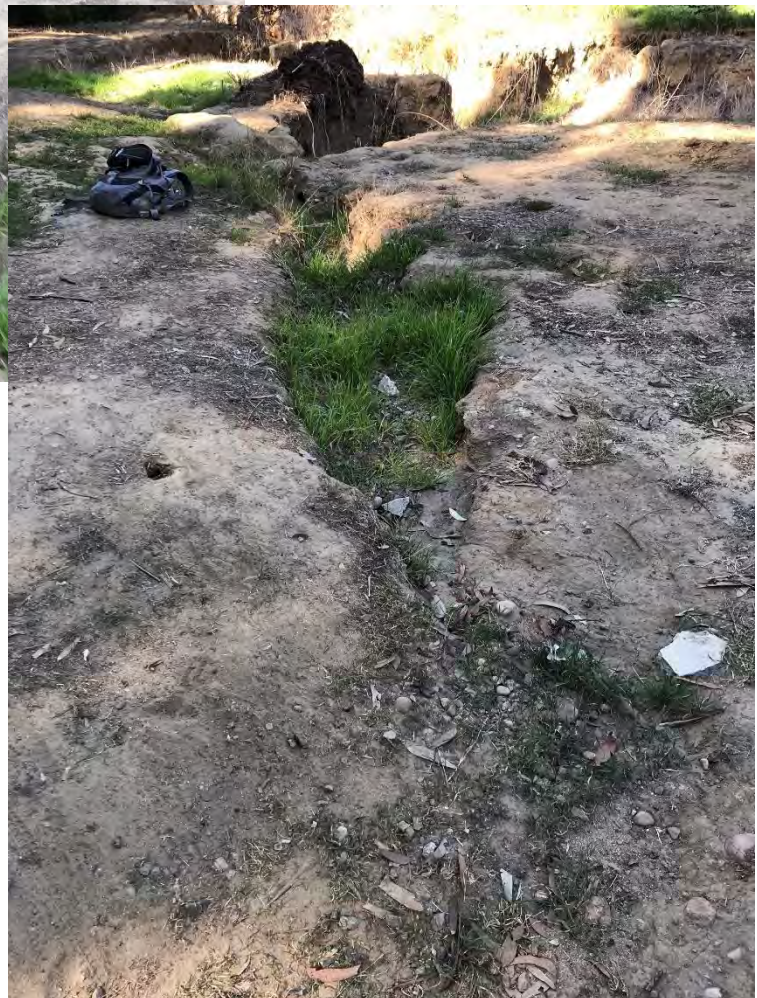
**Photo 3.6:** What appears to be the start of jurisdiction with increasing cut and erosion of a channel and direct connection to Drainage 1.
