Subject:Response to City of San Diego Geology Review Comments, and
Update to Preliminary Geotechnical Engineering Investigation Reports
1561/1545 Camino Del Rio South; San Diego, California

PRELIMINARY GEOTECHNICAL ENGINEERING INVESTIGATION

We are pleased to submit this preliminary geotechnical engineering investigation report prepared for the Entitlement phase of the project to develop a proposed Home Depot store to be located at 1895 Camino Del Rio South (Mission Valley area) in San Diego, California. This report is considered preliminary since the project details had not been finalized at the time this report was completed. The contents of this report include the purpose of the investigation, scope of services, background information, investigative procedures, our findings, evaluation, conclusions, and recommendations.

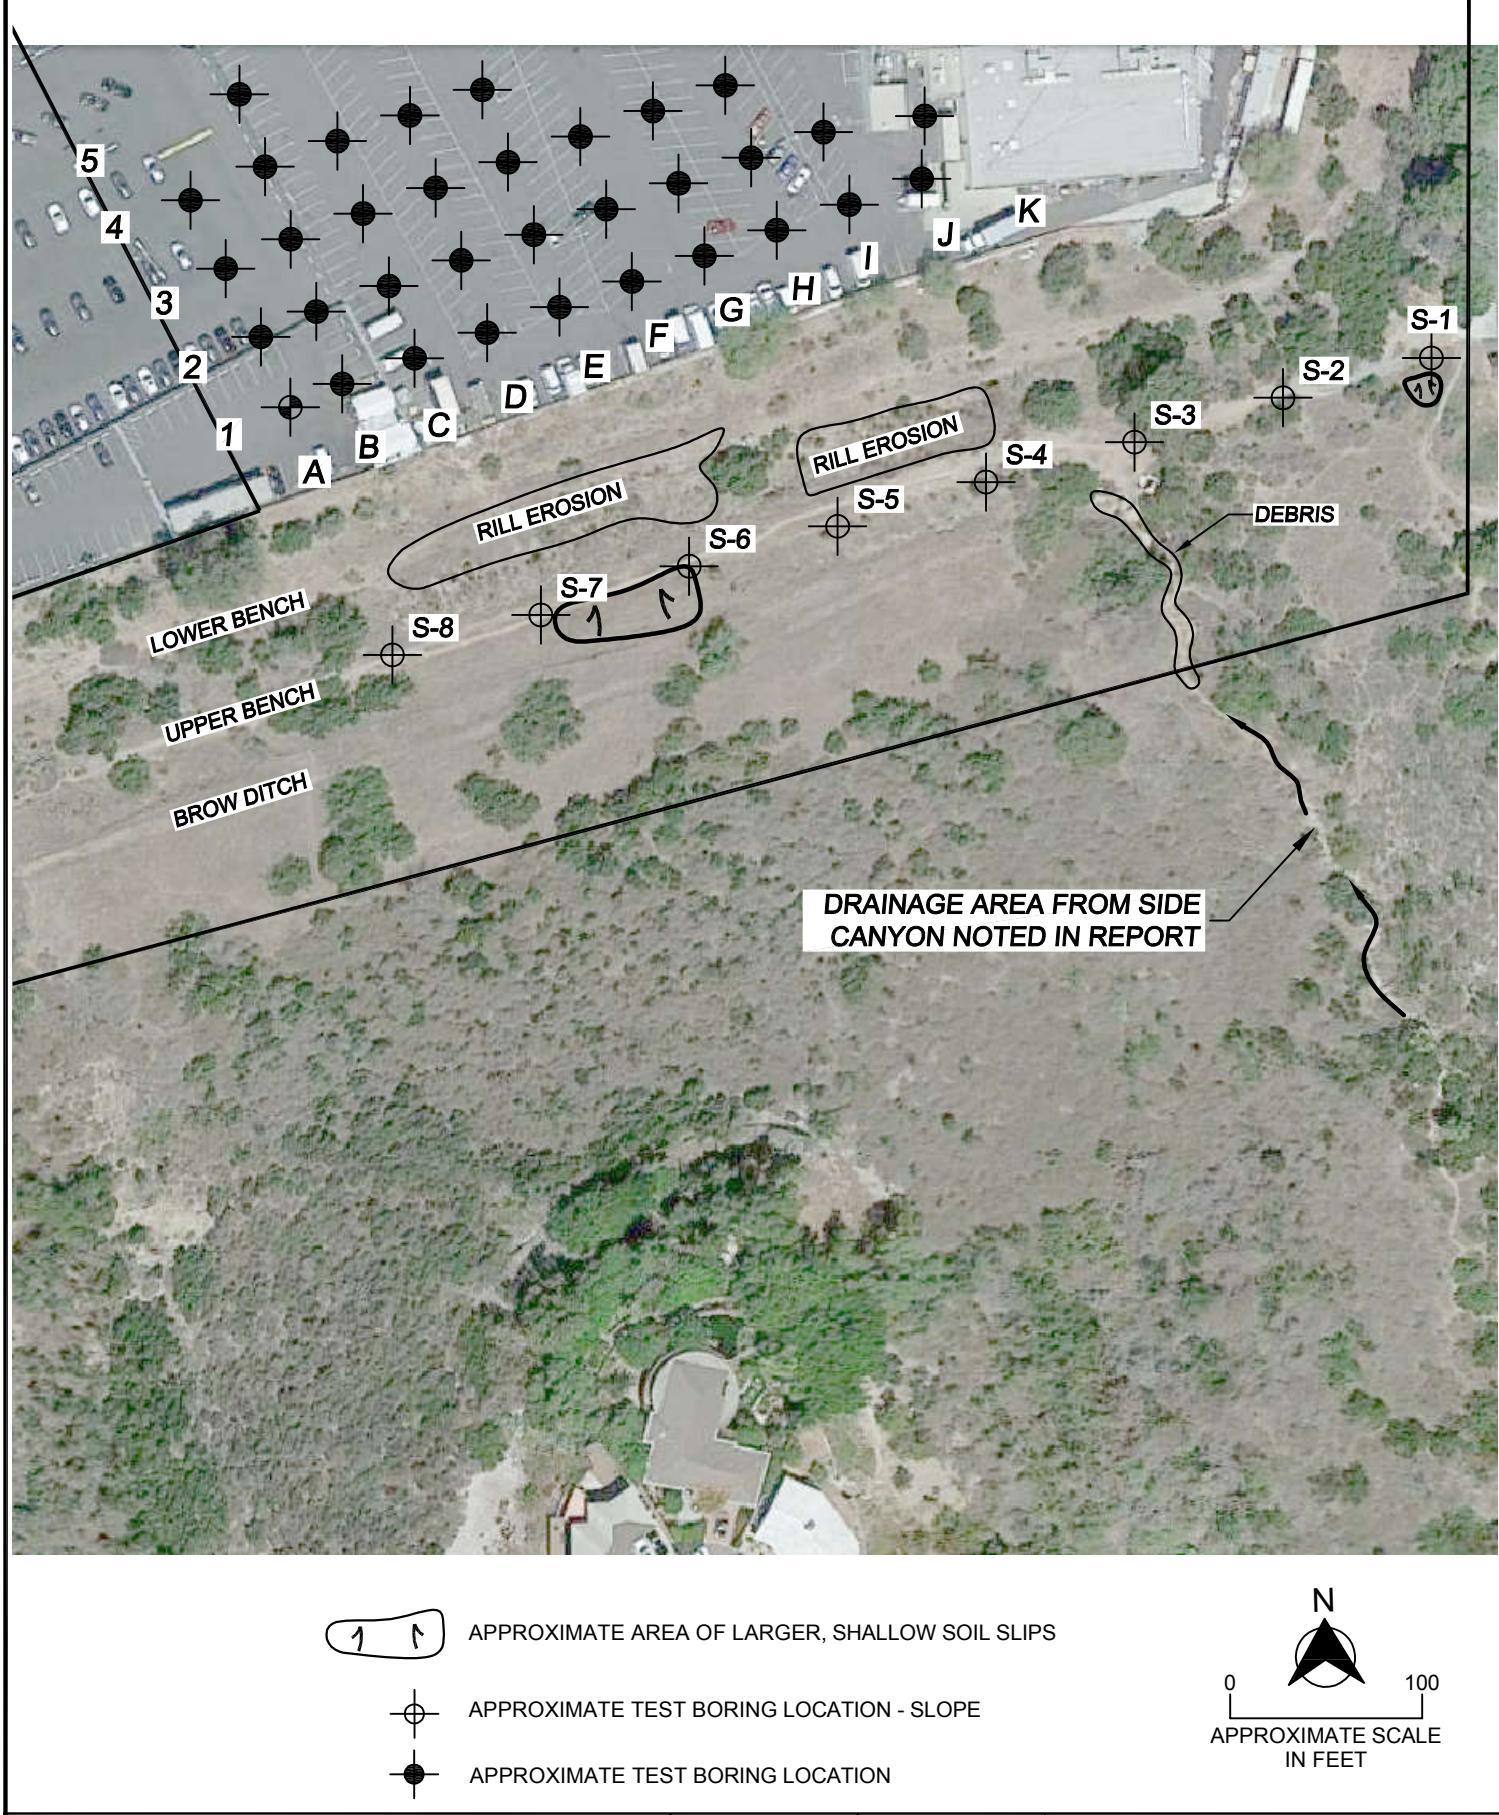
SLOPE OBSERVED CONDITIONS	FILE NO.	DATE DRAWN:	
PROPOSED HOME DEPOT STORE	050R0-01-02	01/09/20	
1895 CAMINO DEL RIO SOUTH SAN DIEGO, CALIFORNIA	DRAWN BY: RM	APPROVED BY:	MOORE TWINING
	PROJECT NO. D050R0.01	DRAWING NO. 3	ASSOCIATES, INC
			•

The lower portion of the existing cut portion of the north-facing slope was observed and evidence of previous erosion, shallow soil slips, remedial erosion control measures, surficial slope repairs, and drainage improvements added after initial construction were noted. The majority of the erosion and soil movement observed was identified in the eastern portion of the north facing slope. In this eastern portion of the slope, the slope was not covered with mature bushes or established native

grasses and evidence of significant erosion, shallow sliding of surface materials, failed erosion control measures, and accumulation of sediments were noted. However, the western portion of the north facing cut slope did not exhibit significant erosion issues or evidence of surficial instability. This area of the slope contained better established vegetation.

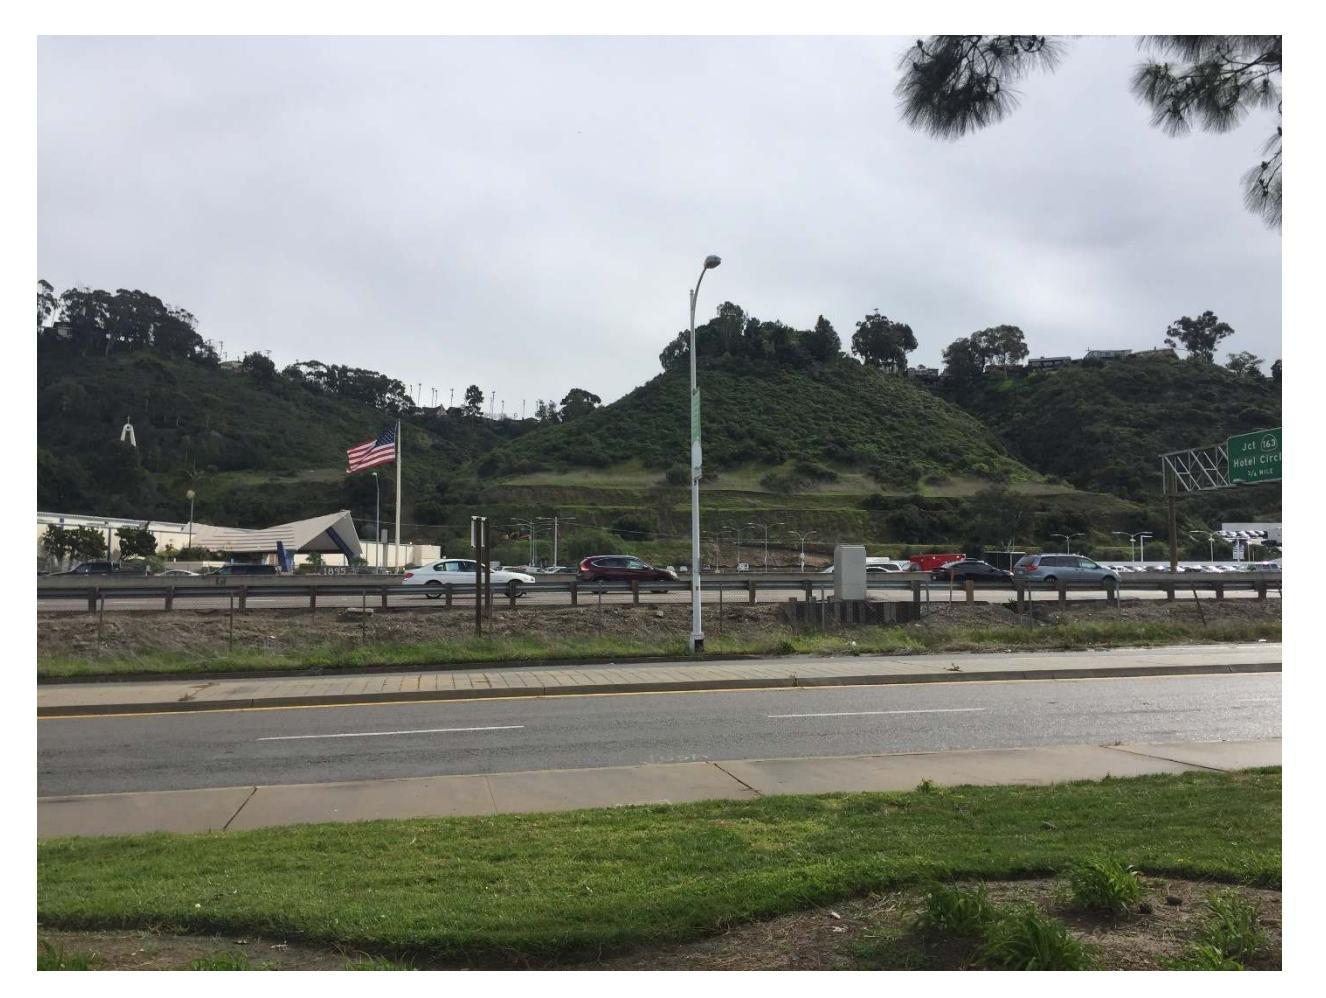
Photograph No.1 – Looking south across Interstate 8 at the site. The upper native and lower benched cut slopes in the background. Also, note drainage canyon in the upper left.

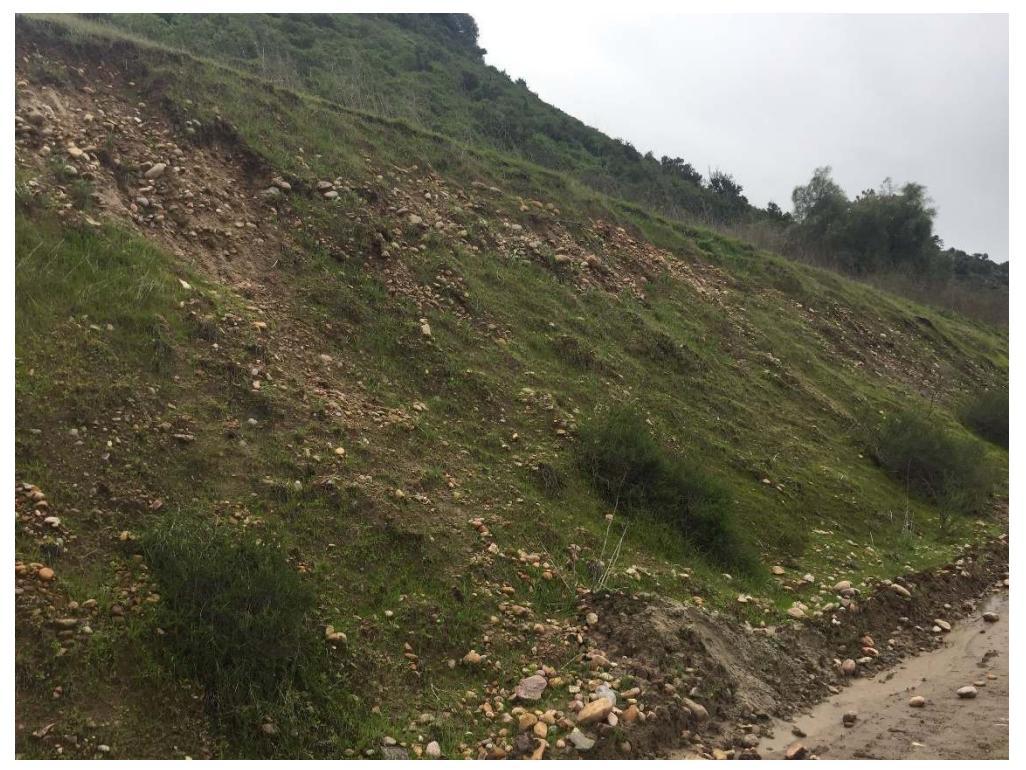
Photograph No. 10 - Showing upper cut slope (section west of drainage). Note abundant cobbles, surface erosion and low cohesive soils

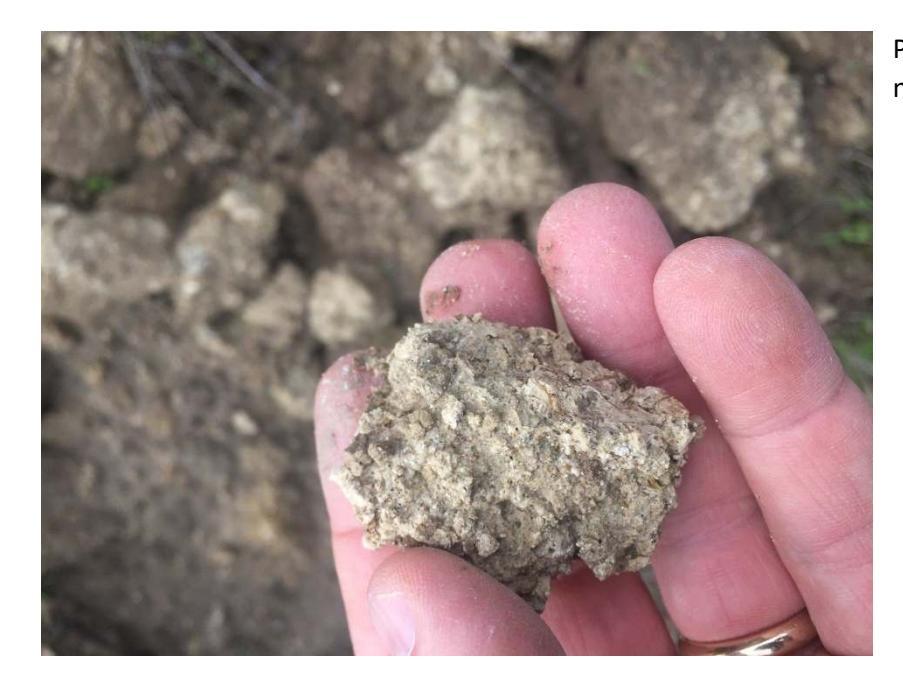
Photograph No. 13 - closeup of native Sandy Lean Clay Unit.

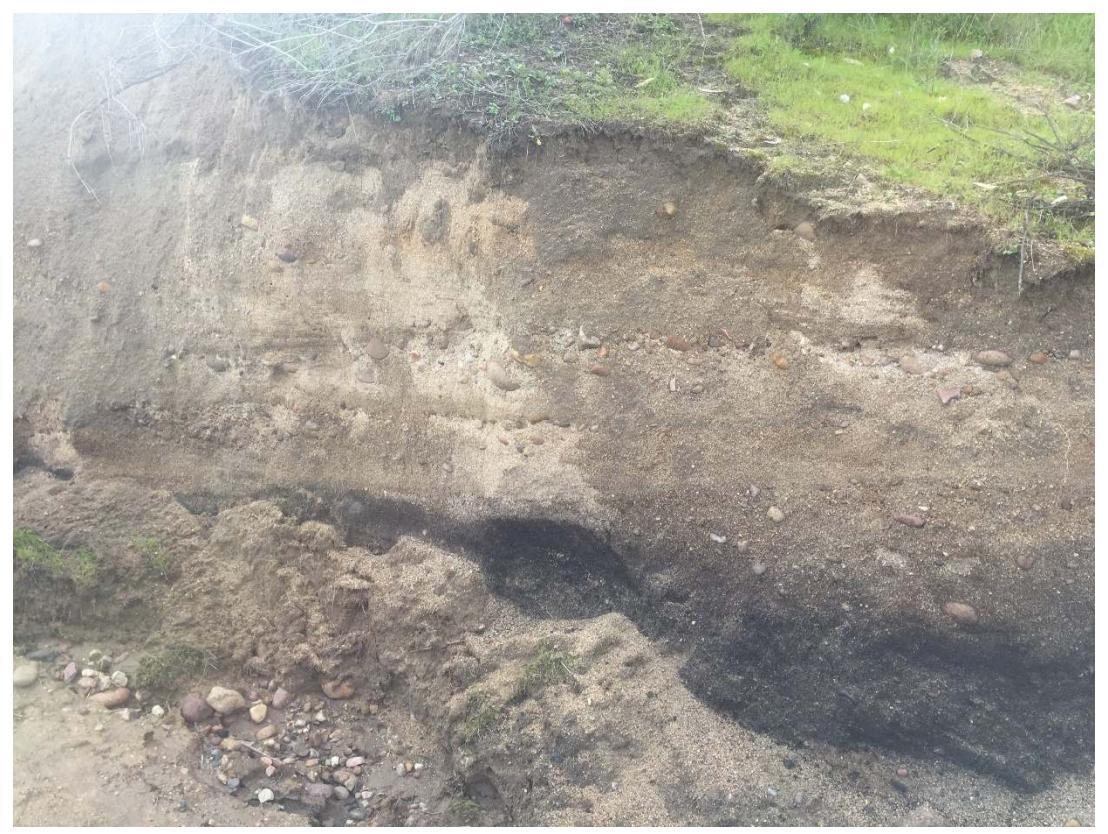
Photograph No. 14 -Showing granular soils in lower portion of exposed temporary road cut between base of slope and lower bench.

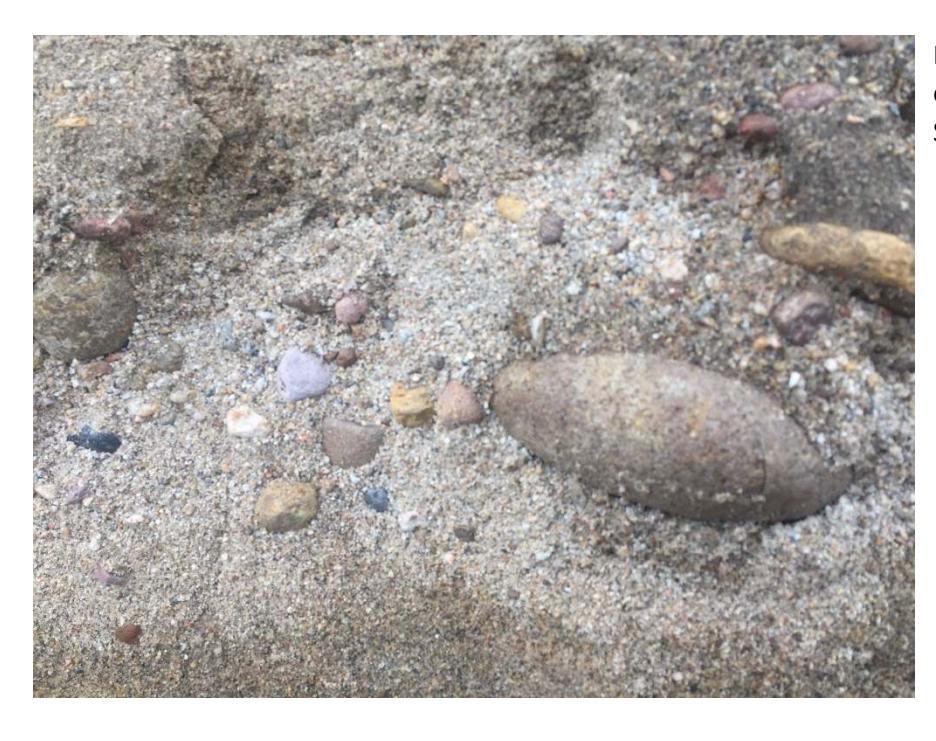
Photograph No. 15 - closeup of native Sand/Gravel/Cobble Unit.
