HISTORICAL RESOURCES TECHNICAL REPORT

HENRY B. JONES HOUSE

4040 FIFTH AVENUE, SAN DIEGO, CA 92103

May 23, 2017

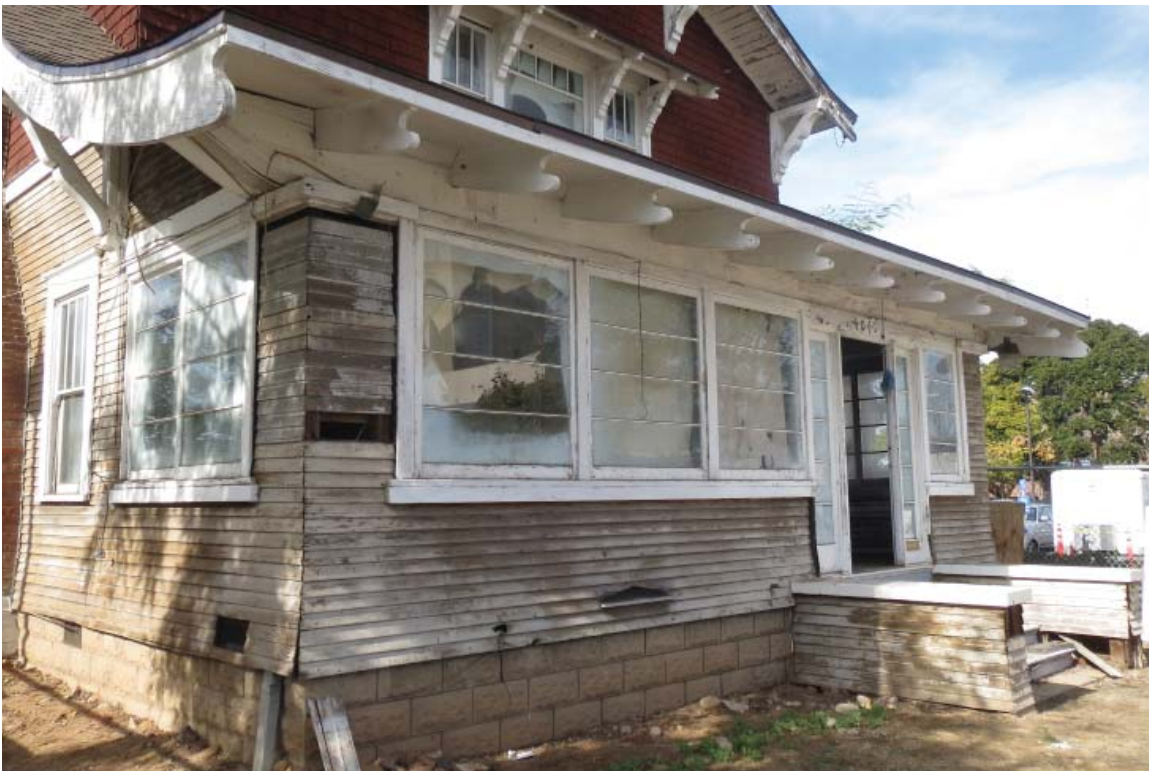
The porch walls are still covered in clapboard and the original front window and door are still in place. The 1945 porch door, side lights, and windows have been inserted between the pillars, ceiling, and balustrade with no inletting or molding on the inside, so there are gaps between the window frames and the clapboard. The front entry porch door is now missing. The side lights are five lite, divided horizontally, with a narrow wood sash. The windows are four lites divided horizontally with narrow wood sashes. There are six wood steps from the ground to the front door.

Figure 3-4: View looking northwest at the infilled porch. Note the original wood clapboard siding.

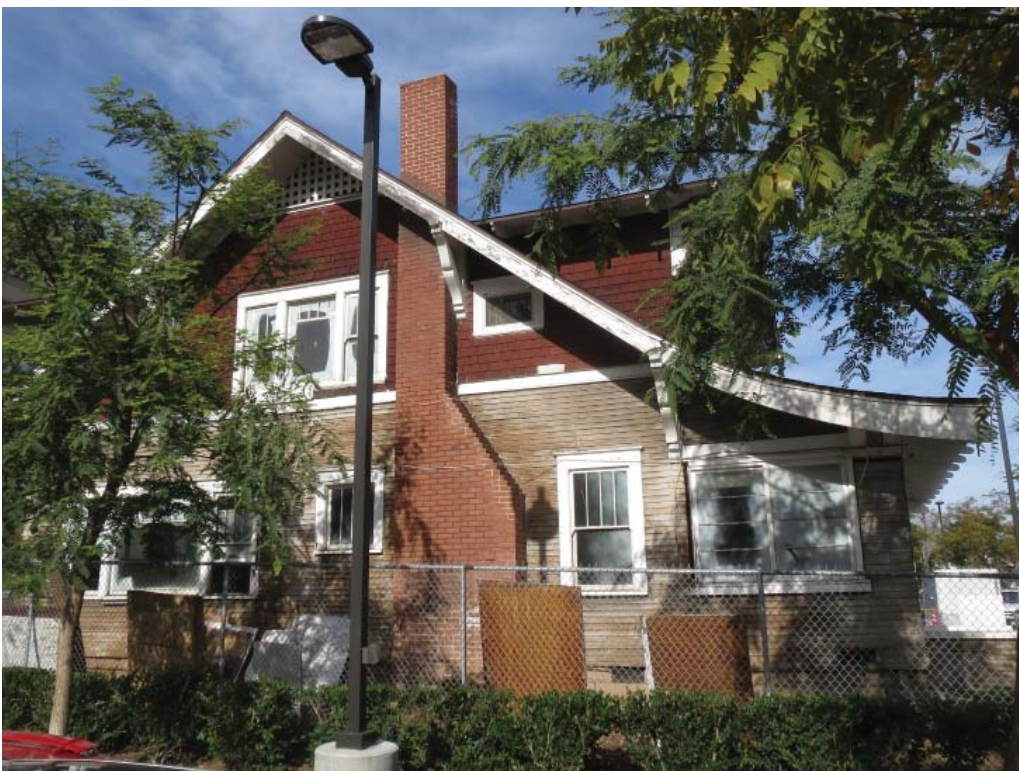
Figure 3-10: View of the south façade showing the original corbelled chimney. The enclosed porch is on the right.

Prior to relocation, the ca.1940s faux stone concrete block foundation walls and wood entry steps will be documented, catalogued, salvaged, and stored. The original extant south brick chimney will be documented, catalogued, salvaged, and reconstructed, probably using new brick due to the poor condition of the current. The main structure will be transported via truck in one piece to the vacant lot at 4114 Ibis Street, approximately one mile northwest of its current location.

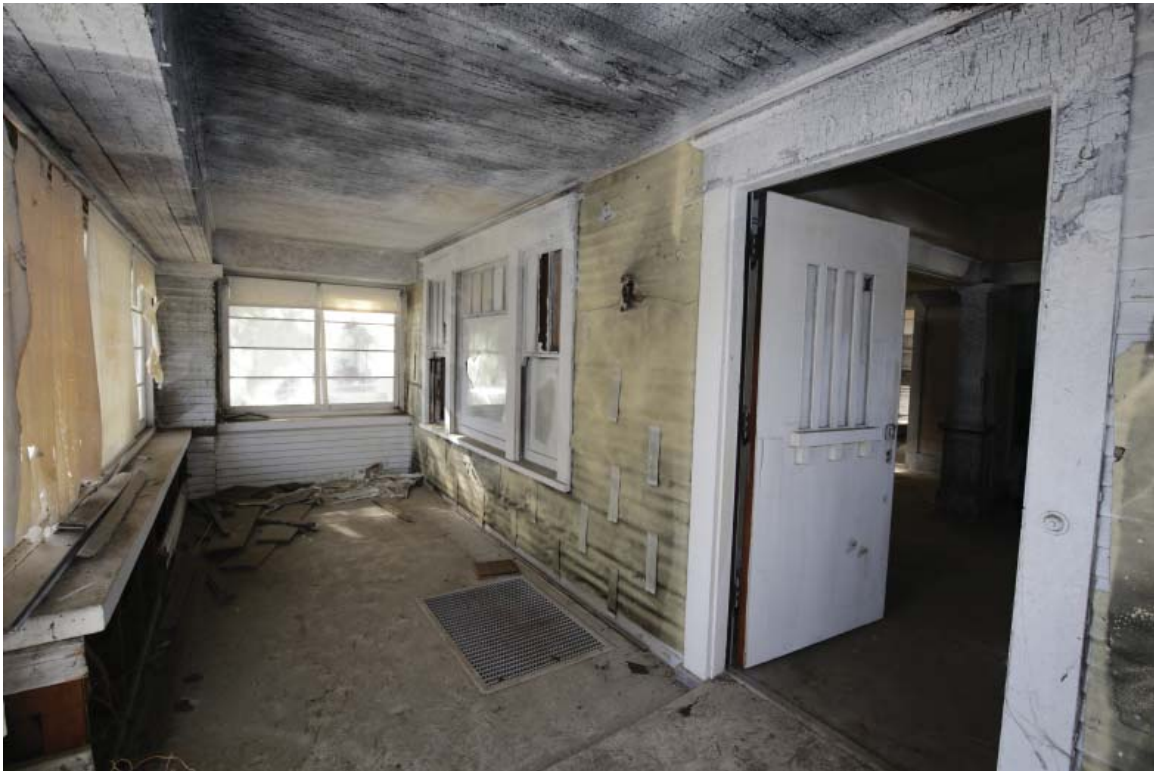
Figure 3-13: View of the enclosed porch, looking south. Note the original entry door on the right.

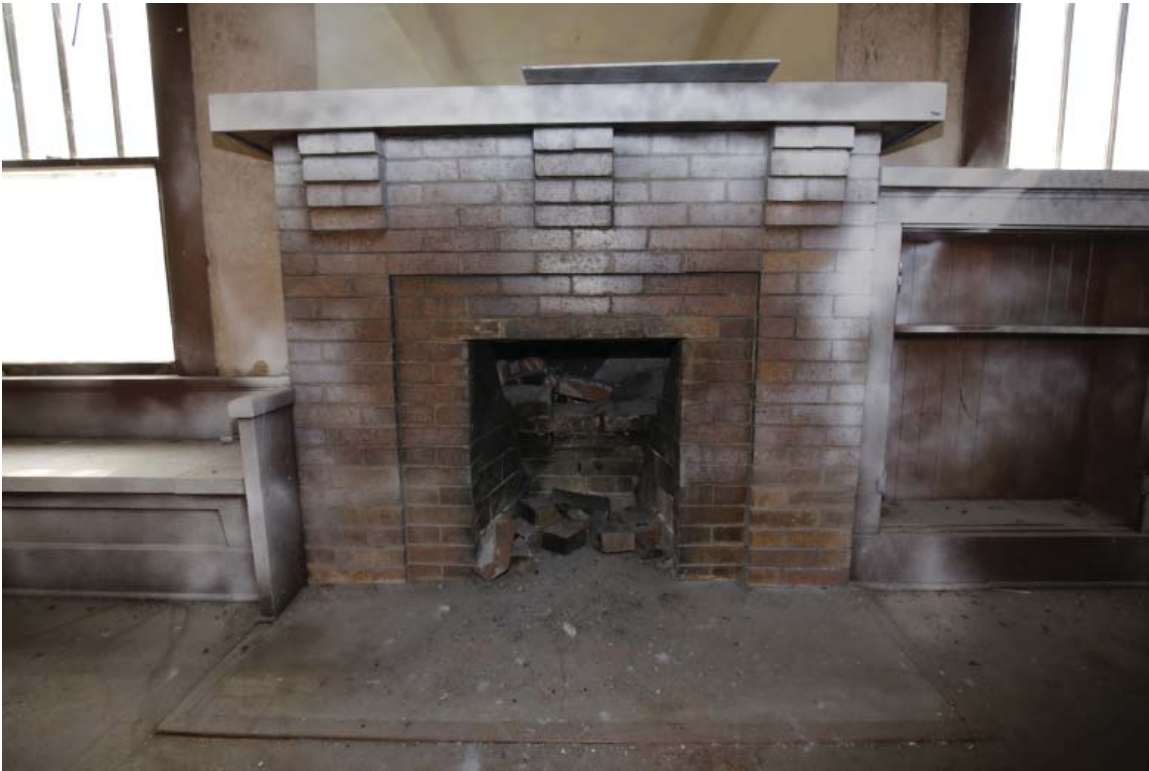
Figure 3-17: The living room fireplace. Note the fallen bricks.

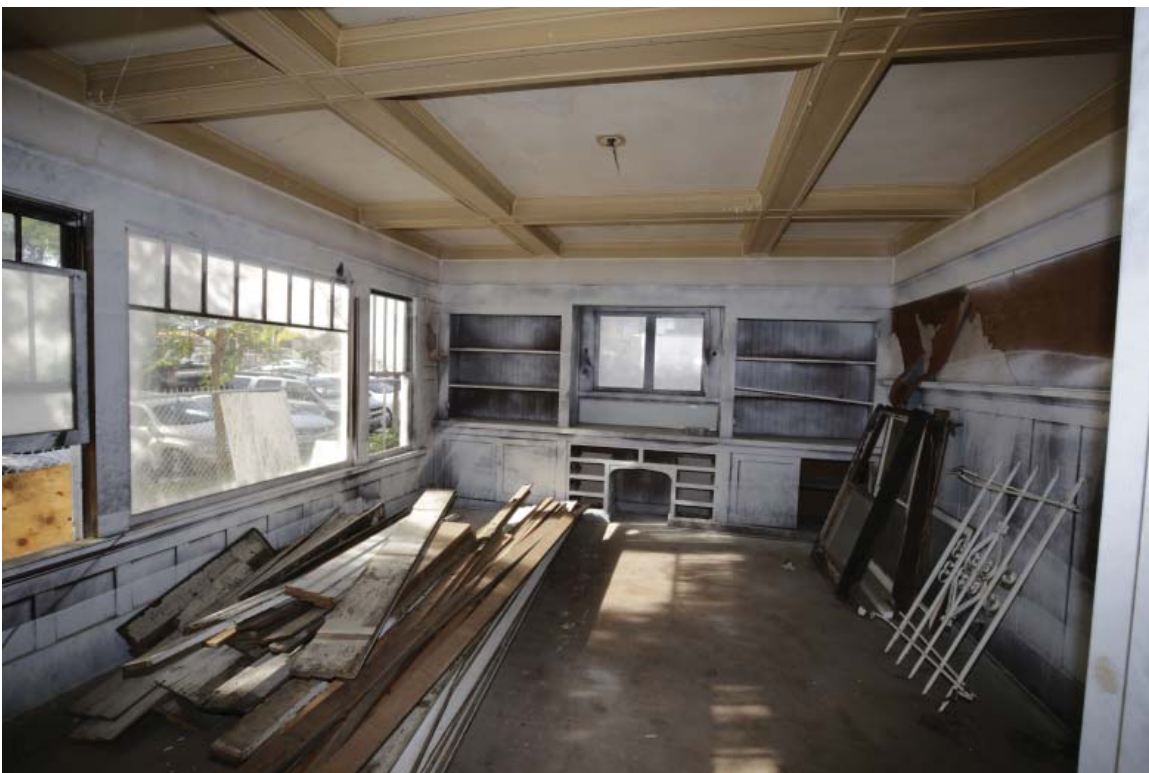
Figure 3-18: The dining room, looking southwest. Note the built-in cabinetry. The salvaged material on the floor appears to be from the demolished garage.

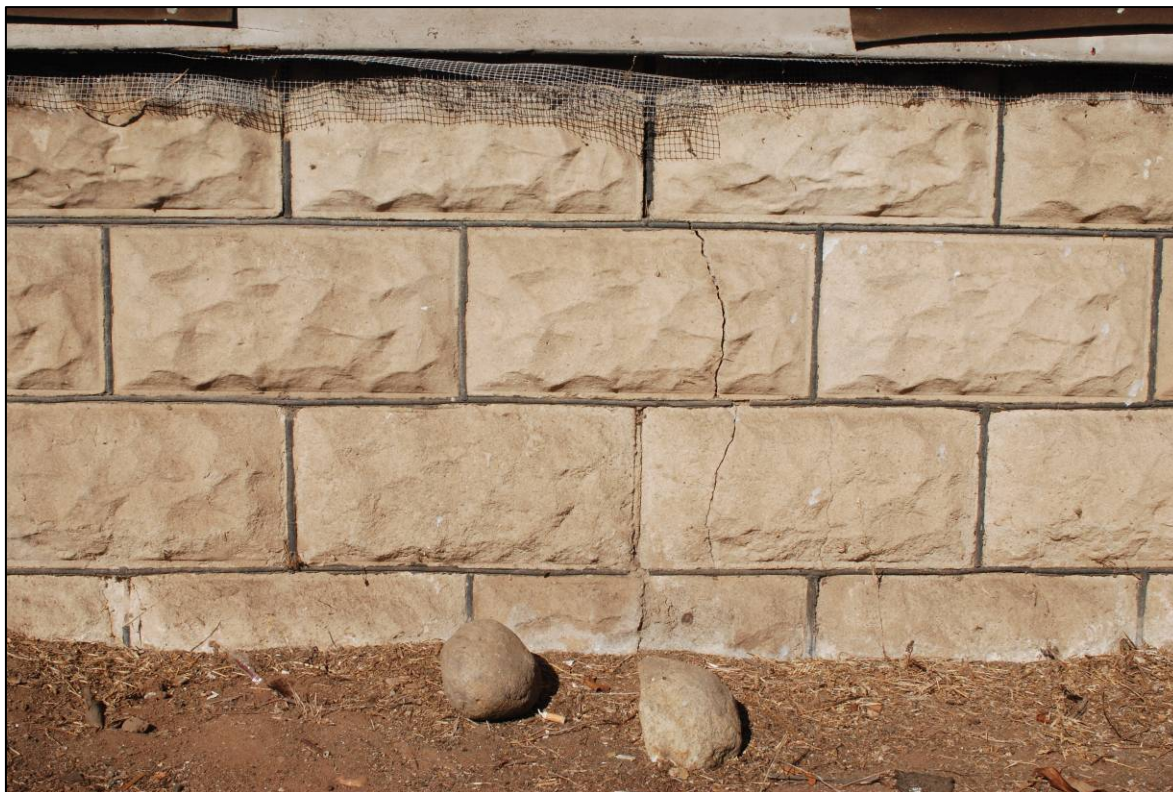
Photograph 2
Foundation,
Concrete
Block Formed
to Resemble
Dressed
Stone

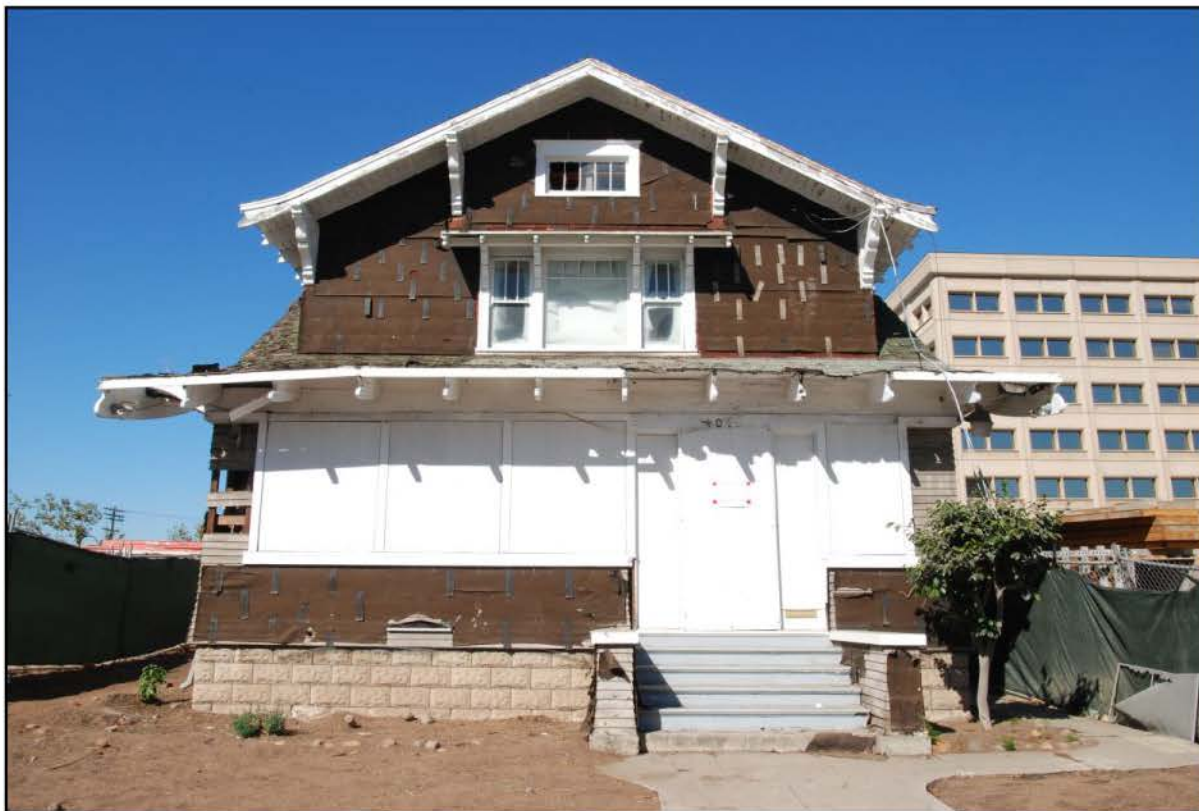
The front of the house is on the east side. The first floor of the house was originally an open porch, which was enclosed in 1945. The residential building report lists Permit 12148 obtained for glassing in the porch. The front door is offset to the right of center (Photo 7). The door has sidelights. Both the door and the sidelights are covered with plywood so no details are visible from the outside except the outside of the trim. The door and sidelights together measure 6 feet wide. There are four windows on the first floor, three grouped together on the left side of the door, and one smaller window on the right side of the door. These windows are also covered by plywood. The casing on the windows and door are similar. The sides are 2½ inches wide and 1 inch thick, and the top is 3¾

Photograph 7
East (Front)
Side of House

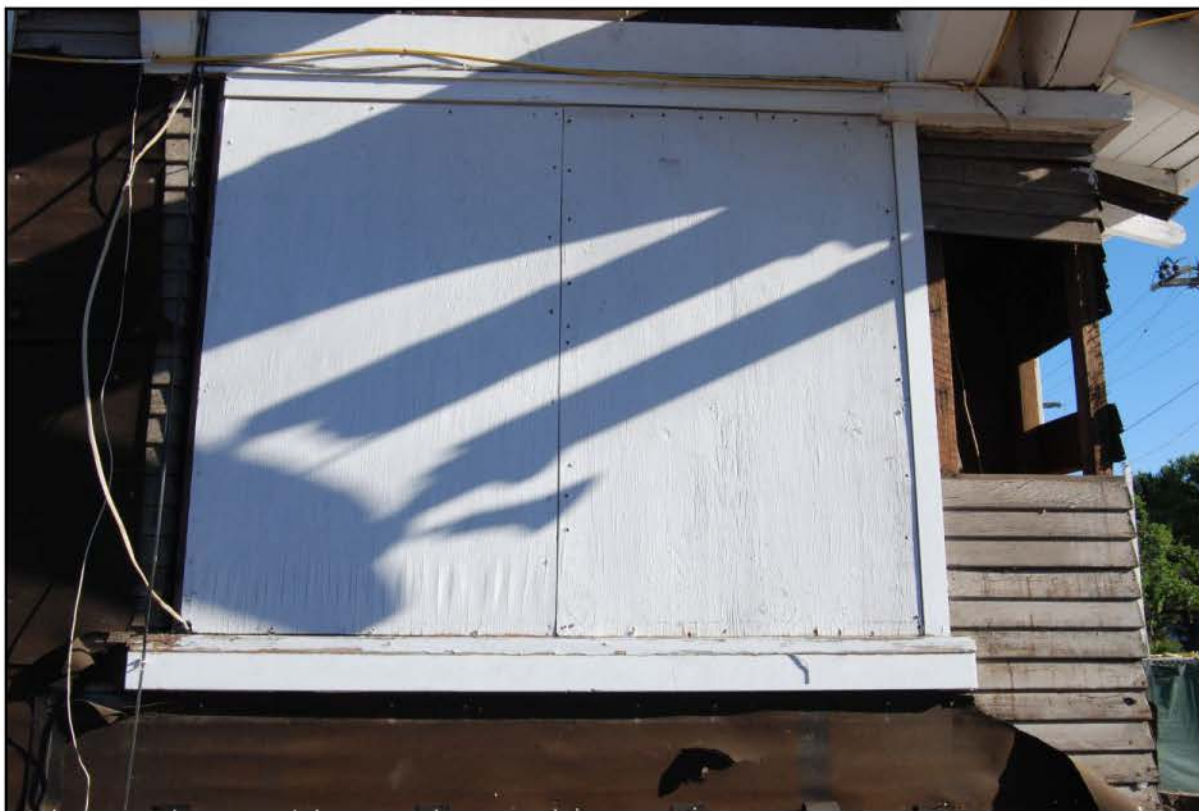
inches wide and 1 inch thick. The sills on the windows are two pieces, and measure 5 inches wide by 1½ inches thick. This casing matches the front side windows, but not the casing on the rest of the windows on the house (Photo 8).

Photograph 8
Window Casing
Detail on Front
Porch Windows,
Note Narrow Side
and Top Casing
Boards. This is
South Side Window

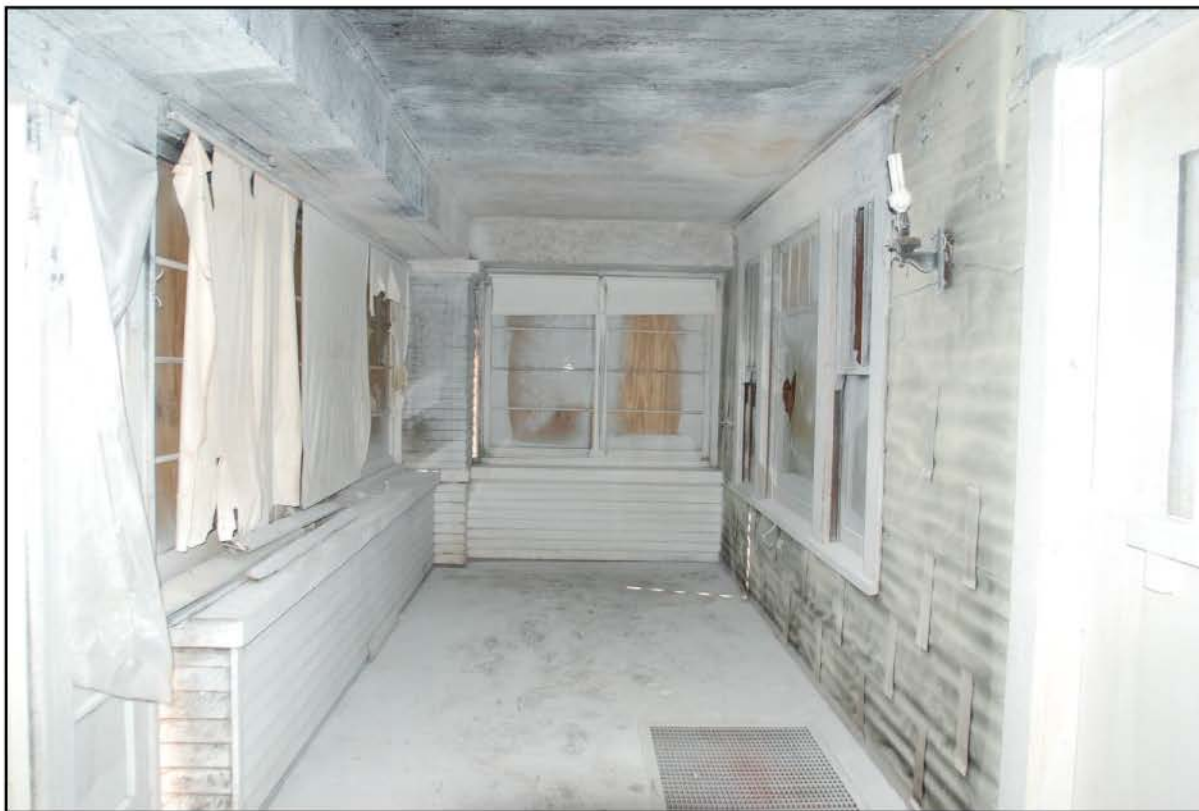
The interior of the porch does not appear to have been significantly altered after it was enclosed. The walls are still covered in clapboard, and the front window and door are still in place. Photographs 9 and 10 show the interior of the porch. The door, sidelights, and windows have been inserted between the pillars, ceiling, and ballustrade with no inletting or moulding on the inside, so there are gaps between the window frames and the clapboard (Photo 11). The front door is now missing. The sidelights are five light, divided horizontally, with narrow wood sash. The windows are four light divided horizontally. With narrow wood sashes. Photographs 9 and 10 show the south and north end windows, respectively, and Photograph 12 shows the east (front) triple window.

Photograph 9
Interior of Porch,
Looking South.
Note South Side
Window

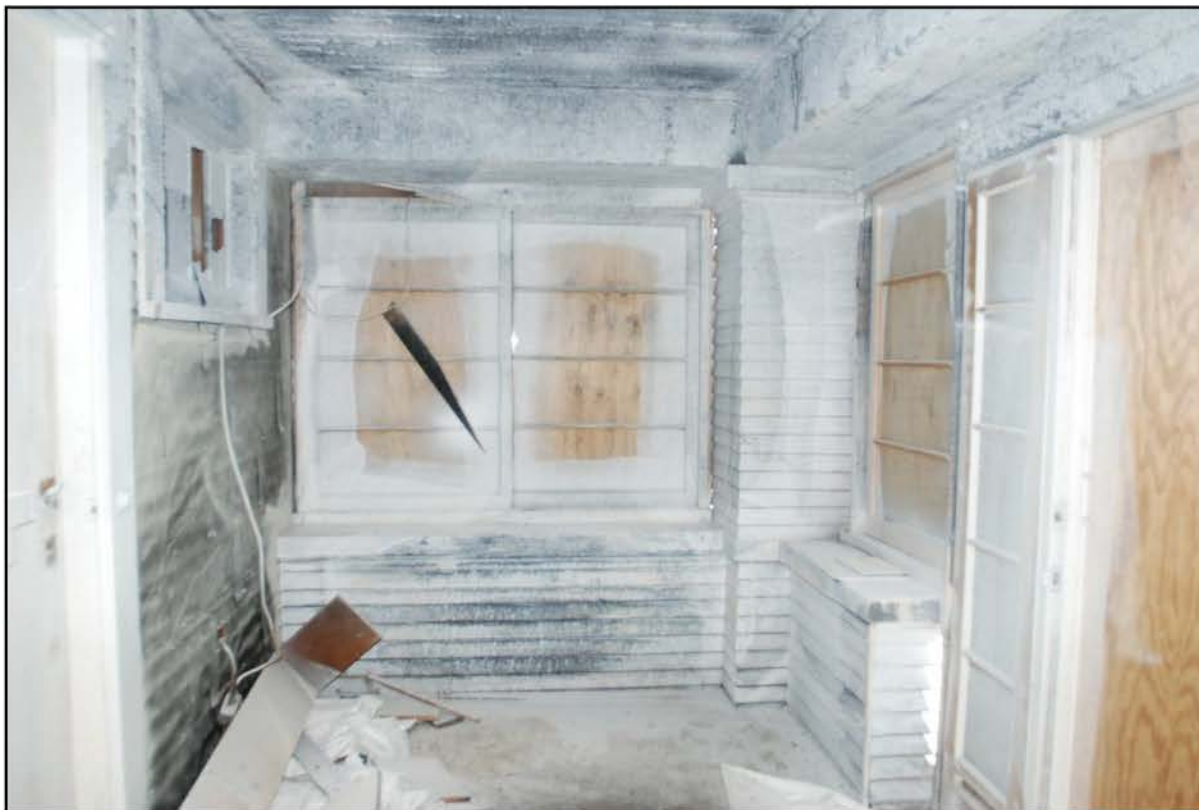
Photograph 10
Interior of Porch,
Looking North

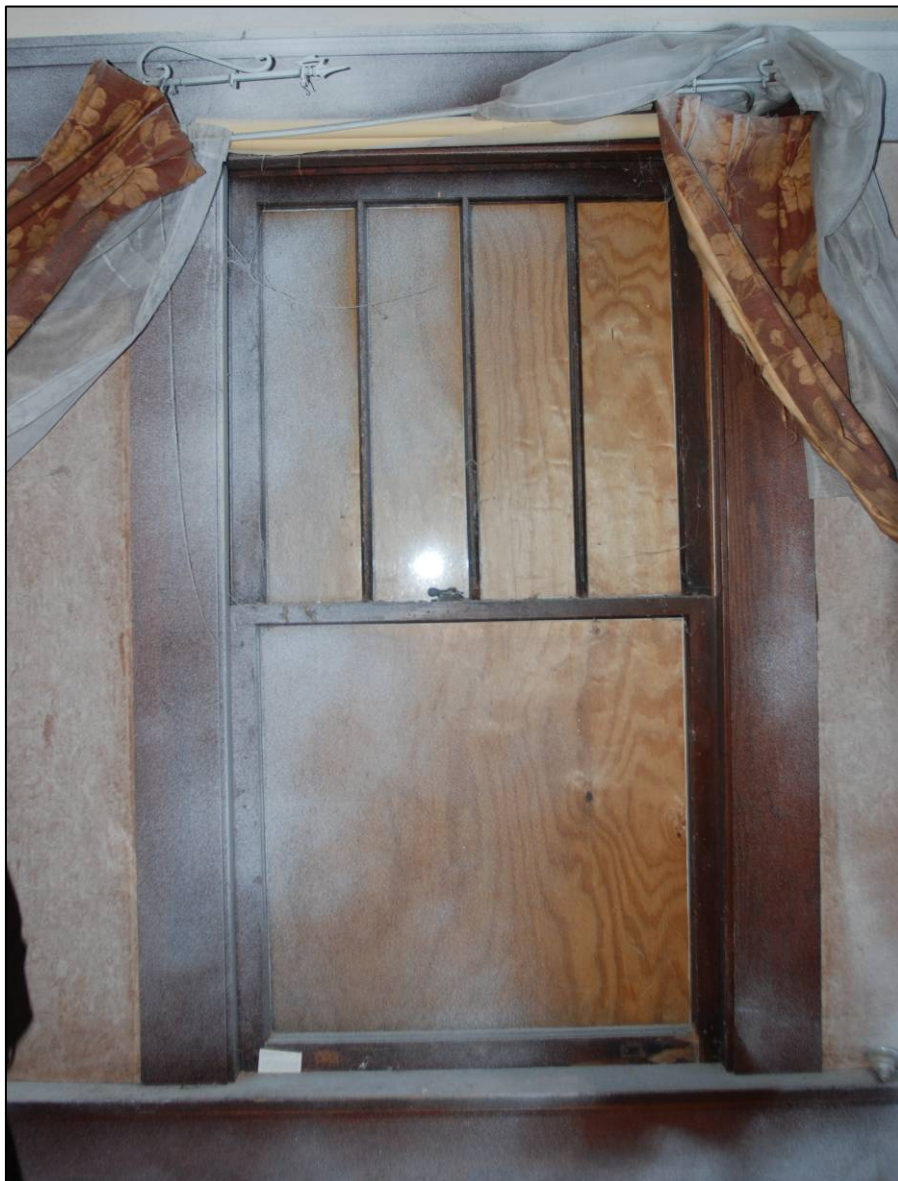
Photograph 20
South Side Window 1,
Interior Shot

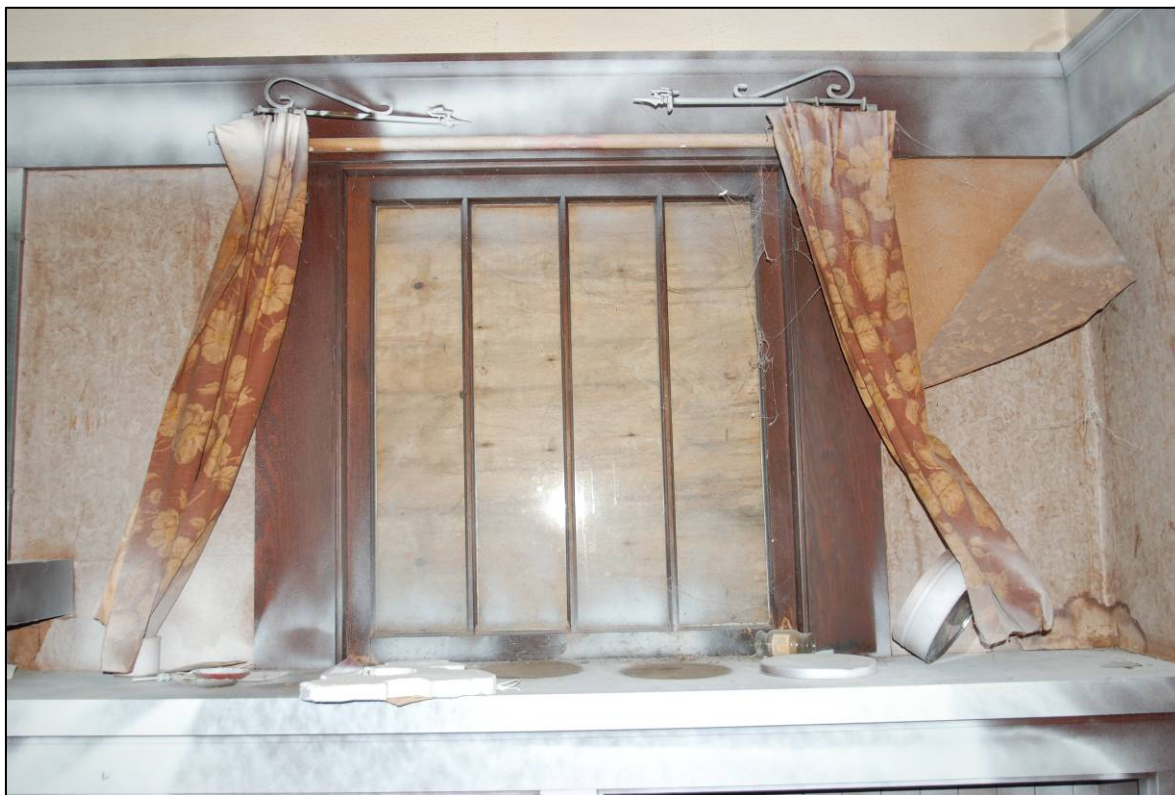
Photograph 21
Southe Side
Window 2, Interior
Shot.

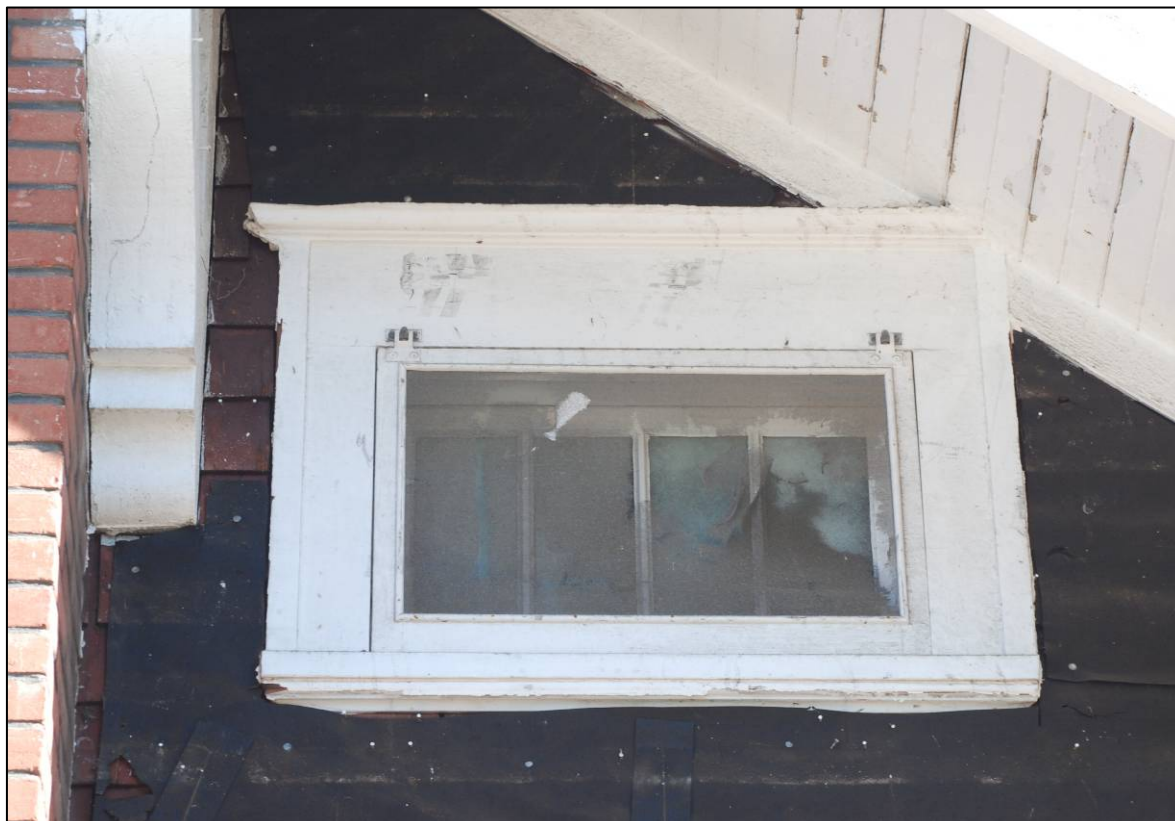
(Photo 22). On the second floor there is a small window between the chimney and the front roofline and a three sash window to the rear of the chimney. The small window sash is hinged at the top (awning hung) (Photo 23). In the large window the center sash is slightly wider than the side sashes. The center sash is fixed and has a single large light with five small lights across the top. The side sashes appear double hung with a single pane on the lower sash and triple panes on the upper sash. These appear to be original windows. As with the north side, there are no windows in the dormer sides.

Photograph 23
Second Floor Top Hinged
Window. Note typical main
house window casing.

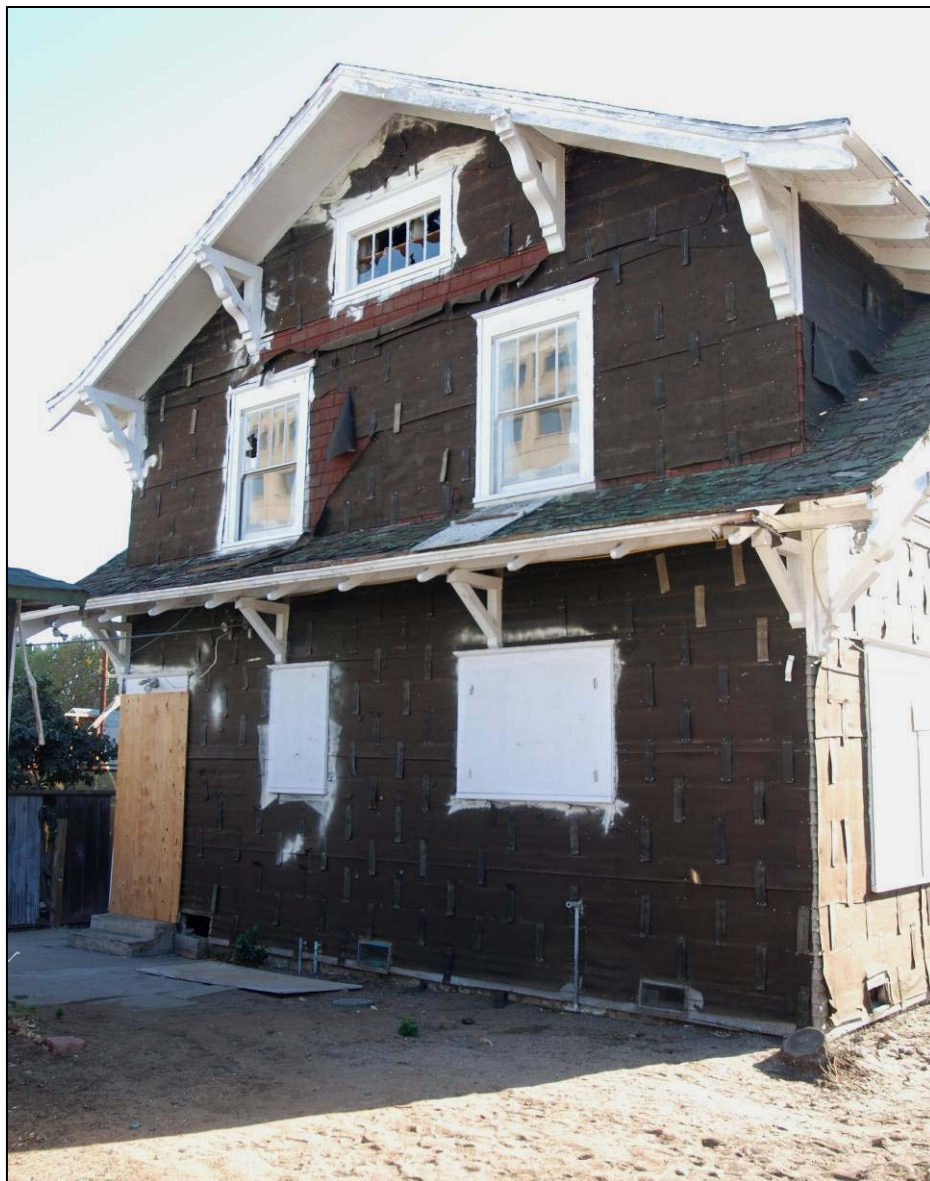
The rear (west side) of the house has two first-floor windows, three second-floor windows, and a door by the north corner (Photo 25). The horizontal roofline eaves extend across the back. The rafters are notched to sit on a horizontal beam that runs from fascia board to fascia board, with four small triangular knee braces supporting it. This is similar to the setup for the front shed window cover. These knee braces are not decorated like the other knee braces on the house. The first- and second- floor walls are on the same vertical plane.

Photograph 25
West Side of House, Looking
Northeast

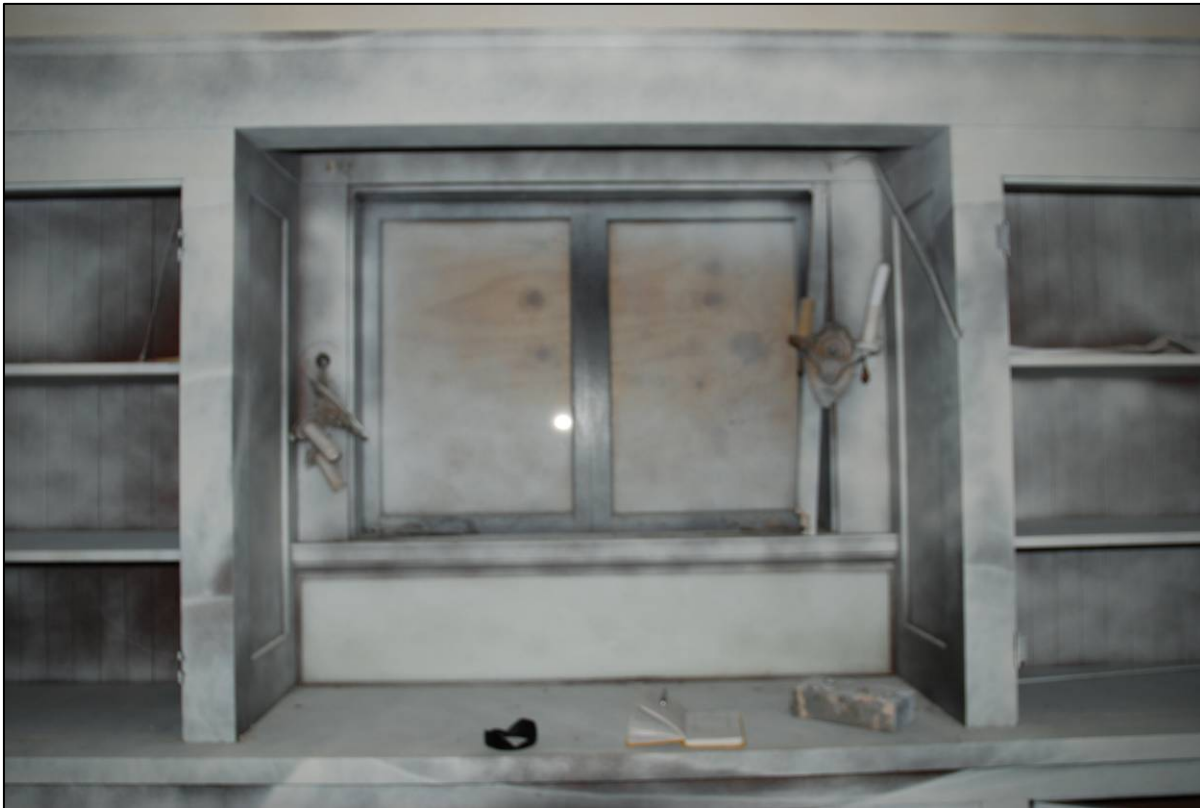
The first-floor windows are different sizes and have the wide casing and decorative top trim found on the majority of the other house windows, as do the second-floor windows. The first-floor windows are covered by plywood. The southern window is casement hung, and each sash has a single light (Photo 26). The northern window is double hung with a single pane on the lower sash and triple panes on the upper sash (Photo 27). The two second-floor windows are evenly spaced off the center line of the wall, and have the same sash layout as the first floor windows (see Photo 25). There is a small, five-pane fixed rectangular window above these two windows. Like the similar window in the front, it appears to be for lighting the attic. The back door has been removed. The casing of the door matches the windows. There are two concrete steps leading up to the door. There is a small crawl space/vent hole in the foundation next to the steps.

Photograph 26
West Side, South
Window, Interior
Shot

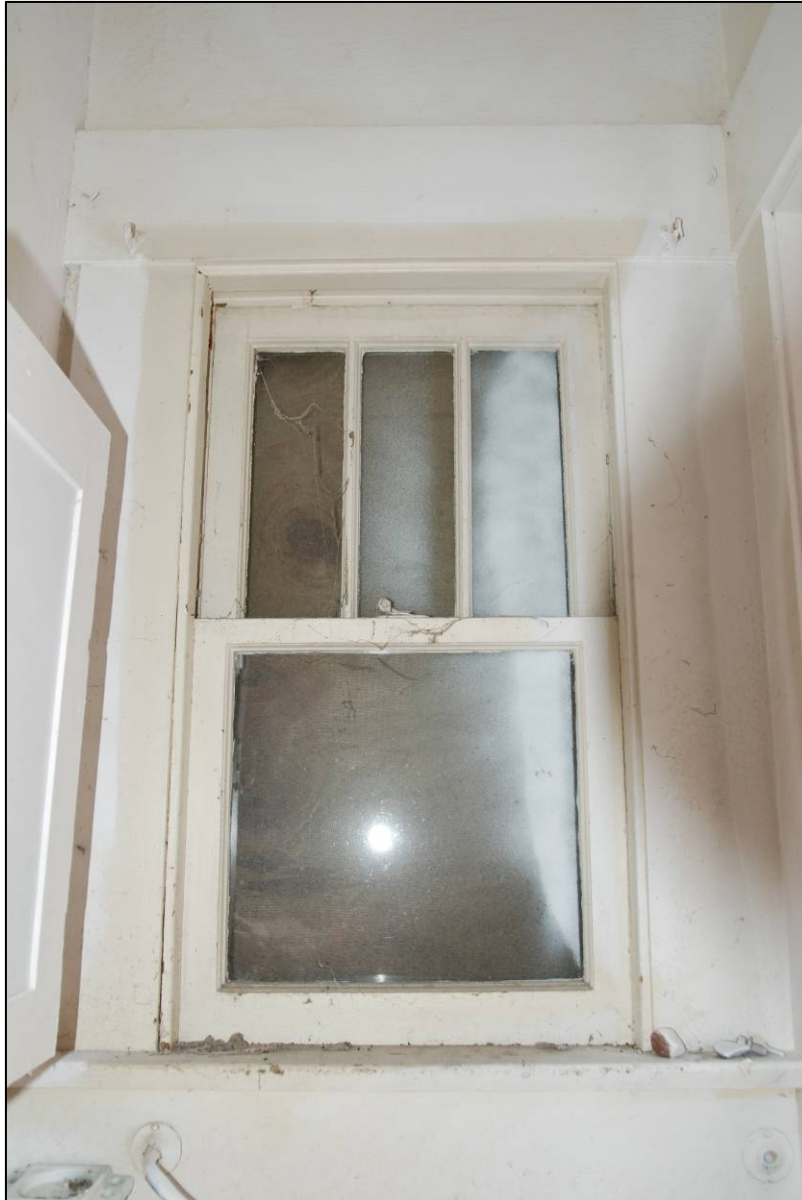
Photograph 27
West Side,
North Window,
Interior Shot

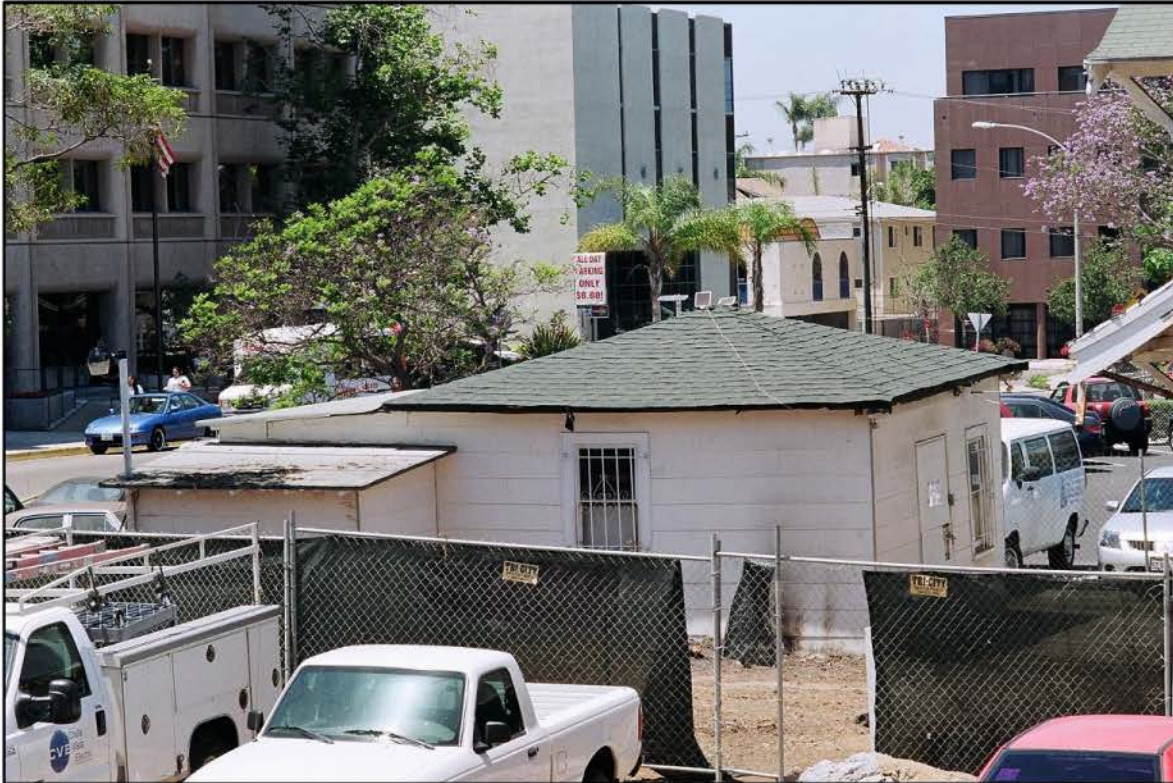
The garage/outbuilding is separated from the house by about 15 feet. It is rectangular with a very low pyramidal roof covering the front and a shed roof covering the rear (Photo 28). There are two additions to the original structure. It appears the garage was originally square, measuring 16 feet 2 inches on a side. The pyramid roof covers this portion. The original roof has exposed rafters with no decoration and is covered in composition shingles. The first addition has been added to the back of the building (fronting on Fourth Avenue). This addition is 8 feet deep and runs the entire width of the garage. It has a very shallow pitched shed roof attached to the underside of the original roof eave. The addition roof also has exposed rafters and is covered in composition shingles.

Photograph 28
Overview of
Garage Building,
Taken Before
Siding Was
Removed

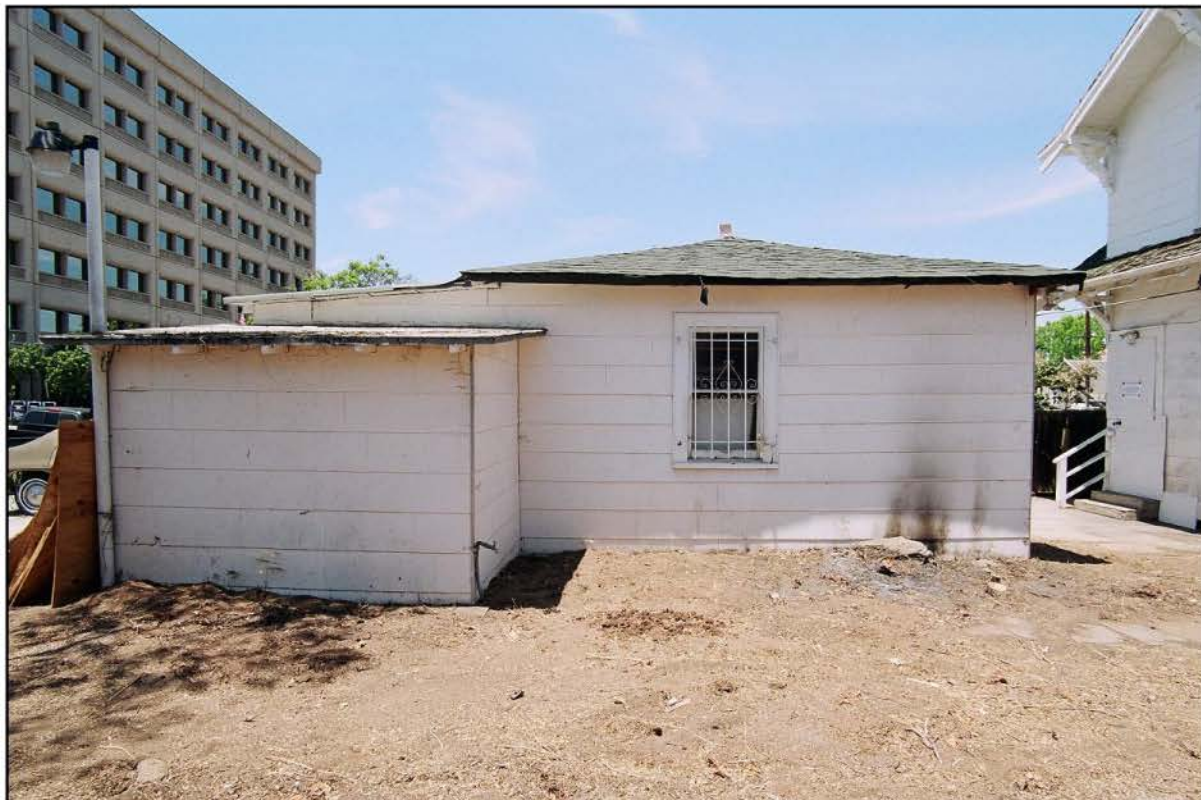
The north side of the garage is bare, with no windows or doors. The south side wall has a single window (Photos 30 and 31). It is centered in the wall of the original garage. The second addition has been added to the Fourth Avenue end of this wall, on the side of the first addition. This addition is 8 feet 6 inches wide and 6 feet 6 inches deep, with a very shallow pitched shed roof attached to the wall approximately 10 inches below the rafters. There are no windows in this addition. A single narrow door is located in the east wall facing the driveway, next to the main garage door.

Photograph 30
Overview of
Garage
Building, Taken
Before Siding
Was Removed,
Showing
Relationship of
Addition (on
Left) to Original
Garage

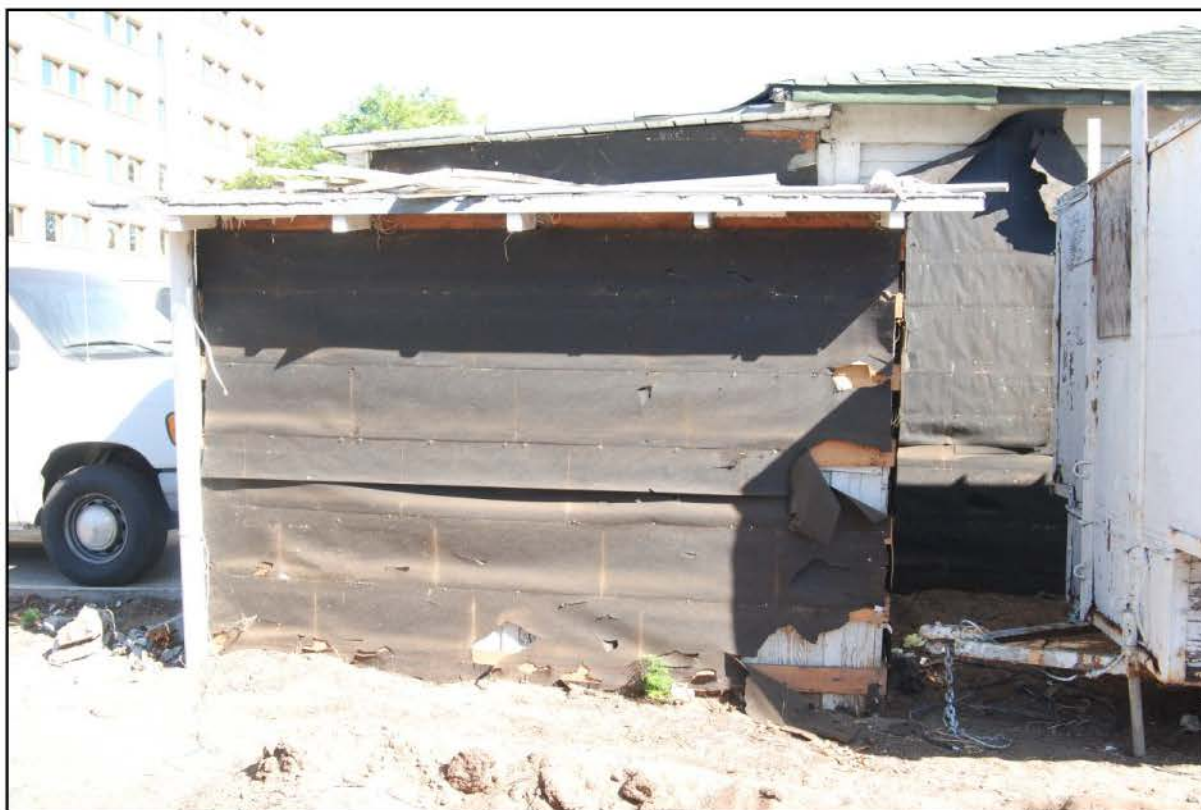
Photograph 31
South Side of
Garage, Current
Condition,
Showing Addition
and Part of
Original Garage

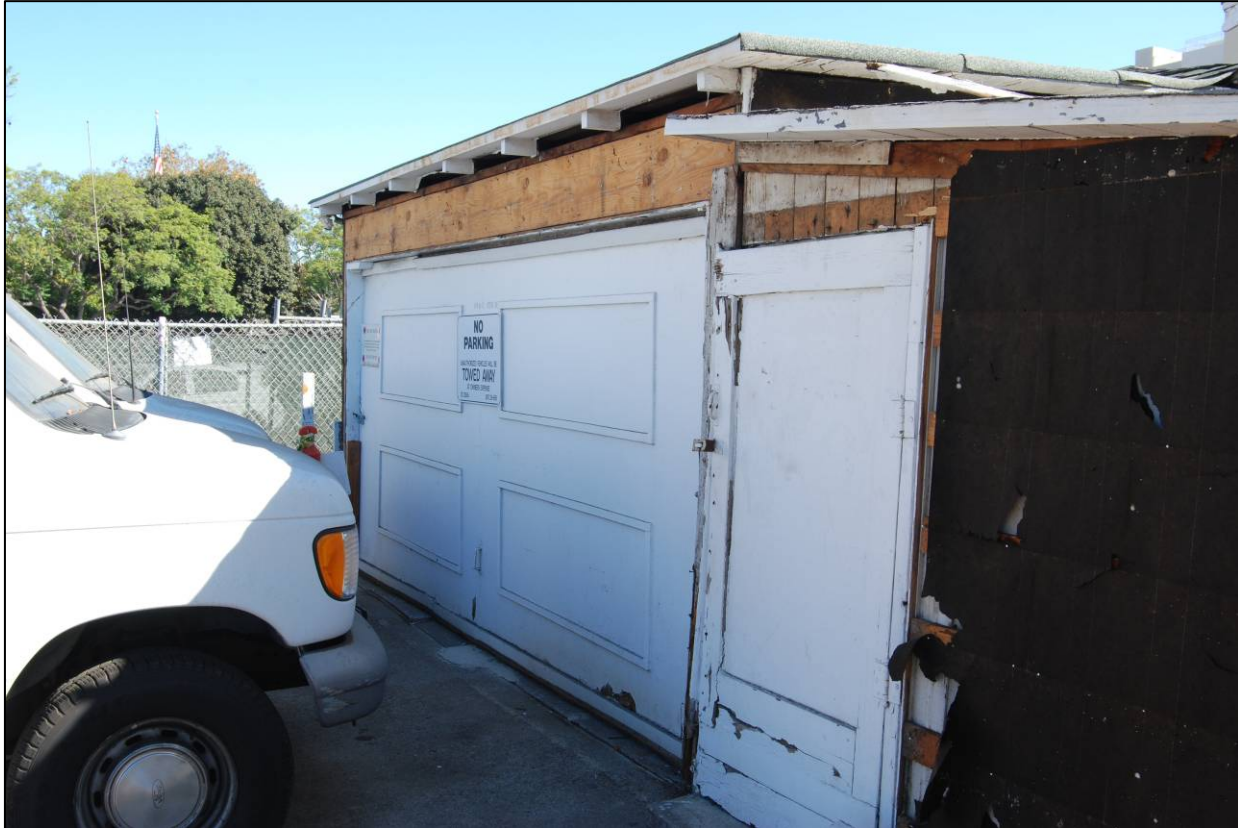
The west wall of the garage is almost completely taken up by a single piece tilt up wooden garage door (Photo 32). The door has 4 raised rectangle outlines for decoration. The second addition west wall is on the same plane as the main west wall. A full width driveway extends from the back of the garage to the sidewalk.

Photograph 32
West Side of Garage
Showing Both West
Addition and South
Addition.

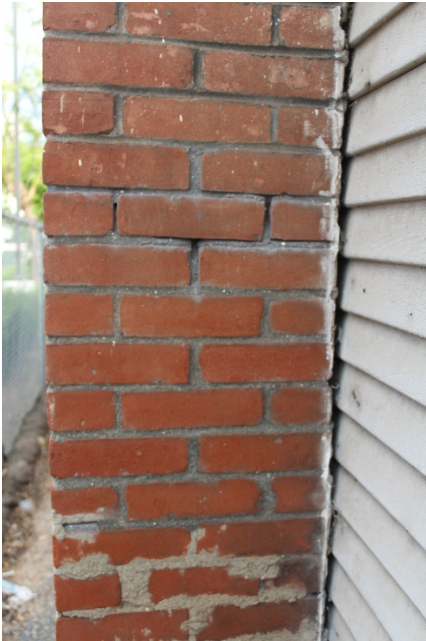
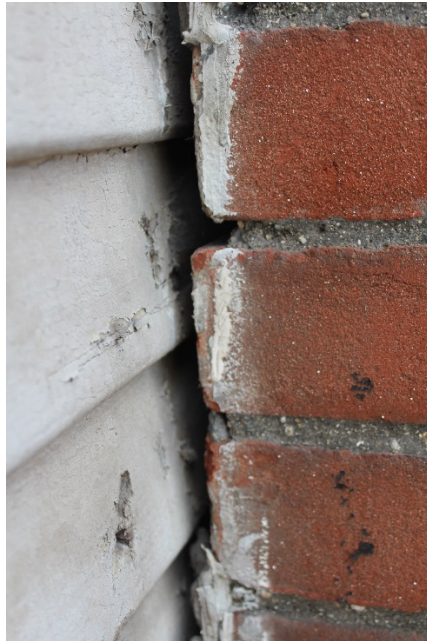
Photos 1 & 2: The north chimney. Note the painted wood siding continuing behind the bricks.

4. Reconstruction of the CMU foundation walls will incorporate new blocks with a matching faux-stone finish.
5. The original south chimney will be transported to the new site. Reconstruction will incorporate salvaged or new matching bricks. The non-original north chimney will not be reconstructed as it is not a historic feature.

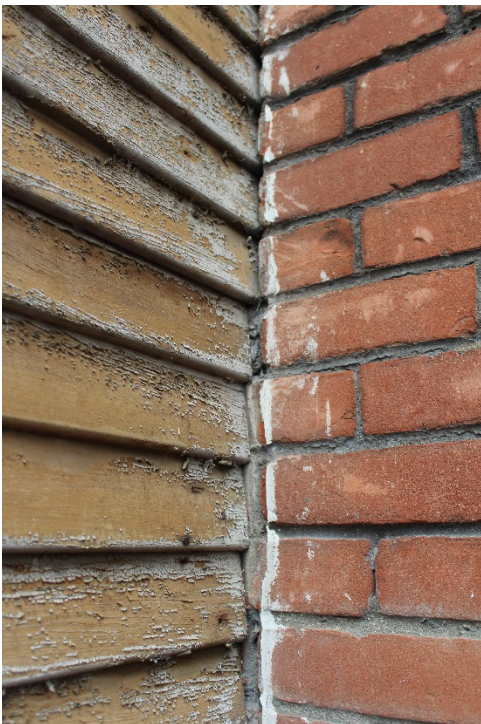
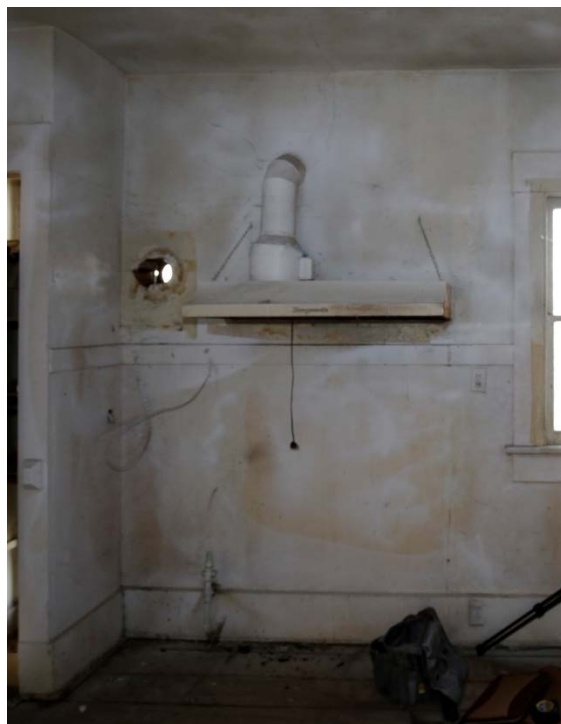
Photos 3 & 4: The original south chimney (left) with the wood siding stopping at the bricks. The stove flue extends into the north chimney (right). Note the older, abandoned flue hole to the left, which didn't connect to the chimney, indicating earlier stoves used an exposed metal flue pipe.
