Facilities Condition Assessment **Qualcomm Stadium**

Facilities Condition Assessment
AECOM
San Diego, California
April 2011

Qualcomm Stadium Facilities Condition Assessment

Qualcomm Stadium Facilities Condition Assessment
Introduction and Methodology

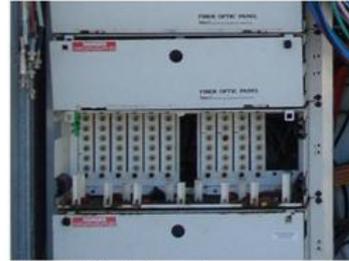
Fiber Patch Panels Uncapped

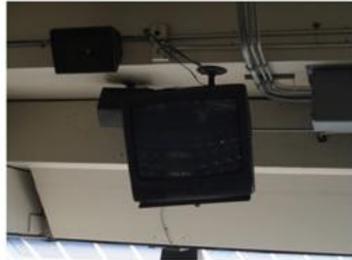
Older Model Monitors

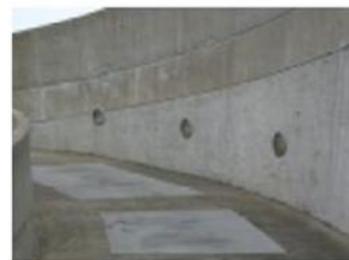
Patched Concrete at Ramp

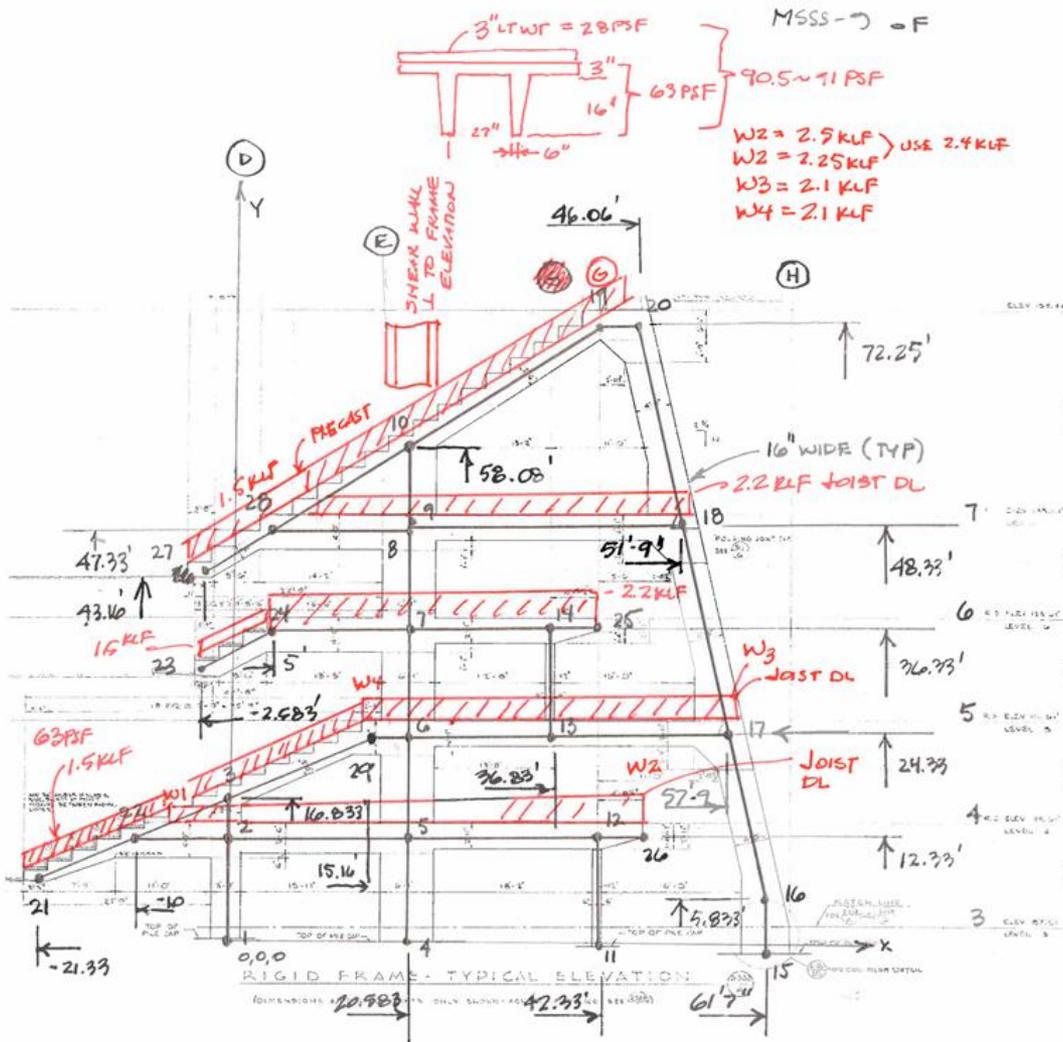
RISA MODEL GEOMETRY

BASED ON RISA MODEL UPPER LEVEL FRAME STIFFNESS = 212 k/11 WHILE THE FRAME BELOW W/ THE ADDER COLUMNS HAS A STIFFNESS = 689 k/11

$212/689 = 30\%$ ∴ DOESN'T COMPLY HOWEVER THIS CRITERIA IS MORE APPROPRIATE TO MULTI STORY BUILDINGS AND CAN BE PROBLEMATIC IN BUILDINGS 5 TO 15 STORIES IN HEIGHT. WE ONLY HAVE 2 LEVELS (EFFECTIVE) AND THE ASCE 7-10 WOULD ALLOW A 2 STEP STATIC CALL

LDCOMP 2 LOAD @ 18 = 100 K → SUPPORT @ 17
 $\Delta_{18} = .472''$ $K = 212 \text{ K/IN}$
 LD COMB 1 LOAD @ 17 = 100 K → SUPPORT RELEASED @ 17
 $\Delta_{17} = .145''$ $K = 689 \text{ K/IN}$

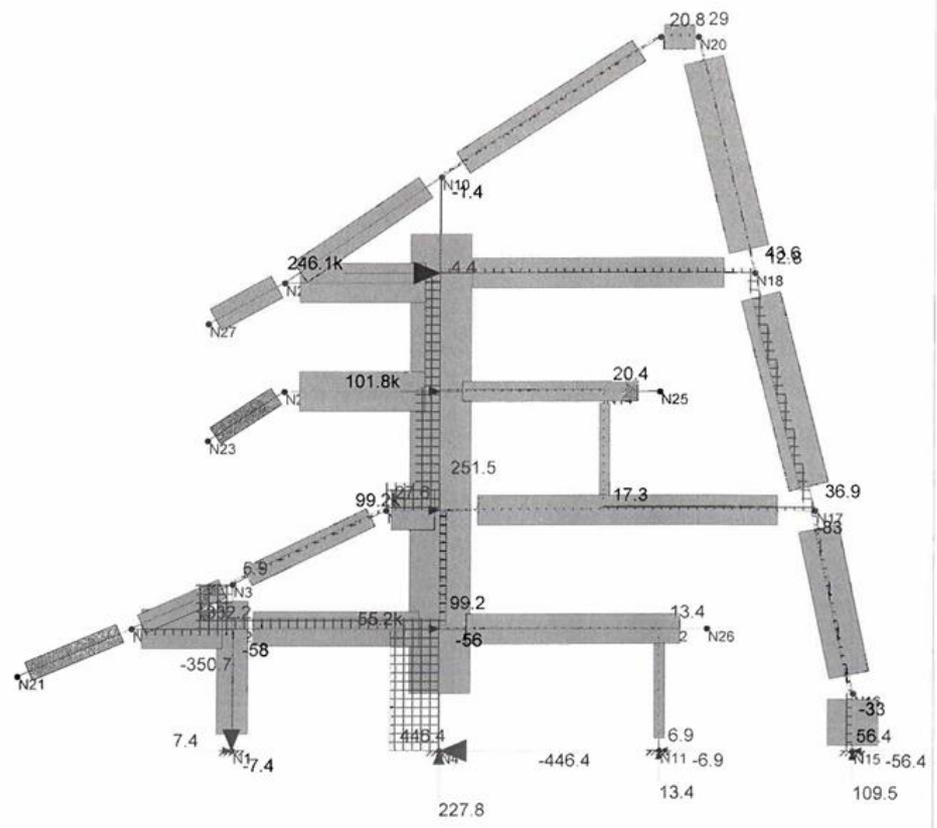
AXIAL LOAD CHECK DUE TO DL -

6'-1" x 1'-4" COL $P_{DL} = 512.5^k$ $f_c = 438.8 \text{ PSL}$
 $.10(3750) = 375 \text{ PSL} < 438.8 \text{ PSL} \therefore \text{OK}$

4" x 16" COLUMN = 153.9^k $f_c = 200 \text{ PSL} \therefore \text{OK}$

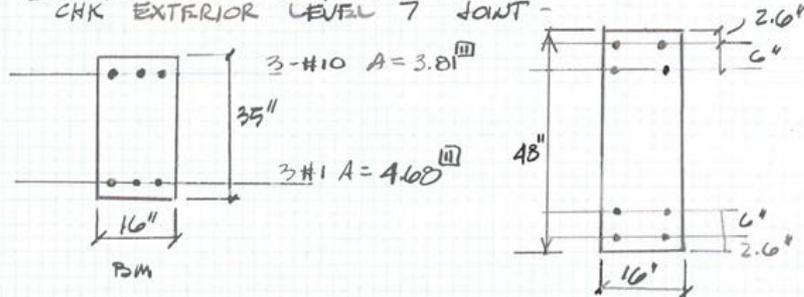
STRONG OR WEAK ISM CHK
 CHK EXTERIOR LEVEL 7 JOINT -

PSI COLUMN MOMENT CAP \gg BM COL
 (TRUE @ ALL BM COL JOINTS.)

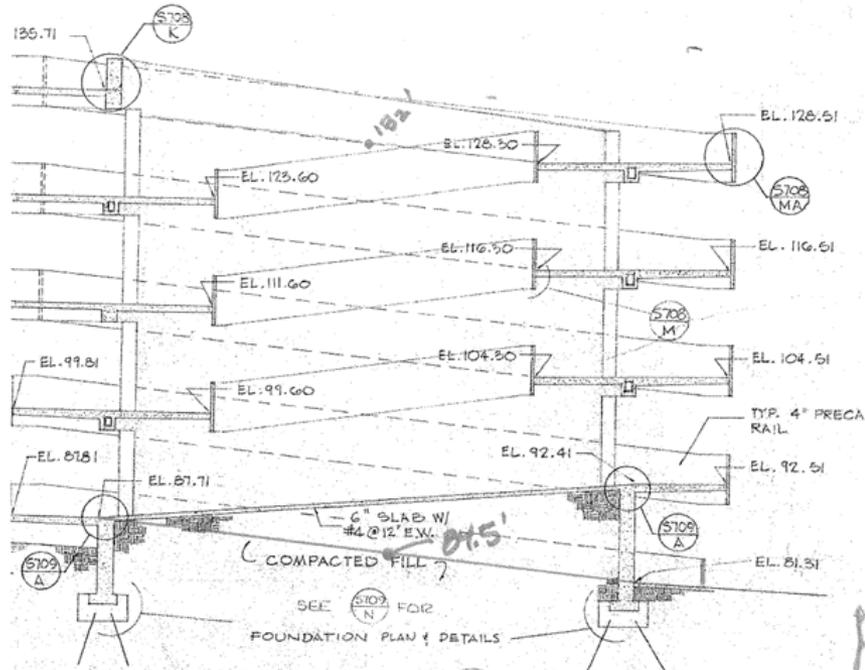
SECTION (S102 F)
 SCALE: 1/8" = 1'-0"
 RAMP # 1, 2, 4, 5, & 6 ONLY
 NTS

RAMP STRUCTURE -

THE RAMP STRUCTURE DOES NOT FIT THE
 CLASSIC CASE OF A BUILDING HOWEVER
 THE SHEARWALL STYLE CHECKLIST WILL BE
 USED.

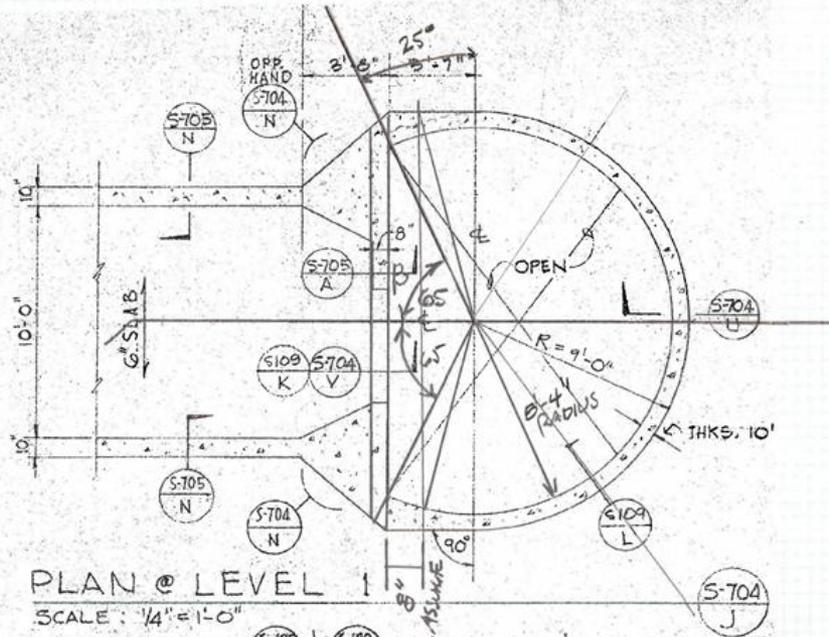
PLAN @ LEVEL 1
 SCALE: 1/4" = 1'-0"
 SEE DETAILS (S-109/A) & (S-109/B) FOR FON. DET.

THE ELEVATOR TOWER IS A CAST IN PLACE CONCRETE TUBE THAT DOESNT SPECIFICALLY FALL INTO AN ASCE 91-03 CHECKLIST. THE STRUCTURE IS COMPLIANT W/ THE MAJORITY OF THE CHECKLIST ITEMS -

VERIFY QUICK CHK SHEAR WALL SHEAR CAPACITY
 VERIFY AMOUNT OF WALL STEEL

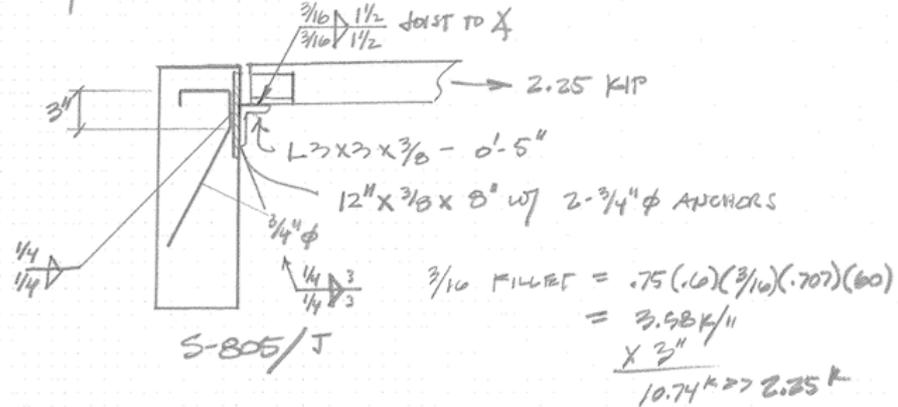
ANGLE TO THE WELD CAPACITY >
 DIST TO ANGLE O.K.
 IT TO 3/4" ROD ANCHORS

$$\therefore \text{CAP} = 2(3) \times 2 \text{ ANCHORS} \times 4.05 = 48.6 \text{ KIPS} \gg 2.25 \text{ K}$$
