Channel: Washington

MMP Map # 84

Channel Maintenance Prioritization Summary Sheet

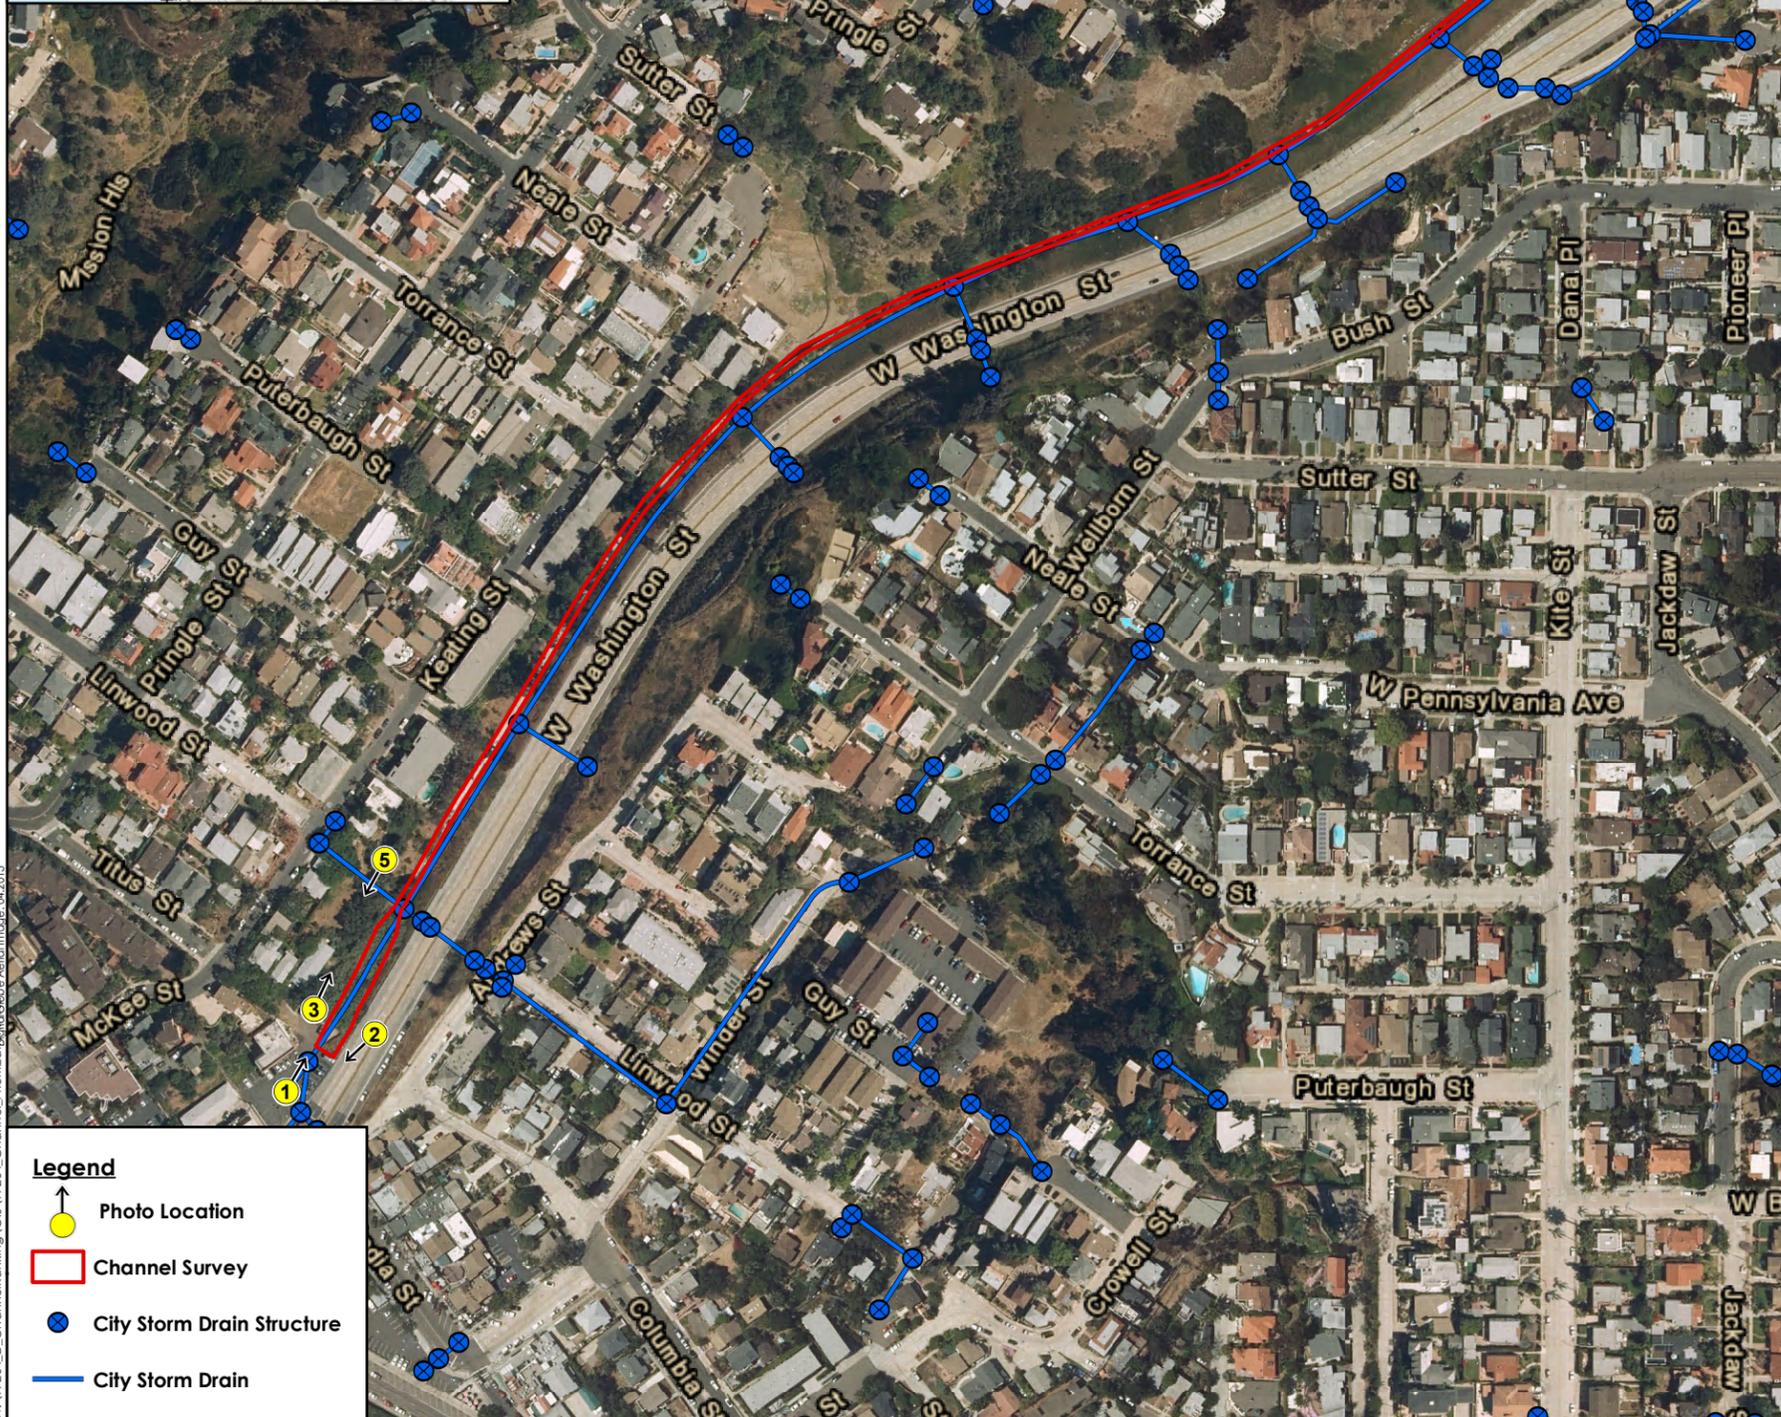
- Channel Prioritization Score: **80.3 out of 100**
 - Flood Hazard Score: **71.3 out of 75**
 - Water Quality Score: **4 out of 10**
 - Community Input Score: **5 out of 10**
 - Aesthetics Score: **0 out of 5**
- Capacity Prior to Maintenance: **Less than 2-year storm event**
- Capacity After Maintenance (As-built Capacity) : **100-year storm event**
- Clogging Potential: **HIGH**
- Approximate Vegetation Coverage: **HIGH**
- Surrounding Area: **Residential**
- Infrastructure Failures: **None**
- Site Evaluation Date: **May 5, 2015**
- Notes/Comments: **Based on site photos taken by the City of San Diego, heavy vegetation exists in the downstream end of the channel. A high risk of vegetation clogging the downstream culvert exists.**

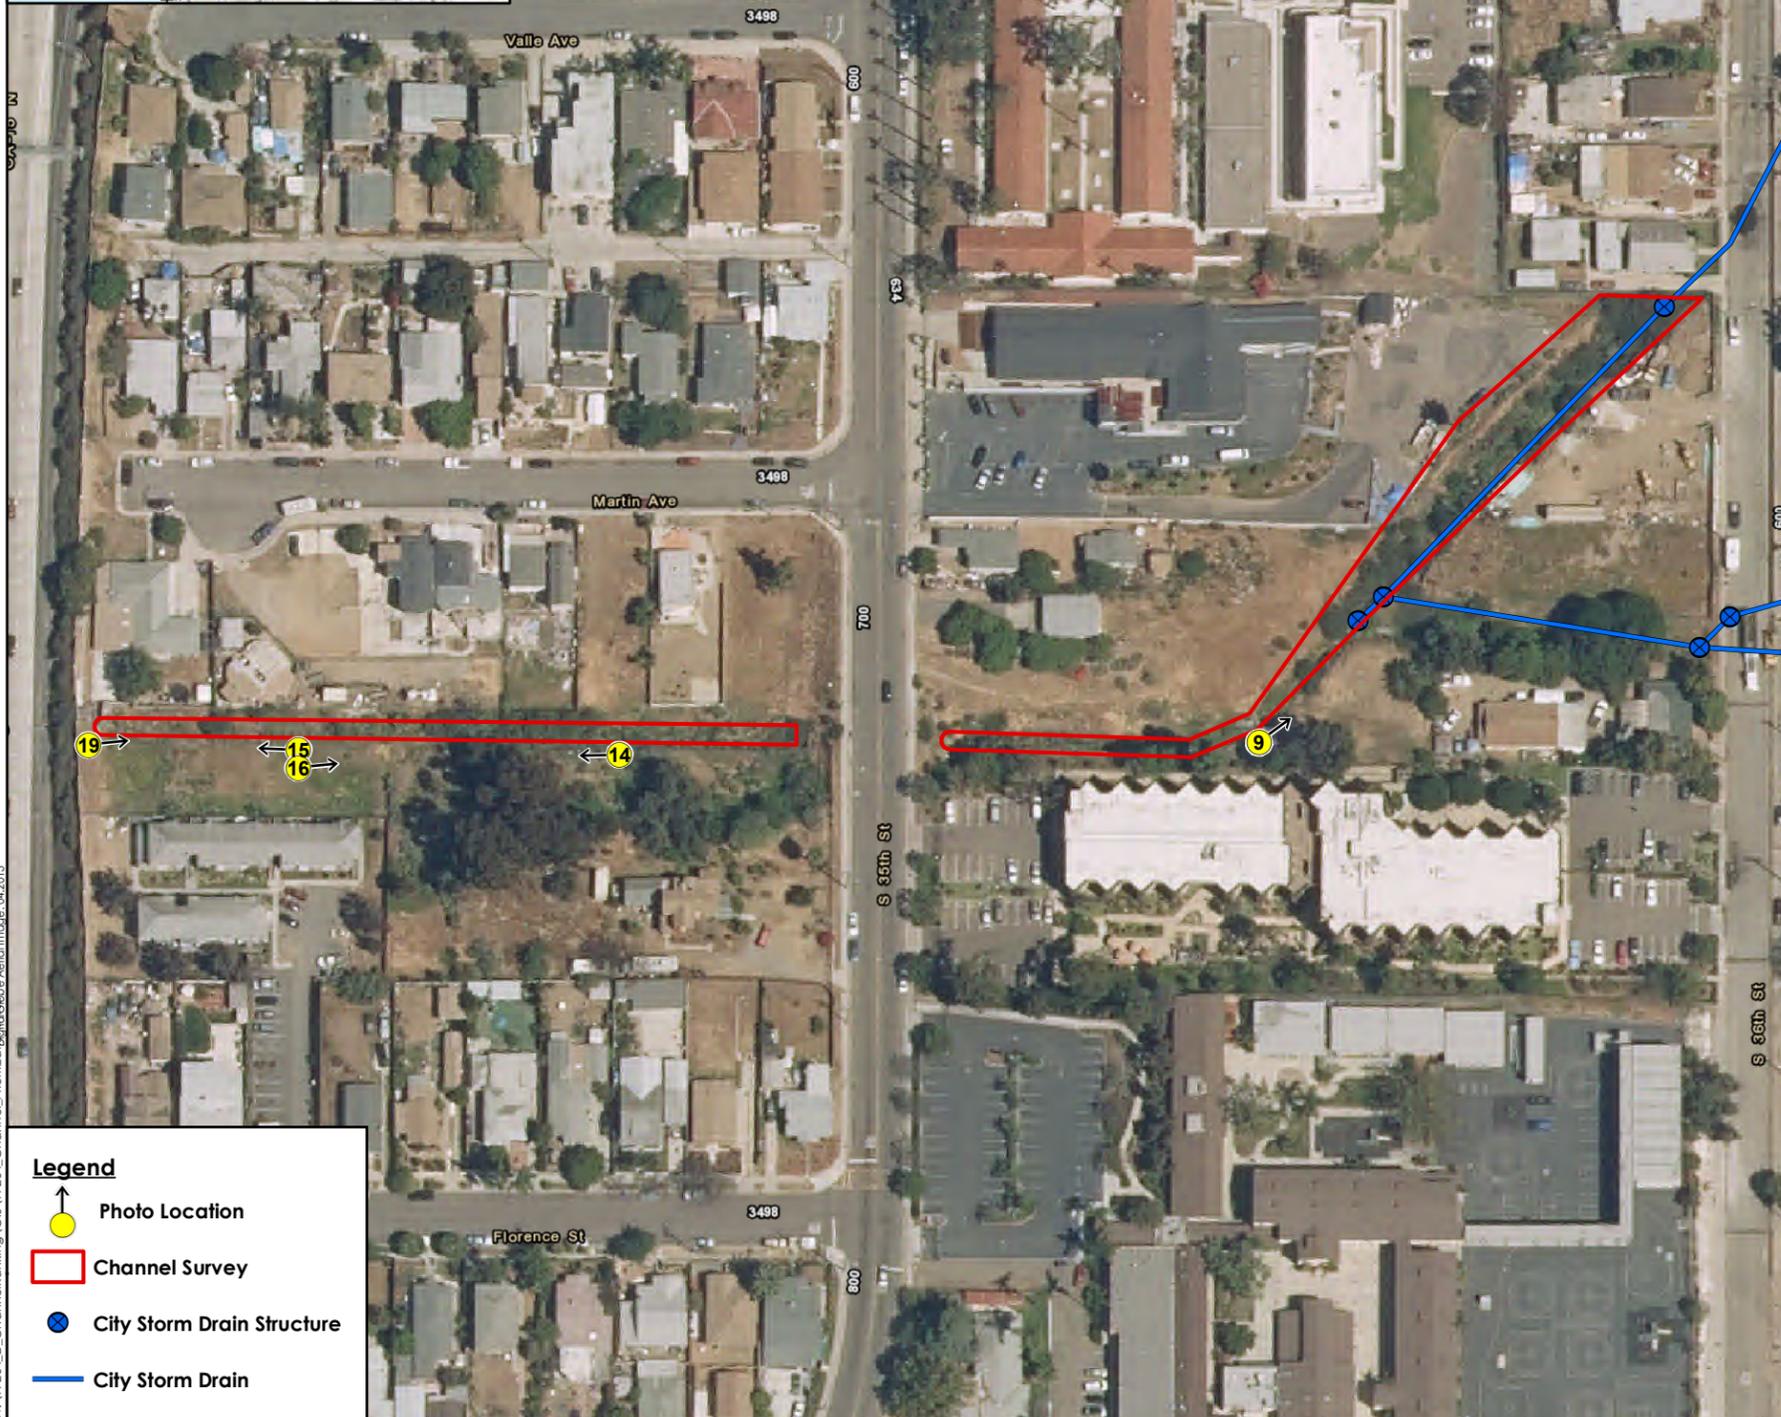
- **Channel Prioritization Score:**
57.4 out of 100
 - Flood Hazard Score:
54.4 out of 75
 - Water Quality Score:
3 out of 10
 - Community Input Score:
0 out of 10
 - Aesthetics Score:
0 out of 5
- **Capacity Prior to Maintenance:**
Less than 2-year storm event
- **Capacity After Maintenance (As-built Capacity):**
Less than 2-year storm event
- **Clogging Potential:** MEDIUM
- **Approximate Vegetation Coverage:** HIGH
- **Surrounding Area:** Residential
- **Infrastructure Failures:**
None
- **Site Evaluation Date:**
July 17, 2015
- **Notes/Comments:**

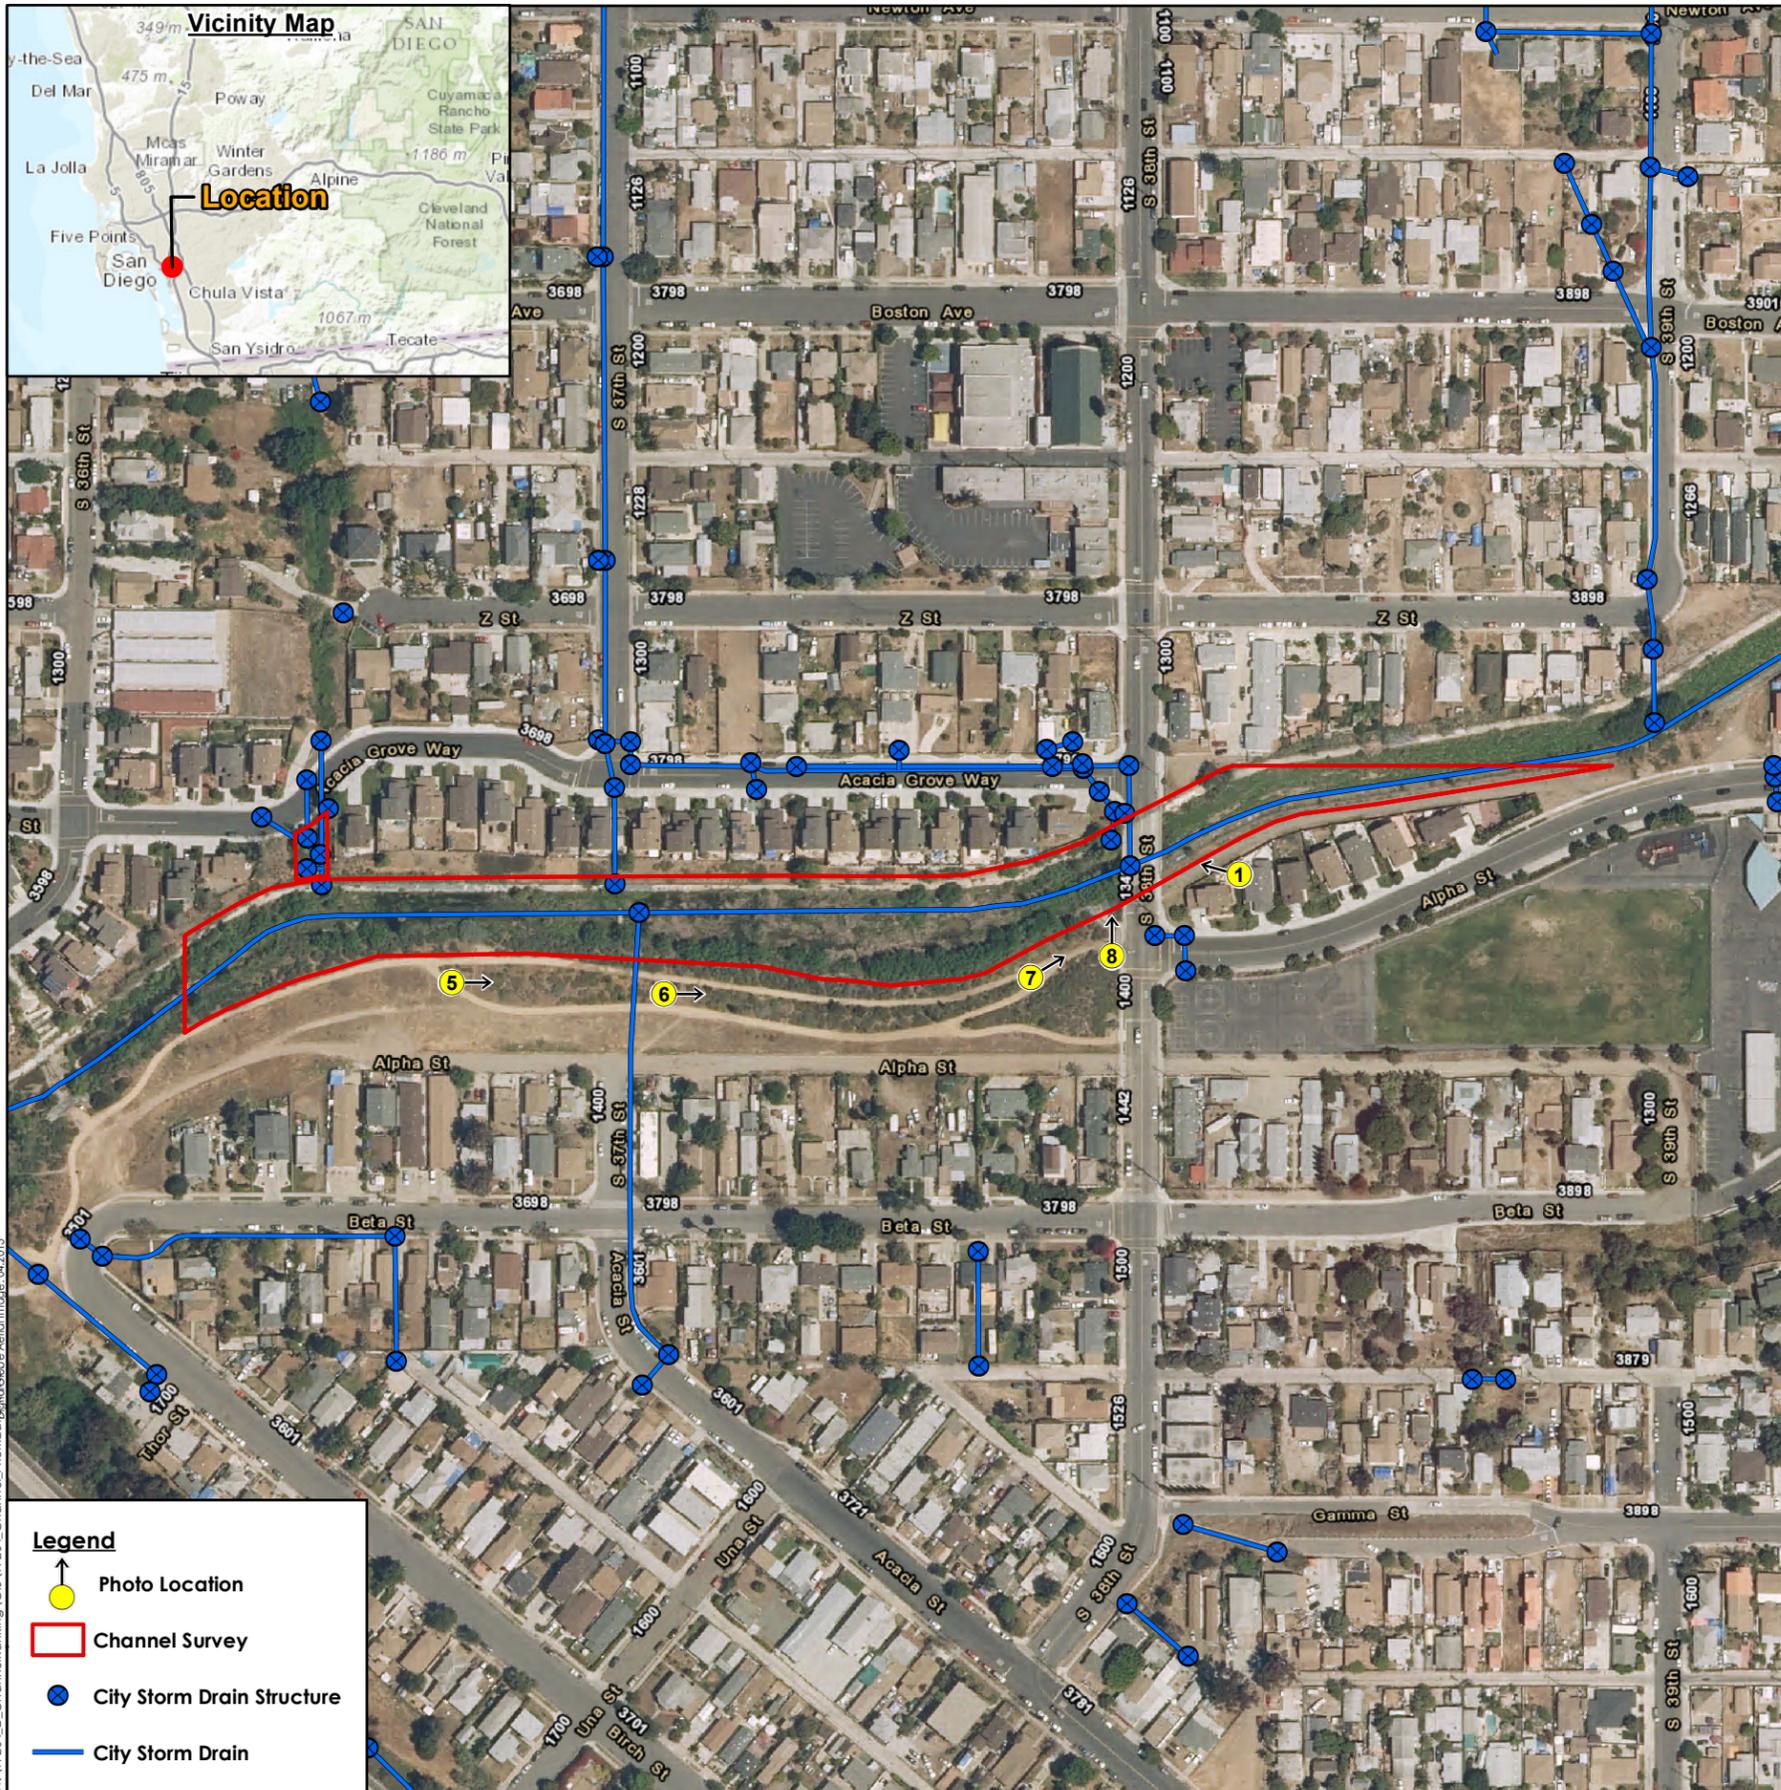
MMP Map # 92

- Channel Prioritization Score: **72.0 out of 100**
 - Flood Hazard Score: **65.0 out of 75**
 - Water Quality Score: **2 out of 10**
 - Community Input Score: **5 out of 10**
 - Aesthetics Score: **0 out of 5**
- Capacity Prior to Maintenance: **5-year storm event**
- Capacity After Maintenance (As-built Capacity) : **25-year storm event**
- Clogging Potential: **HIGH**
- Approximate Vegetation Coverage: **HIGH**
- Surrounding Area: **Residential**
- Infrastructure Failures: **None**
- Site Evaluation Date: **May 5, 2015**
- Notes/Comments: **Moderate erosion in west end of channel near the foot bridge**

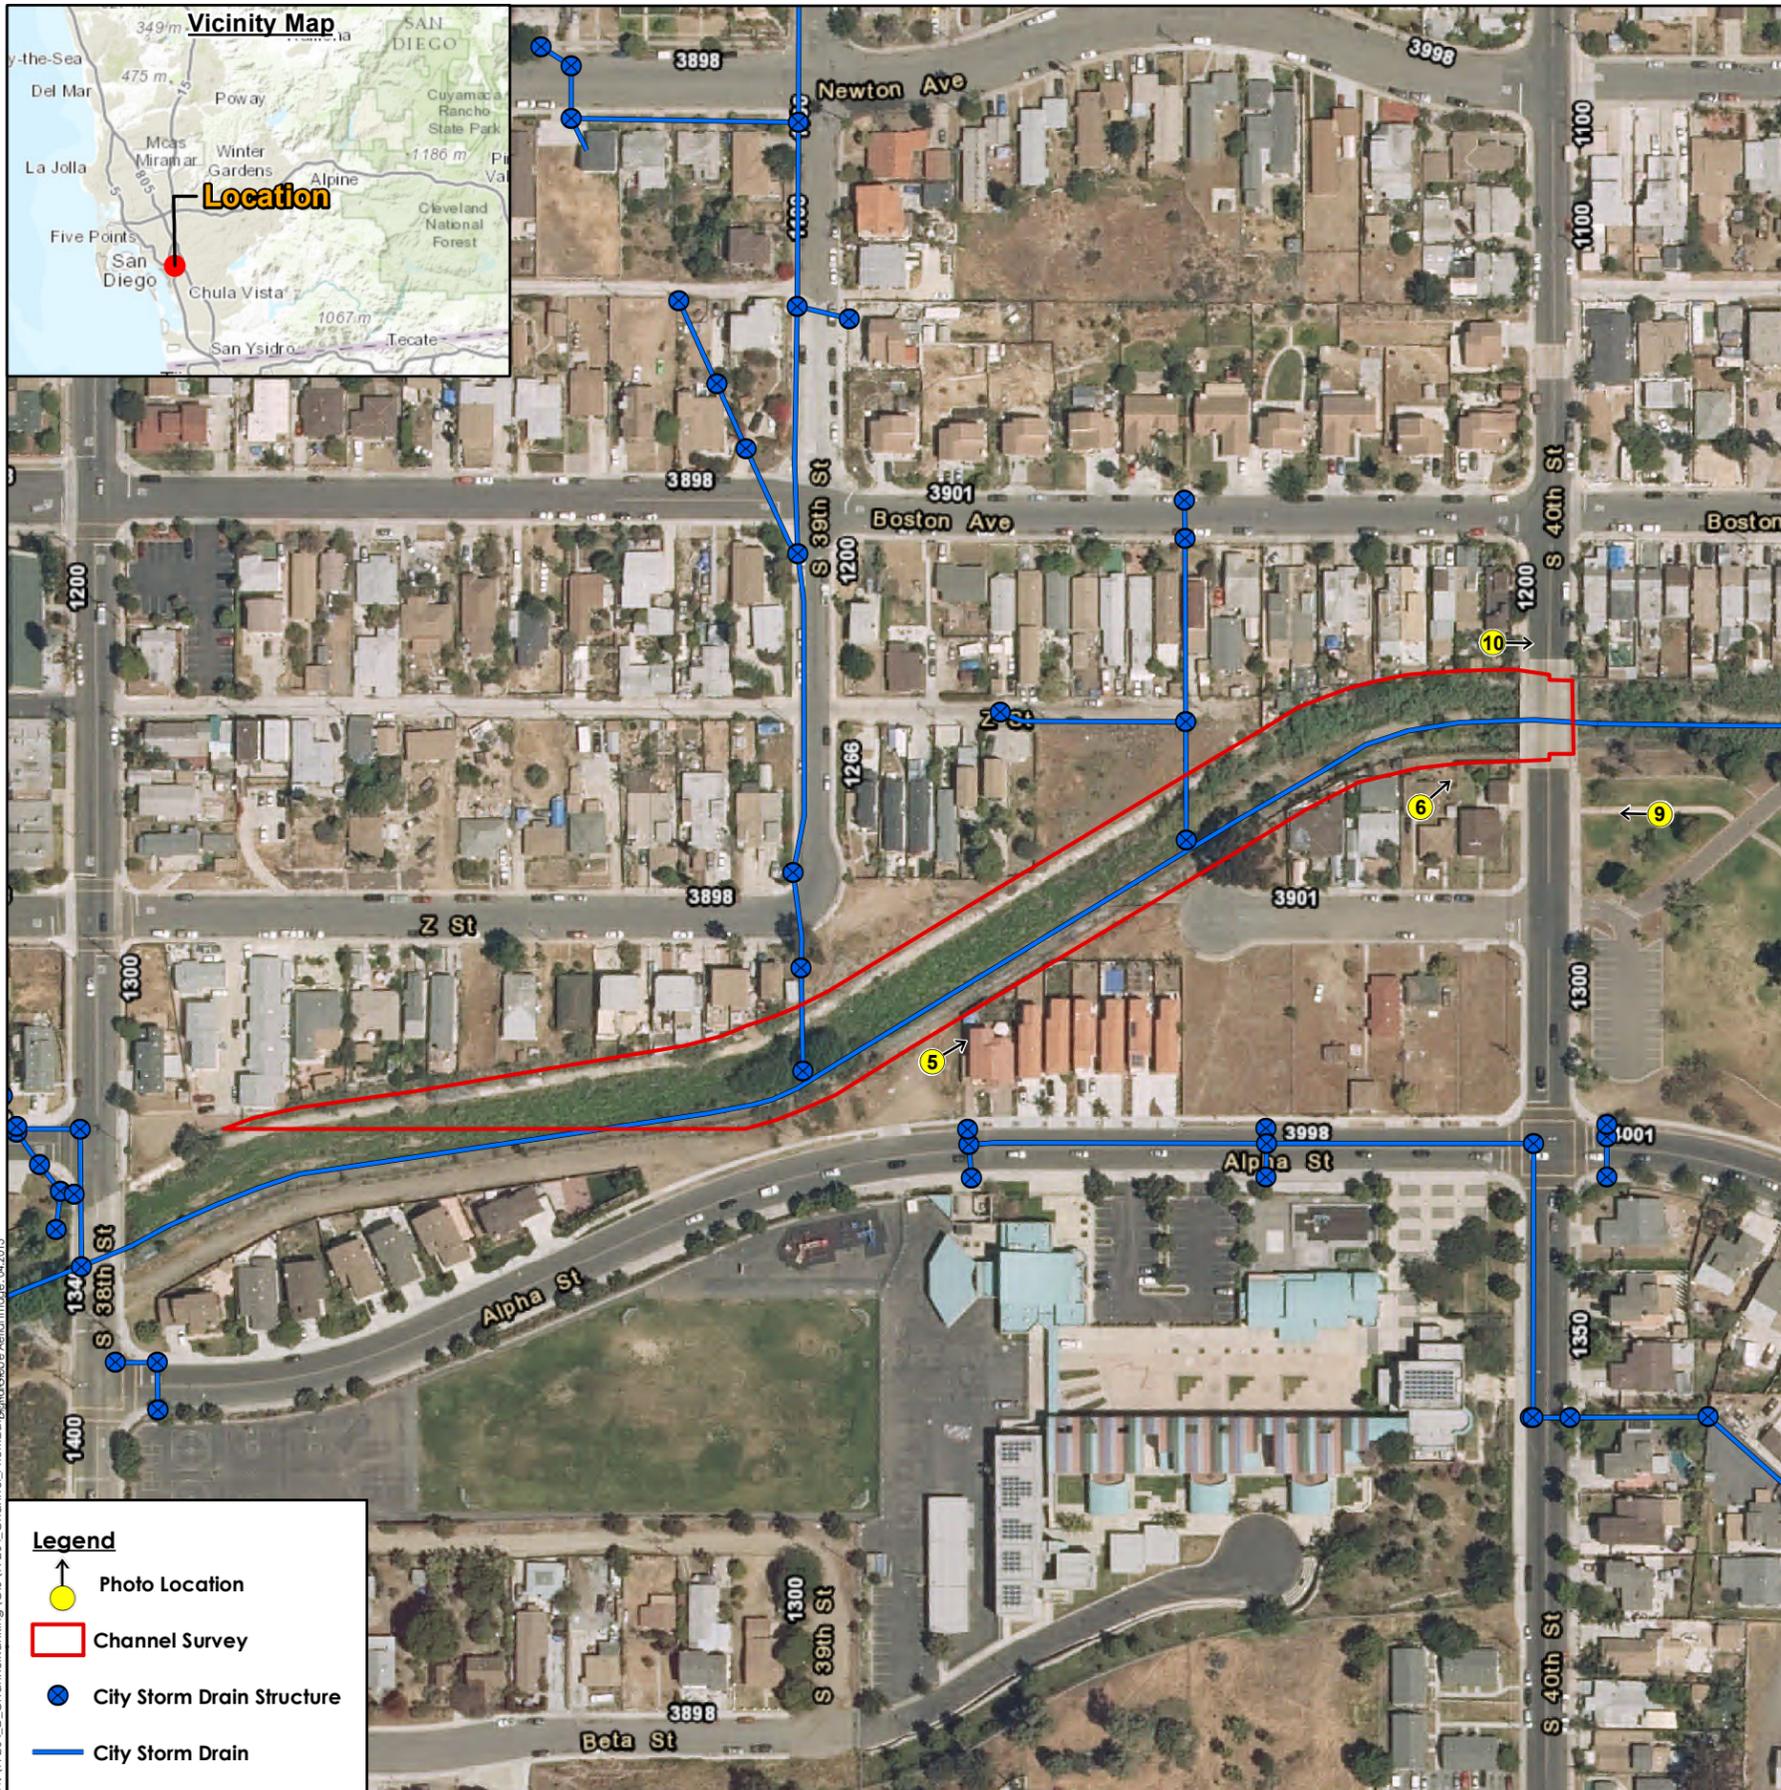
MMP Map # 95

- Channel Prioritization Score: **71.8 out of 100**
 - Flood Hazard Score: **63.8 out of 75**
 - Water Quality Score: **3 out of 10**
 - Community Input Score: **5 out of 10**
 - Aesthetics Score: **0 out of 5**
- Capacity Prior to Maintenance: **10- to 25-year storm event**
- Capacity After Maintenance (As-built Capacity) : **50- to 100-year storm event**
- Clogging Potential: **HIGH**
- Approximate Vegetation Coverage: **HIGH**
- Surrounding Area: **Residential**
- Infrastructure Failures: **NONE**
- Site Evaluation Date: **May 5, 2015**
- Notes/Comments: **A high risk of vegetation flowing downstream and clogging the culvert exists. It was noted on the O&M Channel Maintenance Inspection Form completed for the channel by the City of San Diego that there is broken gunite near the foot bridge to the park.**

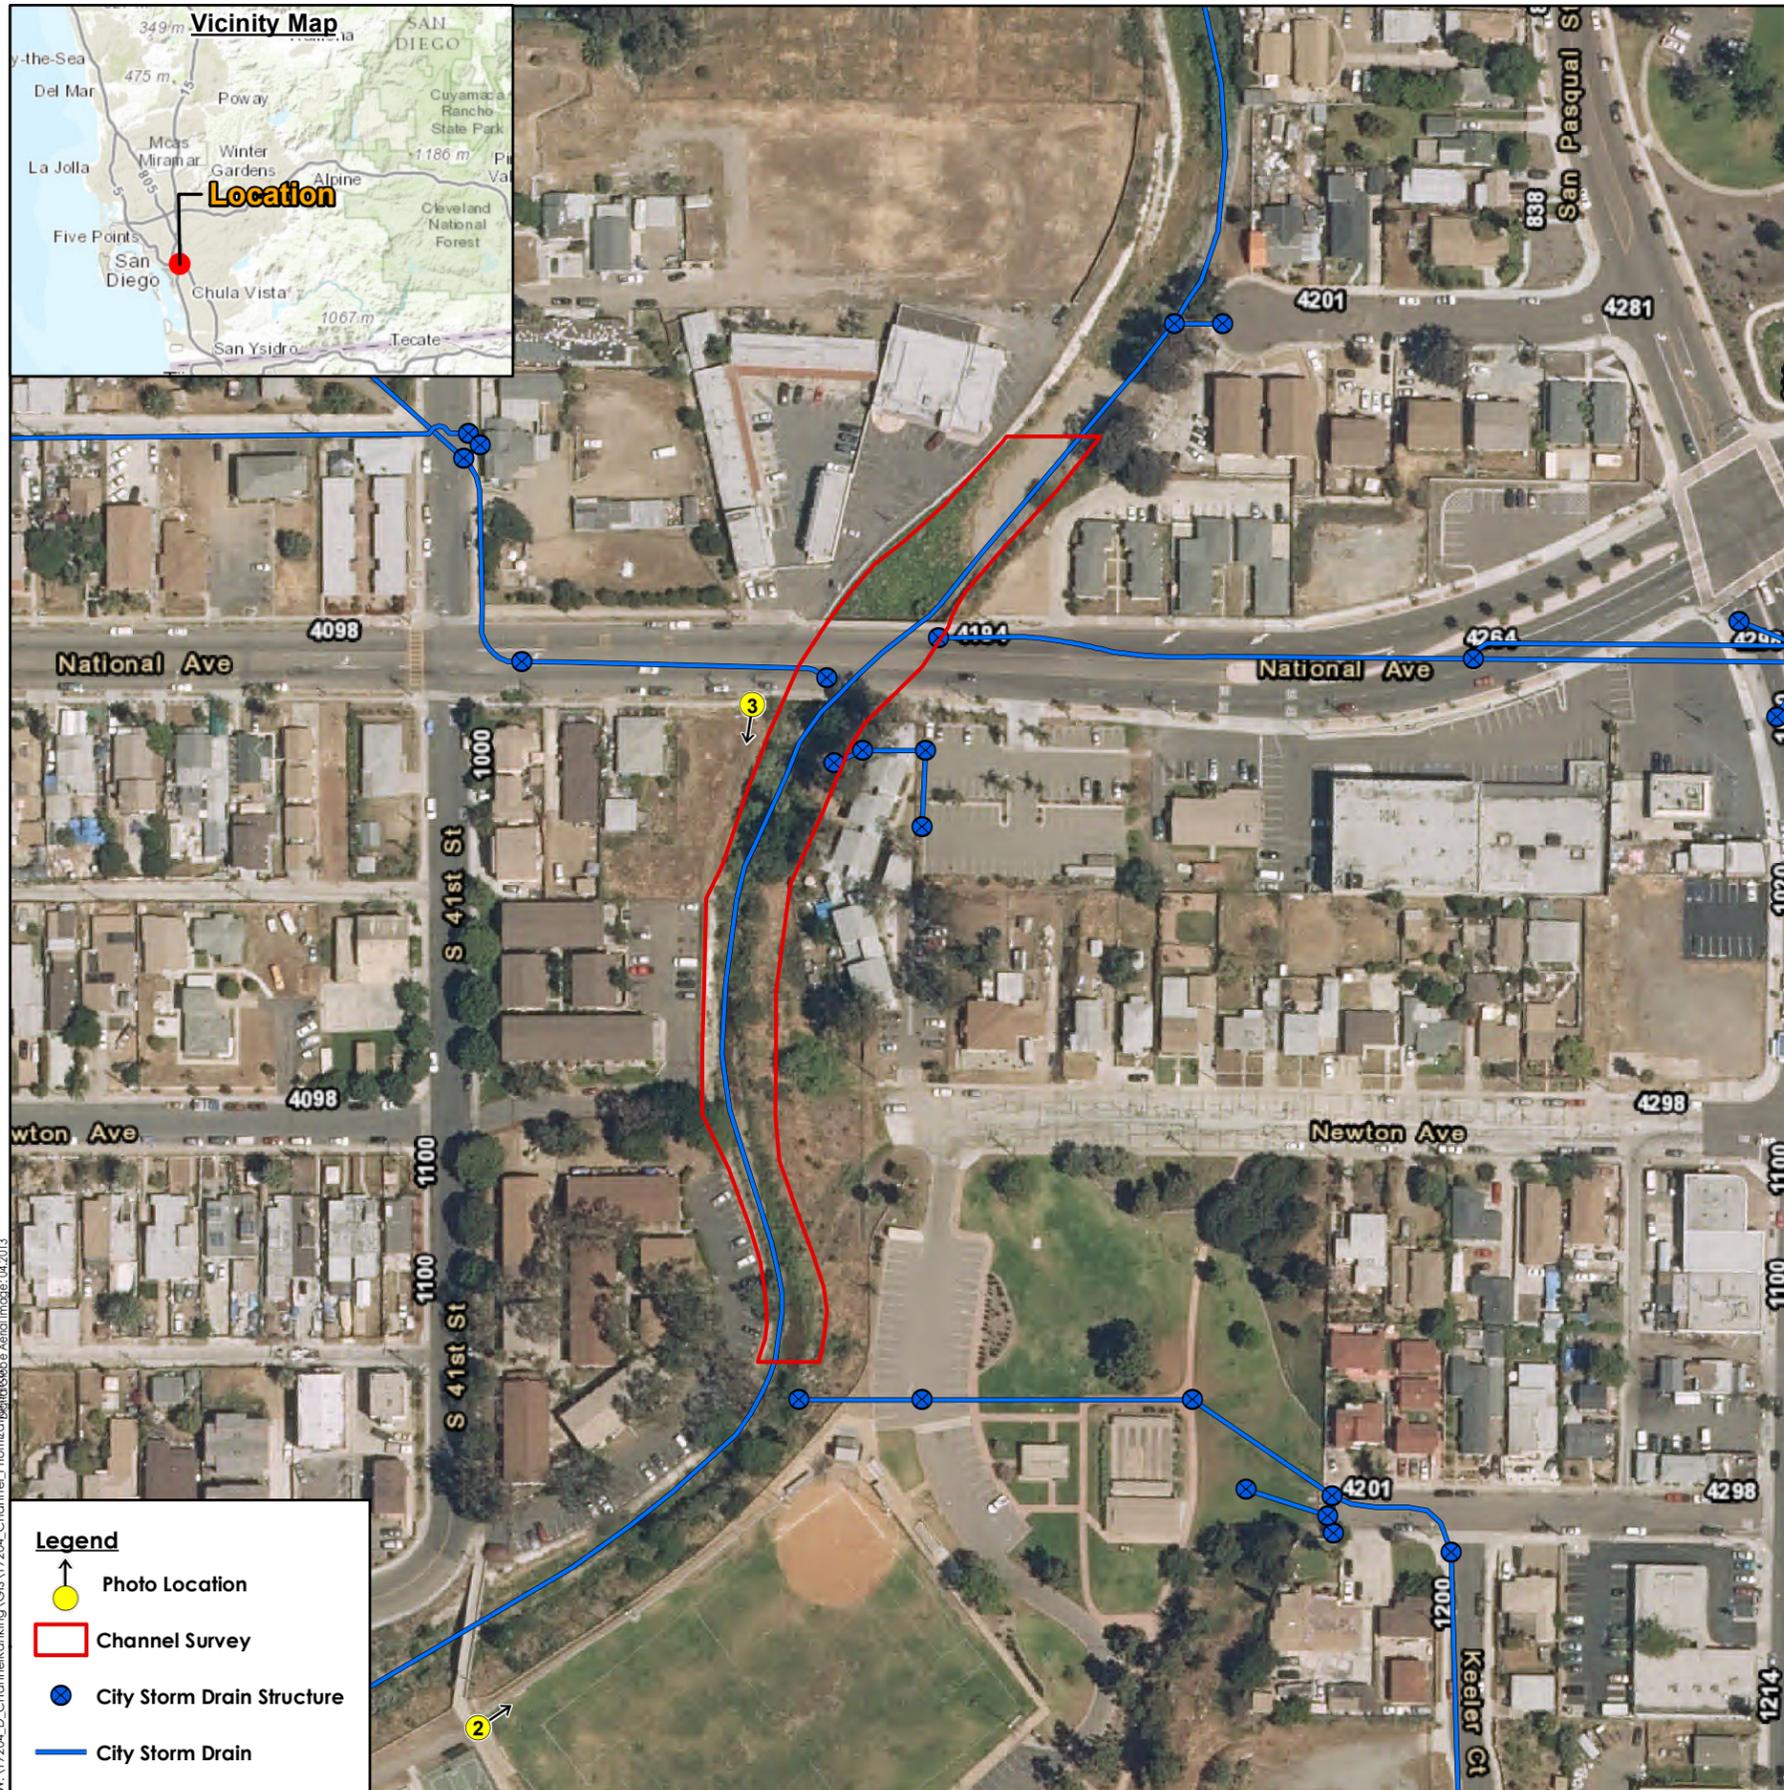
MMP Map # 97

- Channel Prioritization Score: **64.3 out of 100**
 - Flood Hazard Score: **56.3 out of 75**
 - Water Quality Score: **3 out of 10**
 - Community Input Score: **5 out of 10**
 - Aesthetics Score: **0 out of 5**
- Capacity Prior to Maintenance: **2- to 5-year storm event**
- Capacity After Maintenance (As-built Capacity) : **10- to 25-year storm event**
- Clogging Potential: **MEDIUM**
- Approximate Vegetation Coverage: **HIGH**
- Surrounding Area: **Residential**
- Infrastructure Failures: **None**
- Site Evaluation Date: **May 5, 2015**
- Notes/Comments: *It was noted on the O&M Channel Maintenance Inspection Form that there is heavy vegetation in the majority of the channel reach. A high risk of vegetation flowing downstream and clogging the culvert exists.*
