**SUMMARY OF FINDINGS FOR THE
ANNUAL DRAINAGE CHANNEL FIELD
ASSESSMENT AND MAINTENANCE PRIORITIZATION
PROJECT (PHASE 1)
FOR
THE CITY OF SAN DIEGO – MASTER STORM WATER
SYSTEM MAINTENANCE PROGRAM (MMP) 4300
MISSION BAY DRIVE**

**Job Number 17204-D
August 4, 2015**

August 4, 2015

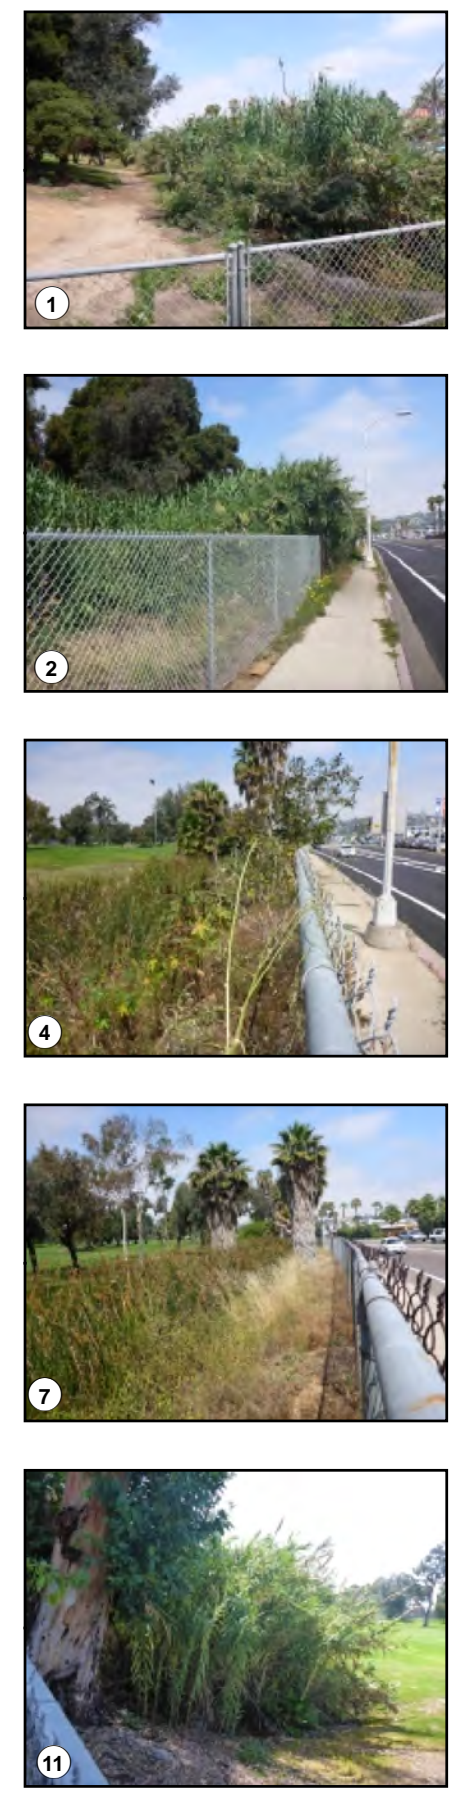
Photos:

- **Channel Prioritization Score:**
54.1 out of 100
 - **Flood Hazard Score:**
38.1 out of 75
 - **Water Quality Score:**
6 out of 10
 - **Community Input Score:**
5 out of 10
 - **Aesthetics Score:**
5 out of 5
- **Capacity Prior to Maintenance:**
5-year storm event
- **Capacity After Maintenance (As-built Capacity):**
100-year storm event
- **Clogging Potential:** *HIGH*
- **Approximate Vegetation Coverage:** *HIGH*
- **Surrounding Area:** *Commercial*
- **Infrastructure Failures:**
NONE
- **Site Evaluation Date:**
May 29, 2015
- **Notes/Comments:**
Based on site photos taken by the City of San Diego, heavy vegetation exists in the channel. A high risk of vegetation flowing downstream and clogging the culvert exists.

It is recommended that this drainage channel be maintained to increase the current capacity of the channel from a 5-year storm event back to a 100-year storm event capacity.
