**SUMMARY OF FINDINGS FOR THE
ANNUAL DRAINAGE CHANNEL FIELD ASSESSMENT
AND MAINTENANCE PRIORITIZATION PROJECT
(PHASE 1)
FOR
THE CITY OF SAN DIEGO –
MASTER STORM WATER SYSTEM MAINTENANCE
PROGRAM (MMP) MAP 47: 7969 AND 7971 ENGINEER
ROAD**

Job Number 17204-D

August 4, 2015

RICK ENGINEERING COMPANY

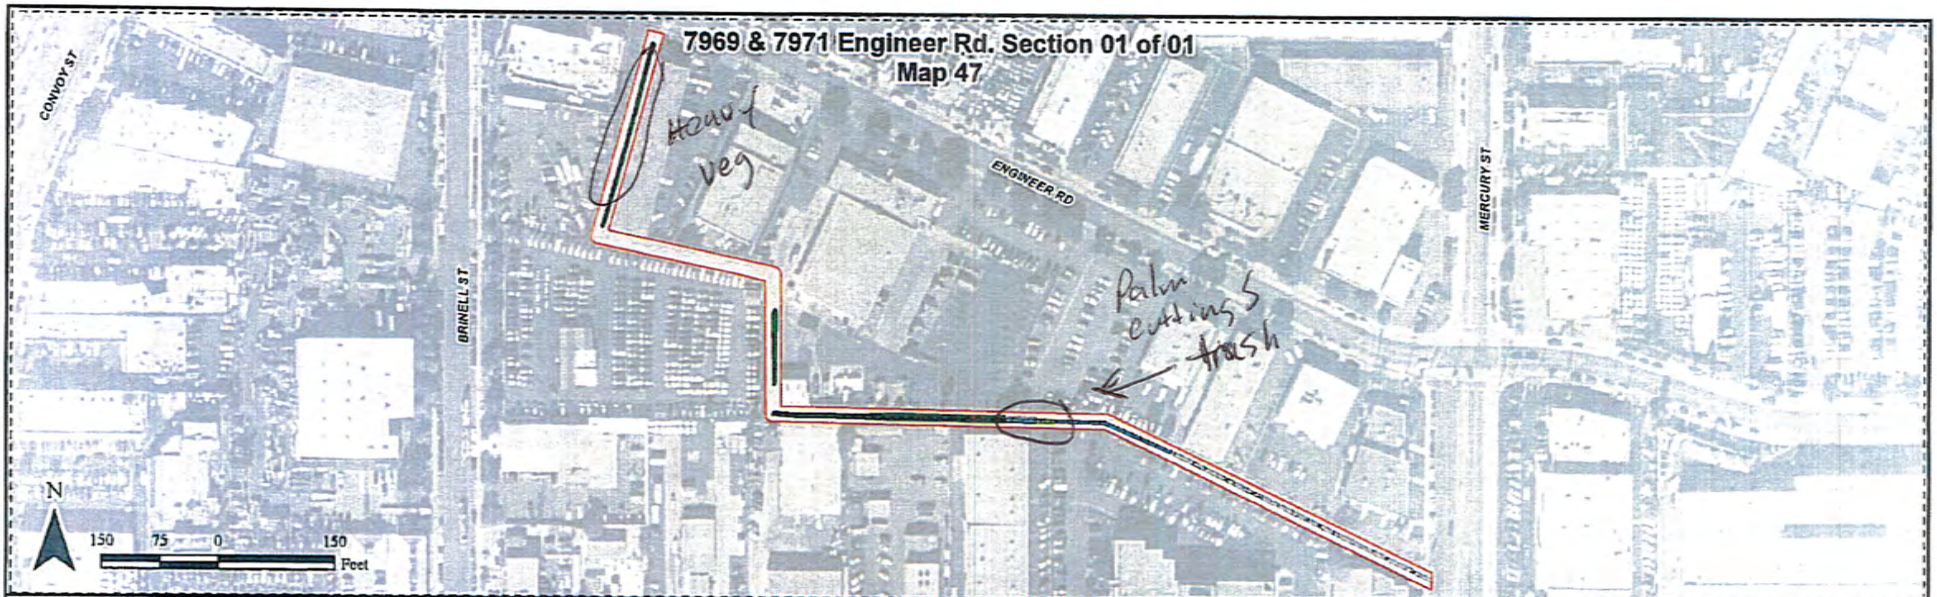
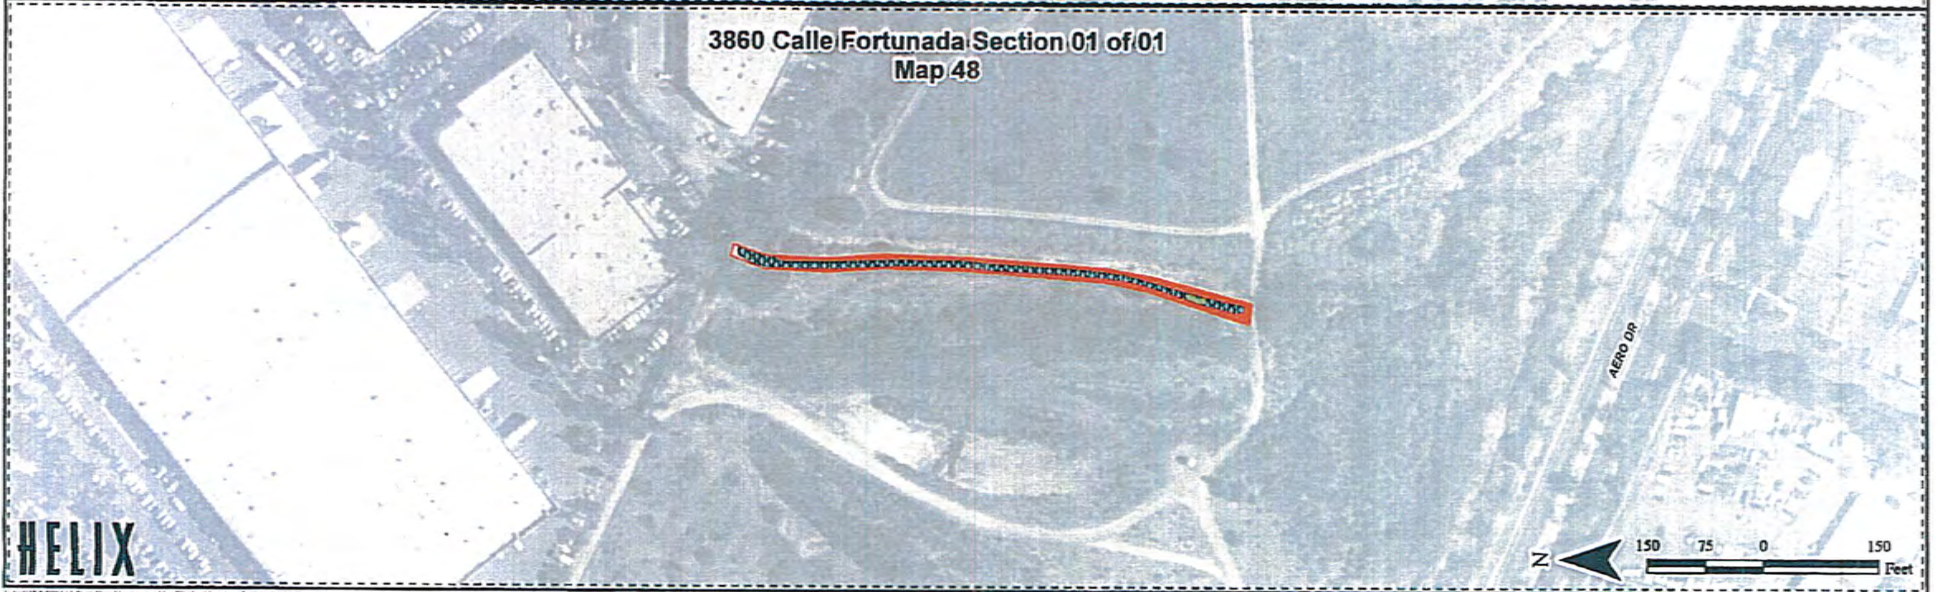
Other Comments/Observations:

Trash and Palm cuttings Behind
7990 Dagget St in channel

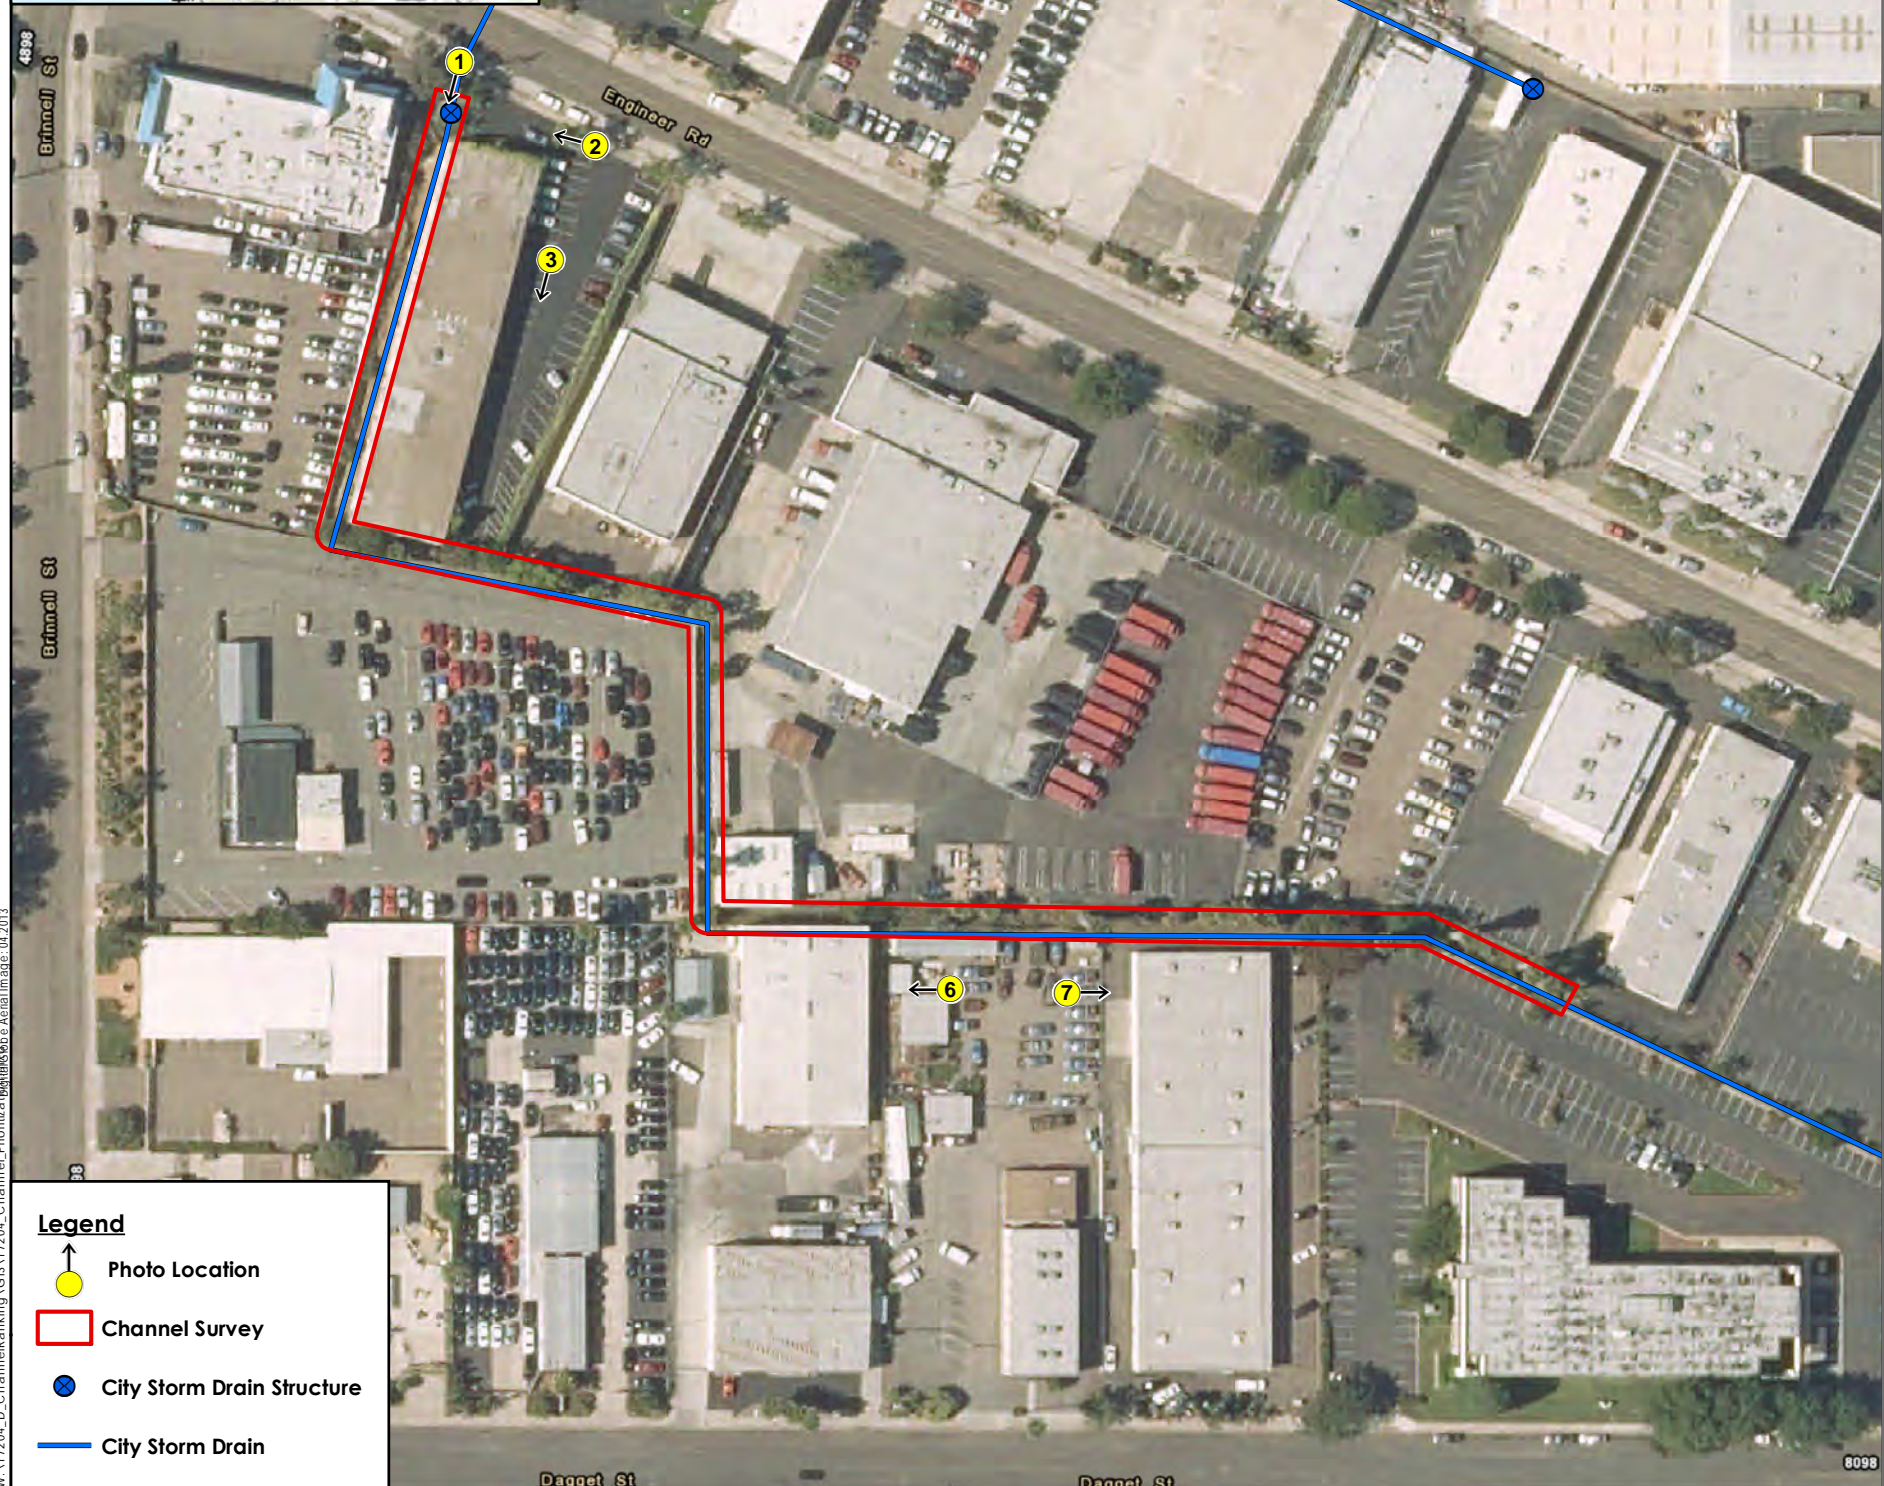
Appendix F
Channel Maintenance Prioritization Summary Sheet

- **Channel Prioritization Score:**
89.8 out of 100
 - **Flood Hazard Score:**
73.8 out of 75
 - **Water Quality Score:**
6 out of 10
 - **Community Input Score:**
5 out of 10
 - **Aesthetics Score:**
5 out of 5
- **Capacity Prior to Maintenance:**
Less than 2-year storm event
- **Capacity After Maintenance (As-built Capacity) :**
100-year storm event
- **Clogging Potential:** *HIGH*
- **Approximate Vegetation Coverage:** *HIGH*
- **Surrounding Area:** *Industrial*
- **Infrastructure Failures:**
NONE
- **Site Evaluation Date:**
May 12, 2015
- **Notes/Comments:**
There are trash and palm cuttings behind 7990 Dagget St. in Channel

It is recommended that this drainage channel be maintained to increase the current capacity of the channel from less than a 2-year storm event back to a 100-year storm event capacity.
