**SUMMARY OF FINDINGS FOR THE  
ANNUAL DRAINAGE CHANNEL FIELD  
ASSESSMENT AND MAINTENANCE  
PRIORITIZATION PROJECT (PHASE 1)  
FOR  
THE CITY OF SAN DIEGO –  
MASTER STORM WATER SYSTEM MAINTENANCE  
PROGRAM (MMP) MAP 69: AUBURN CREEK CHANNEL  
(SECTION 3 OF 4)**

**Job Number 17204-D**

**August 4, 2015**

**Channel Prioritization Assessment Sheet for Auburn Creek Channel (Section 3 of 4) MMP Map 69**

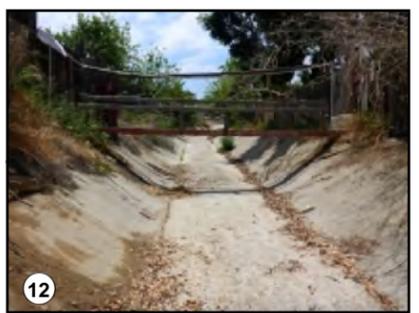
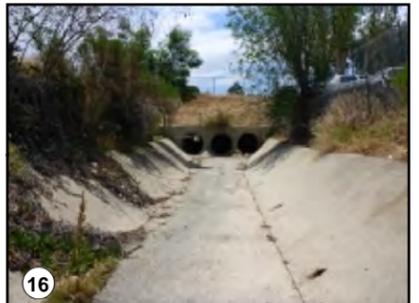
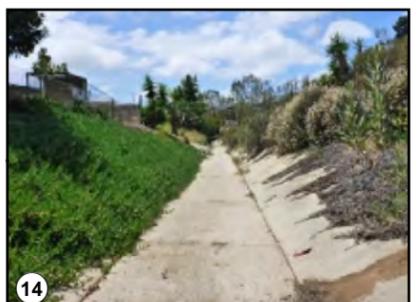
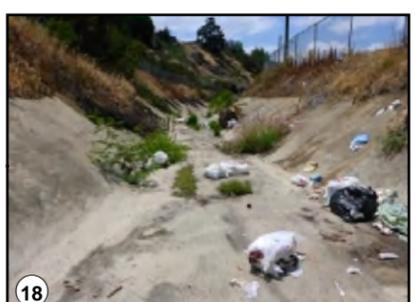
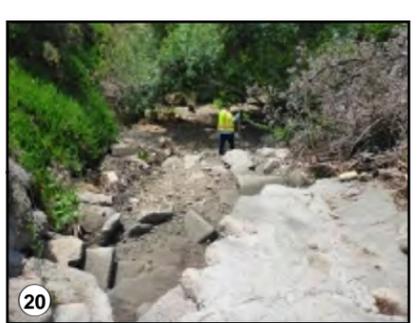
**Photos:**

- **Channel Prioritization Score:**  
*65.6 out of 100*
  - **Flood Hazard Score:**  
*56.3 out of 75*
  - **Water Quality Score:**  
*3 out of 10*
  - **Community Input Score:**  
*5 out of 10*
  - **Aesthetics Score:**  
*1.3 out of 5*
- **Capacity Prior to Maintenance:**  
*100-year storm event*
- **Capacity After Maintenance (As-built Capacity) :**  
*100-year storm event*
- **Clogging Potential:** *HIGH*
- **Approximate Vegetation Coverage:** *MEDIUM*
- **Surrounding Area:** *Residential*
- **Infrastructure Failures:**  
*Broken concrete in channel bottom, Broken fence*
- **Site Evaluation Date:**  
*May 4, 2015*
- **Notes/Comments:**  
*Based on the site photos taken by the City of San Diego, vegetation has grown down over the concrete side slopes. Also there is evidence of transient encampments. A high risk of debris, such as mattresses, clogging the culvert exists*

It is recommended that this drainage channel be maintained to preserve the 100-year storm event capacity. Although the channel currently has 100-year storm event capacity, maintaining it will preserve the 100-year storm event capacity by preventing vegetation from flowing downstream and clogging the culvert.
