**SUMMARY OF FINDINGS FOR THE
ANNUAL DRAINAGE CHANNEL FIELD
ASSESSMENT AND MAINTENANCE PRIORITIZATION
PROJECT (PHASE 1)
FOR
THE CITY OF SAN DIEGO – MASTER STORM WATER
SYSTEM MAINTENANCE PROGRAM (MMP) MAP 70:
AUBURN CREEK CHANNEL (SECTION 4 OF 4)**

**Job Number 17204-D
August 4, 2015**

Prepared For:
City of San Diego
2781 Caminito Chollas
San Diego, California 92105

Prepared By:
Rick Engineering Company
Water Resources Division
5620 Friars Road
San Diego, California 92110-2596
(619) 291-0707

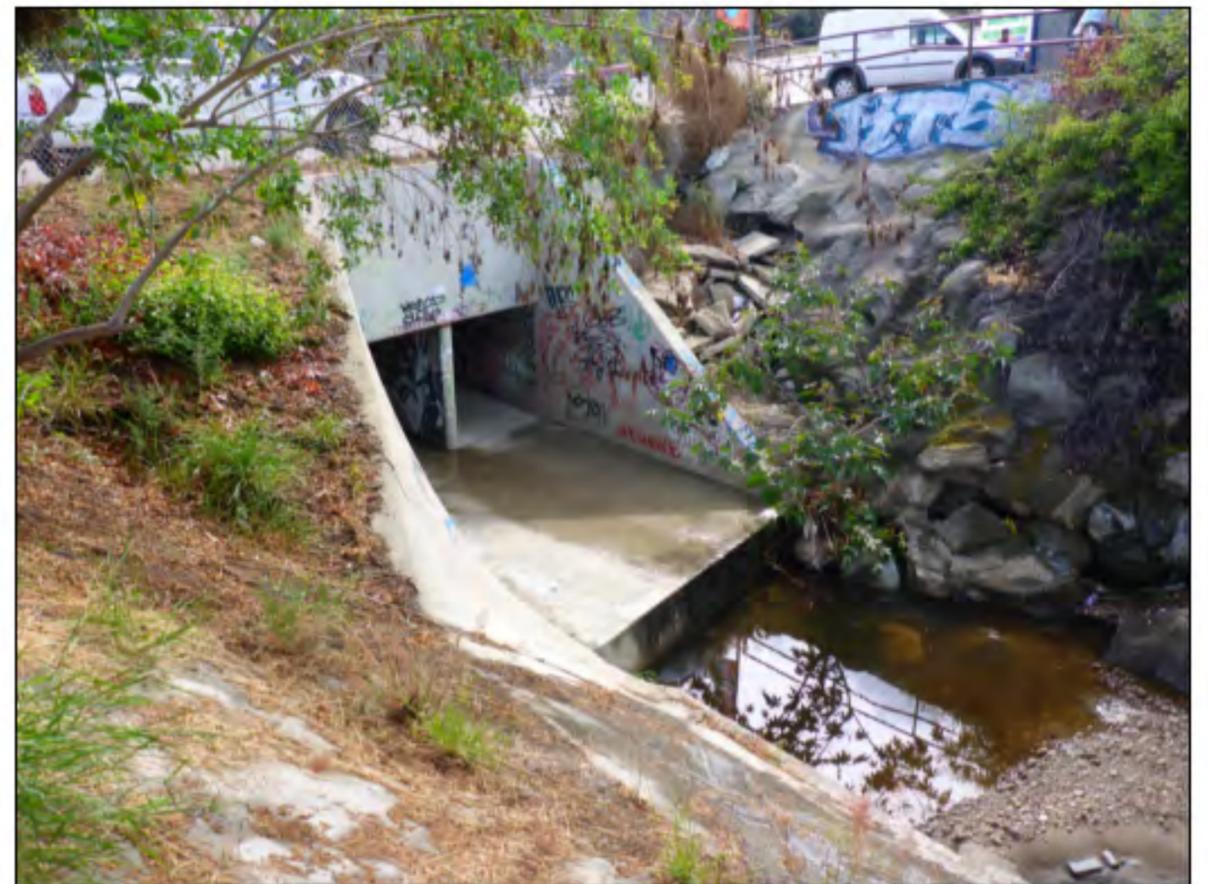
Home Avenue Channel.37 (5-4-2015).JPG

- **Channel Prioritization Score:**
81.5 out of 100
 - **Flood Hazard Score:**
70.0 out of 75
 - **Water Quality Score:**
4 out of 10
 - **Community Input Score:**
5 out of 10
 - **Aesthetics Score:**
2.5 out of 5
- **Capacity Prior to Maintenance:**
5-year storm event
- **Capacity After Maintenance (As-built Capacity) :**
100-year storm event
- **Clogging Potential:** *HIGH*
- **Approximate Vegetation Coverage:** *HIGH*
- **Surrounding Area:** *Commercial*
- **Infrastructure Failures:**
None
- **Site Evaluation Date:**
May 4, 2015
- **Notes/Comments:**
Evidence of scour at outfall of culvert under Fairmount Avenue (photo 37) and along right toe of slope (looking downstream) near middle of reach (photo 35)
