**SUMMARY OF FINDINGS FOR THE
ANNUAL DRAINAGE CHANNEL FIELD
ASSESSMENT AND MAINTENANCE PRIORITIZATION
PROJECT (PHASE 1)
FOR
THE CITY OF SAN DIEGO – MASTER STORM WATER
SYSTEM MAINTENANCE PROGRAM (MMP) MAP 71:
CHOLLAS CREEK CHANNEL**

**Job Number 17204-D
August 4, 2015**

Prepared For:
City of San Diego
2781 Caminito Chollas
San Diego, California 92105

Prepared By:
Rick Engineering Company
Water Resources Division
5620 Friars Road
San Diego, California 92110-2596
(619) 291-0707

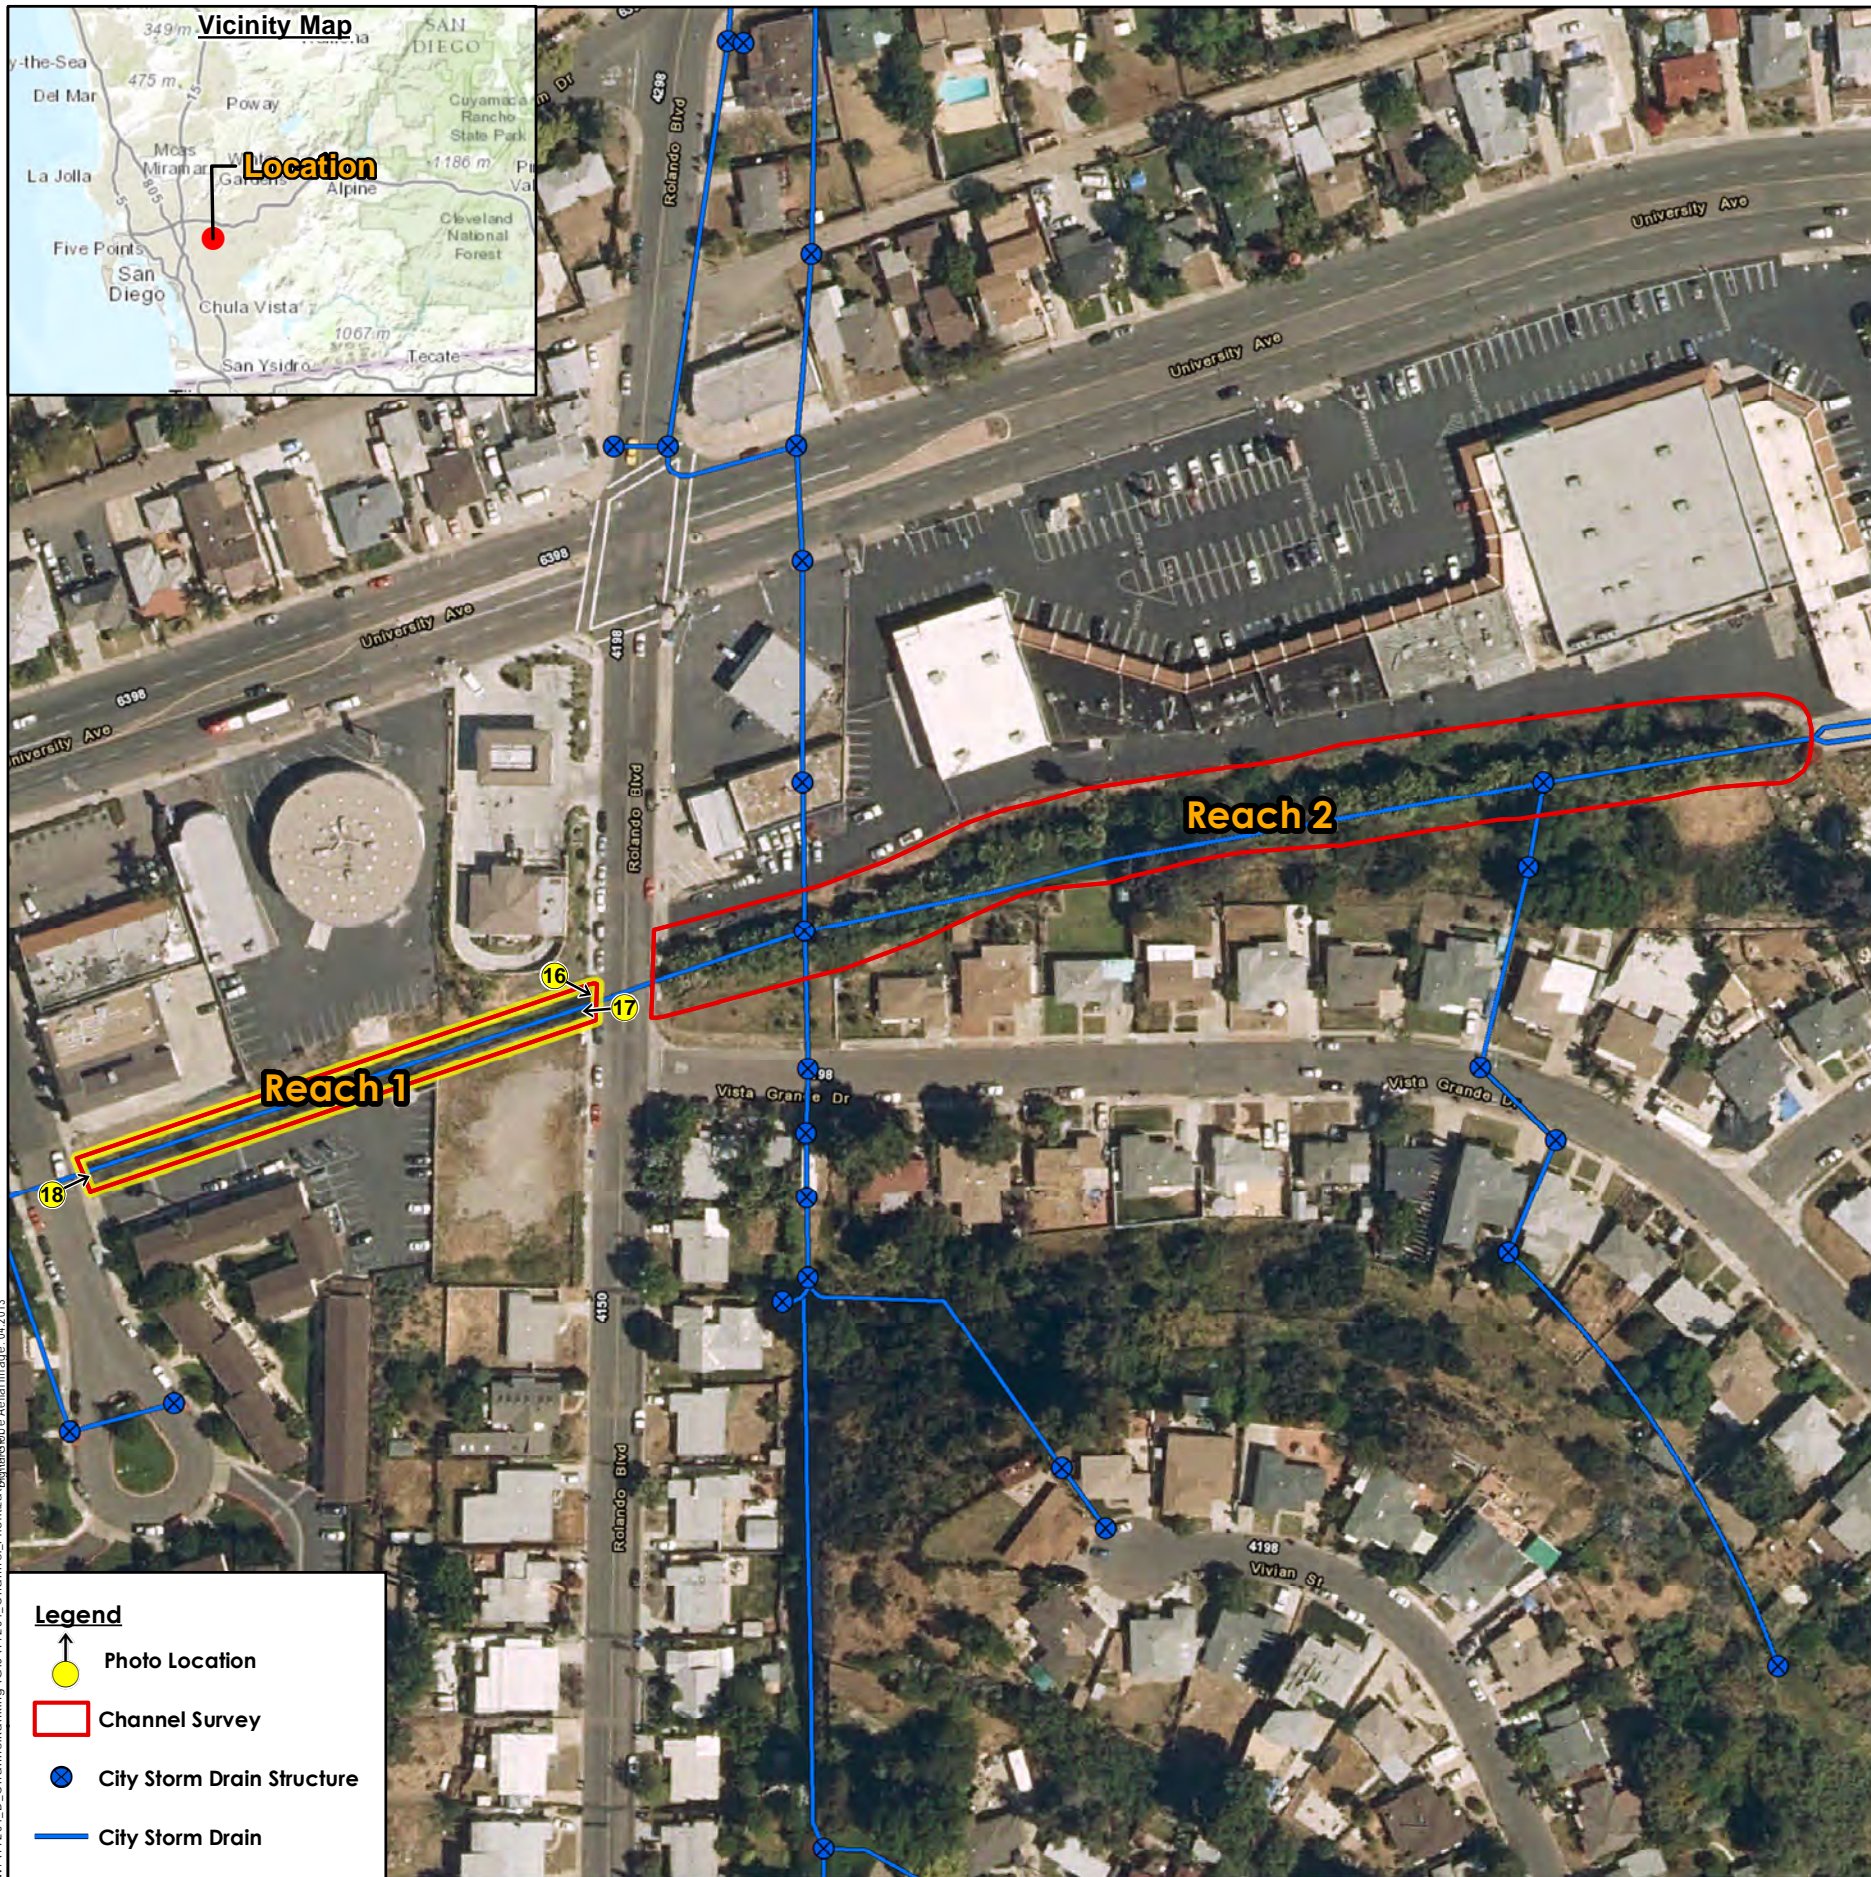
- **Channel Prioritization Score:**
67.8 out of 100
 - **Flood Hazard Score:**
56.3 out of 75
 - **Water Quality Score:**
4 out of 10
 - **Community Input Score:**
5 out of 10
 - **Aesthetics Score:**
2.5 out of 5
- **Capacity Prior to Maintenance:**
100-year storm event
- **Capacity After Maintenance (As-built Capacity):**
100-year storm event
- **Clogging Potential:** *HIGH*
- **Approximate Vegetation Coverage:** *MEDIUM*
- **Surrounding Area:** *Commercial*
- **Infrastructure Failures:**
None
- **Site Evaluation Date:**
May 6, 2015
- **Notes/Comments:**
Based on site photos taken by the City of San Diego, heavier vegetation exists for a small segment of the channel immediately downstream of Roland Boulevard. A high risk of vegetation flowing downstream and clogging the culvert exists.

It is recommended that Reach 1 be maintained to improve water quality and aesthetics and to prevent large vegetation from flowing downstream and clogging the culvert. It is recommended that Reach 2 be maintained to increase the current capacity of the channel from less than a 2-year storm event back to a 50-year storm event capacity.

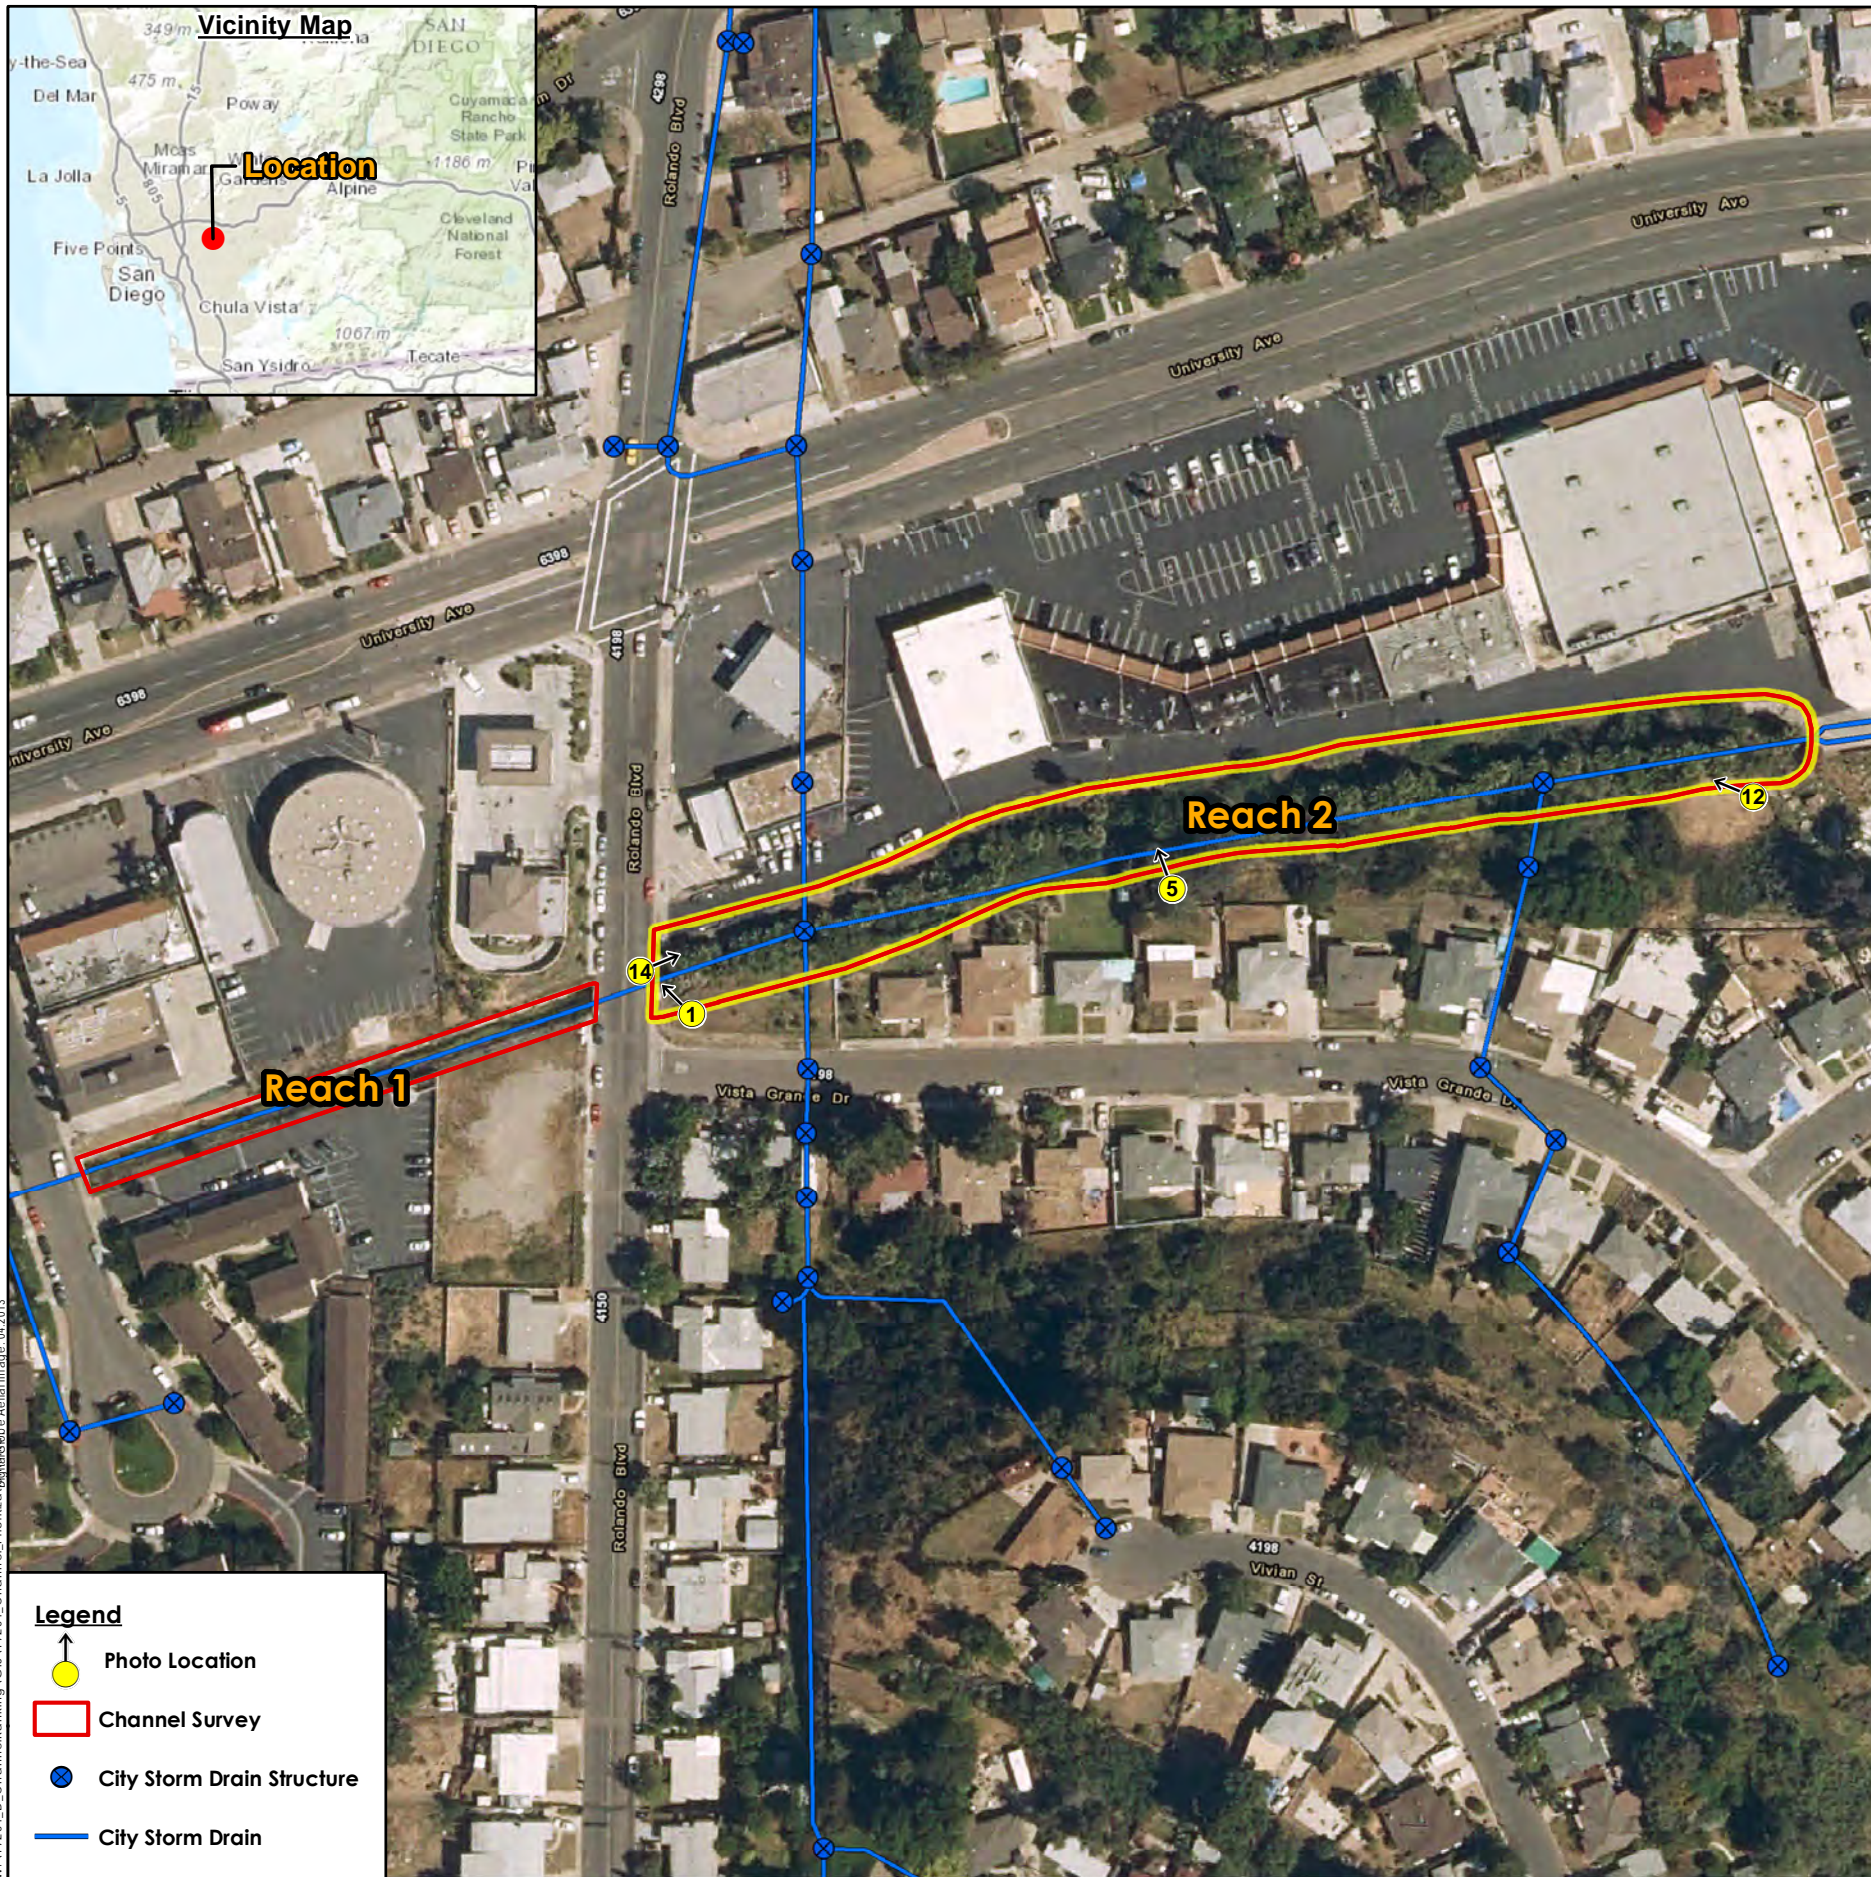
- **Channel Prioritization Score:**
82.3 out of 100
- **Flood Hazard Score:**
68.8 out of 75
- **Water Quality Score:**
6 out of 10
- **Community Input Score:**
5 out of 10
- **Aesthetics Score:**
2.5 out of 5
- **Capacity Prior to Maintenance:**
Less than 2-year storm event
- **Capacity After Maintenance (As-built Capacity):**
50-year storm event
- **Clogging Potential:** *HIGH*
- **Approximate Vegetation Coverage:** *HIGH*
- **Surrounding Area:** *Residential*
- **Infrastructure Failures:**
None
- **Site Evaluation Date:**
May 6, 2015
- **Notes/Comments:**
Palm trees exist along entire reach.
