**SUMMARY OF FINDINGS FOR THE  
ANNUAL DRAINAGE CHANNEL FIELD  
ASSESSMENT AND MAINTENANCE PRIORITIZATION  
PROJECT (PHASE 1)  
FOR  
THE CITY OF SAN DIEGO – MASTER STORM WATER  
SYSTEM MAINTENANCE PROGRAM (MMP) MAP 122:  
PARKSIDE CHANNEL**

**Job Number 17204-D  
August 4, 2015**

**August 4, 2015**

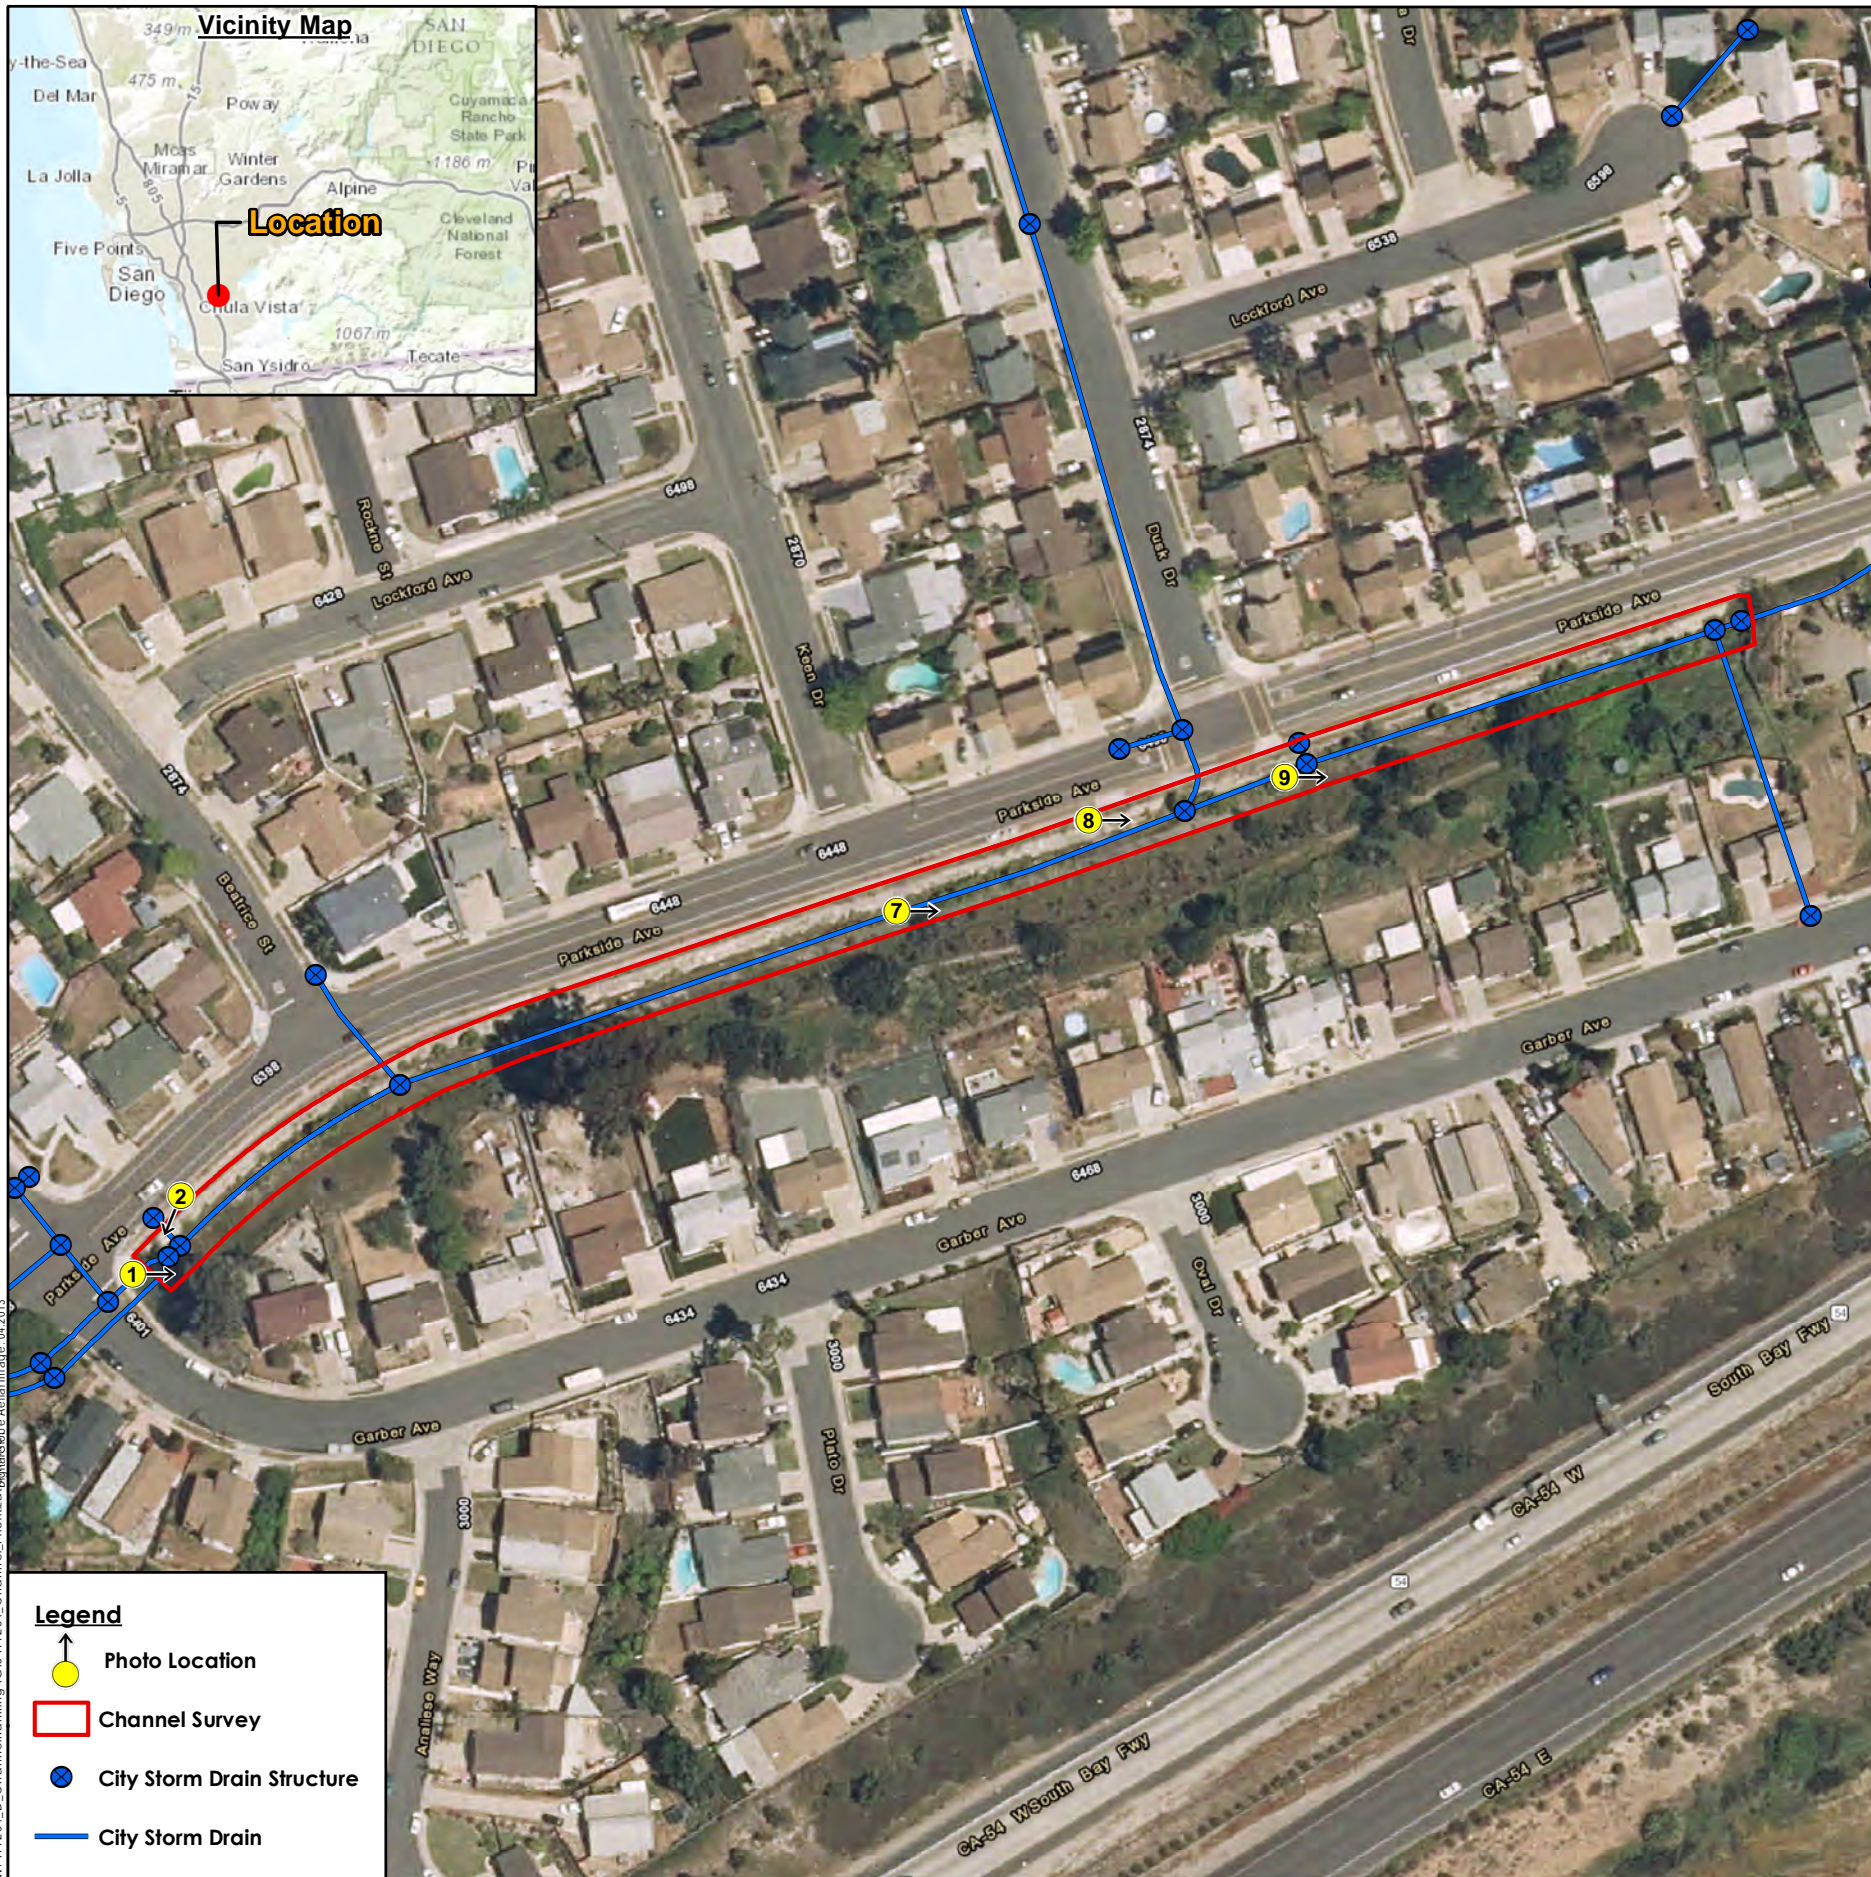
- **Channel Prioritization Score:**  
*79.3 out of 100*
  - **Flood Hazard Score:**  
*71.3 out of 75*
  - **Water Quality Score:**  
*3 out of 10*
  - **Community Input Score:**  
*5 out of 10*
  - **Aesthetics Score:**  
*0 out of 5*
- **Capacity Prior to Maintenance:**  
*Less than 2-year storm event*
- **Capacity After Maintenance (As-built Capacity):**  
*100-year storm event*
- **Clogging Potential:** *HIGH*
- **Approximate Vegetation Coverage:** *MEDIUM*
- **Surrounding Area:** *Residential*
- **Infrastructure Failures:**  
*None*
- **Site Evaluation Date:**  
*May 7, 2015*
- **Notes/Comments:**  
*Vegetation has grown down from the top of the downstream culvert entrance as well as over the channel banks. A high risk of vegetation flowing into the culvert and clogging it exists. It is recommended that this vegetation be maintained.*
