**SUMMARY OF FINDINGS FOR THE
ANNUAL DRAINAGE CHANNEL FIELD
ASSESSMENT AND MAINTENANCE PRIORITIZATION
PROJECT (PHASE 1)
FOR
THE CITY OF SAN DIEGO – MASTER STORM WATER
SYSTEM MAINTENANCE PROGRAM (MMP) MAP 51:
RED RIVER DR & CONESTOGA DR**

Job Number 17204-D

August 4, 2015

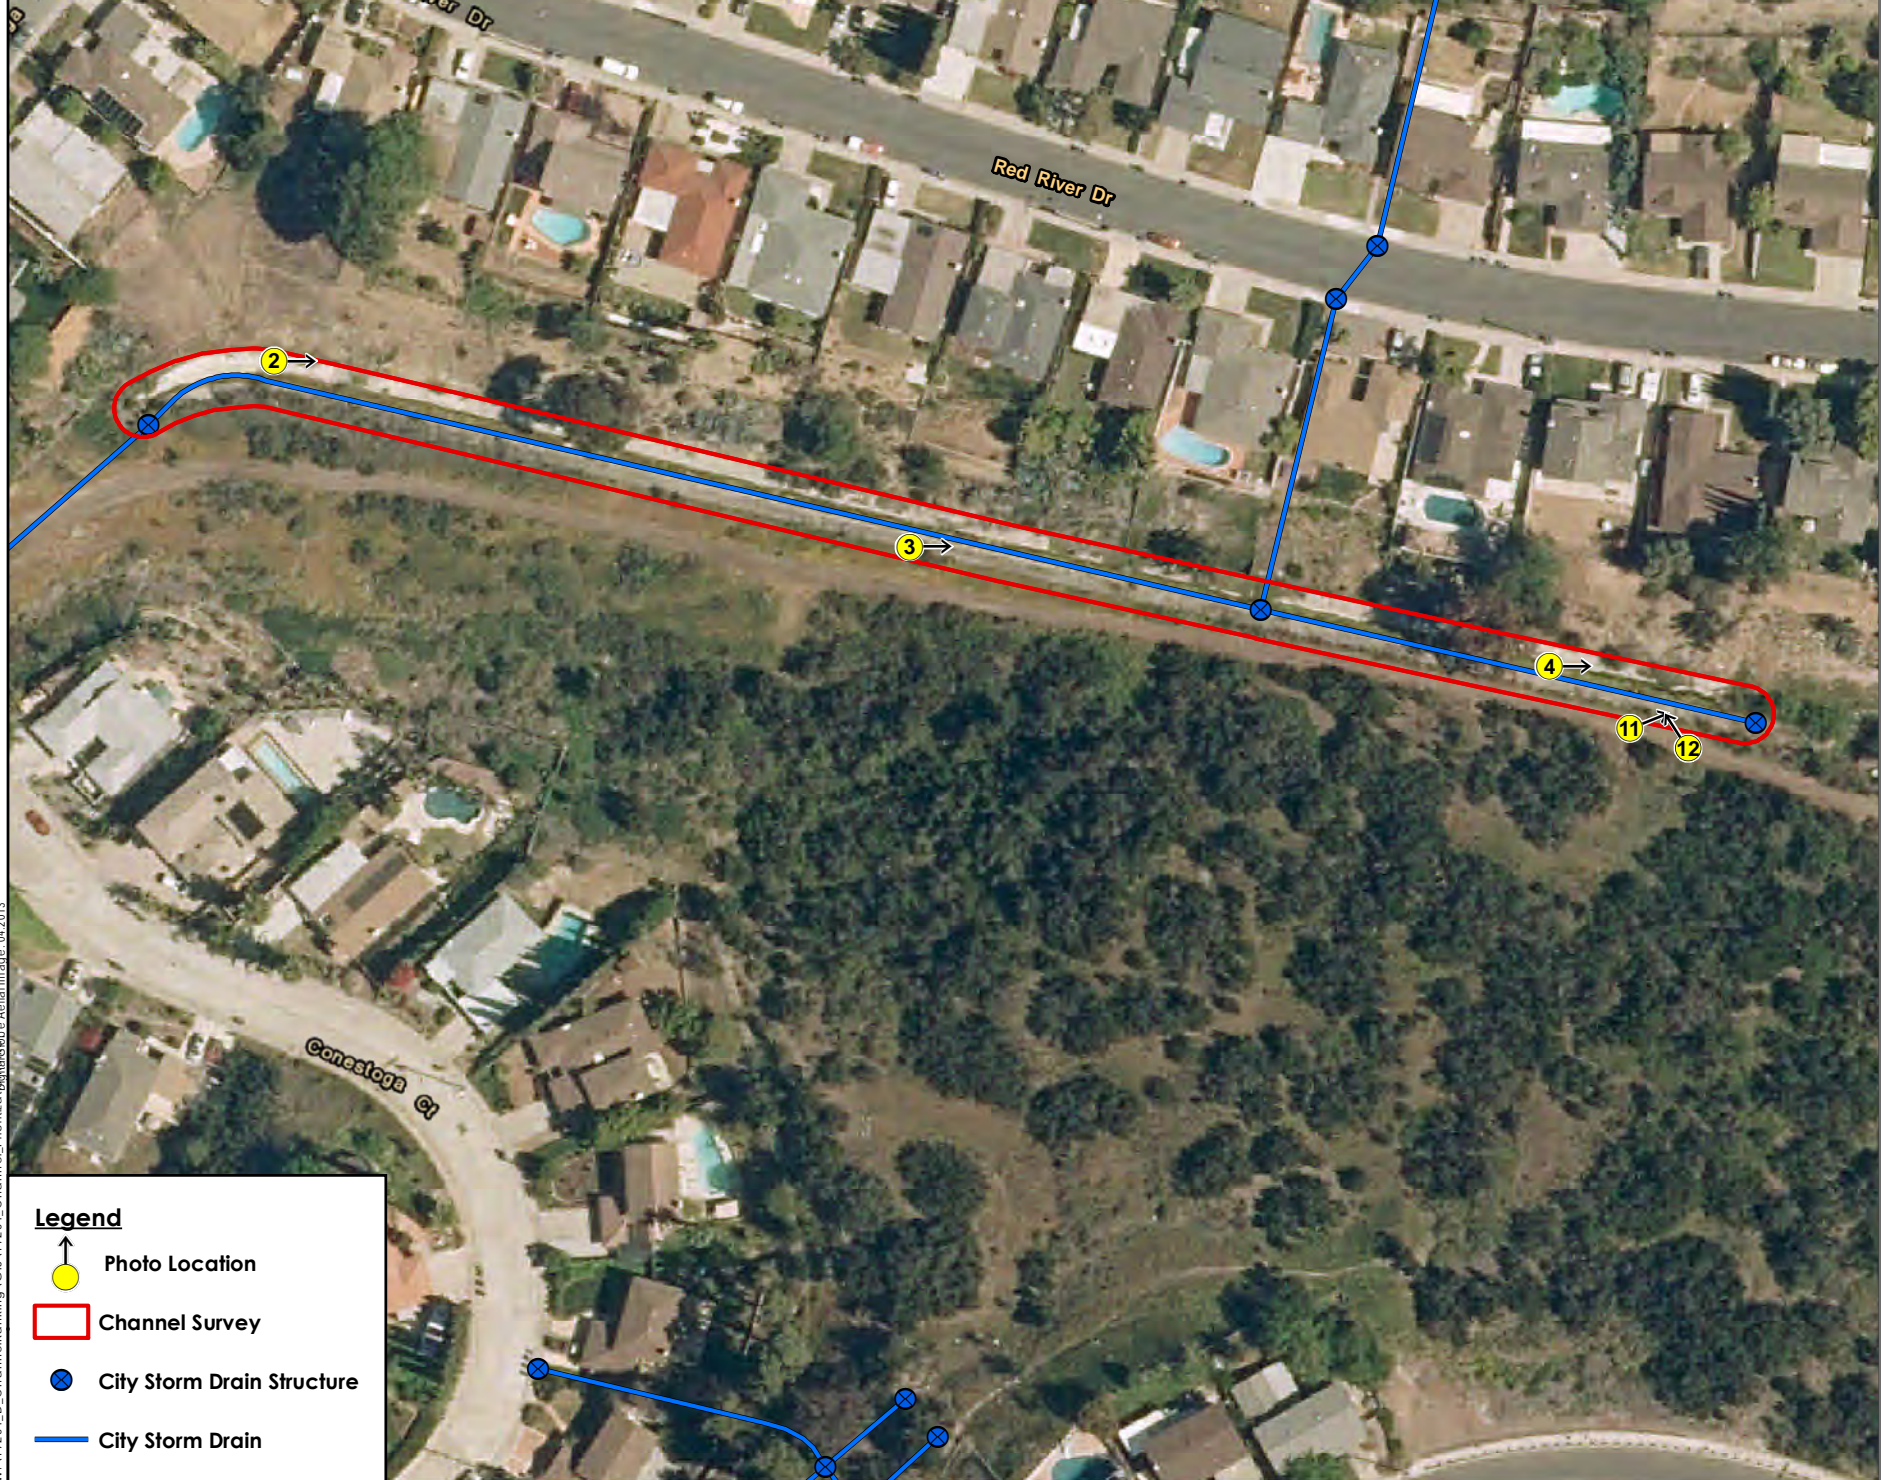
Channel Maintenance Prioritization Summary Sheet

- **Channel Prioritization Score:**
63.9 out of 100
 - **Flood Hazard Score:**
61.9 out of 75
 - **Water Quality Score:**
2 out of 10
 - **Community Input Score:**
0 out of 10
 - **Aesthetics Score:**
0 out of 5
- **Capacity Prior to Maintenance:**
Less than 2 to 2-year storm event
- **Capacity After Maintenance (As-built Capacity):**
100-year storm event
- **Clogging Potential:** *HIGH*
- **Approximate Vegetation Coverage:** *MEDIUM*
- **Surrounding Area:** *Residential*
- **Infrastructure Failures:**
Holes and cracks in gunite channel
- **Site Evaluation Date:**
May 16, 2015
- **Notes/Comments:**
It was noted on the O&M Channel Maintenance Inspection Form that there is a small hole and broken concrete at the downstream end of the channel and cracks in the side slopes along the channel. A high risk of vegetation clogging the culvert exists.

It is recommended that this drainage channel be maintained to increase the current capacity of the channel from less than a 2- to 2-year storm event back to a 100-year storm event capacity.
