**SUMMARY OF FINDINGS FOR THE
ANNUAL DRAINAGE CHANNEL FIELD
ASSESSMENT AND MAINTENANCE PRIORITIZATION
PROJECT (PHASE 1)
FOR
THE CITY OF SAN DIEGO – MASTER STORM WATER
SYSTEM MAINTENANCE PROGRAM (MMP) MAP 97:
SOUTH CHOLLAS CREEK CHANNEL**

**Job Number 17204-D
August 4, 2015**

Prepared By:
Rick Engineering Company
Water Resources Division
5620 Friars Road
San Diego, California 92110-2596
(619) 291-0707

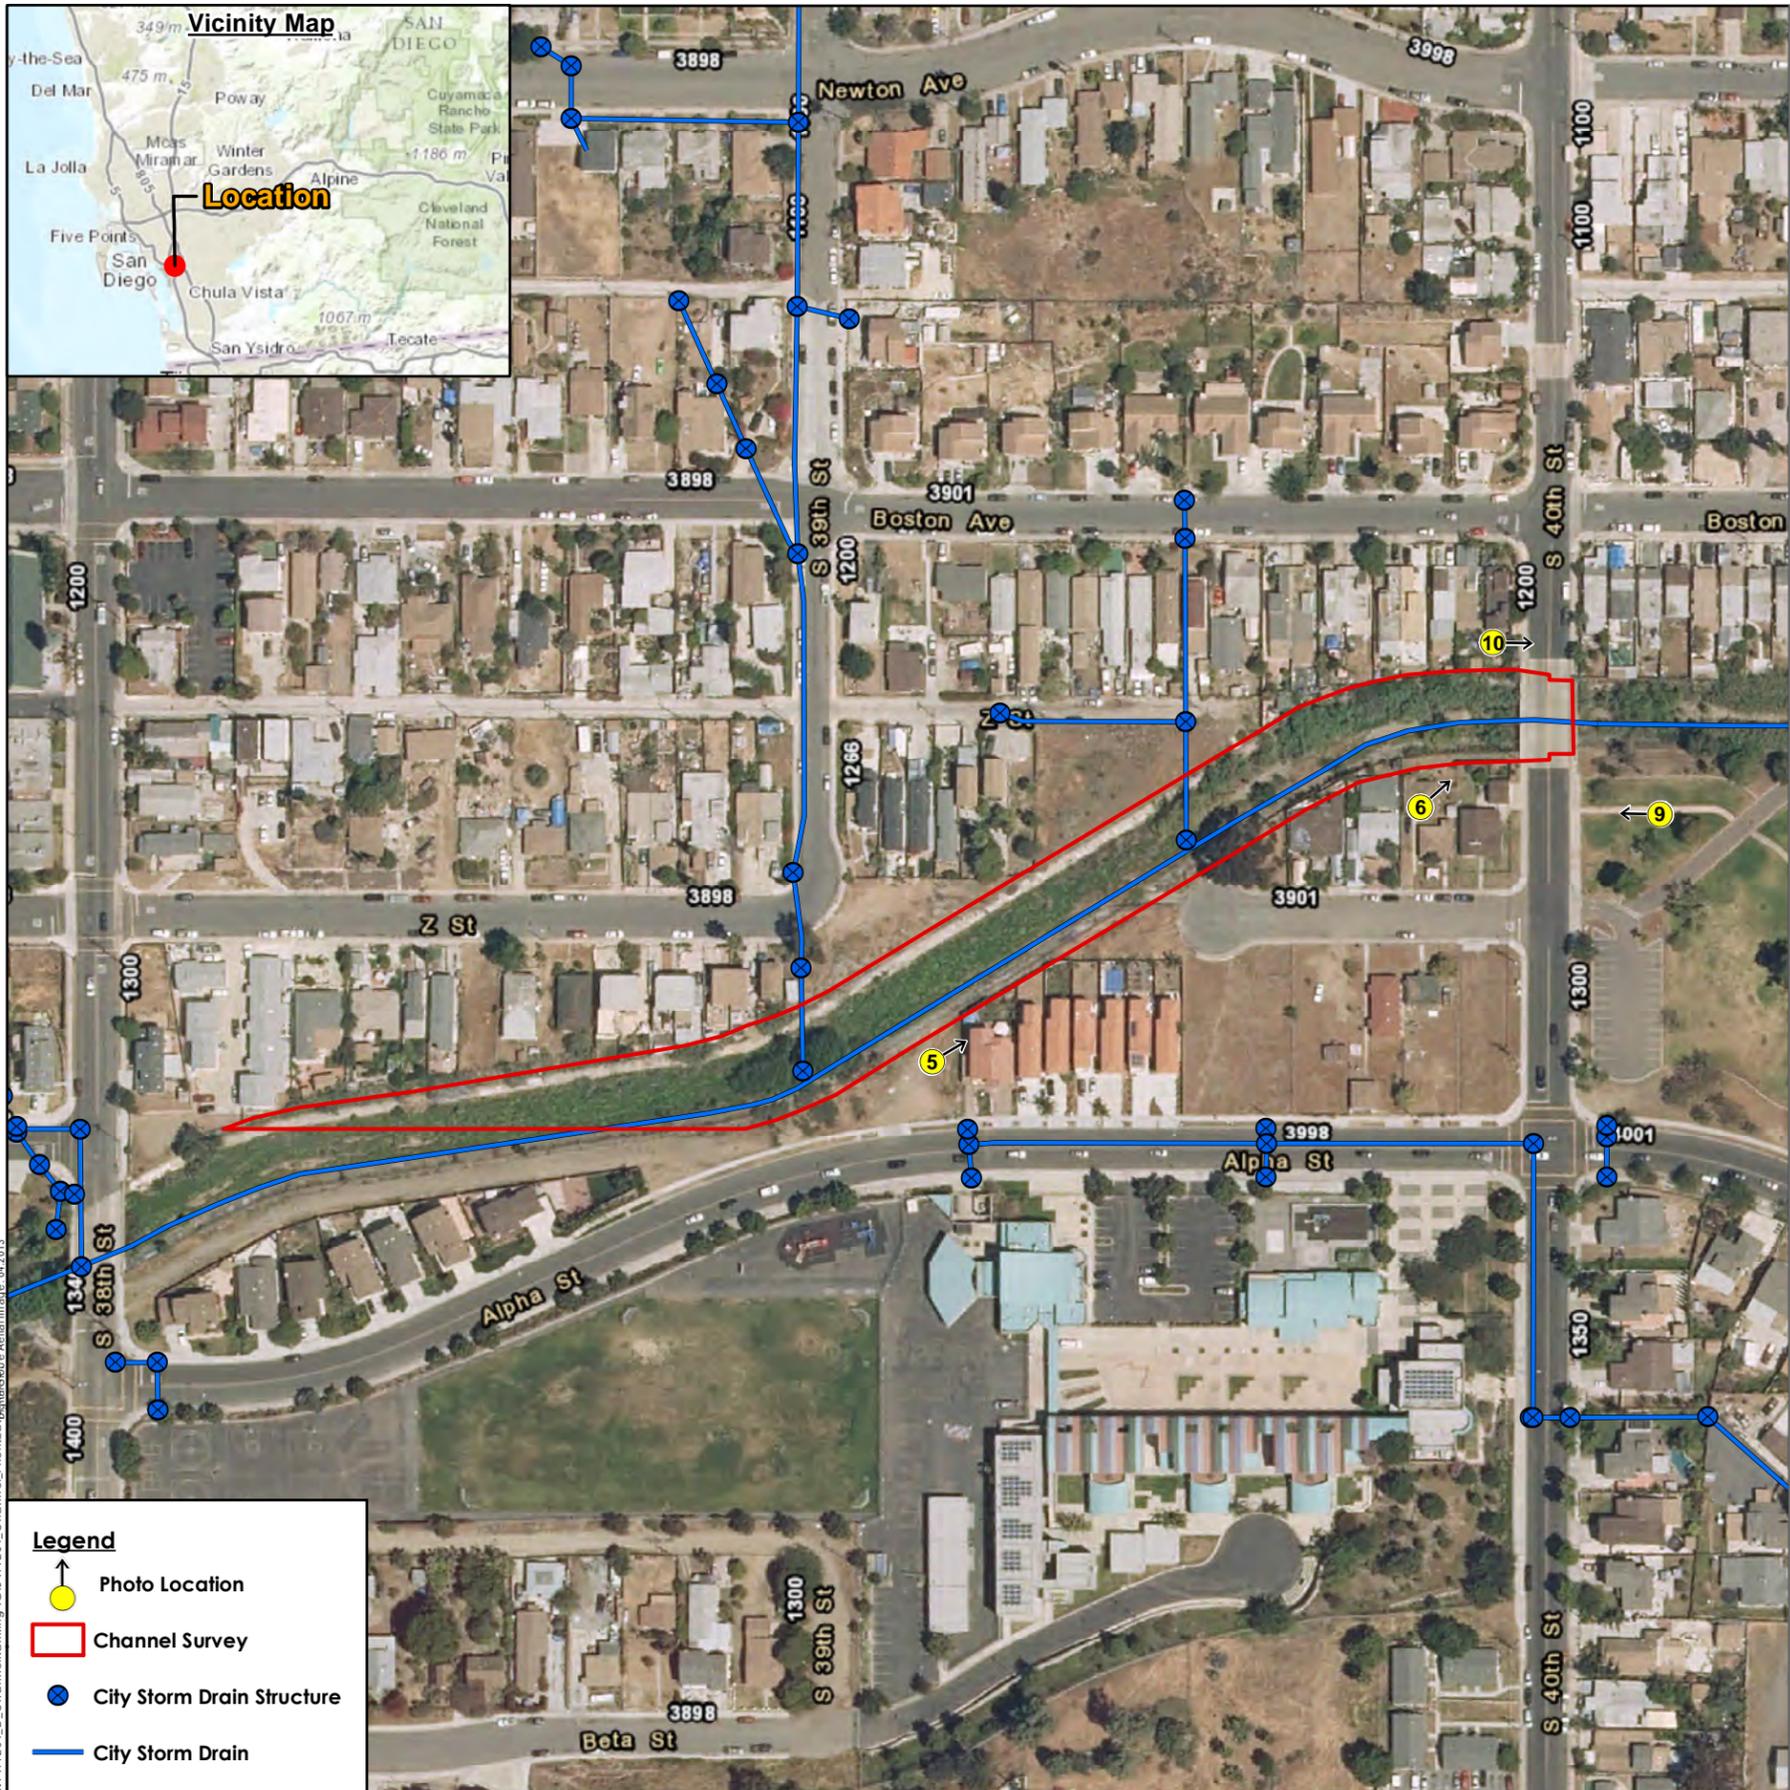
- **Channel Prioritization Score:**
71.8 out of 100
 - **Flood Hazard Score:**
63.8 out of 75
 - **Water Quality Score:**
3 out of 10
 - **Community Input Score:**
5 out of 10
 - **Aesthetics Score:**
0 out of 5
- **Capacity Prior to Maintenance:**
10- to 25-year storm event
- **Capacity After Maintenance (As-built Capacity) :**
50- to 100-year storm event
- **Clogging Potential:** *HIGH*
- **Approximate Vegetation Coverage:** *HIGH*
- **Surrounding Area:** *Residential*
- **Infrastructure Failures:**
NONE
- **Site Evaluation Date:**
May 5, 2015
- **Notes/Comments:**
A high risk of vegetation flowing downstream and clogging the culvert exists. It was noted on the O&M Channel Maintenance Inspection Form completed for the channel by the City of San Diego that there is broken gunite near the foot bridge to the park.

It is recommended that this drainage channel be maintained to increase the current capacity of the channel from a 10- to 25-year storm event back to a 50- to 100-year storm event capacity.
