**SUMMARY OF FINDINGS FOR THE
ANNUAL DRAINAGE CHANNEL FIELD
ASSESSMENT AND MAINTENANCE PRIORITIZATION
PROJECT (PHASE 1)
FOR
THE CITY OF SAN DIEGO – MASTER STORM WATER
SYSTEM MAINTENANCE PROGRAM (MMP) MAP 99:
SOUTH CHOLLAS CREEK CHANNEL**

**Job Number 17204-D
August 4, 2015**

August 4, 2015

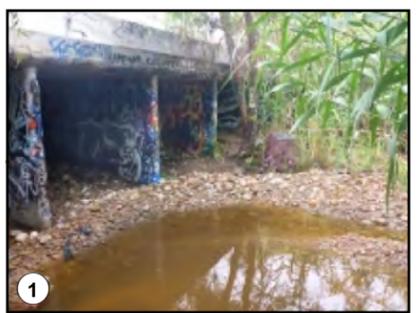
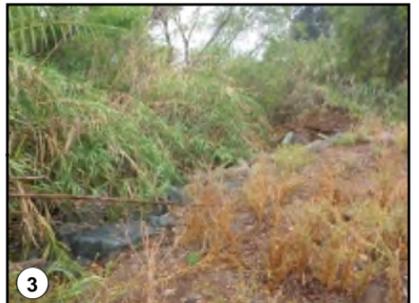
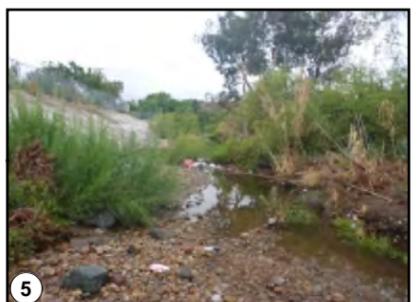
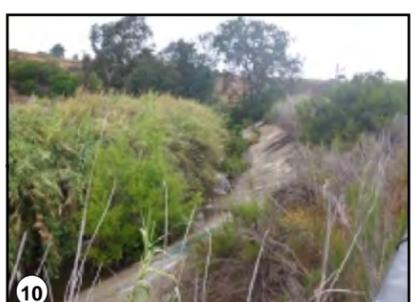
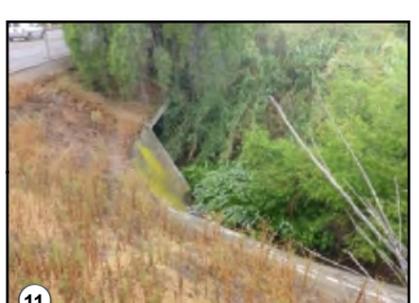
Photos:

- It was noted on the O&M Channel Maintenance Inspection Form completed for the channel by the City of San Diego that there is heavy vegetation in the majority of the channel reach. A high risk of vegetation flowing downstream and clogging the culvert exists.
- The channel is in the vicinity of a YMCA.

Water Quality/Channel Condition (10% of total weight)				Score	factor weight	Weighted Points
<i>Trash/Debris</i>				0 1 2 3 4	20%	0
Type of trash and Source:	shopping cart in photo					
<i>Standing water</i>				0 1 2 3 4	15%	2
Ponding?	Yes					
Noticeable odors?	No					
Algae?	No					
<i>Sediment</i>				0 1 2 3 4	35%	1
Approx. sediment coverage: (Based on information provided on City of San Diego O&M Channel Maintenance Inspection Form)	5%					
Rock/debris Accumulation?	No					
<i>Transients/encampments</i>				0 1 2 3 4	10%	0
<i>Culverts and Outfalls</i>				0 1 2 3 4	10%	0
<i>Infrastructure Issues</i>				0 1 2 3 4	10%	0
Culvert structure condition	Good					
Broken concrete/gunite?	No					
Broken or missing trash fence/fence poles/supports?	N/A					
Slope failure?	No					
				Total Weighted Water Quality Points		3.0

It is recommended that this drainage channel be maintained to increase the current capacity of the channel from a 50-year storm event back to a 100-year storm event capacity.
