**SUMMARY OF FINDINGS FOR THE
ANNUAL DRAINAGE CHANNEL FIELD
ASSESSMENT AND MAINTENANCE PRIORITIZATION
PROJECT (PHASE 1)
FOR
THE CITY OF SAN DIEGO – MASTER STORM WATER
SYSTEM MAINTENANCE PROGRAM (MMP) MAP 137:
TOCAYO CHANNEL**

**Job Number 17204-D
August 4, 2015**

August 4, 2015

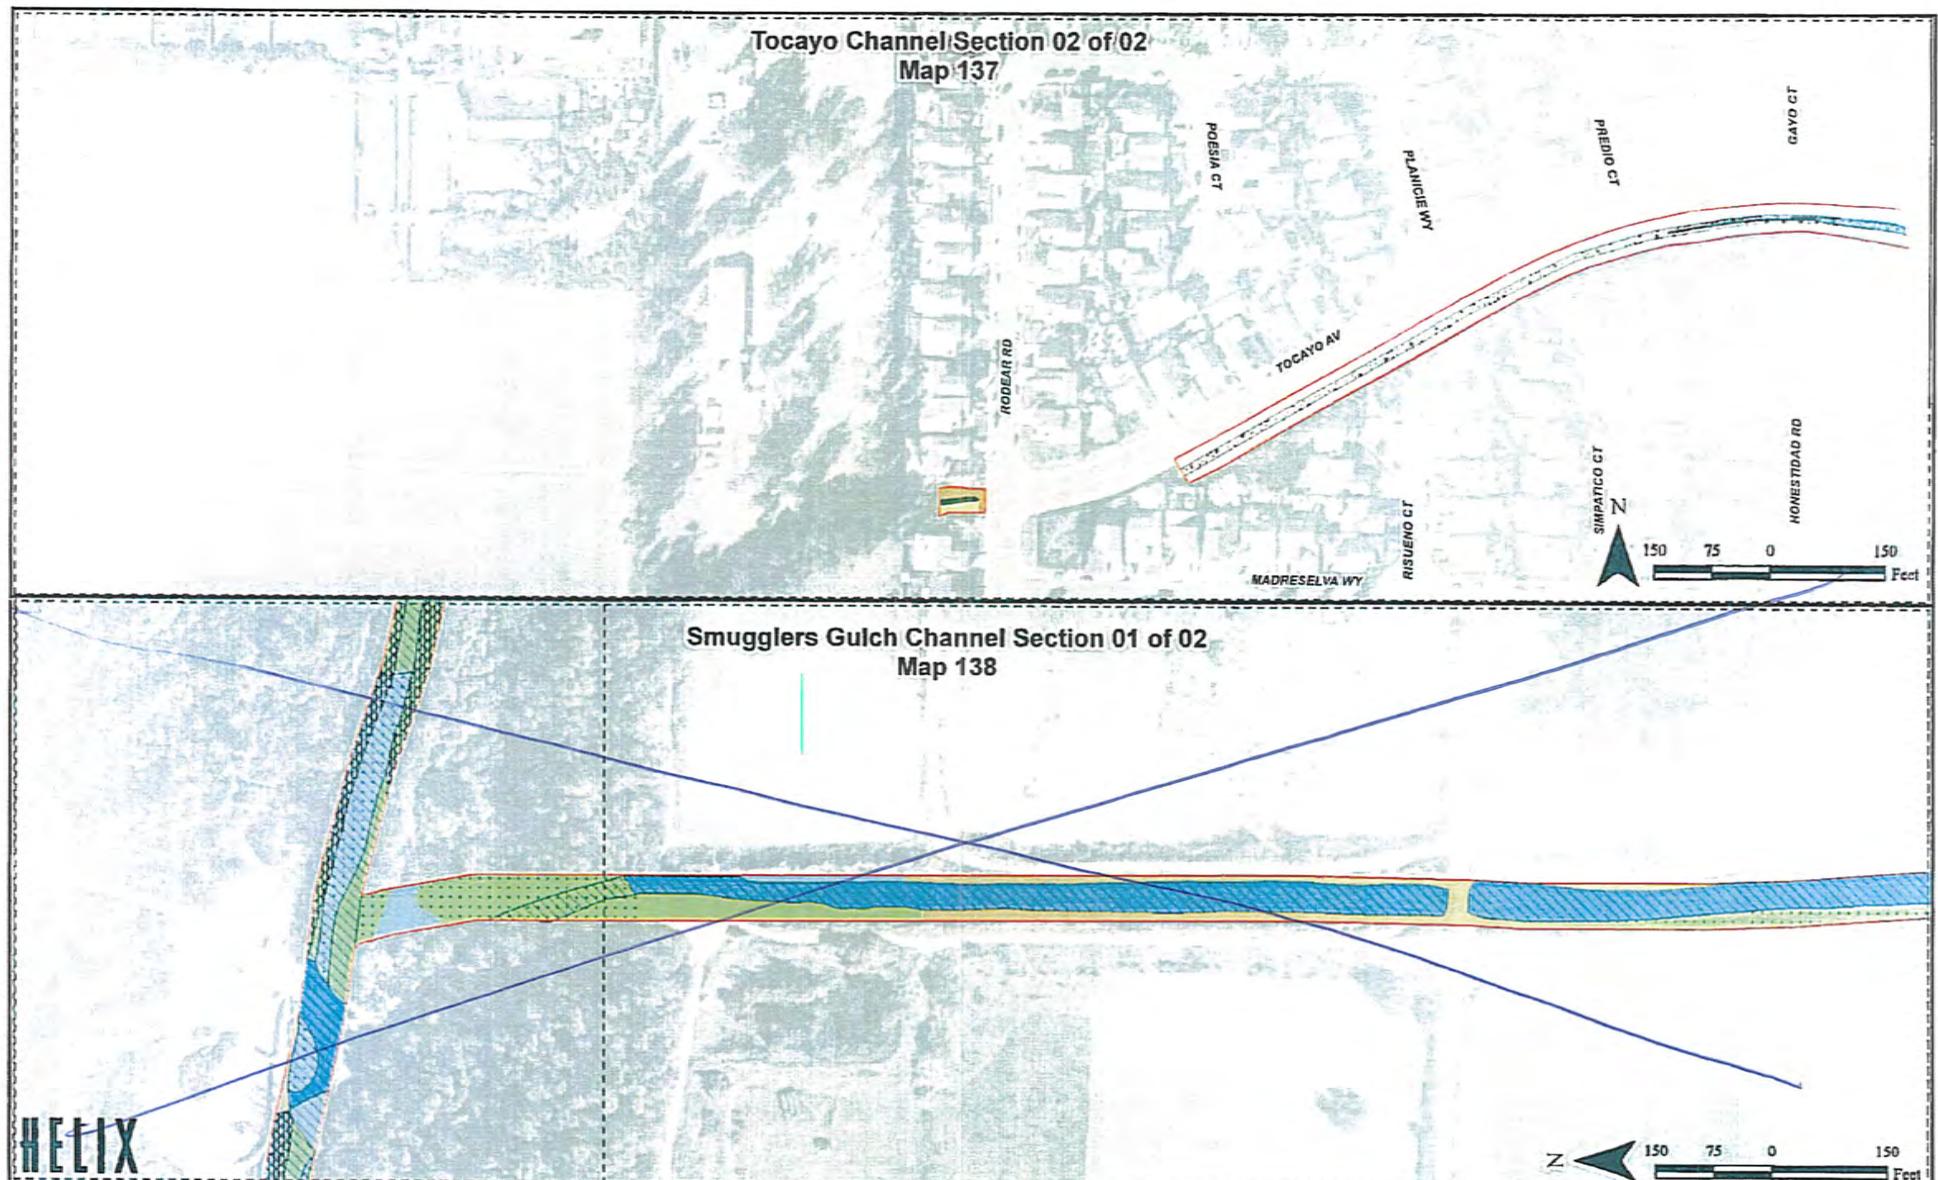
Tocayo Channel Section 02 of 02
Map 137

Vegetation/Wetland Delineation - Maps 137 & 138
CITY OF SAN DIEGO MASTER STORMWATER SYSTEM MAINTENANCE PROGRAM
