**SUMMARY OF FINDINGS FOR THE
ANNUAL DRAINAGE CHANNEL FIELD
ASSESSMENT AND MAINTENANCE PRIORITIZATION
PROJECT (PHASE 1)
FOR
THE CITY OF SAN DIEGO – MASTER STORM WATER
SYSTEM MAINTENANCE PROGRAM (MMP) MAP 84:
WASHINGTON CHANNEL**

**Job Number 17204-D
August 4, 2015**

Prepared For:
City of San Diego
2781 Caminito Chollas
San Diego, California 92105

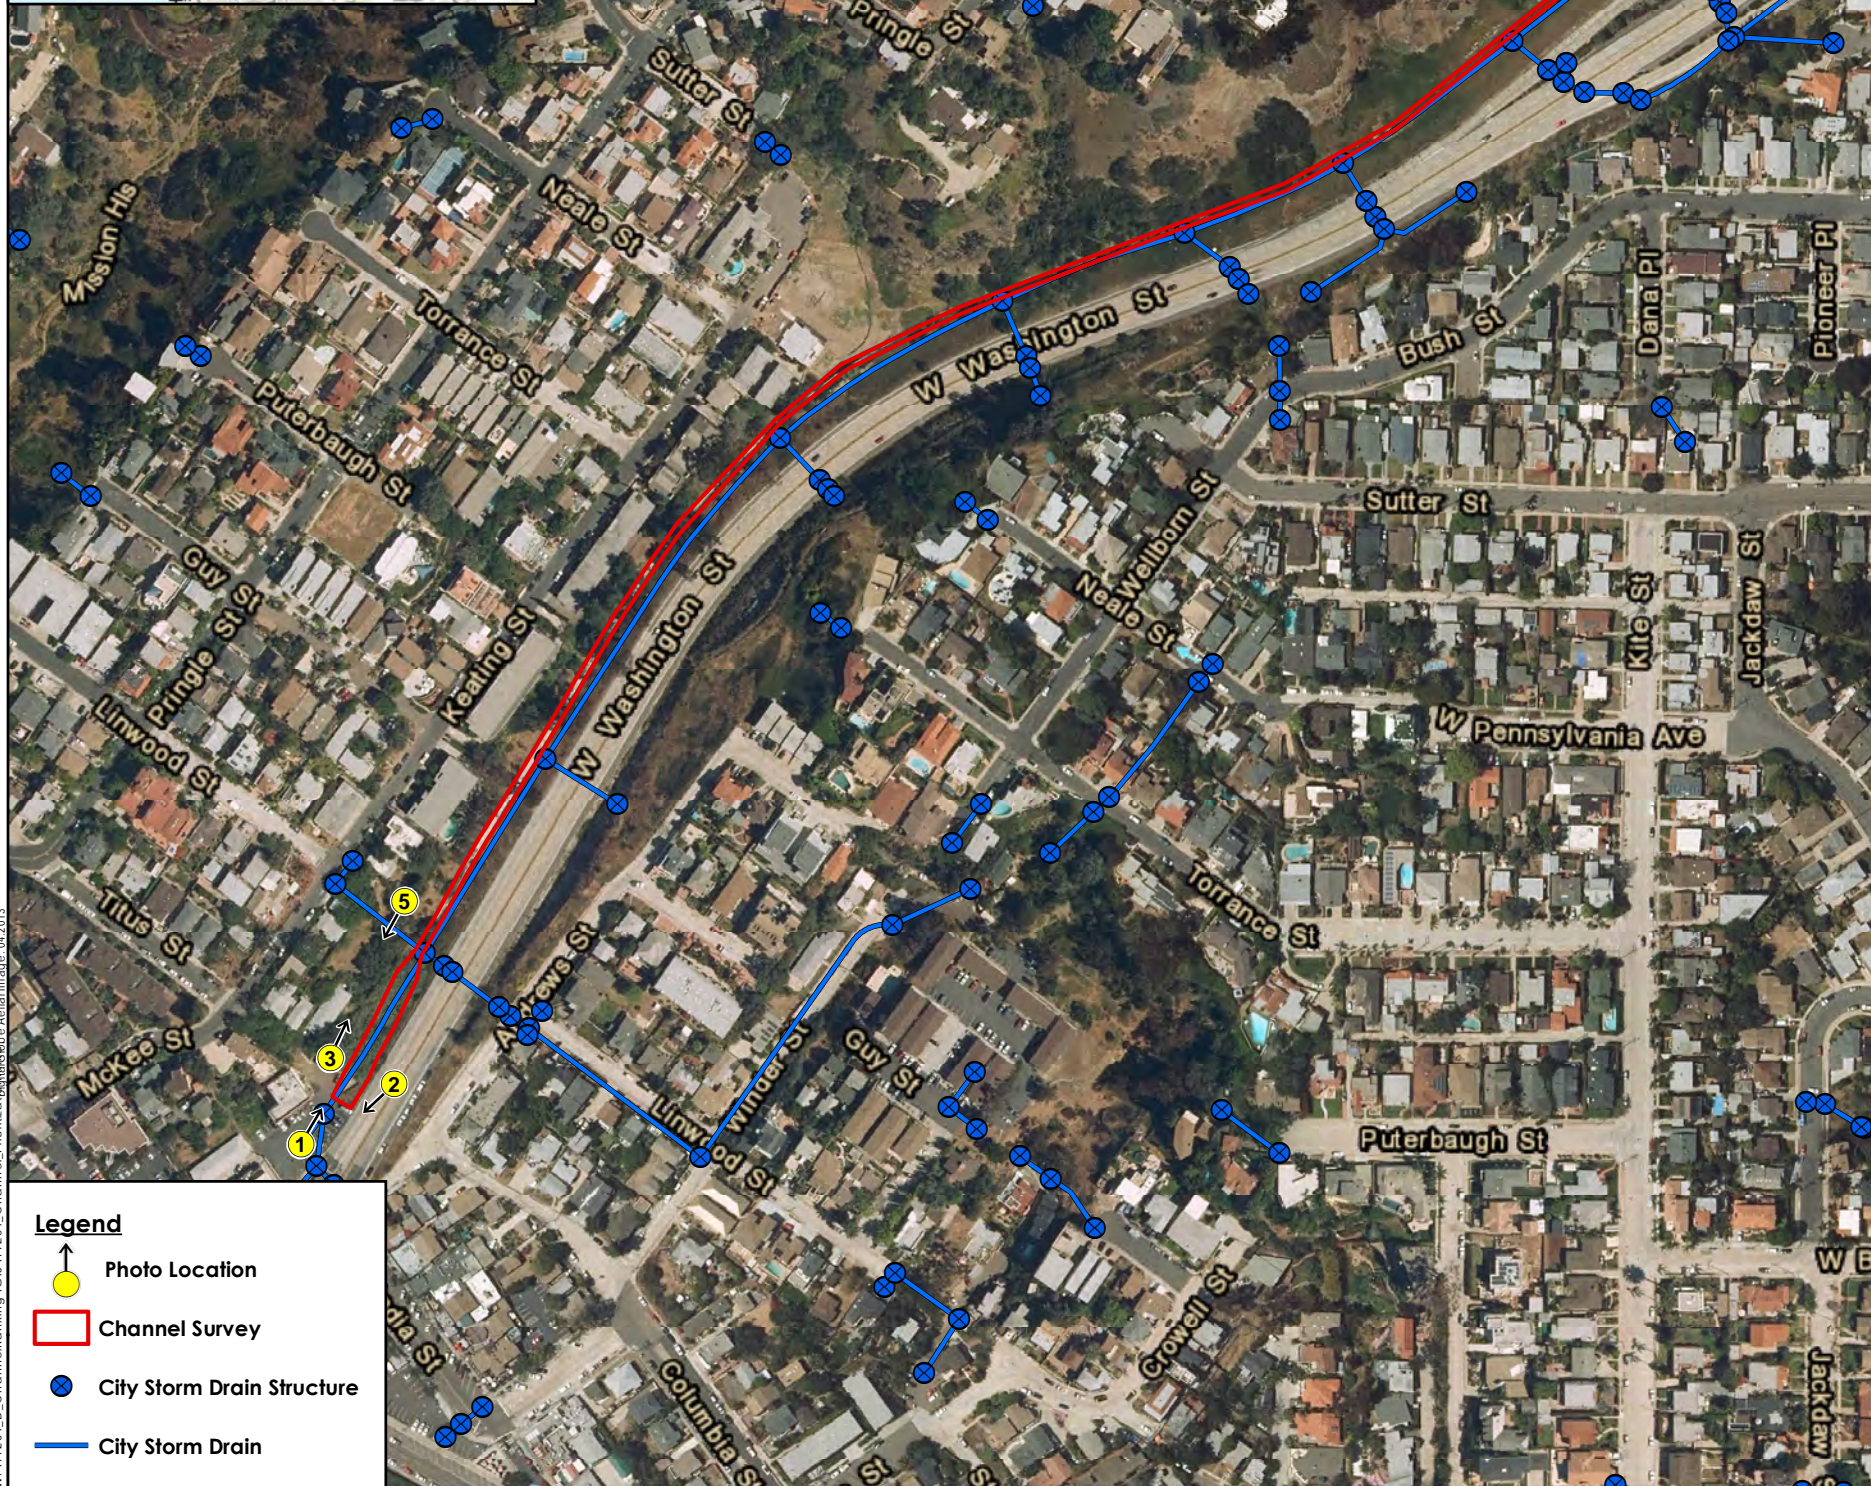
Appendix F
Channel Maintenance Prioritization Summary Sheet

- **Channel Prioritization Score:**
80.3 out of 100
 - **Flood Hazard Score:**
71.3 out of 75
 - **Water Quality Score:**
4 out of 10
 - **Community Input Score:**
5 out of 10
 - **Aesthetics Score:**
0 out of 5
- **Capacity Prior to Maintenance:**
Less than 2-year storm event
- **Capacity After Maintenance (As-built Capacity):**
100-year storm event
- **Clogging Potential:** *HIGH*
- **Approximate Vegetation Coverage:** *HIGH*
- **Surrounding Area:** *Residential*
- **Infrastructure Failures:**
None
- **Site Evaluation Date:**
May 5, 2015
- **Notes/Comments:**
Based on site photos taken by the City of San Diego, heavy vegetation exists in the downstream end of the channel. A high risk of vegetation clogging the downstream culvert exists.

It is recommended that the downstream end of this drainage channel be maintained to increase the current capacity of the channel from a less than 2-year storm event back to a 100-year storm event capacity.
