THE CITY OF SAN DIEGO

Subject: Annual Inspection and Maintenance Report for Inlet Filter per Federal Clean Water Act Section 401 Water Quality Certification for Routine Maintenance of Storm Water Facility, Map 134

Nestor Creek Channel - Proposed Best Management Practices (BMPs) Location Exhibit

Nestor Channel Annual Photo Documentation

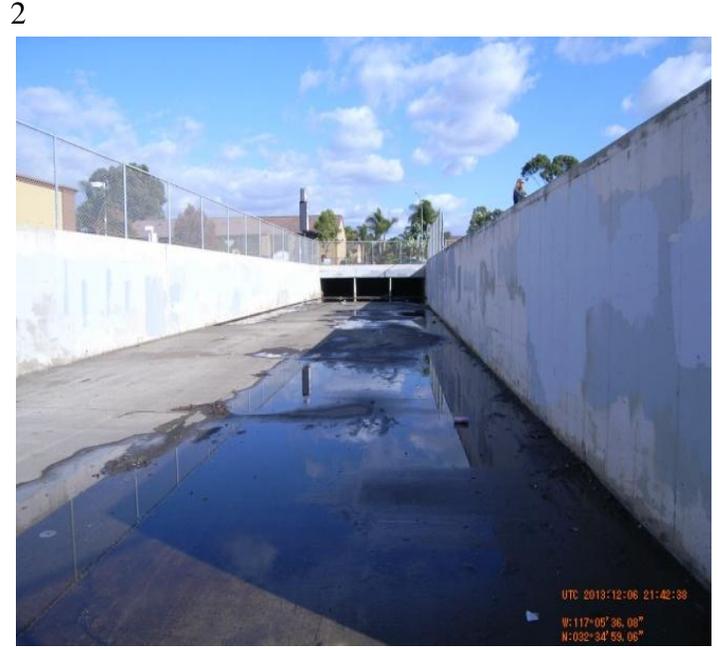
GPS: W: 117°05'36.08"
N: 032°34'59.06"

Photo 2 - Taken from channel bottom looking east toward culverts running under Saturn Street.
