SAN YSDIRO HISTORIC RESOURCES SURVEY

City of San Diego Planning Department

Roth and Associates 2707 Congress Ave., Suite 2A San Diego, California 92110

14 August 1989

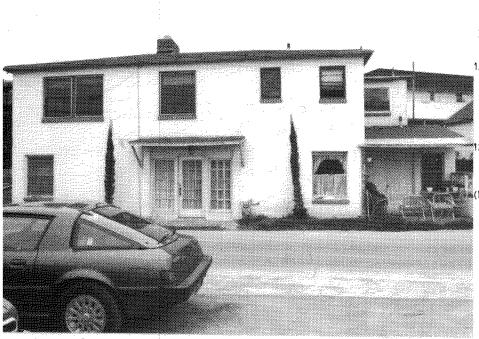
2 story stucco apartment with hip roof; possible side additions. Asymmetrical front facade. <u>STRUCTURAL AND DESIGN ELEMENTS</u>: <u>WALL TREATMENT</u>: stucco with one stucco bracket under side roof; no coping or other detail on wall. <u>ROOF</u>: composition shingle with slight overhang; plain narrow eaves fascia. <u>CHIMNEY</u>: central brick with 2 circular ceramic vents. <u>WINDOWS</u>: 1st story front: 2 double hung single panes at either end of building; 2nd story front: 5 double hung, single pane windows (4 different shapes); windows are inset with brick sills; windows in the back and sides include narrow vertical double hung, cube glass and a small 3 light arched window. <u>DOOR</u>: front facing, glazed with 15 lights with inset 15 light side panels. <u>PORCH</u>: none; shed roof overhang with stick braces over door.

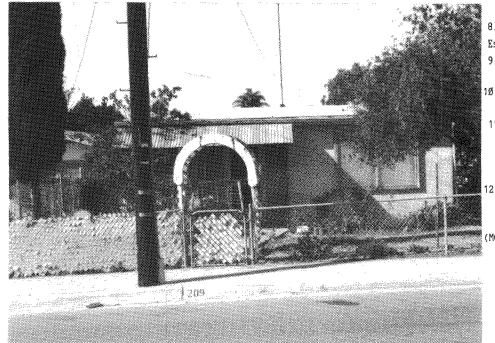
One story house with extremely low pitch side gable and corrugated metal awning extending out beyond 1/2 porch. Asymmetrical front facade. <u>STRUCTURAL AND DESIGN ELEMENTS</u>: <u>WALL</u> <u>TREATMENT</u>: stucco (a wooden structure is to the rear of the house, but we had no access to it). <u>ROOF</u>: composition sheeting; plain eaves fascia and gableboard. <u>CHIMNEY</u>: none. <u>WINDOWS</u>: metal sliding glass. <u>DOOR</u>: inset, front facing; plain board surrounding trim; covered by screen door. <u>PORCH</u>: inset, under principal roof with corrugated awning; wrought iron supports; no steps.

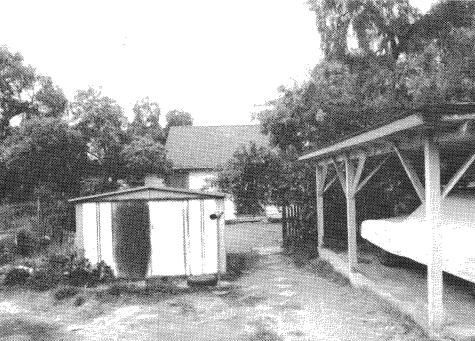
One story house with a medium pitch side facing gable roof and a hip extension along the front (house set deep on lot; behind 211 Cottonwood- clear description of building difficult to impossible). Asymmetrical front facade. <u>STRUCTURAL AND DESIGN ELEMENTS</u>: <u>WALL TREATMENT</u>: wide lap siding with board and batten under gable. <u>ROOF</u>: composition shingles; exposed eaves; plain gableboard. <u>CHIMNEY</u>: none. <u>WINDOWS</u>: double hung with single light panes, both horizontal and vertical orientations; most have small plywood hoods over them; plain surrounding board trim. <u>DOOR</u>: center front, screen door with wood panel <u>PORCH</u>: inset entry porch with small shed roof; no steps.

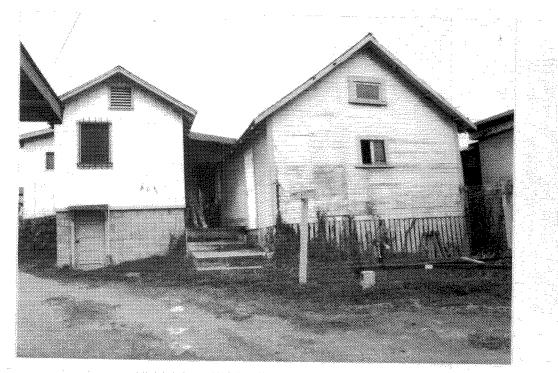
211 COTTONWOOD

BACK VIEW (NOTE DIFFERENCE IN GROUND ELEVATIONS)

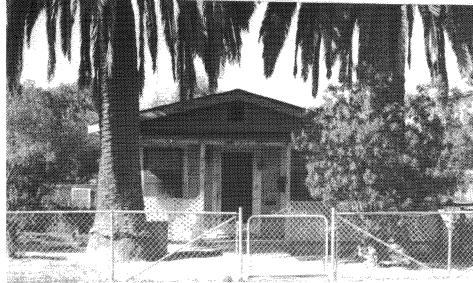
One story rectangularly shaped house with a low pitch front facing gable roof and a dropped shed roof over a full front porch (additions to house in rear). Symmetrical front facade. <u>STRUCTURAL AND DESIGN ELEMENTS</u>: <u>WALL TREATMENT</u>: lap siding in front; sides have lap siding with shingle skirt; widely boxed metal grill vent under gable small jig-saw cut triangle placed below vent as accent. <u>ROOF</u>: composition shingle; exposed eaves; moderate overhang; plain gableboard. <u>CHIMNEY</u>: none. <u>WINDOWS</u>: 2 front facing- 1 on each side of door; rectangular with single light, double hung; plain surrounding board trim. Side windows are fixed; some have been replaced with metal sliders. <u>DOOR</u>: front, centered; covered with screen; plain surrounding board trim. <u>PORCH</u>: open, full porch; dropped shed roof over entire expanse; exposed eaves; stick supportsno braces; lattice work from ground level to approximately 3'; no stairs.

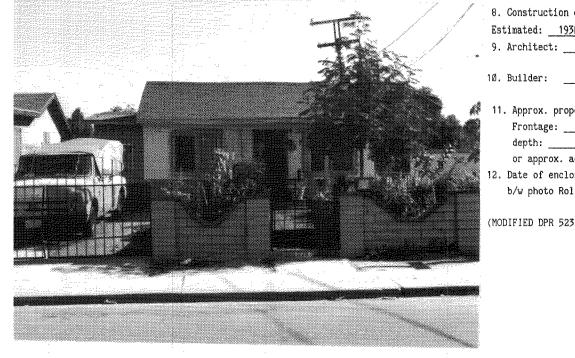
One story house with low pitch side facing gable roof and shed extension in rear (Hall and Parlor configuration); extended shed roof over front door; attached side shed gives aysmmetrical front appearance. <u>STRUCTURAL AND DESIGN ELEMENTS</u>: <u>WALL TREATMENT</u>: stucco. ROOF: composition; slight overhang; plain eaves fascia and gableboard. WINDOWS: all replaced with metal sliders; no surrounding board trim. DOOR: front facing centered; glazed panel on top 1/3, wood inset panel below. PORCH: extended shed roof over door; series of 2 by 2 roof supports.

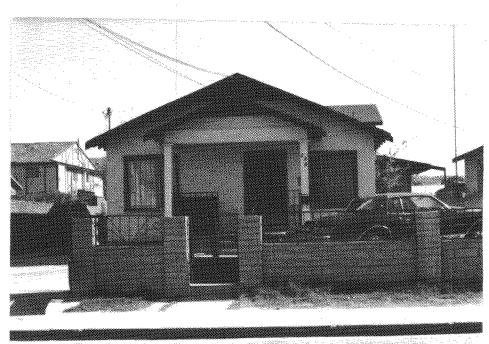
One story bungalow with medium pitch front facing gable roof and a dropped, centered medium pitch gable over partial porch and a pitched dormier on each side of the house. Door is slightly off-set to the right giving the exterior an asymmetrical appearance. <u>STRUCTURAL AND DESIGN ELEMENTS: WALL TREATMENT</u>: lap siding; triangular wood banded pediment under each gable (same lap siding painted a contrasting color for accent). <u>ROOF</u>: composition shingle; moderate overhang; exposed eaves; plain gableboard. <u>CHIMNEY</u>: none. <u>WINDOWS</u>: metal bars on all; front 2 windows appear to be one fixed pane with a single, fixed thin vertical 2 pane side light; plain surrounding board trim. <u>DOOR</u>: front, slightly off-set with metal security screen; plain surrounding board trim. <u>PORCH</u>: open, 1/2 porch; pitch roof over porch with 2 square column supports; simple molded capitals and bases; columns sitting on wide wood block pillars; 3 cement steps to porch; no railing system.

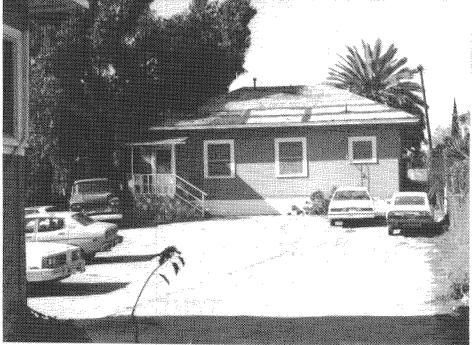
One story house located to the rear of the lot; has a hip roof and a dropped shed roof over offset front door. Asymmetrical front facade. <u>STRUCTURAL AND DESIGN ELEMENTS</u>: <u>WALL TREATMENT</u>: concrete block foundation; lap siding. <u>ROOF</u>: new composition shingle; boxed eaves; plain eaves fascia. <u>CHIMNEY</u>: none. <u>WINDOWS</u>: 3 front facing windows, all to the right of the door: 2 are rectangular, double hung with 4 lights on each pane; 3rd window is smaller, double hung, single light in each pane; plain surrounding board trim. <u>DOOR</u>: located at front left corner; screen and plywood; plain surrounding board trim. <u>PORCH</u>: entry porch, dropped shed roof over door and small entry area; 2 stick supports; stick railing system resting on decorative cement/rock wall; 5 side steps to entry.

| 13. Condition: Excellent Goodx Fair Deteriorated No longer in existence |

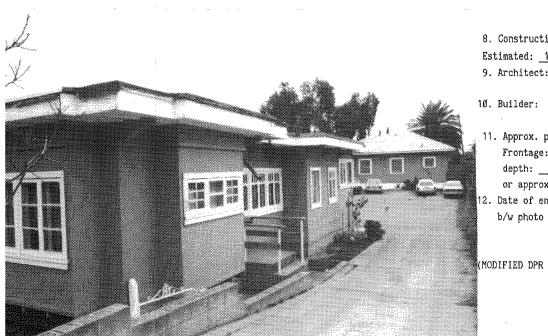
One story, roughly rectangularly shaped house with a flat widely overhanging roof, subtle details and wall/roof recesses emphasizing low linear nature of this house (Only house in study area with this outline). Asymmetrical front facade. <u>STRUCTURAL AND DESIGN ELEMENTS</u>: <u>WALL TREATMENT</u>: stucco with cement foundation; angular recesses at corners; squared bays; simple molded band around entire perimeter of house below brackets; rear and side 1/3 of house covered with plywood. <u>ROOF</u>: composition sheeting; wide boxed overhang; numerous wood brackets at irregular intervals; extremely wide fascia board. <u>CHIMNEY</u>: none. <u>WINDOWS</u>: front 2 sets of windows: to the left 3 small casement windows with 3 small vertical lights on top/ single light below; to the right- set of 3 larger casement windows, 6 lights in each (side windows vary in size and sash pattern); plain, wide surrounding board trim. <u>DOOR</u>: side entrance, glazed with 6 square lights on top/ 3 vertical lights on bottom; plain surrounding board trim. <u>PORCH</u>: entry only; no covering; principal roof extends only slightly; 2 cement steps with plain round metal and board railing.

| 13. Condition: Excellent Good Fair _x Deteriorated No longer in existence |

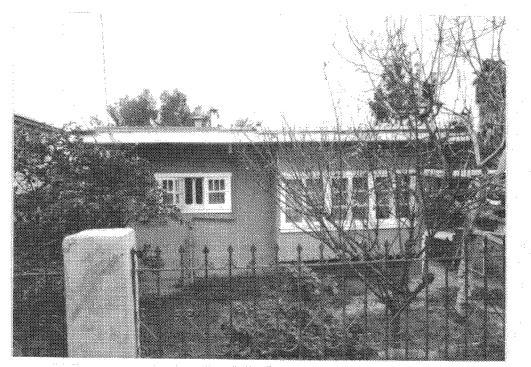
251 COTTONWOOD

FRONT VIEW

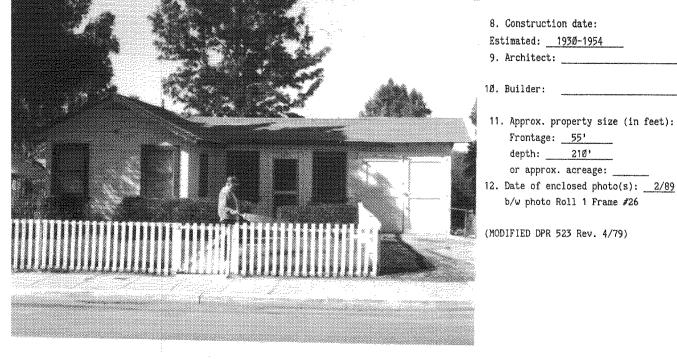
One story "L-shaped" house with medium pitch cross gables and attached single car garage. House is on a slope; asymmetrical front facade. <u>STRUCTURAL AND DESIGN ELEMENTS</u>: WALL TREATMENT: lap siding; plain cornerboards; patching indicative of front wall alterations; small vertical slat vent pediment under gable. ROOF: composition shingle; plain eaves fascia and gableboard. CHIMNEY: none. WINDOWS: double hung- single pane (2 in front; 2 on either side of door); wide surrounding board trim, sill extends slightly beyond window. DOOR: front facing, covered with screen; unglazed; plain surrounding board trim. <u>PORCH</u>: none.

13. Condition: Excellent _____ Good _____ Fair _x __ Deteriorated _____ No longer in existence _____

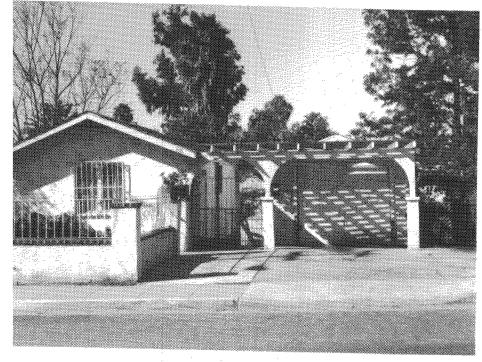
One story house with a medium pitch front facing gable and a trellis porte cochre roof extending from the left of the house. The lot slopes down to the rear. Asymmetrical front facade. <u>STRUCTURAL AND DESIGN ELEMENTS</u>: <u>WALL TREATMENT</u>: stucco; small vertical slat vent pediment under gable. ROOF: composition shingle; slight overhang; plain eaves fascia and gableboard. CHIMNEY: none. WINDOWS: front window appears to be a pair of 12 light, fixed with top of surrounding board slightly curved (windows are covered with security grills); side windows are combination metal sliders and fixed single pane. DOOR: side entrance; can not see. PORCH: none; trellis porte cochere extends from left of house, rests on thin stucco arches and small square piers (2 arches: 1st one at entrance; wider arch for car); no stairs.

Detached garage immediately to right of house- lap siding and a steeper pitch to the roof.

| 13. Condition: Excellent Good Fairx Deteriorated No longer in existence |

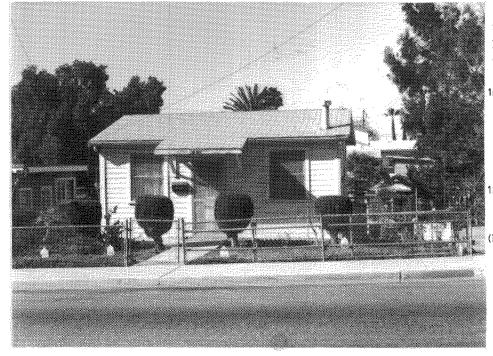
One story house with a medium pitch side facing gable roof and an extended shed roof over front door entry. Asymmetrical front facade. <u>STRUCTURAL AND DESIGN ELEMENTS</u>: <u>WALL TREATMENT</u>: dropped siding with wide corner boards. <u>ROOF</u>: composition shingle; plain eaves fascia and gableboard; rain gutters along roof line. <u>CHIMNEY</u>: none. <u>WINDOWS</u>: 1 double hung window on either side of front door; not evenly spaced; single light in each pane; plain surrounding board trim. <u>DOOR</u>: front facing; single rectangular glass pane on top half, solid wood panel below; covered with screen door. <u>PORCH</u>: none; extended shed roof over door; simple triangular knee braces as support; single step to entry.

13. Condition: Excellent _____ Good __x Fair ____ Deteriorated _____ No longer in existence _____

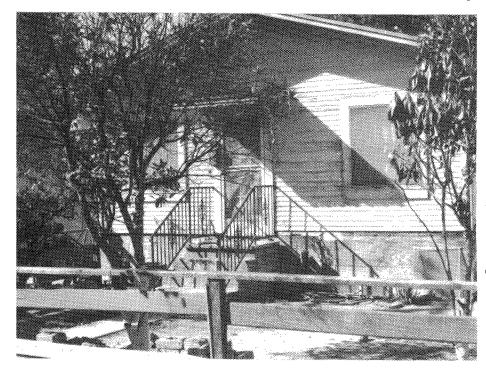
One story house with low pitch front facing gable roof and a dropped shed roof bracketed hood over front door. Asymmetrical front facade (front windows are not evenly spaced).<u>STRUCTURAL</u> <u>AND DESIGN ELEMENTS: WALL TREATMENT</u>: lap with plywood siding along bottom 3-5'. <u>ROOF</u>: composition sheeting; moderate overhang; exposed eaves; plain gableboard; 2 plain knee braces under gable edges. <u>CHIMNEY</u>: none. <u>WINDOWS</u>: 2 front facing double hung- single light in each pane; side windows are same with some replaced by metal sliders; windows covered with screens; plain surrounding board trim. <u>DOOR</u>: front centered, 15 lights covered by screen. <u>PORCH</u>: none; bracketed shed roof hood over door; brackets are single stick braces; jig-saw cut trim fascia along hood; 3 front facing steps with wrought iron railing system to stoop.

| 13. | Condition: | Excellent | Good | Fair | Deteriorate | d x | No | longer | in | existence | |

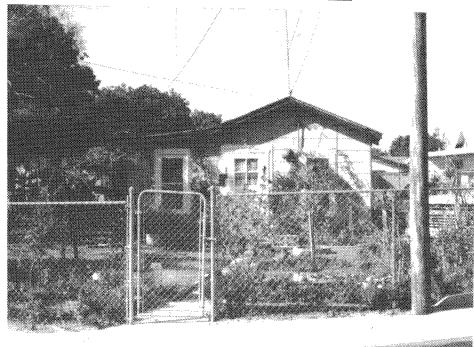
Small, "Hall and Parlor" house with a medium pitch front facing gable roof and a shed extension on the right. Asymmetrical front facade. <u>STRUCTURAL AND DESIGN ELEMENTS</u>: <u>WALL</u> <u>TREATMENT</u>: composition siding. <u>ROOF</u> composition shingle; slight overhang; exposed eaves; plain narrow gableboard. <u>CHIMNEY</u>: none. <u>WINDOWS</u>: one on either side of front door, rectangular in shape; vertical; appear to be 2 light awning over windows, curved with screen; wide surrounding plain board. <u>DOOR</u>: front facing; partially glazed with 4 square lights above; lintel slightly flared; plain surrounding board trim. <u>PORCH</u>: none.

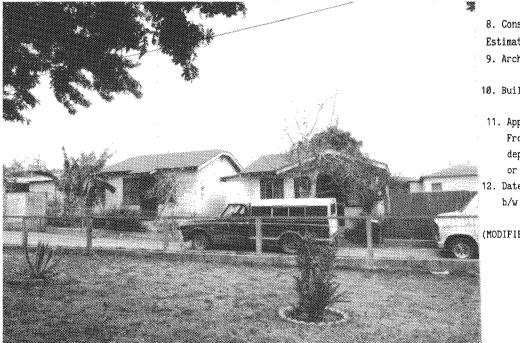
<u>DOOR</u>: (124 Cypress) wood door with four glass panes, covered with security bars; (122 Cypress) can not see, covered with security bars and screen. <u>PORCH</u>: no porch; 124 Cypress has slight shed extension over front door; 122 Cypress entry is located under principal roof.

| 13. | . Condition: Excellent Good Fair _x _ Deteriorated No longer in existence |

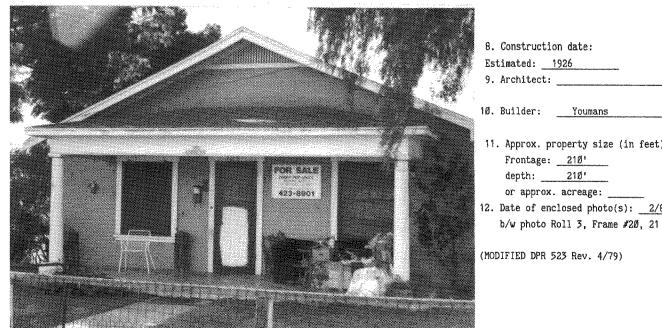
One story house with medium pitch front facing gable roof and front facing dropped hip porch roof. Asymmetrical front facade. STRUCTURAL AND DESIGN ELEMENTS: WALL TREATMENT: lap siding with no corner boards; cement foundation; small boxed loft-like opening under rear gable. ROOF: composition shingles; boxed eaves along porch roof; two 4 by 4 brackers under gable at wall junction; exposed rafters; plain undecorated gableboard; series of vertical strips and horizontal plain board form triangular decorative pediment under the front gable. CHIMNEY: none. WINDOWS: one on either side of door: double hung with 4 vertical lights on top/ 1 on the bottom; windows covered with screen; simple plain board trim with sill and lentils extended slightly beyond window opening. DOOR: front facing, centered; partially glazed with 5 vertical lights on top/ wood panel on the bottom; wood screen door. PORCH: open, front facing with 2 doric support columns; simple molded capitals and bases; plain boxed cornice and frieze along roof; slat finishing under porch roof; 1 front cement step to entry.

| 13. Condition: Excellent Good Fair Deteriorated No longer in existence |
|---|
| 18. Related features: <u>detached garage across alley; good exterior condition; older vegetation</u> <u>includes pepper trees.</u> |

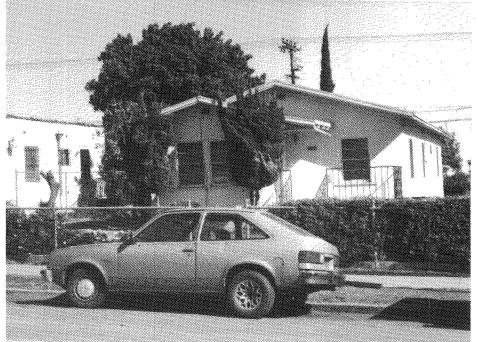
One story cottage with two low pitch front facing gables: lower gable is offset to the left with an extended shed roof over side porch entrance. Asymmetrical front facade. <u>STRUCTURAL AND DESIGN ELEMENTS</u> <u>WALL TREATMENT</u>: white stucco exterior with rounded corners; 3-holed metal boxed vent under each gable. <u>ROOF</u>: composition shingles; moderate eave overhang; undecorated fascia gableboard. <u>CHIMNEY</u>: none. <u>WINDOWS</u>: double hung, horizontal sash bar arrangement with 2 lights in each; plain surrounding board trim; sill extend slightly beyond window opening. <u>DOOR</u>: side entrance; wood panel with 2 square inset panels on top/ 4 rectangular panels on the bottom; attached screen door; plain wood trim around door. <u>PORCH</u>: partial, open porch with wrought iron railing system; 3 front facing cement stairs to entry; roof extension covers only the door.

Detached garage to the rear identical in shape and design to main building.

| 13. Condition: Excellent Good Fair _x Deteriorated No longer in existence |
| 18. Related features:cracked foundation; chain-link fence along perimeter. |

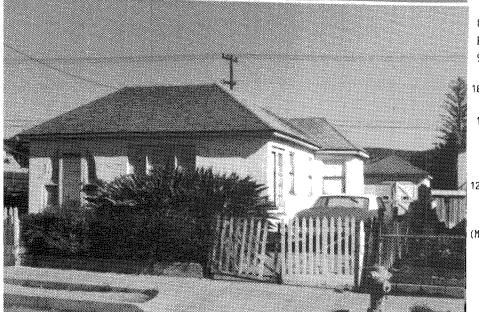
One story house with a flat-topped,hip roof. Asymmetrical front facade. <u>STRUCTURAL AND DESIGN ELEMENTS:</u> <u>WALL TREATMENT</u>: white stucco. <u>ROOF</u>: composition shingle; hip roof with irregular hipped extension on one side; no exposed rafters or beams. <u>CHIMNEY</u>: none. <u>WINDOWS</u>: fixed, inset, rectangular main window with center sash bar arrangement of 6 lights on top/ 3 on bottom; adjacent windows to the side have sash bar arrangement of 4 lights on top/ 2 on bottom; side window is bell shaped with similar sash treatment as the door; windows along sides of the house are combination double hung and multi-light casements. <u>DOOR</u>: surrounding treatment is an inverted bell; glazed door with 6 lights on top/3 vertical panes on bottom; irregularly shaped fixed lights surround the door- panes are cut to fit into the curvature of the inverted bell. <u>PORCH</u>: none; no overhang; 3 front facing cement steps to entry.

Detached garage has pyramidal roof. Detached house to the back (132 East Park) has stucco exterior; roof line is front facing medium gable with two lower hip roofs; no exposed rafters. Porch treatment elements include slender round doric porch supports. The front and rear house appear to have similar construction and were built at the same time.

| 13. Condition: Excellent Good Fairx Deteriorated No longer in existence |

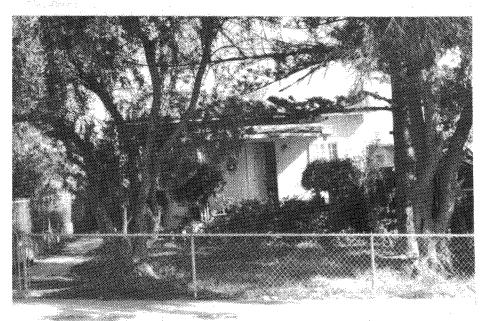
One story structure with medium pitch side gable and shed extension to the rear. ("Hall and Parlor" configuration). Asymmetrical front facade. <u>STRUCTURAL AND DESIGN ELEMENTS</u>: <u>WALL TREATMENT</u>: yellow stucco exterior. <u>ROOF</u>: composition shingles; moderate eave overhang with undecorated eaves fasica and gableboard. <u>CHIMNEY</u>: none. <u>WINDOWS</u>: on either side of entrance: window to the left of the door is fixed with 9 lights on top/ 1 on the bottom; to the right of the door is a small double hung window with 9 lights on top/ 1 on the bottom. plain surrounding flat broad trim; slat-shutter treatment on some of the windows. <u>DOOR</u>: front facing; 6 paneled unglazed wooden door with simple undecorated flat board trim. <u>PORCH</u>: half porch with shed extension roof; porch supports are plain 2 by 2 boards; no trim nor bracing; porch is completely open; 3 cement, side entry steps to cement porch. New structure to the back.

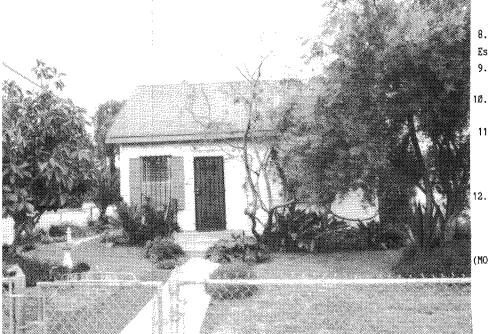
One story structure with medium pitch side facing gable roof and shed roof extension along rear ("Hall and Parlor" configuration). Asymmetrical front facade. <u>STRUCTURAL AND DESIGN ELEMENTS</u>: <u>WALL TREATMENT</u>: lap siding; plain undecorated corner boards and cornice boards (original siding was board and batten). <u>ROOF</u>: composition shingle; moderate overhang; boxed eaves and rafters; plain eaves fascia and gableboard. <u>CHIMNEY</u>: none. <u>WINDOWS</u>: 2 front double hung single pane, unevenly spaced on either side of front door; windows covered with security bars; batten shutters; lentil over windows slightly flared at both ends. <u>DOOR</u>: can not see, security screen; flat column pilasters on each side of door (only house in survey area with this type of door surrounding treatment); narrow bracketed hood tops door. <u>PORCH</u>: none; 3 front facing cement steps to front door; attached lattice covered porch in rear.

Additional structures: single car garage and sheds in rear.

| 13. Condition: Excellent Good Fairx_ Deteriorated No longer in existence |
| 14. Alterations: window/door treatment; wall treatment; shutters; new foundation |

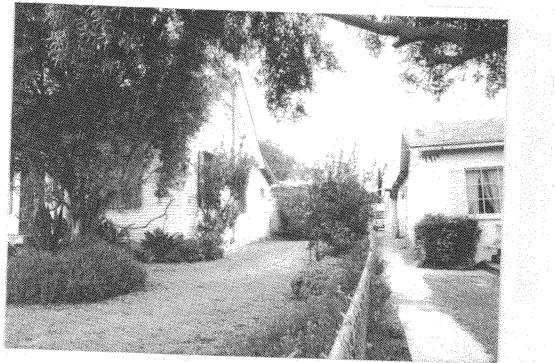
158 EAST PARK

SIDE VIEW SHOWING SHED EXTENSION TO REAR

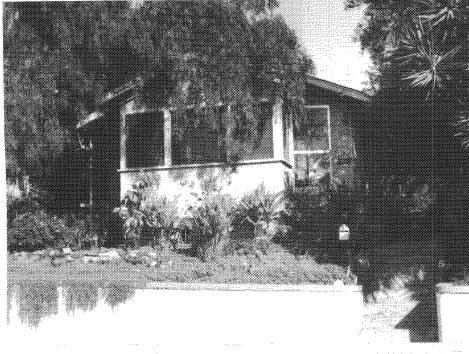
Single story bungalow with a low pitch front facing gable and a slightly dropped, centered gable roof over totally enclosed 3/4 porch. Asymmetrical front facade. <u>STRUCTURAL AND</u> <u>DESIGN ELEMENTS</u>: WALL TREATMENT: composition shingle siding and wide lap siding; possible boxed vent under porch gable. <u>ROOF</u>: moderate overhang, plain eaves fascia and gableboard; decorative wood braces under gable; composition shingle roof. <u>CHIMNEY</u>: none. <u>WINDOWS</u>: front windows are part of fully enclosed porch, can not see elements; plain wood surround with continuous sill lapping around corner. <u>DOOR</u>: side of porch, covered by screen. <u>PORCH</u>: totally enclosed with solid wood from ground level to 3-3 1/2' above floorline; 9 steps to porch entry.

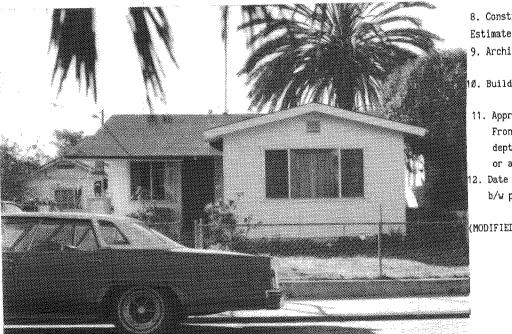
One story bungalow with low pitch, cross-gable roof and semi-enclosed porch. Asymmetrical, "L-shaped" front facade. STRUCTURAL AND DESIGN ELEMENTS: WALL TREATMENT: lap siding; no corner boards; louvered square vent under gable; exposed undersurface of the gable is open rake, resulting in a "ladder" effect. ROOF: composition shingle; plain undecorated eaves fascia and gableboard; 2 square knee braces at side of gable edges. CHIMNEY: none. WINDOWS: all front facing windows have been replaced with metal sliders; side windows are 2 sets of double hung with 4 small lights on top/ 1 rectangular pane on bottom; surrounding trim is very wide undecorated board. DOOR: front facing, plywood with no decorative trim. PORCH: inset, open porch (modified- original porch would have been side entranced; existing porch is likely recent addition); entry has tapered wood pillars with simple molded capitals; pillars rest on large wooden pier that are covered with lap siding and plain undecorated corner boards; porch roof is part of the side gable; 2 cement steps to porch.

13. Condition: Excellent _____ Good _____ Fair _x Deteriorated _____ No longer in existence _____

14. Alterations: window replacement; possible addition of porch; multi-roof line suggests room additions

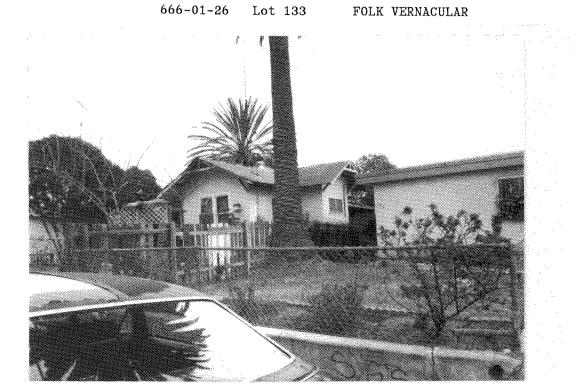
148 Hall

SIDE VIEW SHOWING PORCH ELEMENTS

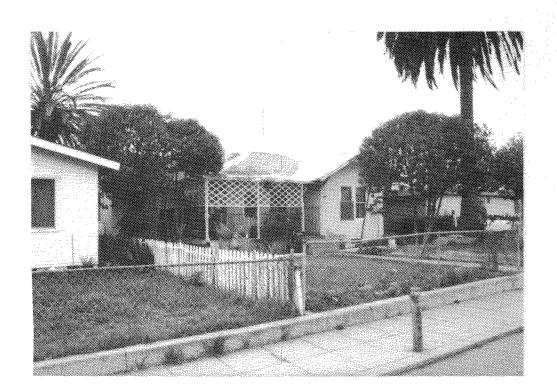
SIDE VIEW SHOWING ROOFLINE

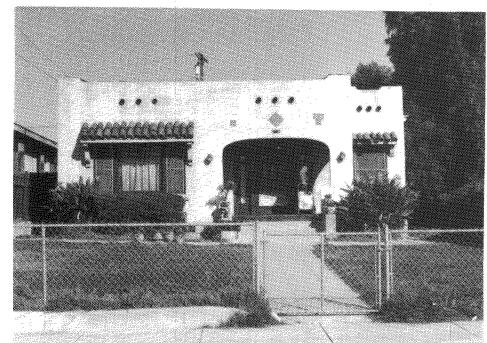
One story front facing house with flat roof. "L-shaped" yet box-like appearance; asymmetrical front facade. <u>STRUCTURAL AND DESIGN ELEMENTS</u>: <u>WALL TREATMENT</u>: stucco with cement foundation. <u>ROOF</u>: decorative tile pattern over flattened arch entry; 3 sets of 3 ceramic drains below roof line; roof corners are slightly parapeted. <u>CHIMNEY</u>: none. <u>WINDOWS</u>: front focal window is 3 sections: center window is fixed with 8 small lights on top/ 1 light on bottom; side panels are double hung with single panes; an additional fixed window is located to the right of the door. Windows along the side of the house are double hung with the same sash bar pattern as the front focal windows. All windows have stucco sills; the 2 front windows have bracketed shed roofs (covered with roofing tile and supported by massive stucco braces). <u>DOOR</u>: glazed with 2 glazed side panels; glaze pattern is 3 square lights on top/ 3 rectangular lights on the bottom; side panel has 1 square light on top/ 1 rectangular light on the bottom; glass sash bar placement emphasizes vertical lines of the door. <u>PORCH</u>: four cement steps to open front facing half porch; entry is accented by a wide flattened arch and stucco wall. No detached structures.

13. Condition: Excellent ____ Good ____ Fair _x Deteriorated ____ No longer in existence ____

- 14. Alterations: ______building has cracked foundation; peeling stucco, needs window repair
- 15. Surroundings:(check appropriate boxes) Open land _____ Scattered buildings ____ Densely built-up _____ Residential _____ Industrial _____ Commercial _____ Other: ______
- 16. Threats to site: None known ____ Private Development _x _ Zoning _x _ Vandalism _____ Public Works Project ____ Other: _____
- 17. Is the structure: On its original site?: _____ Moved? _____ Unknown ? _____
- 18. Related features: <u>older vegetation includes large pepper trees; associated out buildings have been</u><u>removed</u>

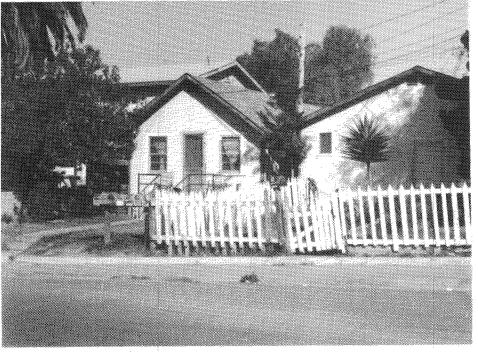
Series of 1 story wood frame/stucco apartments located on the corner of Hall and Pepper; all have low to medium pitch roofs with plain eaves fascia and gableboard. Combination stucco and vertical board siding. Double hung single pane windows with plain board surround. No chimney; no porches.

| 13. C | Condition: Excellent Good Fair Deteriorated _x. No longer in existence |

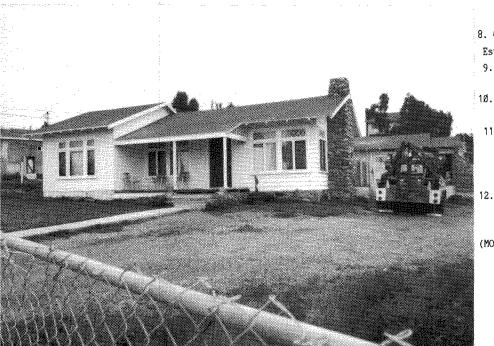
One story bungalow with multiple roof lines including a medium pitch cross gable roof, a medium pitch side gable, a partial hip (in rear) and an extended shed roof over front facing porch (a separate structure adjoins house in rear). Asymmetrical front facade. <u>STRUCTURAL AND DESIGN ELEMENTS</u>: WALL TREATMENT: lap siding (new); louvered vent, boxed and silled under side and back gable roof; cobblestone skirt along foundation. <u>ROOF</u>: composition shingles; exposed eaves, plain gableboard; moderate to wide overhang. <u>CHIMNEY</u>: massive, exterior cobblestone chimney along right side of house <u>WINDOWS</u>: front windows are combination fixed and casement with vertical panes below/ Queen Anne "x" lights above; plain surrounding board trim with sill. <u>DOOR</u>: solid, unglazed with plain surrounding board trim. <u>PORCH</u>: partial front facing porch covered by shed roof that extends as part of principal roof; decorative angular stick work; 2 stick porch supports; totally open- no railing system; 2 brick steps to porch.

| 13. Condition: Excellent Goodx Fair Deteriorated No longer in existence | |
| 14. Alterations: wall treatment; window replacements; new roof | |

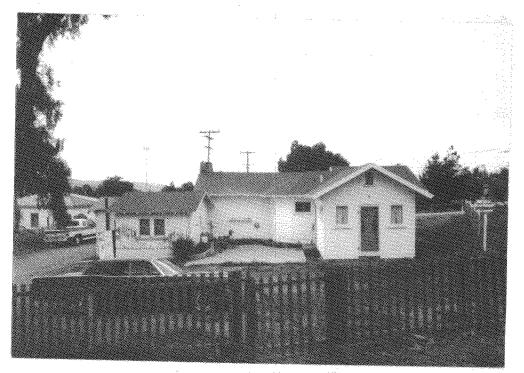
260 MESA

BACK VIEW (NOTE DIFFERENT ROOF LINES)

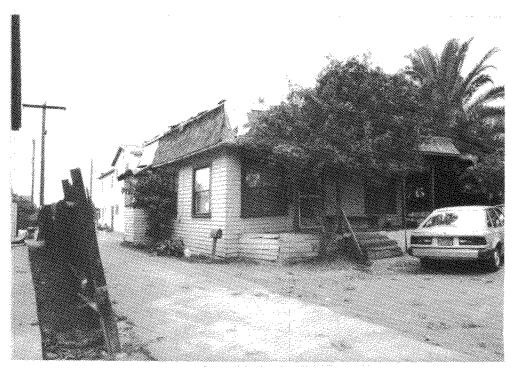
129 WEST OLIVE

SIDE VIEW SHOWING ROOF LINE

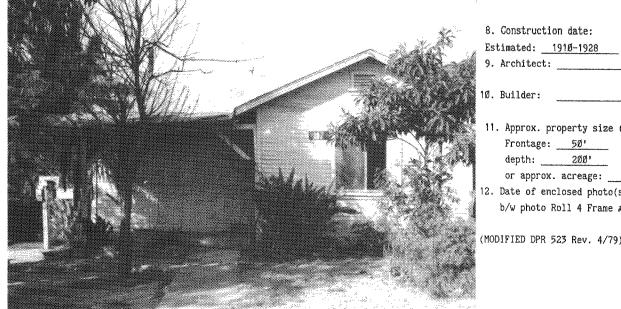
One story "L-shape" house with low pitch cross gable roof and an open porch under principal roof. Asymmetrical front facade. STRUCTURAL AND DESIGN ELEMENTS: WALL TREATMENT: lap siding with plain, narrow corner boards; horizontal boxed and silled slat vent under front gable; fish scale shingle trim under side gable. ROOF: composition shingles; exposed undersurface of the gable is open rake, giving a "laddered" appearance; plain eaves fascia and gableboard. CHIMNEY: none. WINDOWS: combination metal sliders and double hung with single lights; plain undecorated surrounding board trim. DOOR: offset side entrance, partially glazed with single upper glass panel/ 3 bottom wood panels; plain undecorated surrounding board trim. $\underline{PORCH}:$ located under principal roof with slight shed extension; totally open; two 2 by 2 open triangular knee braces; one front entry cement step to cement porch; porch roof is collapsing

13. Condition: Excellent _____ Good _____ Fair ____ Deteriorated _x__ No longer in existence _____

14. Alterations: window replacements; roof replacement; shed extension; exterior trim

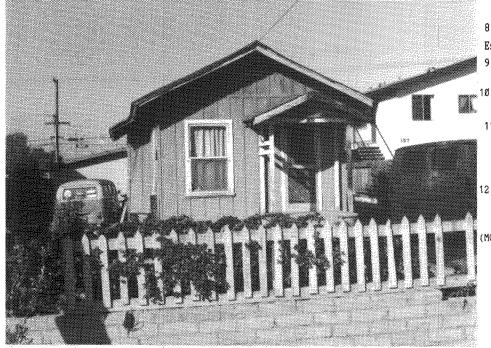
One story, long and narrow house with medium pitch front facing gable and an off set dropped front facing gable over door entry ("shot-gun"). Back of house has a lower gable attachment, suggesting had least one addition to the main structure. Asymmetrical front facade. <u>STRUCTURAL AND DESIGN ELEMENTS: WALL TREATMENT</u>: board and batten exterior with horizontal board cornice; wood or cement pier foundation; small,louvered boxed vent under gable. <u>ROOF</u>: composition sheeting; porch roof has "original" wood shingles; undecorated gableboard; exposed rafters. <u>WINDOWS</u>: front window is double hung with single pane in each; plain undecorated surrounding board treatment; side windows are a combination of fixed and double hung. <u>DOOR</u>: plywood and screen; plain undecorated surrounding board treatment. <u>PORCH</u>: open entry porch; roof supports are four 2 by 2 beams; simple molding at capital; three cement front steps to entry; no railing system.

13. Condition: Excellent _____ Good _____ Fair ____ Deteriorated _x No longer in existence _____

- 14. Alterations: window replacements; roof replacement; shed extension; exterior trim
- 15. Surroundings:(check appropriate boxes) Open land _____ Scattered buildings ____ Densely built-up _____ Residential x Industrial _____ Commercial _____ Other: ______
- 16. Threats to site: None known ____ Private Development _x Zoning _x Vandalism _____ Public Works Project ____ Other: _____
- 17. Is the structure: On its original site?: _____ Moved? _____ Unknown ? _____
- 18. Related features: older vegetation includes palm trees

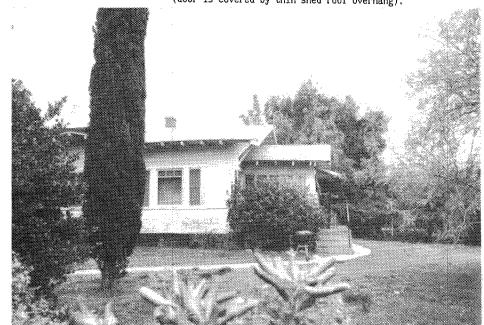
One story bungalow with multiple roof lines including a low pitch front facing gable, shed roof extensions and gables over enclosed porch and above at least 1 side window. Asymmetrical front facade. Extremely dense vegetation/foliage made viewing of house difficult to impossible (front photo was impossible to take). <u>STRUCTURAL AND DESIGN ELEMENTS: WALL TREATMENT</u>: combination lap and flush siding; shingle skirt around entire house from foundation to approximately 3' above ground; boxed lattice vent under main gables. <u>ROOF</u>: composition shingle; ends of gable slightly flared; exposed rafters, plain gableboard; simple, long stick knee braces at gable ends. <u>CHIMNEY</u>: central brick with thin brick cap. <u>WINDOWS</u>: combination of long fixed panes with sash bar arrangement of 3 small lights on top/ 1 large light on bottom, long narrow double hung, and long, narrow fixed with vertical lights; all have wide surrounding board trim with lintels slightly flared. <u>DOOR</u>: can't see. <u>PORCH</u>: totally enclosed, full extension under dropped, low pitch gable roof; solid walling system from ground level to above porch floor is shingled; tapered wood piers at each end; 3 side facing cement stairs with iron rail to door (door is covered by thin shed roof overhang).

| 13. Condition: Excellent Good Fair _x Deteriorated No longer in existence |

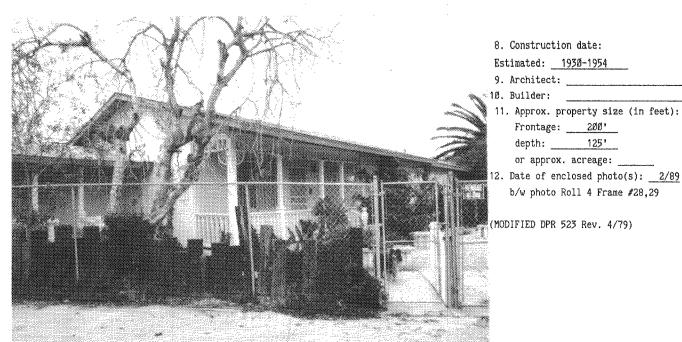
COMPLETELY REDONE/IMPOSSIBLE TO TELL WHAT THE ORIGINAL STRUCTURE LOOKED LIKE. One story rectangularly-shaped house with a front facing low to medium pitch gable and a dropped, off-set low pitch gable addition on the front; side entrance porch under principal roof. <u>STRUCTURAL AND DESIGN ELEMENTS</u>: WALL TREATMENT: stucco. <u>ROOF</u>: composition shingle; undecorated eaves fascia and gableboard. <u>CHIMNEY</u>: none. <u>WINDOWS</u>: metal sliders with security bars. <u>DOOR</u>: side entrance, door covered with security bars. <u>PORCH</u>: partial side porch under principal roof with a second smaller side porch off front addition; porch supports consist of 4 square 4 by 4 posts with simple molded base and capital; 3'high open vertical board railing system; same decorative open-slat system (on a smaller scale) used along top of porch; tops of columns rest on bottom of this element; knee braces are spindle-work, 3/4 wheels; 2 cement steps to porch.

Associated out structures, garden lattice work, large wood planter boxes, and brick walk-way are likely recent additions.

| 12. | condition: | Excellent | 10-10-10-10-10-10-10-10-10-10-10-10-10-1 | Good | <u> </u> | air | Deteriorate | i | No : | longer | in | existence | ange Thiring Igna |
|---|---|---|--|---|---|---|---|---|---|---|---|---|---|
| 14. | Alterations | : <u>associ</u> a | ated out | t str | ructures | ; window | replacement; | garden | ;sid | ing; r | oof | | |

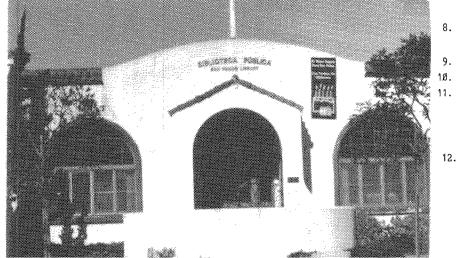
One story rectangularly shaped, flat roof library building. Symmetrical front facade with arched front focal windows on either side of a recessed, central entry. Plain in overall appearance. <u>STRUCTURAL AND DESIGN ELEMENTS</u>: WALL TREATMENT: stucco with sets of 3 tiles placed at corners at top of wall extension; small vertically shaped vents centered above each window. <u>ROOF</u>: flat with slightly parpated walls and gentle curve at centers; roof tile slopes from roof at either side of curved parapet; wall corners extend above roof line and are blocked and stucco capped (identical to chimney). <u>CHIMNEY</u>: exterior, side; stucco, blocked with thin stucco cap; no extending chimney vents or decorative emblishments. <u>WINDOWS</u>: 2 inset, front facing focal windows; semi-elliptical arches with stucco band surrounding trim; top half is small multi-light (19), bottom contains 4 vertical casement windows; side windows are smaller but contain some theme. <u>DOOR</u>: front facing, ressessed; semif-glazed with large single pane on top 2/3's; similar side lights. <u>PORCH</u>: centered entry porch with dropped medium pitch tiled roof; arched, stuccoed entry; low stucco wall has been added to fron to enclose entry way (originally entry was open with 3 front facing cement stairs to door).

Final clarification of the title to the library building was achieved as a result of a title suit against the San Ysidro Irrigation District by the County of San Diego. The county's title to the building was finalized on May 22, 1957. In 1983, the library was closed for remodeling and expansion, including the addition of an atrium. However, the exterior of the original structure was only slightly altered (see attached 1924 and 1989 photographs).

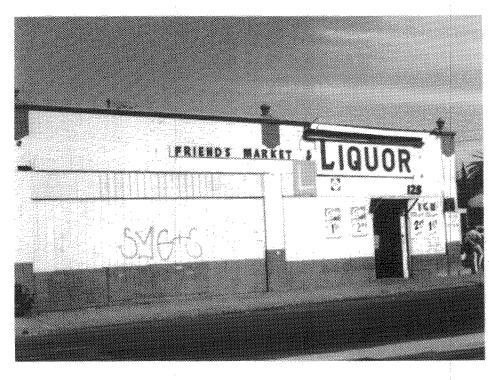
One story rectangular shaped building now used for commercial purposes. Appears to have been a garage. Structural details include flat roof, stucco over brick siding, wide garage entry, front windows and garage entry now boarded up with flush siding. Building has molded "Moorish" design knob-like elements spaced along roof with corresponding shield on wall face below each design elements.

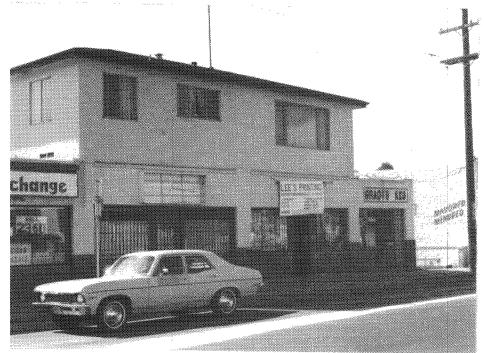
Long rectangularly shaped one story painted brick building; asymmetrical front facade. Design elements include: flat roof (no parapets or coping), 5 brick pilasters with plain caps along front (serving as corner blocks and store divisions), glazed tile skirting along front facade, inset windows (plate glass covered with security bars) and partially glazed entry door.

2nd story has been added over the center half of the building.

| 13. | . Condition: Excellent Good Fair _x Deteriorated No longer in existence |
|---|---|
| 14. | Alterations:2nd floor addition; window replacements |

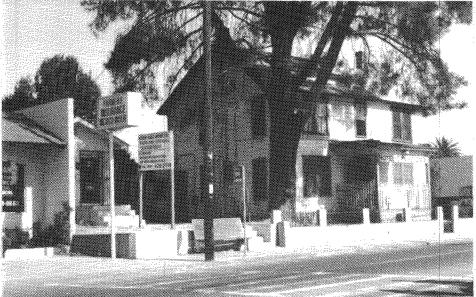
Two story rectangularly shaped structure with medium pitch side gable roof and a dropped single story flat roof over centered partial porch. Symmetrical front facade. <u>STRUCTURAL AND</u> <u>DESIGN ELEMENTS</u>: <u>WALL TREATMENT</u>: vertical board siding. <u>ROOF</u>: composition shingles; plain eaves fascia and gableboard; slight overhang (roof collapsing). <u>CHIMNEY</u>: 2, one on each side (interior) brick with brick cap. <u>WINDOWS</u>: all front windows are narrow, vertical; 2nd story- 2 sets of double hung multi paned at each side; center is single double hung; plain board surround (added). 1st floor: set of double hung multi-glazed on each side of door (directly below 2nd story windows), plain board surround with narrow classical molded lintel (added). Rear windows same- some boarded up. <u>DOOR</u>: front center. <u>PORCH</u>: front, centered, partial porch with flat roof; 2 simple stick supports resting on wood porch (enclosure to ground level added); picket fence railing system; side entrance steps to porch (added). THIS IS THE OLDEST STRUCTURE IN THE SAN YSIDRO STUDY AREA; PRE-DATES 1909 LITTLE LANDERS SETTLEMENT

| 13. Condition: Excellent Good Fair Deteriorated _x No longer in existence |

Pictorial evidence of the structure suggests that although the exterior is deteriorated and in need of immediate care, the facade of the Hotel has changed little since 1909. The only known historic photograph shows the building alone, facing the railroad tracks. The structure represents San Ysidro's rural past; over time, infilling as occurred has the commercial strip of San Ysidro Blvd developed in response to the growing population of the town. Immediate stabilization or restoration of this structure is highly recommended.

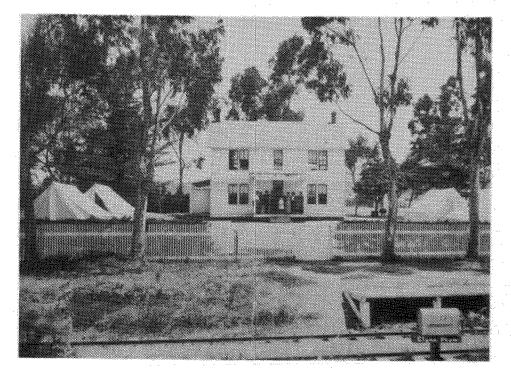
HISTORIC PHOTO; NOTE ALTERATIONS IN MODERN PHOTO

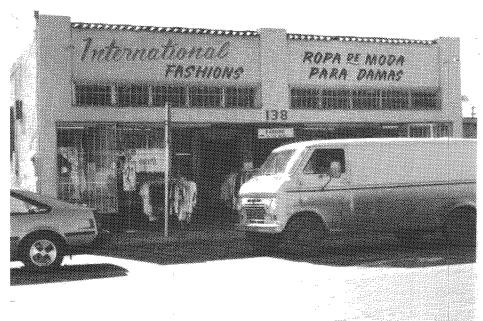
One and a-half story commercial building with flat roof and tile coping along roof. Entry door set slightly to the left giving the building an asymmetrical front facade. <u>STRUCTURAL AND DESIGN ELEMENTS</u>: WALL TREATMENT: stucco; corner and central block pilaster; relief with no caps extends several inches above roof line center block extends from roof to 1st story ceiling line. <u>ROOF</u>: can not see covering; tile copping along front of the building. <u>CHIMNEY</u>: none. <u>WINDOWS</u>: set of 5 rectangularly fixed, inset windows above 1st floor covered with security bars; no surrounding trim; front 1st floor windows at side edge and inset under principal wall; large plate glass covered with security bars. <u>DOOR</u>: double hung multi-paned off set to left of center.

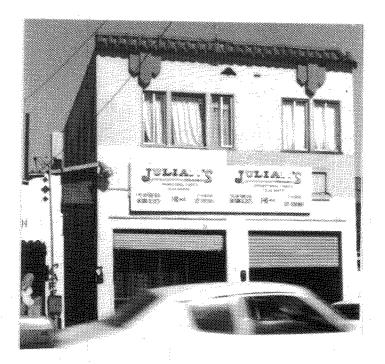
Simple two story rectangularly shaped stucco building (short side, street facing) with flat roof. <u>STRUCTURAL AND DESIGN ELEMENTS</u>: <u>WALL TREATMENT</u>: stucco; several circular vents below roof line; small centered front facing drain surrounded by small stucco arch; 2 sets of 3 molded arrow shaped elements on front wall immediately below coping. <u>ROOF</u>: flat with angled tile coping along roofline. <u>CHIMNEY</u>: none. <u>WINDOWS</u>: 2nd floor- front facing 2 sets; to left is a rectangular fixed window with 2 thin vertical slider side lights. Windows to right are 2 vertical sliders. 1st floor street frontage- inset, large plate glass, subtle stucco relief frames square store front openings (possible long narrow expanse of windows between floors- now boarded up). <u>DOORS</u>: inset under front wall. <u>PORCHES</u>: none.

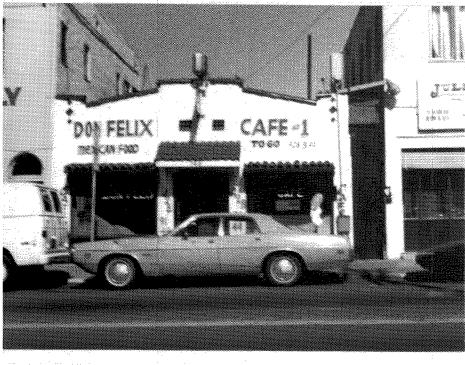
Single story rectangular shaped commercial building with a flat roof having a slight angular parapet stepped and tile coping. <u>STRUCTURAL AND DESIGN ELEMENTS</u>: <u>WALL TREATMENT</u>: stucco; 3 diamond tiles placed vertically at either corner; 2 sets of 6 small circular drains boxed at center front. <u>ROOF</u>: flat roof (can not see covering); stucco and tile bracketed shed roof over entry. <u>CHIMNEY</u>: none. <u>WINDOWS</u>: 2 front inset fixed windows; tiled hoods over windows. <u>DOOR</u>:centered, glazed, front facing. <u>PORCH</u>: none.

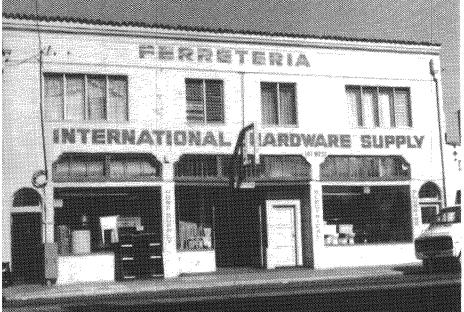
Two story rectangular stucco commercial building with molded coping and tile along flat roof line and 3- 1 story flattened arches along front. Symmetrical front facade. <u>STRUCTURAL AND DESIGN</u> <u>ELEMENTS</u>: <u>WALL TREATMENT</u>: combination stucco over brick and plain brick side wall. <u>ROOF</u>: flat roof line (can not see covering); tile coping along front; drains along either side of building. <u>CHIMNEY</u>: none. <u>WINDOWS</u>: original second story- inset multi-paned casement windows have been replaced with metal sliders, louvers and fixed windows. <u>DOOR</u>: 1st floor consists of partially glazed doors with fan lights at each end of building and 3 arched areas evenly spaced between the doors; top of arches have fixed multi-light panes; plate glass below. Main entry door inset front facing under front wall; glazed. <u>PORCH</u>: none.

| 13. Condition: Excellent Good Fair _x Deteriorated No longer in existence |

In addition to its importance as a Gill designed structure (one of two remaining in San Ysidro), the Commercial Company, located in what by 1927 was becoming the tightly grouped commercial core of San Ysidro, symbolizes the expanding economic needs of the community. Restoration of this structure to its 1927 form is highly recommended.

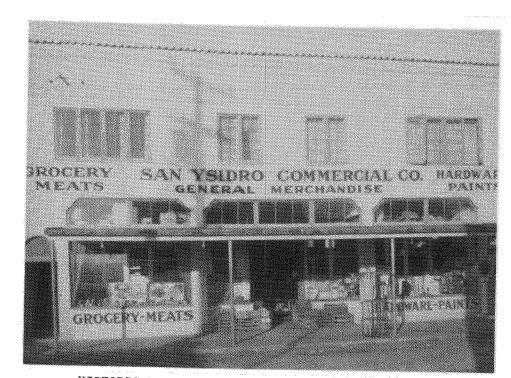
HISTORIC PHOTO- NOTE ALTERATIONS IN MODERN PHOTO

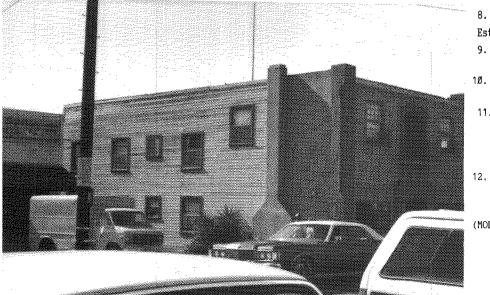
Large two story rectangularly shaped building, flat roof, originally used as a hotel; currently used as shops and apartments. Front facade has been entirely redone with a Spanish motif. Symmetrical front facade. <u>STRUCTURAL AND DESIGN ELEMENTS</u>: <u>WALL TREATMENT</u>: stucco front, narrow irregular length channel siding along sides; large stucco corner blocks with slight angular relief extend slightly beyond roof line; concrete block skirt along bottom 2 1/2' of front. <u>ROOF</u>: flat, can not see covering; no eaves; front facade roof line slants in toward roof top (shed-like appearance), tile covered. Side roofline flat with plain board along top. <u>CHIMNEY</u>: side, stucco. <u>WINDOWS</u>: 2nd story front- double hung on either side of balcony, 12 lights on top/ single pane below; inset with narrow board surround; iron grill work railing. 1st floor front- large horizontal plate glass with extremely wide stucco lintel. Side windows- irregularly spaced, all appear to have been replaced. <u>DOOR</u> main door set under front wall with flattened arch entry surrounded by extremely wide flattened arch stucco relief. 2nd story center balcony with grill work railing, massive stucco brace relief; opening into balcony is segmental arch with wide molded arched detail serving as surround (edges of arch flared).

| 13. Condition: Excellent Good Fairx Deteriorated No longer in existence |

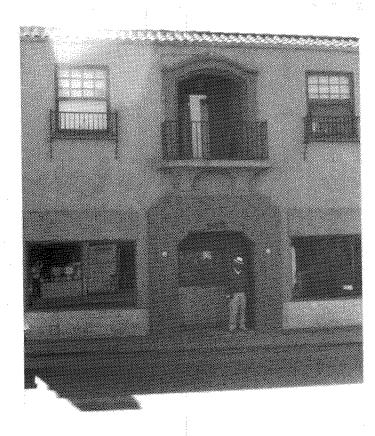
148 SAN YSIDRO 666-370-38 LOT A31 COMMERCIAL SPANISH ECLECTIC

CLOSE OF FRONT- BALCONY/WINDOW TREATMENT

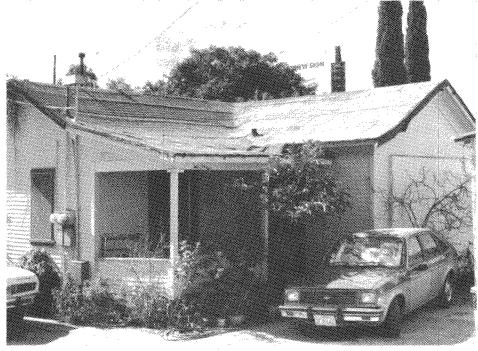
One story "L-shaped" house with medium pitched cross gables and shed extension roof covering inset partial porch. House is set to the rear of San Ysidro frontage buildings. Asymmetrical front facade. <u>STRUCTURAL AND DESIGN ELEMENTS</u>: <u>WALL TREATMENT</u>: lap siding; plain corner boards. <u>ROOF</u>: composition sheeting; moderate overhang; boxed eaves, plain eaves fascia and gableboards (roof appears to be collapsing). <u>CHIMNEY</u>: none. <u>WINDOWS</u>: 2 pane double hung; plain board surround; sill extends slightly beyond window; covered by screens. <u>DOOR</u>: inset in "L"; can not see details. <u>PORCH</u>: extended shed roof over inset porch; solid lap siding railing system; 2 stick column supports with simple molded capital; one step to entry.

13. Condition: Excellent _____ Good _____ Fair _____ Deteriorated __x__ No longer in existence _____

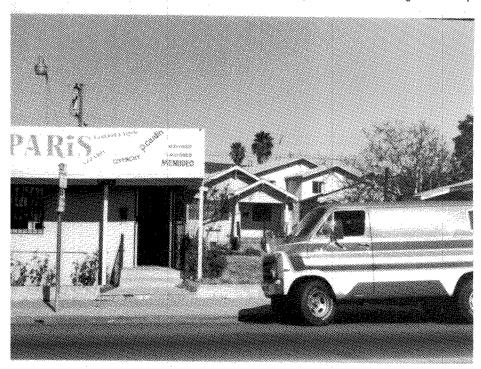
One story bungalow set back off San Ysidro Blvd with a medium pitch front facing gable and a dropped off-set medium pitch gable over 1/2 porch. Asymmetrical front facade. <u>STRUCTURAL</u> <u>AND DESIGN ELEMENTS: WALL TREATMENT</u>: lap siding with shingle siding under main gable; triangularly framed vent under each front facing gable. <u>ROOF</u>: composition sheeting; moderate overhang; plain eaves fascia and gableboard. <u>CHIMNEY</u>: none. <u>WINDOWS</u>: front facing appear to be double hung with surrounding fixed pane; covered with security screens- can not see details from street; plain surrounding board trim. <u>DOOR</u>: left, side entrance under 1/2 off-set porch. <u>PORCH</u>: 1/2 porch, front facing, open; thin tapered wood pillars with plain molded capital sitting on cement porch; 4 front facing cement steps with wrought iron railing system.

| 13. Condition: Excellent Good Fair _x Deteriorated No longer in existence |

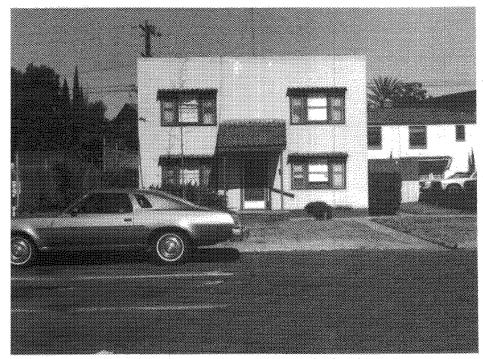
Simple two story apartment building with flat roof; symmetrical front facade. <u>STRUCTURAL</u> <u>AND DESIGN ELEMENTS</u>: <u>WALL TREATMENT</u>: stucco in the front; lap siding in the rear. <u>ROOF</u>: flat, composition sheeting; no coping, parapets or roofline detail. <u>CHIMNEY</u>: none. <u>WINDOWS</u>: front facing, 2nd story 2 evenly spaced sets of single pane double hang with narrow vertical double hung sidelights; plain board surrounding; simple tile hoods over each set. 1st floor- same windows- aligned directly below 2nd floor windows; same hoods. <u>DOOR</u>: centered, front facing, partially glazed with screen covering. <u>PORCH</u>: entry only, open with dropped, wood and tile covered shed roof; 2 stick supports; no railing system; one step to front entry; rear has 2 sets of steps to 2nd floor entry/ wood railing with plywood and metal awning over entry.

| 15. | Condition: | Excellent | Good | Fair | х | Deteriorated | No | longer | in existence | |

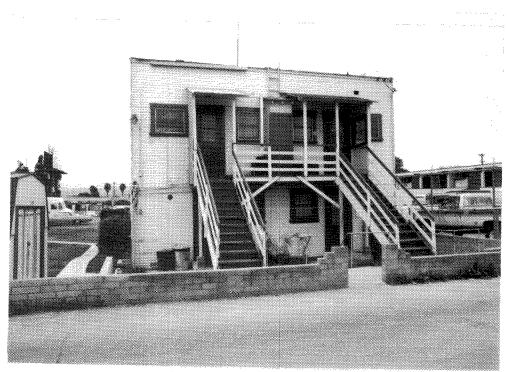
171 SAN YSIDRO

REAR VIEW- VERNACULAR ELEMENTS

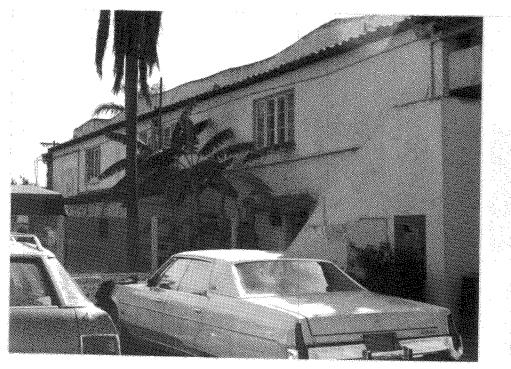
631 EAST SAN YSDIRO EL TOREDOR MOTEL SPANISH ECLECTIC

SIDE VIEW OF FRONT BUILDING

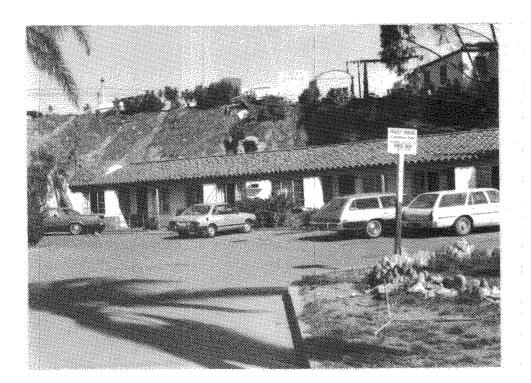
UNITS IN REAR

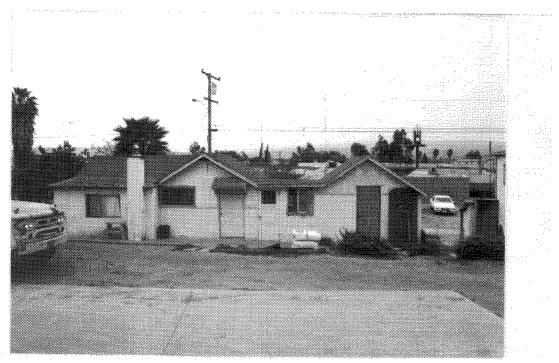
98 SANGER

BACK VIEW (NOTE DIFFERENT ROOF LINES)

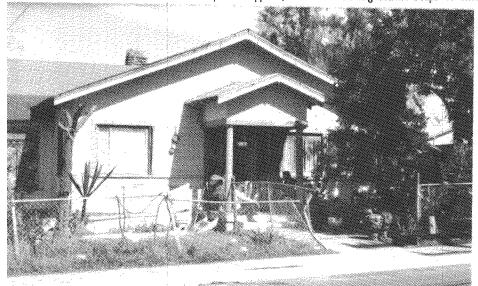
One story cottage with medium pitch cross gables; numerous additions to both the side and rear of the structure; dropped medium pitch gable roof over door entry. Asymmetrical front facade. <u>STRUCTURAL AND DESIGN ELEMENTS</u>: WALL TREATMENT: lap siding. ROOF: composition sheet; exposed rafters; plain undecorated gableboard; at the apex of both front facing gables, a jig-saw design element has been added for accent (keystone). <u>CHIMNEY</u>: cement/cobblestone extending from the current center of the house. <u>WINDOWS</u>: each side of the house has different sash bar arrangements reflecting constant change/alterations to the structure; elements include double hung with transom, double hung with no transom, diamond pane, clear and colored glass; all windows have undecorated plain board trim. The three main front windows (left of the door) are fixed with 4 lights on one side, single pane on other side (Queen Anne element put in sideways); to the right of the door is a set of casement windows with an irregular sash bar division and a set of ribbon windows. <u>DOOR</u>: front center, partially glazed with 4 decorative panels on top/ 4 rectangular wood panels on the bottom. <u>PORCH</u>: front entry porch; open boxed under gable; 2 slender wood doric-like columns serve as porch support; two front facing cement steps to entry.

13. Condition: Excellent _____ Good _____ Fair _____ Deteriorated __x__ No longer in existence _____

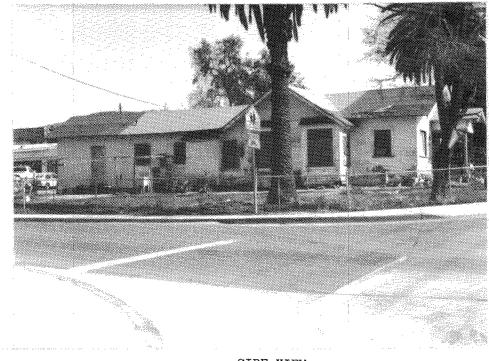
117 SEAWARD

SIDE VIEW
