SAN YSDIRO HISTORIC RESOURCES SURVEY

City of San Diego Planning Department

Roth and Associates 2707 Congress Ave., Suite 2A San Diego, California 92110

14 August 1989

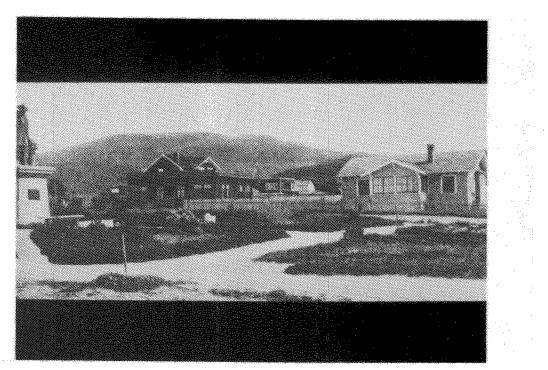
123 SEAWARD

HISTORIC PHOTO NOTE ROOF LINE IN BACKGROUND

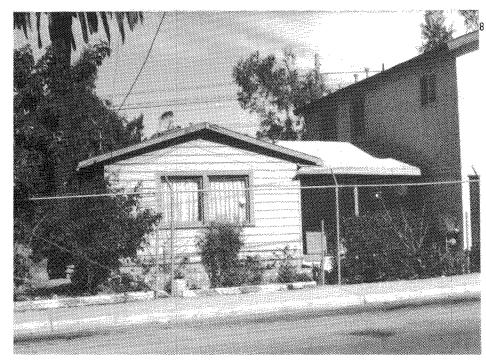
"L-shape", one story structure with low pitch cross gable. Asymmetrical front facade. <u>STRUCTURAL AND DESIGN ELEMENTS</u>: WALL TREATMENT: one story portion of structure has new lap siding with thin corner boards; square metal vent under gable. <u>ROOF</u>: composition shingle with exposed rafters; plain, undecorated gable board. <u>CHIMNEY</u>: none. <u>WINDOWS</u>: front (left) set of 2 single panes in wooden slider with plain board surrounding detail; window in porch is a fixed, single pane. <u>DOOR</u>: side entrance; wrought iron screen obscures door. <u>PORCH</u>: located under principal roof; single 2 by 2 porch support; 1 front facing cement step to entry.

Additions to original structure include modern 2 story stucco apartment (garage with upper apartment). Original structure contains little/no remaining historic integrity.

14. Alterations: _attached 2 story stucco garage/apartment; window replacement; new siding ______

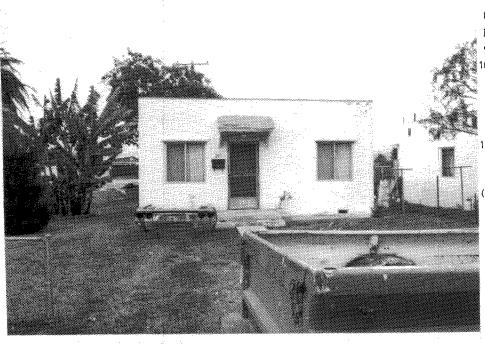
One story bungalow with flat roof; box-like shape with stucco bracketed hood over door. House sits on same lot as 285 Seaward. Asymmetrical front facade (unevenly spaced front windows). <u>STRUCTURAL AND DESIGN ELEMENTS: WALL TREATMENT</u>: white stucco. <u>ROOF</u>: flat, no relief at roof/ wall junction; can not see roof covering. <u>CHIMNEY</u>: none. <u>WINDOWS</u>: 2 front facing metal sliders with thick molded stucco lentils above each. <u>DOOR</u>: front facing, glazed with 8 lights; braced stucco hood over door covered with composition sheeting. <u>PORCH</u>: none; one front facing cement step to stoop area.

| 13. | Condition: Excellent Good Fair _x Deteriorated No longer in existence |

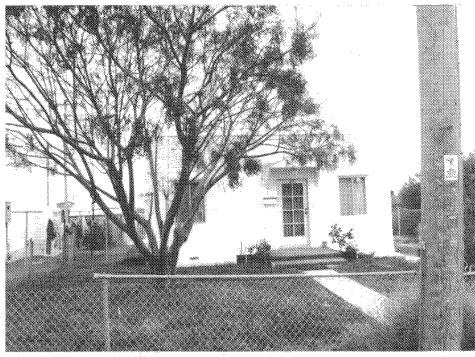
One story bungalow with flat roof, box-like shape with stucco bracketed hood over door. Asymmetrical front facade (2 front windows are not evenly spaced). <u>STRUCTURAL AND DESIGN ELEMENTS</u>: <u>WALL TREATMENT</u>: stucco. <u>ROOF</u>: flat, no relief at roof and wall junction; can not see covering. <u>CHIMNEY</u>: none. <u>WINDOWS</u>: 2 front facing metal sliders with thick molded stucco lentils above each. <u>DOOR</u>: front facing, glazed with 8 lights; braced stucco hood over door. <u>PORCH</u>: none; one front facing cement step to stoop.

| 13. | Condition: Excellent Good Fairx Deteriorated No longer in existence |

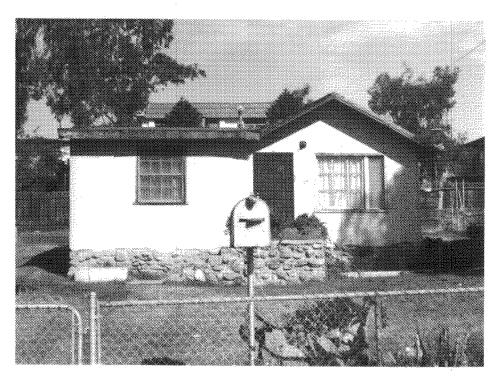
One story house with cross gable (medium pitch front gable; extremely low pitch side gable). Asymmetrical front facade. <u>STRUCTURAL AND DESIGN ELEMENTS</u>: WALL TREATMENT: stucco with decorative cobble/cement skirting along bottom 2' of structure; small horizontal vent under side gable. <u>ROOF</u>: combination wood shingles, composition sheeting and composition shingles; undecorated fascia and gable boards; exposed rafters along one side of building. <u>CHIMNEY</u> : none. <u>WINDOWS</u>: left of door- double hung with 8 lights on top and bottom; right of door- fixed window with 9 lights on top/tall narrow louvered window along right outer edge; plain board surrounding trim; side windows are double hung with same light pattern as front. <u>DOOR</u>: plywood with metal security screen. <u>PORCH</u>: open porch with no roof overhang; side approach with 5 cement steps; low cement/cobble wall accents perimeter of porch.

13. Condition: Excellent _____ Good _____ Fair _x __ Deteriorated _____ No longer in existence _____

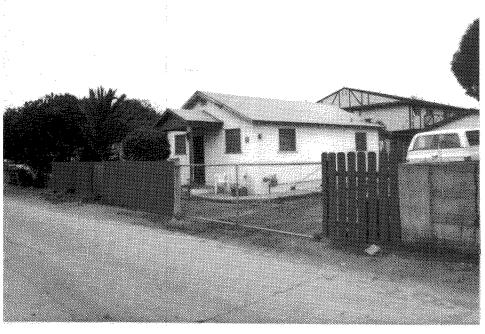
One story bungalow with front facing medium pitch gable and dropped medium pitch porch entry roof. Symmetrical front facade. <u>STRUCTURAL AND DESIGN ELEMENTS</u>: <u>WALL TREATMENT</u>: stucco; horizontal louvered vent under gable (partially boxed). <u>ROOF</u>: composition shingles; exposed rafters; plain undecorated gableboard on both house and porch. <u>CHIMNEY</u>: none. <u>WINDOWS</u>: 2 front inset windows, fixed with 3 horizontal panes; window sill extends slightly beyond opening. <u>DOOR</u>: front facing, unglazed with 3 square wood panels. <u>PORCH</u>: open, entry porch; boxed pediment under porch gable; 2 stick supports; 1 front facing cement step to stoop inset

- 13. Condition: Excellent _____ Good _____ Fair _x __ Deteriorated _____ No longer in existence _____
- 14. Alterations: shed additions in the back
- 15. Surroundings:(check appropriate boxes) Open land _____ Scattered buildings _____ Densely built-up _____ Residential _____ Industrial _____ Commercial _____ Other: ______
- 16. Threats to site: None known ____ Private Development _x Zoning _x Vandalism _____ Public Works Project ____ Other: _____
- 17. Is the structure: On its original site?: _____ Moved? _____ Unknown ? _____
- 18. Related features: detached garage; chain link and open board fencing along perimeter

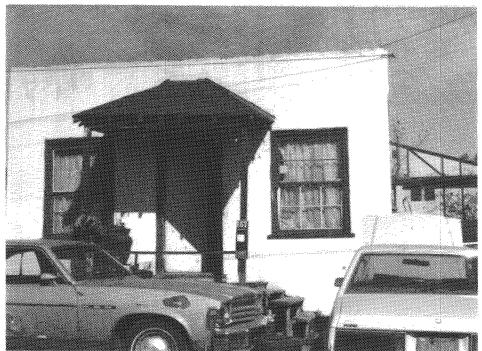
One story bungalow with flat roof; symmetrical facade. <u>STRUCTURAL AND DESIGN ELEMENTS</u>: <u>WALL TREATMENT</u>: white stucco; diamond shaped tile below roof line in a decorative pattern. Initials on tile include "LYJ, CYM<, SYJ". <u>CHIMNEY</u>: none. <u>WINDOWS</u>: double hung windows on either side of door; window to left has 1 double light on top/1 on bottom; other window has 2 horizontal lights on top/ 6 lights on the bottom. <u>DOOR</u>: plywood; undecorated. <u>PORCH</u>: hipped roof over entry porch; porch roof supported with 2 by 2's; roof covered with composition sheet; exposed eaves; 3

| 13. Condition: Excellent Good Fair Deteriorated No longer in existence |
|---|
| 14. Alterations:(cracked foundation; stucco falling off; window repair needed; poor exterior) |

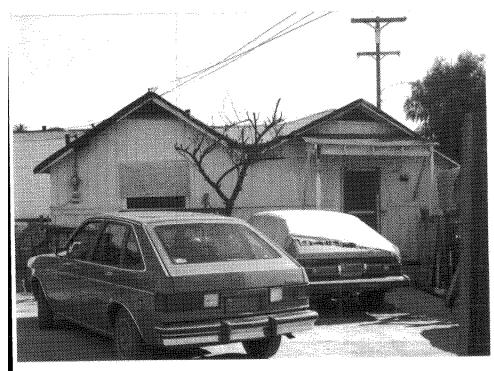
Two-one story structures, each with side facing parallel medium pitched gables. Asymmetrical front facade (door under one gable, window under the other).

STRUCTURAL AND DESIGN ELEMENTS: WALL TREATMENT: vertical flushed siding on one; combination of horizontal and vertical flushed siding on the other; both buildings are sitting on concrete piers; triangular framed vent under gable. <u>ROOF</u>: composition sheeting. <u>CHIMNEY</u>: none. <u>WINDOWS</u>: single double hung. <u>DOOR</u>: can not see. <u>PORCH</u>: no porch; small shed extension over door supported by 2 by 2's; no steps to entry.

| 13. | Condition: Excellent Good Fair Deteriorated _ x No longer in existence |

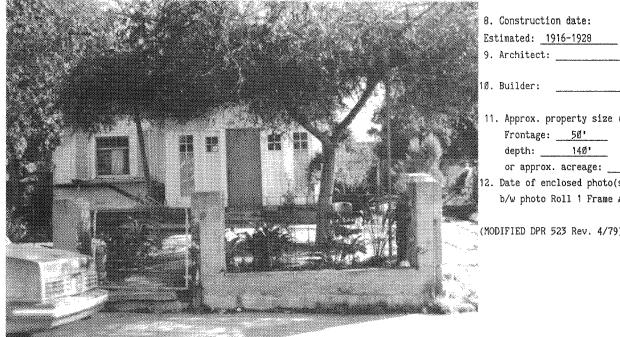
One story bungalow with 2 low pitch front facing gables (one is dropped and off-set from the principal roof. Asymmetrical front facade. STRUCTURAL AND DESIGN ELEMENTS: WALL TREATMENT: lap siding; vertical slat vent, triangularly framed under gables. ROOF: composition sheeting; wide overhang; exposed eaves, plain gableboard; 2 simple beam braces under sides of gable. CHIMNEY: has been removed, was on side of house. WINDOWS: front window- fixed with sash bar of 4 lights along top/ larger pane below; shutters on each side (possible that they cover 2 sidelights); plain surrounding board trim with sills extending slightly beyond window. On either side of front door are 2 narrow, vertical fixed windows with sash bar pattern of 4 square lights on top third/ 2 vertical lights on bottom. DOOR: front facing, plywood (this door and sidelights were added when porch was totally enclosed. PORCH: totally inclosed; 2 front facing steps to door.

| 3. | Condition: | Excellent | | Good |] | Fair | | Deteriorated | x | No | longer in | existence | |

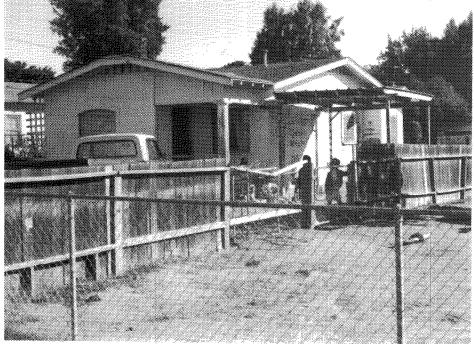
One story bungalow with multiple roof lines including a low pitch front facing hip gable and 2 different sized medium pitch gables along the sides; porch is inset under principal front facing gable; stick trellis extends to right of house. Asymmetrical front facade. <u>STRUCTURAL AND DESIGN ELEMENTS</u>: WALL TREATMENT: lap siding, alternating with thin and wide vertical slats framed as a triangular vent under gables. <u>ROOF</u>: composition shingle; moderate overhang; exposed eaves; plain gableboard. <u>CHIMNEY</u>:exterior side, brick with narrow brick cap. <u>WINDOWS</u>: main front window- large fixed pane with segmental arch, plain surrounding board trim; front facing window at porch rear are square, single pane, fixed with no surrounding detail. <u>DOOR</u>: plywood. <u>PORCH</u>: open, partial inset under principal roof; single wood column with molded base and capital serves as porch support; single horizontal stick serves as railing; 1 side step to porch

| 3. | Condition: | Excellent | Good | Fair | Deteriorated | х | No | longer | in existence | |

14. Alterations: deteriorated detached garage to rear

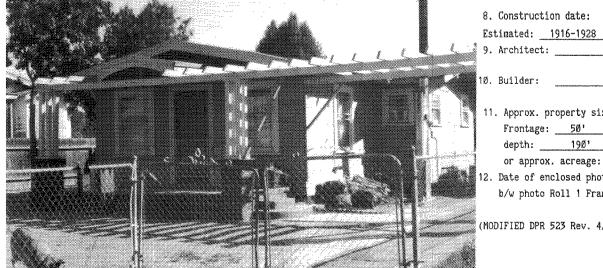
One story "L-shaped" bungalow has a low pitch cross gable roof line with a dropped low pitch front facing gable roof and trellis work over full front porch; a trellised porte cocherre roof extends to the right of the house-giving an asymmetrical front facade. STRUCTURAL AND DESIGN ELEMENTS: WALL TREATMENT: alternate width lap siding; boxed slat vent under gables. ROOF: composition shingles; moderate to wide eave overhang; plain eaves fascia and gableboard on main house; gableboard along porch roof rake is arched. CHIMNEY: side, exterior brick. WINDOWS: 1 window on either side of centered door; doublehung- top pane has 9 light pattern (sash division at edges emphasizes horizontal lines)/single pane below; plain wide surrounding board trim; sill extends slightly beyond opening. Side windows are smaller than front windows but are double hung with same sash pattern and surrounding trim; all windows appear to be original DOOR: center front partially glazed, plain surrounding board trim; screen door. PORCH: full, open front facing porch; porch covering is a centered low pitch front facing gable roof with a trellised roof extending on both sides; roof gableboard is arched and rests on trellis; two brick piers located at each end of porch extend from ground level to approximately 2' above porch level; a third pier is located at the end of the porte cochere; 4 clustered 2 by 2 sits on each pier and connect with trellis; 3 cement side stairs to porch.

- 13. Condition: Excellent _____ Good _____ Fair ___x Deteriorated _____ No longer in existence _____
- 14. Alterations: <u>detached garage converted to apartment</u>
- 15. Surroundings:(check appropriate boxes) Open land _____ Scattered buildings _____ Densely built-up _____ Residential _____ Industrial _____ Commercial _____ Other: ______
- 16. Threats to site: None known ____ Private Development ___ Zoning ___ Vandalism ____ Public Works Project ____ Other: _____
- 17. Is the structure: On its original site?: ____ Moved? ____ Unknown ? _____

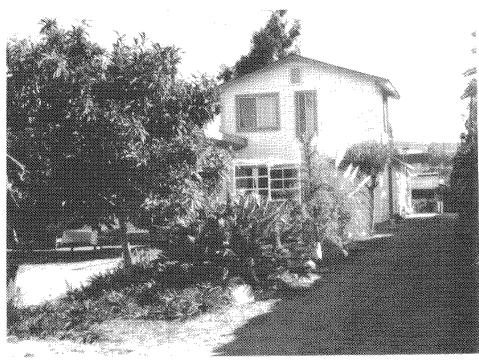
House has undergone so many alterations and additions original style and structural elements difficult if not impossible to determine. Original house was positioned toward the rear of the lot, backing onto Cottonwood. It was a one story cottage with parallel gables. A portion of the original structure has been incorporated into the newer 2 story house; the older portion of the house can not be seen from the street.

| 13. | Condition: | Excellent | Good | Fair | х | Deteriorated | No | longer | in | existence | |

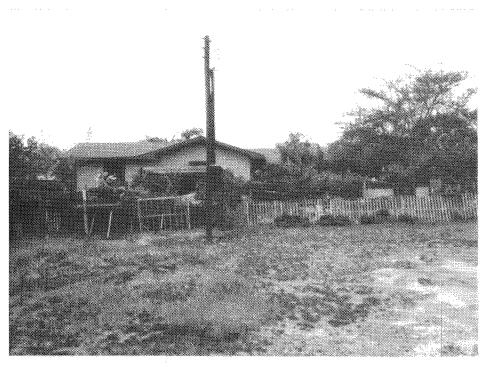
One story "L-shaped" house set back on the lot; house has a low pitch cross gable roof with a shed extension over porch. Asymmetrical front facade. Dense surrounding vegetation and trash made it difficult to describe details. <u>STRUCTURAL AND DESIGN ELEMENTS</u>: <u>WALL TREATMENT</u>: lap siding; moderate overhang; boxed eaves; plain eaves fascia and gableboard. <u>CHIMNEY</u>: none. <u>WINDOWS</u>: casement covered with screens and security bars; can not see detail; plain surrounding board trim. <u>DOOR</u>: can not see; likely inset in "L". <u>PORCH</u>: two cement stairs, wrought iron railing; shed overhang; partial (set into "L").

| 13. Condition: Excellent Good Fair _x Deteriorated No longer in existence |

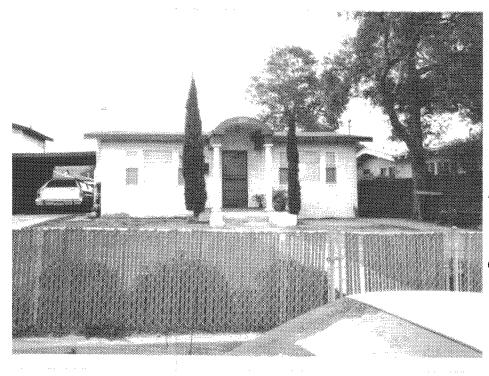
One story house with low pitch side gable roof and extended arched roof over front door. Symmetrical front facade. <u>STRUCTURAL AND DESIGN ELEMENTS</u>: <u>WALL TREATMENT</u>: stucco. <u>ROOF</u>: composition, moderate overhang; boxed eaves; plain eaves fascia and gableboard. <u>CHIMNEY</u>: right side, stucco. <u>WINDOWS</u>: front set on either side of door: center fixed with sash bar pattern of 9 lights in upper 1/3 of each side windows are double hung with 9 lights on top/ 1 on bottom; sash bars emphasize horizontal lines; thin strip surrounding trim. <u>DOOR</u>: center, front; partially glazed; screen obscures pattern. <u>PORCH</u>: open entry porch only; covered by arched roof with curved underside supported by doric columns (porch roof and columns extremely out of proportion with house); 1 front facing step to entry.

- 13. Condition: Excellent _____ Good _____ Fair __x Deteriorated _____ No longer in existence _____
- 14. Alterations: <u>window/door treatment; wall treatment</u>
- 15. Surroundings:(check appropriate boxes) Open land _____ Scattered buildings ____ Densely built-up _____ Residential ____ Industrial _____ Commercial ____ Other: _____
- 16. Threats to site: None known ____ Private Development ___ Zoning ___ Vandalism _____ Public Works Project ____ Other: _____
- 17. Is the structure: On its original site?: _____ Moved? _____ Unknown ? _____
- 18. Related features: carport to left of house; extensive alterations

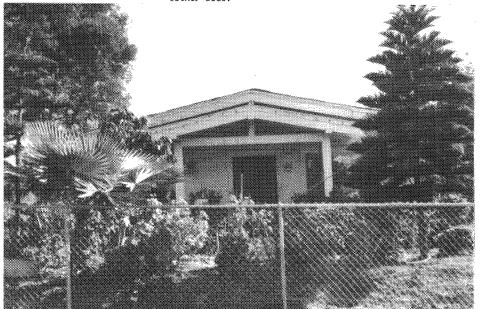
One story bungalow with multiple roof lines including a low pitch front facing gable roof, parallel gables (can not see from street) and a dropped, low pitch front facing gable over full porch. Asymmetrical front facade. <u>STRUCTURAL AND DESIGN ELEMENTS</u>: <u>WALL TREATMENT</u>: shingle skirt with lap siding; decorated corner boards. <u>ROOF</u>: composition shingle; **3** plain beam braces under front porch gable; wide overhang; exposed eaves; plain gableboard. <u>CHINNEY</u>: exterior, side brick. <u>WINDOWS</u>: 1 set to right of door has large center fixed with a 2 light horizontal sash bar pattern; upper light smaller than bottom; long, narrow 2 light double hung window on each side with surrounding plain board trim and molded lentil. <u>DOOR</u>: front, wood with **3** small square lights angularly descending down door; plain surrounding board trim with molded trim at top. <u>PORCH</u>: front, full open porch under gable roof; cross beams and 2 porch supports- simple cut beam; supports sit on brick piers that begin at ground level and continue to slightly above porch floor; **3** front facing cement steps to porch.

House also has side entrance between parallel gables; entry is door with 2 vertical windows on either side.

| 13. Condition: Excellent Good Fair _x Deteriorated No longer in existence |

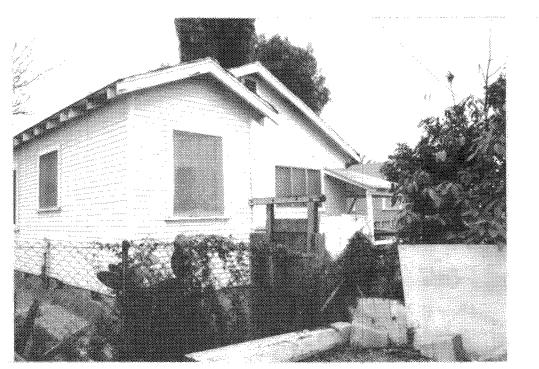
2374 SMYTHE

One story house with medium pitch side facing hip-gable and centered, extended front facing low pitch hip gable roof over entry door. Symmetrical front facade. <u>STRUCTURAL AND DESIGN ELEMENTS</u>: WALL TREATMENT: stucco; boxed, lattice vent under side hip- gable. ROOF: composition shingles; plain eaves fascia and gableboard; moderate overhang; boxed eaves. CHIMNEY: none. WINDOWS: front, evenly spaced on either side of front door; each set is a central fixed with 4 lights on top/ 1 light below; 2 narrow, double hung side lights on either side of central window with 4 lights on top/ 1 on bottom; sill extends beyond window; no surrounding board trim. DOOR: center, front facing; wood covered with screen door. PORCH: none; entry only; extended hip-gable roof with massive stucco supports and lattice work pediment; one side step to cement entry area.

| 13. Condition: Excellent Good Fair Deteriorated No longer in existence |
| 14. Alterations: shed extension in rear; window replacements; converted garage in rear |

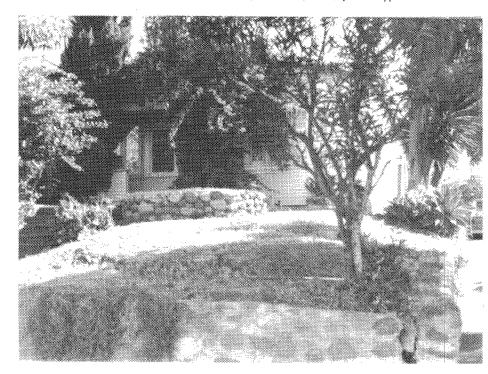
Structure is a one story bungalow with a front facing, low pitch gable roof and a dropped, offset roof over the porch entry. Asymmetrical front facade. <u>STRUCTURAL AND DESIGN ELEMENTS: WALL TREATMENT</u>: lap siding with channel siding under porch gable; small lattice vent under main front facing gable. <u>ROOF</u>: composition shingle; undecorated gableboard. <u>CHIMNEY</u>: none.

<u>WINDOWS</u>: window treatment difficult to observe; main front window has a fixed, single pane with a sash bar pattern of 2 lights on top/ a single pane on the bottom. Two narrow, vertical fixed windows are located on either side of the door (sash bar pattern of 2 lights on top/ 1 on the bottom). Window to the left of the door is fixed (sash bar pattern of 4 lights on top/ 1 on the bottom). Surrounding window treatment consists of plain undecorated board. <u>DOOR</u>: slightly off-set; partially glazed with 4 vertical panes at the top/ 3 wood panels on the bottom; screen door has been added to original configuration. <u>PORCH</u>: semi-enclosed, recessed half porch with lap siding along solid railing system; two cement steps to entry door; porch supports consist of untapered 2 by 2 beams.

13. Condition: Excellent _____ Good ____ Fair _x Deteriorated _____ No longer in existence _____

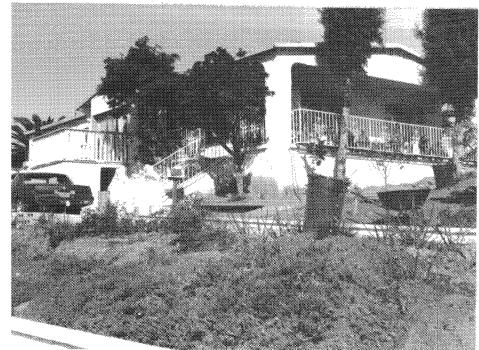
One story rectangularly shaped house located on a large corner lot; house has a low pitch side facing gable with a centered low pitch front, centered gable extension and a wrap around porch. Asymmetrical front facade. <u>STRUCTURAL AND DESIGN ELEMENTS</u>: <u>WALL TREATMENT</u>: stucco; vertical slat pediment under gables; Mexican code-of-arms painted over main focal windows. <u>ROOF</u>: composition sheeting; very slight eave overhang; plain eaves fascia and gableboard. <u>CHIMNEY</u>: back, stucco, double width with 2 squared stucco vents. <u>WINDOWS</u>: side windows are inset, fixed with 4 small lights on top/ large single light below. Other windows include casement and sliders; plain surrounding board trim. <u>DOOR</u>: sliding glass door front center; can not see main door. <u>PORCH</u>: 2 porches: a small front facing, unroofed balcony porch with open wood slat railing and a wrap around porch under principal roof with broad flattened arches; wrought iron railing system; 13 steps to front entry.

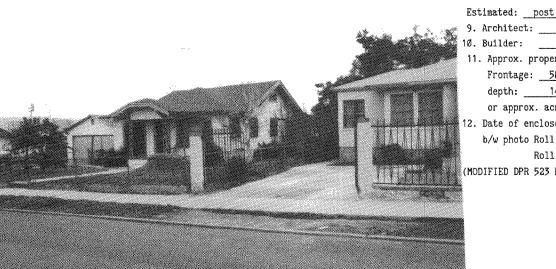
One story cottage with multiple roof types including a medium pitch side gable, a partially hipped, front facing roof and a hip gable roof over a front porch entry. Asymmetrical front facade. STRUCTURAL AND DESIGN ELEMENTS: WALL TREATMENT: stucco over wood; horizontal louvered boxed vent under side gable. ROOF: composition sheeting; exposed eaves; undecorated gableboard; open, triangular knee braces under side and front gables; moderate overhang. CHIMNEY: none. WINDOWS: 3 front facing: main focal window (left of door) is fixed, tall semi-ellipitical with plain surrounding board trim, window right of door is shorter and wider than one to the left of the door (semi-elleptical in shape, fixed pane in middle with 2 narrow fixed side lights arched at corners), window at right front corner is single, narrow double hung; all windows have wide surrounding board trim with attached security bars. DOOR: can't see; covered by security bars. PORCH: totally open, partial stucco under roof; 2 wrought iron lattice-like porch supports; 1 front facing cement step to entry.

| 13. Condition: Excellent Good Fairx Deteriorated No longer in existence |

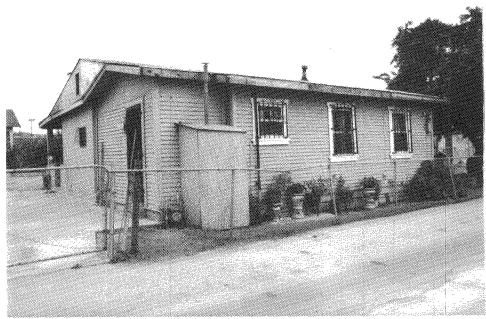
Structure is to the rear of 129 West Park, backs onto Cypress. The older part of this one story structure contains a low pitch side facing gable (an entire new front with higher roofline is currently under construction). <u>STRUCTURAL AND DESIGN ELEMENTS</u>: <u>WALL TREATMENT</u>: lap siding in back; cement block and stucco in front. <u>ROOF</u>: composition shingle; undecorated eaves fascia and gableboard. <u>CHIMNEY</u>: none. <u>WINDOWS</u>: (3 visible) double hung with single light; plain surrounding board trim with lentils slightly flared; sill extends slightly beyond window opening. <u>DOOR</u>: side entry; can not see (covered by security screen); plain surrounding board trim. <u>PORCH</u>: none.

| 13. Condition: Excellent Good Fair _x Deteriorated No longer in existence |

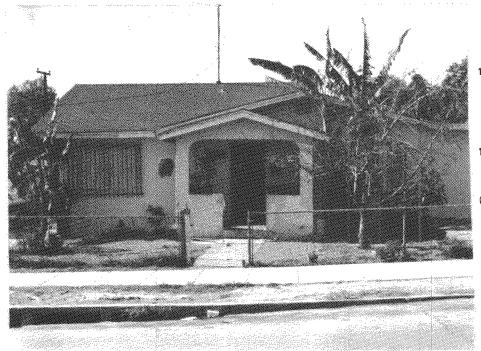
One story structure with low pitch cross gable roof and an off-set, dropped low pitch roof over partial porch; shed roof extension has been added to the right side. Asymmetrical front facade. <u>STRUCTURAL AND DESIGN ELEMENTS</u>: <u>WALL TREATMENT</u>: stucco; cement block foundation; small boxed and silled lattice vent under main gable. <u>ROOF</u>: composition shingles; undecorated eaves fascia and gableboard. <u>CHIMNEY</u>: none. <u>WINDOWS</u>: metal sliders left of the door; vertical double hung with 2 long fixed sidelights; security grill over windows; no surrounding trim. <u>DOOR</u>: can not see, covered with security screen. <u>PORCH</u>: stuccoed partial porch; solid to 3' height, flattened arch opening, low pitch gable roof over porch; 1 cement front facing step to cement porch.

| 13. Condition: Excellent Good Fairx Deteriorated No longer in existence |

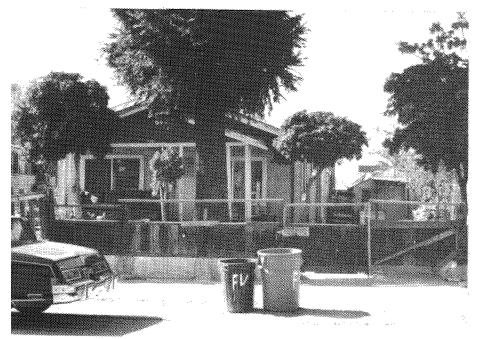
One story cottage with a low pitch front facing gable and dropped, low pitch front facing gable over porch. Symmetrical front facade. <u>STRUCTURAL AND DESIGN ELEMENTS</u>: <u>WALL TREATMENT</u>: lap siding with plain corner boards; slat grill pattern boxed by narrow boards under both gables (only "decorative element"). <u>ROOF</u>: composition shingle; wide eave overhang; undecorated fascia board under gable. <u>CHIMNEY</u>: none. <u>WINDOWS</u>: wide pair on either side of door, sliding glass with plain surrounding board trim. <u>DOORS</u>: plywood with 1 square broken window; plain board trim. <u>PORCH</u>: totally open, full extension; 2 by 2 porch supports (2 clusters of 3).

|)*. Condition: Excellent Good Father Deteriorated x No longer in existence | |

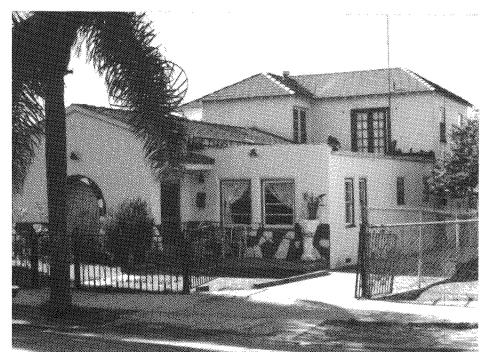
Combination one and two story building with multiple roof planes including: a low pitch, front facing gable, a flat roof, and a hip roof on the rear second story. Asymmetrical front facade. <u>STRUCTURAL AND DESIGN ELEMENTS: WALL TREATMENT</u>: cream stucco with fake rock skirt around bottom 3' of the house's front; clusters of three drains midway below gable and directly under flat roof edge. <u>ROOF</u>: composition shingles with tile along hips and ridge; front of flat roof is slightly parapeted; exposed rafters; no overhang at gable; stucco rake relief. <u>CHIMNEY</u>: none. <u>WINDOWS</u>: inset, fixed parabolic shaped main focal window; rock facade used as wallskirting frames window; other two front facing windows (associated with the flat roof portion of the house) are inset rectangular with fixed panes, sash bar arrangement 4 horizontal lights on one, 2 irregularly spaced horizontal lights on the other. <u>DOOR</u>: offset to side of gable; solid wood. <u>PORCH</u> no porch per se; dropped stucco/tile shed extension over door.

- 13. Condition: Excellent _____ Good _____ Fair _x Deteriorated _____ No longer in existence _____
- 14. Alterations: window/door treatment; multiple roofs; exterior treatment
- 15. Surroundings:(check appropriate boxes) Open land _____ Scattered buildings ____ Densely built-up _____ Residential ____ Industrial _____ Commercial _____ Other: ______
- 16. Threats to site: None known ____ Private Development ___ Zoning ___ Vandalism ____ Public Works Project ____ Other: _____
- 17. Is the structure: On its original site?: _____ Moved? _____ Unknown ? _____
- 18. Related features: wrought iron fence along perimeter

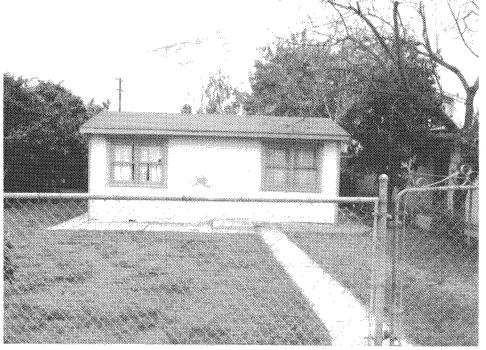
One story structure with low pitch side gable. Currently symmetrical front facade; original door was off-set and front facing. <u>STRUCTURAL AND DESIGN ELEMENTS</u>: <u>MALL TREATMENT</u>: lap siding with plain corner boards; pier foundation, <u>ROOF</u>: very slight overhang; composition sheeting, no exposed rafters; plain, undecorated eaves fascia and gableboard. <u>CHIMNEY</u>: none. <u>WINDOWS</u>: (facing street) 2 pairs of double hung- single light; plain board surrounding trim. <u>DOOR</u>: side door; covered with screen. <u>PORCH</u>: none; 2 wood steps to side door.

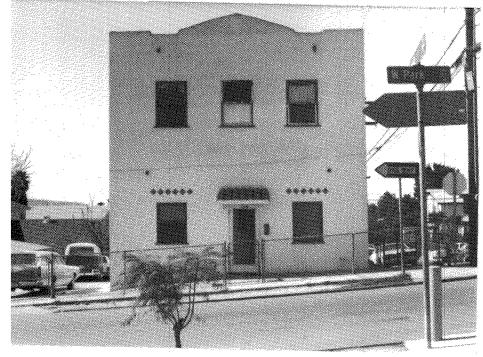
2 story rectangularly shaped, flat roof apartment building. Symmetrical front facade. <u>STRUCTURAL AND DESIGN ELEMENTS</u>: <u>WALL TREATMENT</u>: white stucco with 6 diamond-shaped tiles aligned above each of the bottom 2 windows; 4 circular drains at 2nd floor line and below roof. <u>ROOF</u>: flat with slight parapet at corners and higher low pitch triangular central parapet. <u>CHIMNEY</u>: none. <u>WINDOWS</u>: (3 on 2nd floor, 2 on 1st floor, 1 on each side of door) inset double hung with single pane; wood sills extend slightly beyond window opening; awnings over side windows. <u>DOOR</u>: center, front facing partially glazed with 1 rectangular pane on top/ 1 inset wood panel on the bottom; doors covered with screening. <u>PORCH</u>: none; tile and stucco bracketed hoods over each door.

| 13. Condition: Excellent Good Fair _x Deteriorated No longer in existence |
