INDIVIDUAL WATER QUALITY ASSESSMENT REPORT

Siempre Viva and Bristow Channels

Maps 126 and 127

March 21, 2017; Revised April 28, 2017

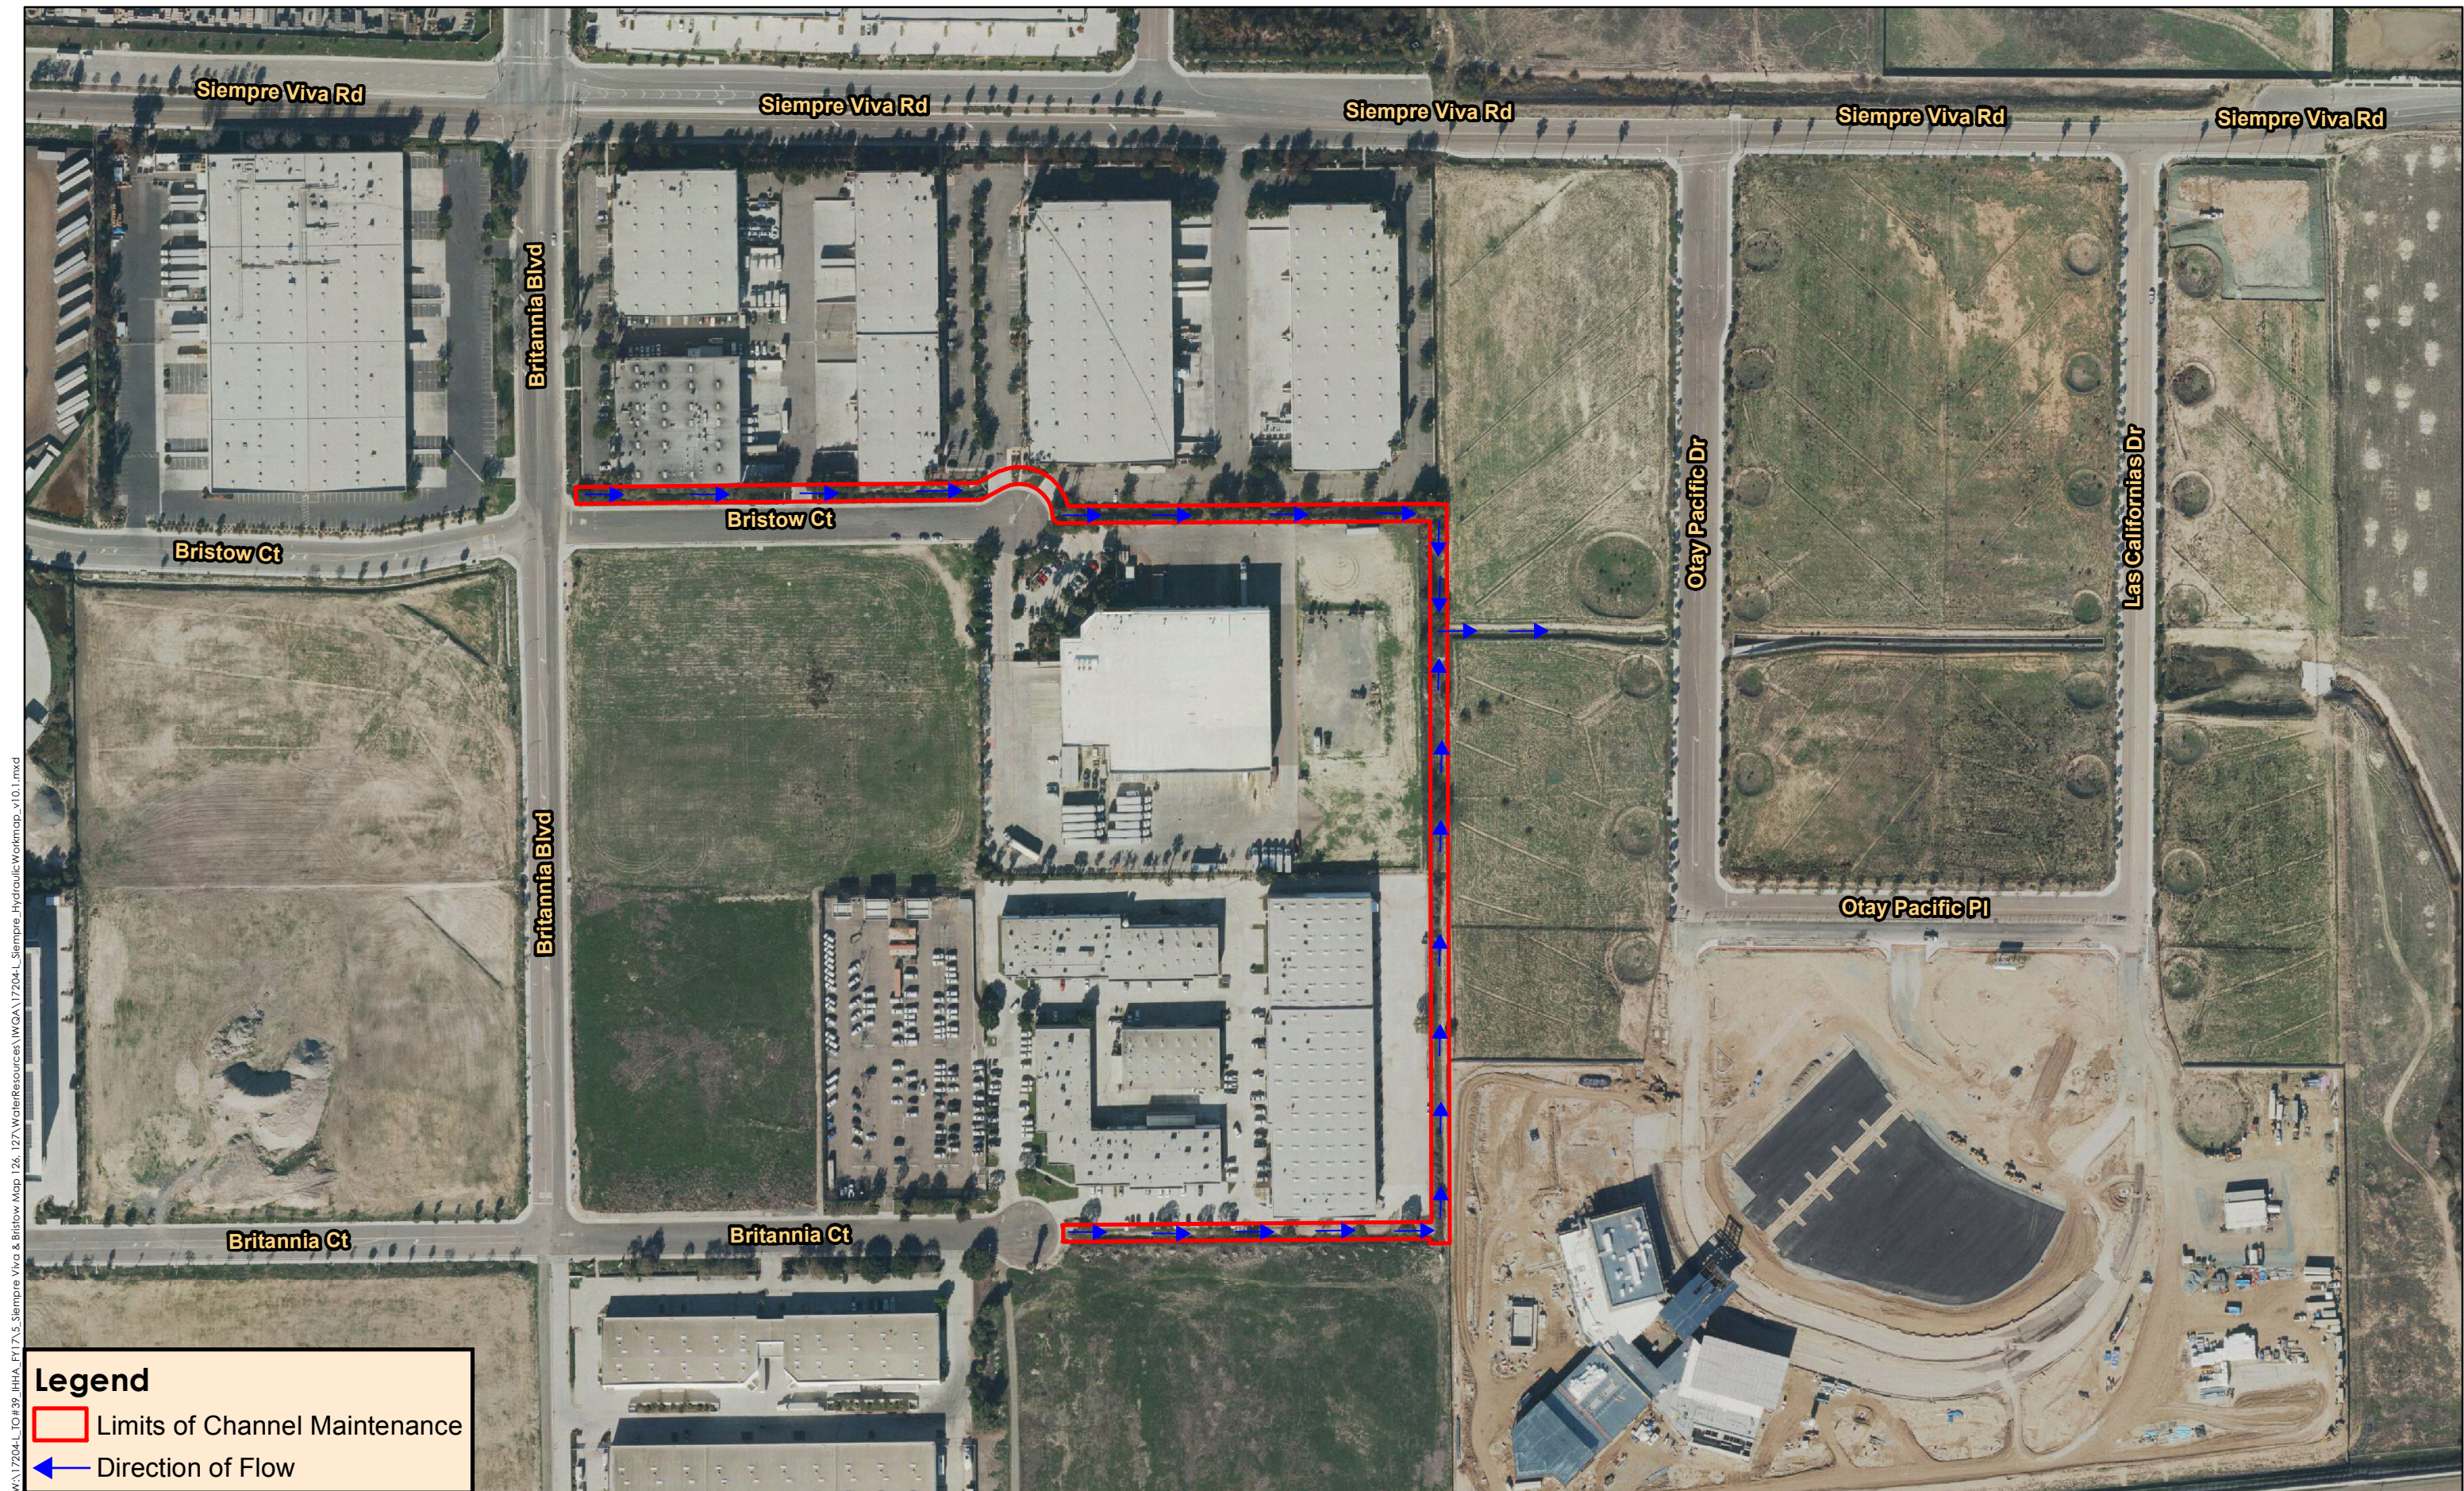
Figure 3 - IWQA Limits of Channel Maintenance for Siempre Viva and Bristow Channels MMP Maps 126 and 127

Pursuant to the MMP, the Individual Hydrologic and Hydraulic Assessment (IHHA) recommends the limits and amount of maintenance for each channel. The IHHA Report for Siempre Viva and Bristow Channels consists of three reaches (Reach 1, 2, and 3). Pursuant to the IHHA, it should be noted that all reaches (Reach 1, Reach 2, and Reach 3) are proposed for maintenance.
