# HARBOR DRIVE SEGMENT BAYSHORE BIKEWAY

PARKING,  
TRAIL LAYOUT,  
AND URBAN  
DESIGN FEATURES

Unified Port  
of San Diego

December 2011

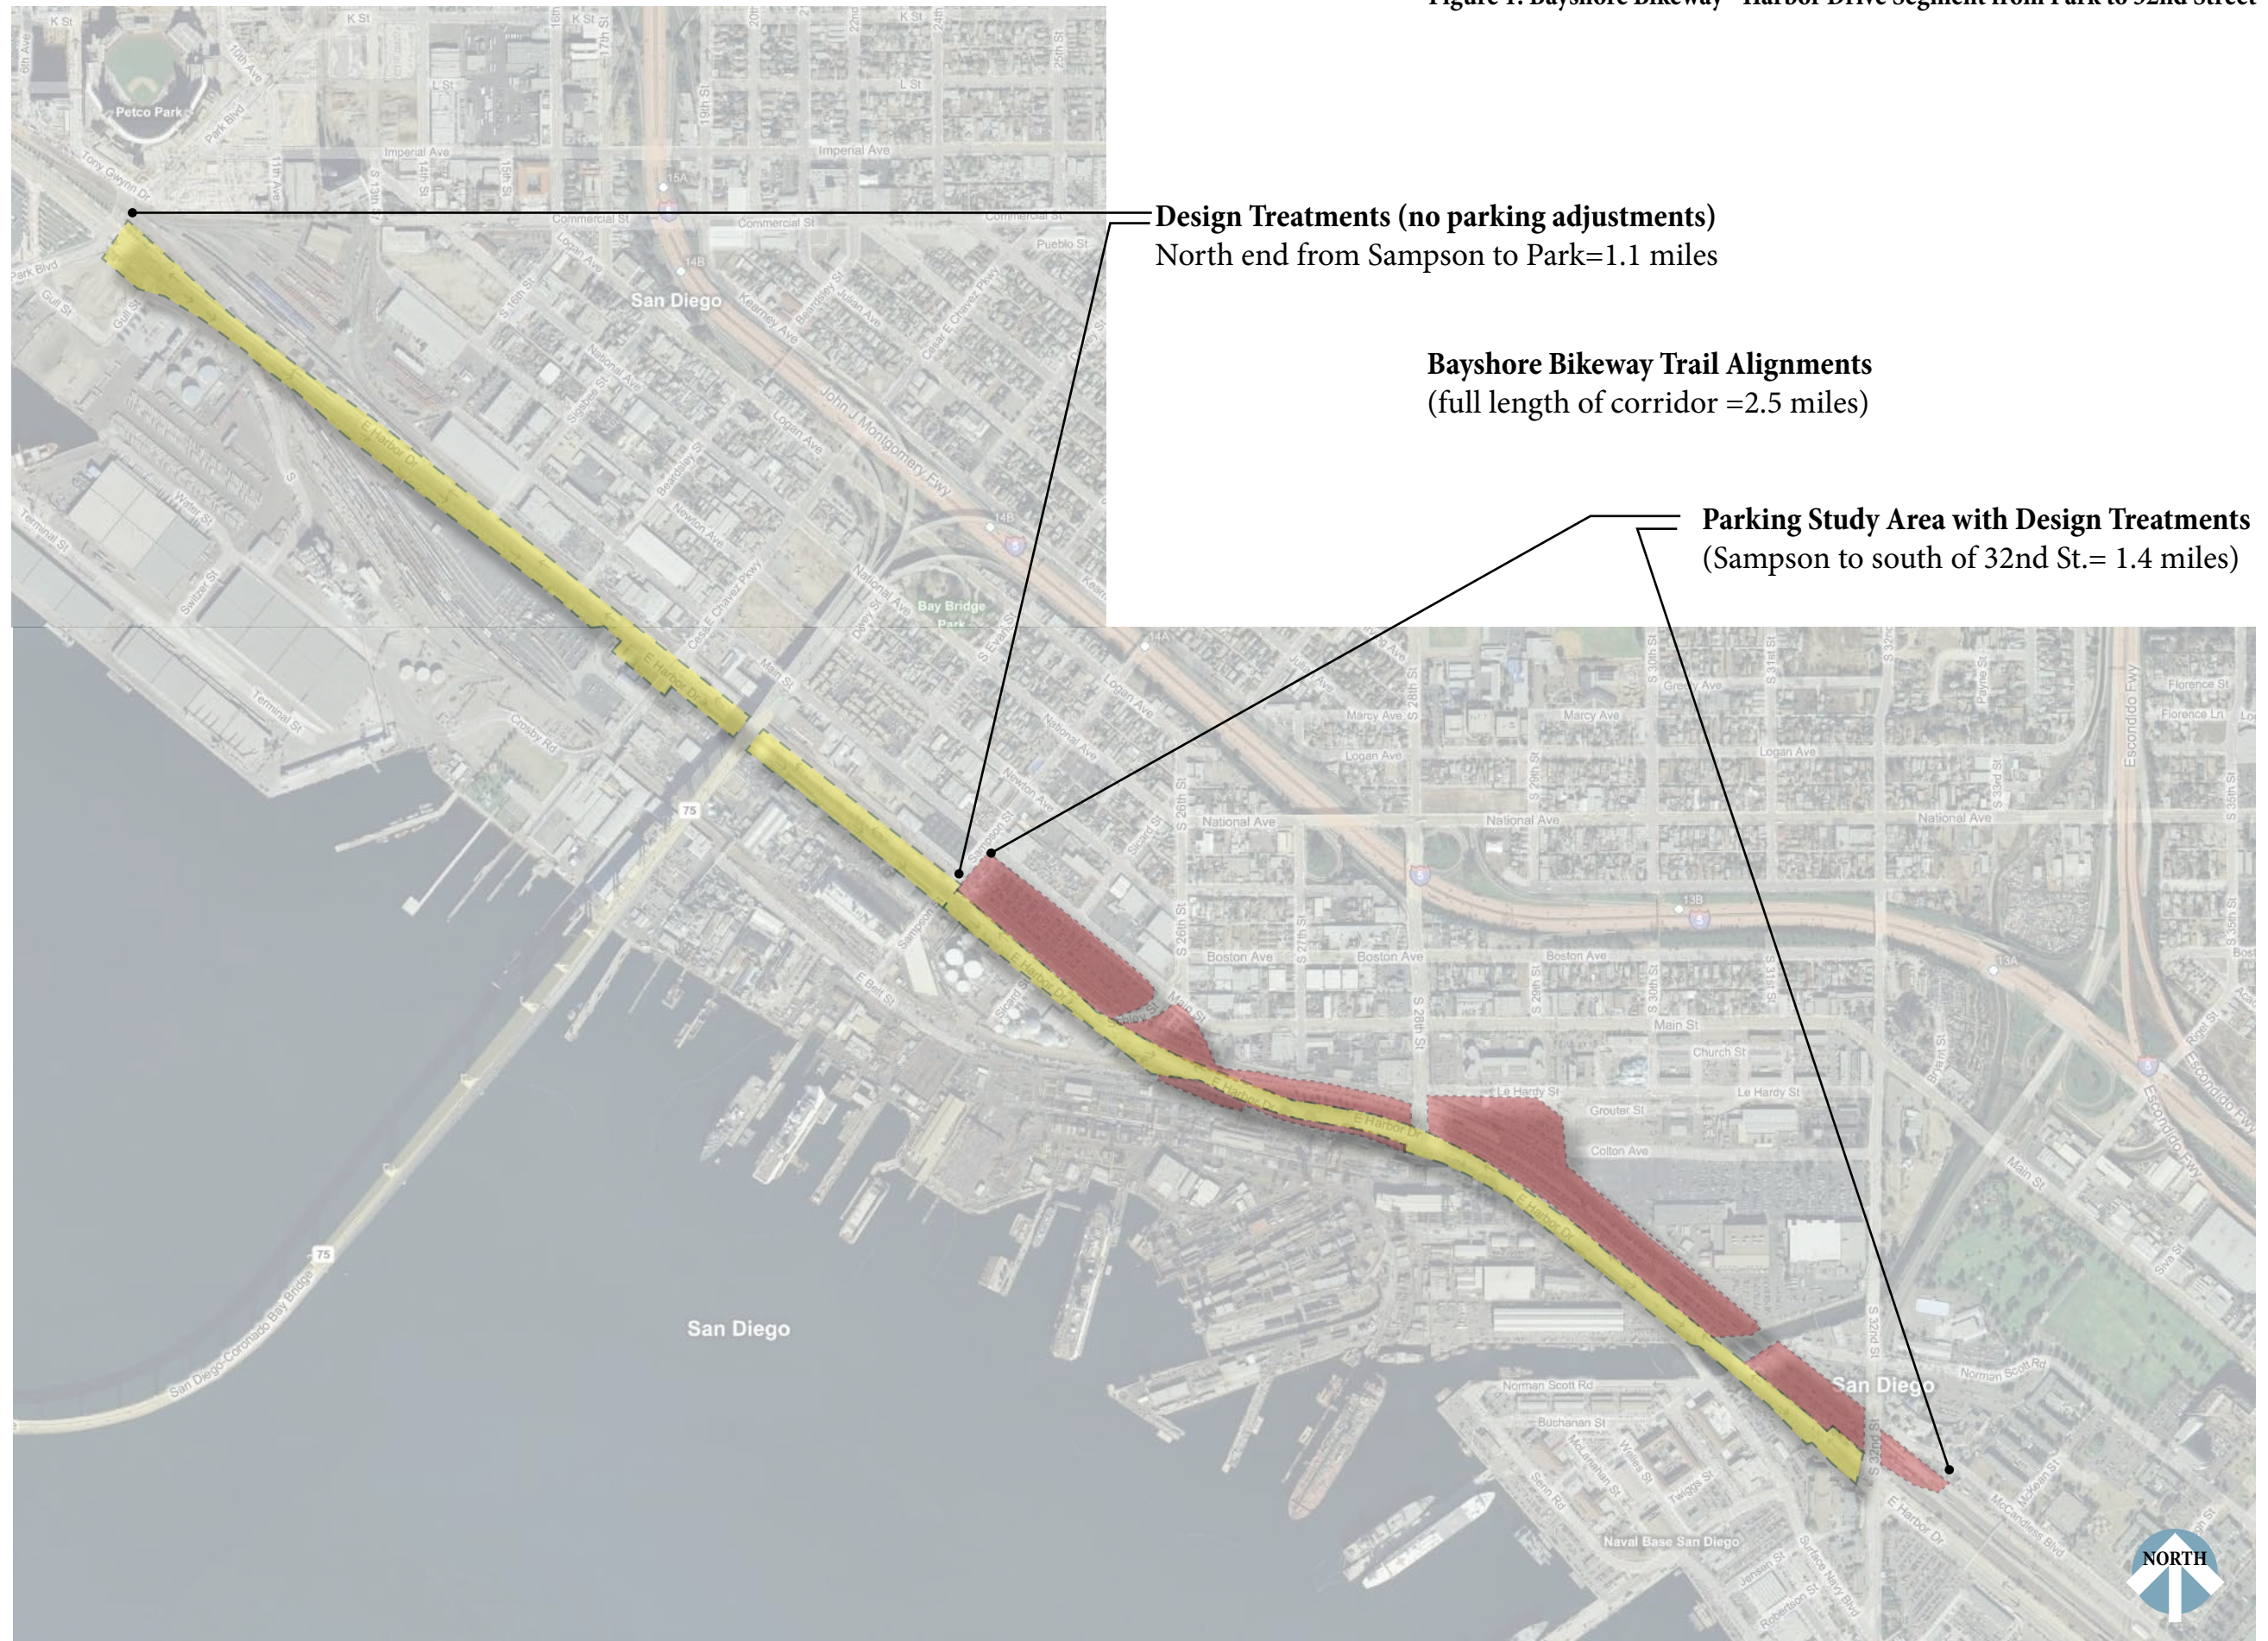
Figure 1: Bayshore Bikeway - Harbor Drive Segment from Park to 32nd Street

Figure 1 shows the study limits of the project. The study area includes all public rights of way along Harbor Drive, from just slightly south of 32nd Street, northwesterly to Park Boulevard, slightly passed the new pedestrian bridge in downtown San Diego. The study area length is approximately 2.5 miles in length.

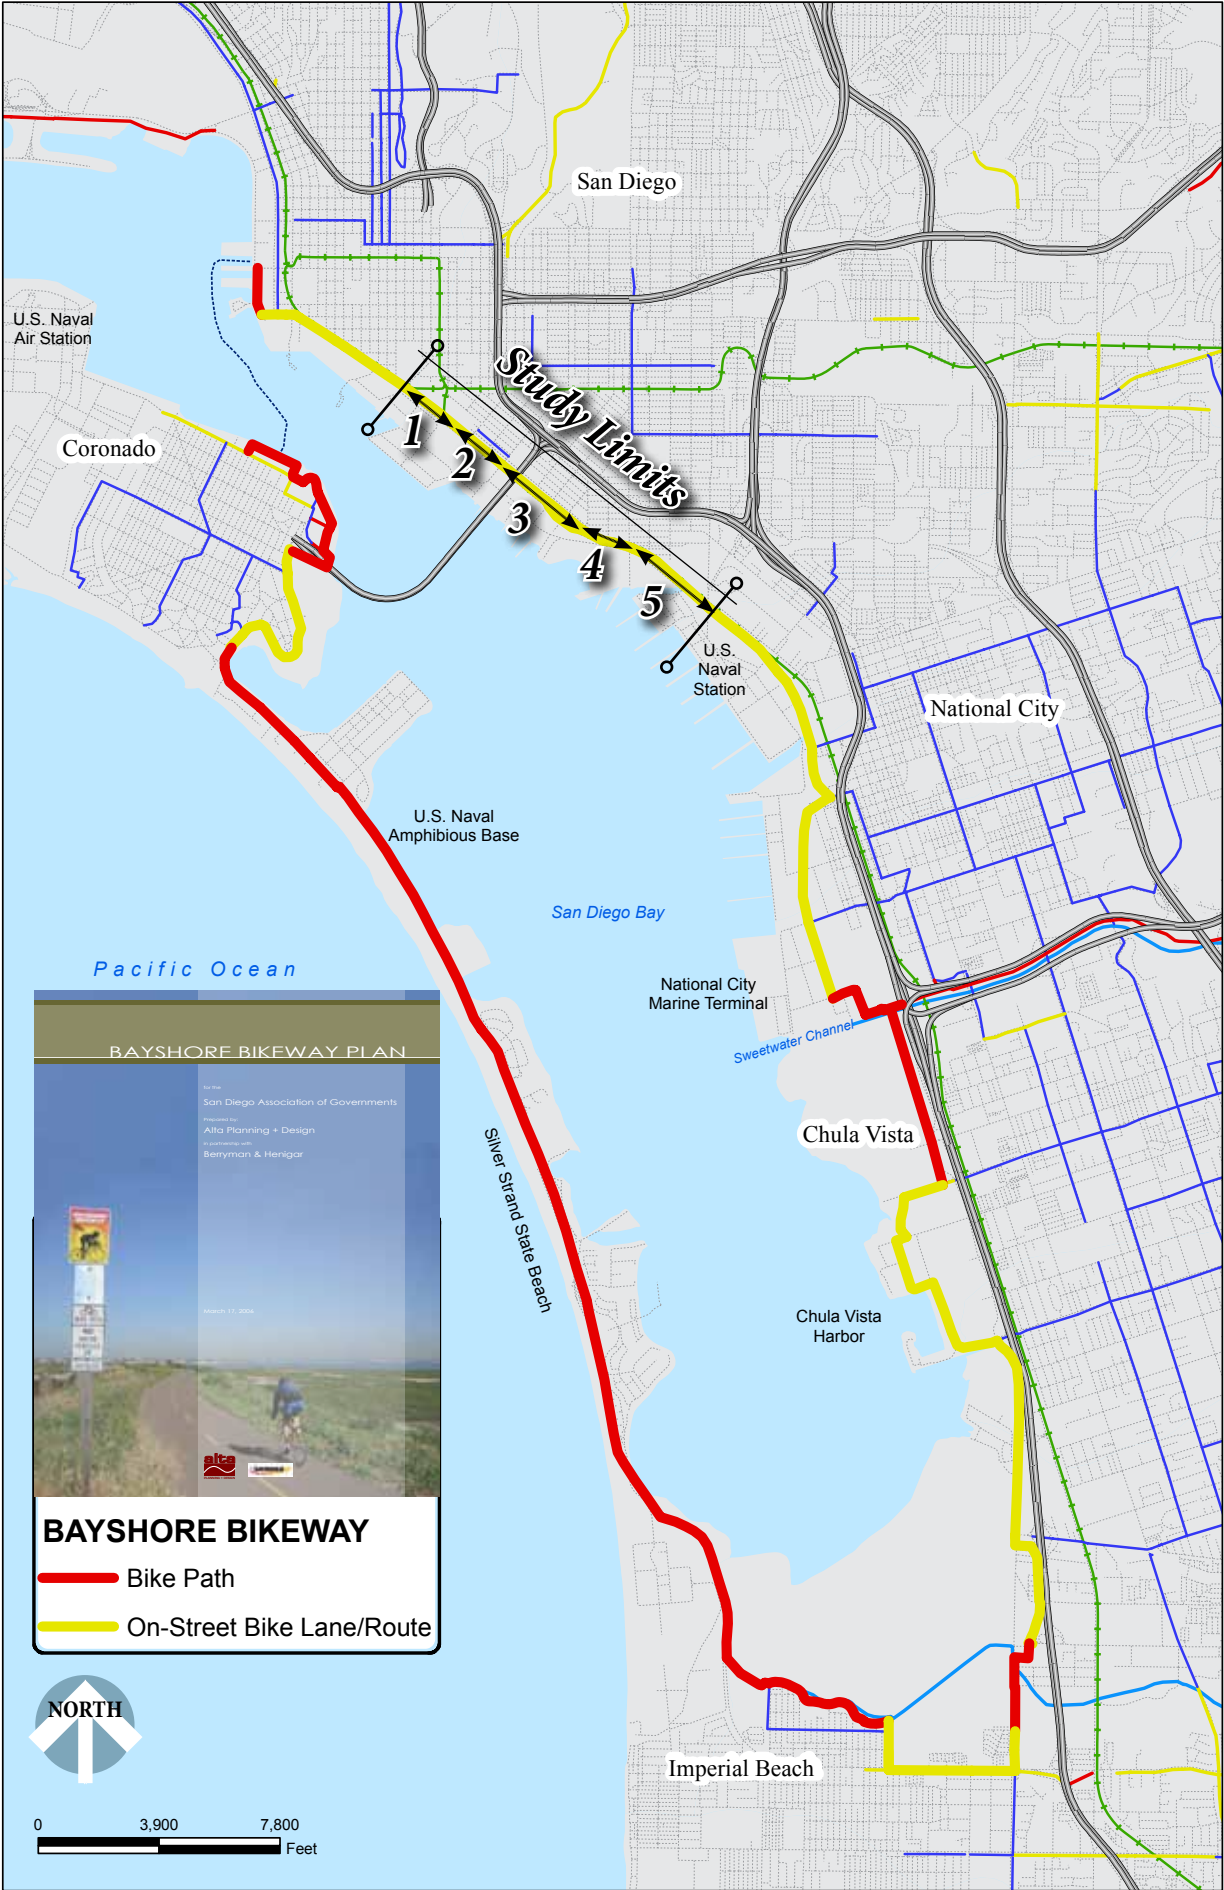
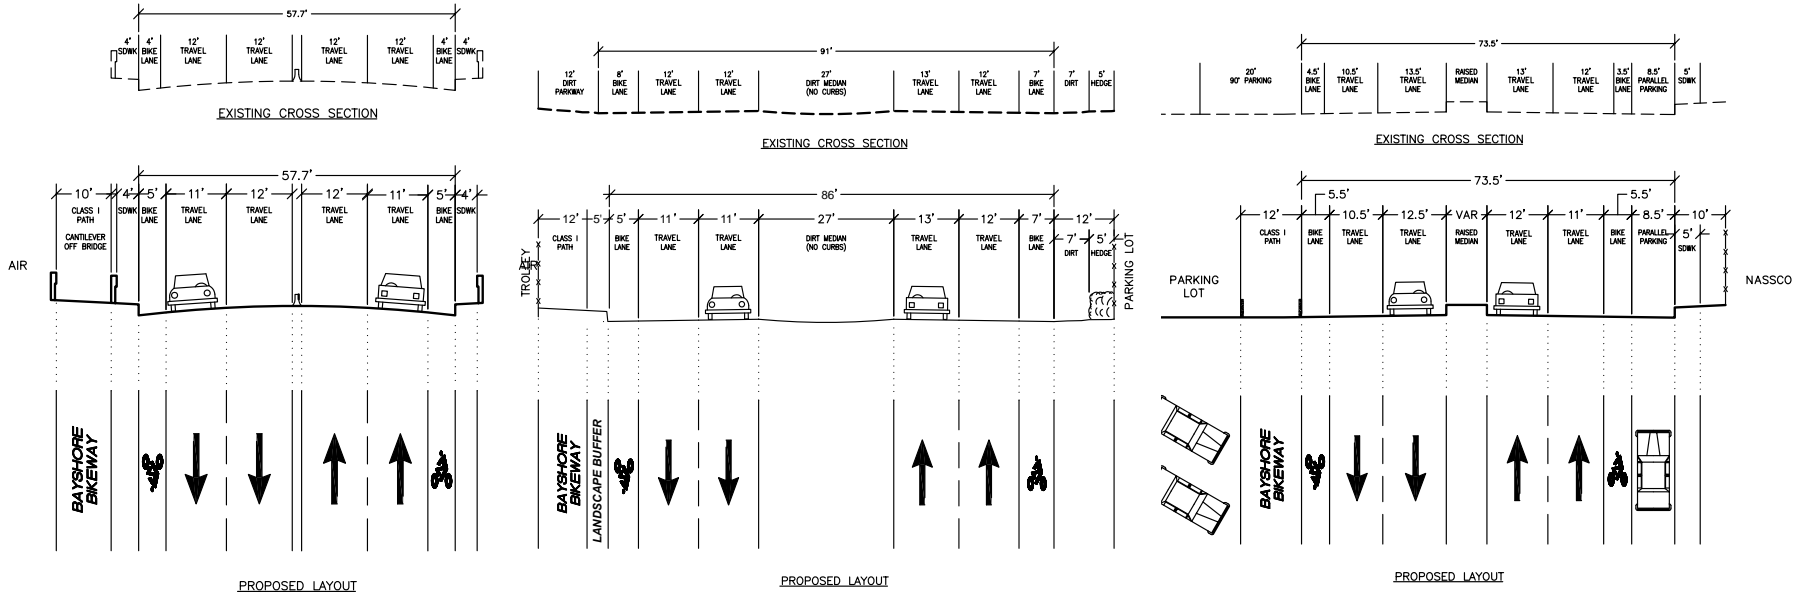
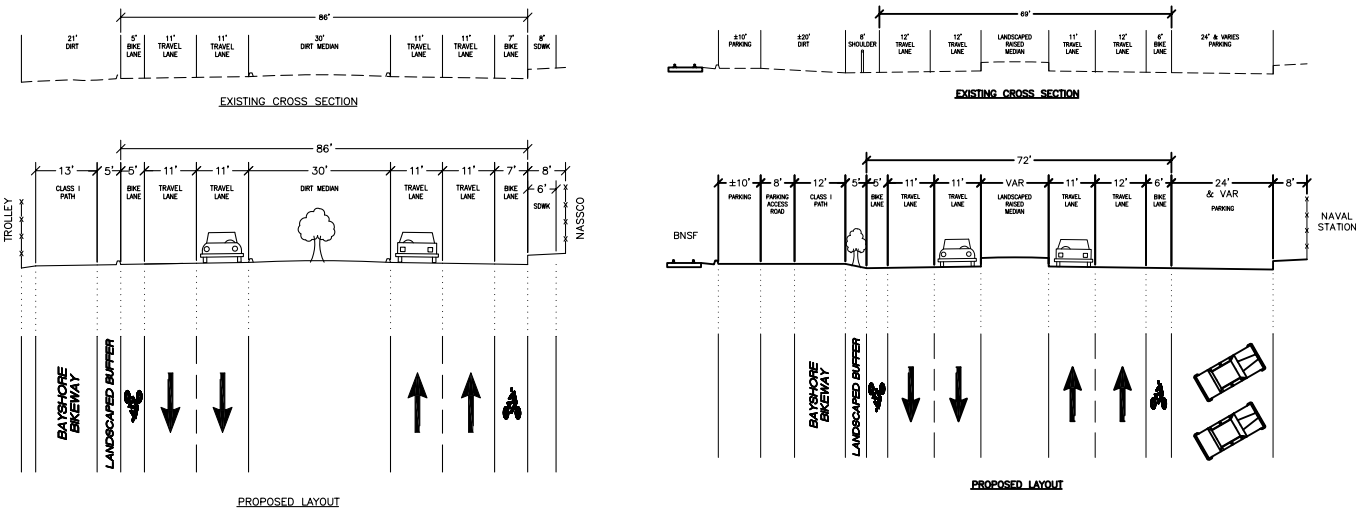
Figure 2: Bayshore Bikeway (2006) Overview Map and Approved Cross Sections

1: Approved Cross Section at Harbor Drive Bridge  
 2: Approved Cross Section between Harbor Dr. Bridge and Cesar Chavez Parkway  
 3: Approved Cross Section between Sampson and 28th Street

All Cross Sections are Looking from the Northwest to the Southeast

4: Approved Cross Section between Cesar Chavez and Sampson Street  
 5: Approved Cross Section between 28th and 32nd Street

Figure 2 includes an overall map of the Bayshore Bikeway system, with the study area for this project, overlaid on the map. The figure also includes the proposed cross sections for various segments of the study area. In most cases, the cross sections have been matched with the layout facilities in this plan. However, the City of San Diego did not agree to reducing both travel lanes to 11 feet in width. Based on speeds and the volume of truck traffic, the City required a 13’ outer lane, with the interior lane allowed to be reduced to 11’. In addition, single left turn lanes were required to be 11’ in width, versus an assumed 10’ in width. Finally, the City of San Diego had requested a 6’ on-street bike lane, versus the 5’ indicated in the previous study. A compromise was reached, requiring a 6’ Class 2 lane when next to on-street parking, and a 5’ Class 2 lane when next to a gutter or buffer bio-swale strip.

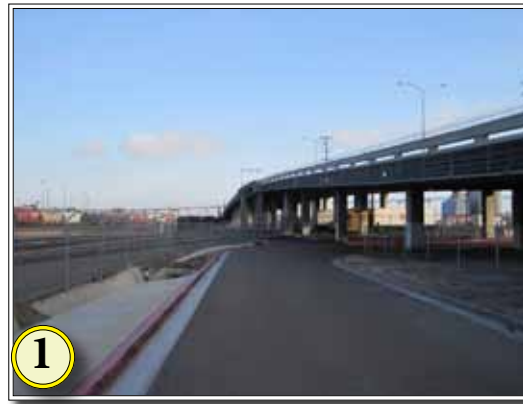
1  
North side of the Harbor Drive Bridge and Frontage Road underpass

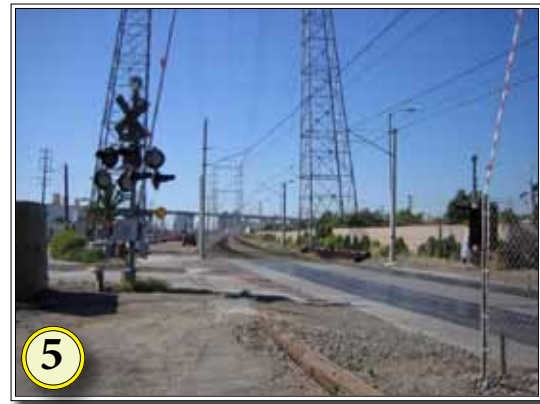
5  
Corridor is dominated by the rail line, industrial uses and large scaled powerline facilities

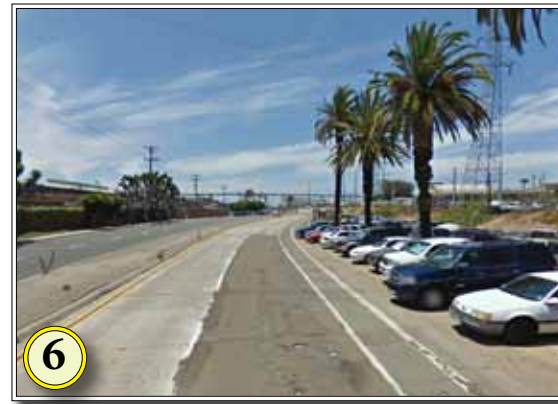
6  
Parking exists along a major portion of the corridor

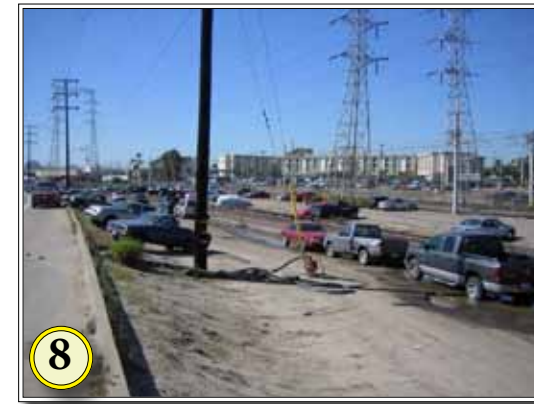
8  
All types of parking conditions exist, much of which does not meet industry parking layout standards

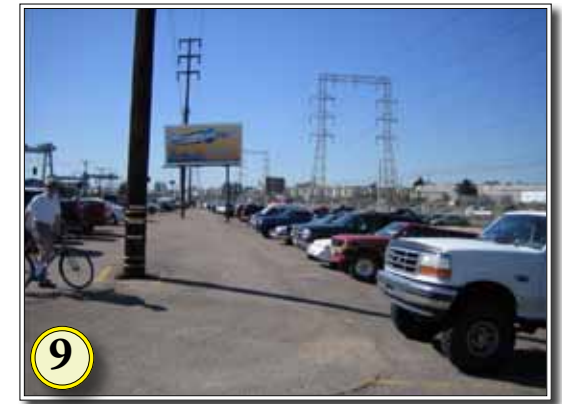
9  
Almost all available spaces are filled with parking, especially those south of Sampson

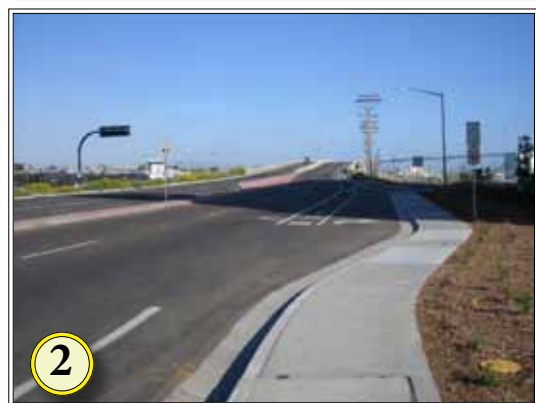
2  
The visual quality of the corridor, drops dramatically at Harbor Drive bridge, going southeasterly

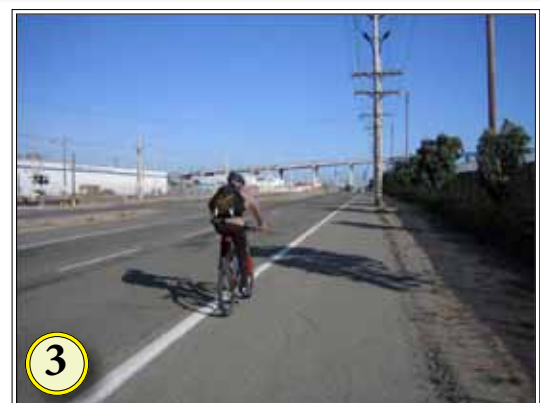
3  
The condition of the road, dominance of on-street parking & higher speeds creates challenges for cyclists

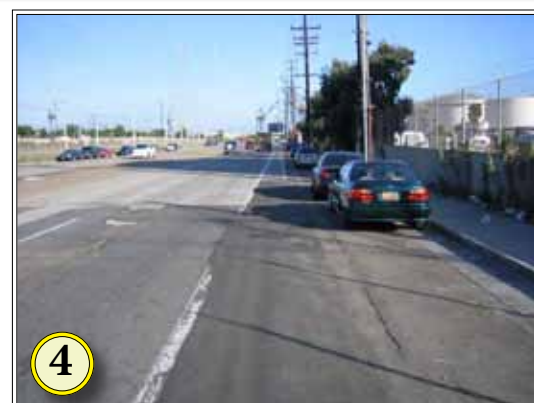
4  
Though some landscaping and screening exists, the corridor is mostly devoid of positive aesthetic elements

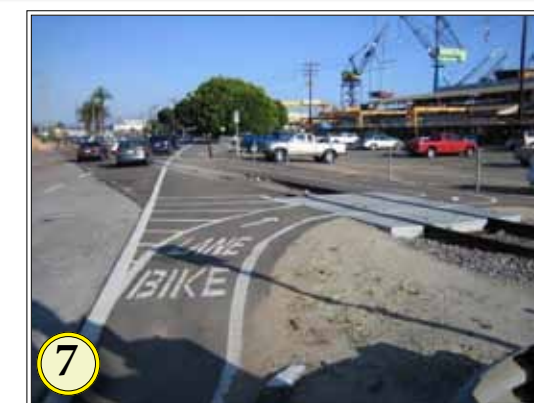
7  
The existing rail lines create additional challenges for cyclists

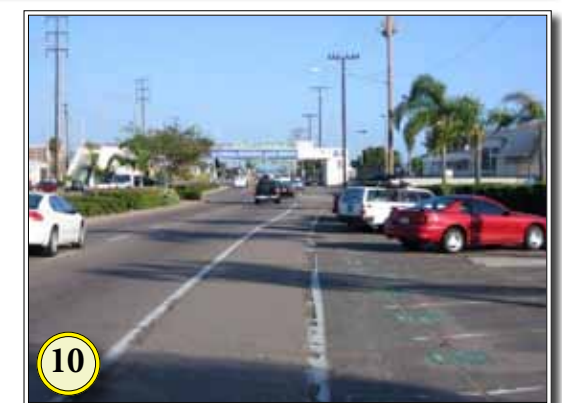
10  
Parallel parking, angled parking and straight in parking all exist along the corridor

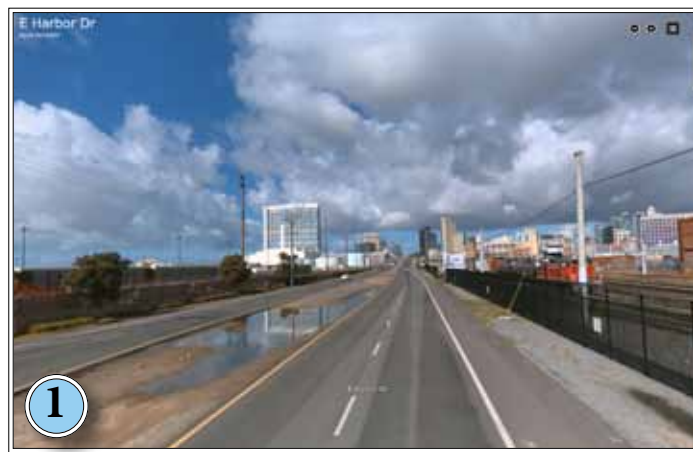
1 Nearly all of the median along Harbor Drive in the study area is devoid of curbs, gutters and storm drains

Another significant issue is roadway surface conditions. Pavement quality varies considerably, but is generally worse within the southern half of the study corridor. While the northern segment's asphalt surface is in fair condition, the remainder of the roadway is a patchwork of concrete and asphalt repair overlays, creating a very uneven surface. Intersections and roadway edges are often not well defined and the pavement quality within the roadway shoulders where cyclists are expected to ride is the poorest of all. Along with relatively high vehicular speeds, oblique rail line crossings and a lack of bikeway facilities, these conditions make cycling through this area less than ideal. See Figure 12: Drainage and Pavement Conditions.

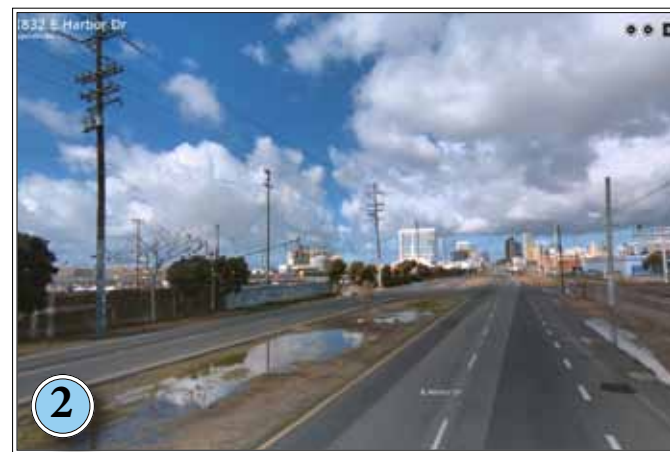
2 Most runoff ponds and eventually evaporates slowly with limited percolation or stormwater collection

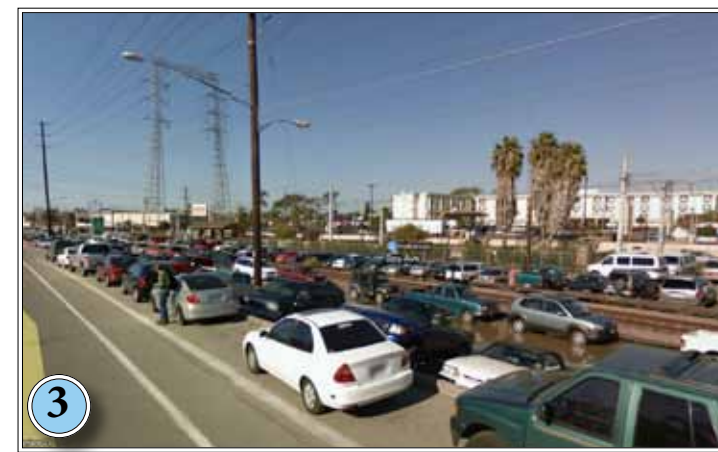
3 Many of the adjacent parking areas used by NASSCO, become inundated but are still parked in

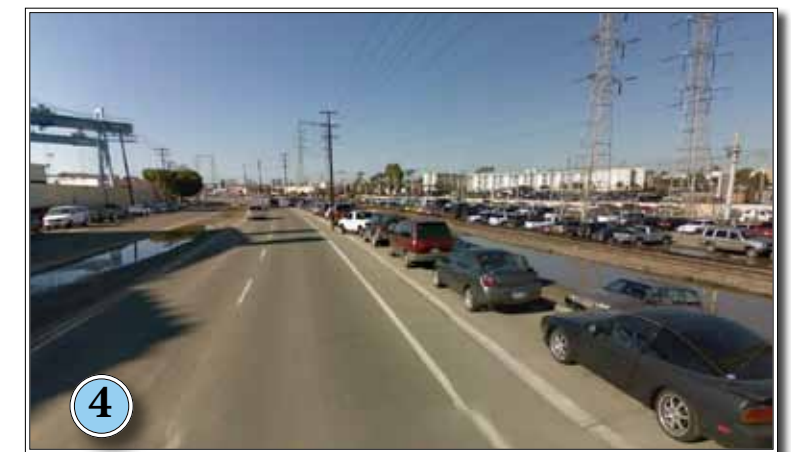
4 Several low lying areas become inundated easily after rain

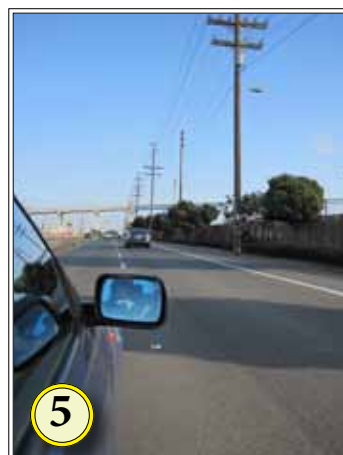
5 The northern segments with asphalt are in fair condition

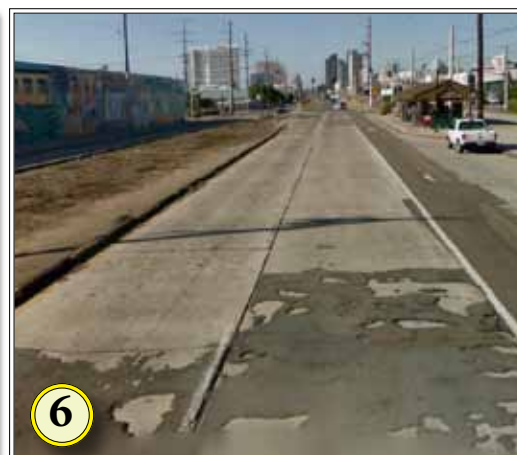
6 Areas where asphalt has been used over the concrete surface, are in very poor condition

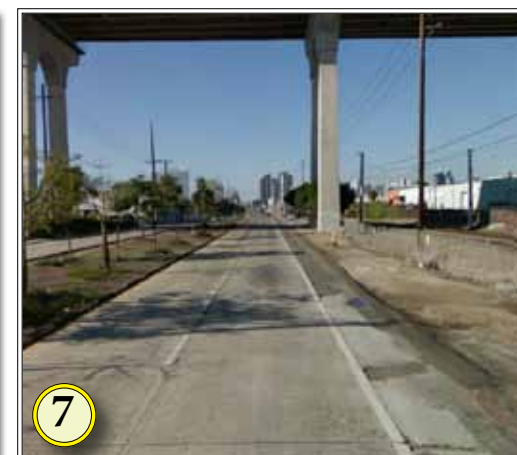
7 The shoulders where most cyclist have to ride, are in very poor condition with safety issues

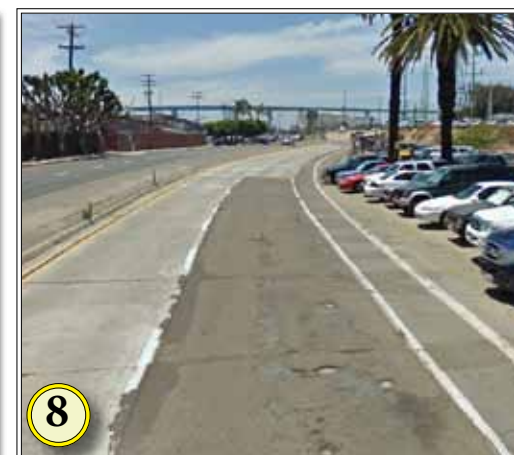
8 Asphalt overlays have been patched numerous times, creating an even more uneven surface

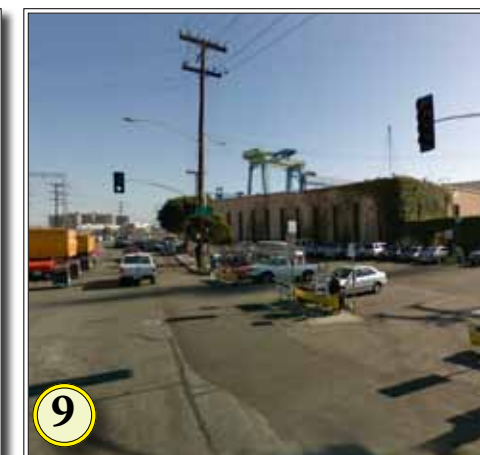
9 Intersections and road edges are poorly defined

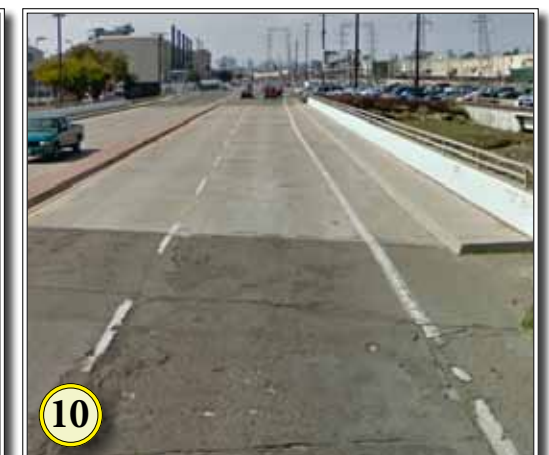
10 Concrete and asphalt conditions are poorest in the middle and southern segment of the corridor

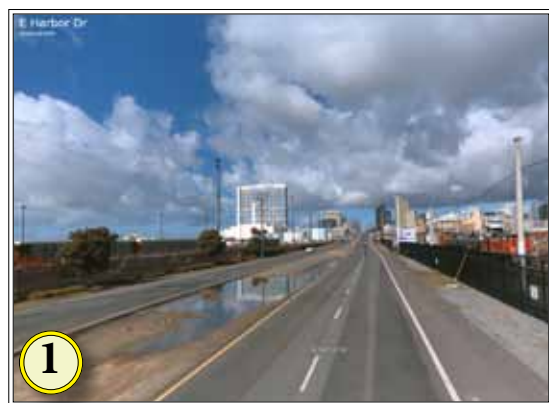
Figure 12: Parking Conditions

1 Both sides of Harbor Drive along the north segments do not allow for on-street parking

Figure 12, Parking Conditions, provides several images that capture the difficult and somewhat chaotic arrangement of parking for several major Port District tenants. NASSCO shipyard, and to a lesser extent BAE, all rely heavily on on-street parking

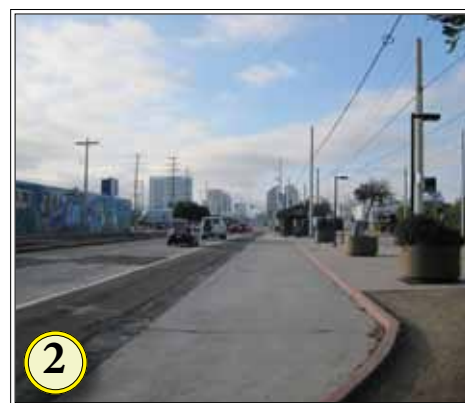
2 The trolley station has a drop-off zone and bus pull-out lane that is no longer used

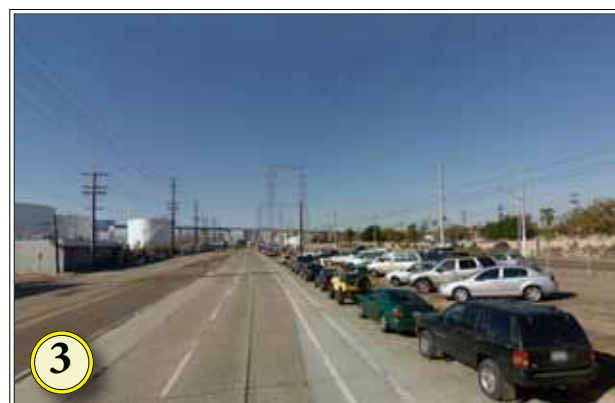
3 Parallel parking exists along both sides of Harbor Drive along much of the roadway southeast of Sampson

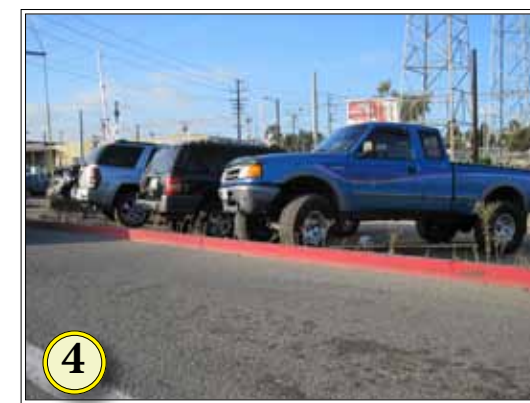
4 Some of the off-street parking actually overhangs the public rights-of-way

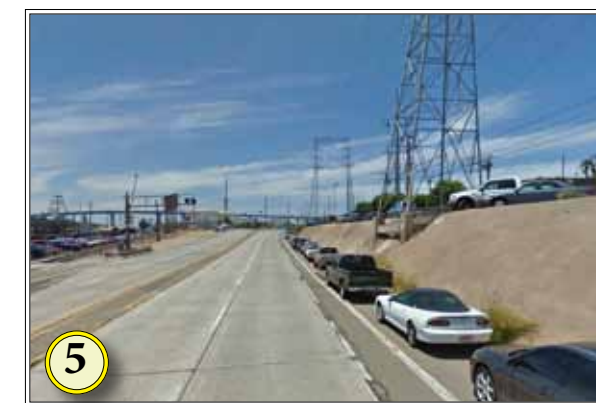
5 Off-street parking is used heavily by BAE and NASSCO employees

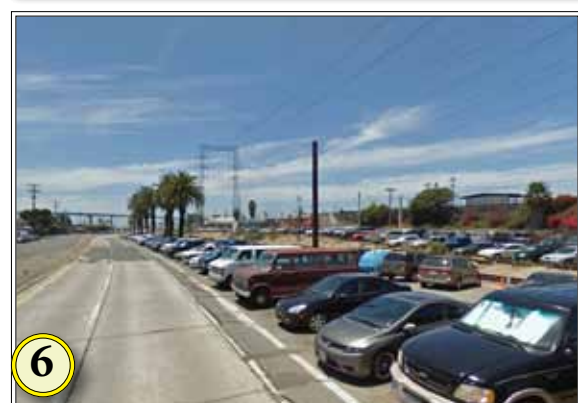
6 Back in parking exists just north of 28th Street

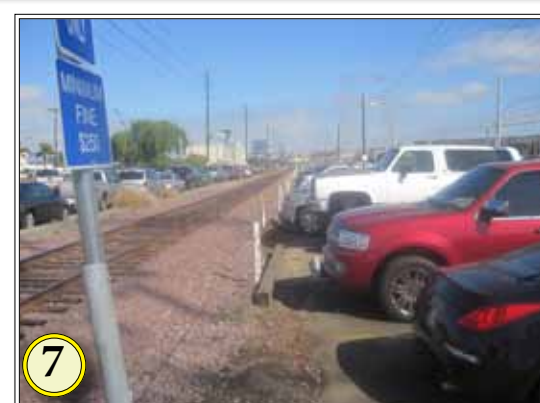
7 On street parking is within the public rights of way and is used heavily by NASSCO staff

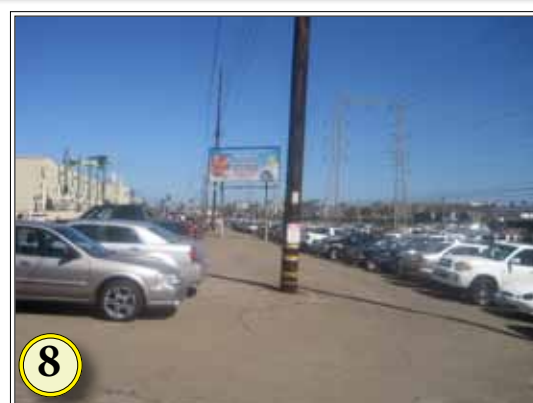
8 A variety of poles, structures and various obstacles do affect the overall parking capacity of the area

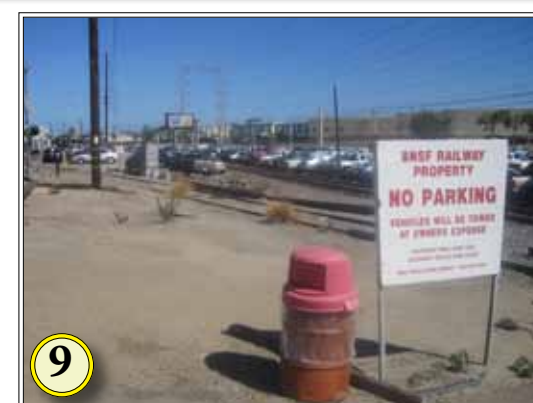
9 Parking spaces are squeezed onto NASSCO owned land or leased land from SDG&E or the railroad

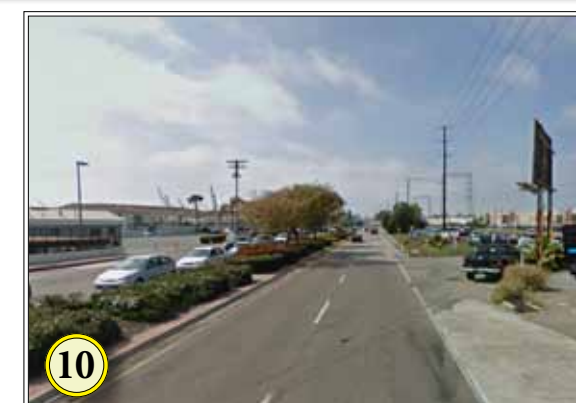
10 The southern most segment of the corridor has limited on-street parking
