City of San Diego

Park Amenity Assessment:

# BALBOA PARK CUMULATIVE REPORT

June 30, 2016

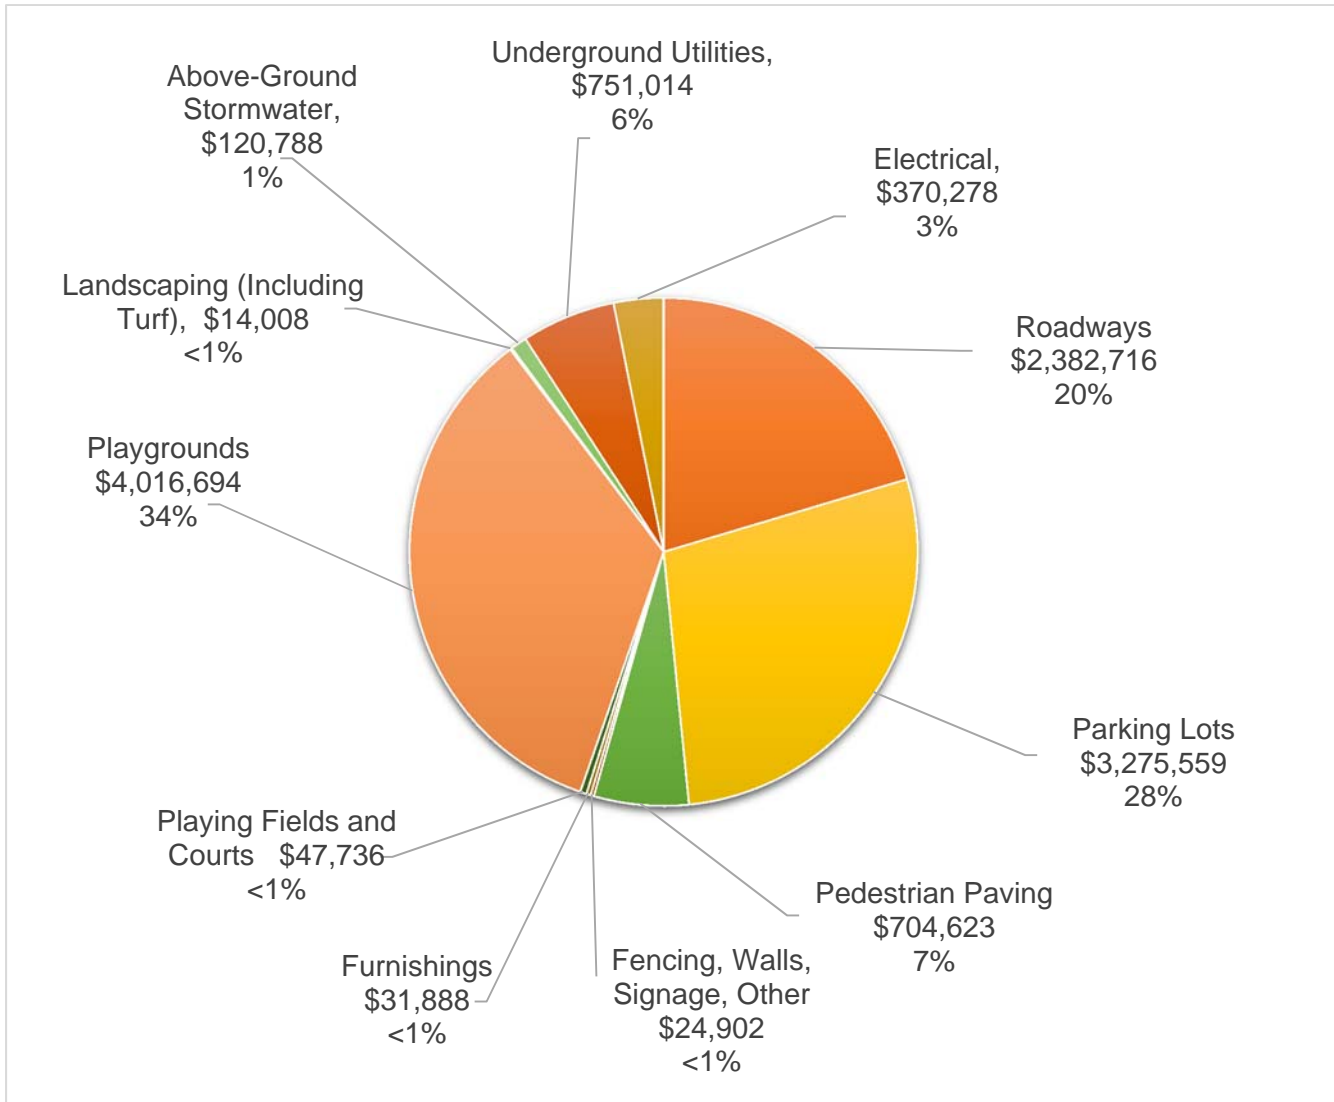
**Figure 1. Total Backlog by Park Systems – Balboa Park**

The following table and figure illustrate the maintenance and capital backlog totals for the assessed park area by **Park System**. The table and chart shows each major park system assessed. Of interest to note is that the highest backlog costs were for playgrounds, followed by parking lots. Overall, the majority of the playgrounds observed had exceeded their useful life, and/or required upgrades to meet current code requirements for accessibility.

**Total Backlog by Park Systems – \$ 11,740,206**

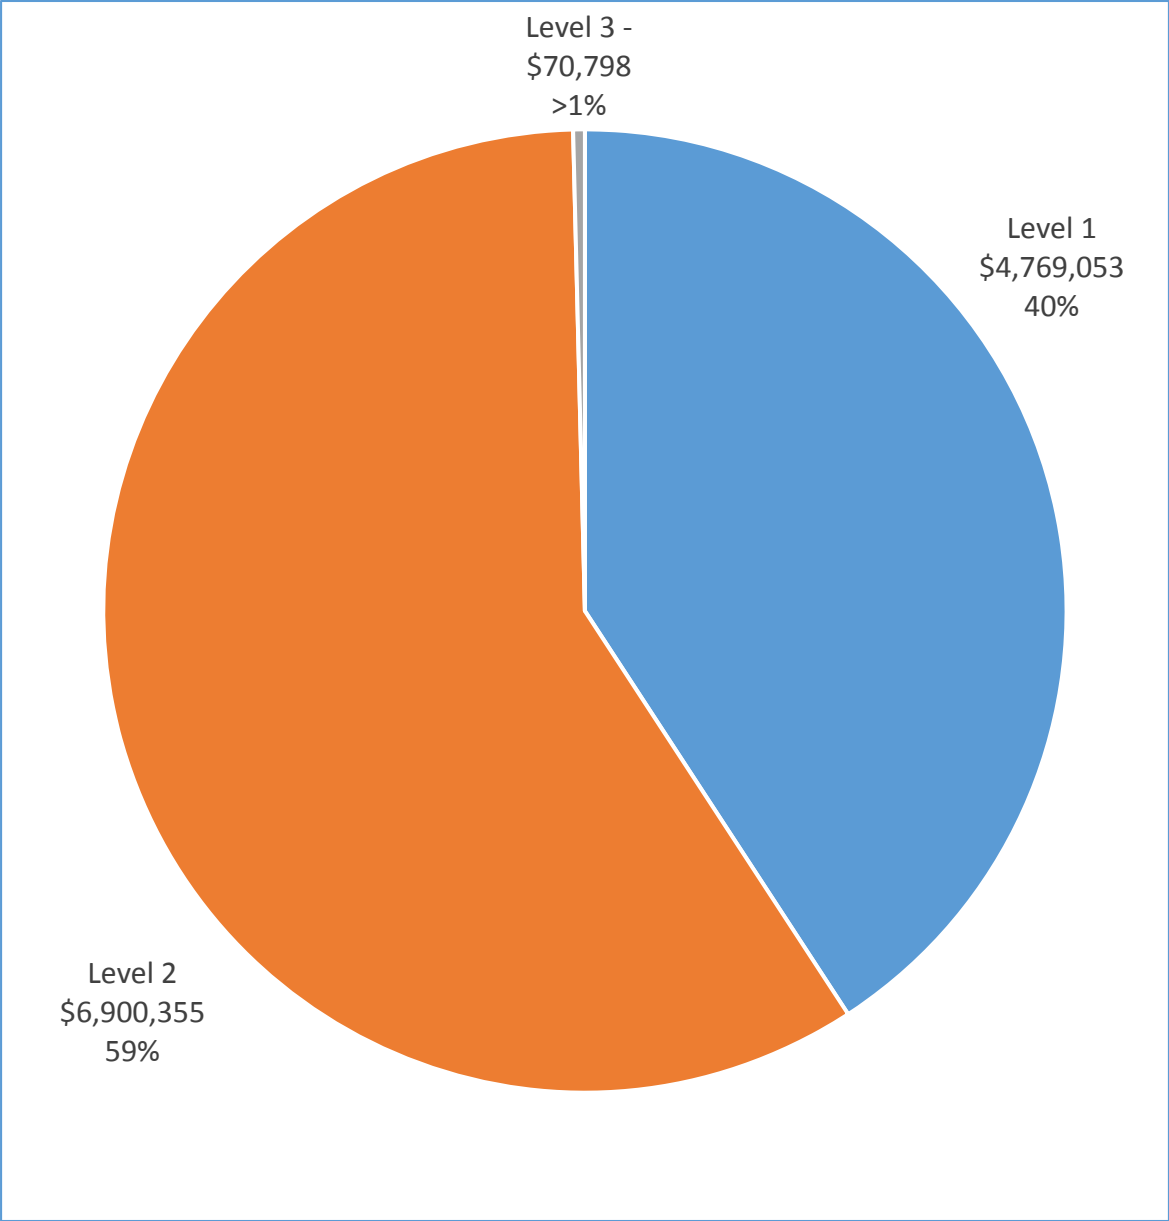
The following tables and charts reveal the findings total maintenance and capital backlogs for Balboa Park. To achieve optimum service reliability for the park systems, it is important to first address the Level 1 Operations Impacts followed by Level 2 Deterioration to ensure reliability of the Park facilities.

Total Maintenance & Capital Backlog by Reliability Levels:

\$ 11,740,206
