**EIR-LEVEL
UPDATE GEOTECHNICAL REPORT**

**OTAY MESA
COMMUNITY PLAN UPDATE
SAN DIEGO, CALIFORNIA**

**OCTOBER 9, 2012
PROJECT NO. 07254-42-03**

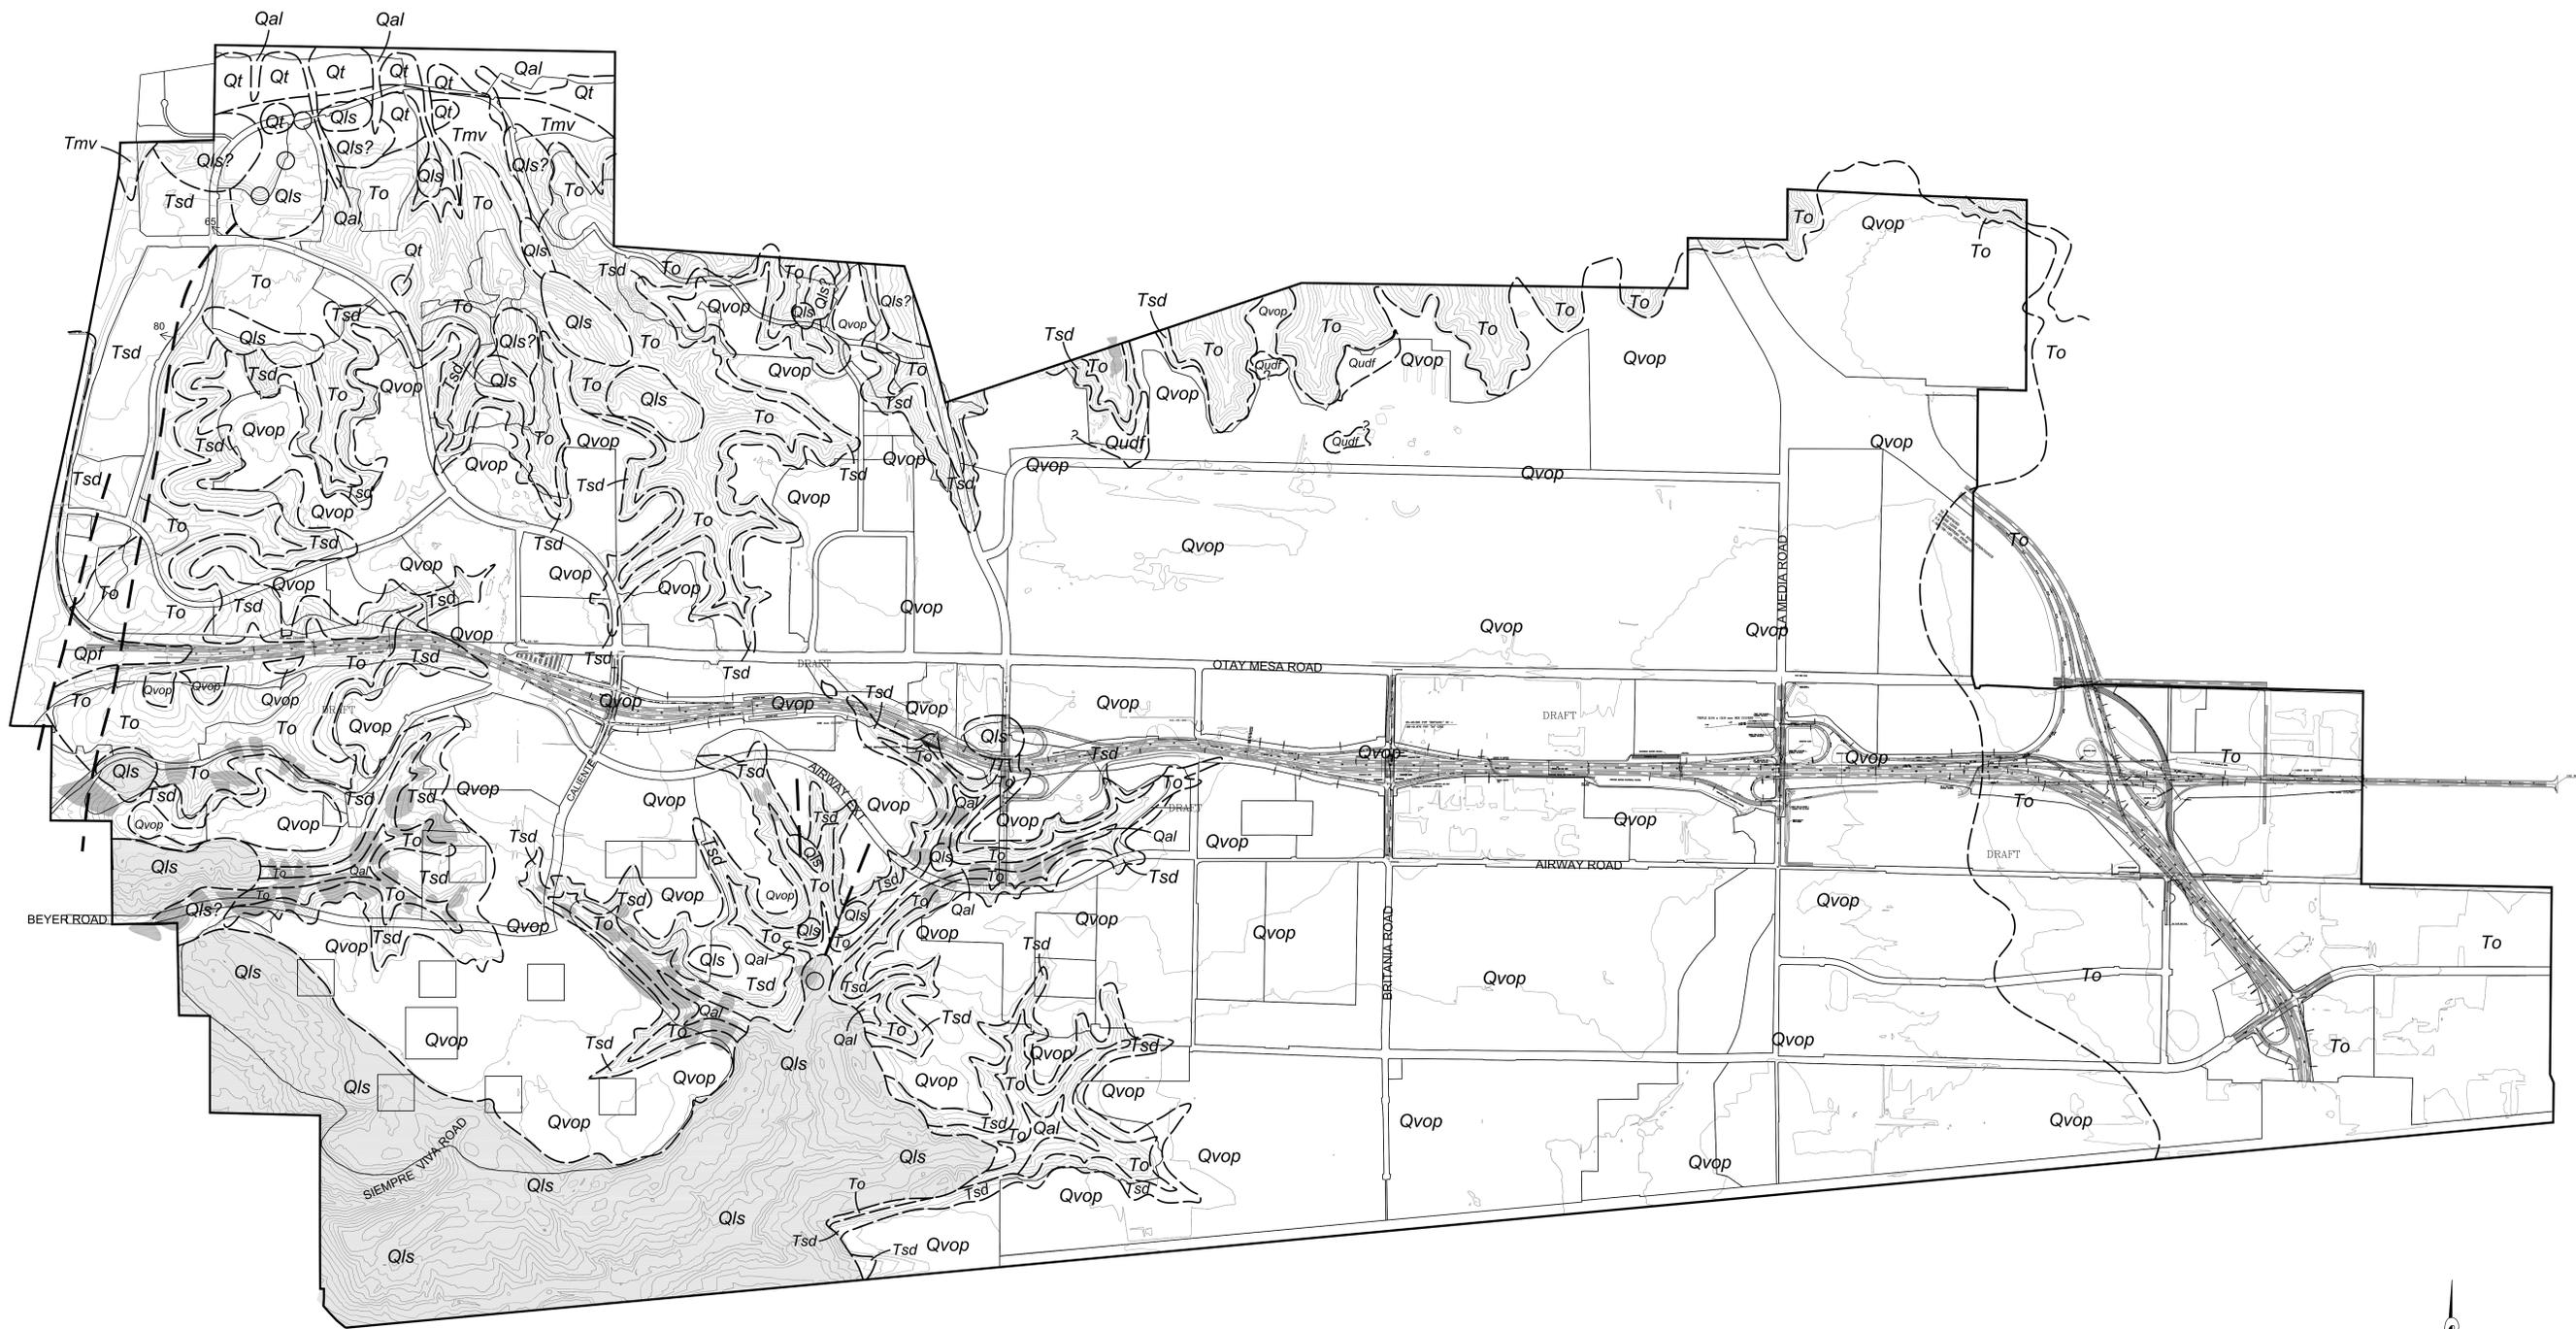
- Qudf** — ARTIFICIAL FILL, PRESUMED UNDOCUMENTED
- Qal** — ALLUVIUM
- Qls** — LANDSLIDE DEBRIS
-

— LANDSLIDE MAPPED BASED UPON SURFACE EXPRESSION AND CORROBORATION FROM PUBLISHED SOURCES
-

GEOLOGIC MAP	
OTAY MESA COMMUNITY PLAN OTAY MESA AREA SAN DIEGO, CALIFORNIA	
GEOCON 1715 G ST. # 200 SAN DIEGO, CALIFORNIA 92101 PHONE 619 594-6900 FAX 619 594-6999	SCALE 1" = 800' DATE 10-09-2012 PROJECT NO. 07254-42-03 SHEET 1 OF 2

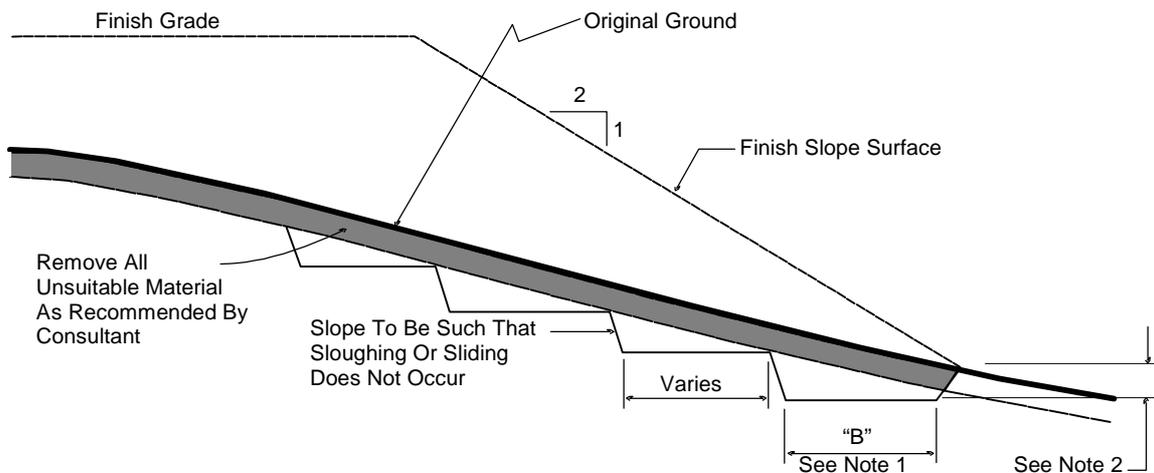
TYPICAL BENCHING DETAIL

- DETAIL NOTES:
- (1) Key width "B" should be a minimum of 10 feet, or sufficiently wide to permit complete coverage with the compaction equipment used. The base of the key should be graded horizontal, or inclined slightly into the natural slope.
 - (2) The outside of the key should be below the topsoil or unsuitable surficial material and at least 2 feet into dense formational material. Where hard rock is exposed in the bottom of the key, the depth and configuration of the key may be modified as approved by the Consultant.

- 4.4 Where the slope ratio of the original ground is steeper than 5:1 (horizontal:vertical), or where recommended by the Consultant, the original ground should be benched in accordance with the following illustration.
