**REPORT OF PRELIMINARY GEOTECHNICAL INVESTIGATION**

**PROPOSED SINGLE-FAMILY RESIDENCE  
6110 CAMINO DE LA COSTA  
LA JOLLA, CALIFORNIA**

**Subject: Report of Preliminary Geotechnical Investigation  
Proposed Single-Family Residence 6110 Camino de la Costa, La Jolla, California**

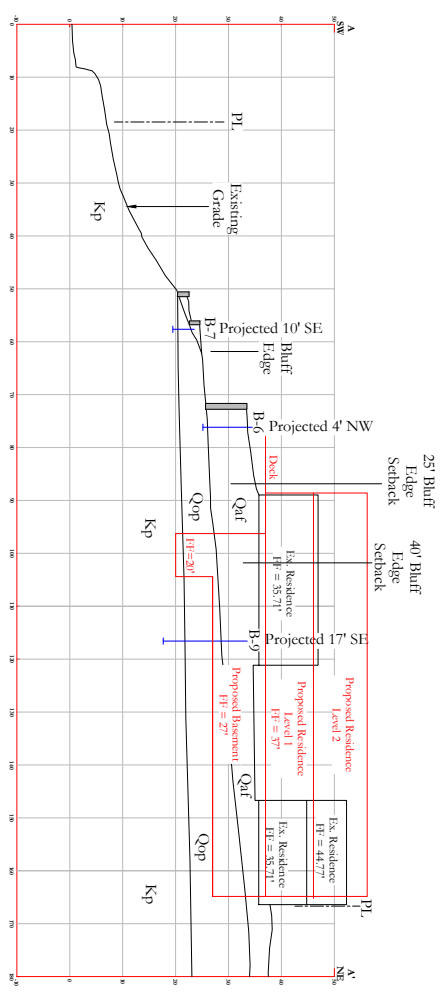
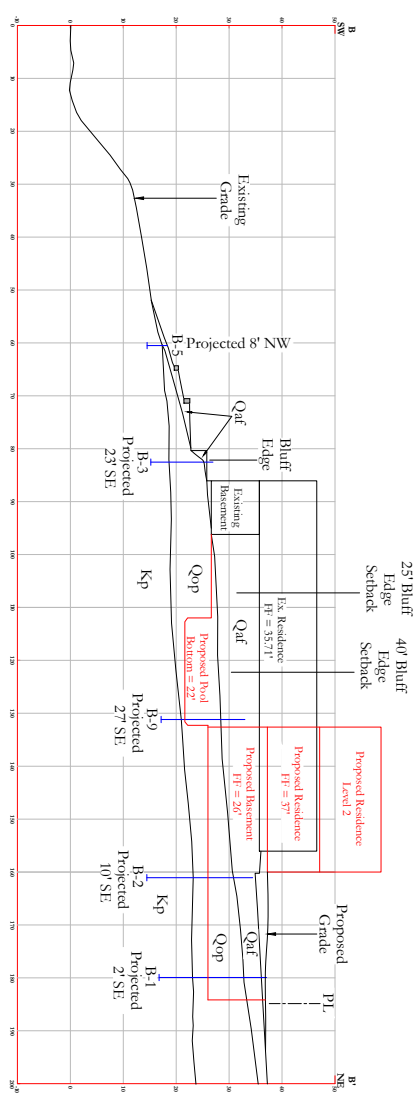
**GEOLOGIC CROSS SECTIONS**  
**A-A' AND B-B'**

CWE LEGEND	
Qat	Artificial Fill
Qop	Old Pacific Deposits
Kp	Point Loma Formation

**ARTIFICIAL FILL (Qaf):** Man-placed fill materials underlie the developed portions of the property and mantle the upper portions of the coastal bluff face (see Plate Nos. 1 through 3). As encountered in our subsurface explorations, the artificial fill typically consisted of light brown to dark brown, damp to moist, silty sand (SM) with lesser amounts of clayey sand (SC). The artificial fill was found to be generally loose in all the subsurface explorations. In general, the fill soils ranged in thickness from about 5 feet within the eastern portion of the lot to about 8½ feet along the southwest side of the existing residence (see B-6). Deeper fill soils may exist in areas of the site not investigated. From the west side of the existing structure, the artificial fill thins towards the central portion of the coastal bluff face. The fill soils were judged to possess a low expansion potential (EI between 21 and 50).

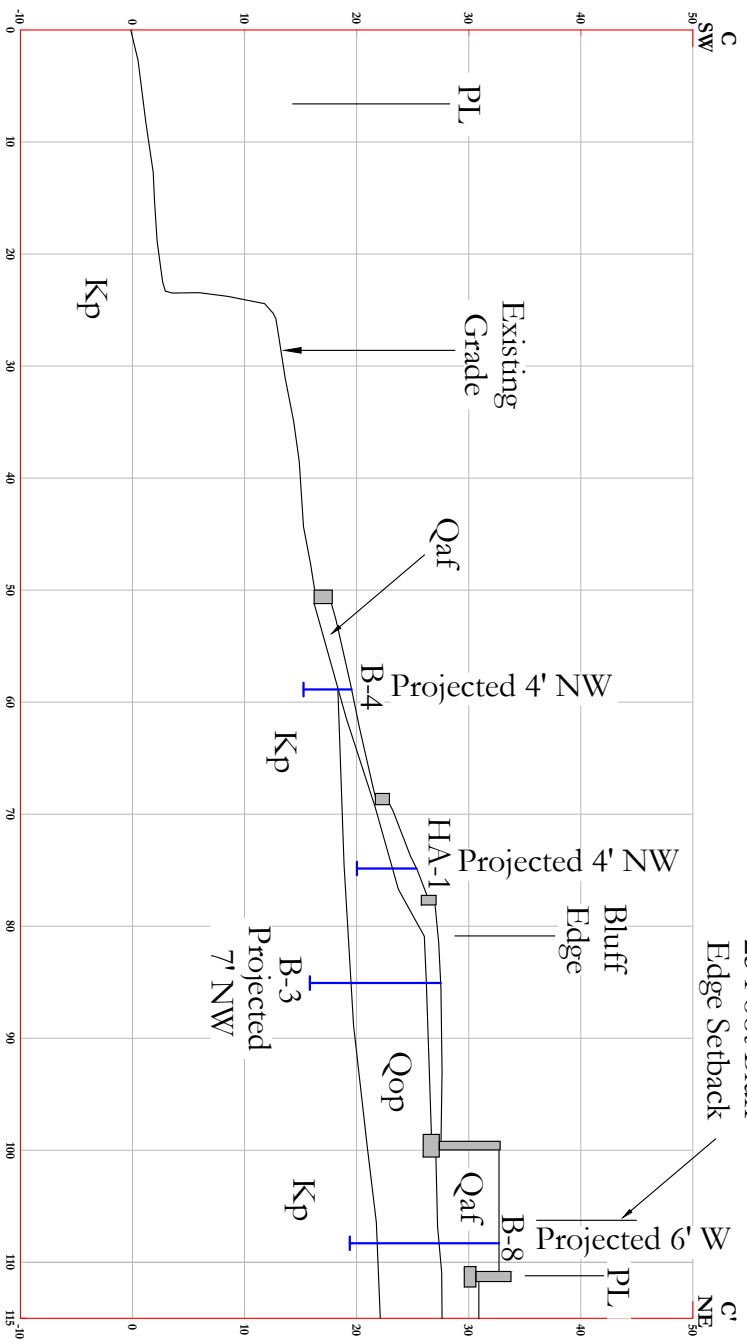
**GEOLOGIC CROSS SECTION C-C'**

CWE LEGEND	
Qaf	Artificial Fill
Qop	Old Paralic Deposits
Kp	Point Loma Formation

PROPOSED SINGLE-FAMILY RESIDENCE 6100 CAMINO DE LA COSTA LA JOLLA, CALIFORNIA	
DATE:	JULY 2022
JOB NO.:	2220191.01
BY:	SD
PLATE NO.:	3

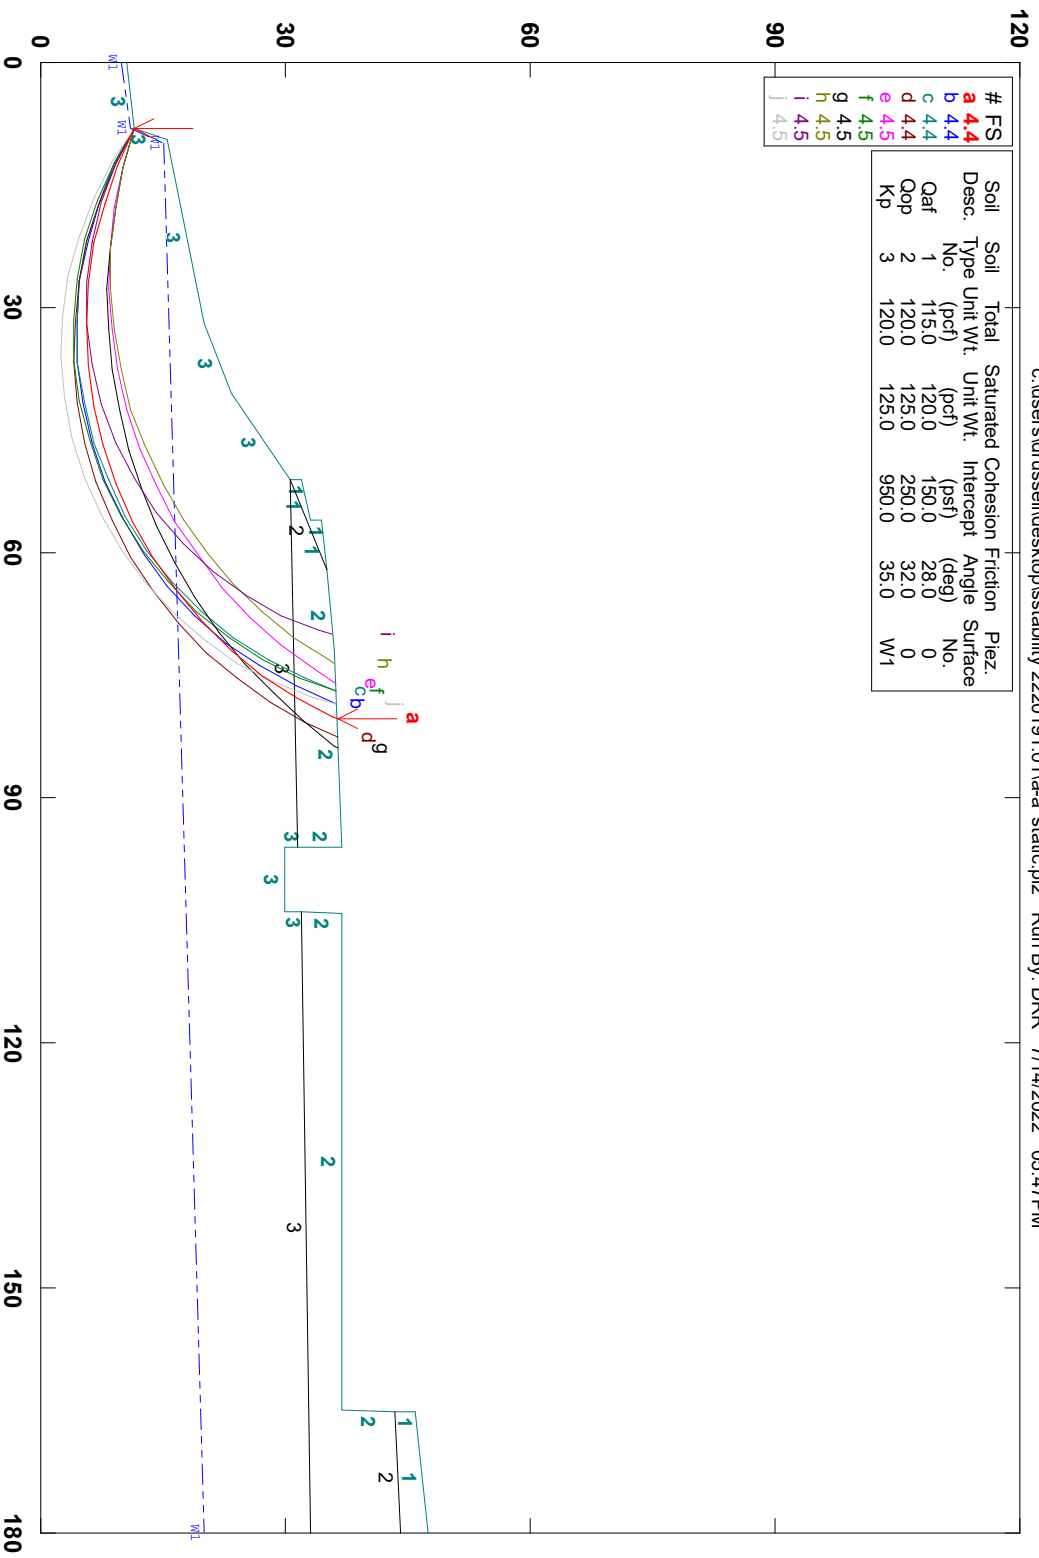
# Proposed SFR - 6110 Camino de La Costa A-A' Static

GSTABL7 v.2 F<sub>Smin</sub>=4.4  
 Safety Factors Are Calculated By The Modified Bishop Method
