**PRELIMINARY
GEOTECHNICAL INVESTIGATION**

**SOUTHWEST VILLAGE
VESTING TENTATIVE MAP
SAN DIEGO, CALIFORNIA**

**MARCH 28, 2019
PROJECT NO. 06847-42-03**

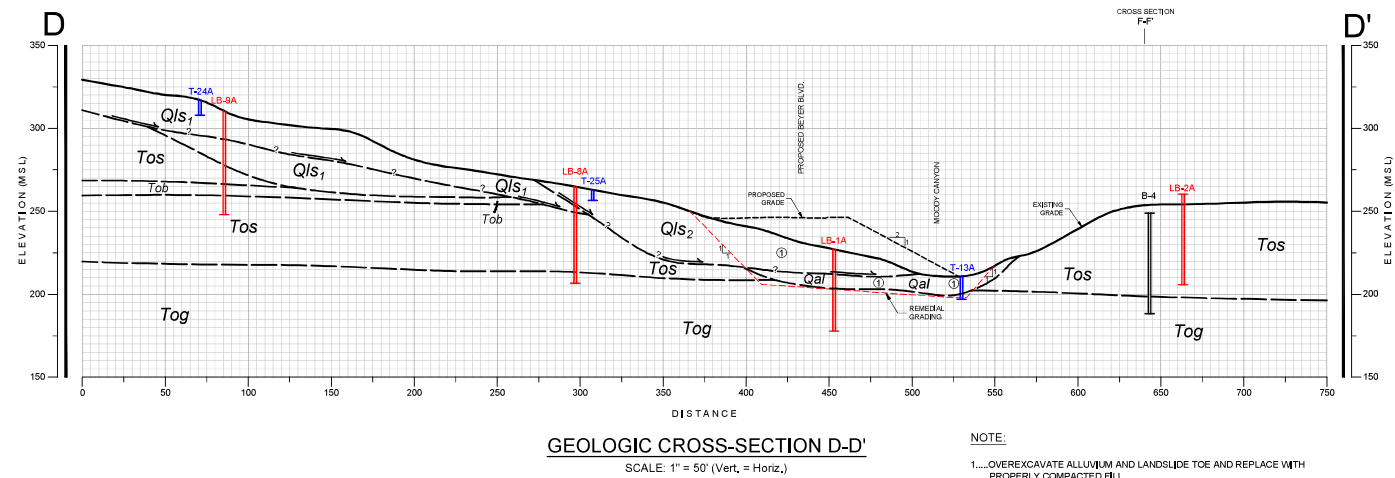
DATE 03 - 26 - 2019
 FIGURE 8

GEOLOGIC CROSS SECTION
 SOUTHWEST VILLAGE
 VESTING TENTATIVE MAP
 SAN DIEGO, CALIFORNIA

The mapped location of the San Ysidro Landslides (mapped as Qls1, designating older landslide debris) is shown on the Geologic Maps (Figures 2 and 3). Geologic cross sections (A-A' through J-J', Figures 7 through 10) depict geologic profiles based on interpretation of subsurface data.

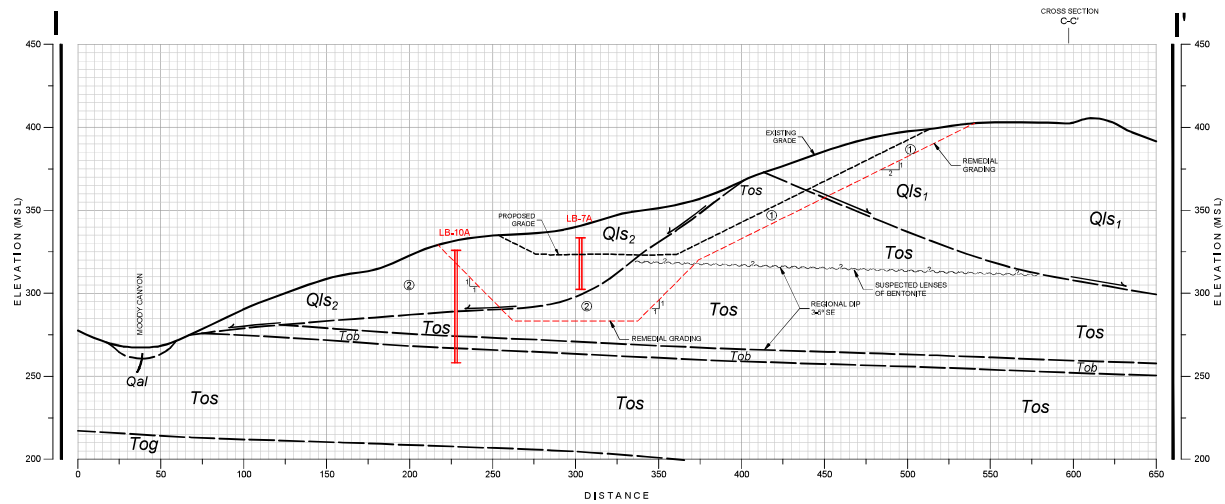
GEOLOGIC CROSS-SECTION I-I'
SCALE: 1" = 50' (Vert. = Horiz.)

- NOTES:
- 1.....CONSTRUCT 20' STABILITY FILL.
 - 2.....CONSTRUCT BUTTRESS.

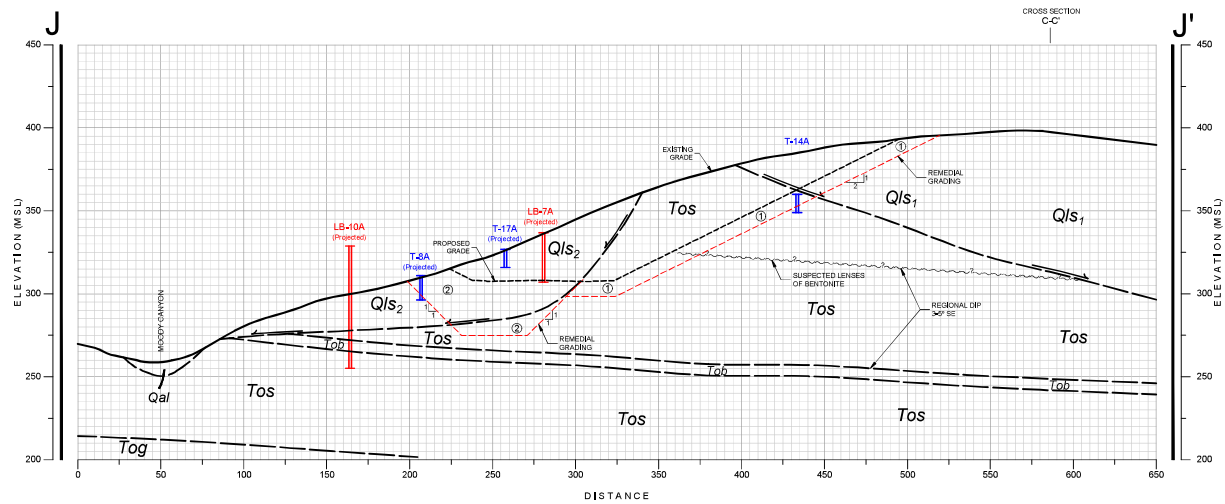
GEOLOGIC CROSS-SECTION J-J'
SCALE: 1" = 50' (Vert. = Horiz.)

- NOTES:
- 1.....CONSTRUCT 20' STABILITY FILL.
 - 2.....REMOVE AND RECOMPACT LANDSLIDE BENEATH ROADWAY.
