**REPORT OF PRELIMINARY GEOTECHNICAL AND GEOLOGIC FAULT  
INVESTIGATION**

Proposed Javaheri Residence  
2072 Via Casa Alta  
La Jolla, California

**JOB NO. 21-13556**

Subject: **Report of Preliminary Geotechnical Investigation and Geologic Fault Investigation**  
Proposed Javaheri Residence  
2072 Via Casa Alta  
La Jolla, California

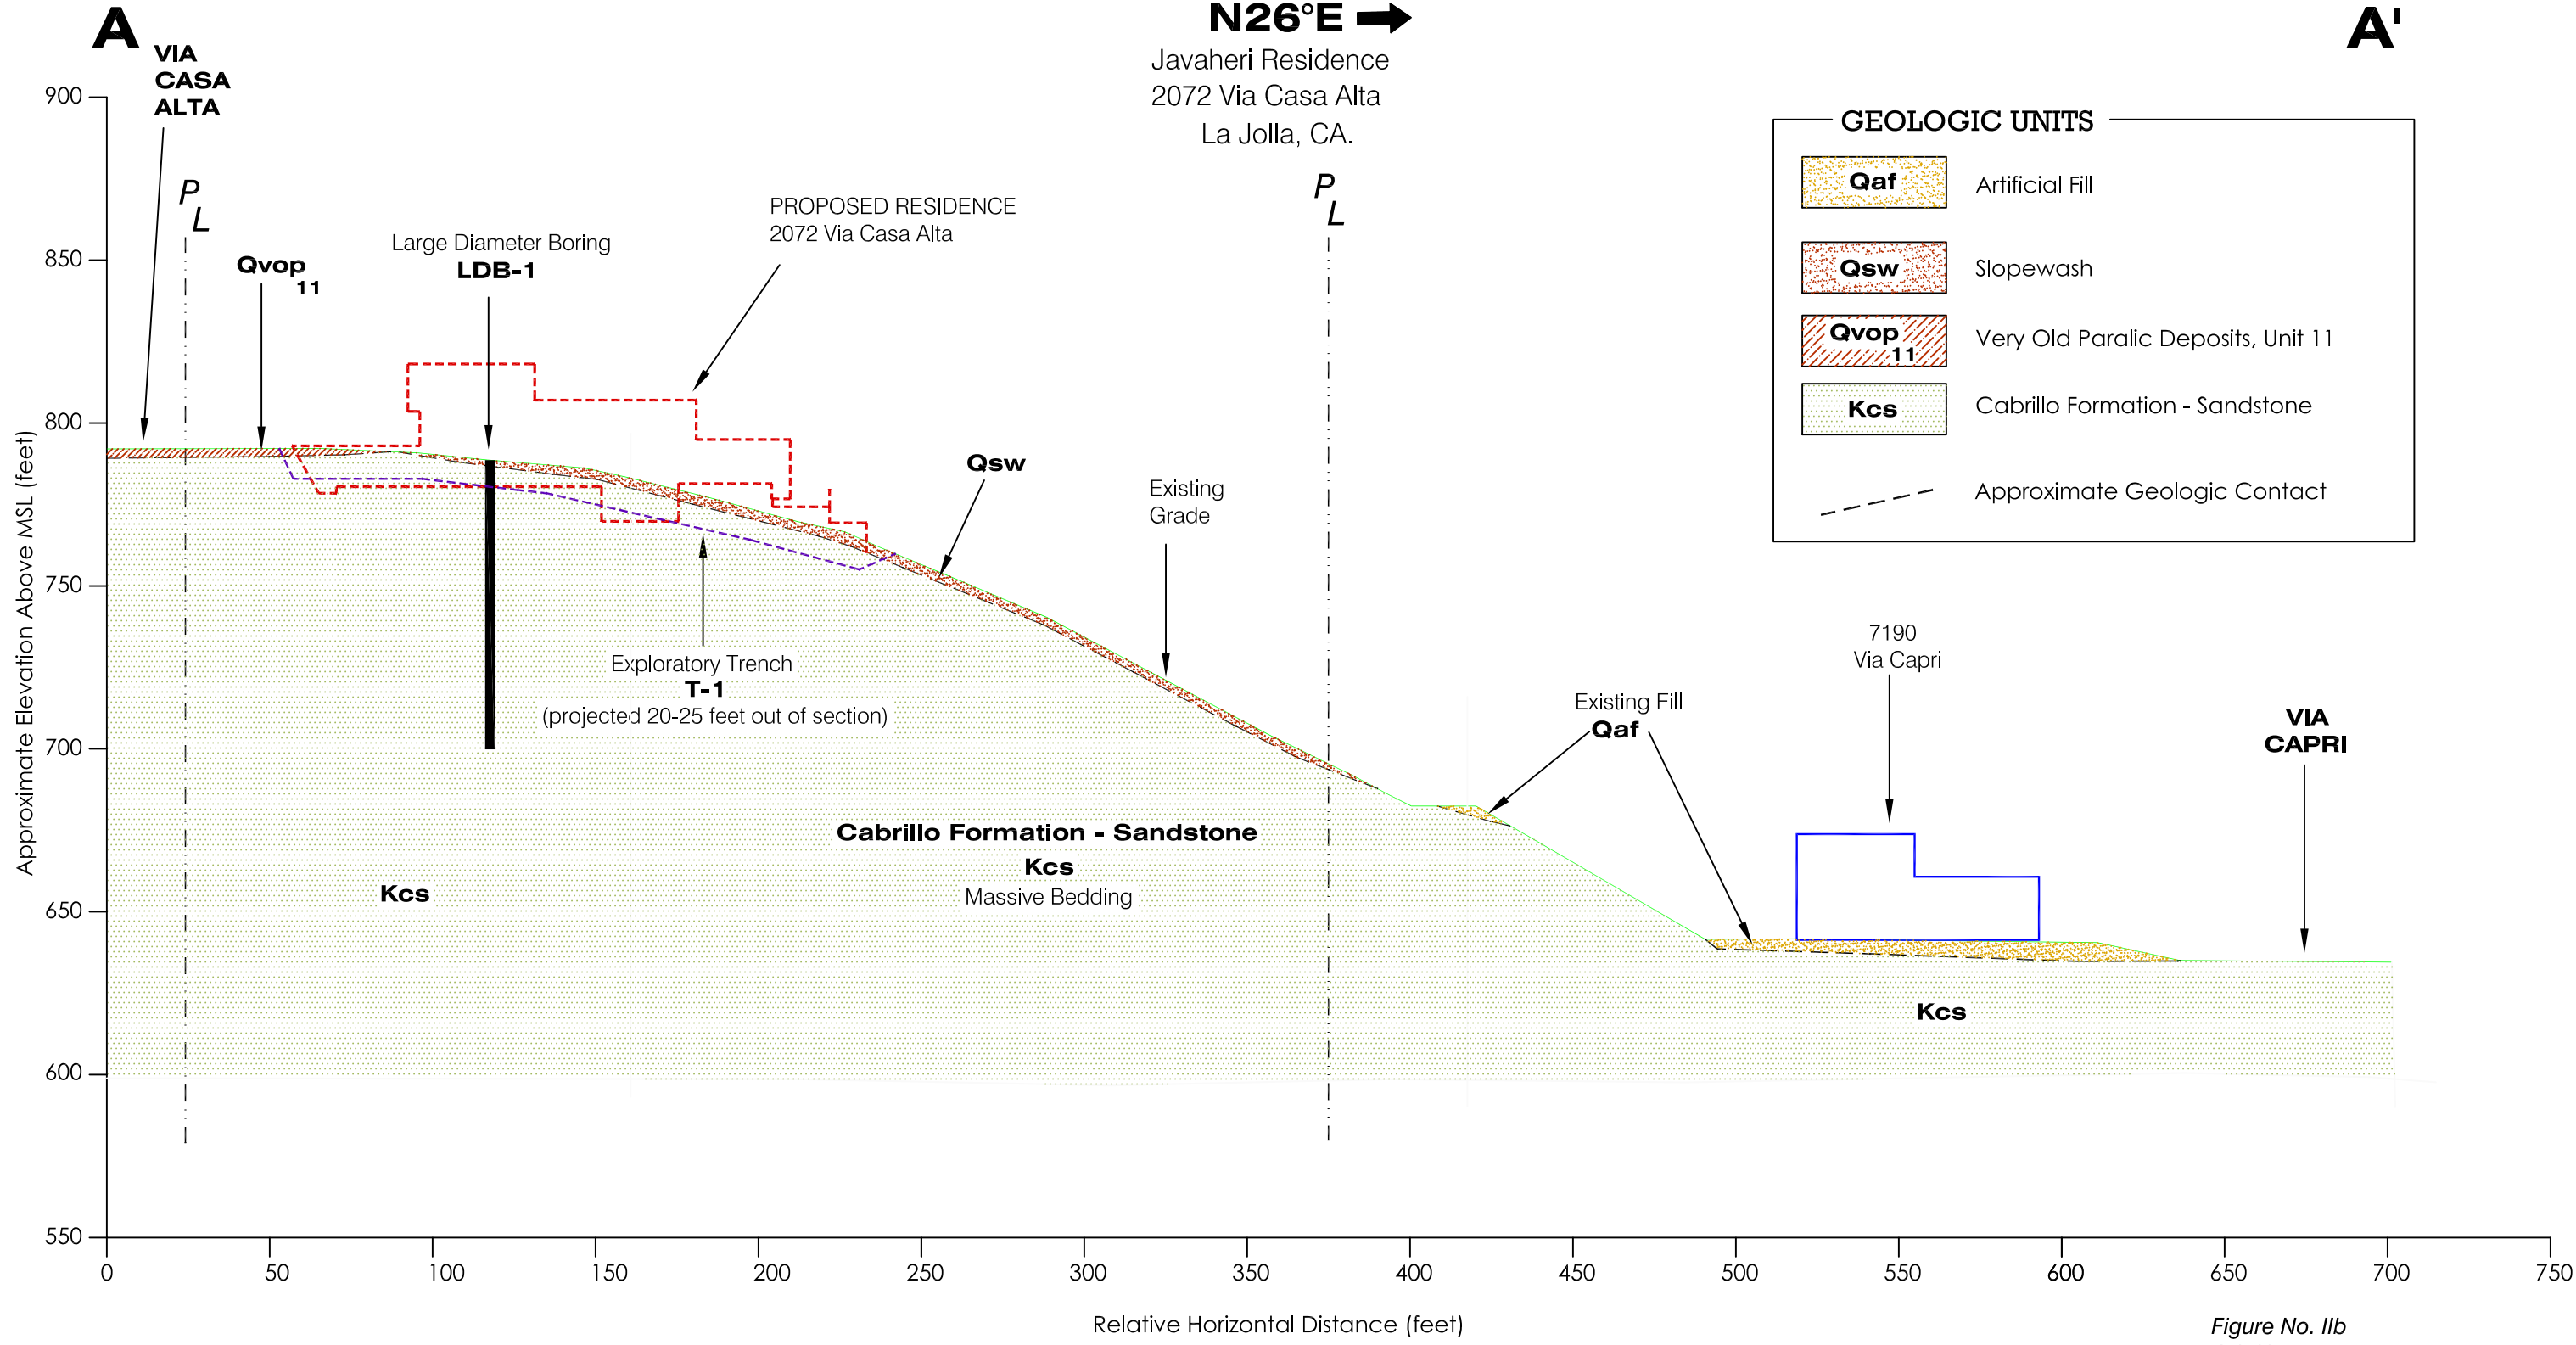
**GEOLOGIC UNITS**

<b>Qaf</b>	Artificial Fill
<b>Qsw</b>	Slopewash
<b>Qvop<sub>11</sub></b>	Very Old Paralic Deposits, Unit 11
<b>Kcs</b>	Cabrillo Formation - Sandstone
--- Approximate Geologic Contact

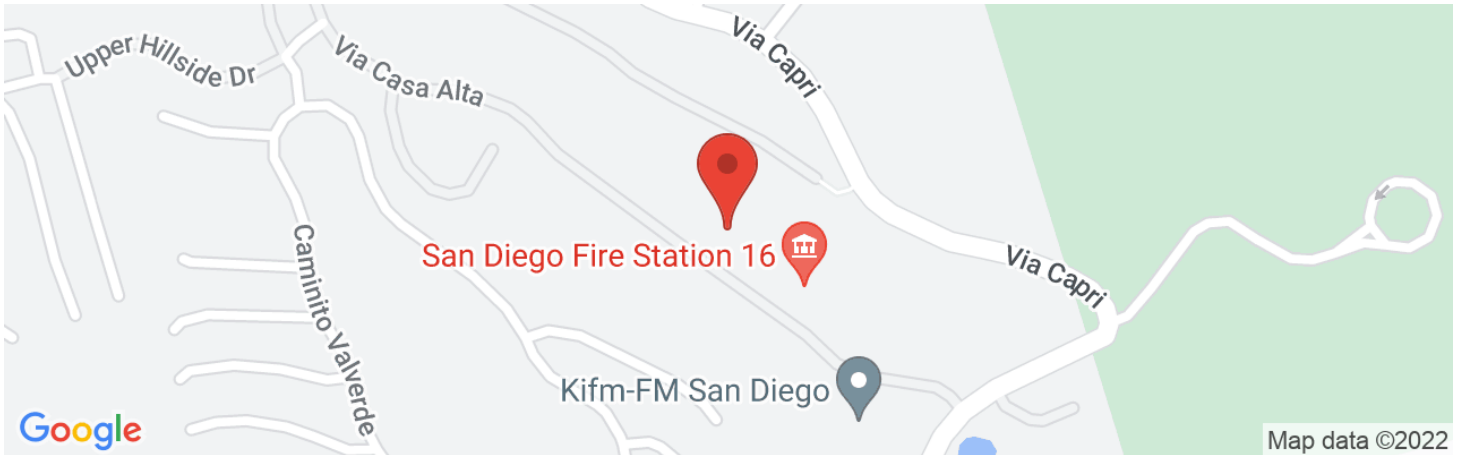
Date	7/22/2022, 10:32:17 AM
Design Code Reference Document	ASCE7-16
Risk Category	II
Site Class	C - Very Dense Soil and Soft Rock

Type	Value	Description
$S_S$	1.416	$MCE_R$ ground motion. (for 0.2 second period)
$S_1$	0.494	$MCE_R$ ground motion. (for 1.0s period)
$S_{MS}$	1.699	Site-modified spectral acceleration value
$S_{M1}$	0.742	Site-modified spectral acceleration value
$S_{DS}$	1.133	Numeric seismic design value at 0.2 second SA
$S_{D1}$	0.494	Numeric seismic design value at 1.0 second SA
