PRIORITY DEVELOPMENT PROJECT (PDP) STORM WATER QUALITY MANAGEMENT PLAN (SWQMP) FOR

2072 Via Casa Alta

Labib Funk & Associates 319 Main St. El Segundo, CA, 90245 (213)239-3922

January 13, 2025

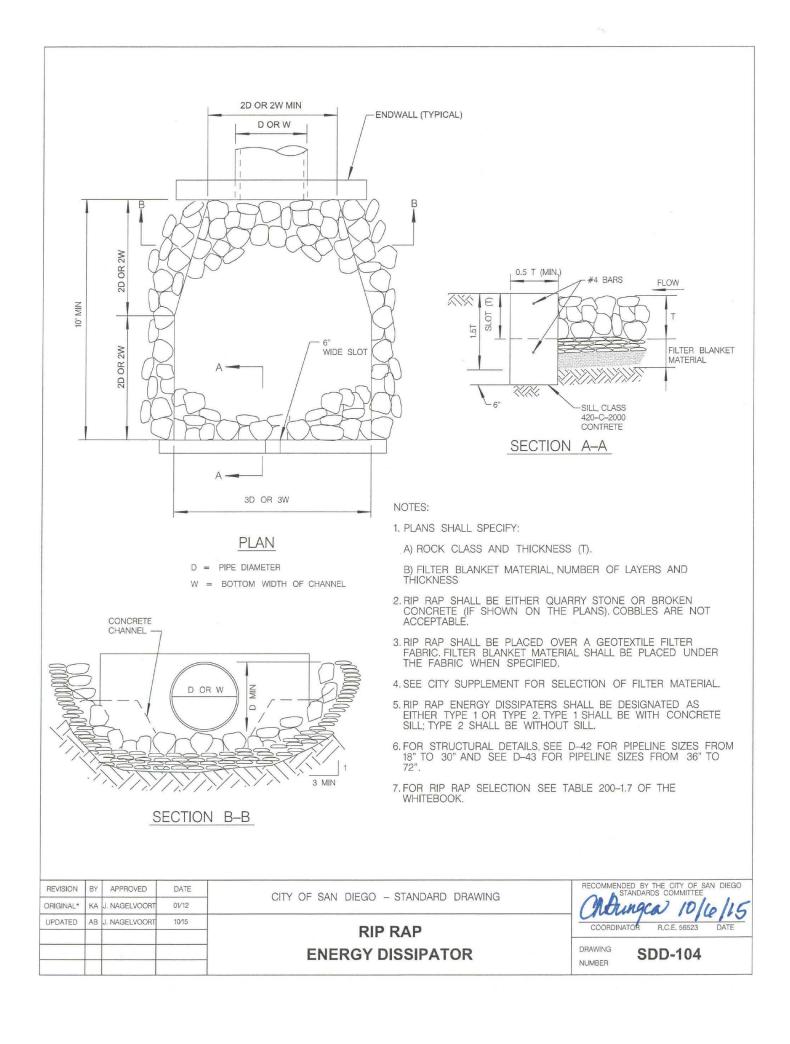
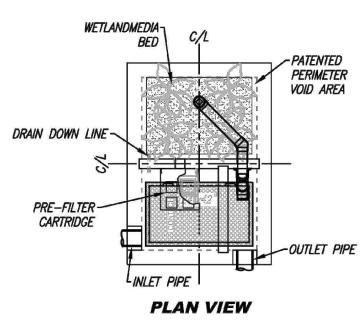
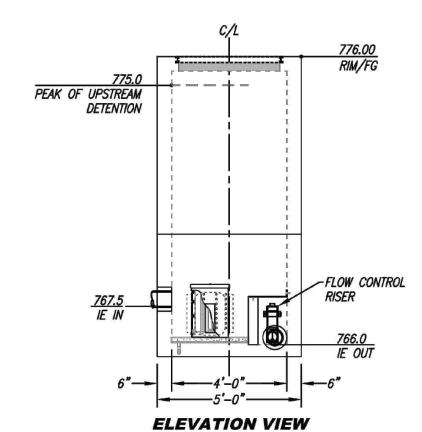
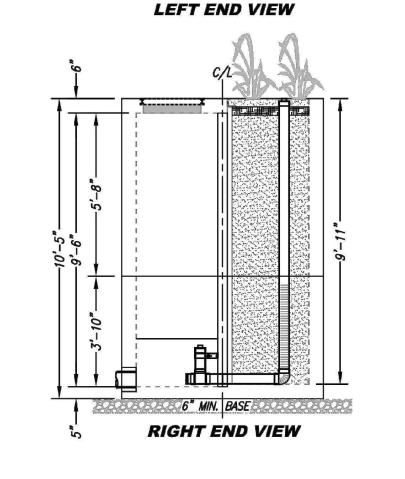
1 CONTECH MWS BIOFILTRATION SYSTEM DETAIL C300 CONTECH

- UNIT MUST BE INSTALLED ON LEVEL BASE. MANUFACTURER RECOMMENDS A MINIMUM 6" LEVEL ROCK BASE UNLESS SPECIFIED BY THE PROJECT ENGINEER. CONTRACTOR IS RESPONSIBLE FOR VERIFYING PROJECT ENGINEER'S RECOMMENDED BASE SPECIFICATIONS.

MWS-L-4-6-9'-11"-V STORMWATER BIOFILTRATION SYSTEM STANDARD DETAIL

Form I-6 Page 3 of X (Copy as many as needed)			
Structural BMP Su	mmary Information		
Structural BMP ID No. 1			
Construction Plan Sheet No. C300,C310 & C311			
Type of structural BMP:			
Retention by harvest and use (HU-1)			
Retention by infiltration basin (INF-1)			
Retention by bioretention (INF-2)			
Retention by permeable pavement (INF-3)			
Partial retention by biofiltration with partial retentio	n (PR-1)		
☑ Biofiltration (BF-1)			
Flow-thru treatment control with prior lawful appr (BMP type/description in discussion section below	oval to meet earlier PDP requirements (provide		
Flow-thru treatment control included as pre-treatm BMP (provide BMP type/description and indicate discussion section below)			
Flow-thru treatment control with alternative compl	iance (provide BMP type/description in discussion		
Detention pond or vault for hydromodification ma	nnagement		
Other (describe in discussion section below)

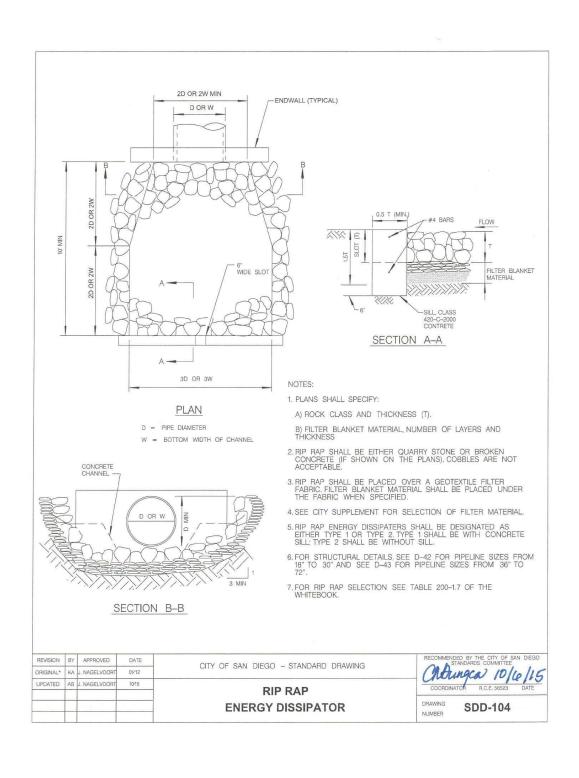
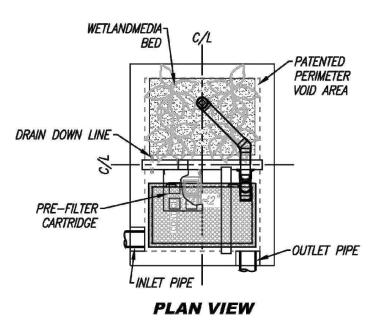
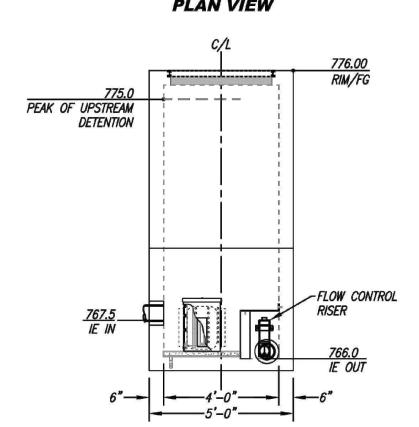
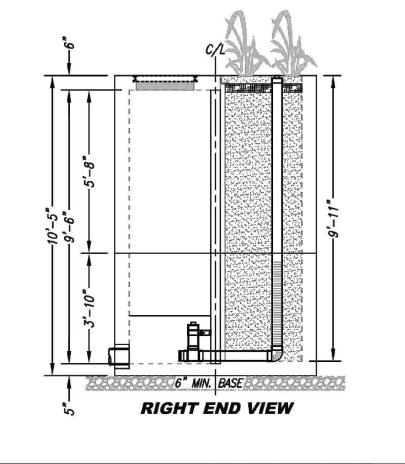
1 CONTECH MWS BIOFILTRATION SYSTEM DETAIL C300 CONTECH

LEFT END VIEW

MWS-L-4-6-9'-11"-V STORMWATER BIOFILTRATION SYSTEM STANDARD DETAIL

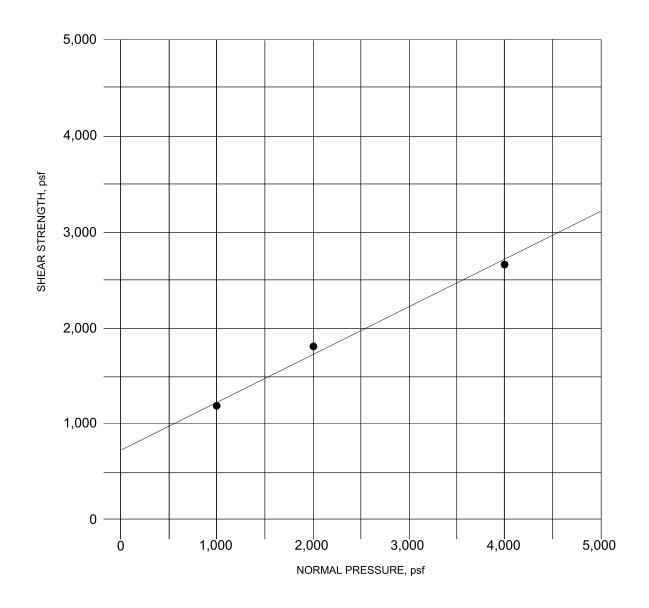
Sp	pecimen I.D.	Classification	γ_{d}	MC%	С	ф
•	T-1 @ 29-29.5'	SILTY SAND (SM), Undisturbed, Saturated			756	25.9

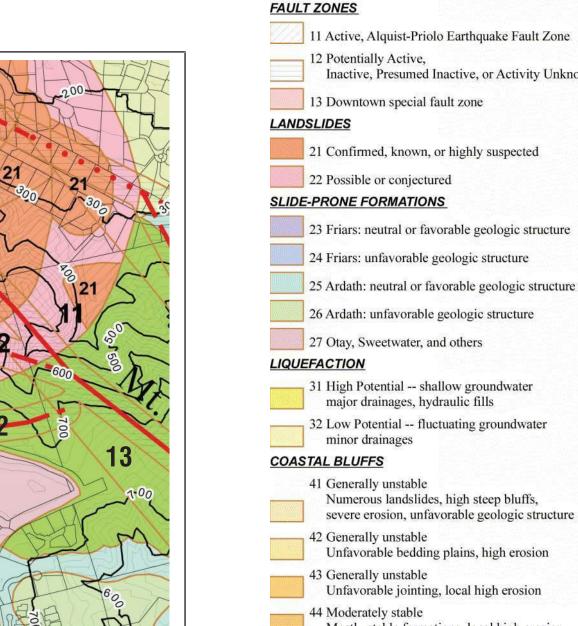
deologic Hazard Categories	
ONES	OTHER TERRAIN
Active, Alquist-Priolo Earthquake Fault Zone	51 Level mesas underlain by terrace deposits and bedrock nomimal risk
Potentially Active, Inactive, Presumed Inactive, or Activity Unknown	52 Other level areas, gently sloping to steep terrain, favorable geologic structure, Low risk
Downtown special fault zone	53 Level or sloping terrain, unfavorable geologic structure,
<u>IDES</u>	Low to moderate risk
Confirmed, known, or highly suspected	54 Steeply sloping terrain, unfavorable or fault controlled geologic structure, Moderate risk
Possible or conjectured	55 Modified terrain (graded sites)
RONE FORMATIONS	Nominal risk
Friars: neutral or favorable geologic structure	Water (Bays and Lakes)
Friars: unfavorable geologic structure	
Ardath: neutral or favorable geologic structure	Fault
Ardath: unfavorable geologic structure	
Otay, Sweetwater, and others	Inferred Fault

CTION	• Concealed Fault
High Potential shallow groundwater major drainages, hydraulic fills	white Shear Zone
Low Potential fluctuating groundwater minor drainages	
<u>L BLUFFS</u>	
Generally unstable Numerous landslides, high steep bluffs, severe erosion, unfavorable geologic structure

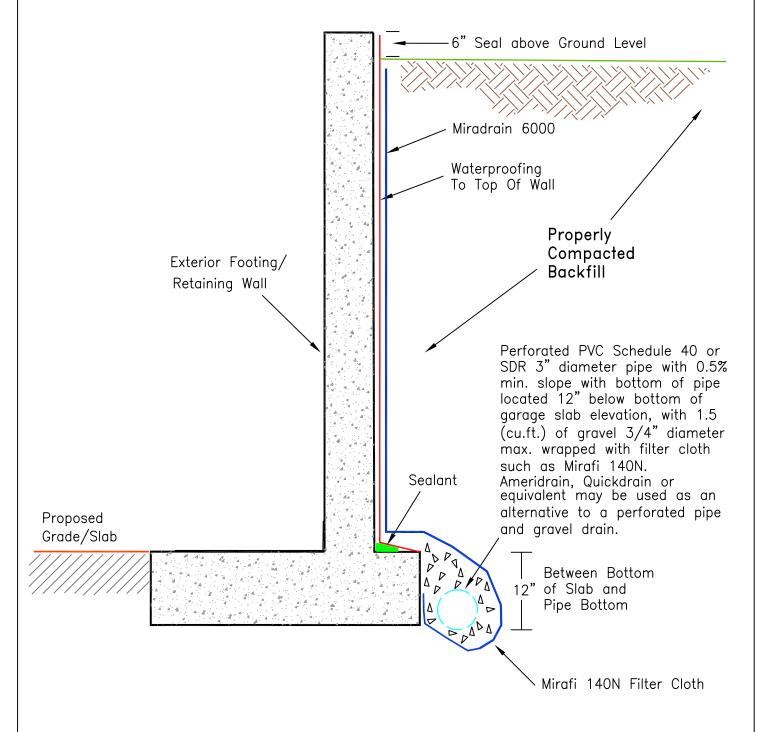
SUBGRADE RETAINING WALL DRAINAGE RECOMMENDATIONS

NOTE: As an option to Miradrain 6000, gravel or crushed rock 3/4" maximum diameter may be used with a minimum 12" thickness along the exterior face of the wall and 2.0 cu/ft of pipe.

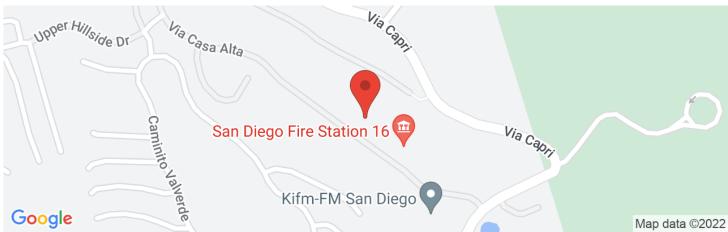
Date		7/2	2/2022, 10:32:17 AM	
Design Code Ref	ference Document	AS	CE7-16	
Risk Category		II		
Site Class		C -	Very Dense Soil and Soft Rock

Туре	Value	Description
S _S	1.416	MCE _R ground motion. (for 0.2 second period)
S ₁	0.494	MCE _R ground motion. (for 1.0s period)
S _{MS}	1.699	Site-modified spectral acceleration value
S _{M1}	0.742	Site-modified spectral acceleration value
S _{DS}	1.133	Numeric seismic design value at 0.2 second SA
S _{D1}	0.494	Numeric seismic design value at 1.0 second SA

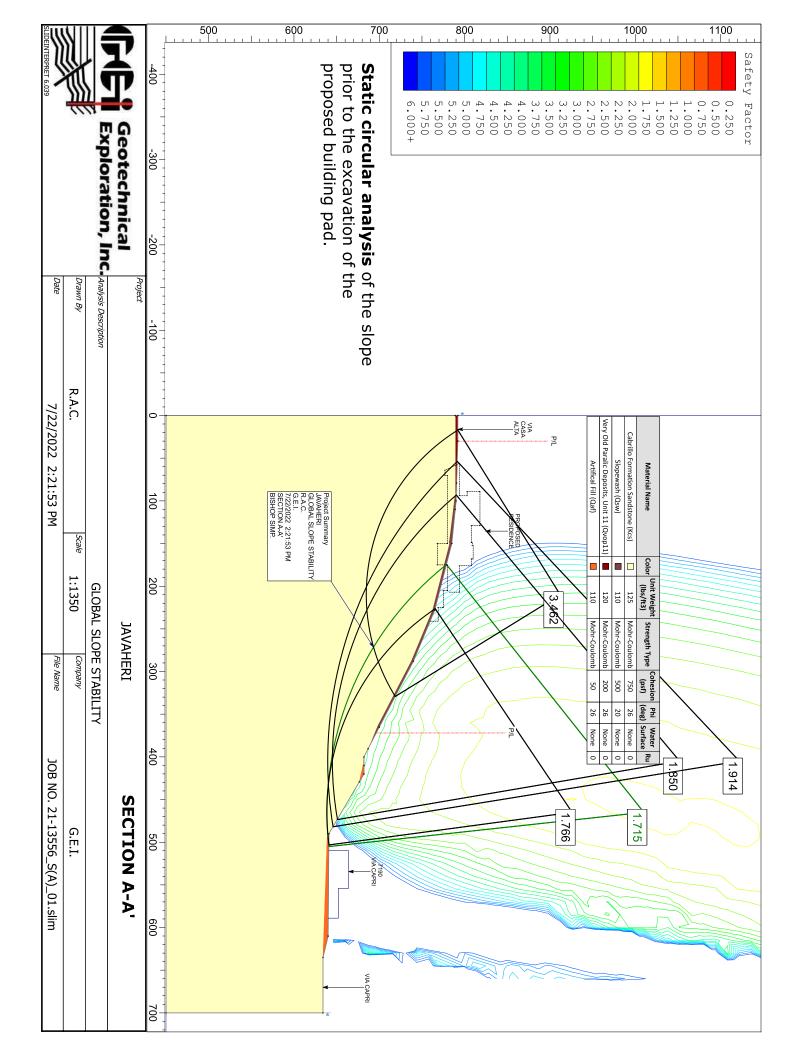
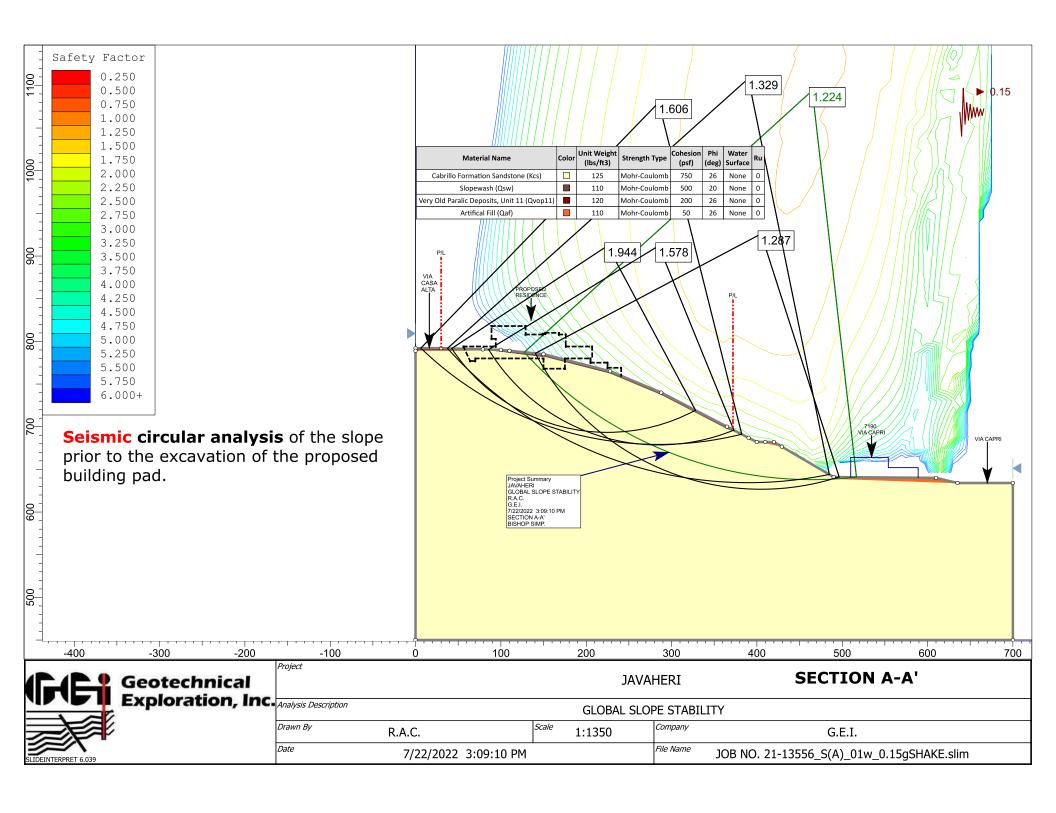
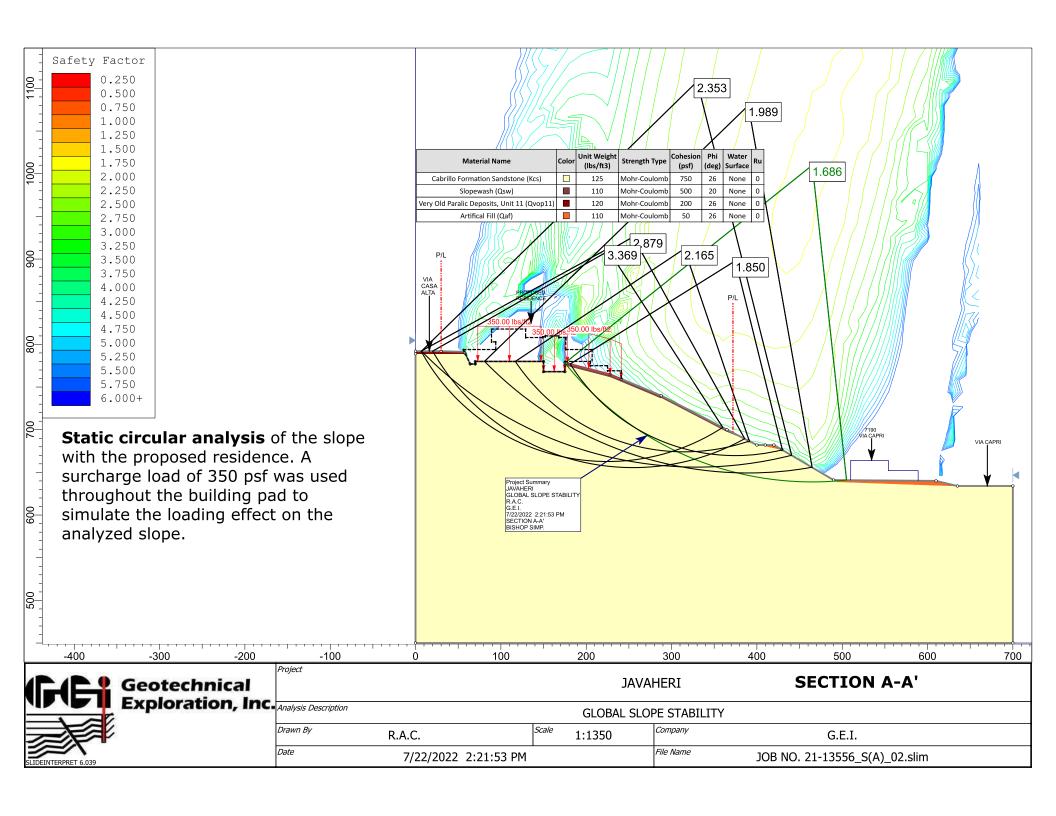
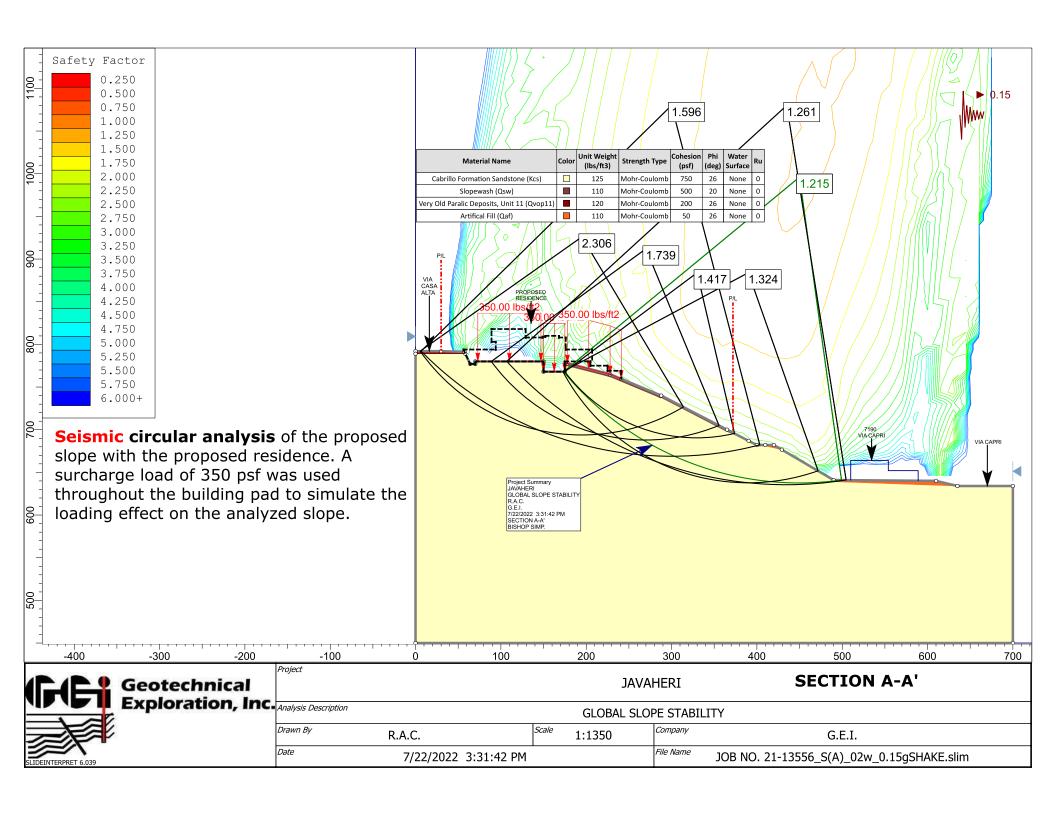
Slope Stability Analysis

FOS = $\frac{c' + (\gamma_T - \gamma_W) \mathbf{z}_W \cos(\alpha)^2 \tan \phi'}{\gamma_T \mathbf{z}_W \sin \alpha \cos \alpha}$
