REPORT OF PRELIMINARY GEOTECHNICAL INVESTIGATION

PROPOSED CIELO MAR RESIDENTIAL SUBDIVISION

8303 LA JOLLA SHORES DRIVE

LA JOLLA, CALIFORNIA

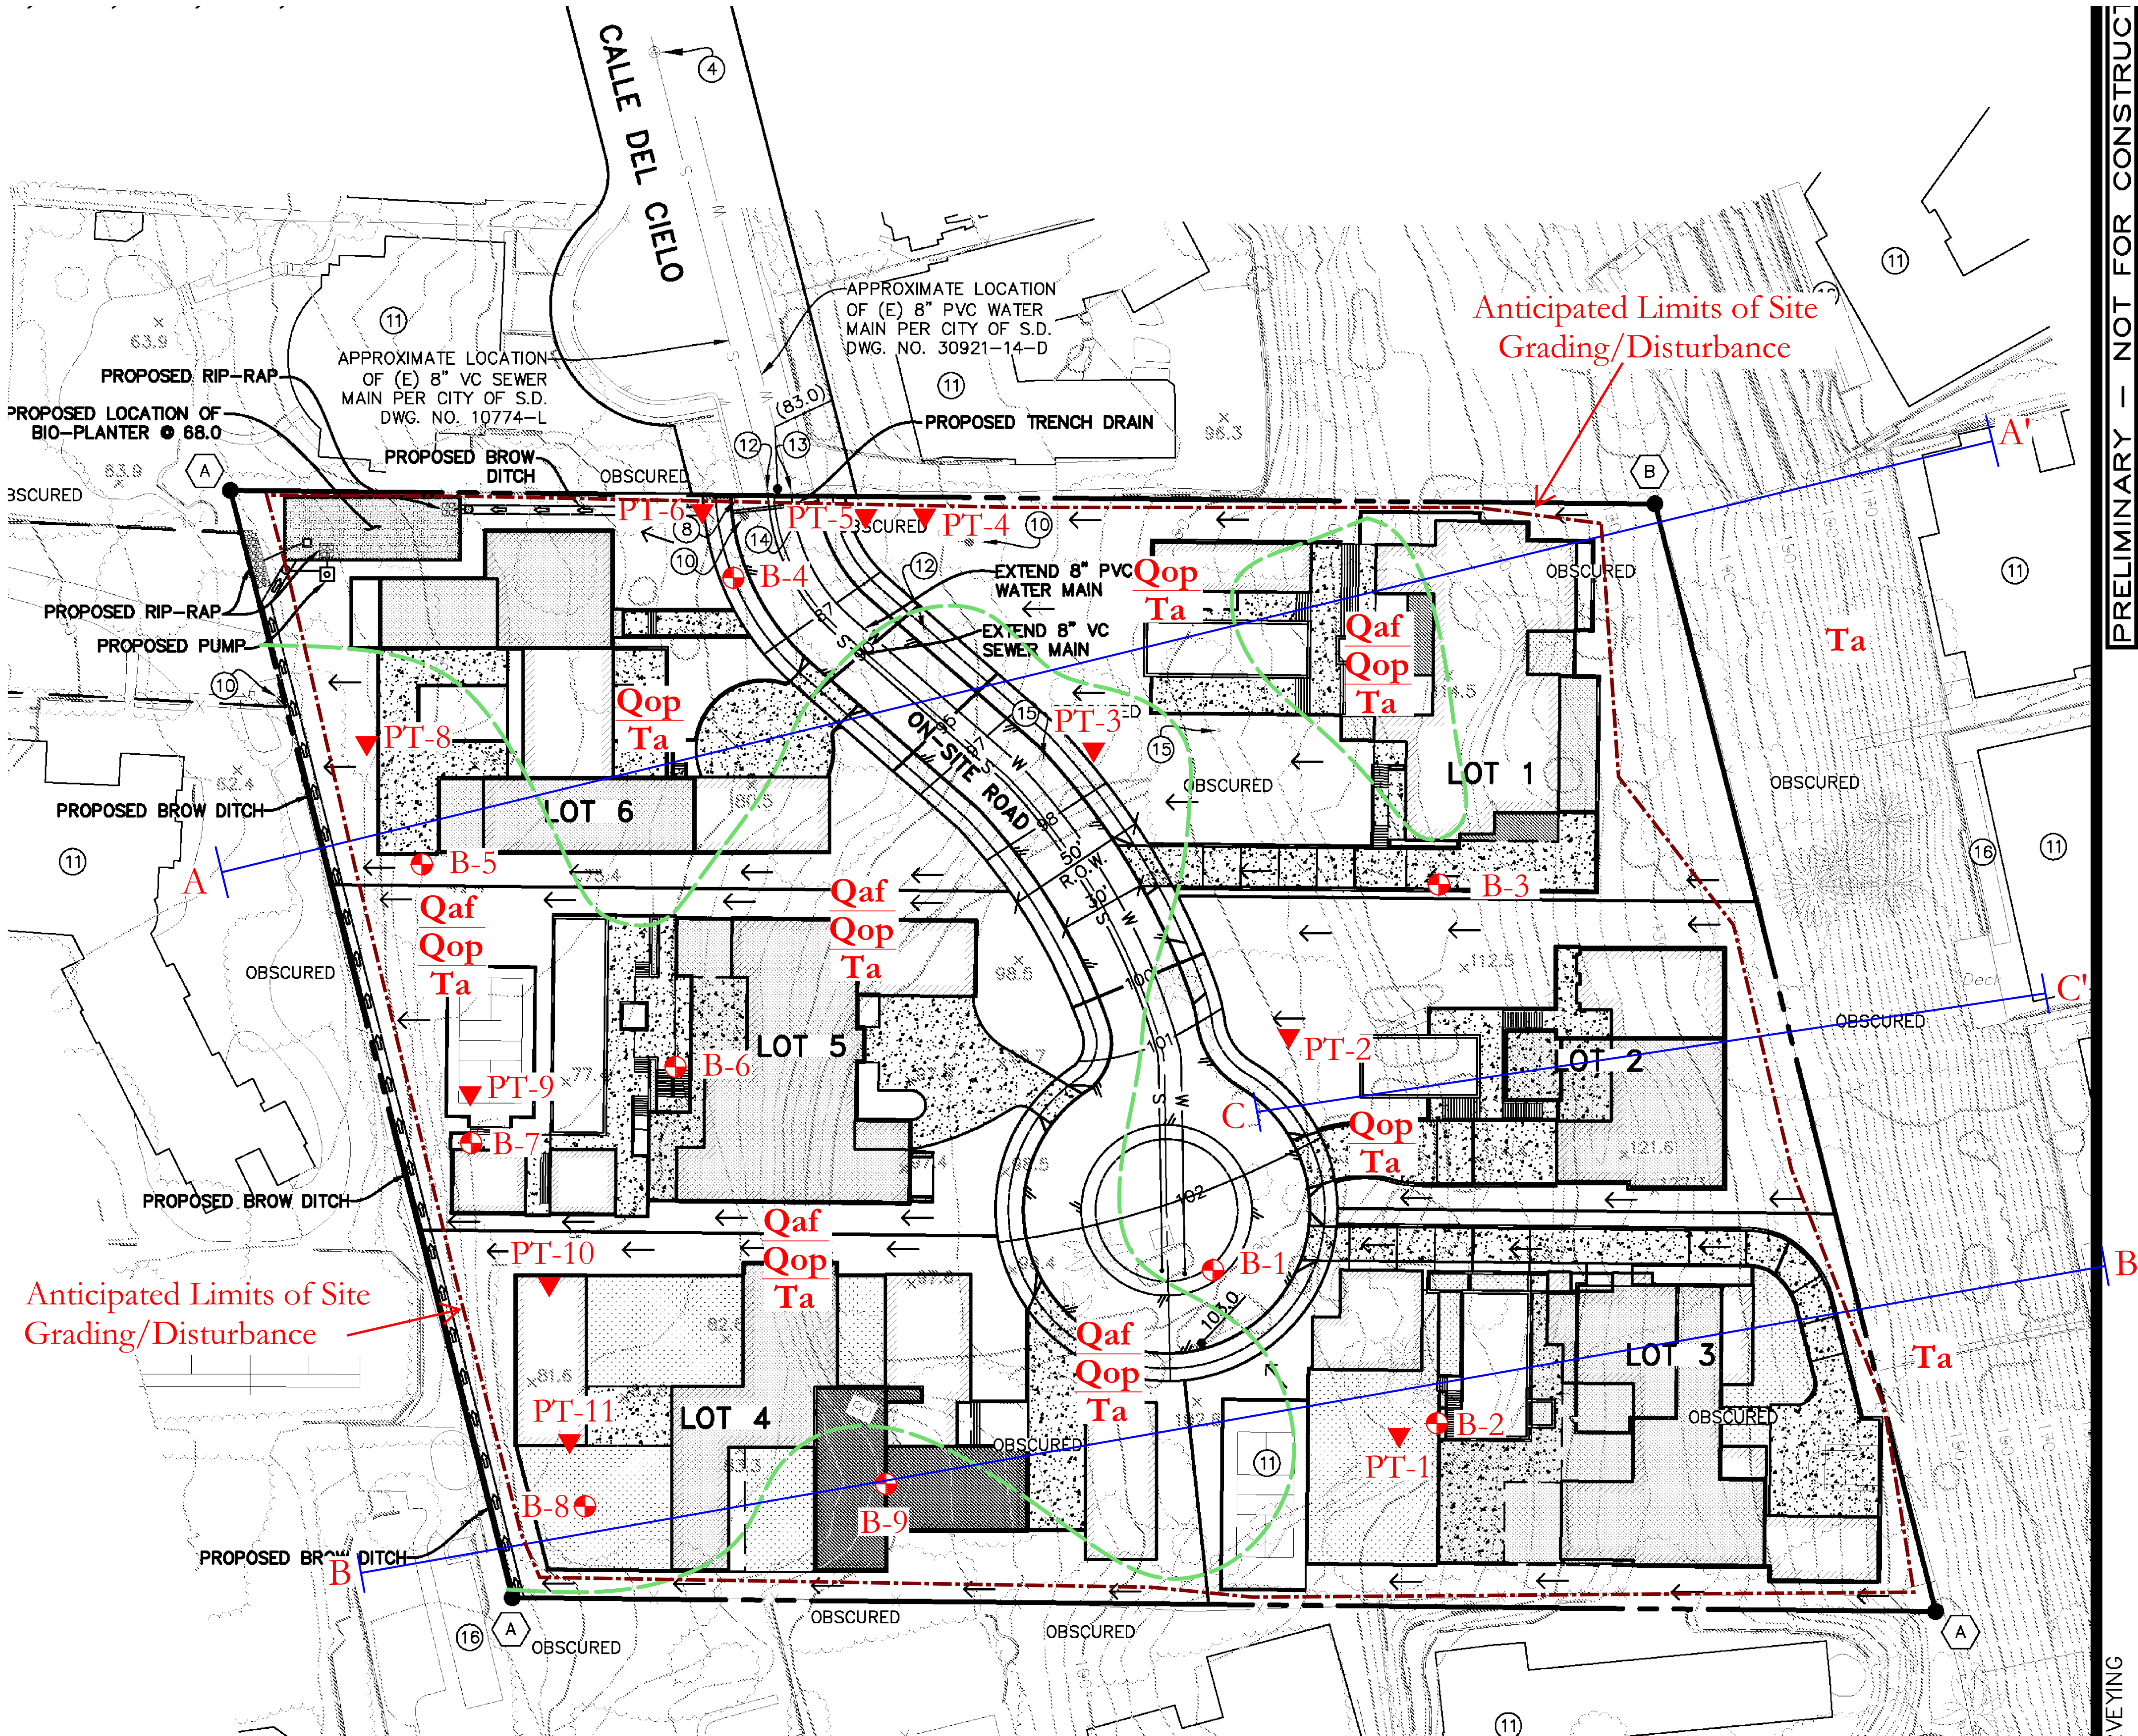
PROPOSED CIELO MAR RESIDENTIAL SUBDIVISION
8303 LA JOLLA SHORES DRIVE
LA JOLLA, CALIFORNIA
DATE: SEPTEMBER 2023 JOB NO.: 2220609.01
BY: SD PLATE NO.: 1

- B-9 APPROXIMATE BORING LOCATION
- PT-11 APPROXIMATE PERCOLATION TEST LOCATION
- GEOLOGIC CONTACT
- ARTIFICIAL FILL OVER OLD PARALIC DEPOSITS
- OLD PARALIC DEPOSITS OVER ARDATH SHALE
- ARDATH SHALE
- GEOLOGIC CROSS SECTION

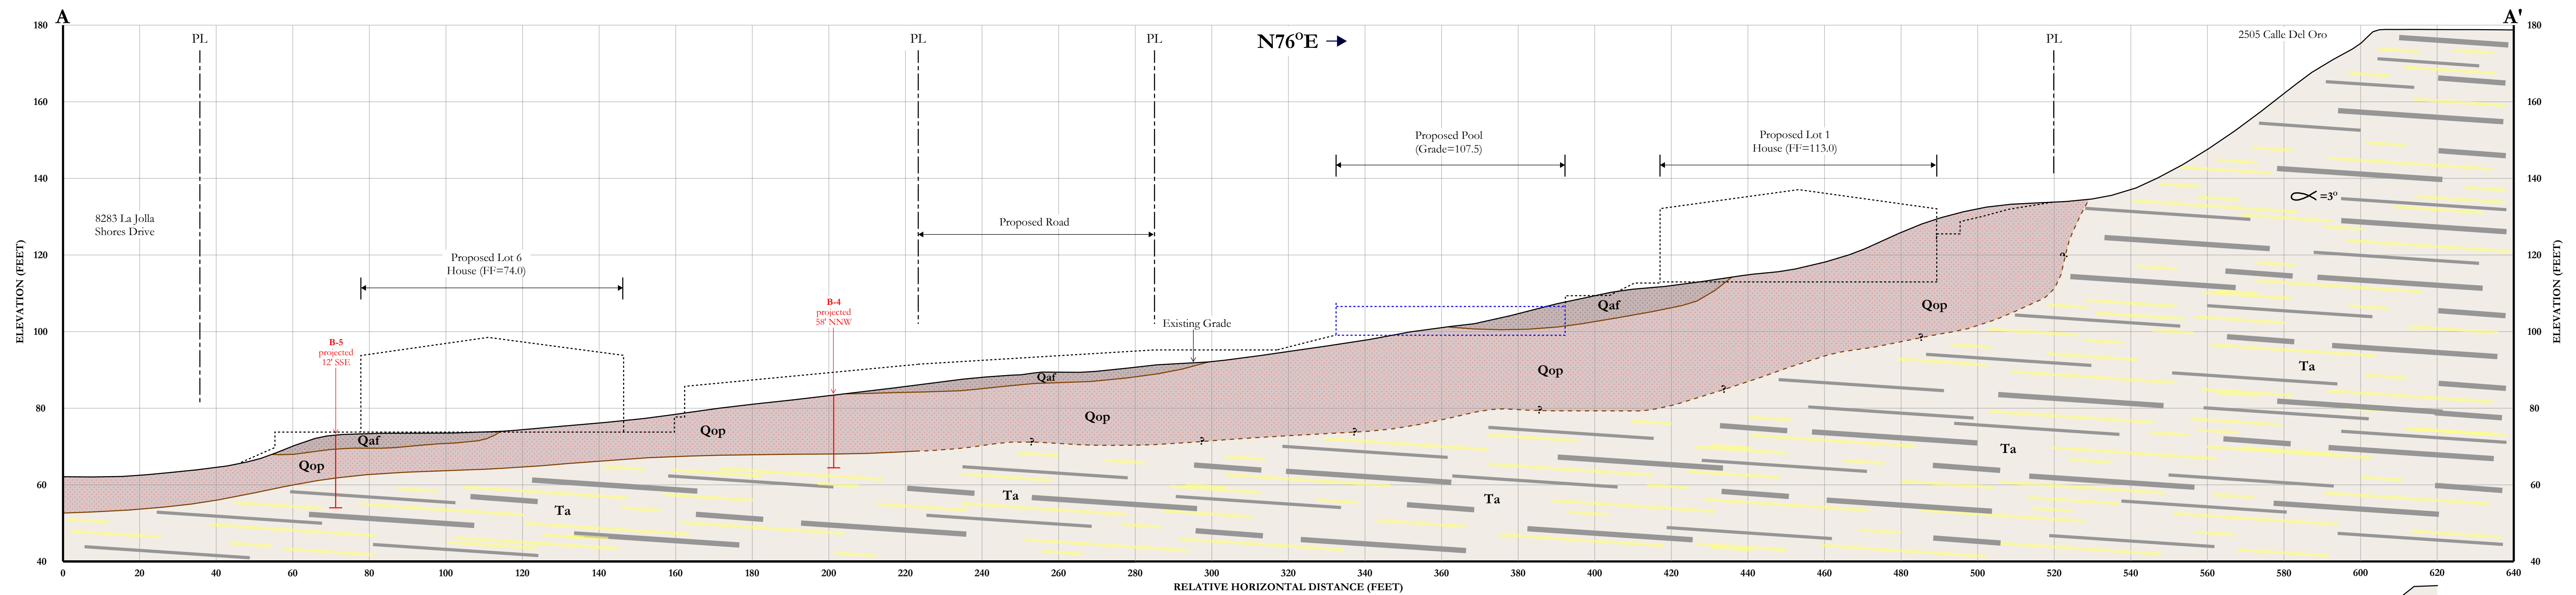
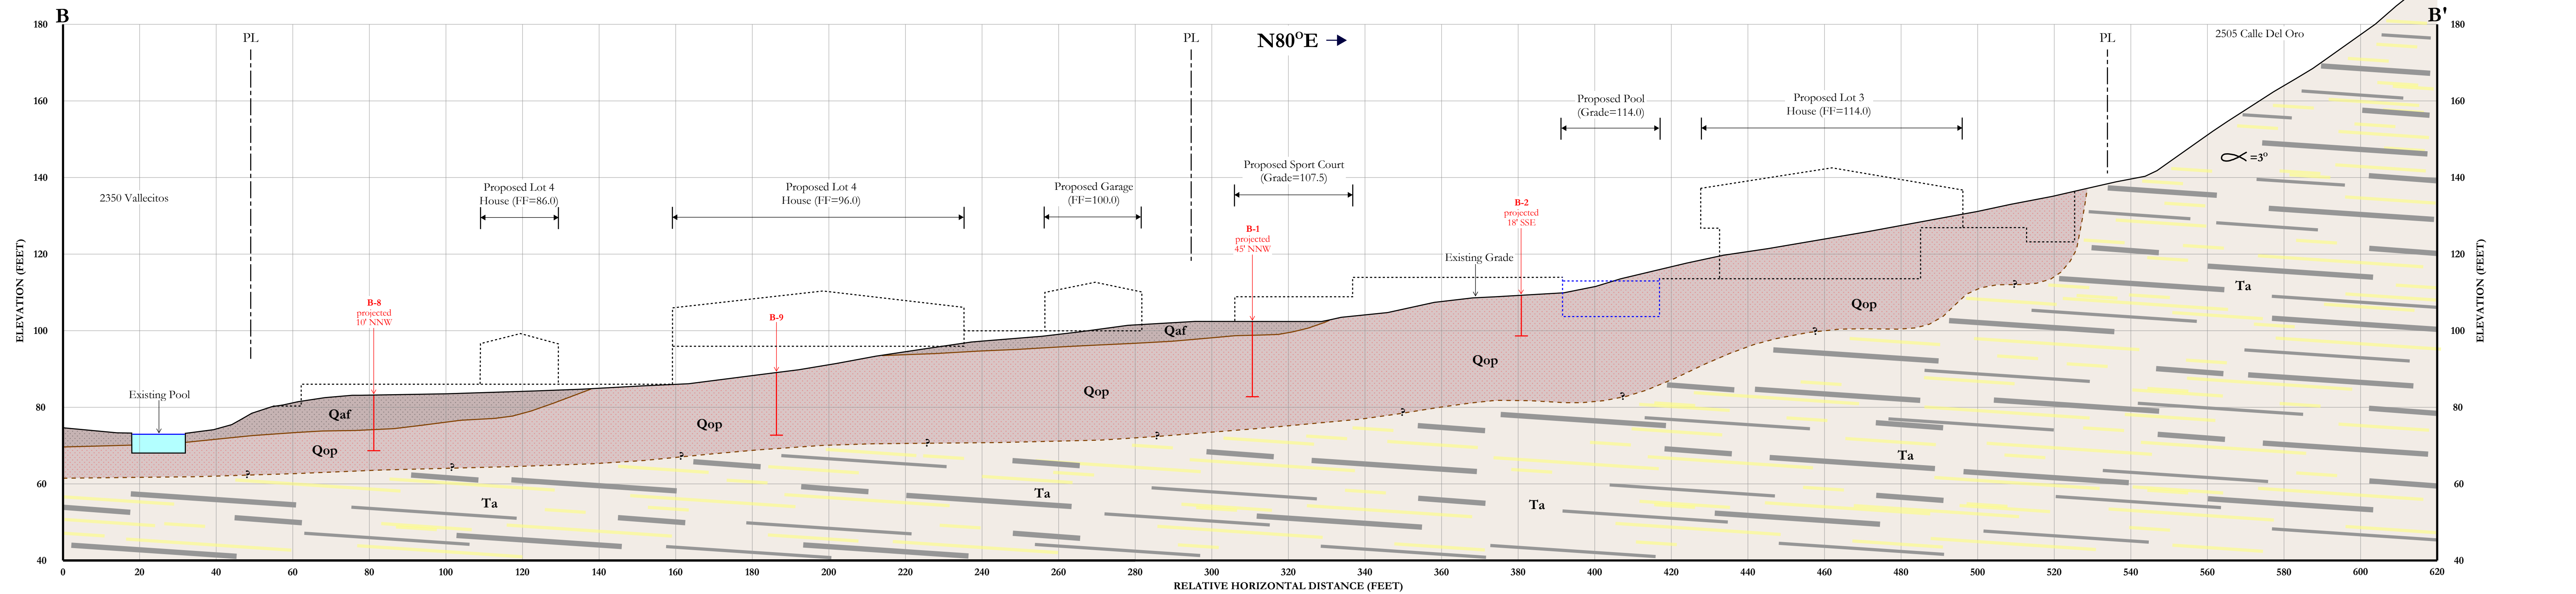
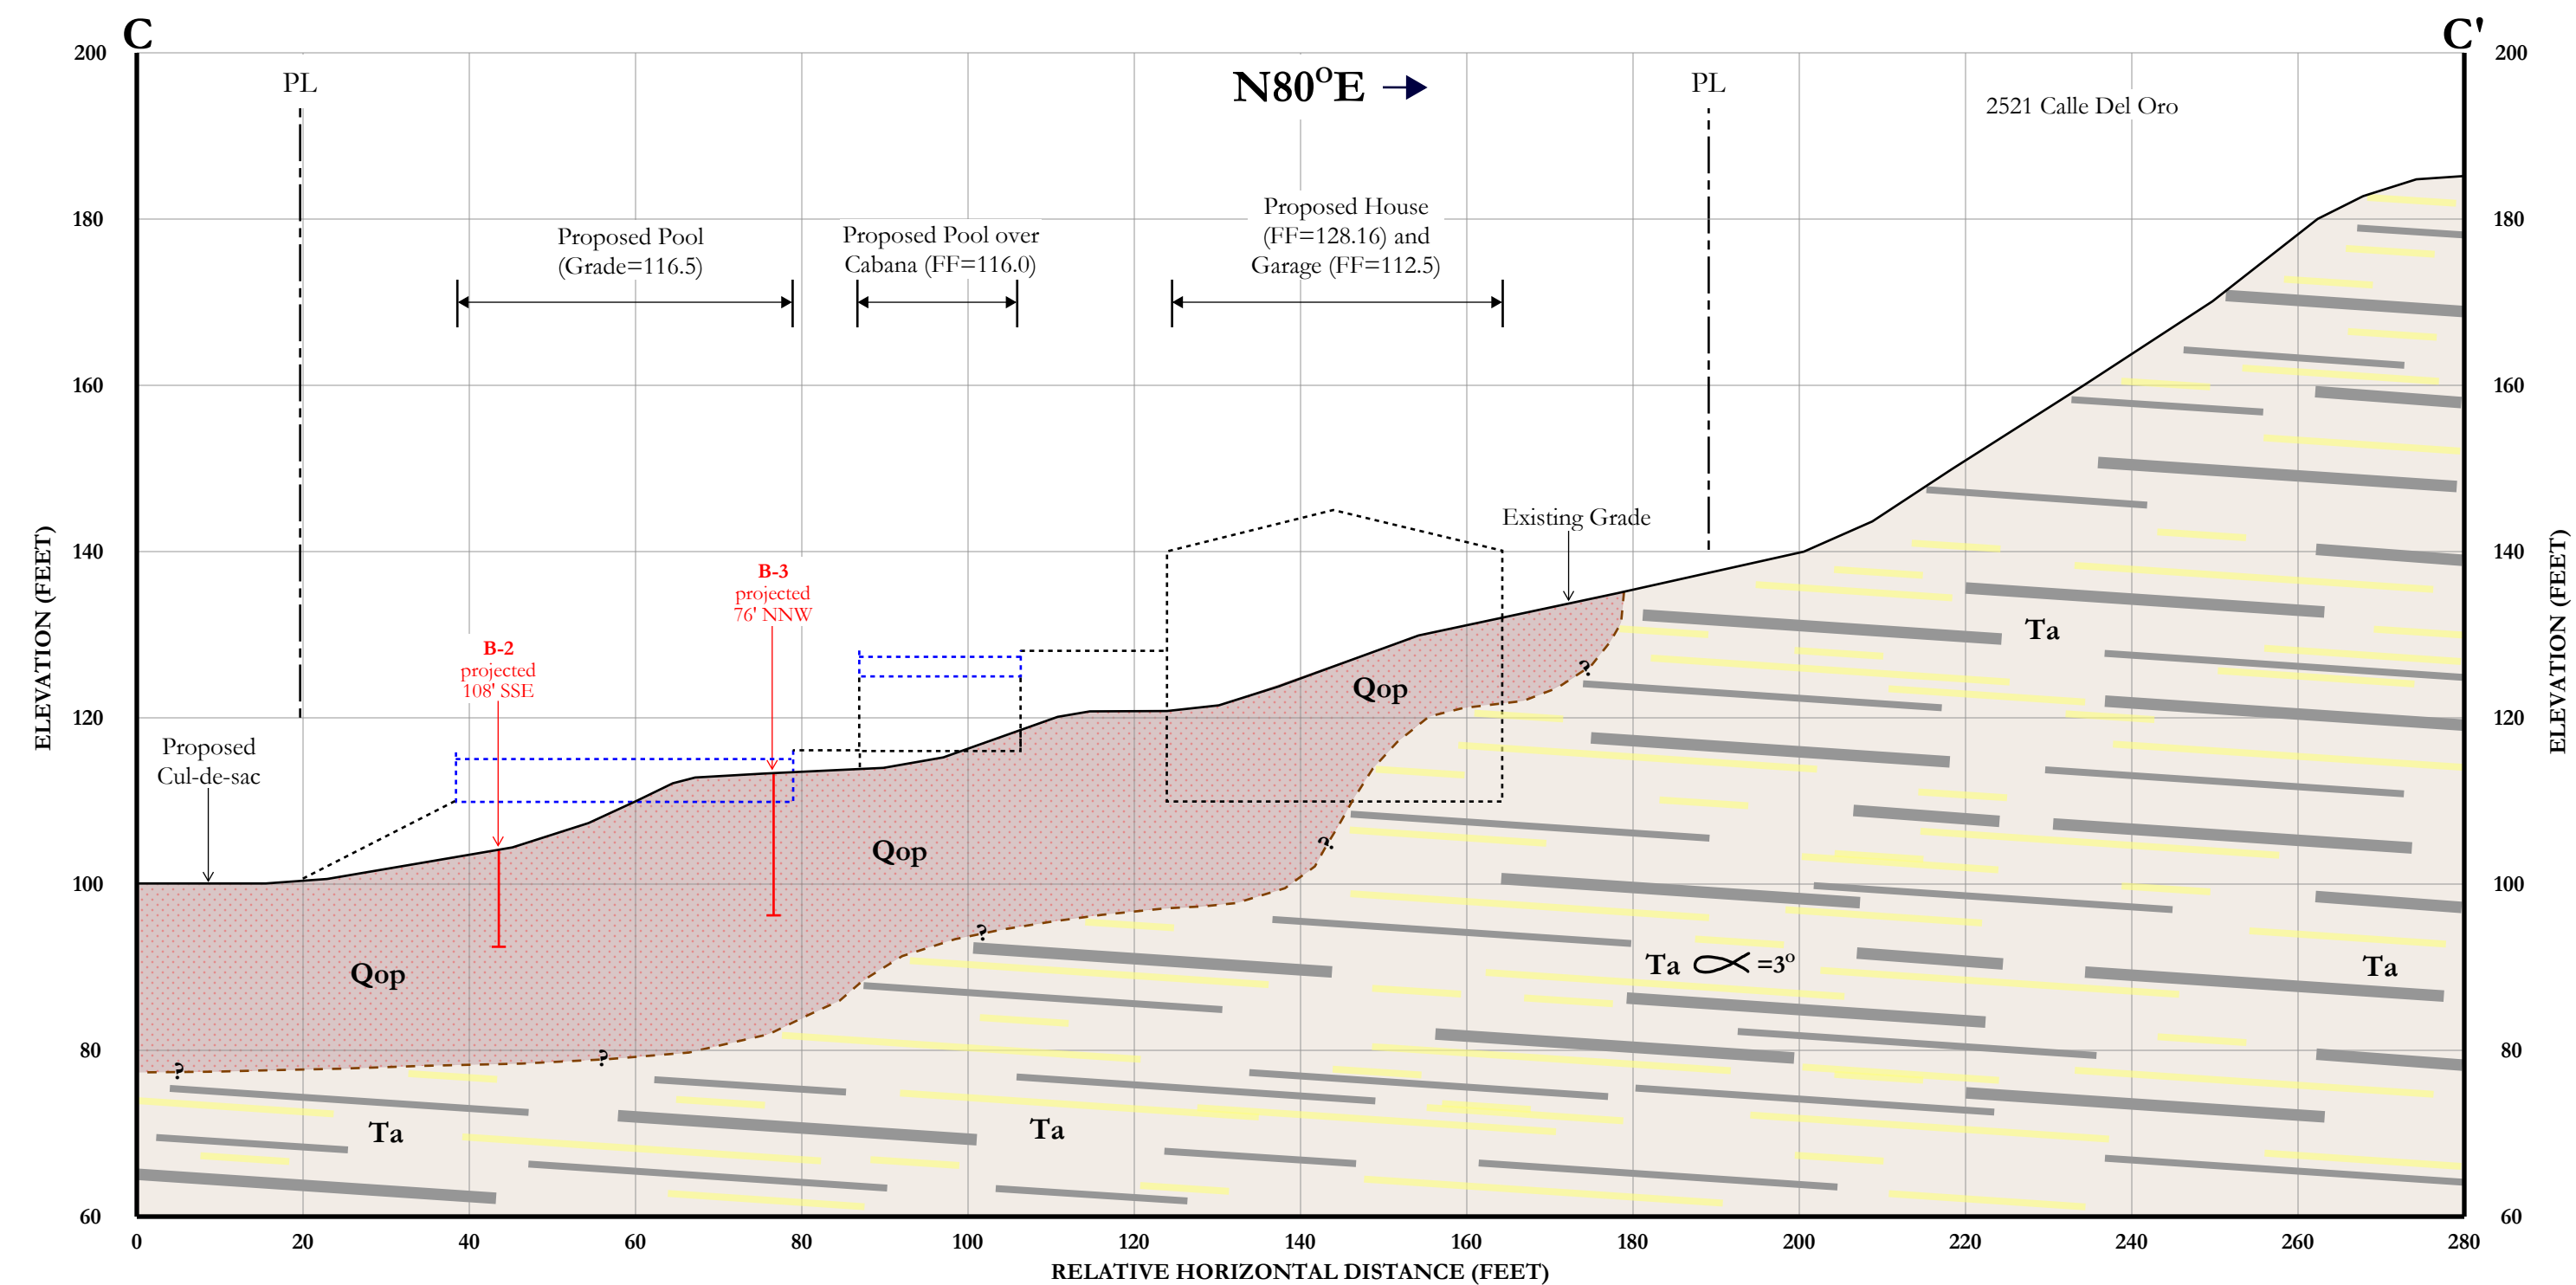
| PROPOSED CIELO MAR RESIDENTIAL SUBDIVISION 8303 LA JOLLA SHORES DRIVE LA JOLLA, CA | |
|--|---|
| BY: JMM | PLATE NO.: 2 |

| CWE LEGEND | |
|---|---|
| Qaf | ARTIFICIAL FILL SOILS |

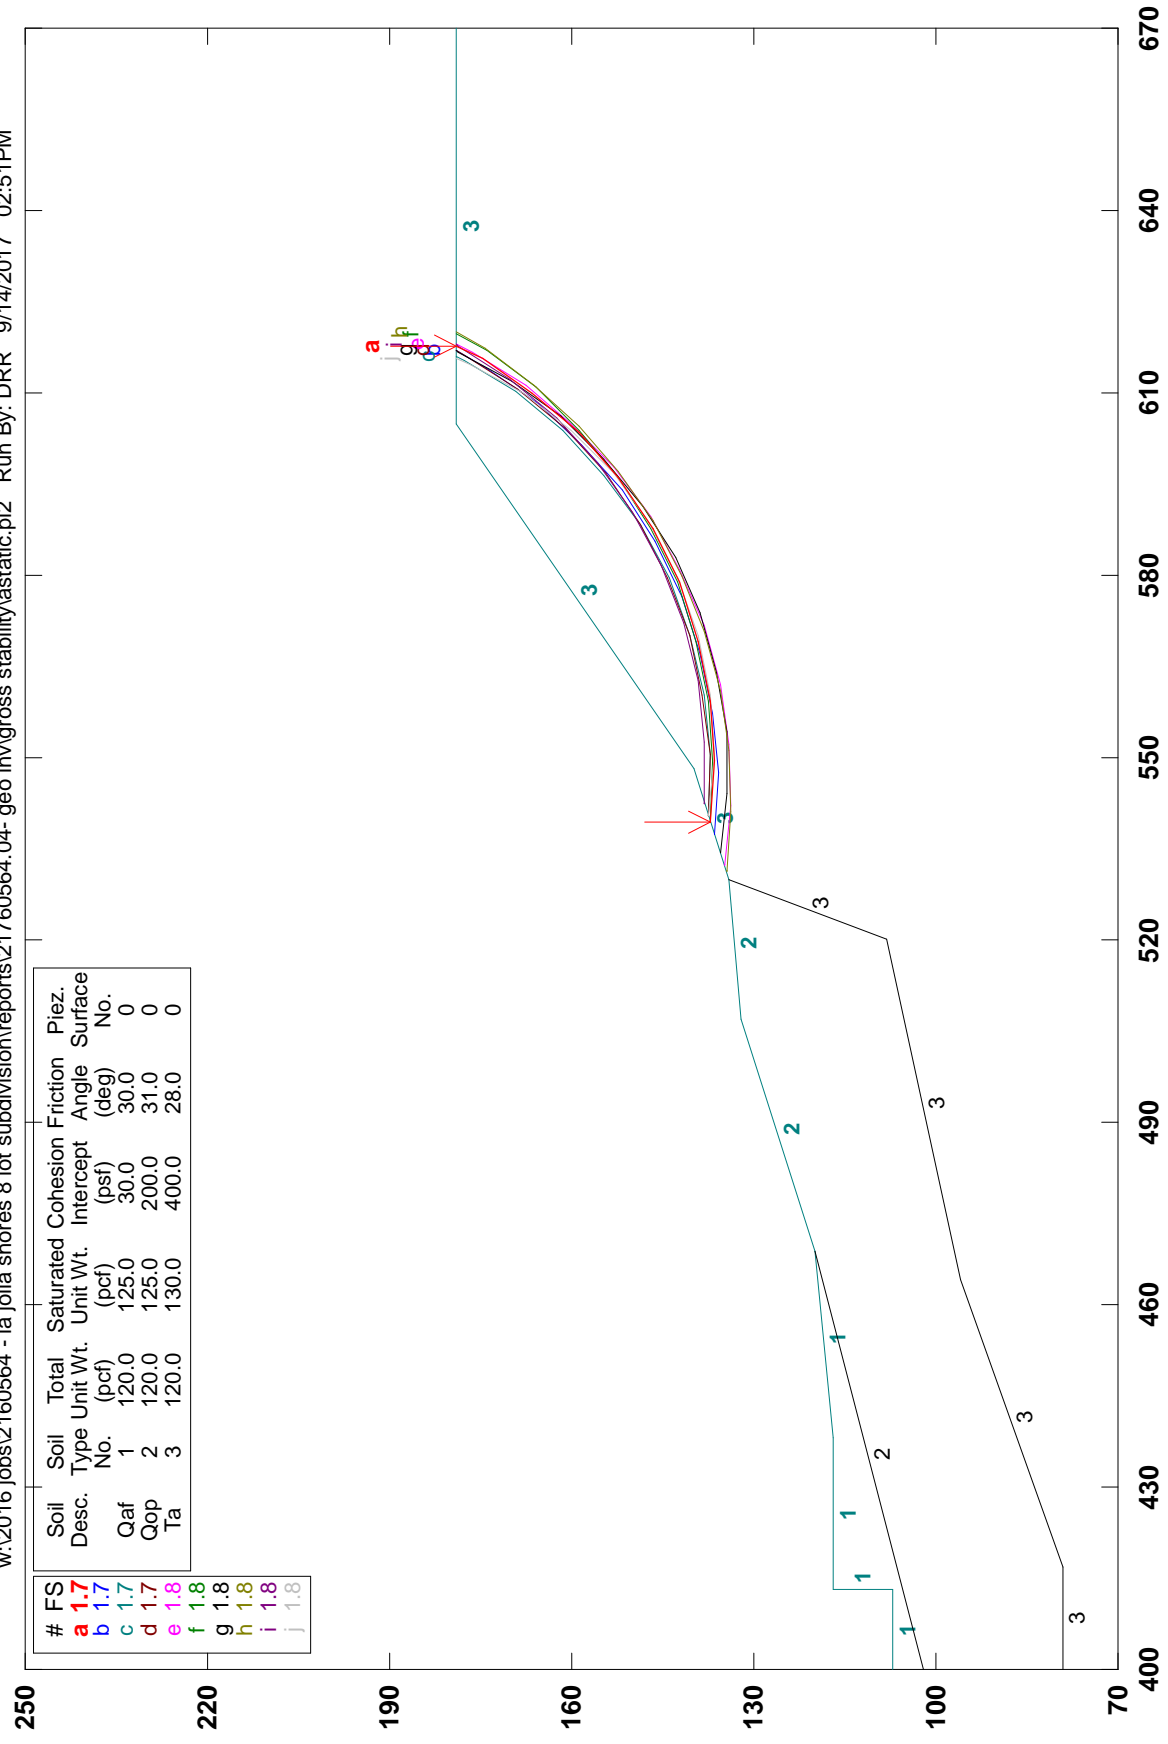
CWE 2160654.04 Cross Section A+400 - A'

GSTABL7 v.2 FSmin=1.7
Safety Factors Are Calculated By The Modified Bishop Method

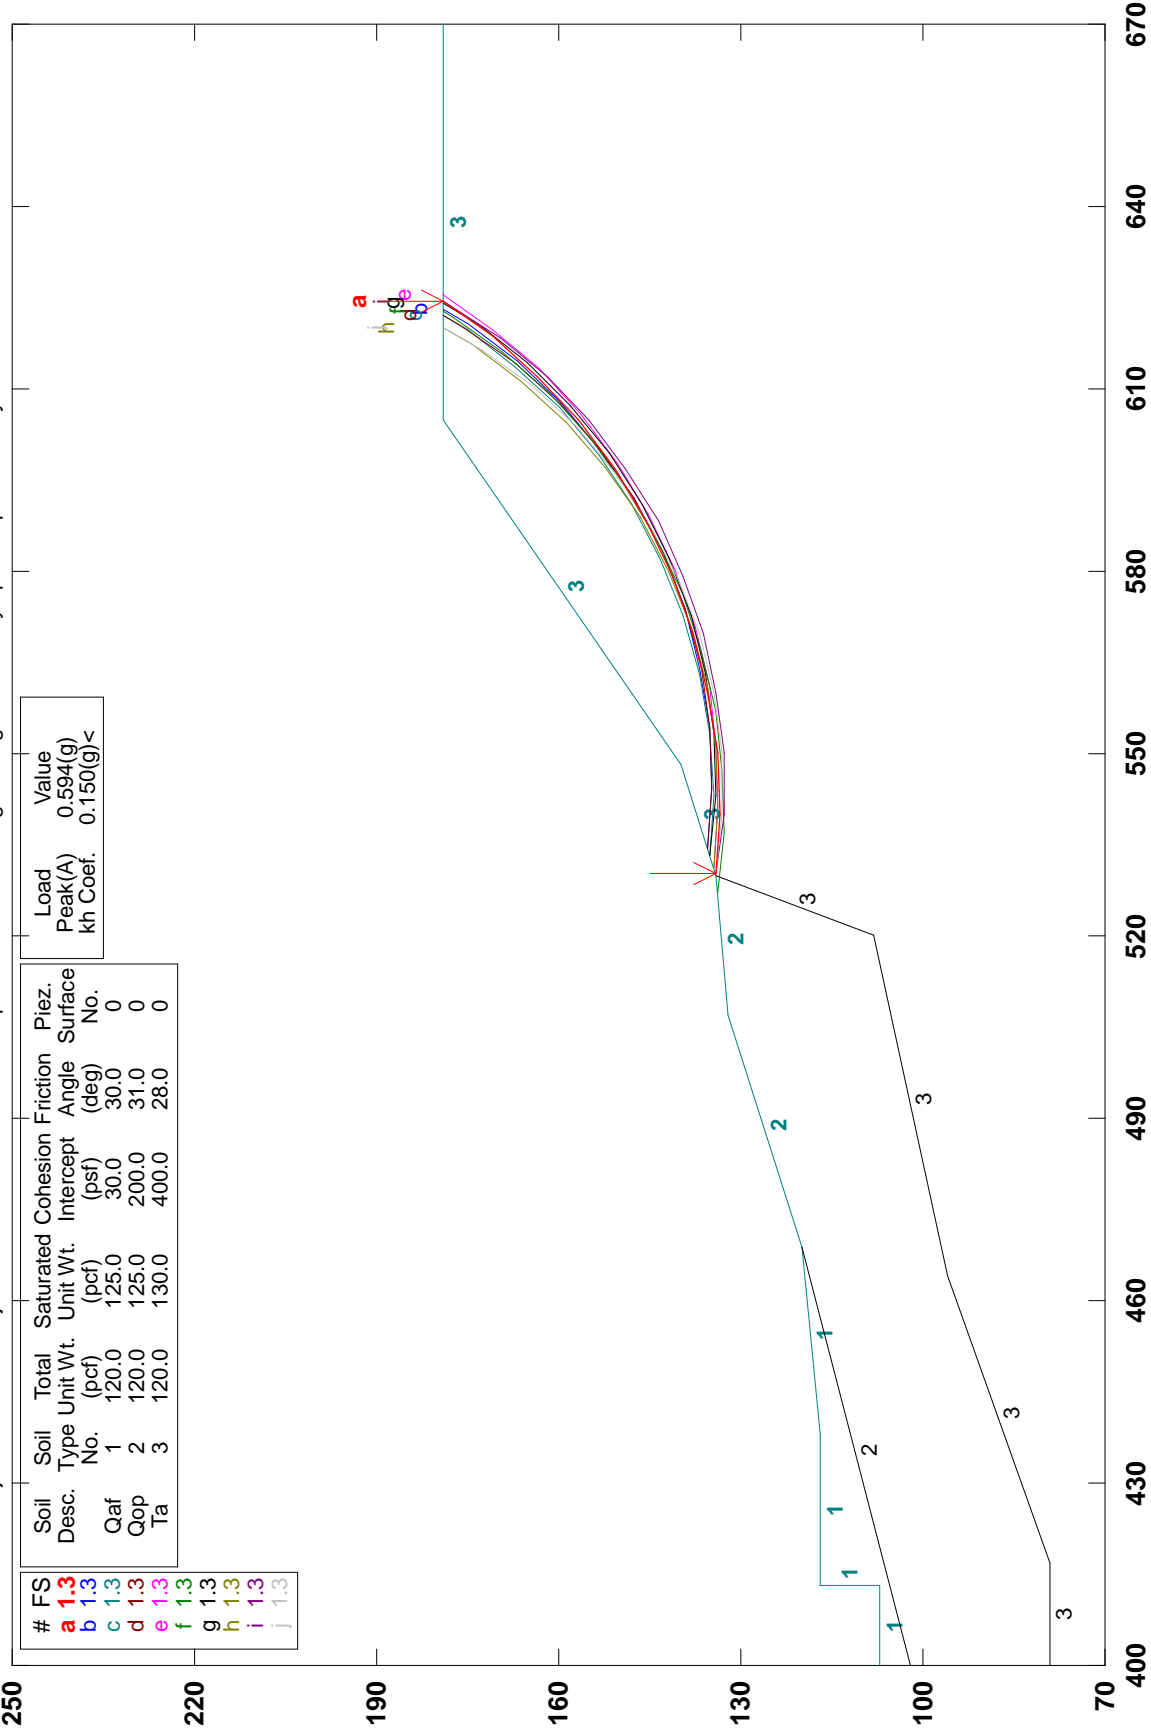
CWE 2160654.04 Cross Section A+400 - A'

GSTABL7 v.2 FSmin=1.3
Safety Factors Are Calculated By The Modified Bishop Method

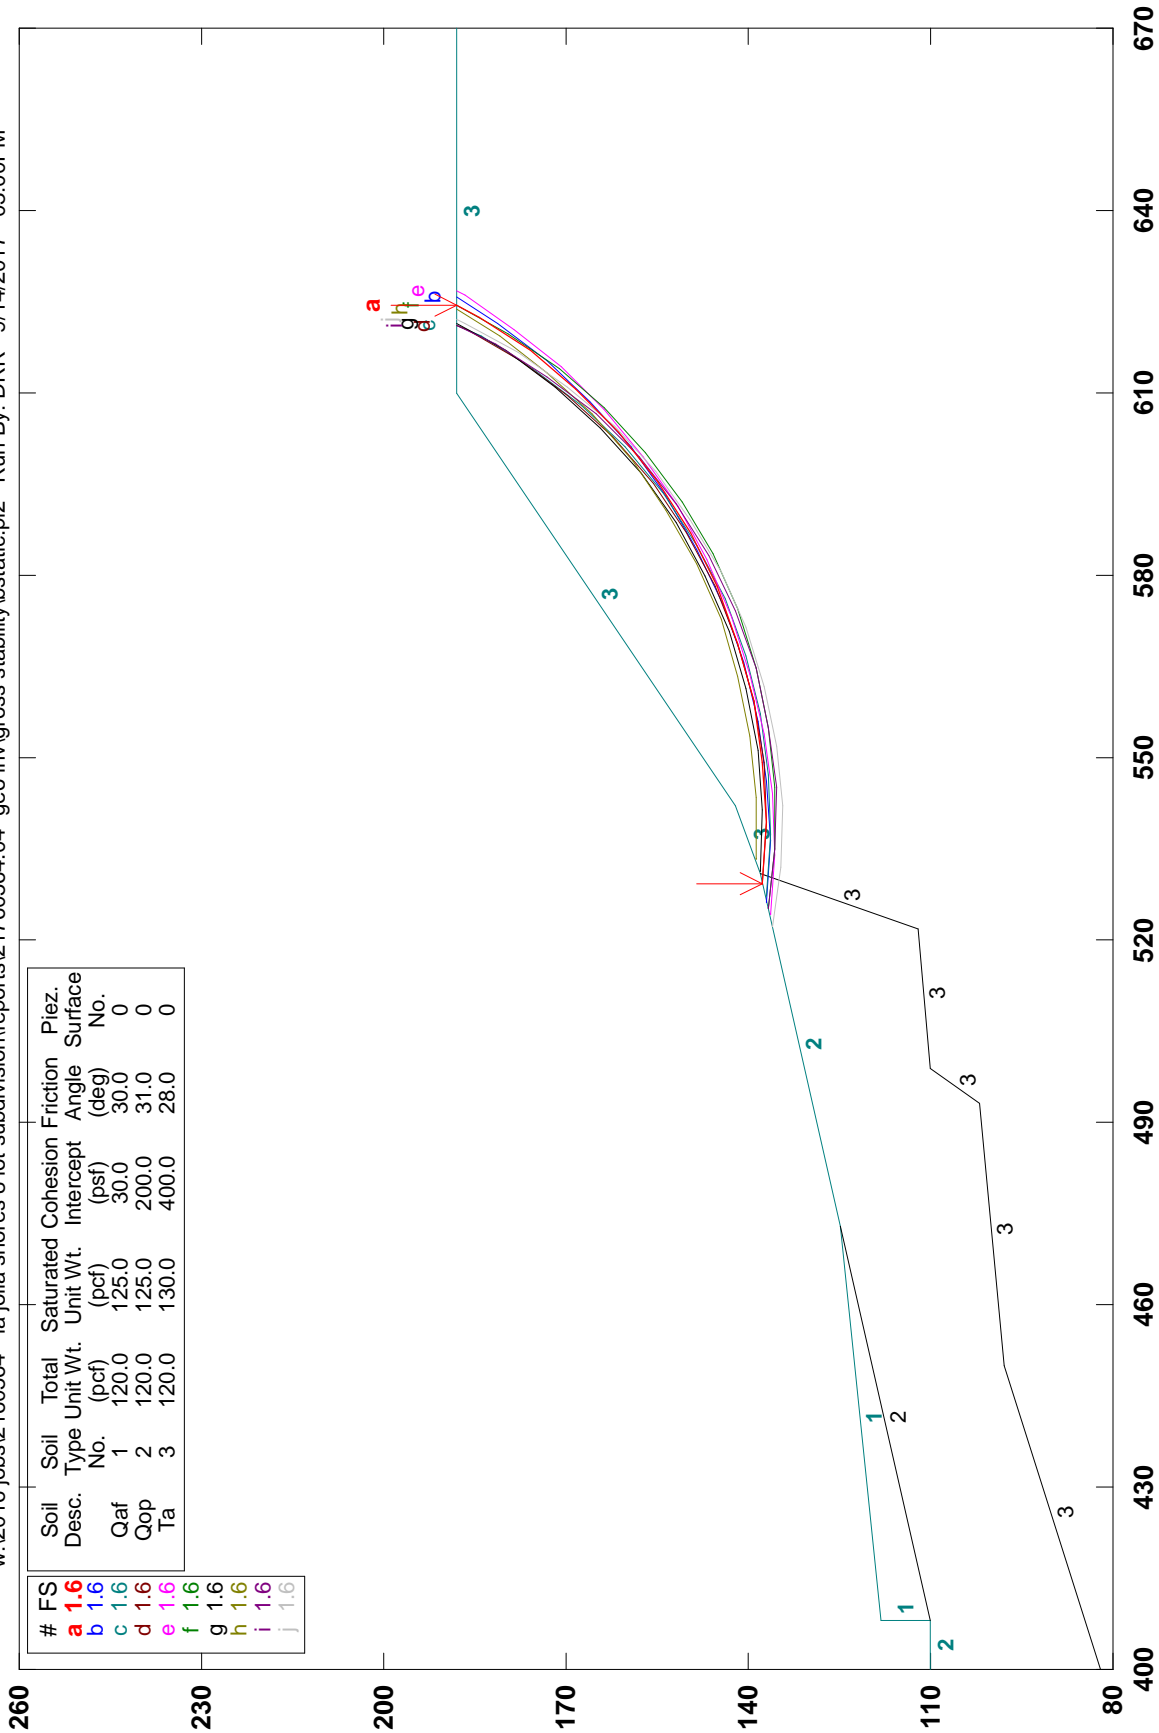
CWE 2160654.04 Cross Section B+400 - B'

GSTABL7 v.2 FSmin=1.6
Safety Factors Are Calculated By The Modified Bishop Method

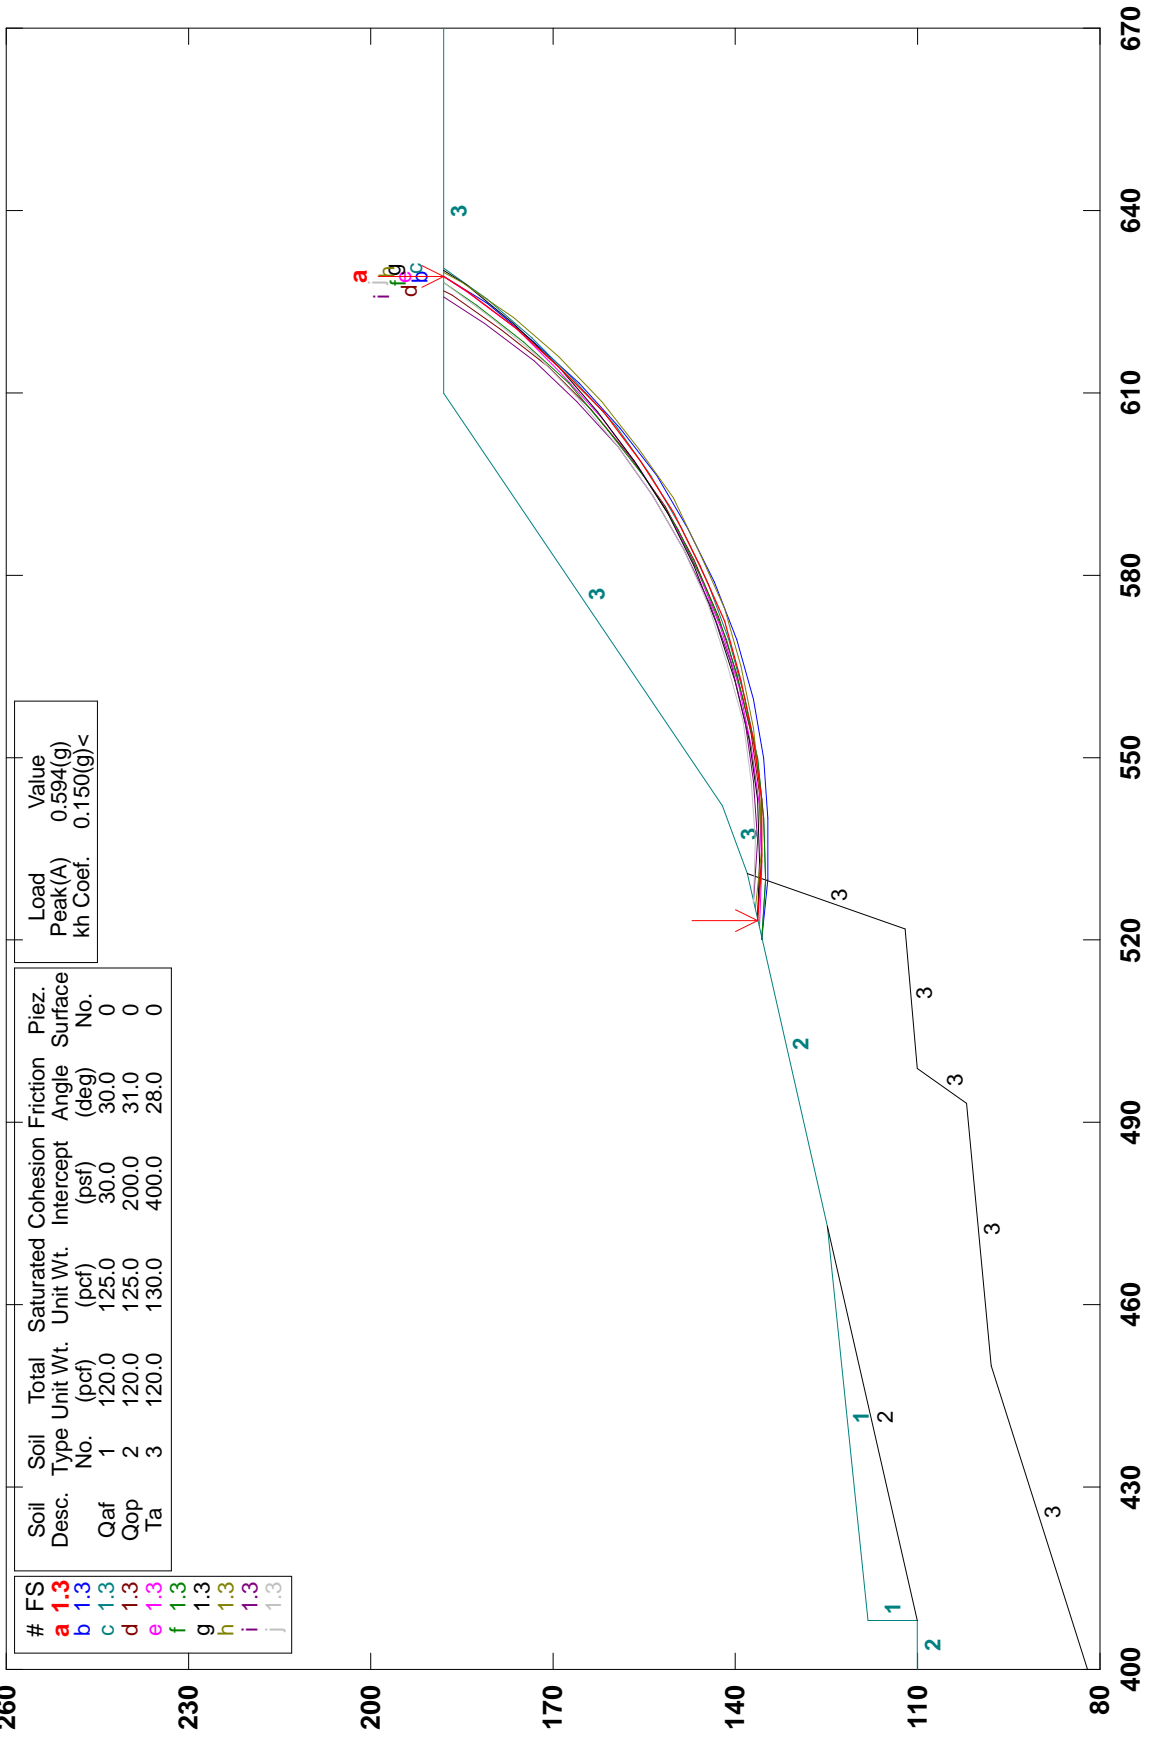
CWE 2160654.04 Cross Section B+400 - B'

| # | FS | Soil Desc. | Soil Type No. | Total Unit Wt. (pcf) | Saturated Unit Wt. (pcf) | Cohesion Intercept (psf) | Friction Angle (deg) | Piez. Surface No. |
| a | 1.3 | Qaf | 1 | 120.0 | 125.0 | 30.0 | 30.0 | 0 |

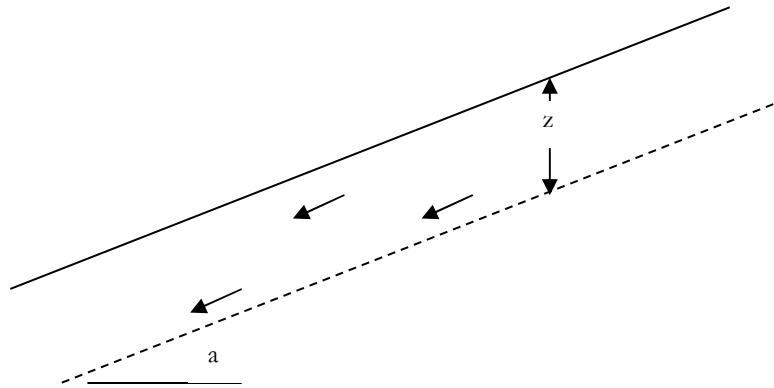
SURFICIAL SLOPE STABILITY - 2:1 (H:V) Qaf

SEEPAGE PARALLEL TO SLOPE

ASSUMED PARAMETERS

Surficial Stability Analysis

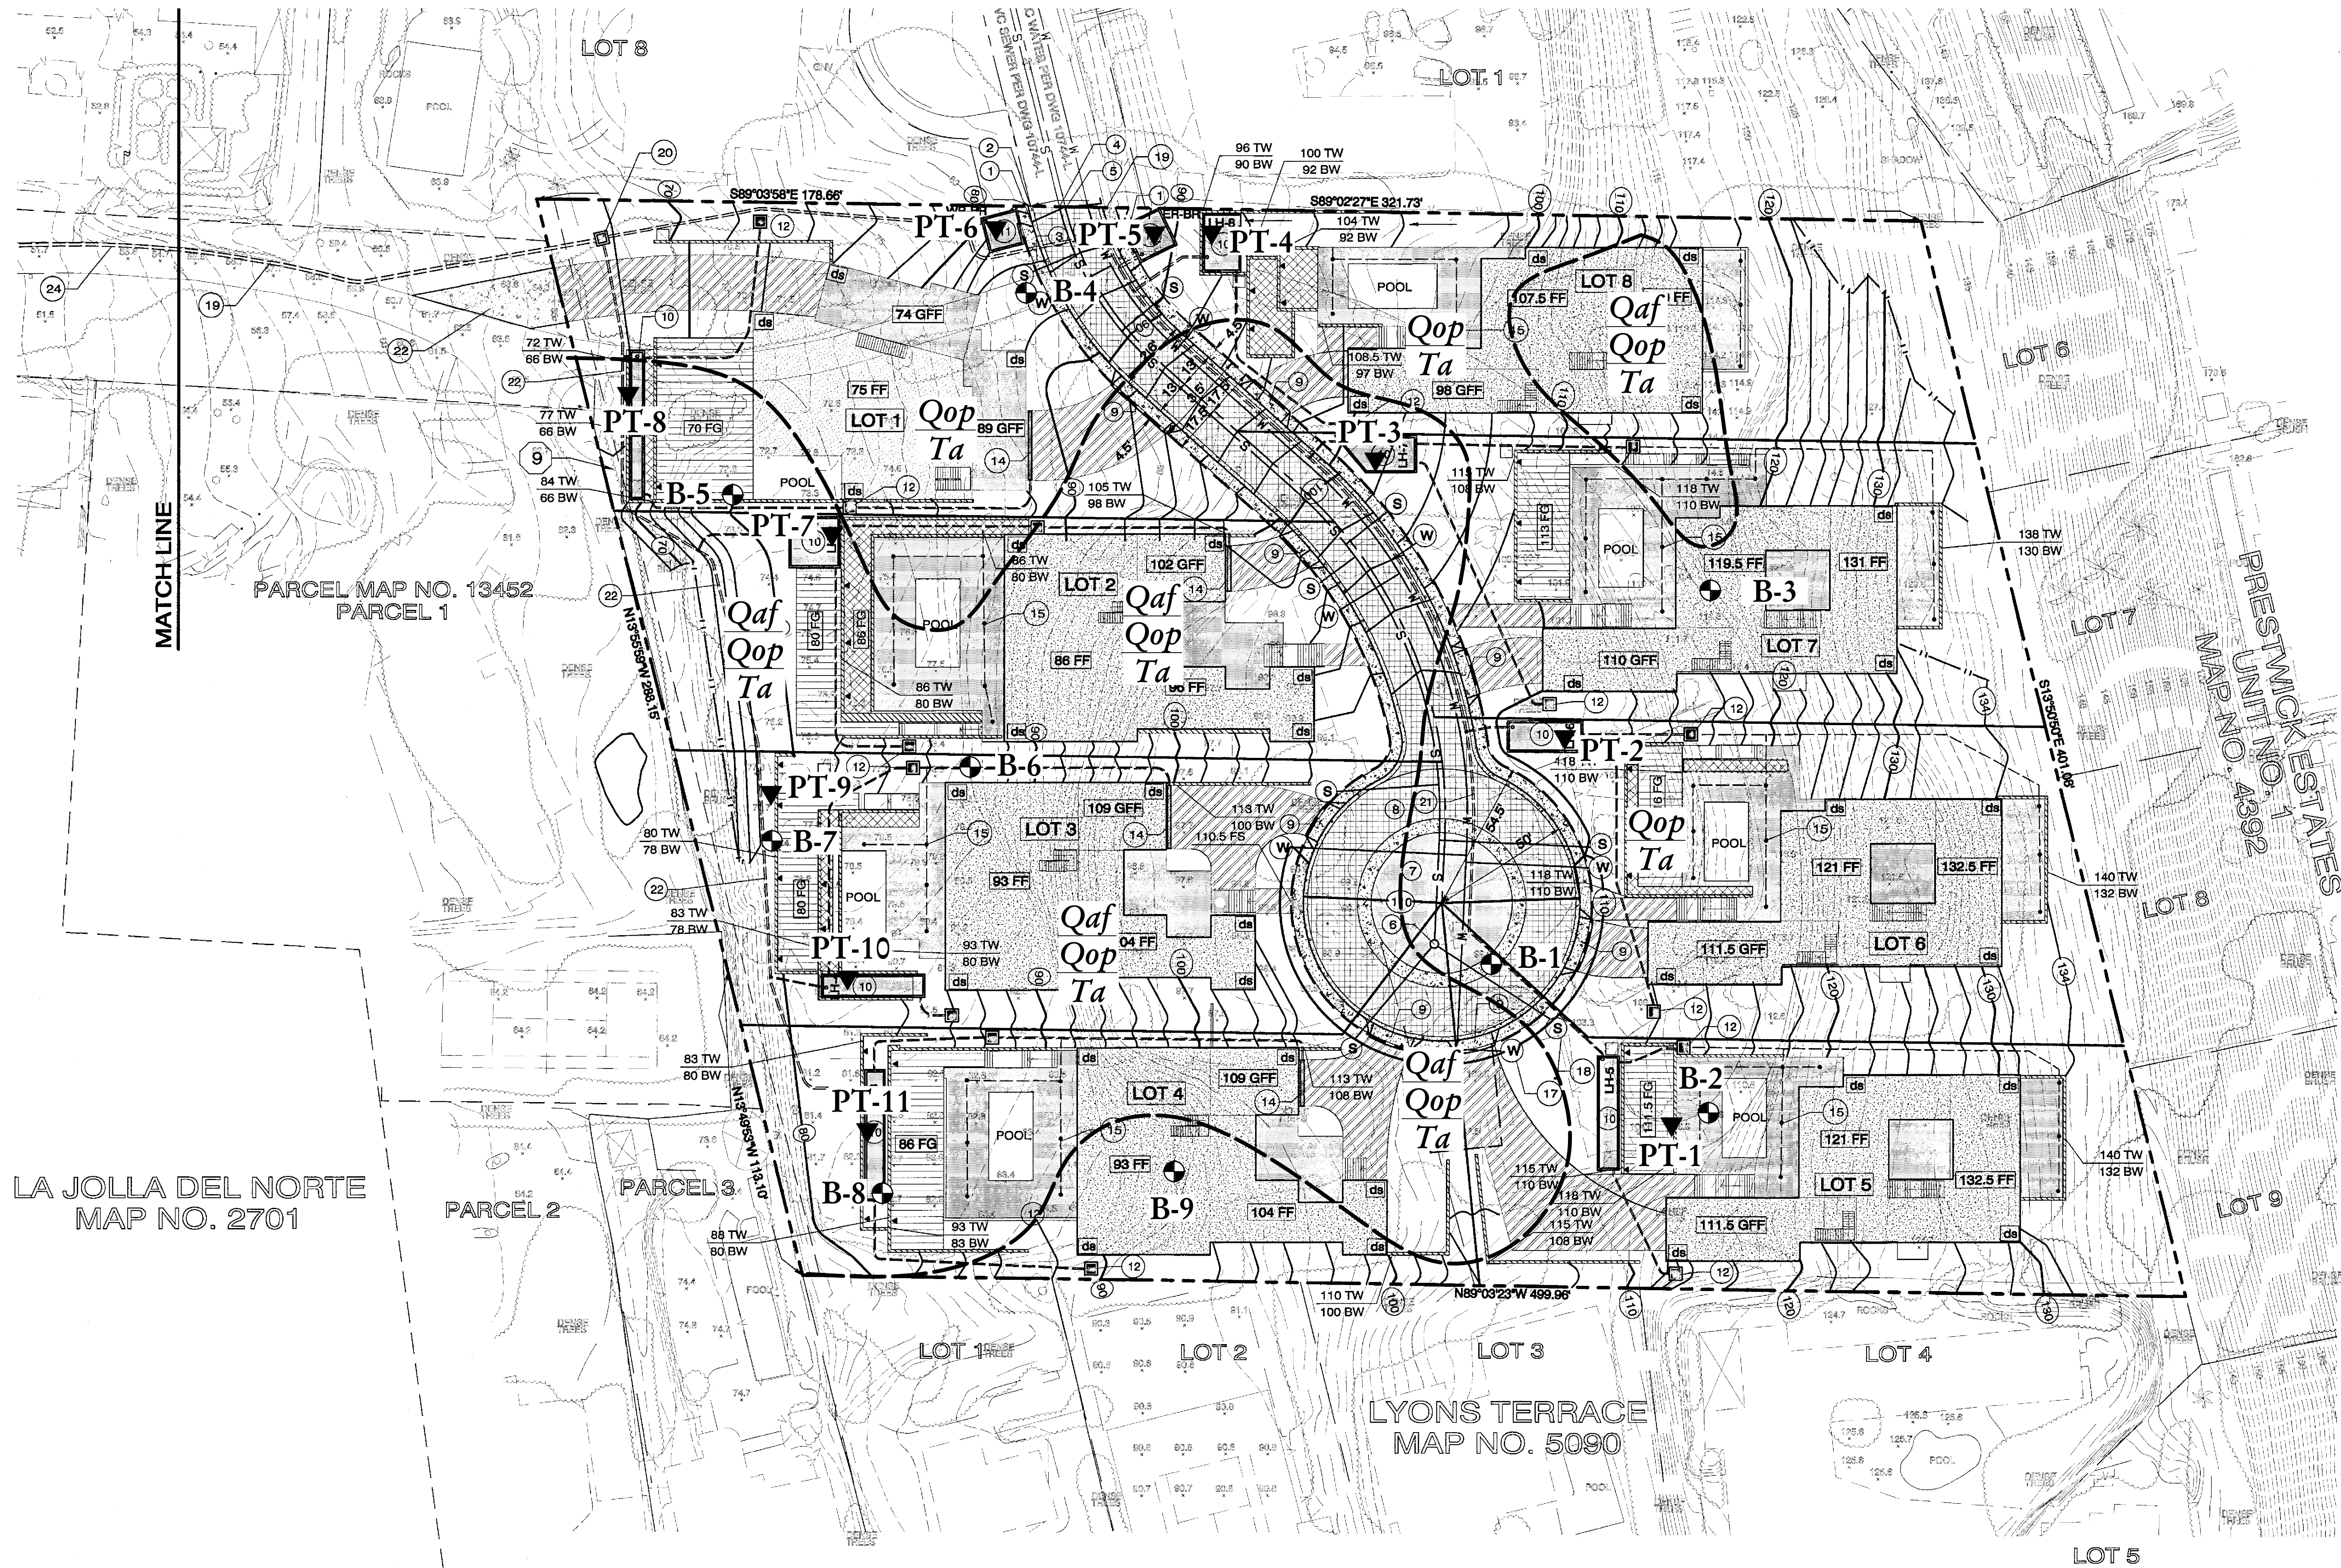
| CWE LEGEND | |
|---|--|
| | APPROXIMATE BORING LOCATION |
