GEOTECHNICAL INVESTIGATION FAIRMOUNT AVENUE FIRE STATION

47th Street &
Fairmount Avenue
San Diego, California

Prepared By:
SCST, LLC
6280 Riverdale Street
San Diego, California 92120

SCST No. 170446P4.1
Report No. 1

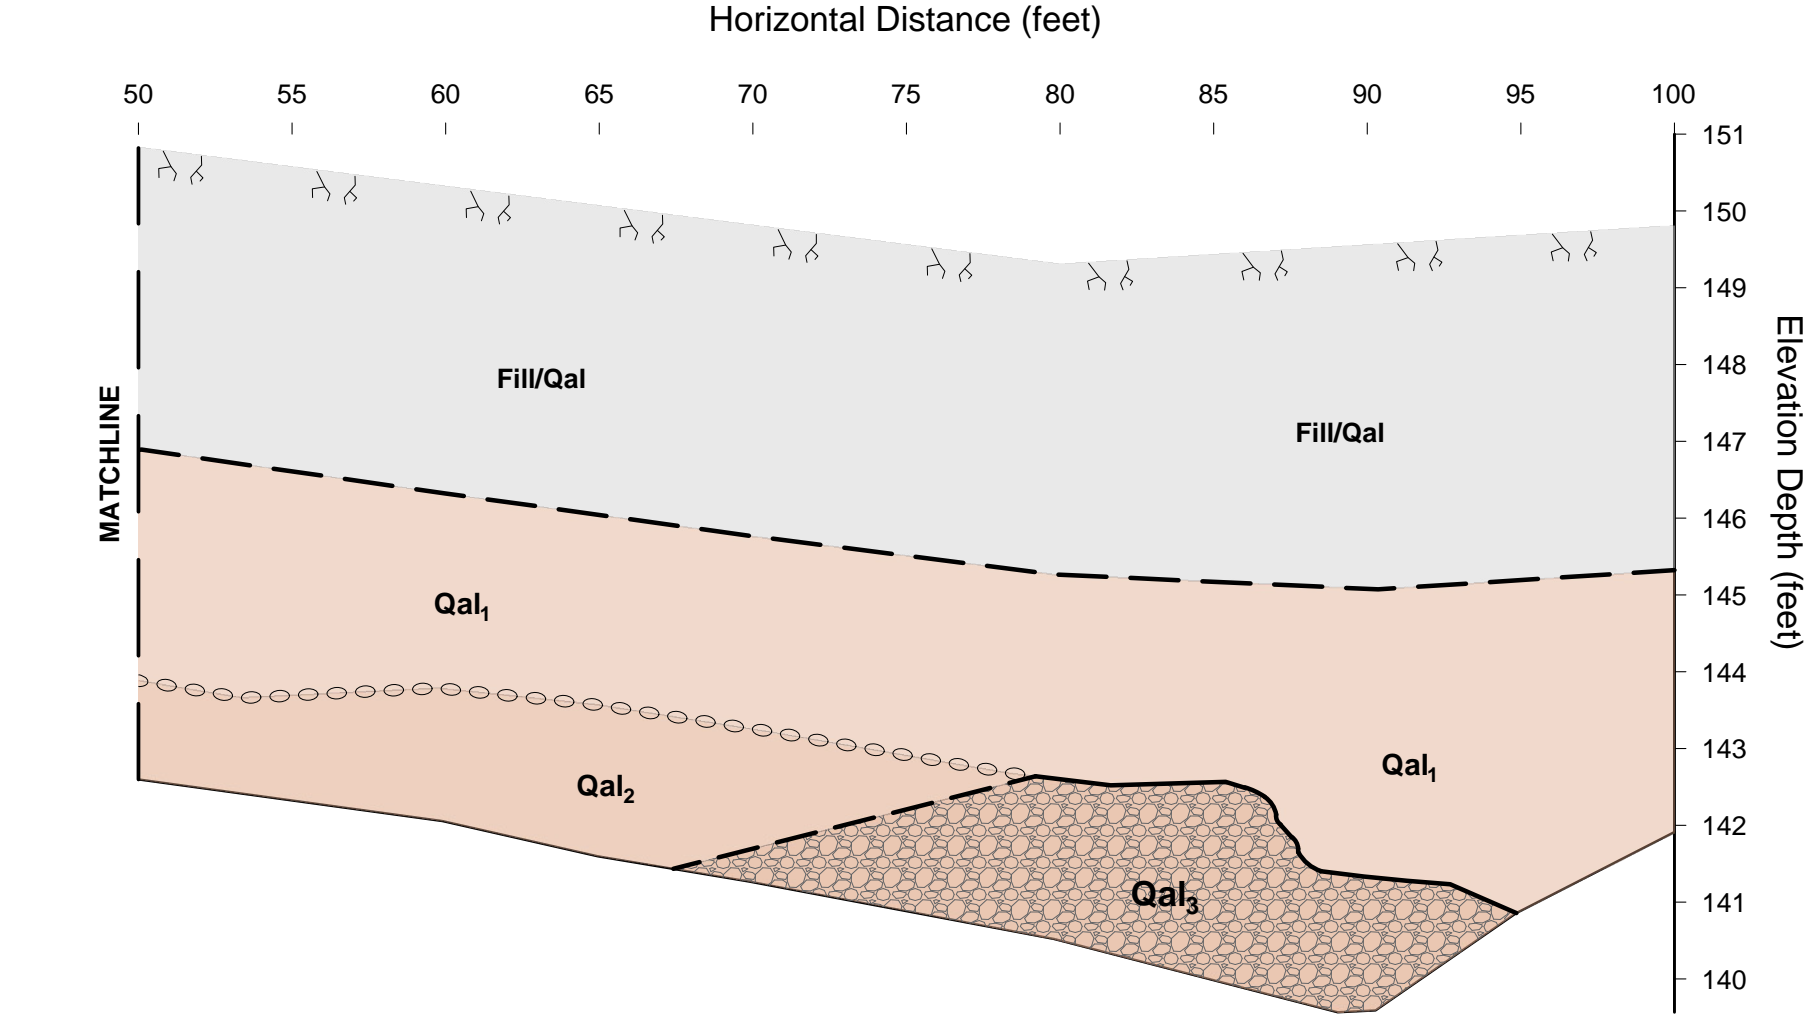
By:	PFL	Date:	March, 2019
Job Number:	170446N-1	Figure:	I-6

- Geologic Contact, Queried Where Uncertain
- Cobbles or Boulders
- Roots
- Fill/Qal** SILTY SAND, loose, brown, moist, fine to coarse grained, abundant organics including roots, few debris (glass, trash, etc.). Locally abundant cobbles (as shown).
- Qal₁** SILTY SAND, loose to medium dense, dark brown, moist, fine to medium grained, fewer organics (roots), few coarse gravel
- Qal₂** SILTY SAND, medium dense, moist, light brown, moist, fine to medium grained.
- Qal₃** SILTY GRAVEL with SAND, medium dense, brown, moist, fine to coarse grained.

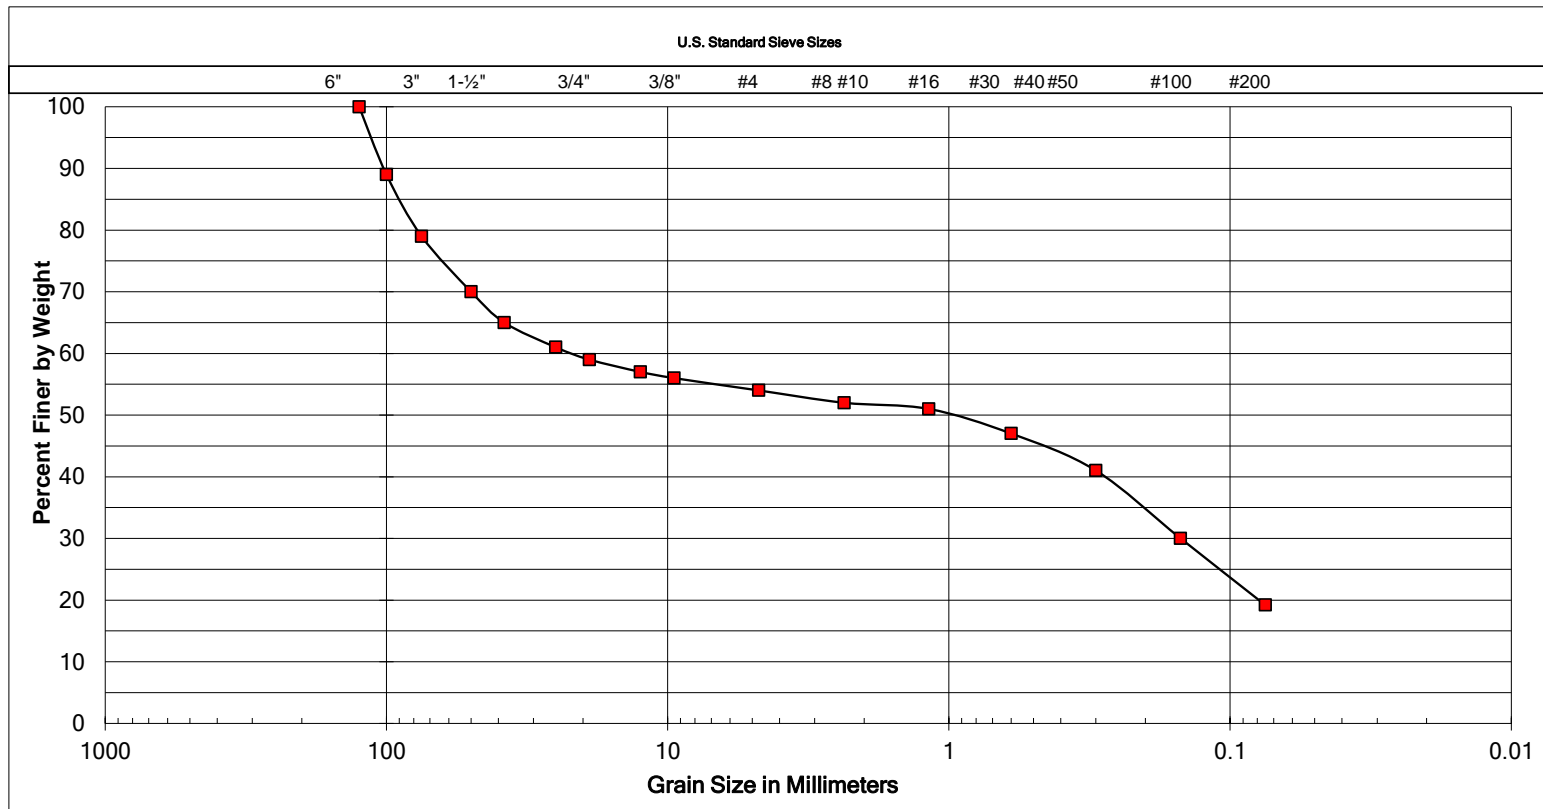
Fairmount Avenue Fire Station San Diego, California	
By: CT	Date: March, 2019
Job Number: 170446P4	Figure: II-1

SAMPLE LOCATION
FT at 80', 3' to 6' depth
SAMPLE NUMBER
37989

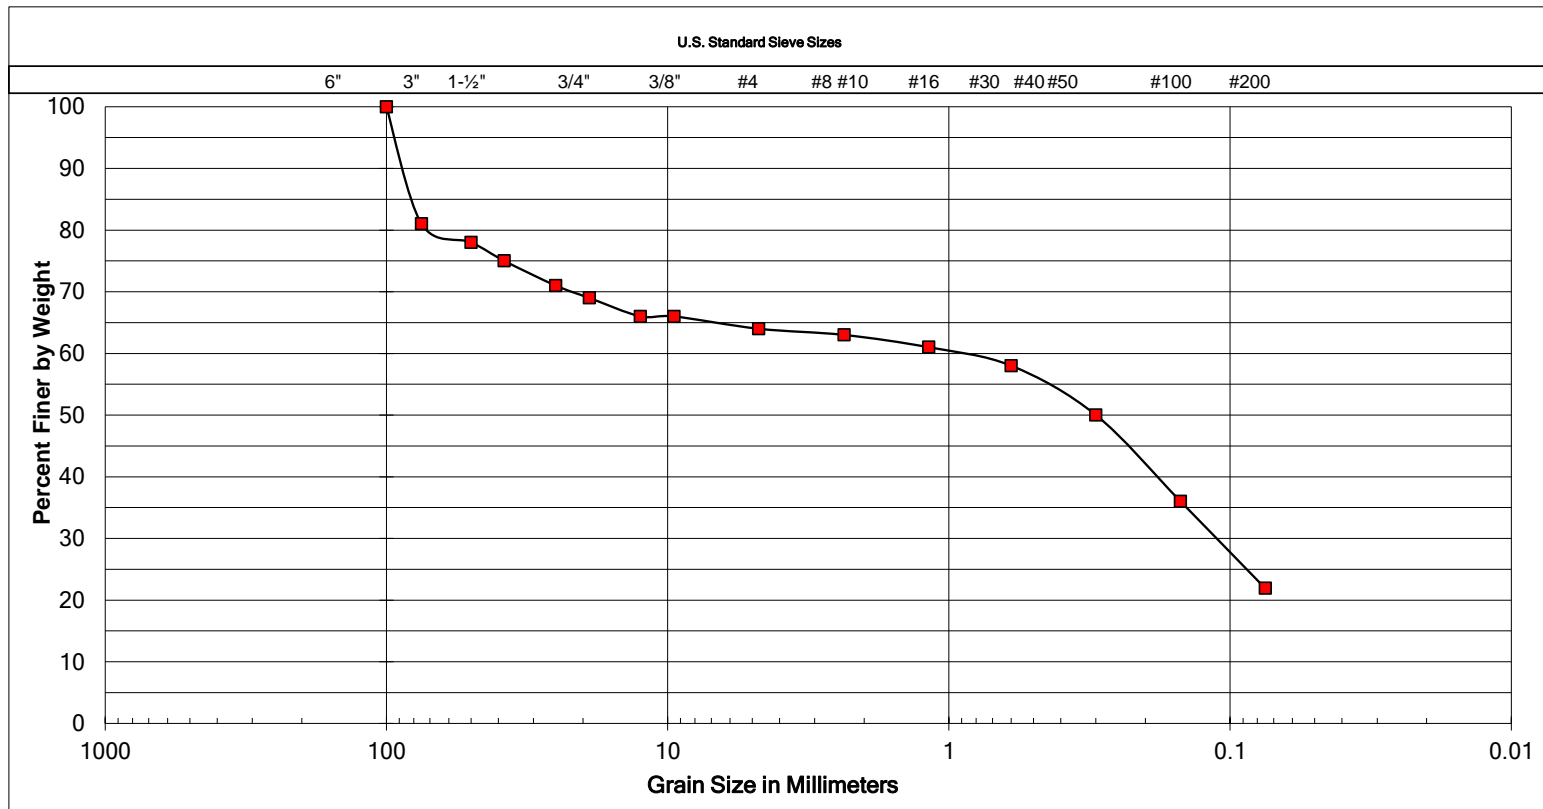
Fairmount Avenue Fire Station San Diego, California	
By: CT	Date: March, 2019
Job Number: 170446P4	Figure: II-2

SAMPLE LOCATION
FT at various locations, at 0 to 2' depth
SAMPLE NUMBER
37990
