UPDATED GEOTECHNICAL INVESTIGATION

FAIRMOUNT AVENUE FIRE STATION

San Diego, California

SCST No. 170446P4
Report No. 5

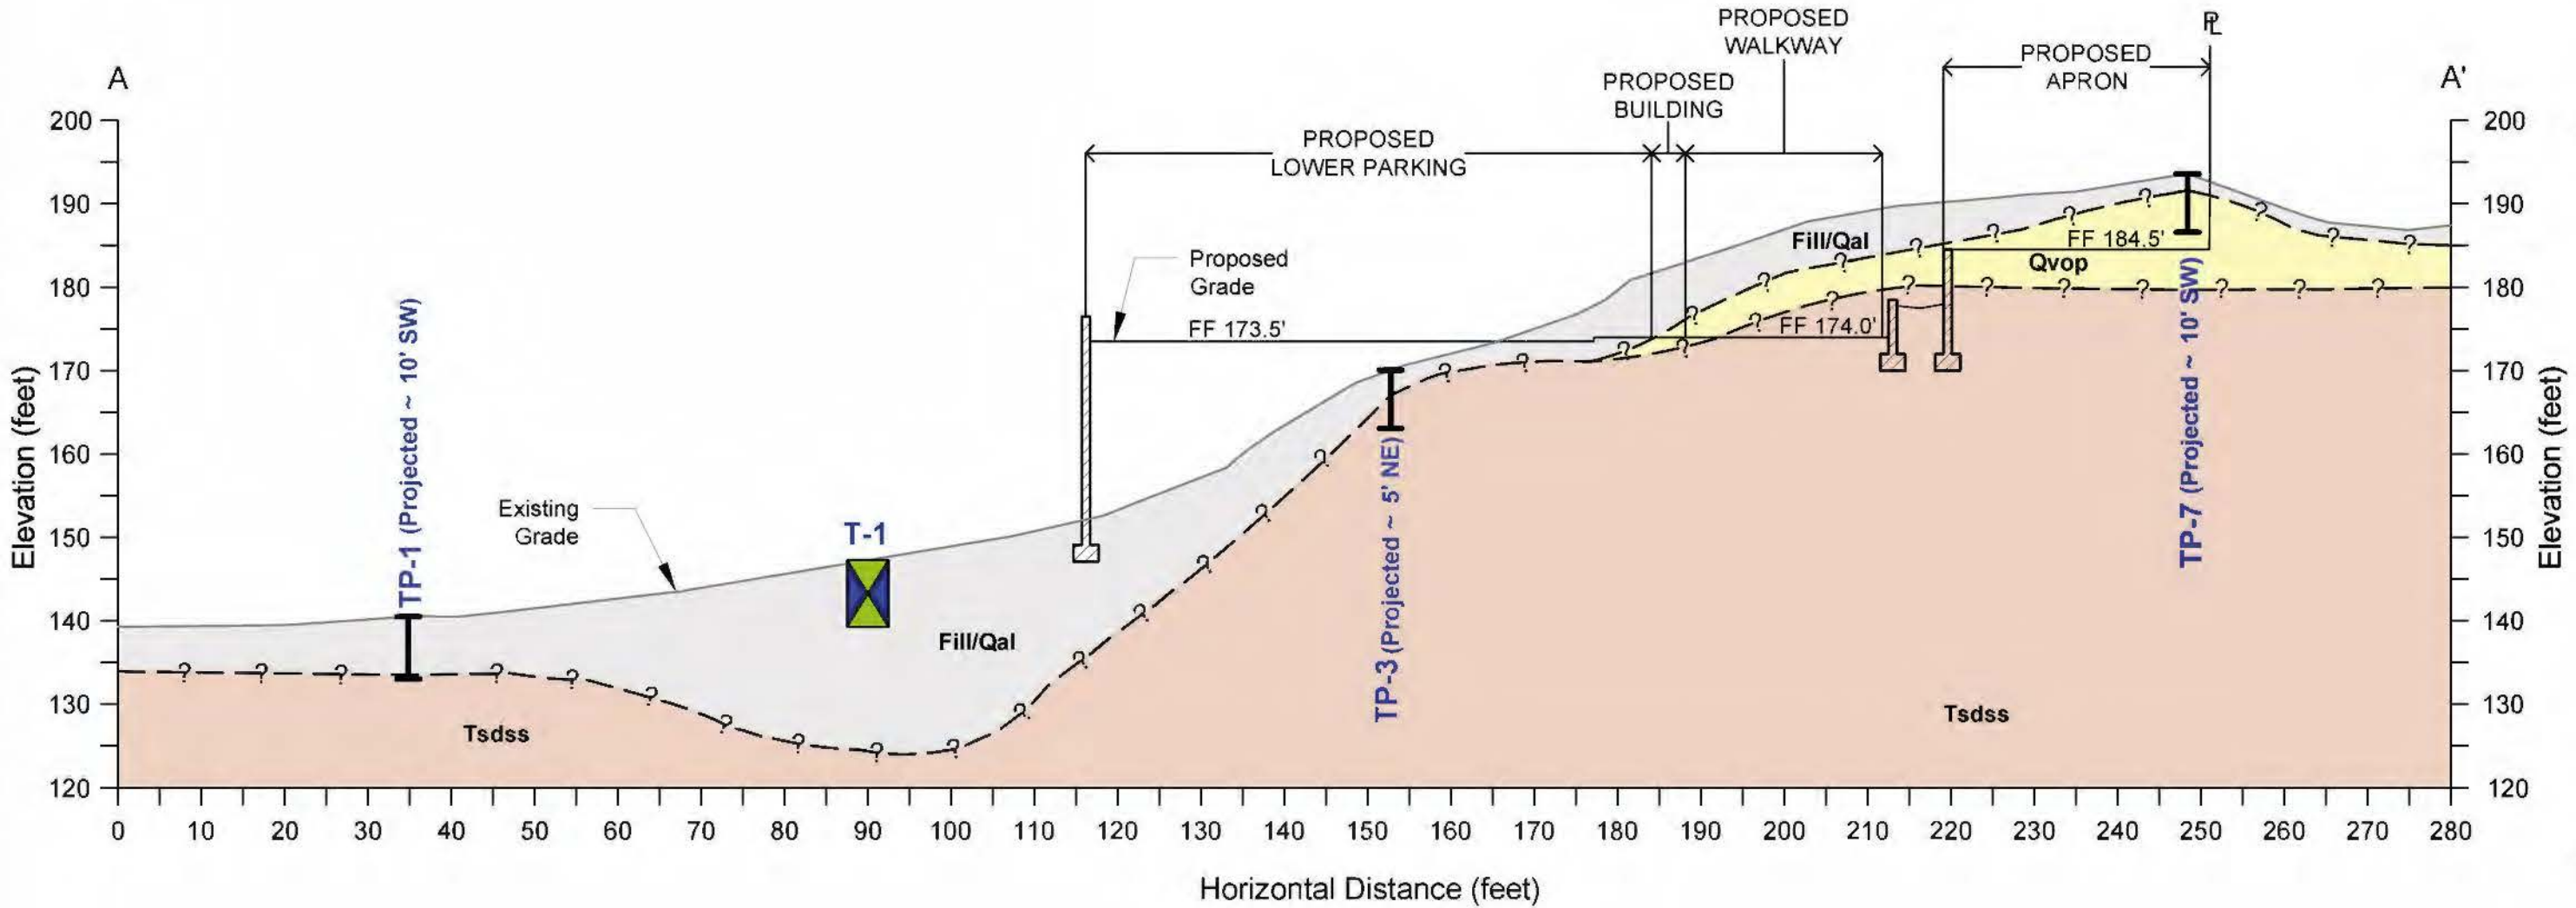
GEOLOGIC CROSS-SECTION A-A'
Fairmount Avenue Fire Station
San Diego, California

NOTE: All locations and depths are approximate.

SCALE
1" = 20'

The site is located within the Peninsular Ranges Geomorphic Province of California, which stretches from the Los Angeles basin to the tip of Baja California. This province is characterized as a series of northwest-trending mountain ranges separated by subparallel fault zones and a coastal plain of subdued landforms. The mountain ranges are underlain primarily by Mesozoic metamorphic rocks that were intruded by plutonic rocks of the southern California batholith, while the coastal plain is underlain by subsequently deposited marine and non-marine sedimentary formations. The site is located within the coastal plain portion of the province and, per published mapping, is underlain by the Plio-Pleistocene-age San Diego Formation (Kennedy and Tan, 2008). However, based on our explorations, site soils consist of fill, alluvium, very old paralic deposits, and Plio-Pleistocene-age San Diego Formation. Figure 3 presents a geologic cross-section. Figure 4 presents the regional geology.

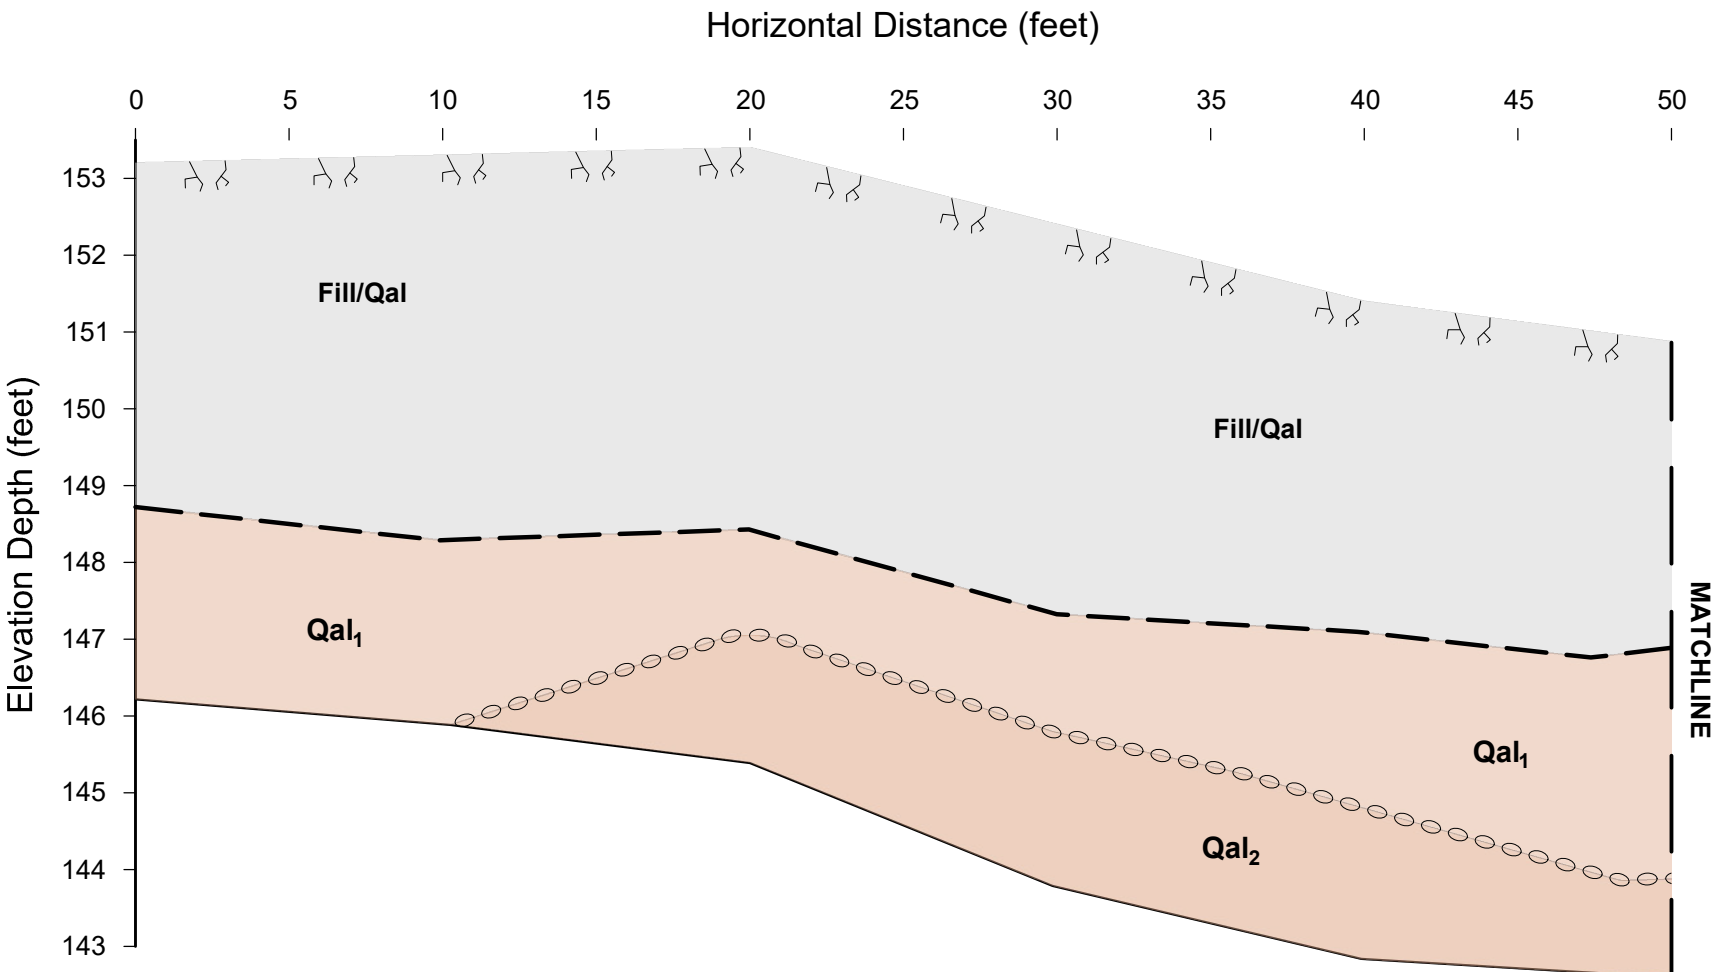
- SCST LEGEND:**
- ?— Geologic Contact, Queried Where Uncertain
 - ○ ○ Cobbles or Boulders
 - Roots
 - Fill/Qal** SILTY SAND, loose, brown, moist, fine to coarse grained, abundant organics including roots, few debris (glass, trash, etc.). Locally abundant cobbles (as shown). Predominantly silty sand; varying amounts of gravel.
 - Qal₁** SILTY SAND, loose to medium dense, dark brown, moist, fine to medium grained, fewer organics (roots), few coarse gravel
 - Qal₂** SILTY SAND, medium dense, moist, light brown, moist, fine to medium grained.
 - Qal₃** SILTY GRAVEL with SAND, medium dense, brown, moist, fine to coarse grained.

Note: All locations, depths and elevations are approximate. SCALE AS SHOWN

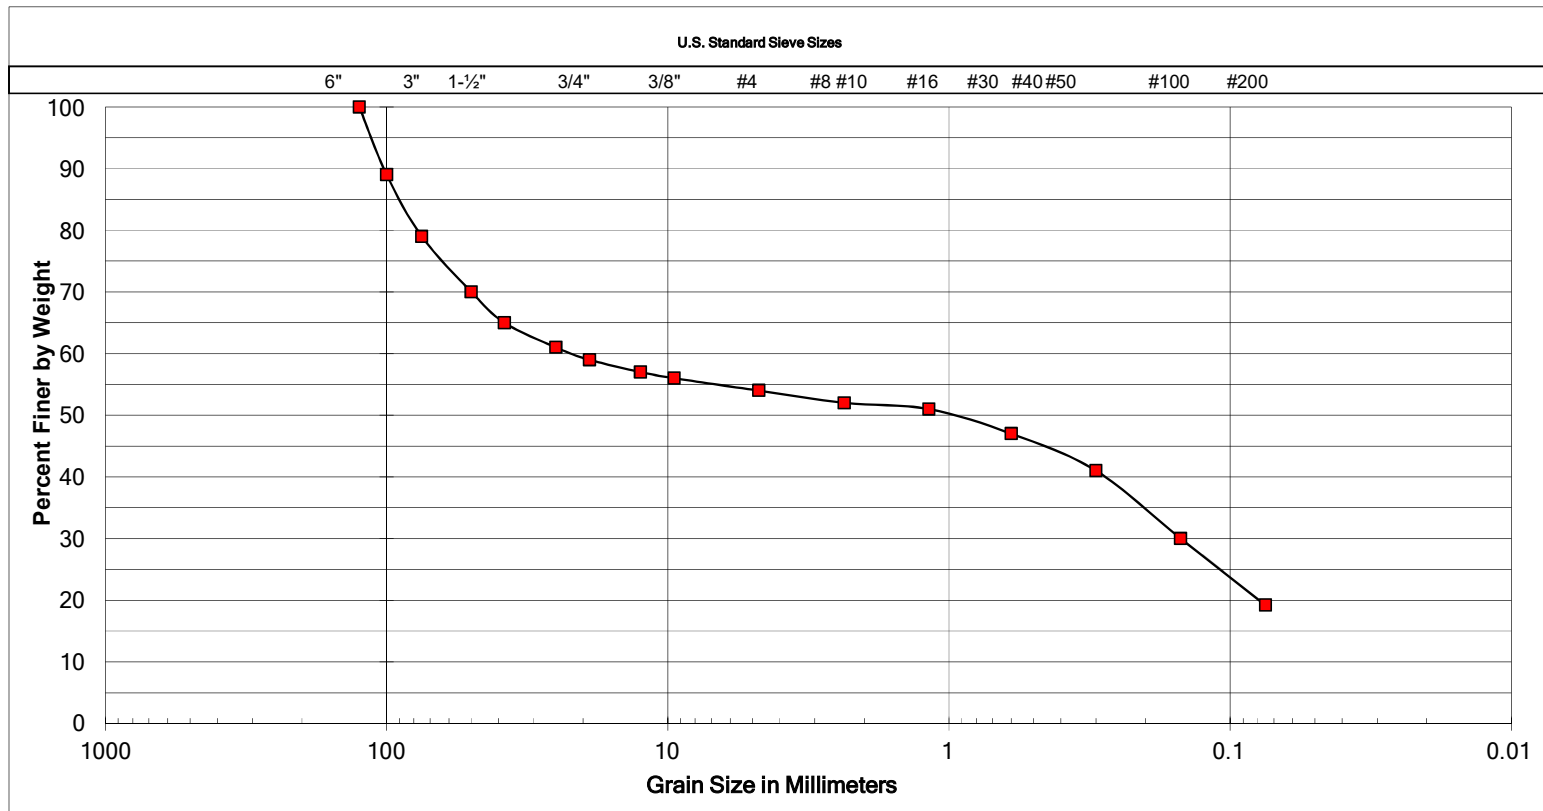
By:	CT	Date:	February, 2020
Job Number:	170446P4-5	Figure:	II-1

Cobbles	Gravel		Sand			Silt or Clay
	Coarse	Fine	Coarse	Medium	Fine

SAMPLE LOCATION
FT at 80', 3' to 6' depth
SAMPLE NUMBER
37989

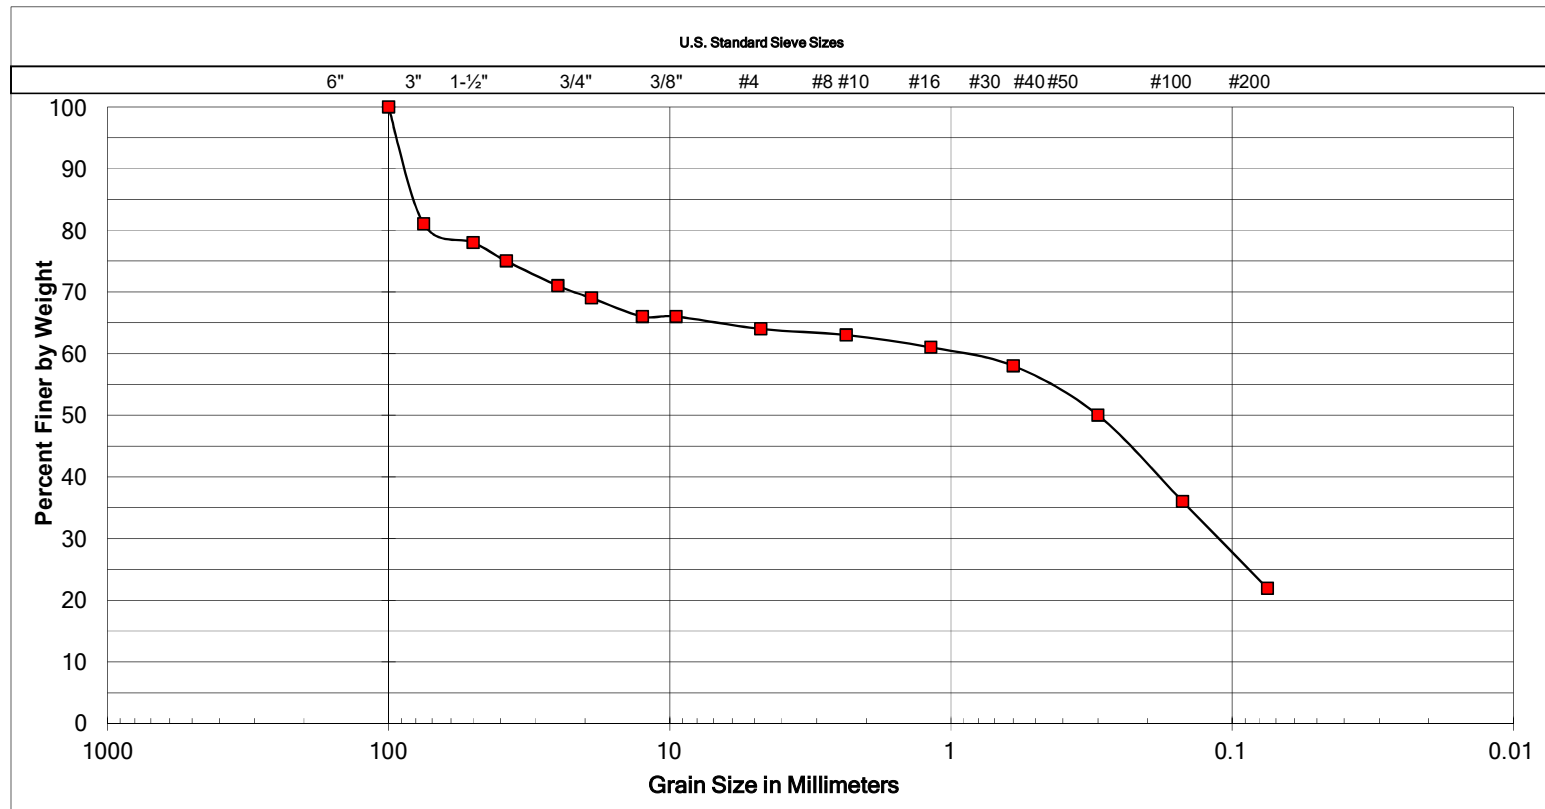
By:	CT	Date:	February, 2020
Job Number:	170446P4-5	Figure:	II-2

Cobbles	Gravel		Sand			Silt or Clay
	Coarse	Fine	Coarse	Medium	Fine

SAMPLE LOCATION
FT at various locations, at 0 to 2' depth
SAMPLE NUMBER
37990

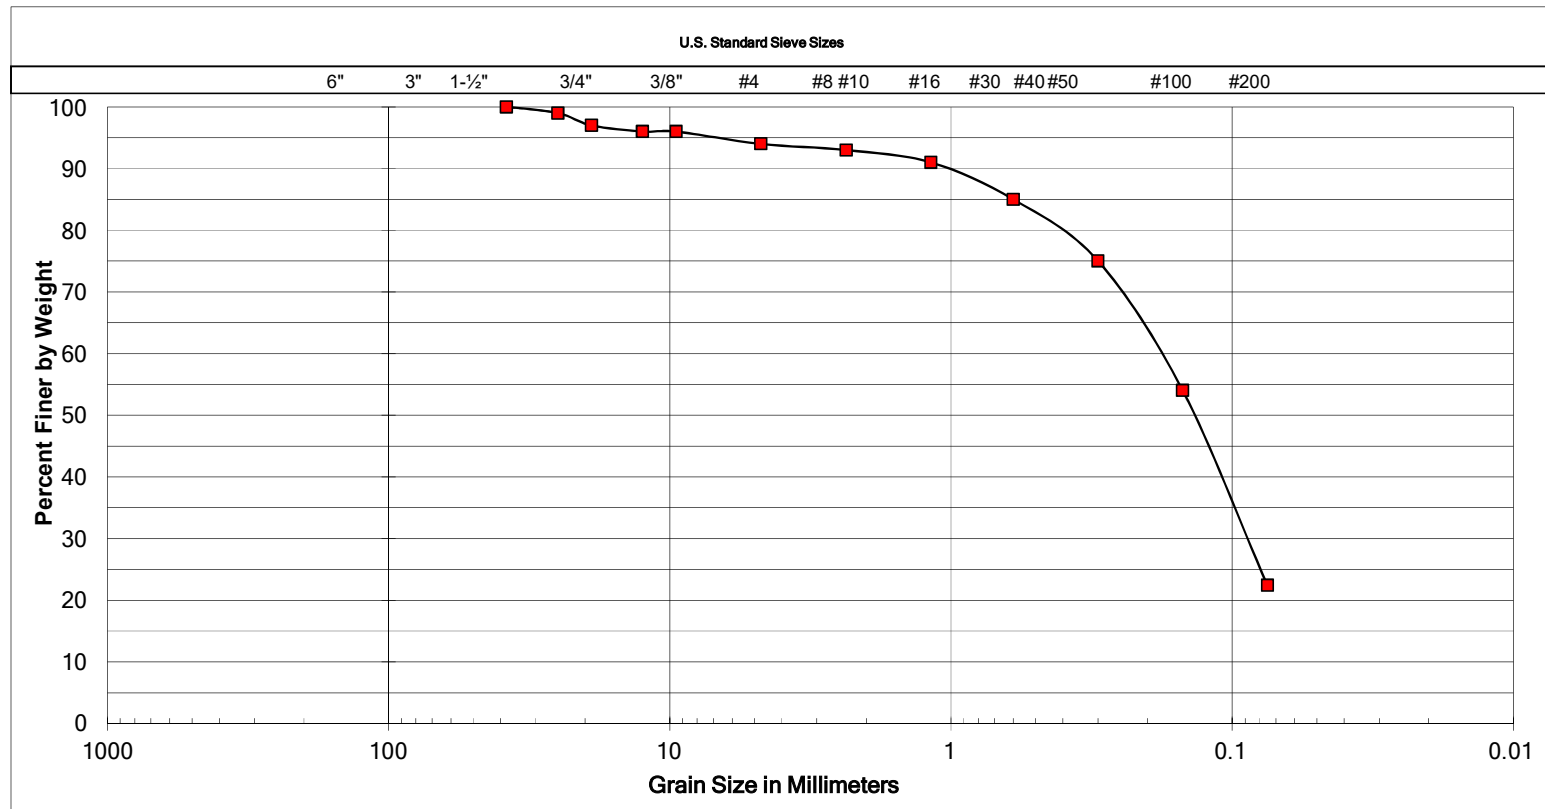
By:	CT	Date:	February, 2020
Job Number:	170446P4-5	Figure:	II-3

Cobbles	Gravel		Sand			Silt or Clay
	Coarse	Fine	Coarse	Medium	Fine

SAMPLE LOCATION
FT at 38', 2' to 4' depth
SAMPLE NUMBER
37991

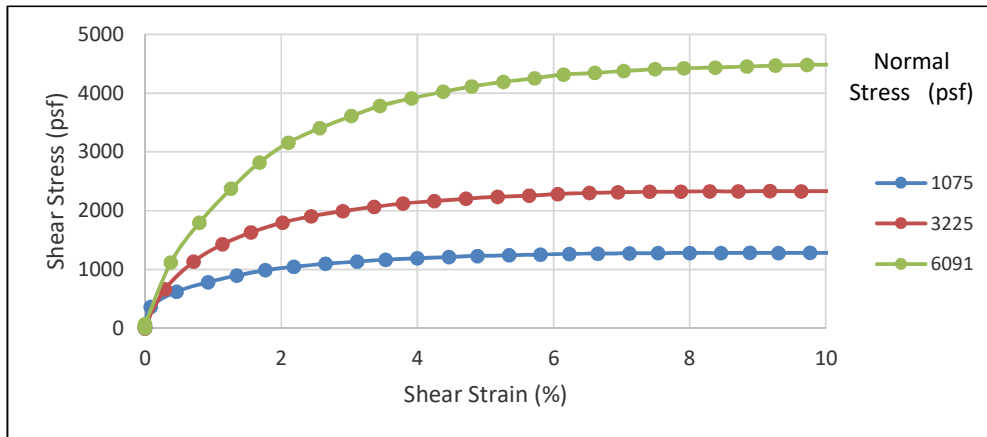
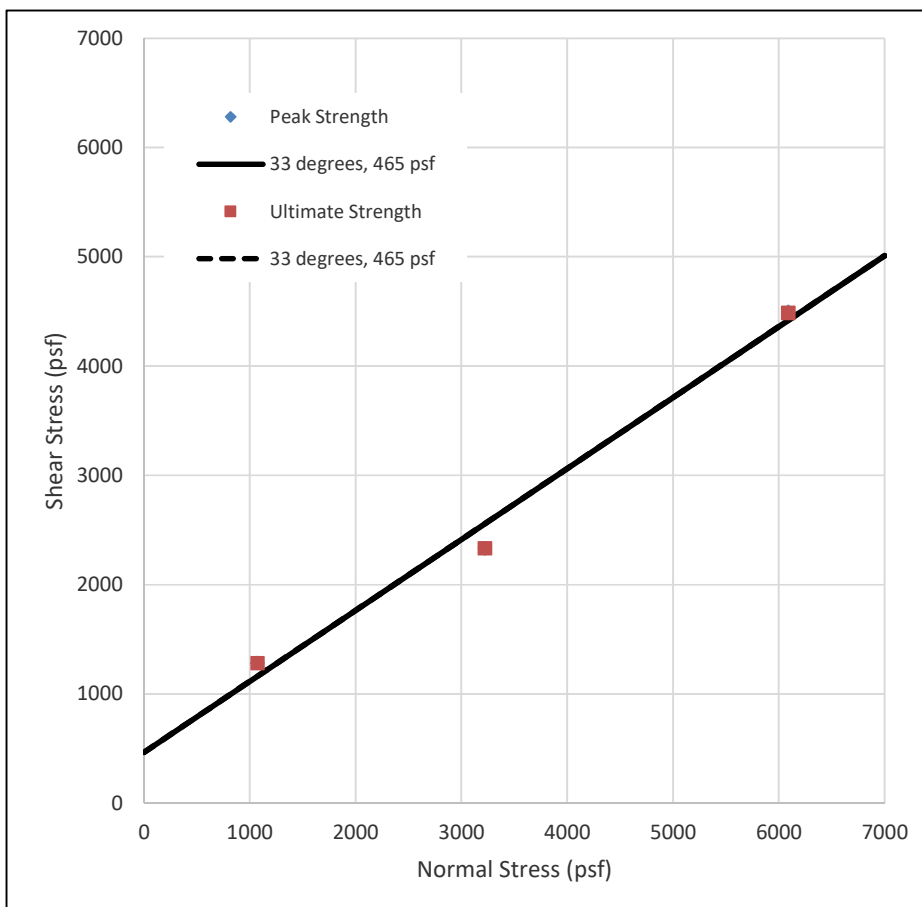
By: DRB	Date: February, 2020
Job Number: 170446P4-5	Figure: II-6

SAMPLE ID:	FT at 38', 2' to 4' depth	ϕ	Peak	Ultimate
			33 °	33 °
Silty Sand		c	465 psf	465 psf
NOTES: Remolded	Strain Rate: 0.003 in/min	γ_d	Initial	Final
			111.4 pcf	111.4 pcf
			11.2 %	16.5 %
Sample was consolidated and drained		Saturation	60 %	88 %

- **DIRECT SHEAR:** Direct shear testing was performed on three samples in accordance with ASTM D3080. The shear stress was applied at a constant rate of strain of 0.003 inch per minute.

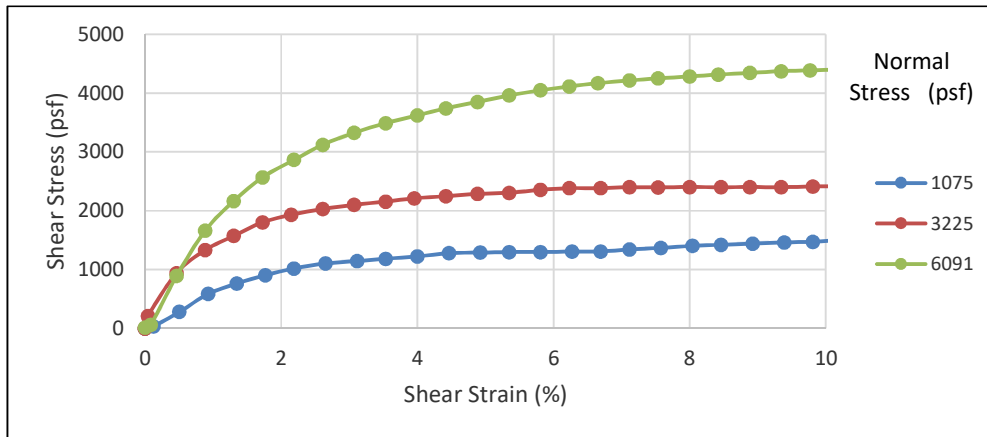
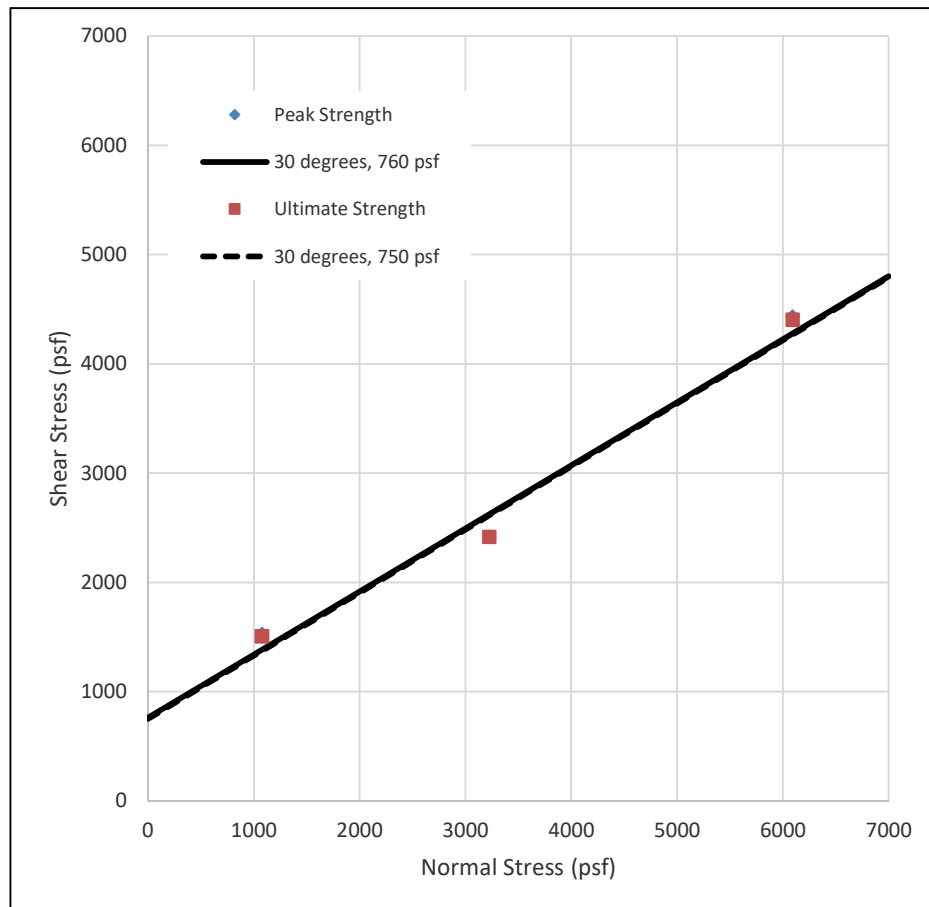
By: DRB	Date: February, 2020
Job Number: 170446P4-5	Figure: II-7

SAMPLE ID: TP-3 at 6 to 7½ feet

Silty Sandstone, San Diego Formation

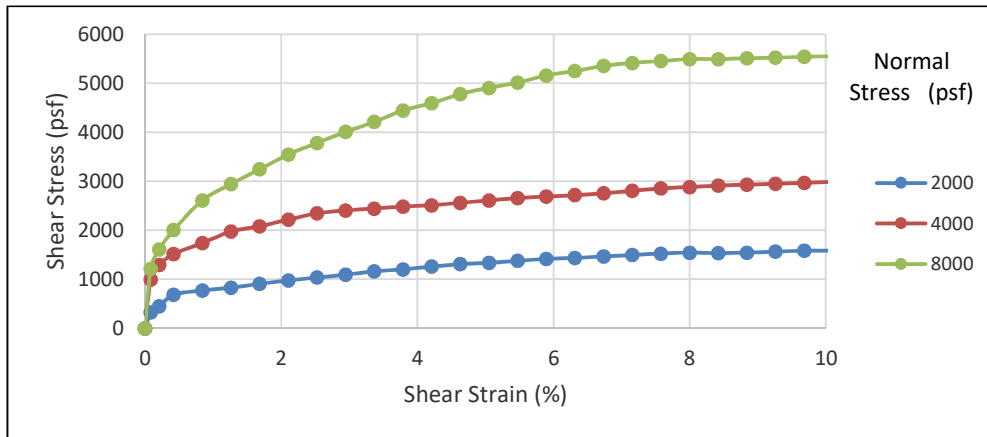
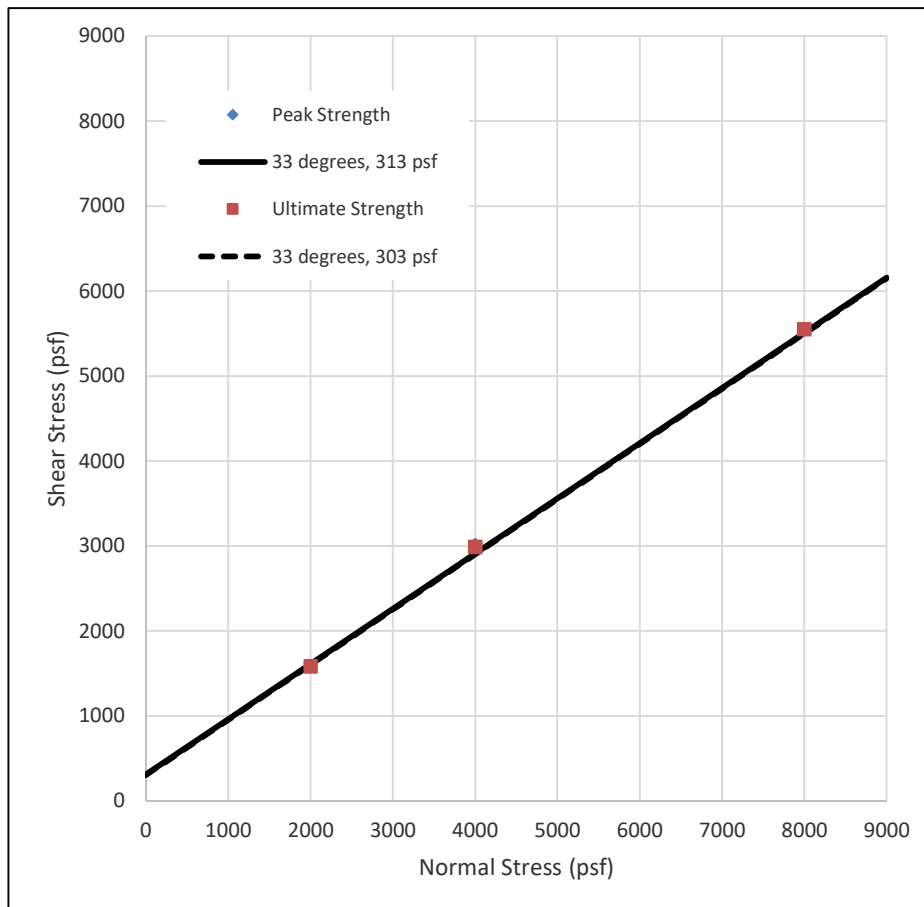
SAMPLE ID: TP-8 at 3 to 3½ feet

Clayey Sandstone, San Diego Formation

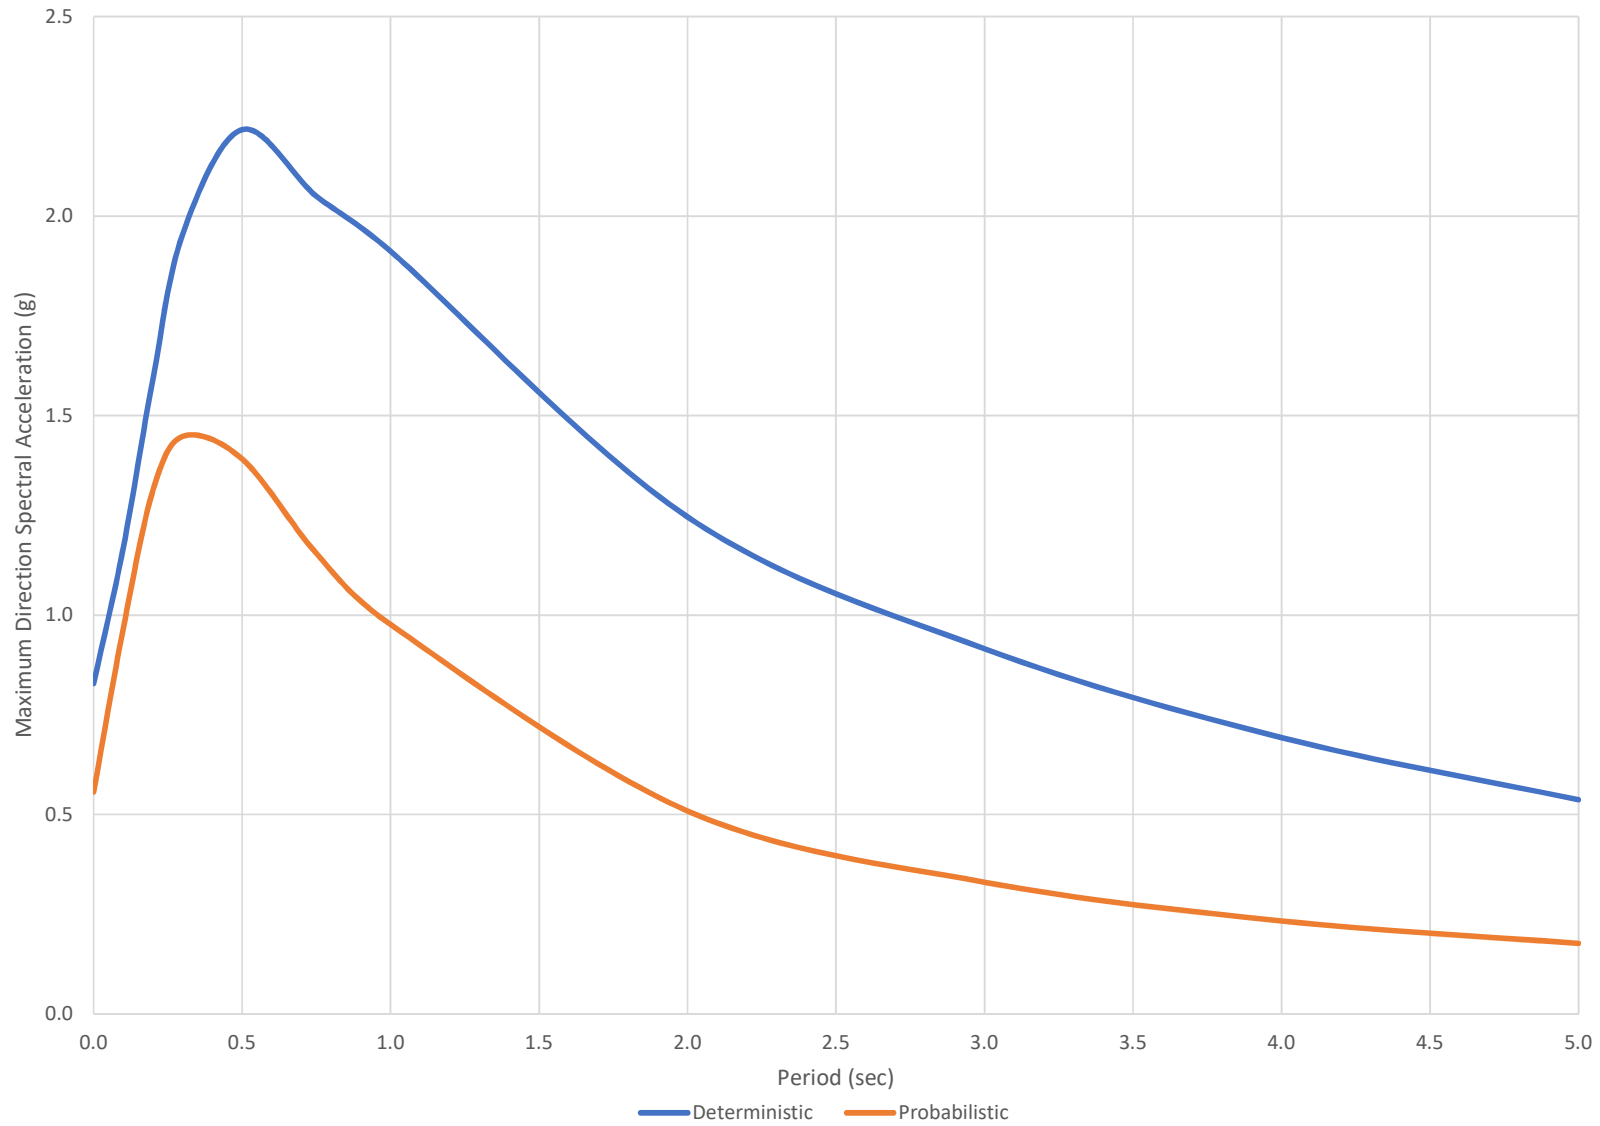
S _{D5} =	0.869	90% of max S _a (ASCE 7-16 Sect 21.4)
S _{MS} =	1.303	MCE _R , 5% Damped, adjusted for Site Class
S _{D1} =	0.679	Design, 5% Damped, at T=1s (Sect 11.4.5)
S _{M1} =	1.018	MCE _R , 5% Damped, at T=1s, adjusted for Site
F _a =	1.063	Short Period Site Coefficient
F _v =	2.500	Long Period Site Coefficient (7-16 Sect 21.3)
S ₅ =	1.226	MCE _R , 5% Damped at T=0.2s
S ₁ =	0.407	MCE _R , 5% Damped at T=1s
PGA _{Probabilistic} (g)=	0.557	Peak Ground Acceleration, Probabilistic
PGA _{Deterministic} (g)=	0.753	Peak Ground Acceleration, Deterministic
F _{PGA} (g)=	1.115	Site Coefficient for PGA
0.5*F _{PGA} (g)=	0.5575	OK (Check PGA _{Deterministic} > 0.5 x F _{PGA})
Site Specific PGA (g) =	0.557	OK (Check PGA _{Site Specific} > 0.8 x PGA _M)

MCE_R Response Spectra Accelerations, ASCE 7-16

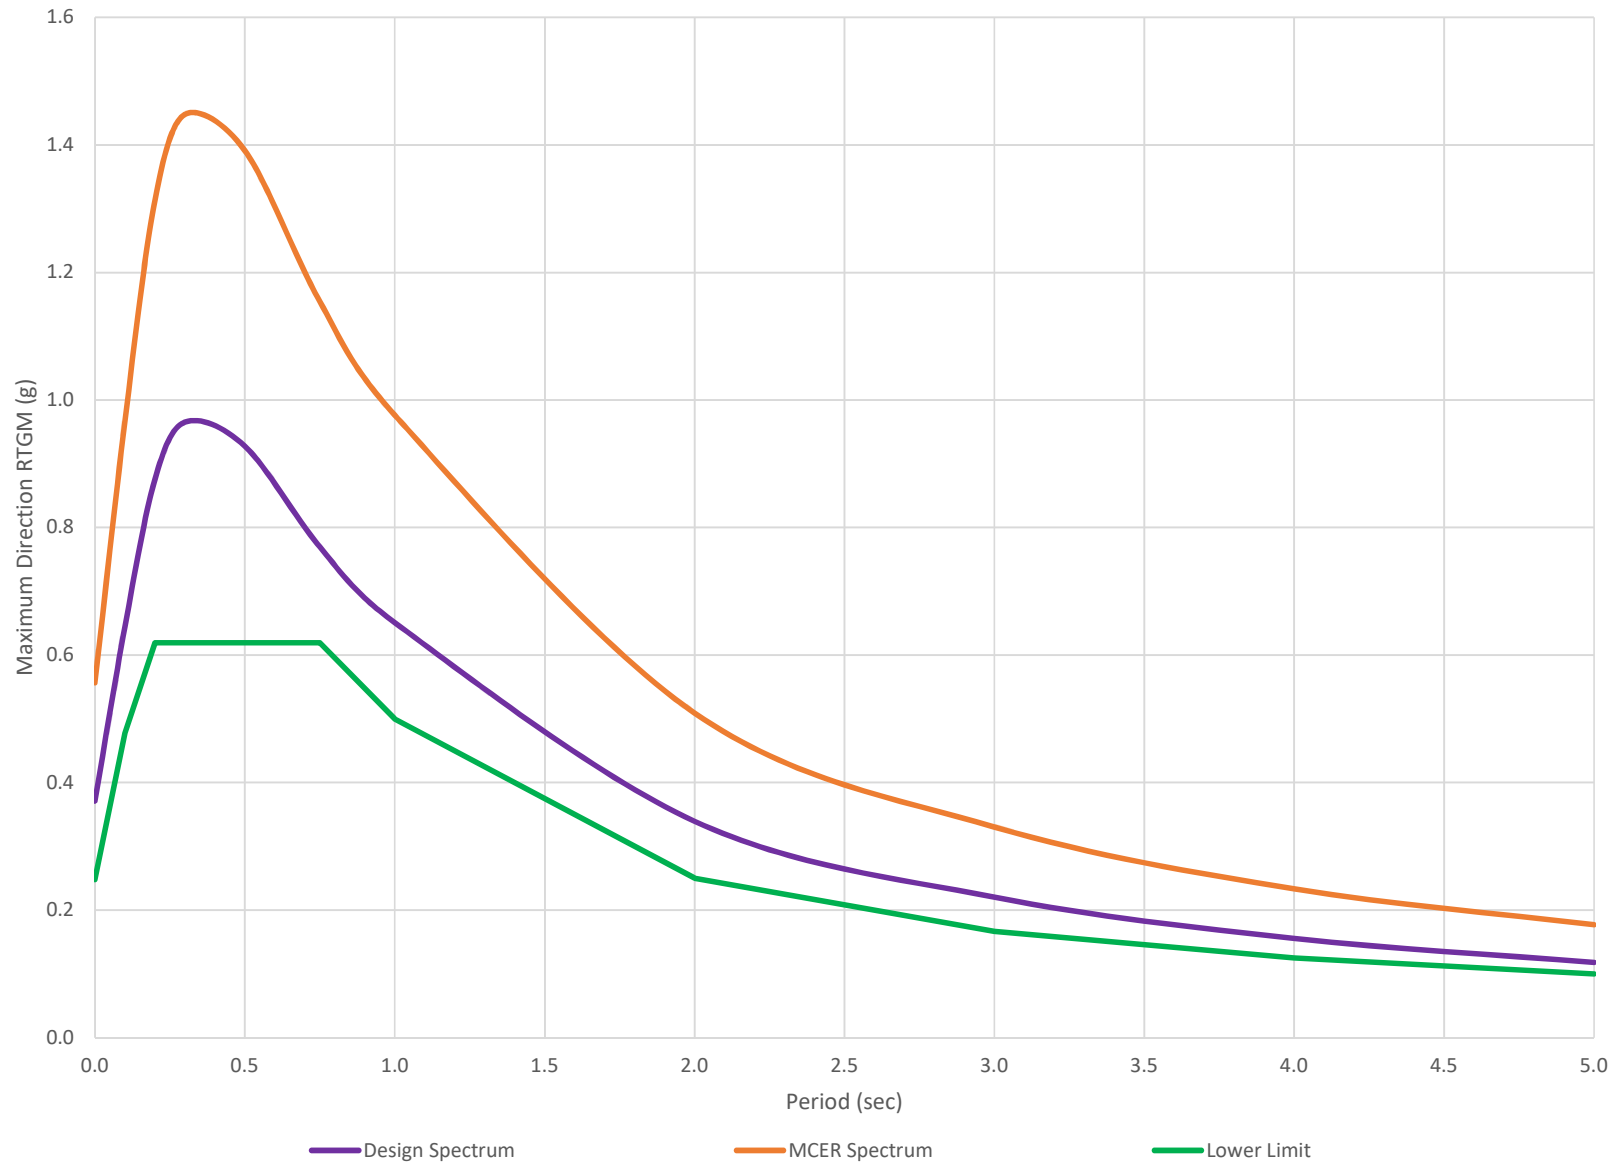
Design Response Spectrum per ASCE 7-16
