Geo Report

**GEOTECHNICAL AND GEOLOGIC HAZARD EVALUATION
MISSION BAY PARK IMPROVEMENTS PROJECTS
SAN DIEGO, CALIFORNIA**

**JUNE 2025
PROJECT No. 9127010**

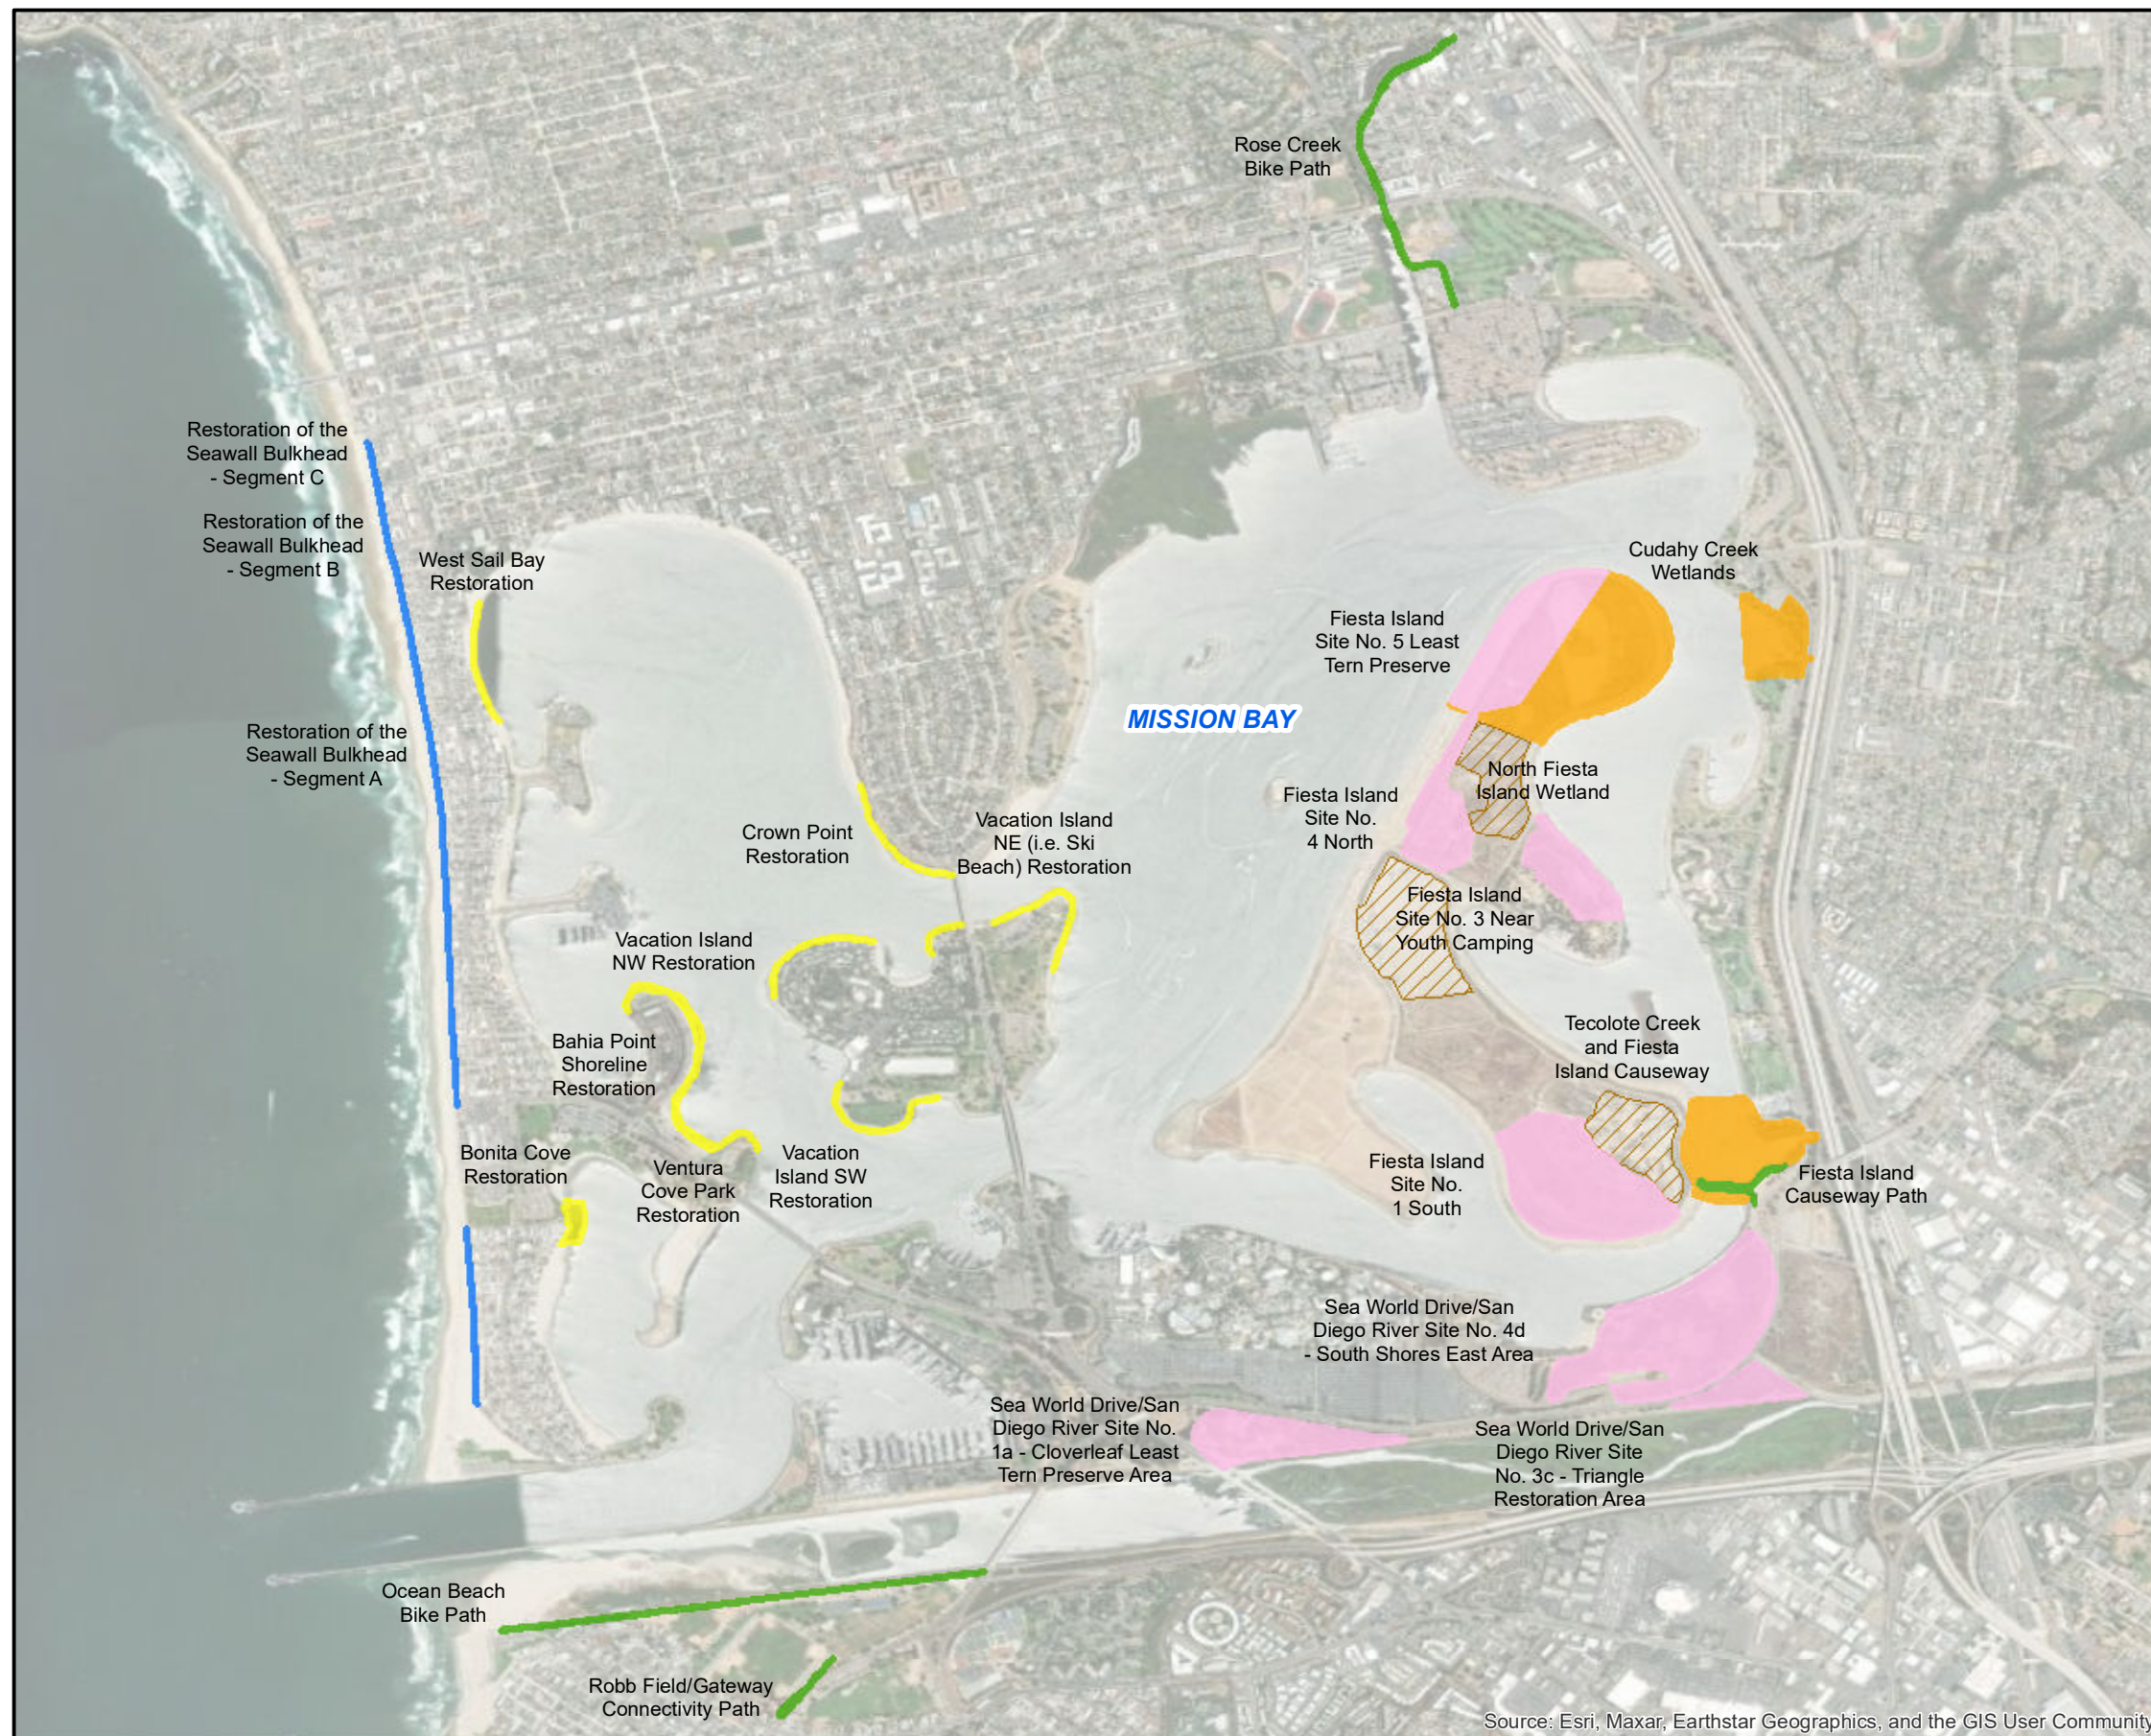
FIGURE 1

Figure 1 – Mission Bay Park Improvement Zone and Project Elements

This Updated Geotechnical and Geological Hazard Evaluation (Study) has been prepared for the City of San Diego on behalf of Dudek as part of an Environmental Impact Report (EIR) for the Mission Bay Park Improvements Program (Program) in San Diego, California. The Program is inclusive of site-specific project elements and bay-wide programmatic elements (Dudek 2025). The Program location consists of the Mission Bay Park Improvement Zone (Improvement Zone and Study Area), as defined in City of San Diego Charter Section 55.2 and shown on Figure 1.

The Mission Bay Park Improvement Zone/Study Area is located in the City of San Diego, between Interstate 5 to the east and the Pacific Ocean to the west, generally bounded by the communities of Pacific Beach on the northern side and Ocean Beach on the southern side, as shown on Figure 1. The Improvement Zone encompasses the 4,235-acre Mission Bay Park as well as several additional nearby areas. Specific project areas (“elements”) are located within the Improvement Zone, as shown on Figure 1.

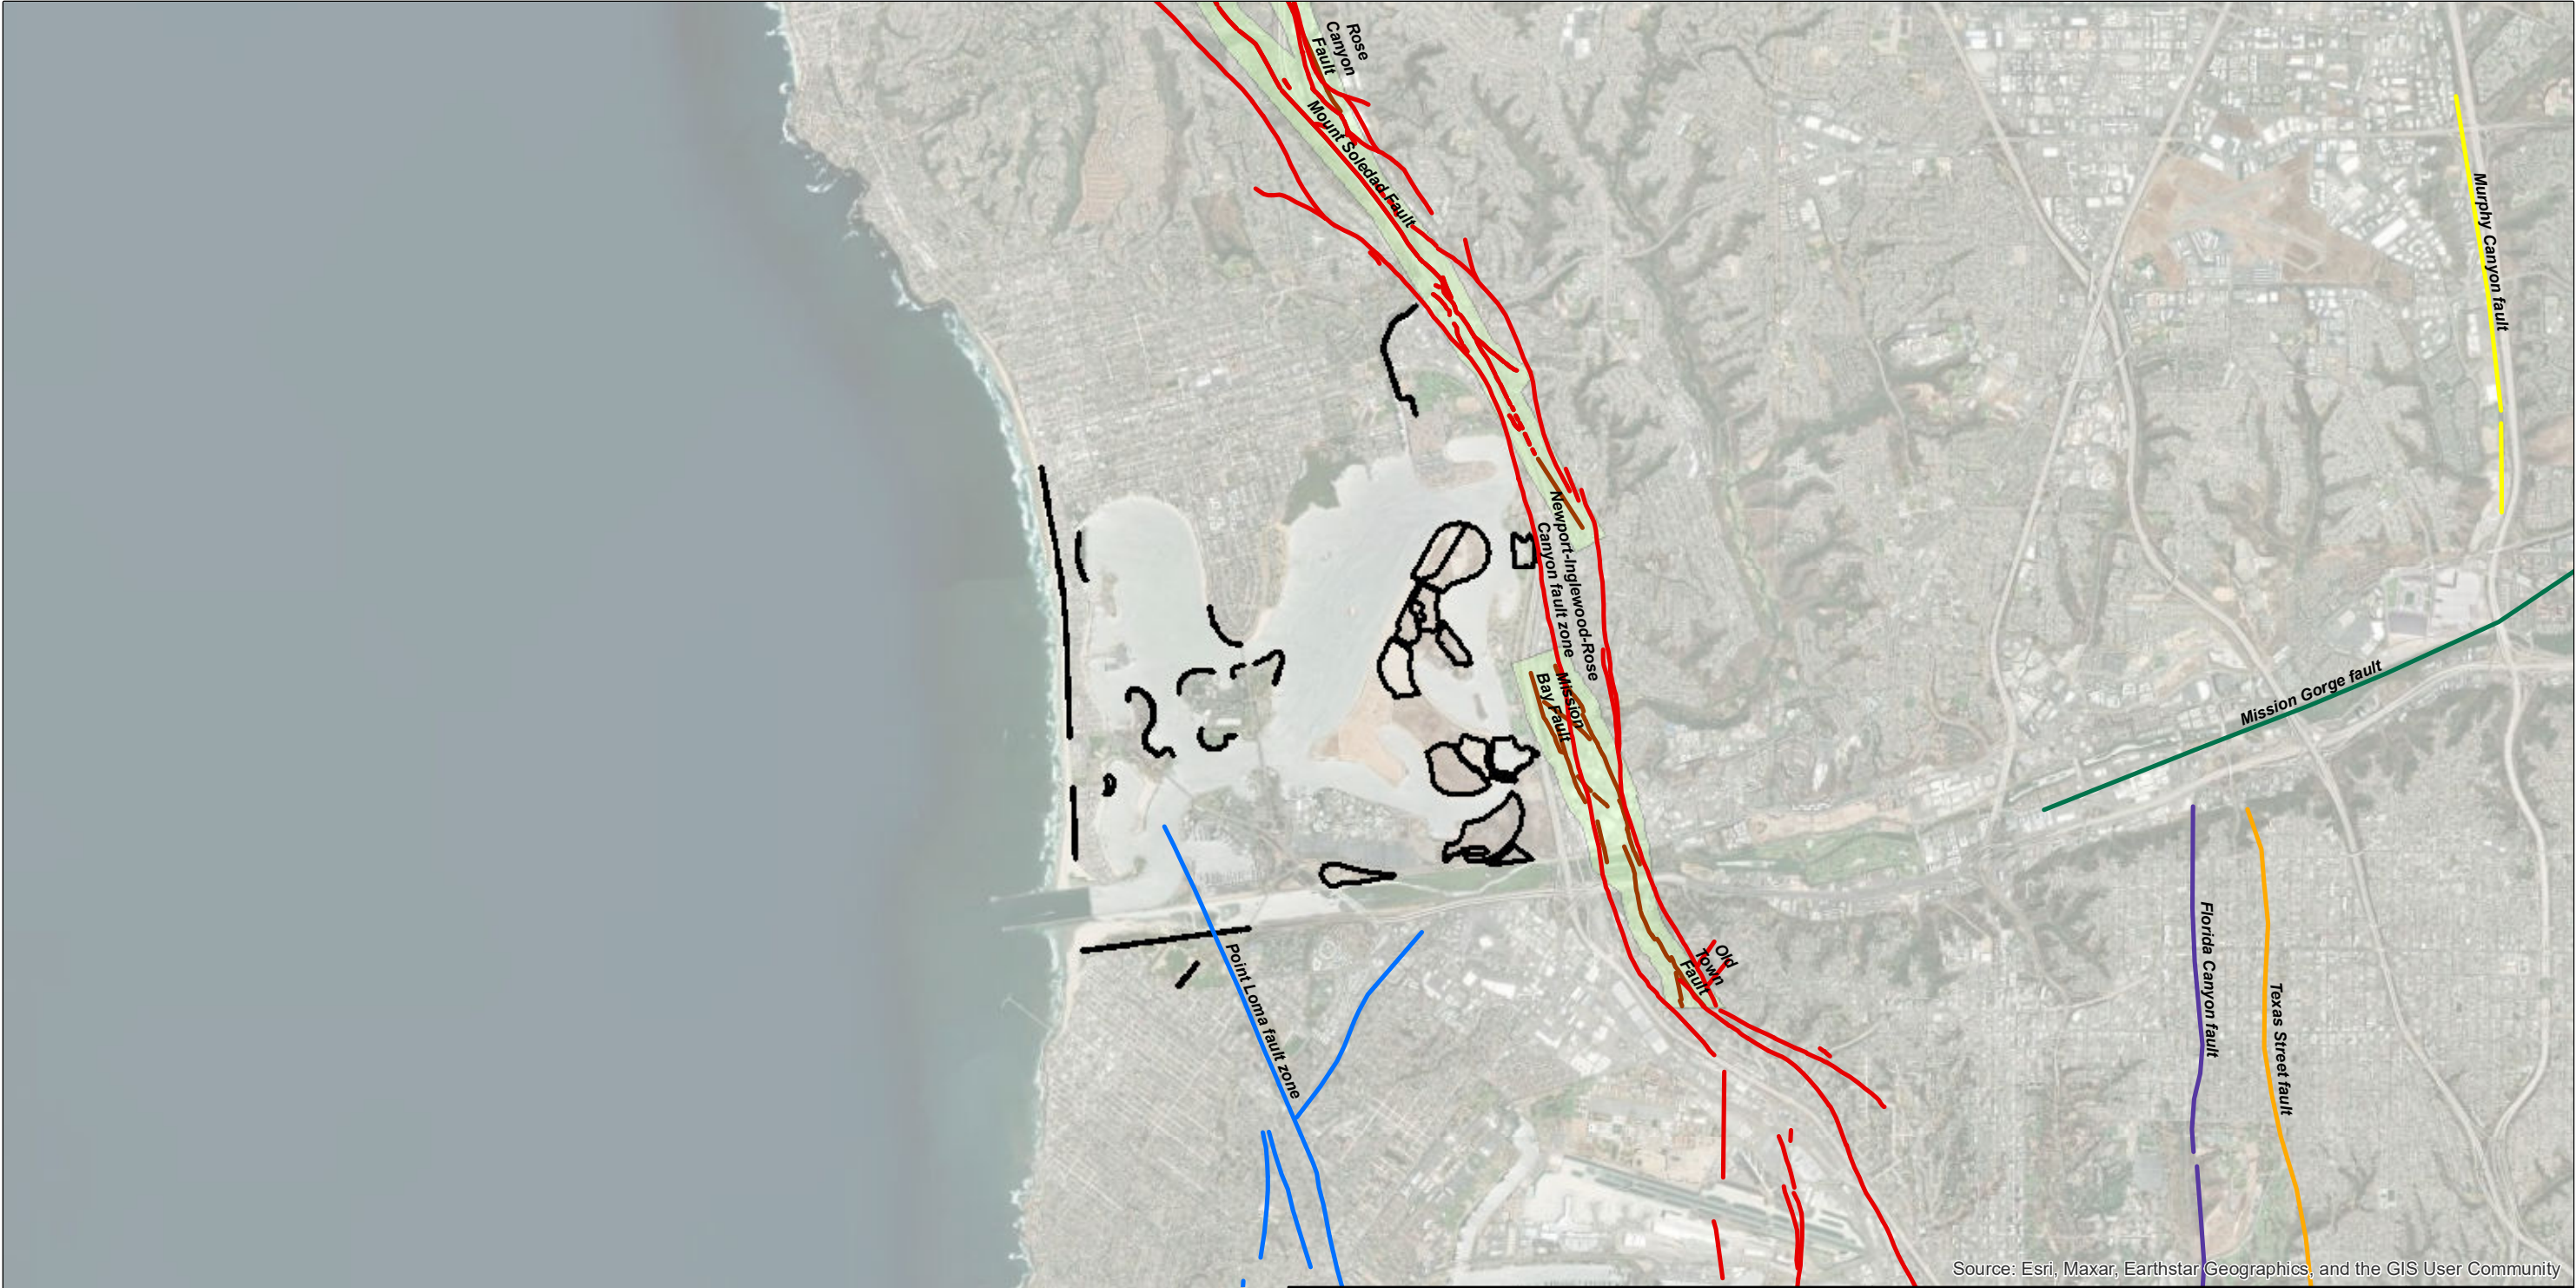
Figure 3 – Regional Fault Map

Structurally, the Peninsular Ranges are traversed by several major active faults. The Elsinore, San Jacinto, and the San Andreas faults are major active fault systems located northeast of San Diego and the Rose Canyon, San Diego Trough, Coronado Bank and San Clemente faults are major active faults located within or west-southwest of San Diego. Major tectonic activity associated with these and other faults within this regional tectonic framework is generally right-lateral strike-slip movement. These faults, as well as other faults in the region, have the potential for generating strong ground motions in the Study Area. Figure 3 – Regional Fault map shows the proximity of the Study Area to nearby mapped Quaternary faults.

San Diego is affected by the boundary between the North American and Pacific tectonic plates. The boundary, in southern California, is characterized by a wide zone of predominantly northwest-striking, right-slip faults that span the Imperial Valley and Peninsular Range to the offshore California Continental Borderland Province (from the California continental slope to the coast). The San Clemente fault zone located 60 miles west of San Diego and the San Andreas fault zone 70 miles east of San Diego define the plate boundary that affects the Study Area. The most active faults based on geodetic and seismic data are the San Andreas, San Jacinto, and Imperial faults. These faults take up most of the plate motion. Smaller faults, however, are active enough to create damaging earthquakes and these include the Elsinore, Newport-Inglewood-Rose Canyon, and the offshore Coronado Banks, San Diego Trough, and San Clemente fault zones (Figure 3).

As noted, the Study Area is subject to ground shaking hazards caused by earthquakes on regional active faults (Figure 3). Based on a Probabilistic Seismic Hazards Ground Motion Interpolator provided by the California Department of Conservation (2008), the Study Area (Longitude -117.229562, Latitude

Large earthquakes (usually in excess of Magnitude M5) often rupture the ground surface, shifting the ground up or down or shearing sideways on either side of the fault. The active Rose Canyon fault zone trace mapped beneath North Mission Bay Drive (Figure 3) could possibly cause a combination of sideways (right lateral) and vertical rupture (up on the west side of the fault) on the order of several inches to a foot if a large magnitude earthquake occurred on that specific trace. The precise location of the fault is not well documented and was based on 1929 aerial photographs and older topographic maps.
