REPORT OF LIMITED GEOTECHNICAL INVESTIGATION

Cunningham/Shaw Residence ADU
2734 Bordeaux Avenue
La Jolla, California

JOB NO. 22-14083

15 March 2023

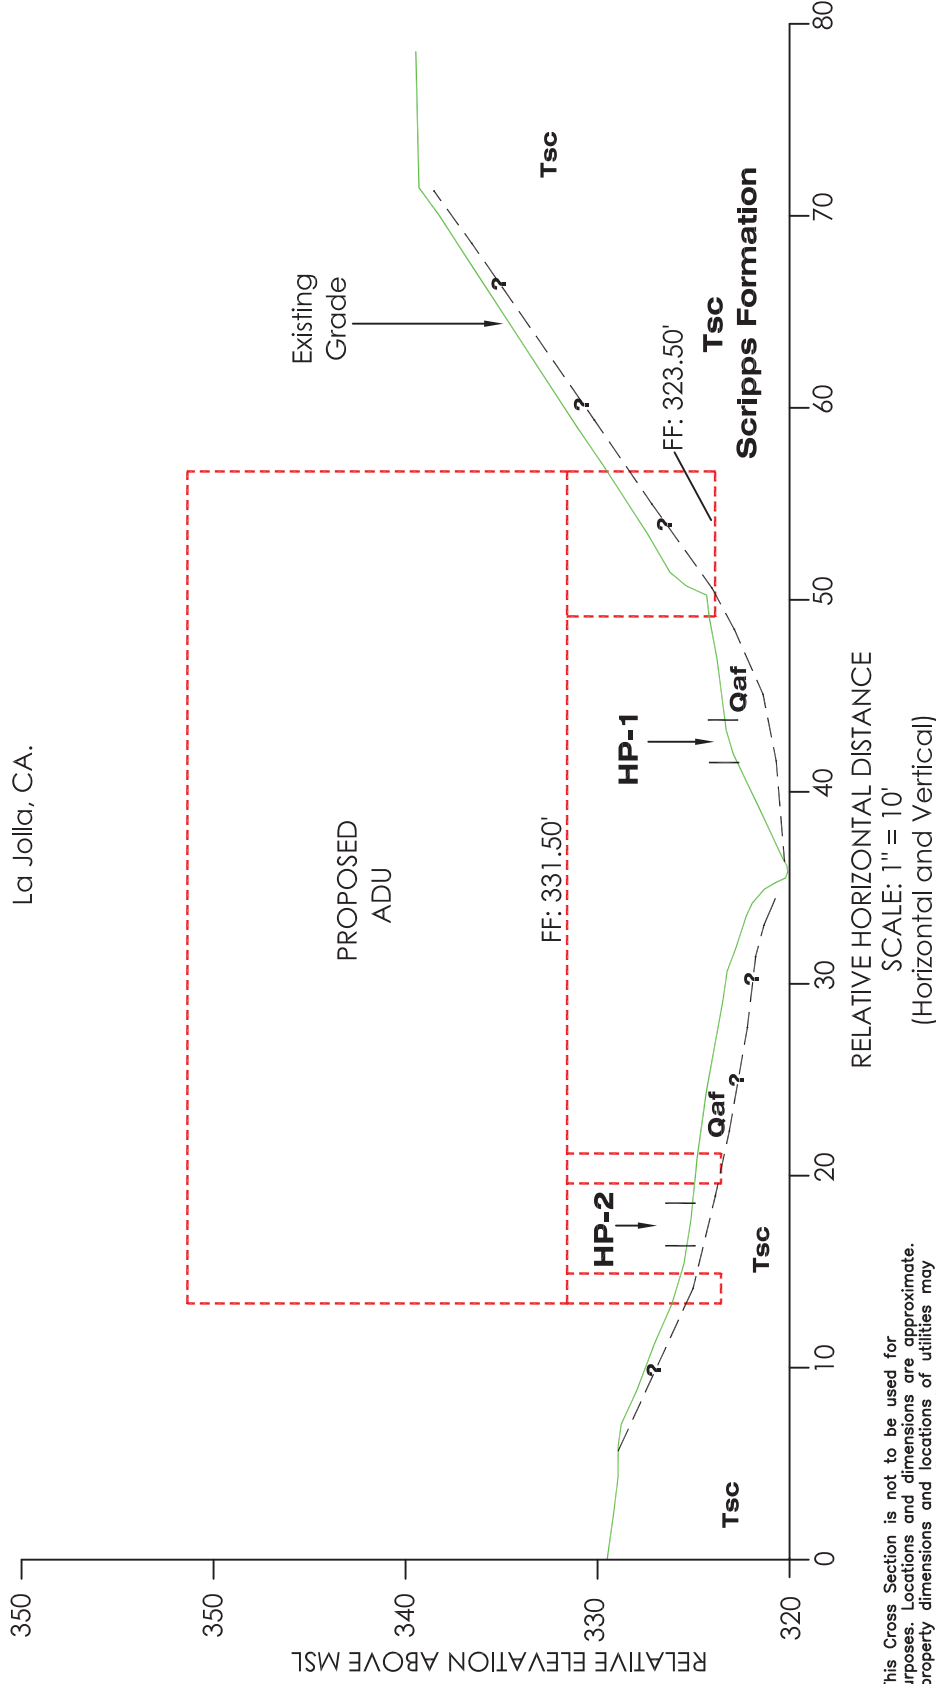
C'

NOTE: This Cross Section is not to be used for legal purposes. Locations and dimensions are approximate. Actual property dimensions and locations of utilities may be obtained from the Approved Building Plans or the "As-Built" Grading Plans.

Qaf	Artificial Fill	- ? - ? -	Approximate Geologic Contact
Tsc	Scripps Formation

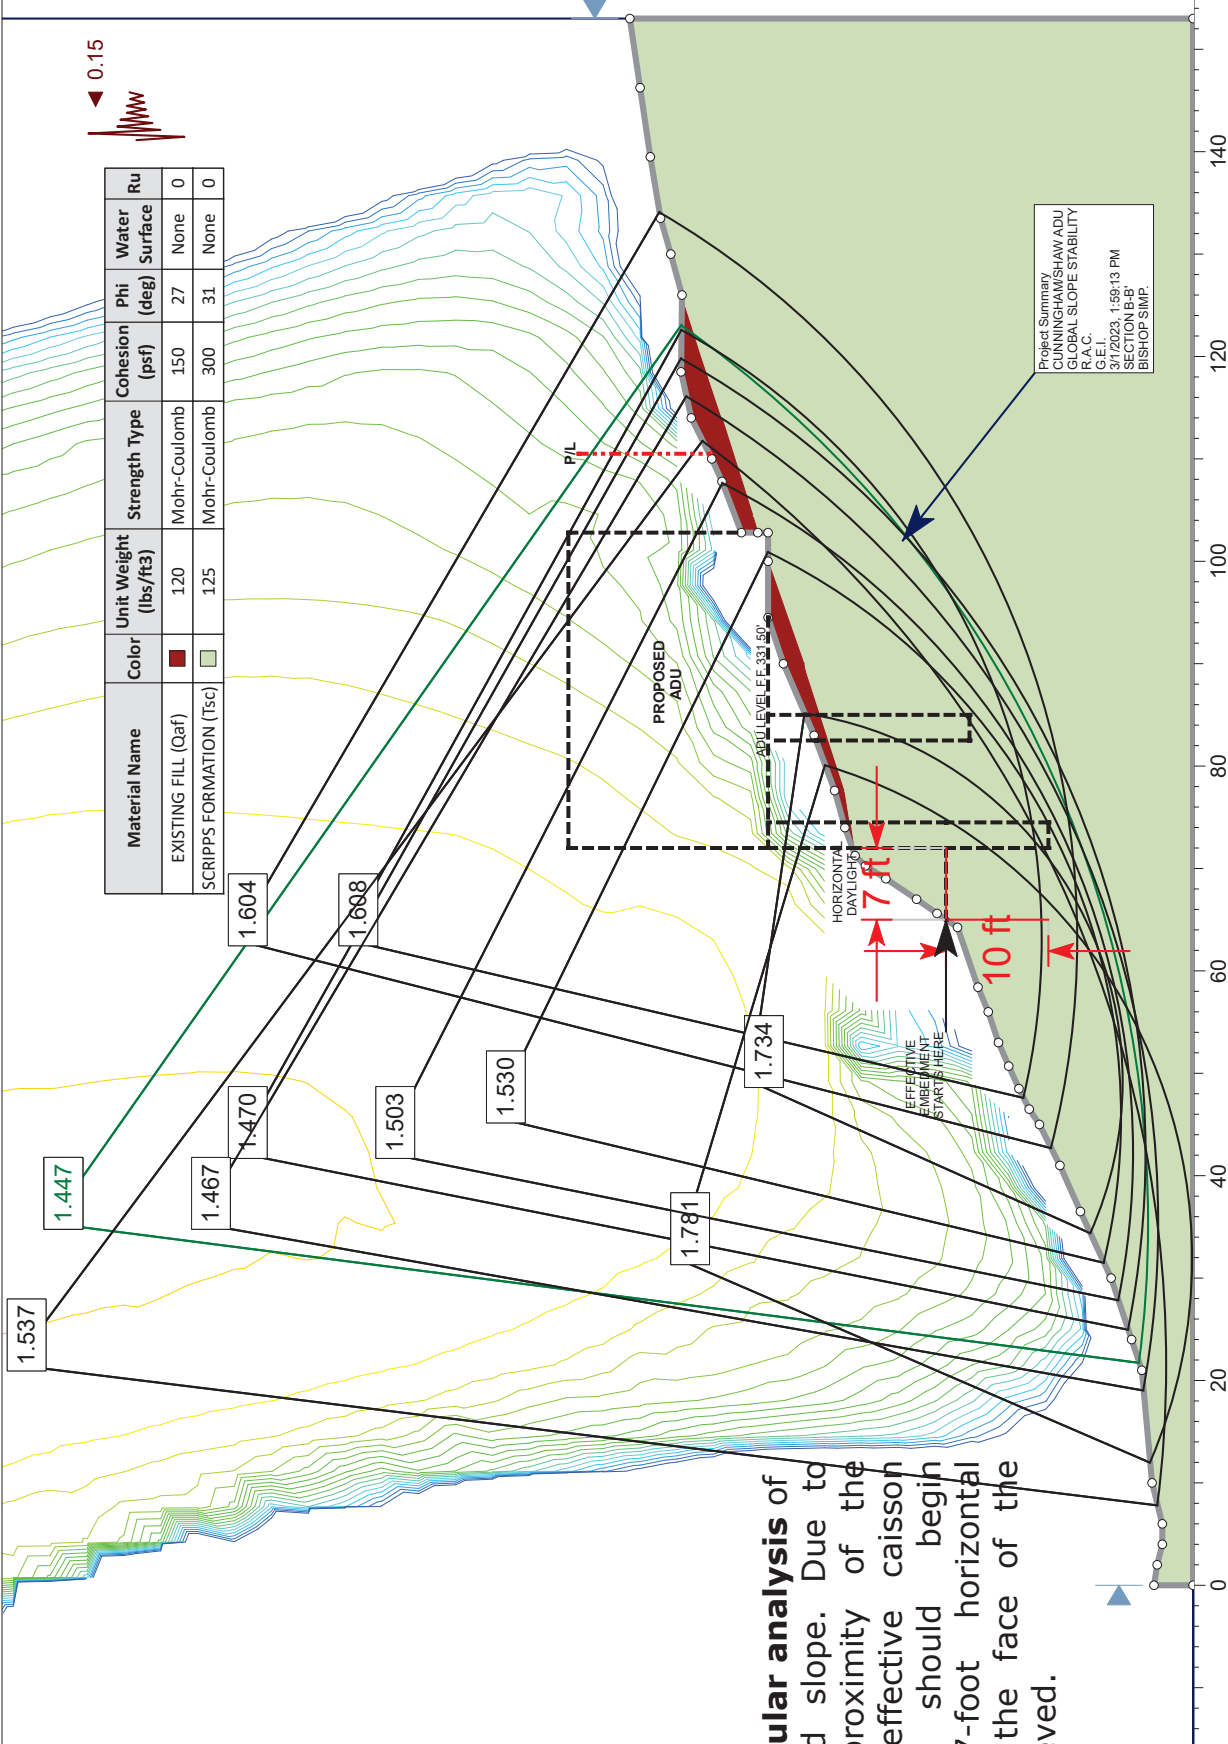
Project Summary:
 CUNNINGHAM/SHAW ADU
 GLOBAL SLOPE STABILITY
 R.A.C.
 G.E.I.
 3/1/2023, 1:59:13 PM
 SECTION B-B'
 BISHOP SIMP.

Seismic circular analysis of the proposed slope. Due to the close proximity of the slope, the effective caisson embedment should begin where a 7-foot horizontal distance to the face of the slope is achieved.

Material Name	Color	Unit Weight (lbs/ft ³)	Strength Type	Cohesion (psf)	Phi (deg)	Water Surface	Ru
EXISTING FILL (Qaf)	Red	120	Mohr-Coulomb	150	27	None	0
SCRIPPS FORMATION (Tsc)	Green	125	Mohr-Coulomb	300	31	None	0
