REPORT OF LIMITED GEOTECHNICAL INVESTIGATION UPDATE

Cunningham/Shaw Residence ADU
2734 Bordeaux Avenue
La Jolla, California

JOB NO. 22-14083

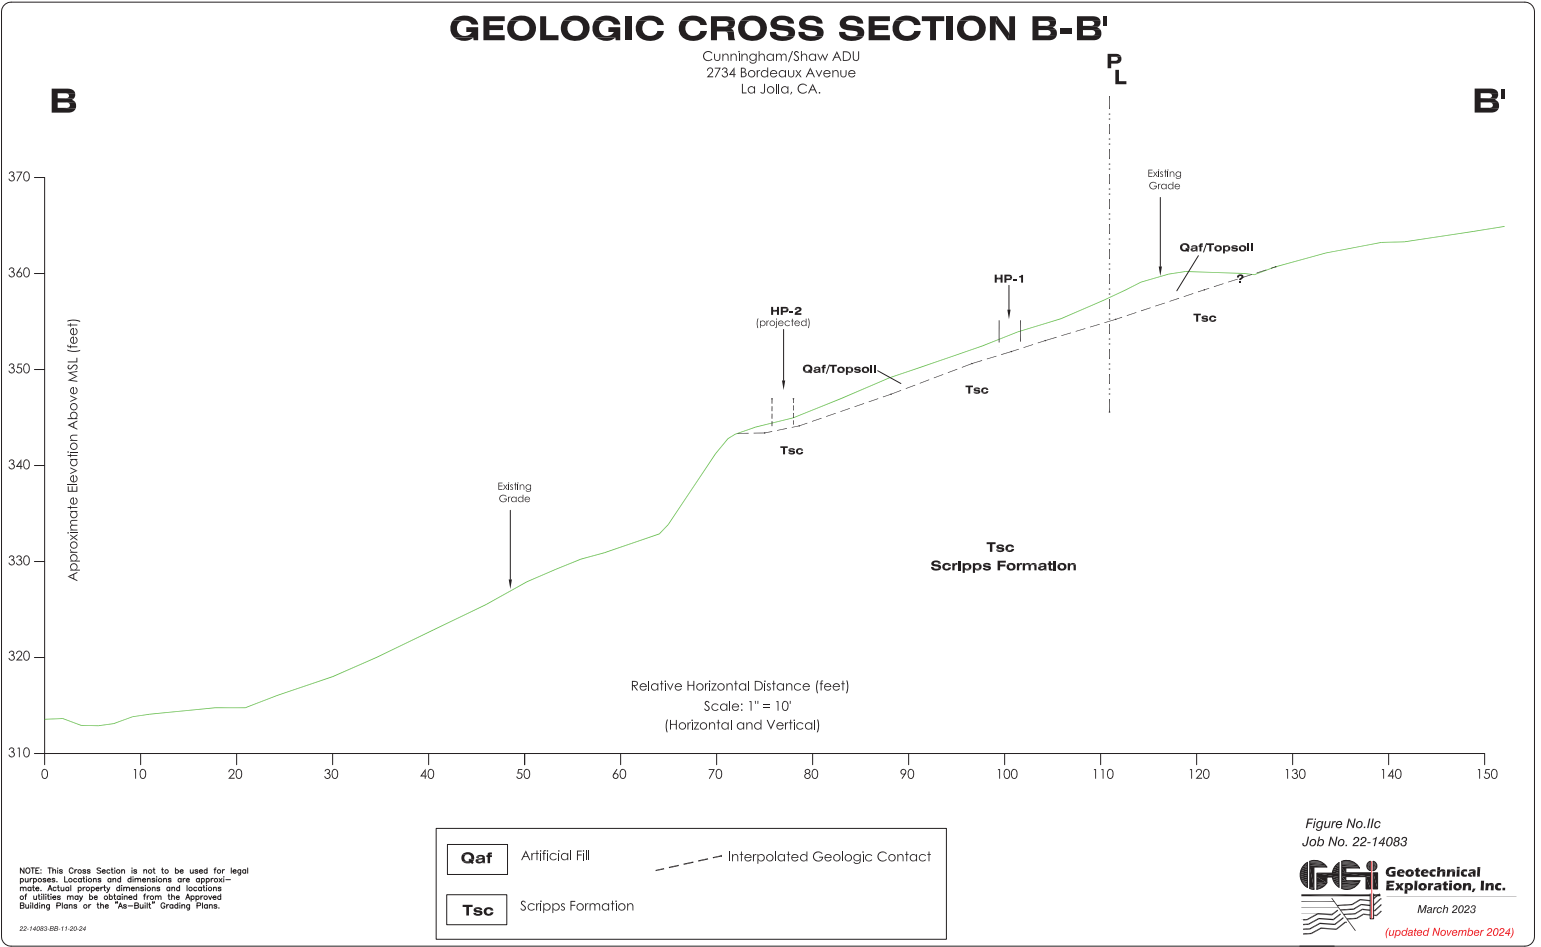
GEOLOGIC CROSS SECTION B-B'

Cunningham/Shaw ADU
2734 Bordeaux Avenue
La Jolla, CA.

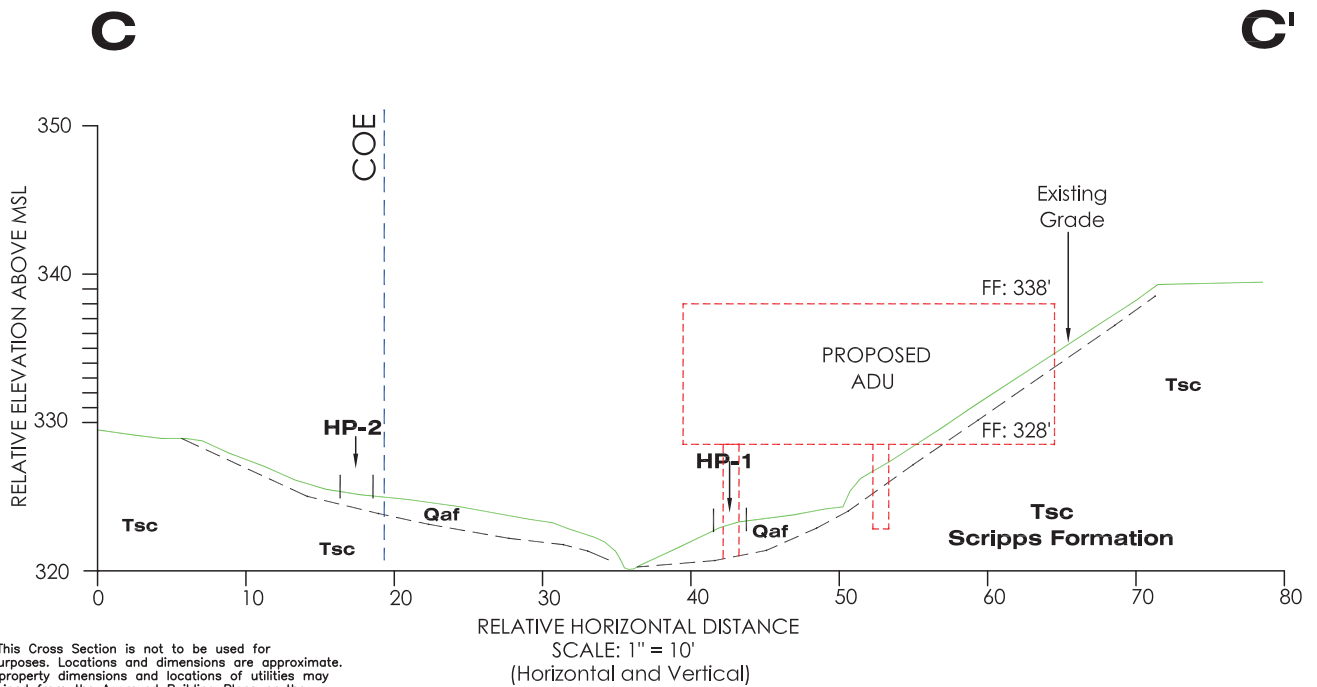
GEOLOGIC CROSS SECTION C-C'

Qaf	Artificial Fill		Interpolated Geologic Contact
Tsc	Scripps Formation

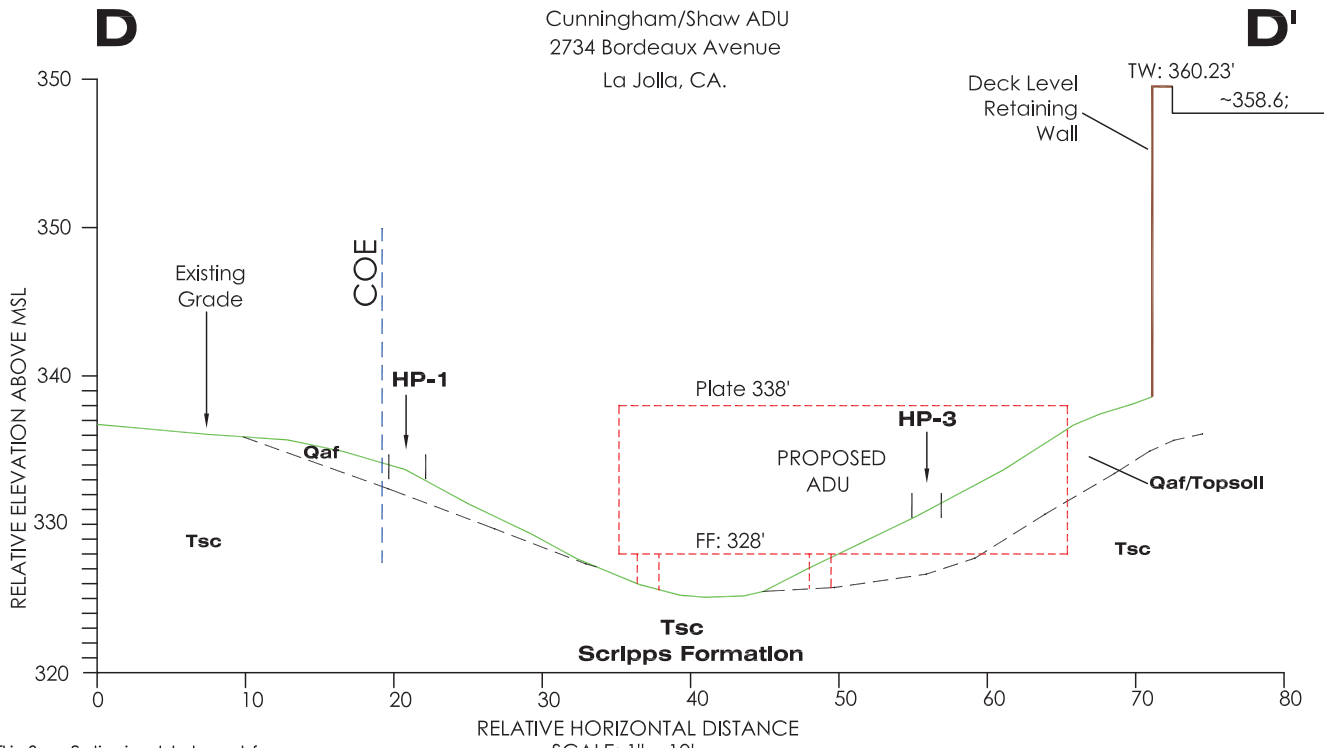
GEOLOGIC CROSS SECTION D-D'

SCALE: 1" = 10'
(Horizontal and Vertical)

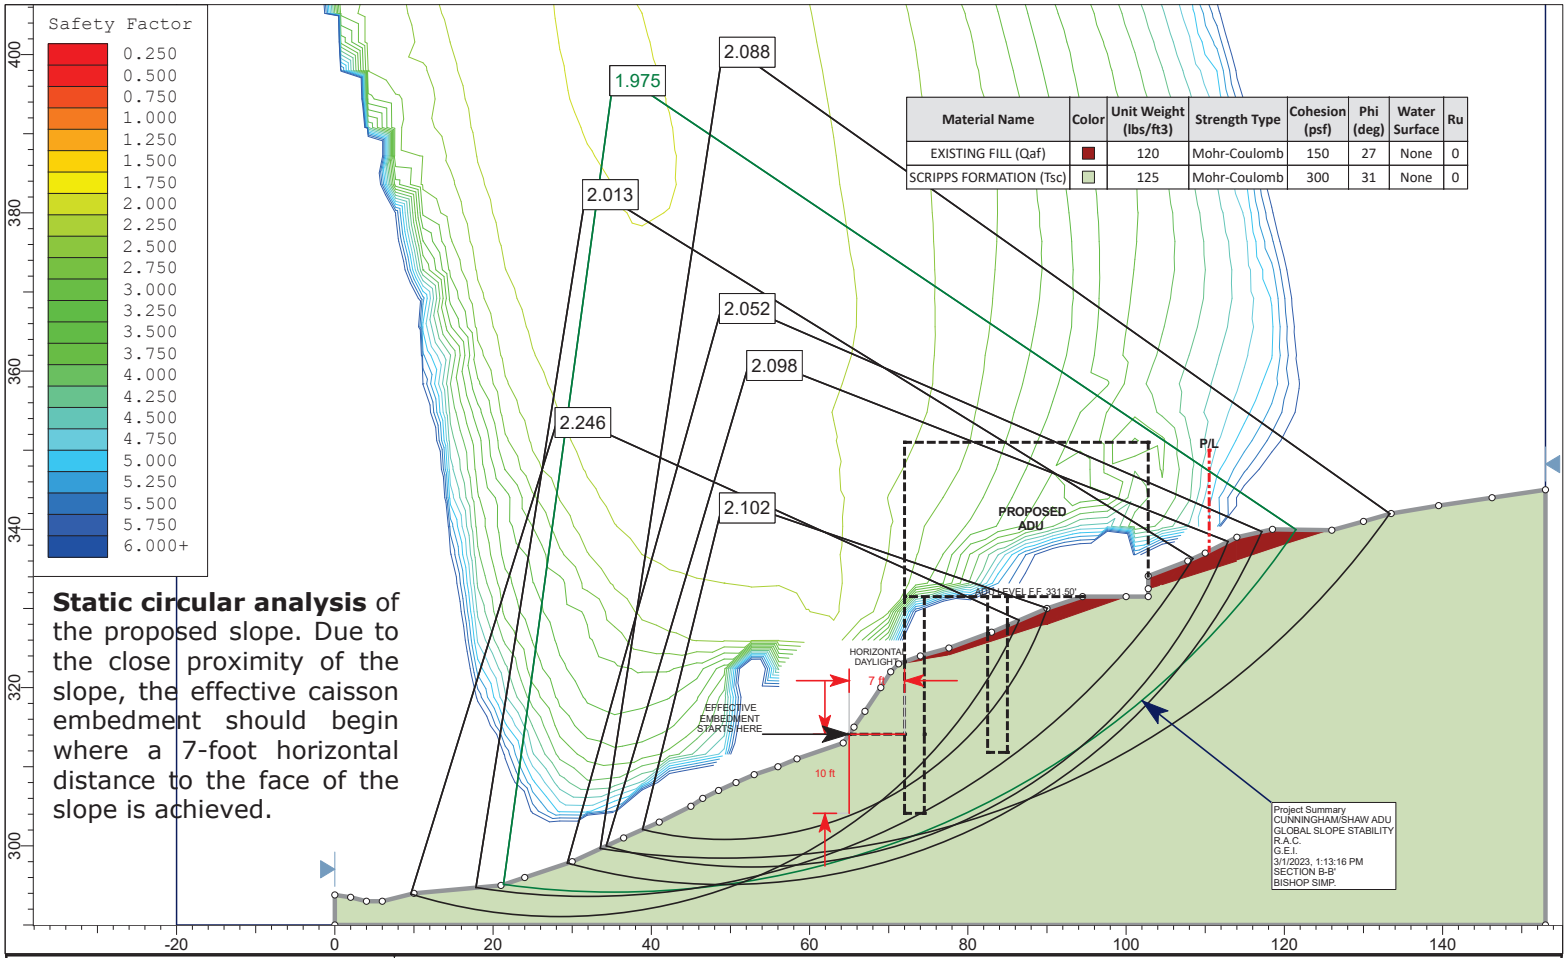
<p>Geotechnical Exploration, Inc.</p> <p style="font-size: x-small;">SLIDEINTERPRET 6.039</p>	<i>Project</i>		CUNNINGHAM/SHAW ADU		SECTION B-B'
	<i>Analysis Description</i>				
	GLOBAL SLOPE STABILITY				
	<i>Drawn By</i>	R.A.C.	<i>Scale</i>	1:225	<i>Company</i>
<i>Date</i>	3/1/2023, 1:13:16 PM		<i>File Name</i>	JOB NO. 22-14083_S(B)_01.slim

We performed gross slope stability calculations using the *SLIDE 6* program by Roc Science. The program is a limit equilibrium method, slope stability program that allows the use of several slope stability methods to calculate the factors of safety against shear failure. On this project the Bishop Simplified method was used as the basis for calculations when using circular slide surfaces for analysis through the site geologic cross sections.

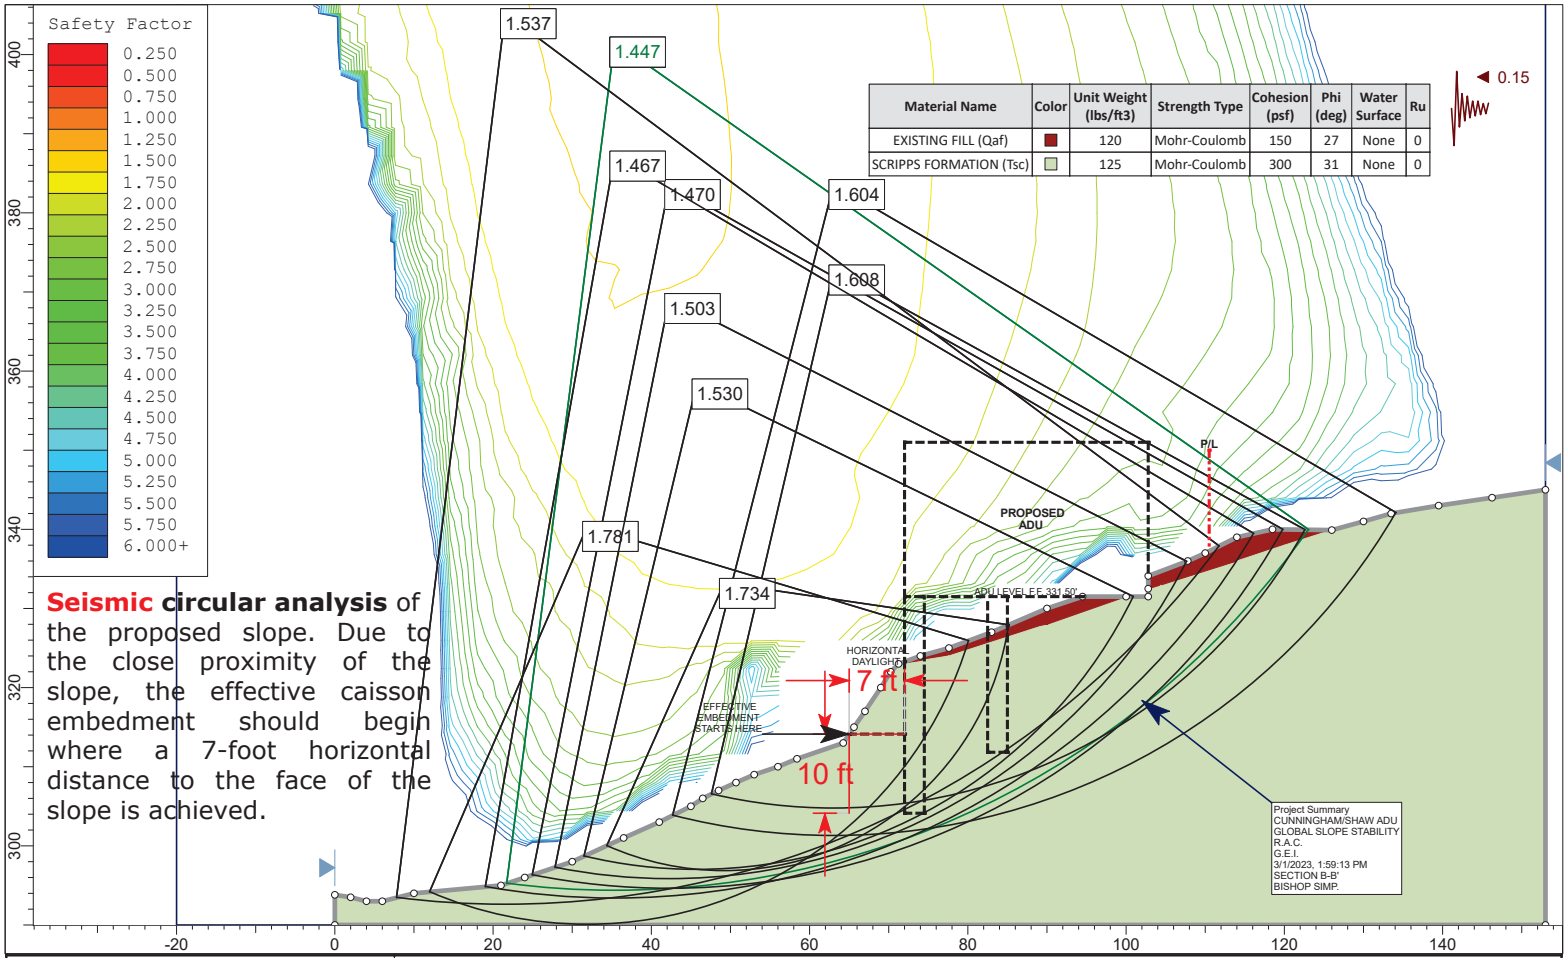
Project		CUNNINGHAM/SHAW ADU		SECTION B-B'	
	Analysis Description		GLOBAL SLOPE STABILITY			
	Drawn By	R.A.C.	Scale	1:225	Company	G.E.I.
	Date	3/1/2023, 1:59:13 PM	File Name	JOB NO. 22-14083_S(B)_02.slim

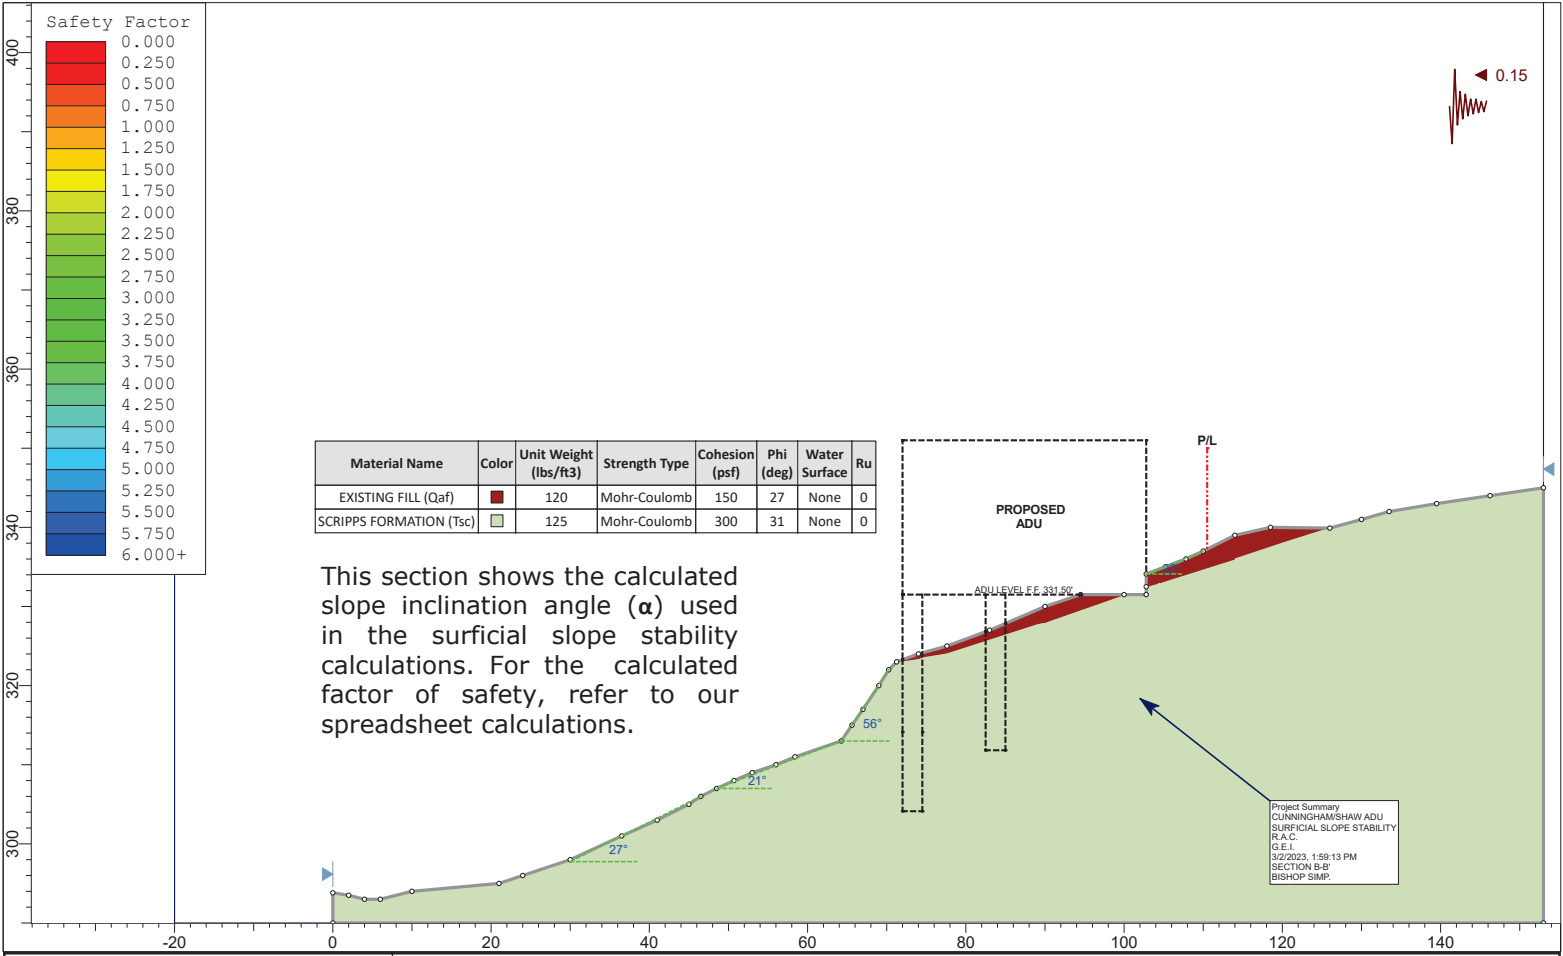
Project		CUNNINGHAM/SHAW ADU		SECTION B-B'	
Analysis Description		SURFICIAL SLOPE STABILITY			
Drawn By	R.A.C.	Scale	1:225	Company	G.E.I.
Date	3/2/2023, 1:59:13 PM	File Name	JOB NO. 22-14083_S(B)_03.slim

opinion that the slope segment analyzed was assumed to have an infinite length. Based on the current existing slope, the calculations yielded the factor of safety against shear failure below 1.5 for a sliding block of 1 meter (3.28 feet) high against the soil shear strength frictional and cohesion strength opposing the driving force.

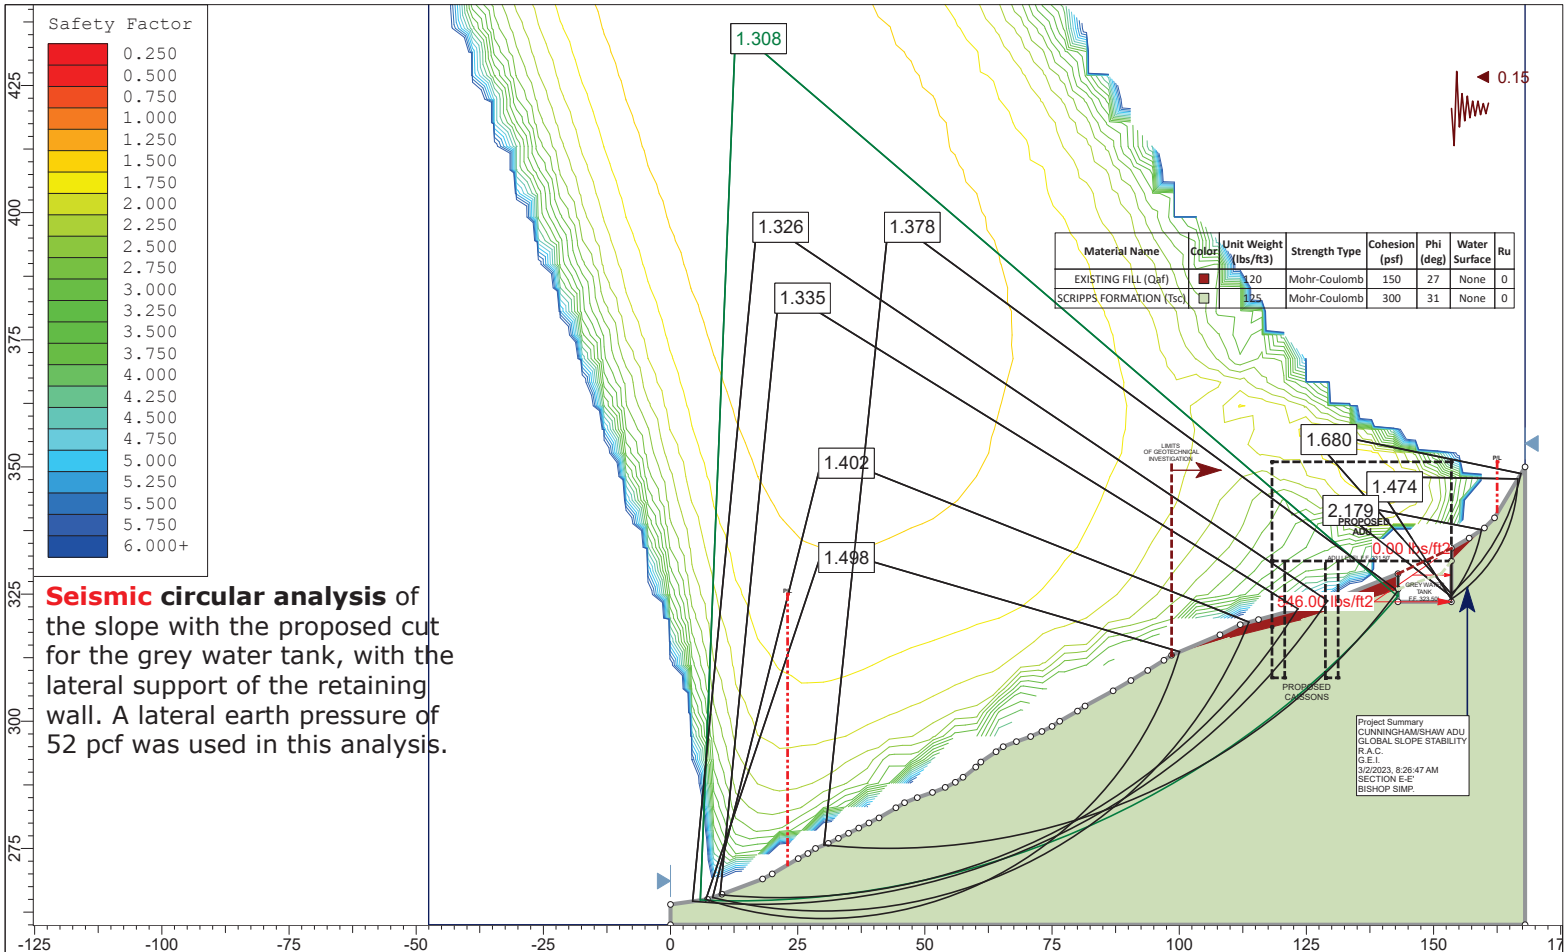
Seismic circular analysis of the slope with the proposed cut for the grey water tank, with the lateral support of the retaining wall. A lateral earth pressure of 52 pcf was used in this analysis.

<p>SLIDEINTERPRET 6.039</p>	<i>Project</i>		CUNNINGHAM/SHAW ADU		SECTION E-E'	
	<i>Analysis Description</i>					
	GLOBAL SLOPE STABILITY					
	<i>Drawn By</i>	R.A.C.	<i>Scale</i>	1:350	<i>Company</i>	G.E.I.
<i>Date</i>	3/2/2023, 8:26:47 AM			<i>File Name</i>	JOB NO. 22-14083_S(E)_03.slim

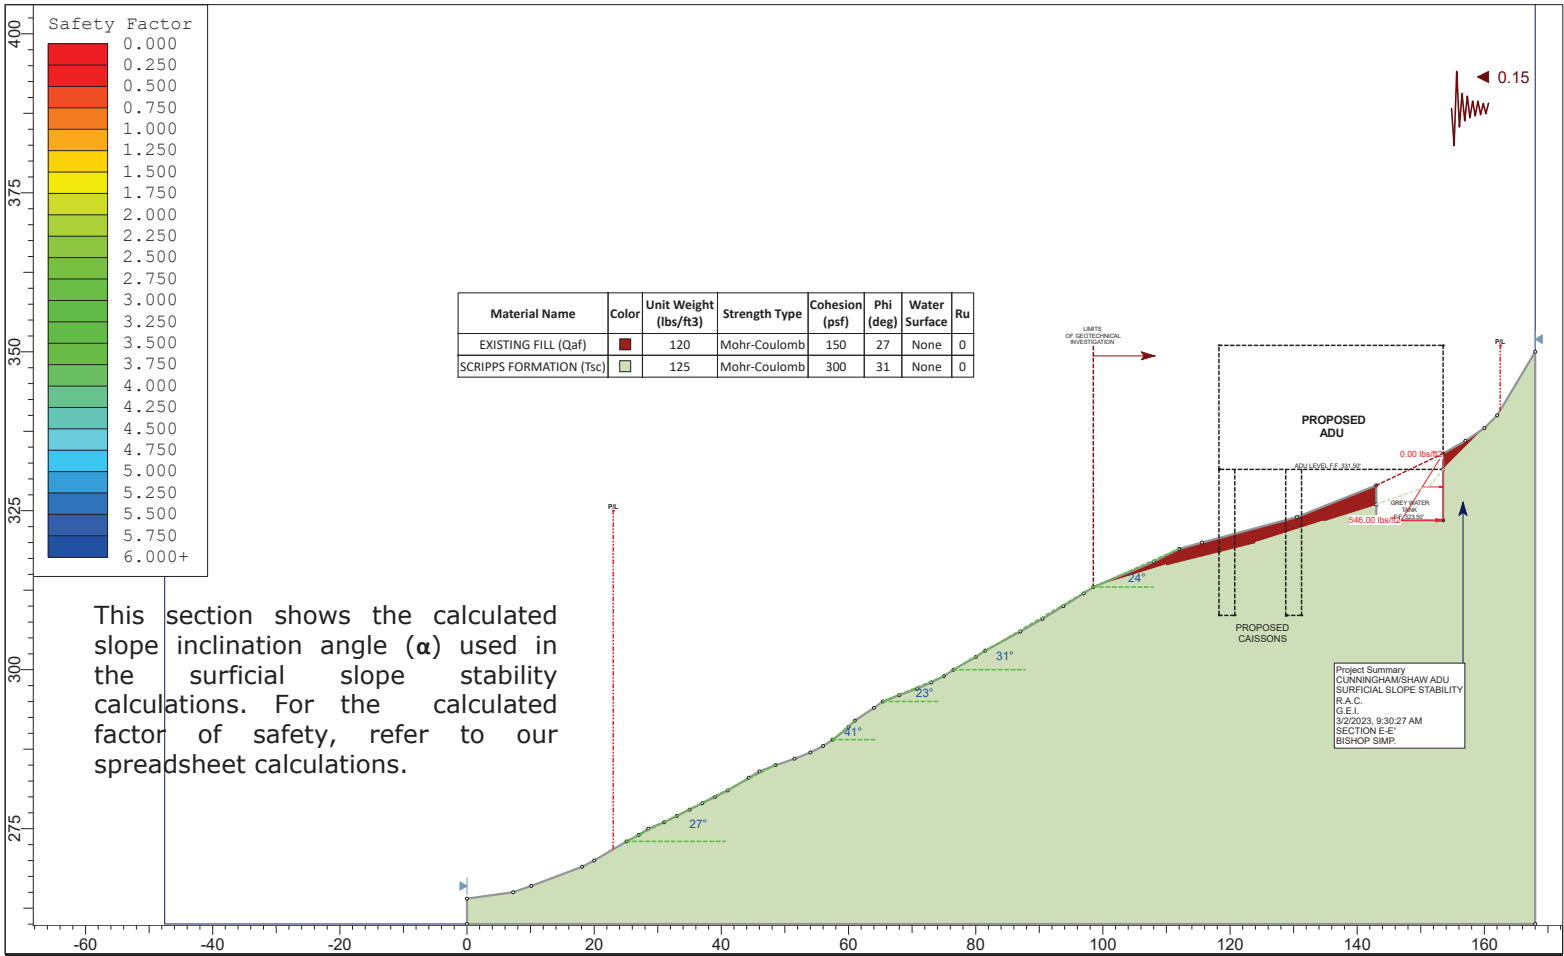
<small>SLIDEINTERPRET 6.039</small>	Project		CUNNINGHAM/SHAW ADU		SECTION E-E'	
	Analysis Description		SURFICIAL SLOPE STABILITY			
	Drawn By	R.A.C.	Scale	1:280	Company	G.E.I.
	Date	3/2/2023, 9:30:27 AM	File Name	JOB NO. 22-14083_S(E)_04.slim

SURFICIAL FAILURE
