**GEOTECHNICAL STUDY**

**SOUTHWEST VILLAGE  
EMERGENCY VEHICLE ACCESS ROAD  
SAN DIEGO, CALIFORNIA**

**TRI POINTE HOMES  
SAN DIEGO, CALIFORNIA**

**MARCH 27, 2024  
PROJECT NO. 06847-42-04A**

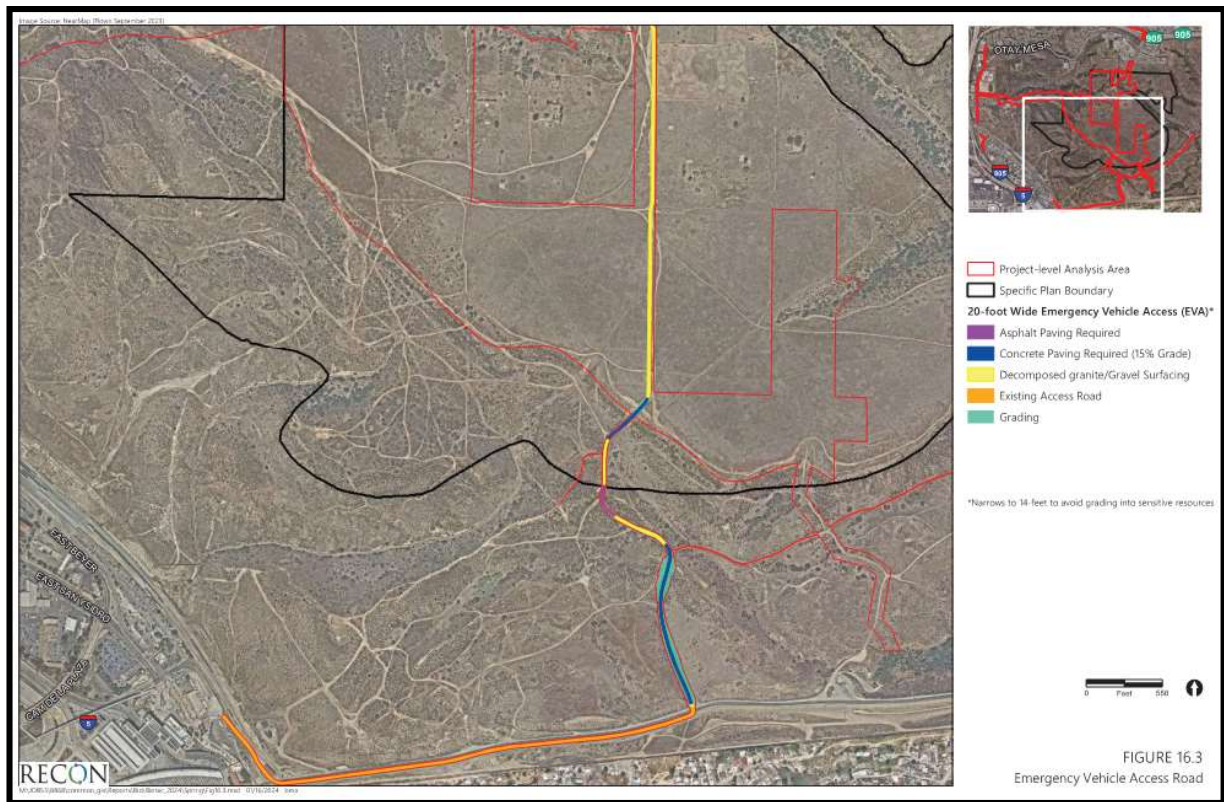
The majority of the roadway will be surfaced with disintegrated granite (DG). Steeper hillside portions will be surfaced with Portland cement concrete pavement (Stations 47+00 to 54+00 and 70+00 to 73+50). One area will be surfaced with asphalt concrete (Stations 63+00 to 66+00). The figure below shows the location of the planned roadway paving surfaces.

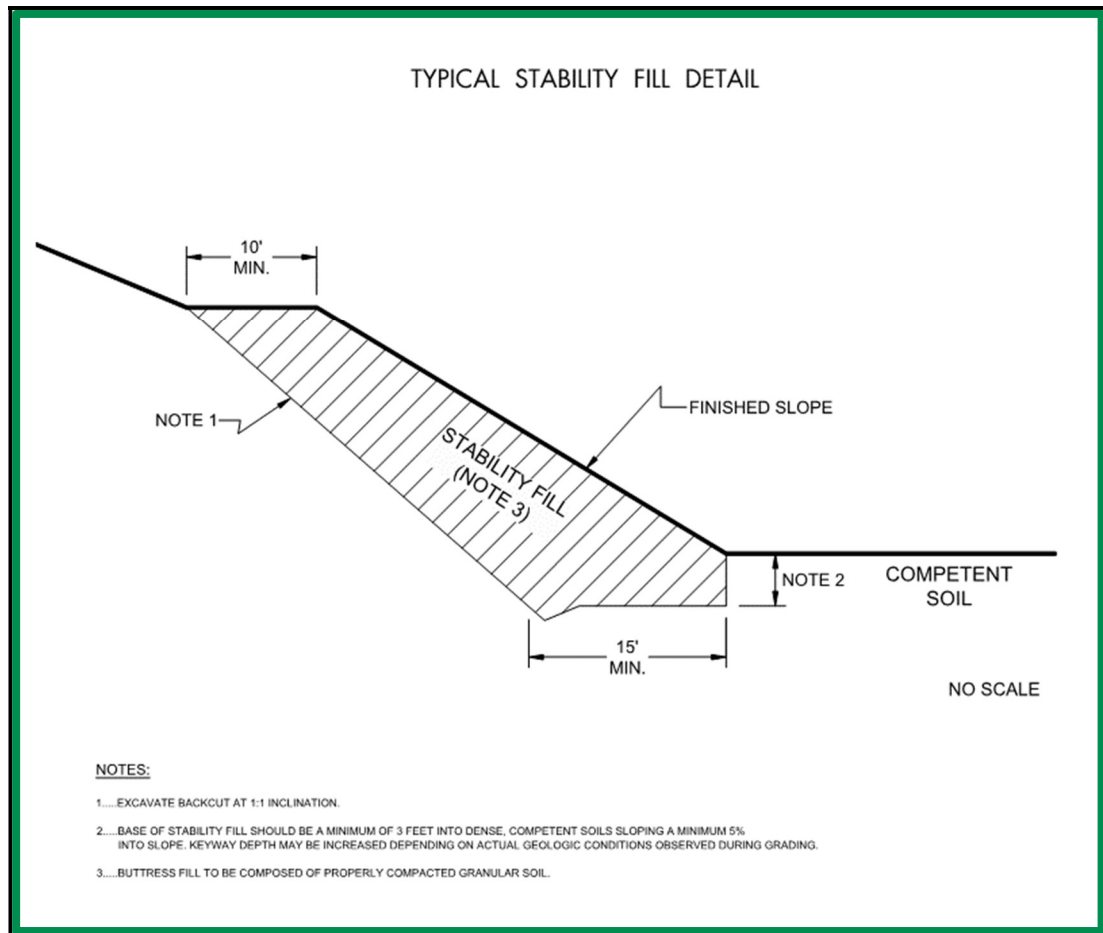
- 8.3.12 Cuts slopes in the landslide debris may require a stability fill. The need for stability fills will be determined during grading once the condition of soils in the cut excavation can be assessed. A typical stability fill detail is provided below.

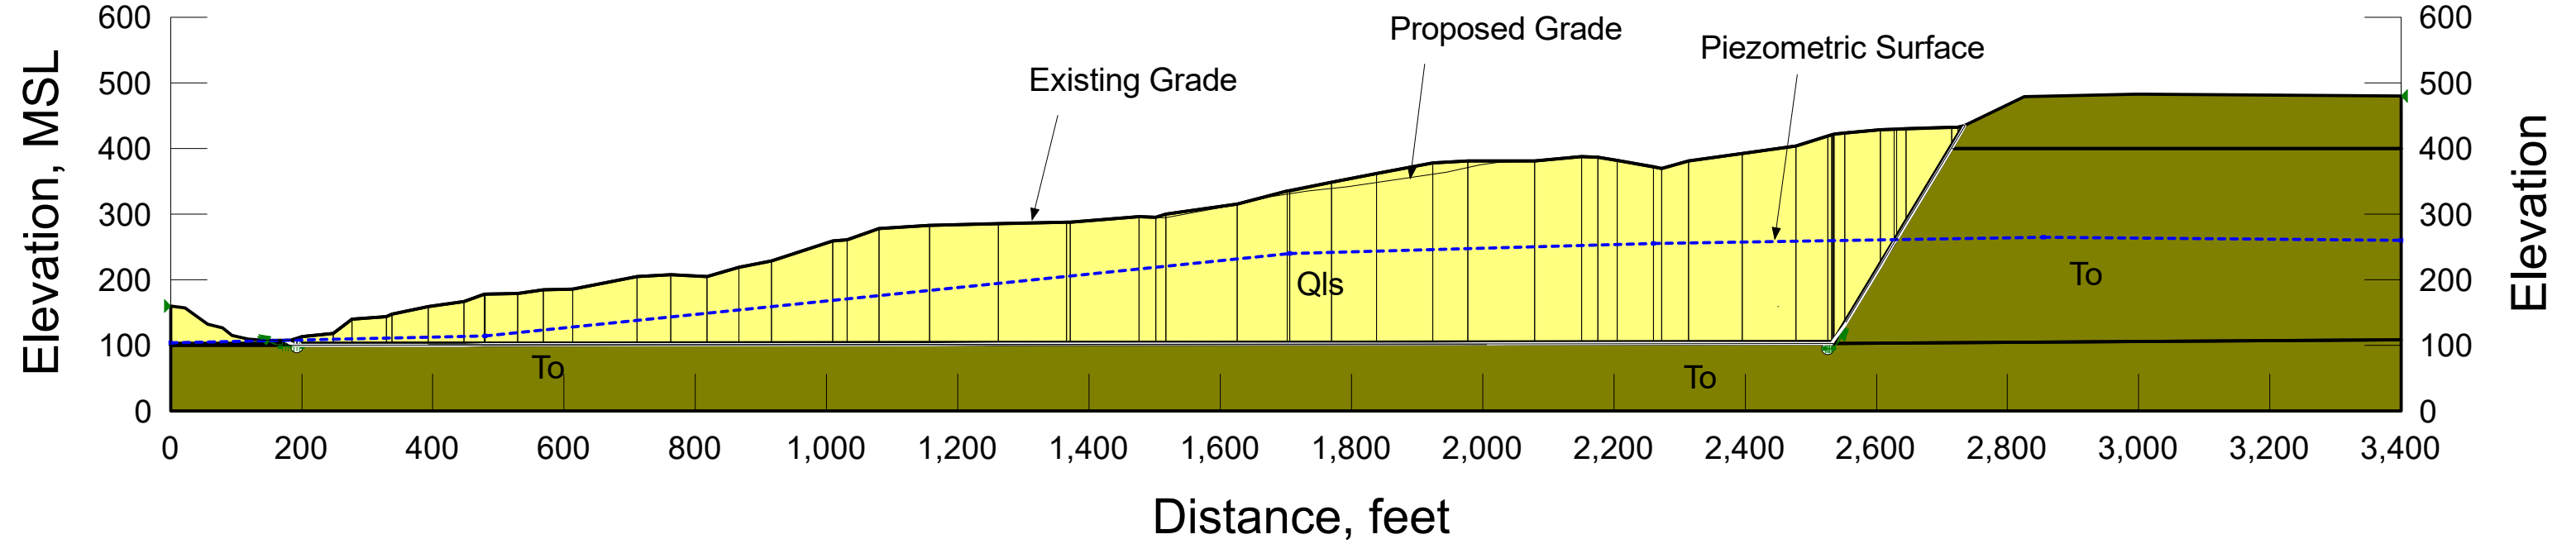
FIGURE 4

1.25

Southwest Village  
Project No. 06847-42-04A  
Cross Section: A-A'

The computer program searches for the critical failure surface based on parameters inputted, including the location of the "left" and "right" sliding blocks. The output files and calculated factor of safety for the cross-sections analyzed are presented on Figures 4 and 5. The critical failure surface for each analysis is shown on computer-generated output. The factor of safety is shown on each figure directly above the failure surface.

To assess the factor of safety for the existing hillside in the area of the EVA, we performed a slope stability analysis using Cross Section A-A'. We analyzed a failure along the basal slide plane and up the assumed landslide headscarp. The strength parameters used for the basal surface was also used along the landslide headscarp. The result of this analysis is shown on Figure 4 which indicates a factor of safety of 1.25 for existing conditions.

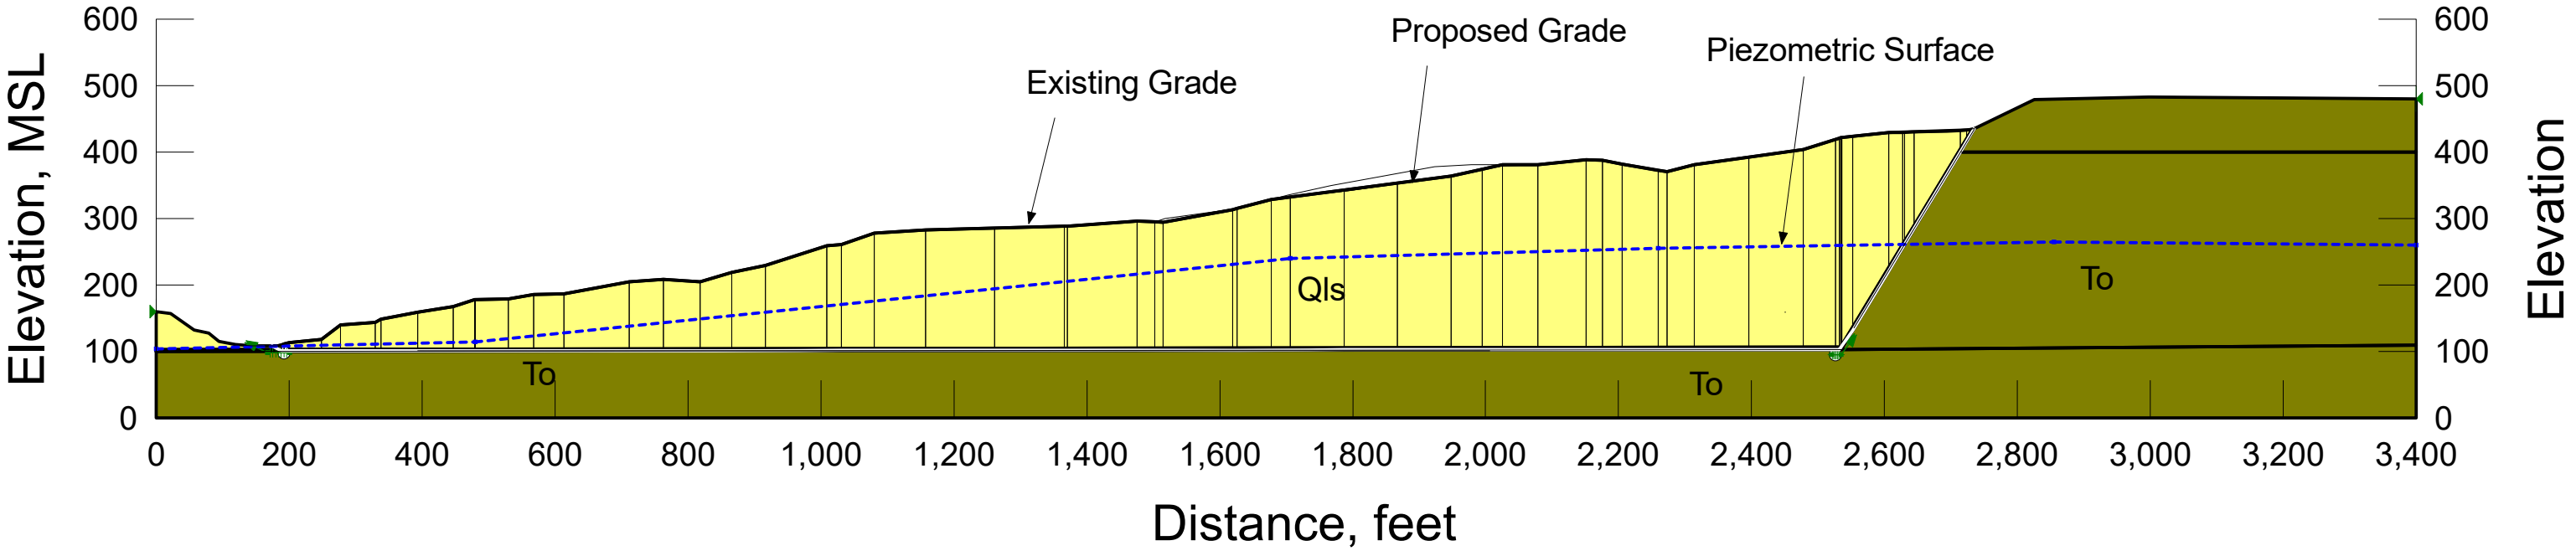
FIGURE 5

1.24

To assess if the proposed EVA roadway grading impacts the existing hillside stability, we analyzed the stability section with the roadway grading included. The result of this analysis is shown on Figure 5. Based on our analysis, the factor of safety for the proposed roadway grading is essentially the same as it is for existing conditions (1.24). This demonstrates that the proposed EVA road construction does not impact the stability of the hillside slope. It is our opinion that a factor of safety greater than 1.2 is appropriate for the intended development of an EVA roadway.

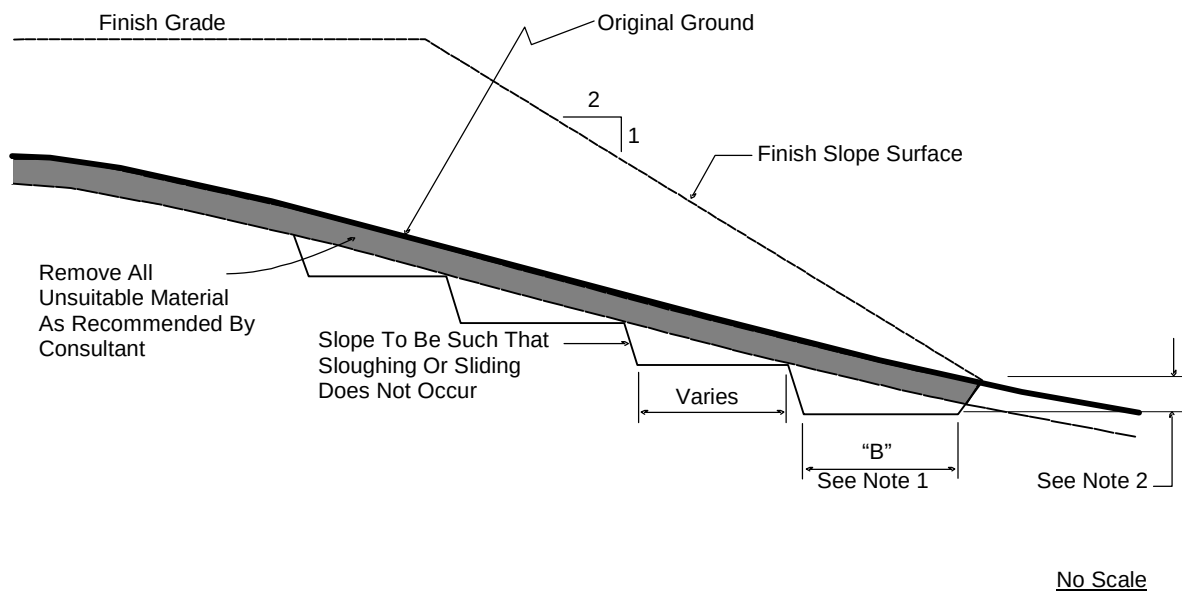
#### TYPICAL BENCHING DETAIL

- 4.4 Where the slope ratio of the original ground is steeper than 5:1 (horizontal:vertical), or where recommended by the Consultant, the original ground should be benched in accordance with the following illustration.

- DETAIL NOTES:
- (1) Key width "B" should be a minimum of 10 feet, or sufficiently wide to permit complete coverage with the compaction equipment used. The base of the key should be graded horizontal, or inclined slightly into the natural slope.
  - (2) The outside of the key should be below the topsoil or unsuitable surficial material and at least 2 feet into dense formational material. Where hard rock is exposed in the bottom of the key, the depth and configuration of the key may be modified as approved by the Consultant.

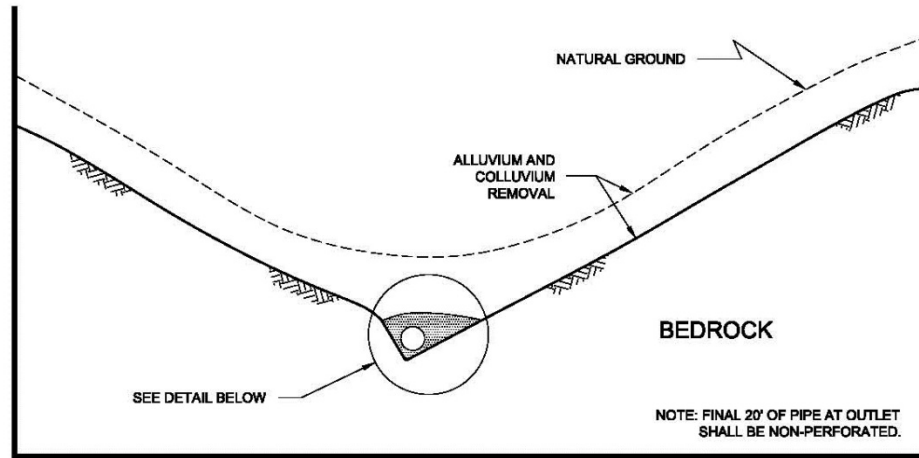
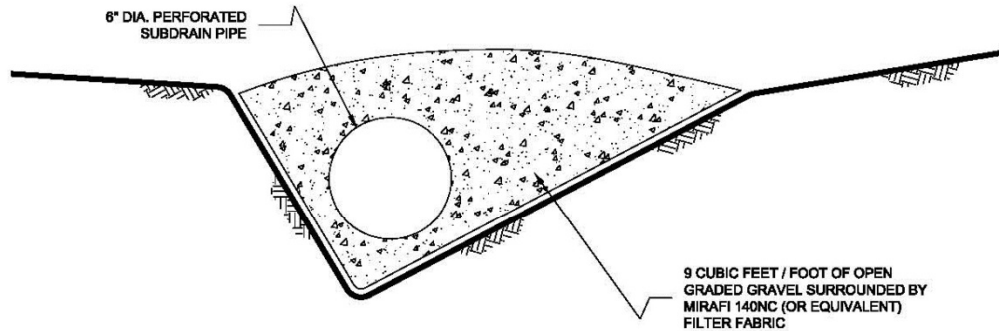
## TYPICAL CANYON DRAIN DETAIL

- 7.1 The geologic units on the site may have permeability characteristics and/or fracture systems that could be susceptible under certain conditions to seepage. The use of canyon subdrains may be necessary to mitigate the potential for adverse impacts associated with seepage conditions. Canyon subdrains with lengths in excess of 500 feet or extensions of existing offsite subdrains should use 8-inch-diameter pipes. Canyon subdrains less than 500 feet in length should use 6-inch-diameter pipes.

- 1.....8-INCH DIAMETER, SCHEDULE 80 PVC PERFORATED PIPE FOR FILLS IN EXCESS OF 100-FEET IN DEPTH OR A PIPE LENGTH OF LONGER THAN 500 FEET.
- 2.....8-INCH DIAMETER, SCHEDULE 40 PVC PERFORATED PIPE FOR FILLS LESS THAN 100-FEET IN DEPTH OR A PIPE LENGTH SHORTER THAN 500 FEET.

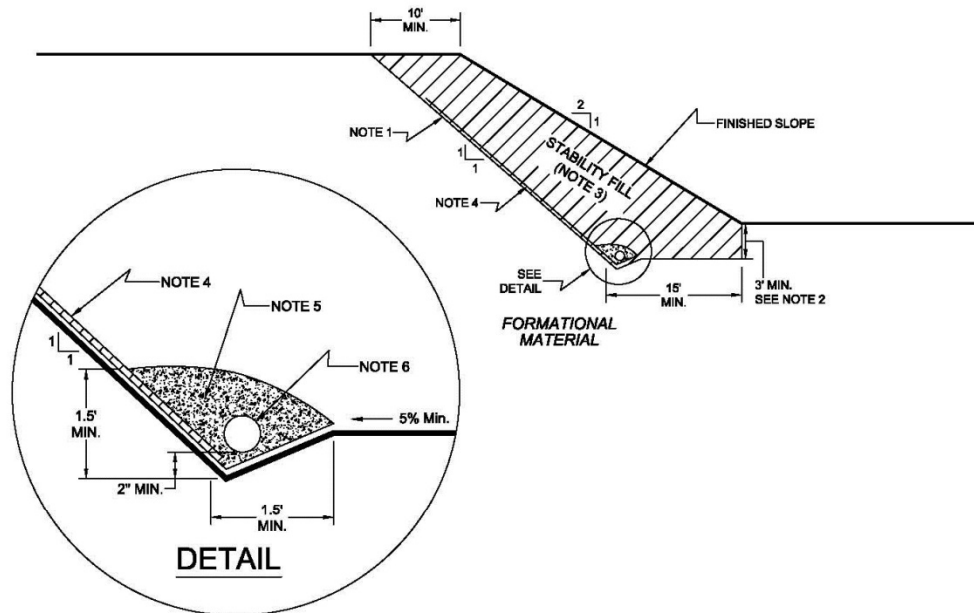
## TYPICAL STABILITY FILL DETAIL

7.2 Slope drains within stability fill keyways should use 4-inch-diameter (or larger) pipes.

- 1.....EXCAVATE BACKCUT AT 1:1 INCLINATION (UNLESS OTHERWISE NOTED).
- 2.....BASE OF STABILITY FILL TO BE 3 FEET INTO FORMATIONAL MATERIAL, SLOPING A MINIMUM 5% INTO SLOPE.
- 3.....STABILITY FILL TO BE COMPOSED OF PROPERLY COMPACTED GRANULAR SOIL.
- 4.....CHIMNEY DRAINS TO BE APPROVED PREFABRICATED CHIMNEY DRAIN PANELS (MIRADRAIN G200N OR EQUIVALENT) SPACED APPROXIMATELY 20 FEET CENTER TO CENTER AND 4 FEET WIDE. CLOSER SPACING MAY BE REQUIRED IF SEEPAGE IS ENCOUNTERED.
- 5.....FILTER MATERIAL TO BE 3/4-INCH, OPEN-GRADED CRUSHED ROCK ENCLOSED IN APPROVED FILTER FABRIC (MIRAFI 140NC).
- 6.....COLLECTOR PIPE TO BE 4-INCH MINIMUM DIAMETER, PERFORATED, THICK-WALLED PVC SCHEDULE 40 OR EQUIVALENT, AND SLOPED TO DRAIN AT 1 PERCENT MINIMUM TO APPROVED OUTLET.

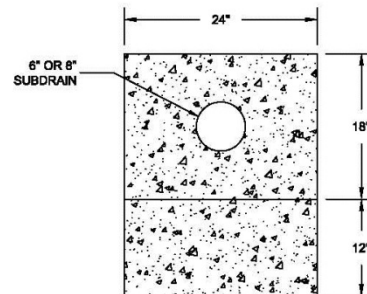
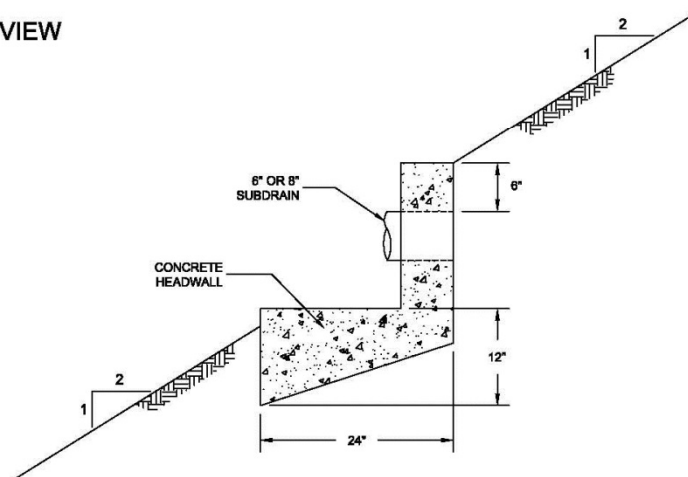
## TYPICAL HEADWALL DETAIL

- 7.6 Subdrains that discharge into a natural drainage course or open space area should be provided with a permanent headwall structure.

NOTE: HEADWALL SHOULD OUTLET AT TOE OF FILL SLOPE  
OR INTO CONTROLLED SURFACE DRAINAGE
