**PRELIMINARY GEOTECHNICAL
EVALUATION AND SLOPE STABILITY
ANALYSIS**

**SOUTHWEST VILLAGE VTM-2
(BORROW/FILL SITE)
SAN DIEGO, CALIFORNIA**

**JULY 2, 2021
PROJECT NO. 06847-42-04**

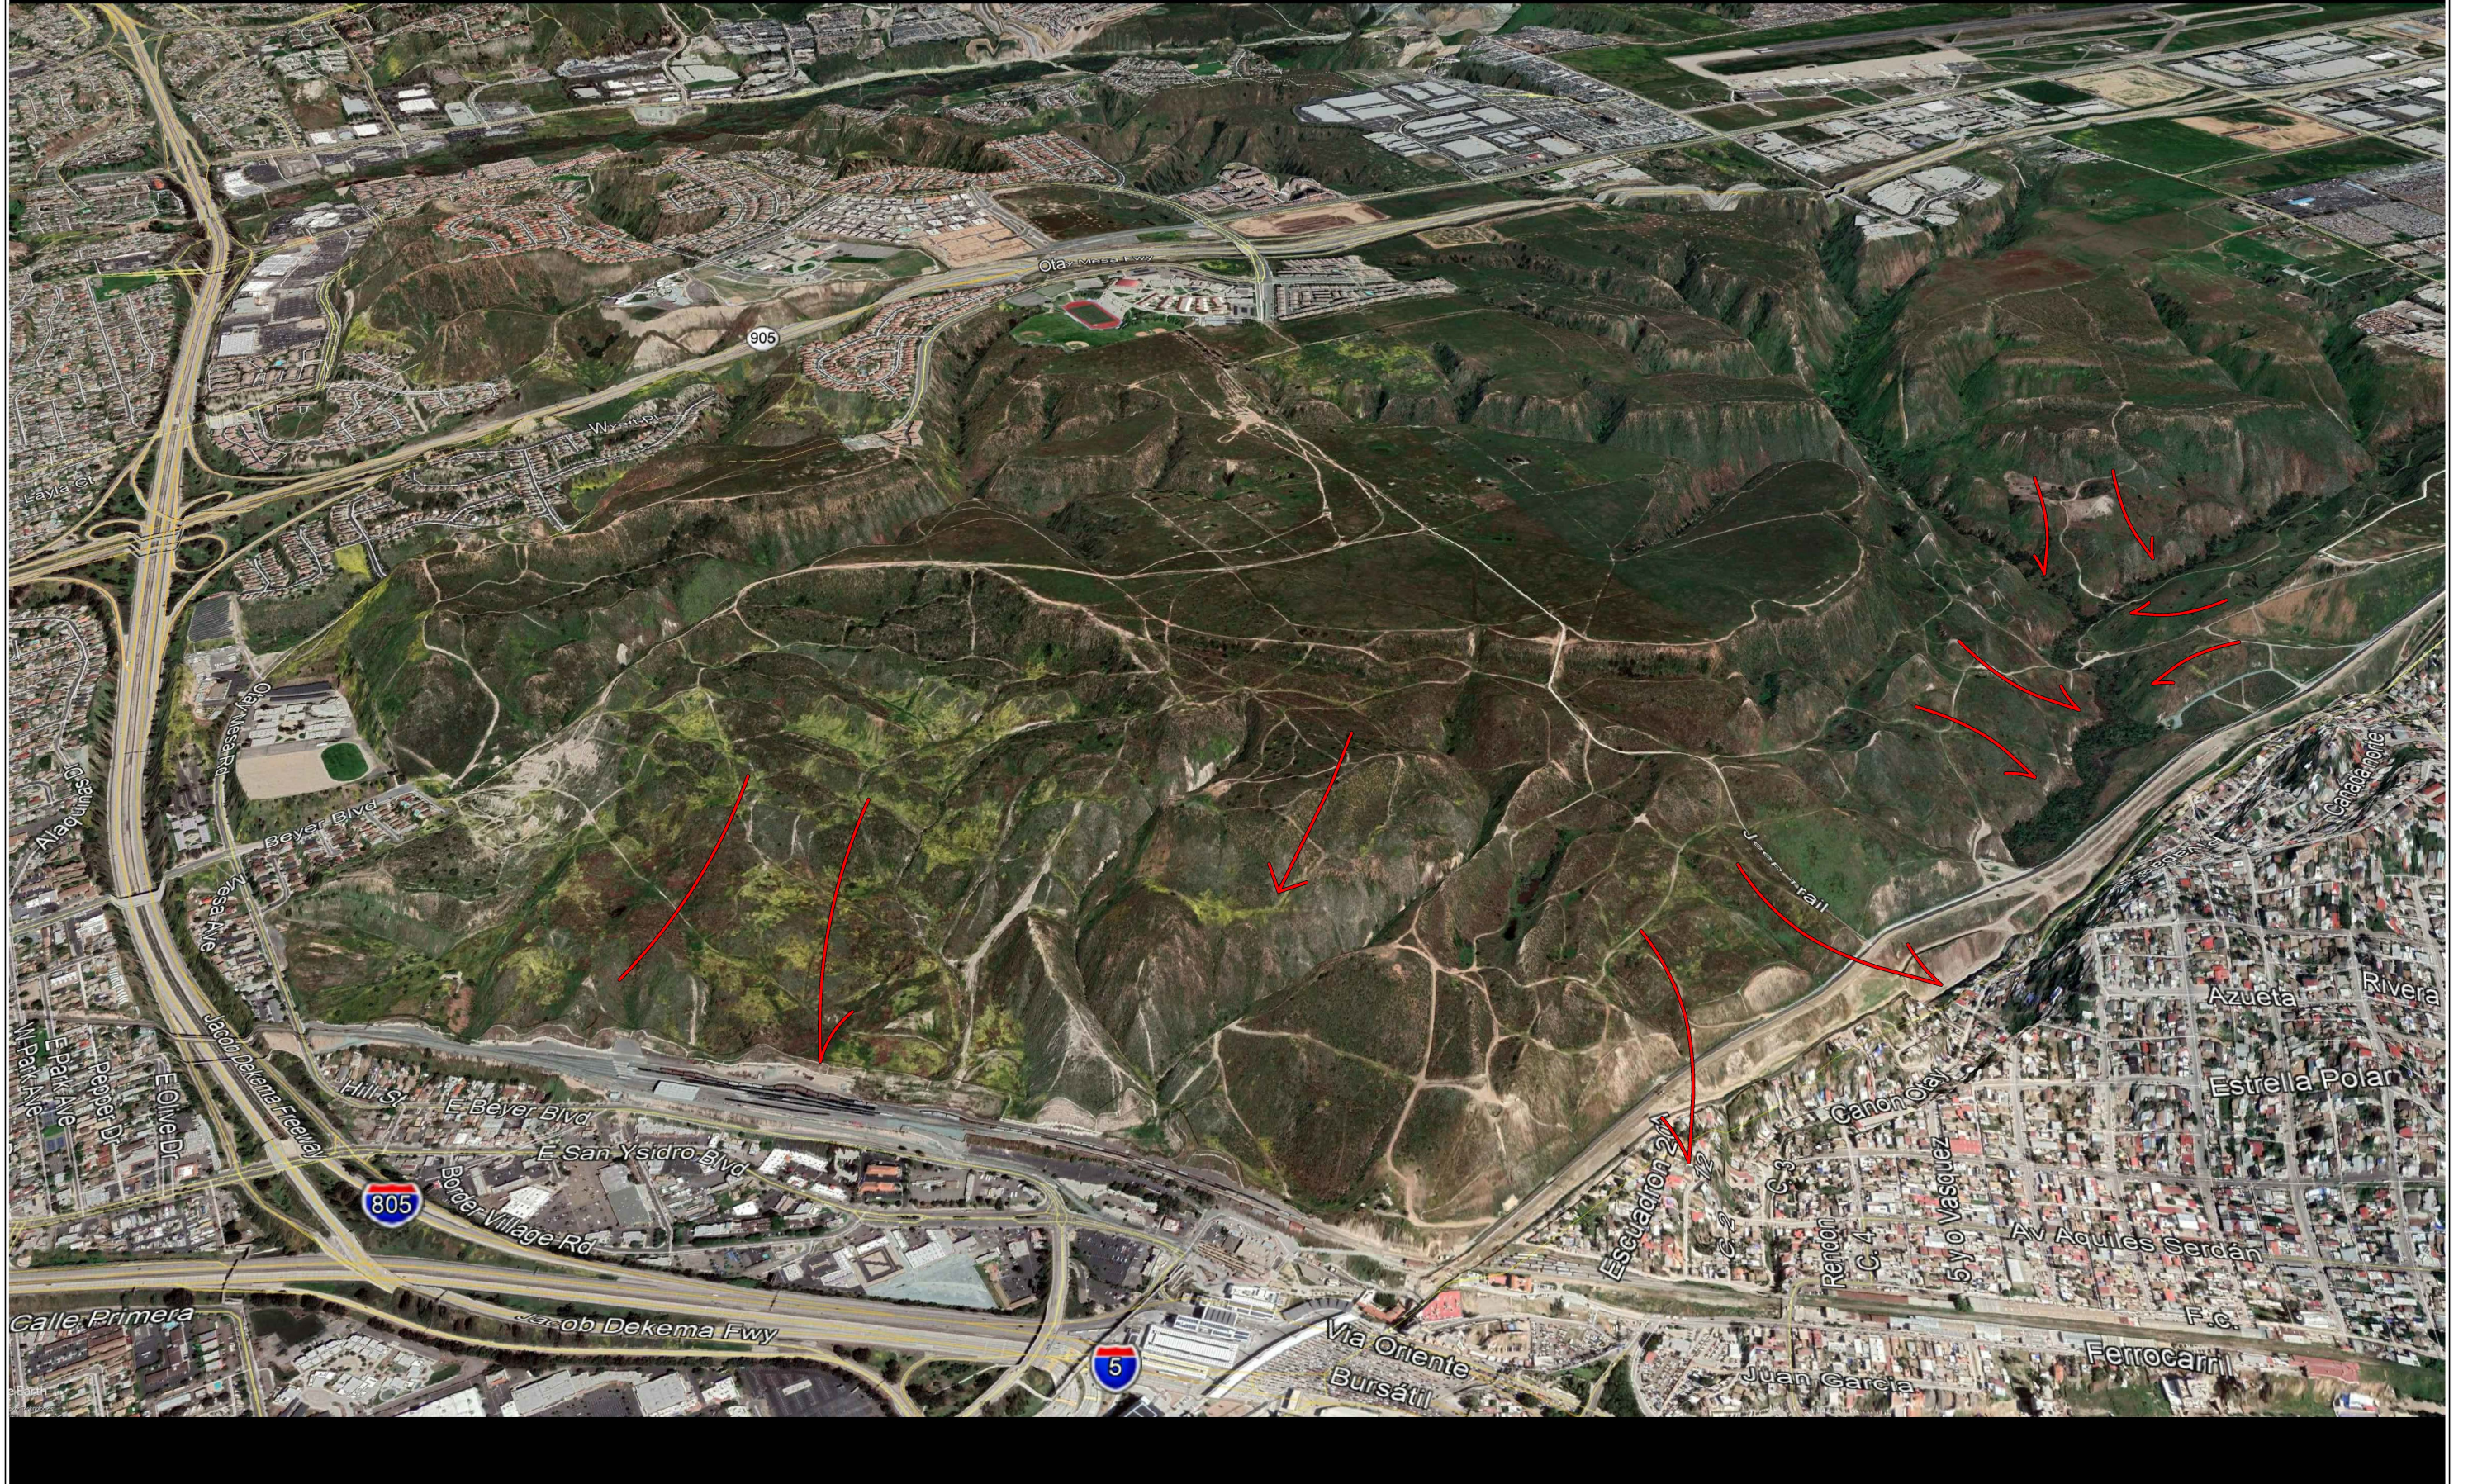
OBLIQUE VIEW OF THE SAN YSIDRO LANDSLIDE COMPLEX

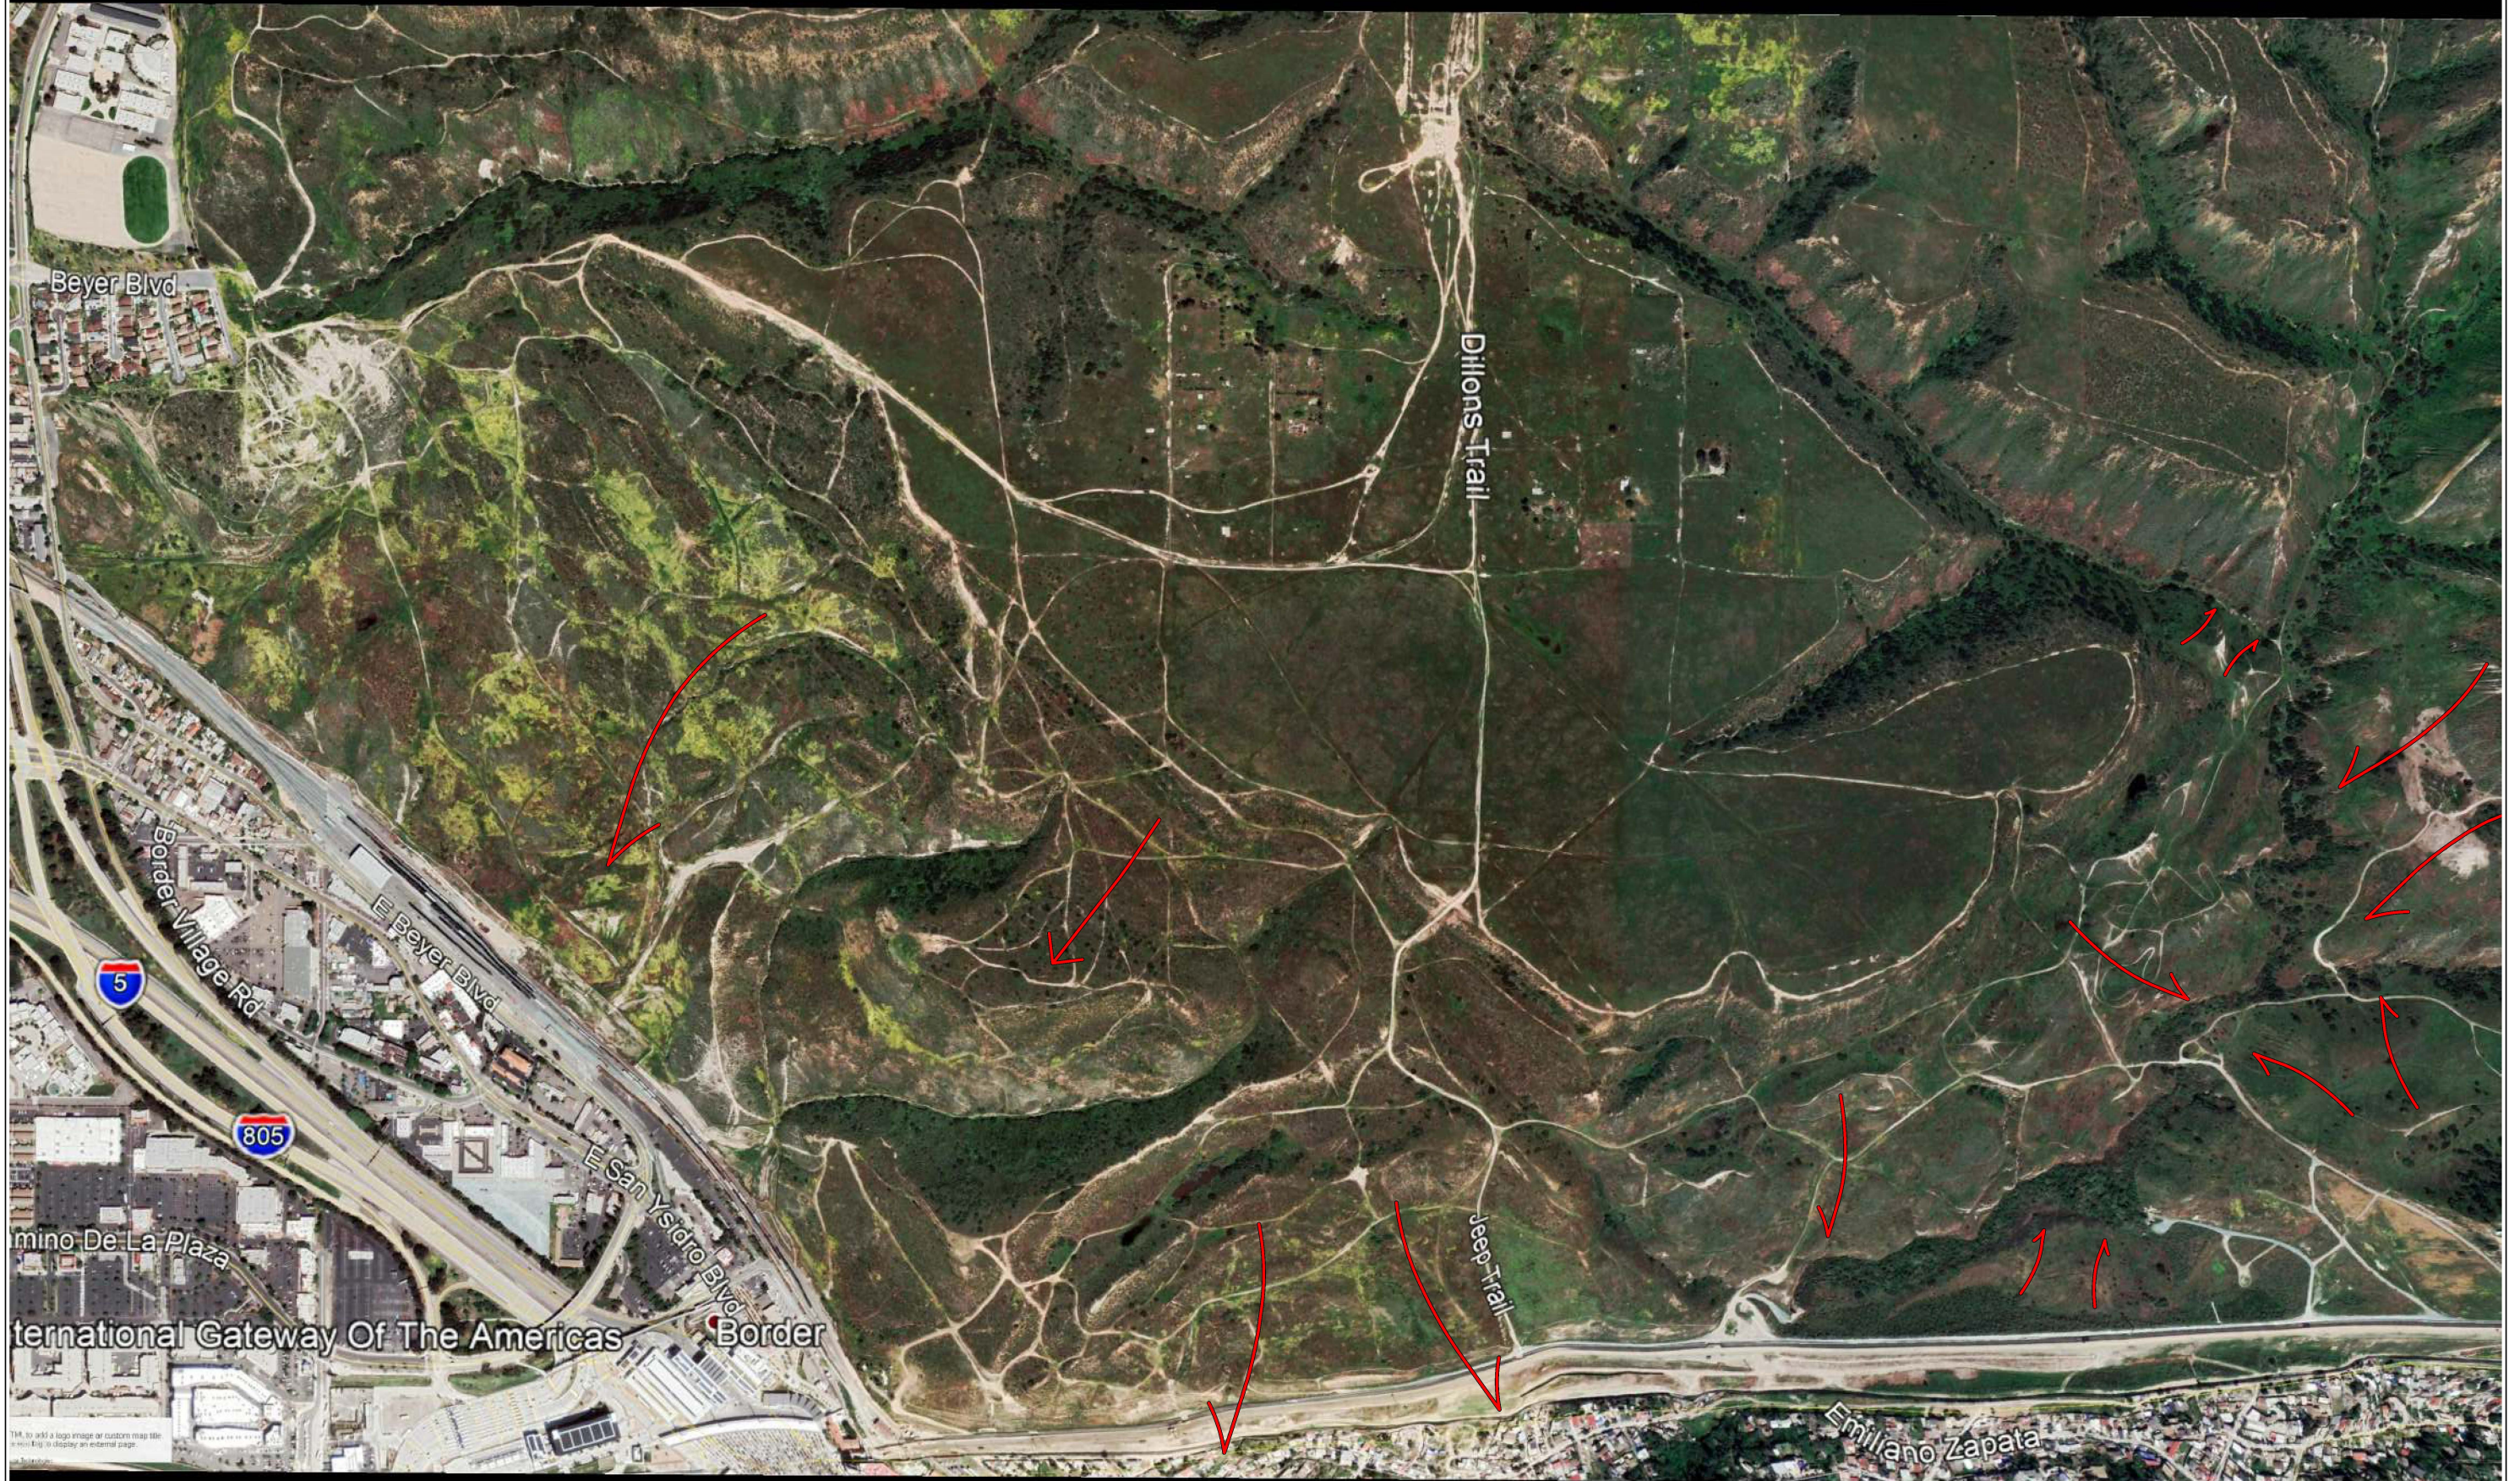
MAP VIEW OF THE SAN YSIDRO LANDSLIDE COMPLEX

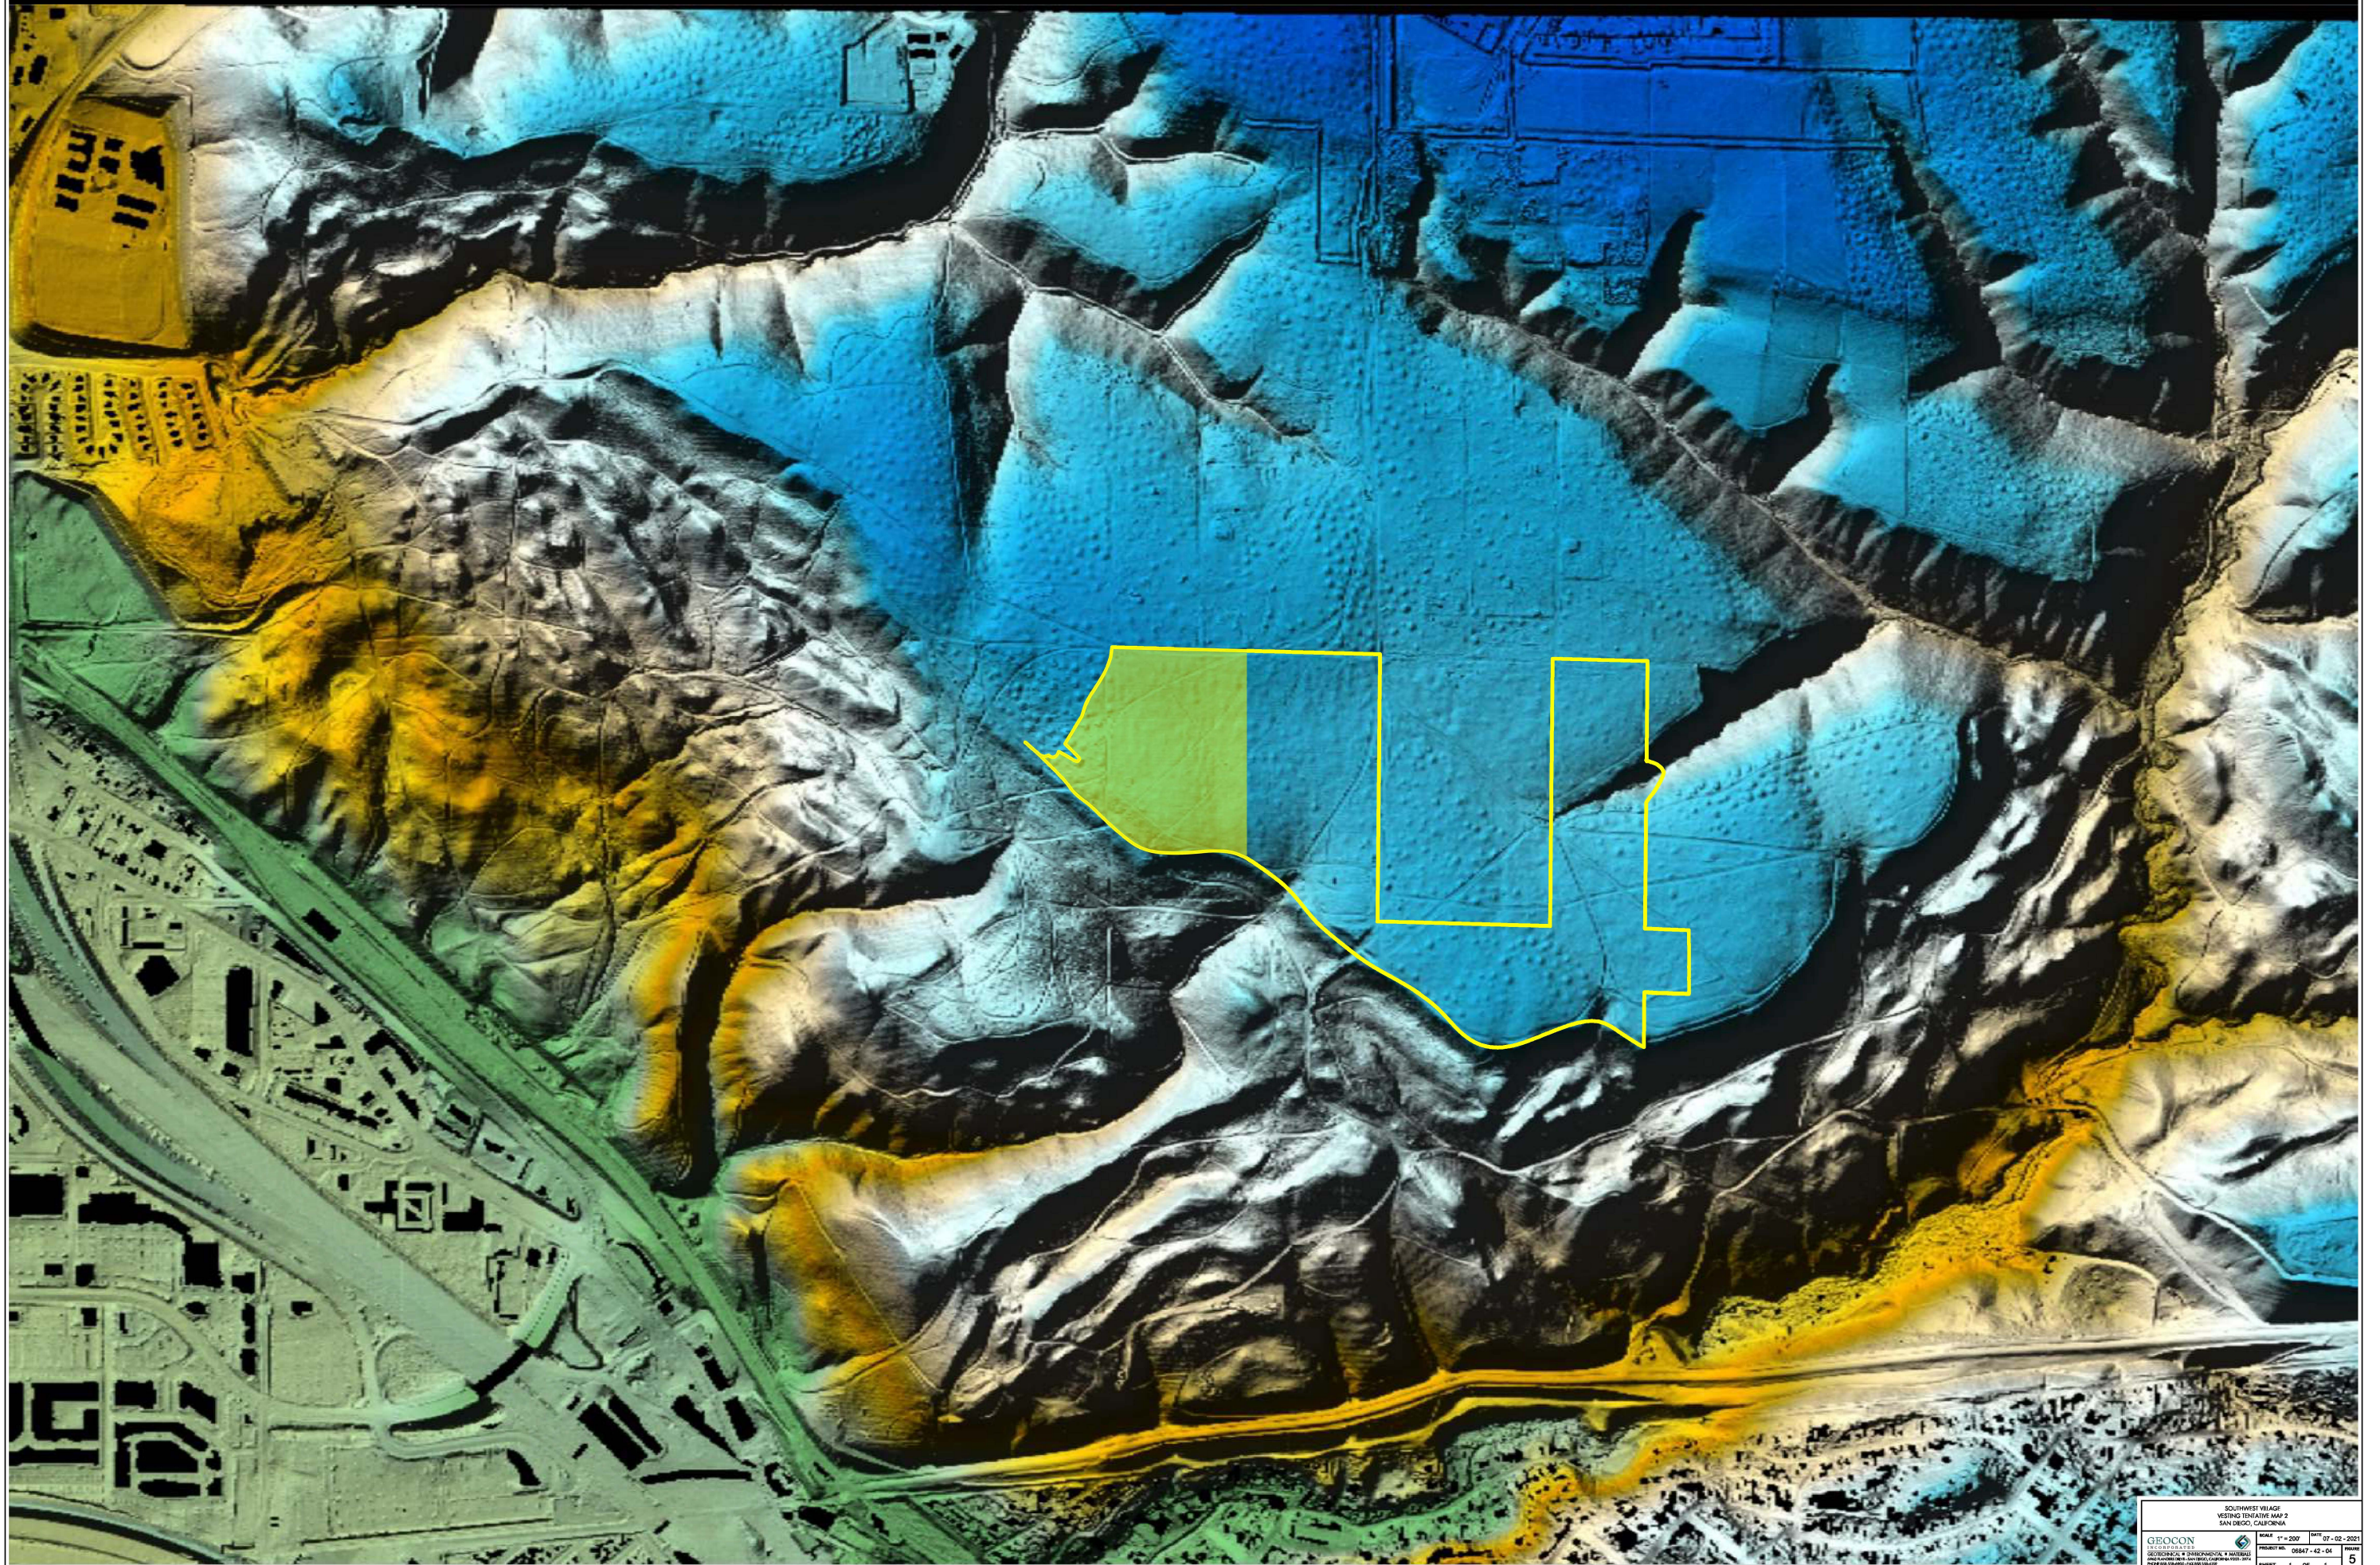
VTM-2 DEVELOPMENT FOOTPRINT; COLOR TERRAIN MAP

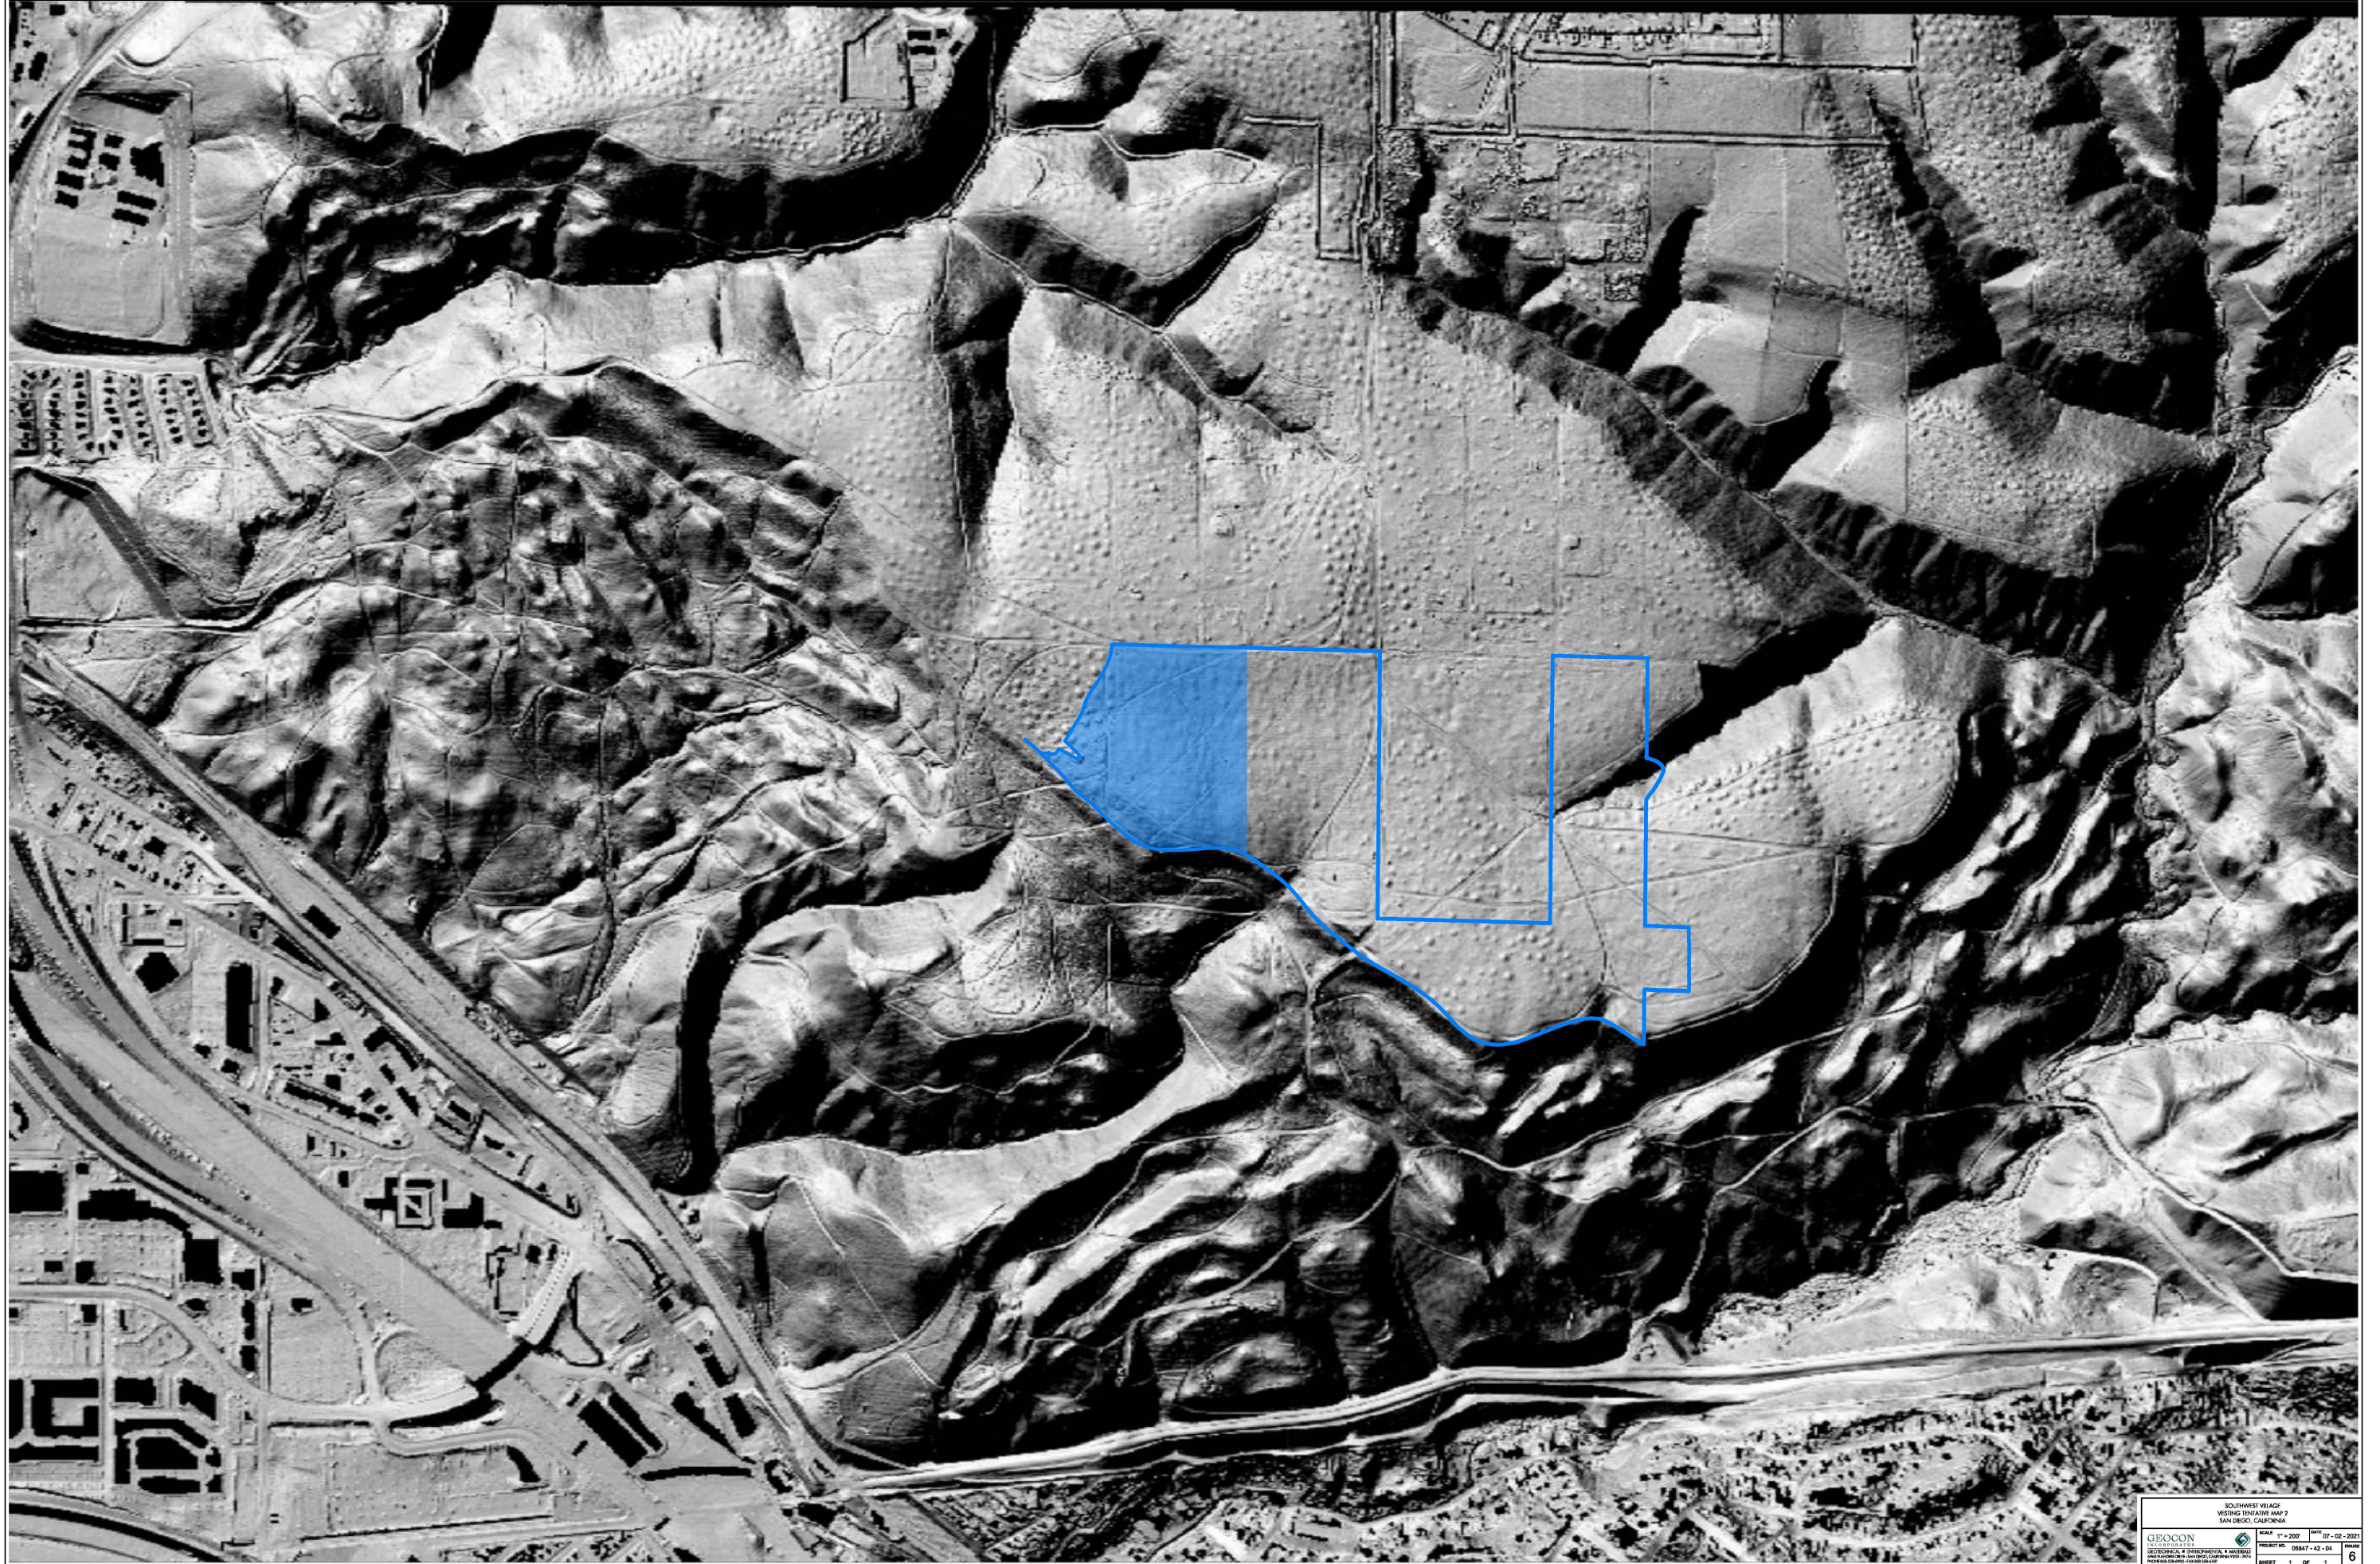
VTM-2 DEVELOPMENT FOOTPRINT; TERRAIN
REFLECTANCE MAP

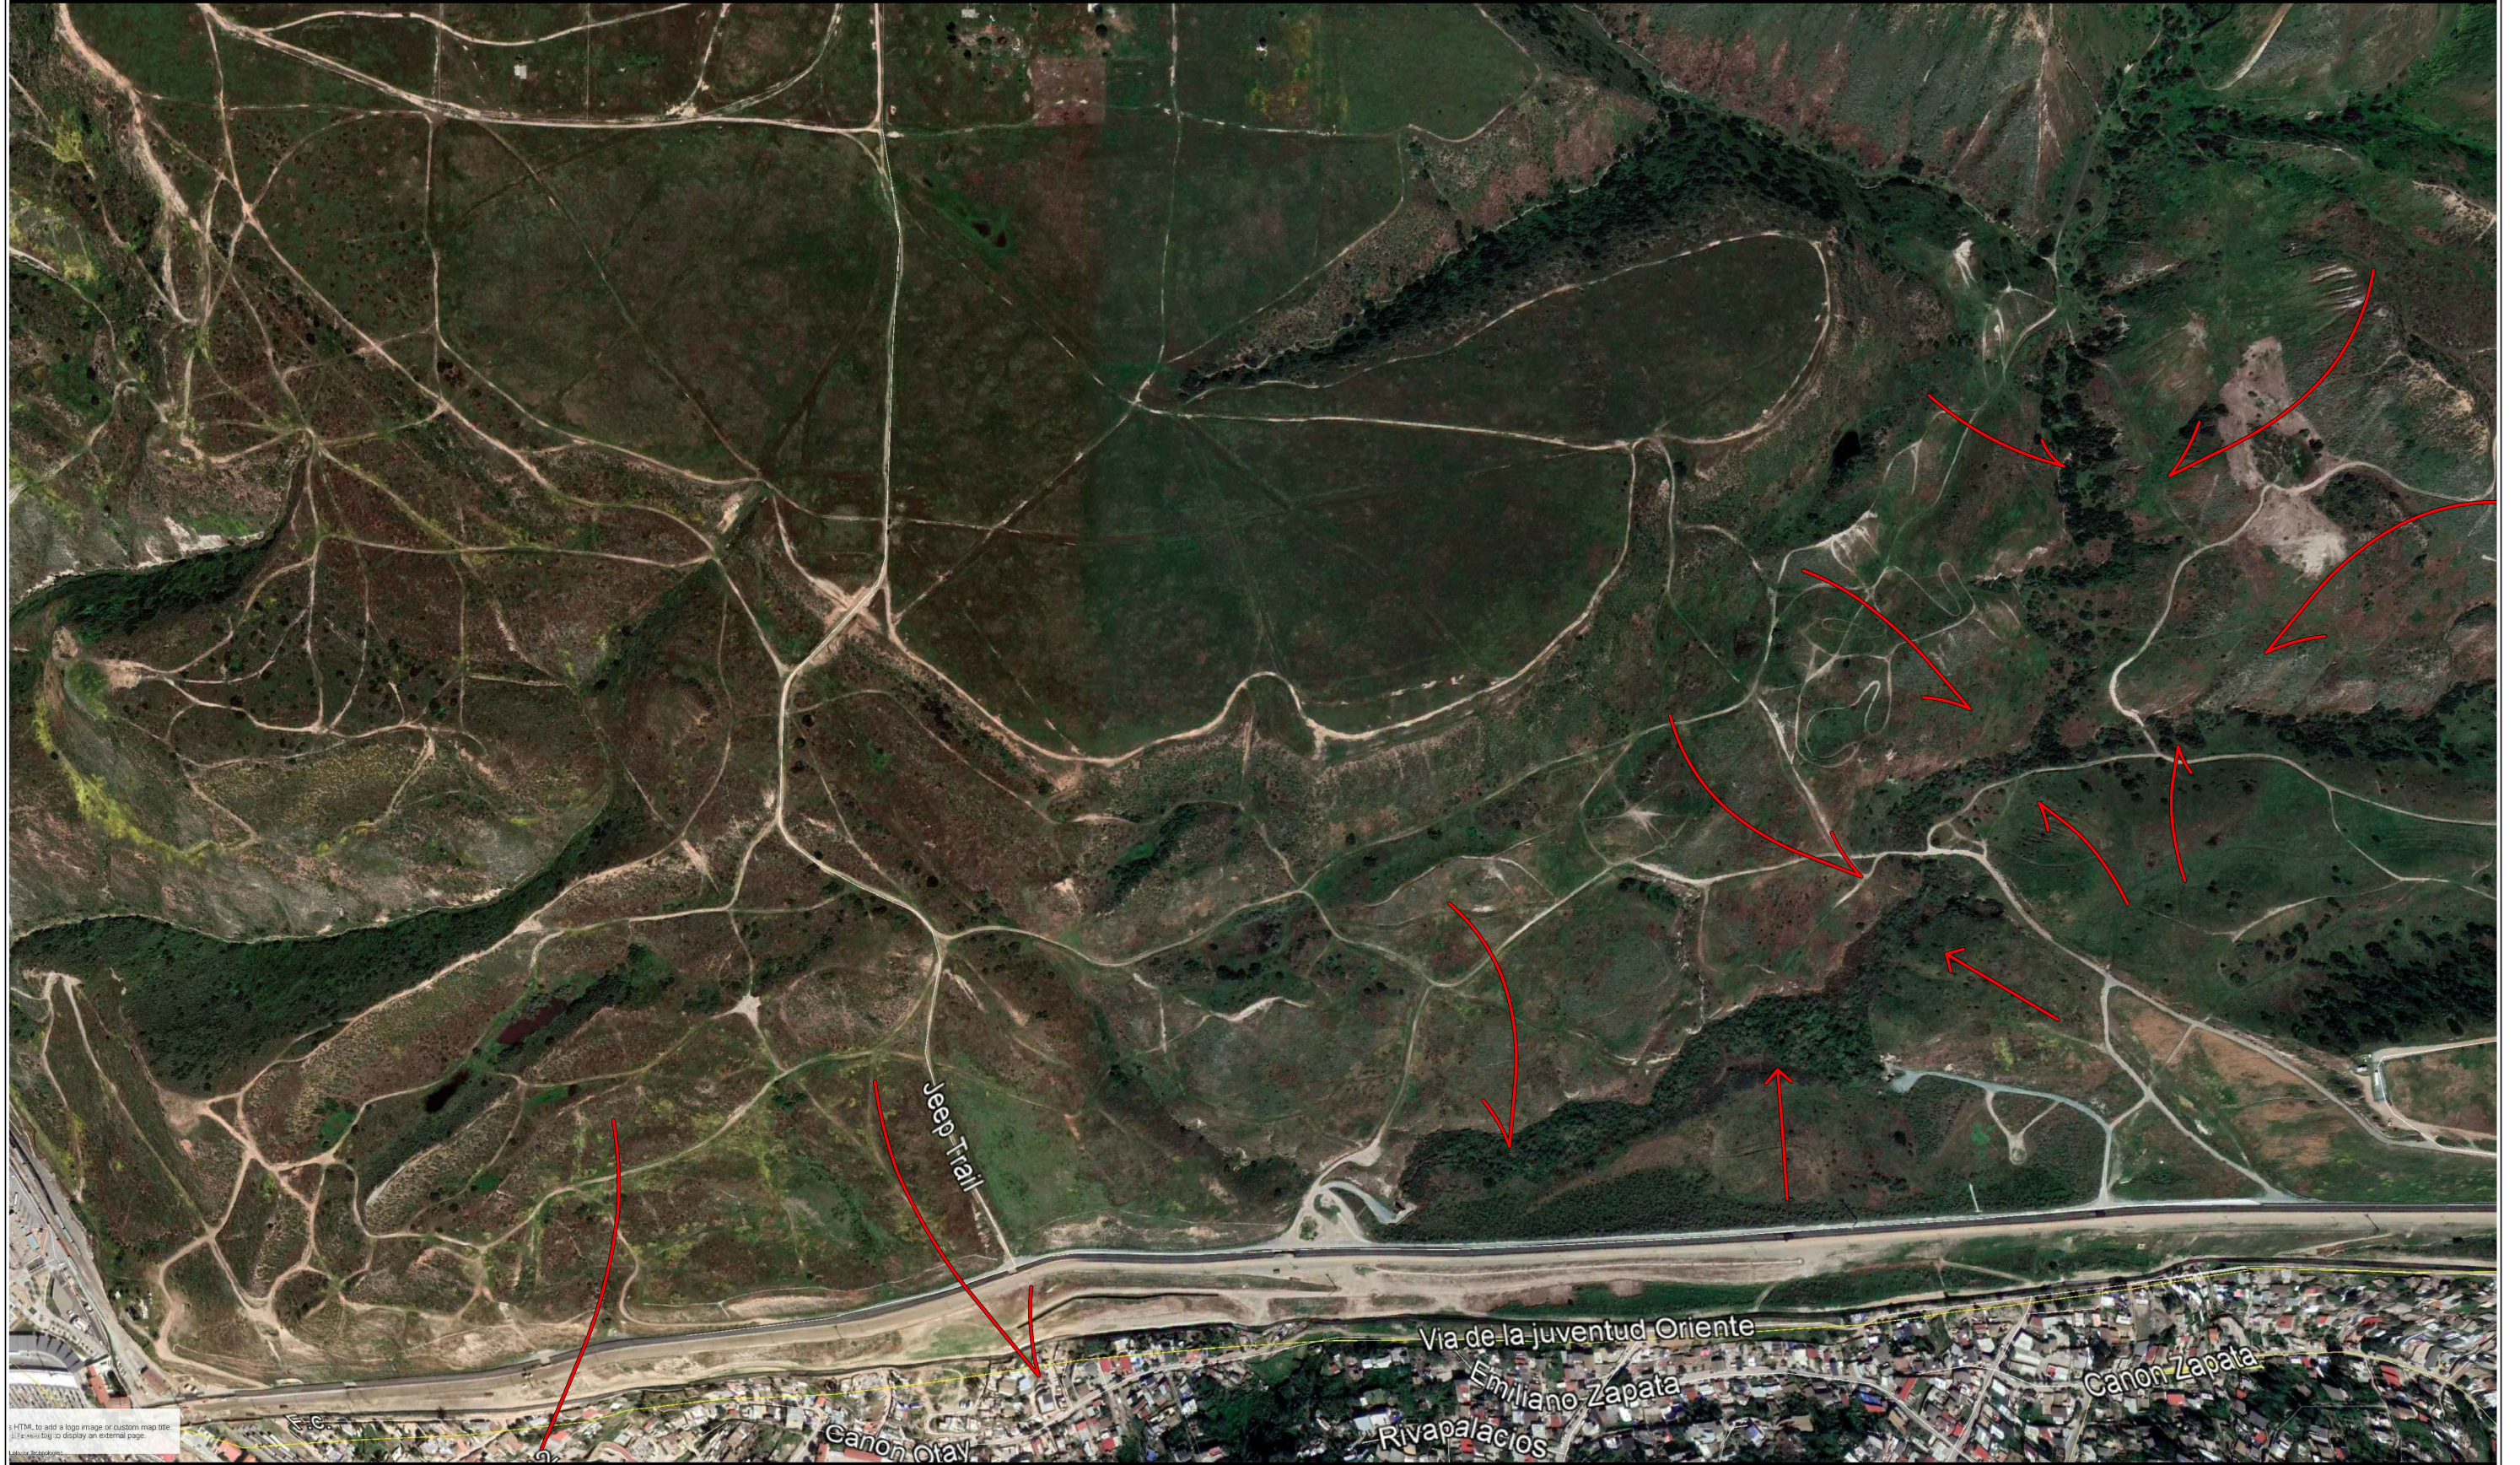
MAP VIEW IMAGE OF LANDSLIDE C

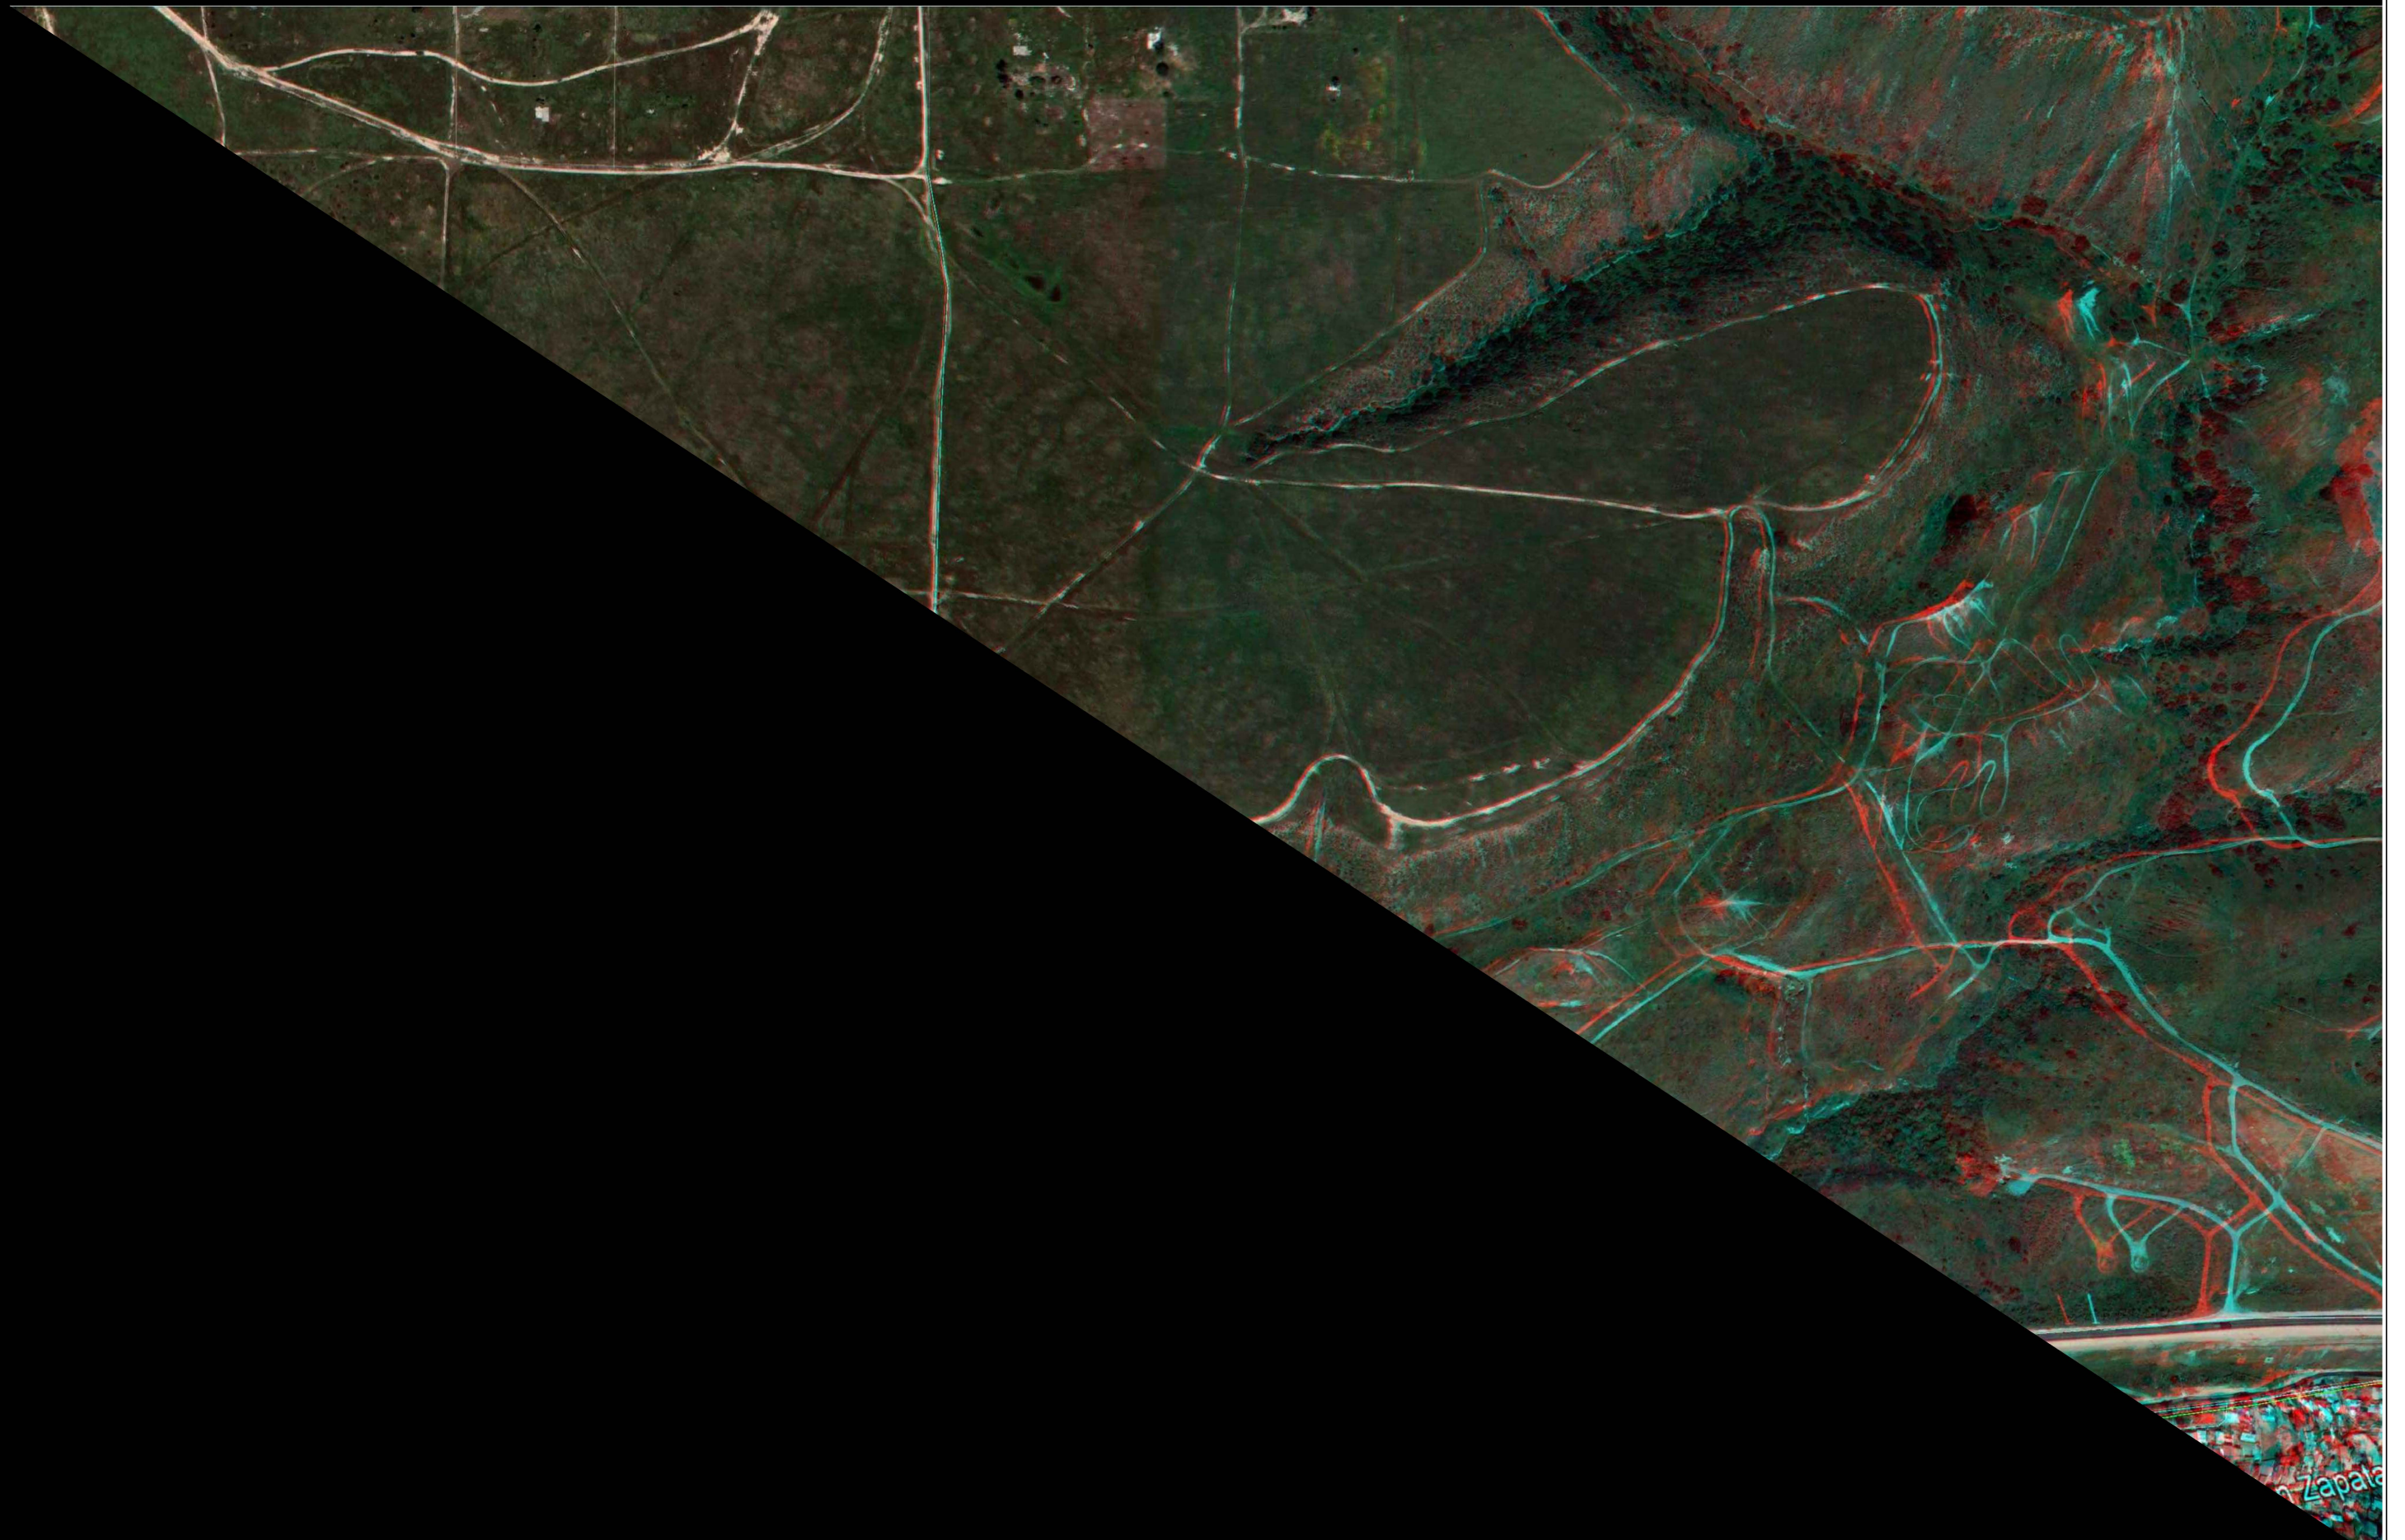
ANAGLYPHIC STEREOSCOPIC IMAGE OF LANDSLIDE C
