**PRELIMINARY GEOTECHNICAL
EVALUATION AND SLOPE STABILITY
ANALYSIS**

**SOUTHWEST VILLAGE VTM-2
(BORROW/FILL SITE)
SAN DIEGO, CALIFORNIA**

**JULY 2, 2021
PROJECT NO. 06847-42-04**

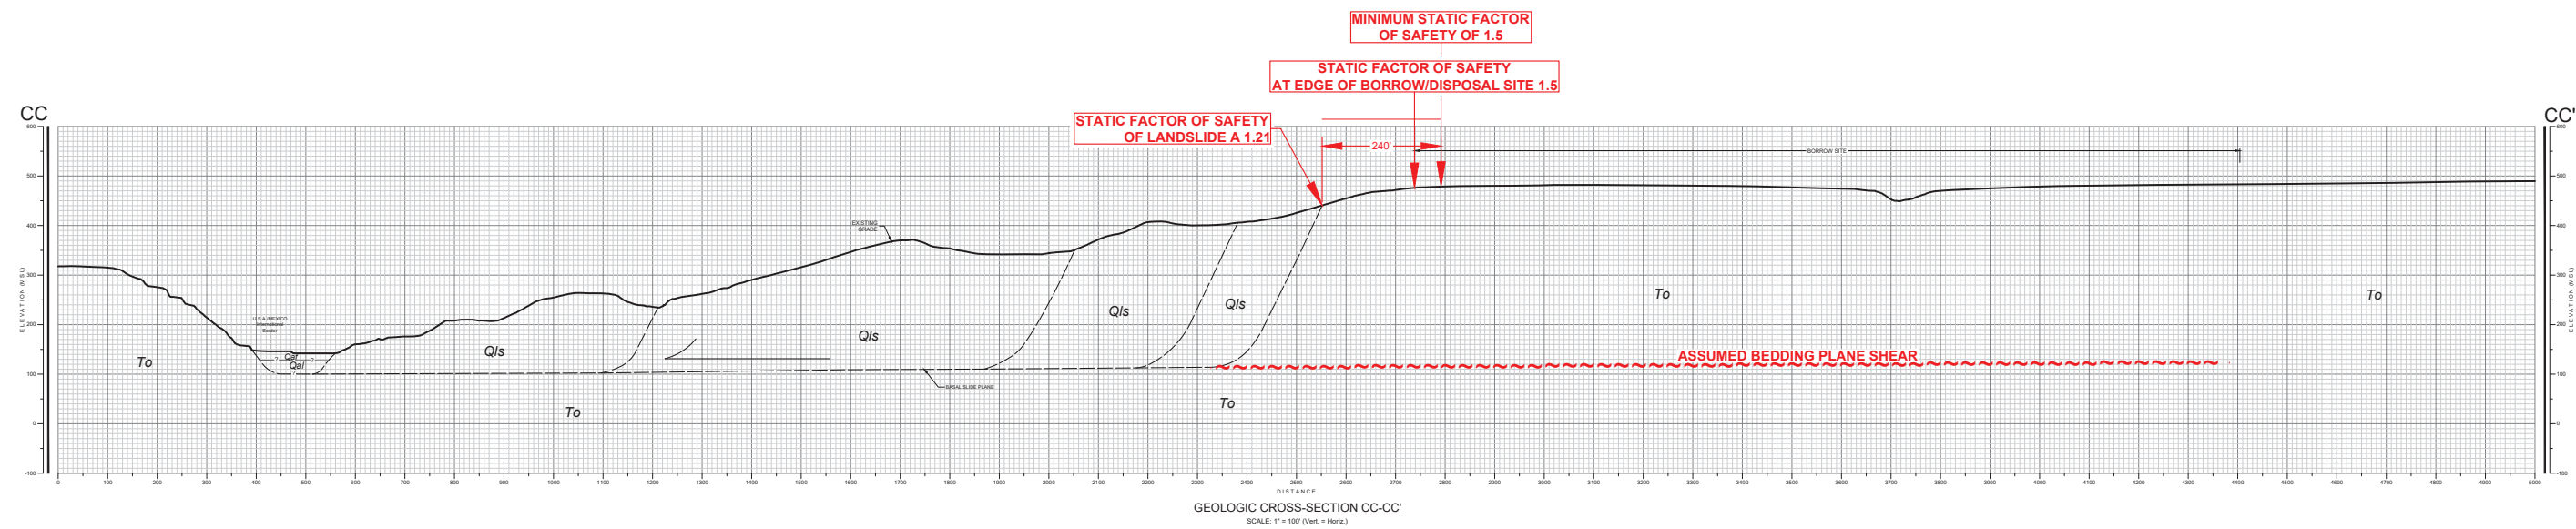
SLOPE STABILITY SUMMARY

Condition Analyzed	Cross Section	Factor-of-Safety	Estimated Deformation Under Seismic Loading
Along Headscarp	CC-CC'	1.21	--
Extended Bedding Plane Shear	CC-CC'	1.50	--
At Edge of Development	CC-CC'	1.50	--
Higher Exposed Headscarp	CC-CC'	2.15 (at edge of borrow/fill limits)	--
Seismic Analysis	CC-CC'	--	0 to 12 cm

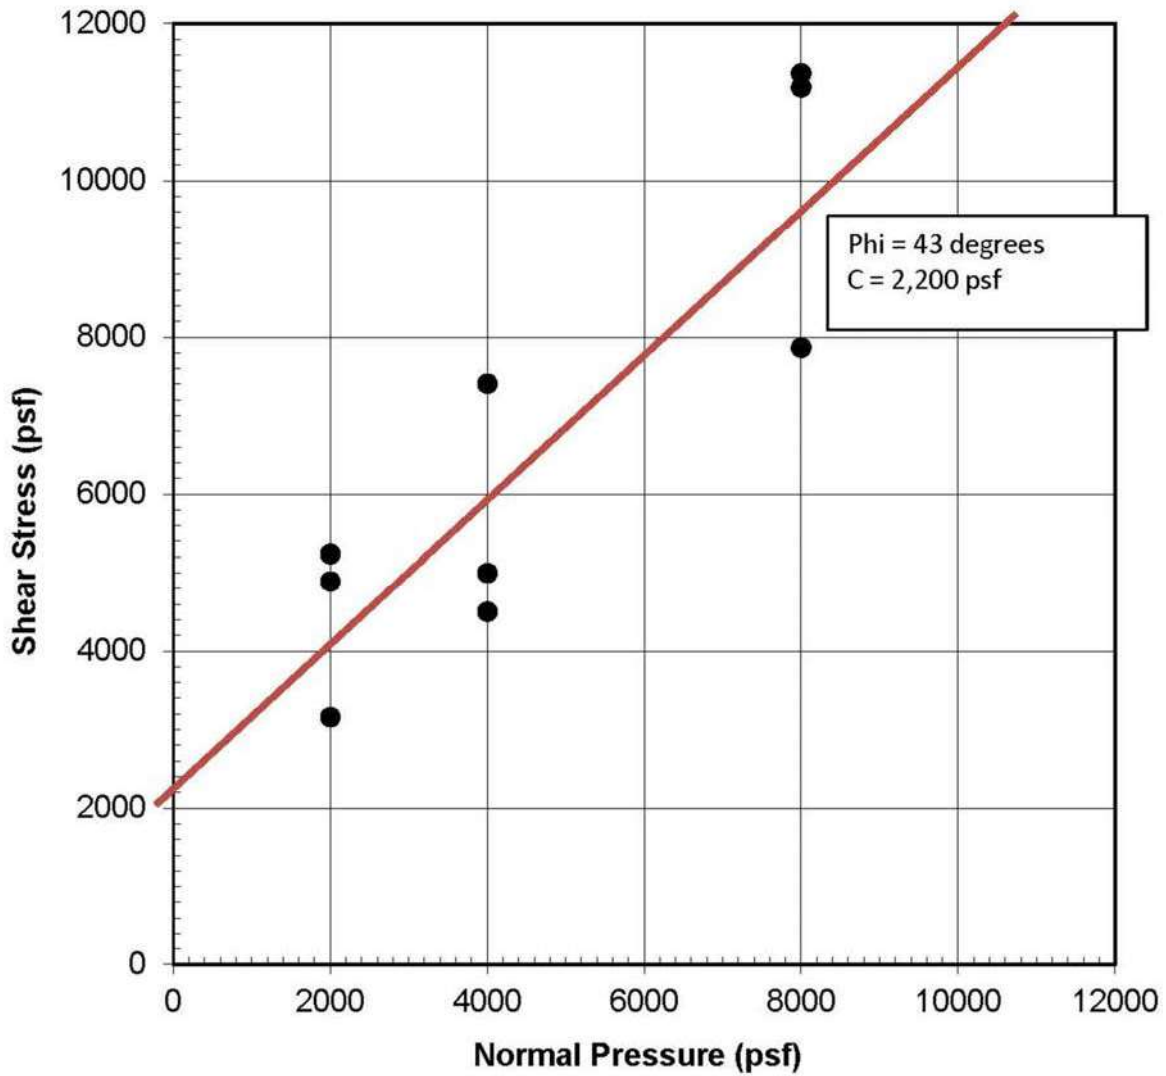
To (PEAK)

SHEAR PLOTS - PEAK

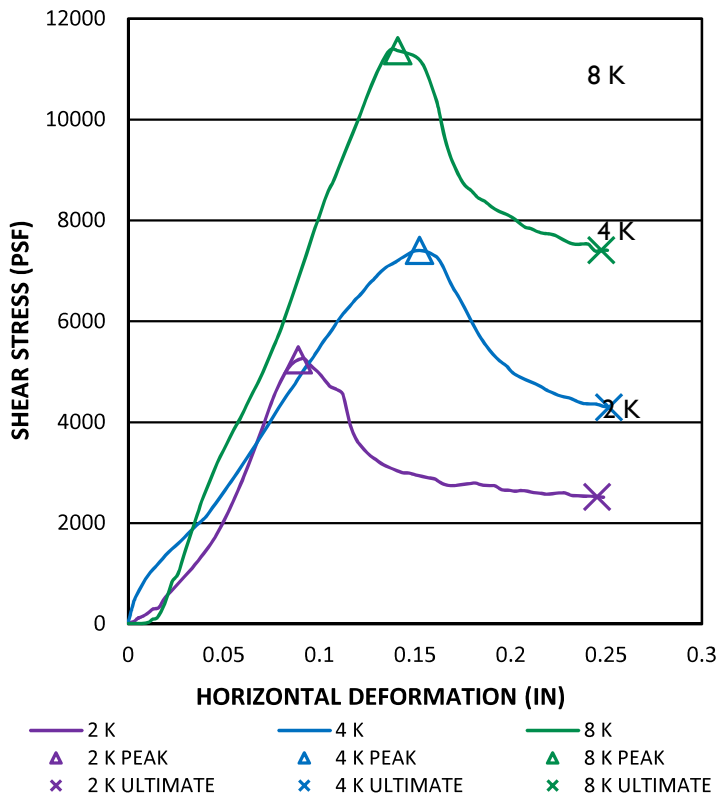
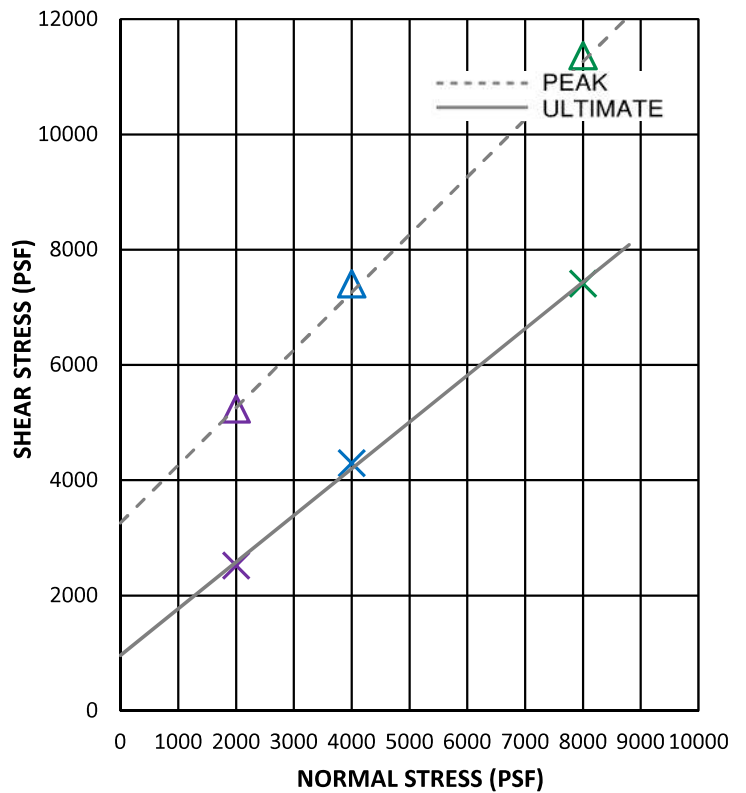
INITIAL CONDITIONS				
NORMAL STRESS TEST LOAD	2 K	4 K	8 K	AVERAGE
ACTUAL NORMAL STRESS (PSF):	2000	4000	8000	--
WATER CONTENT (%):	6.1	6.5	5.7	6.1
DRY DENSITY (PCF):	121.2	119.4	123.0	121.2

AFTER TEST CONDITIONS				
NORMAL STRESS TEST LOAD	2 K	4 K	8 K	AVERAGE
WATER CONTENT (%):	12.6	13.5	12.2	12.8
PEAK SHEAR STRESS (PSF):	5236	7406	11365	--
ULT.-E.O.T. SHEAR STRESS (PSF):	2522	4294	7412	--

RESULTS		
PEAK	COHESION, C (PSF)	3260
	FRICTION ANGLE (DEGREES)	45
ULTIMATE	COHESION, C (PSF)	960
	FRICTION ANGLE (DEGREES)	39

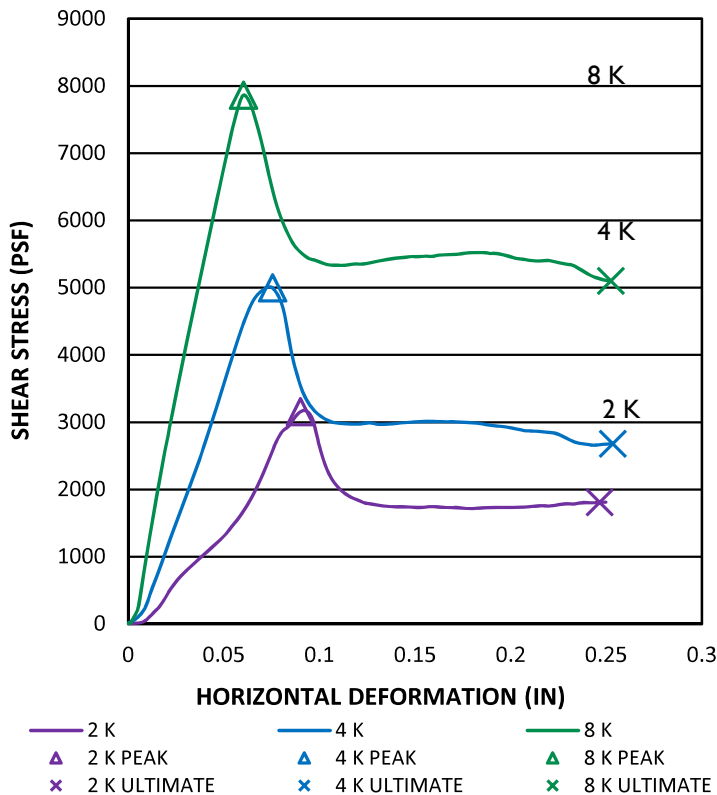
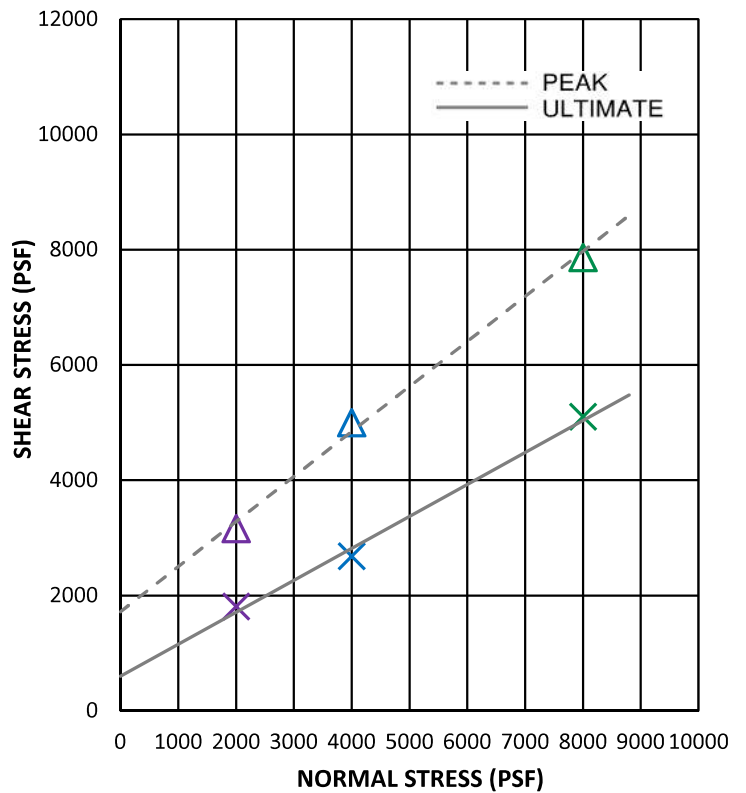
INITIAL CONDITIONS				
NORMAL STRESS TEST LOAD	2 K	4 K	8 K	AVERAGE
ACTUAL NORMAL STRESS (PSF):	2000	4000	8000	--
WATER CONTENT (%):	6.2	6.4	6.5	6.4
DRY DENSITY (PCF):	116.5	115.6	117.0	116.4

AFTER TEST CONDITIONS				
NORMAL STRESS TEST LOAD	2 K	4 K	8 K	AVERAGE
WATER CONTENT (%):	13.4	13.8	13.5	13.6
PEAK SHEAR STRESS (PSF):	3156	4996	7863	--
ULT.-E.O.T. SHEAR STRESS (PSF):	1811	2678	5100	--

RESULTS		
PEAK	COHESION, C (PSF)	1720
	FRICTION ANGLE (DEGREES)	38
ULTIMATE	COHESION, C (PSF)	600
	FRICTION ANGLE (DEGREES)	29

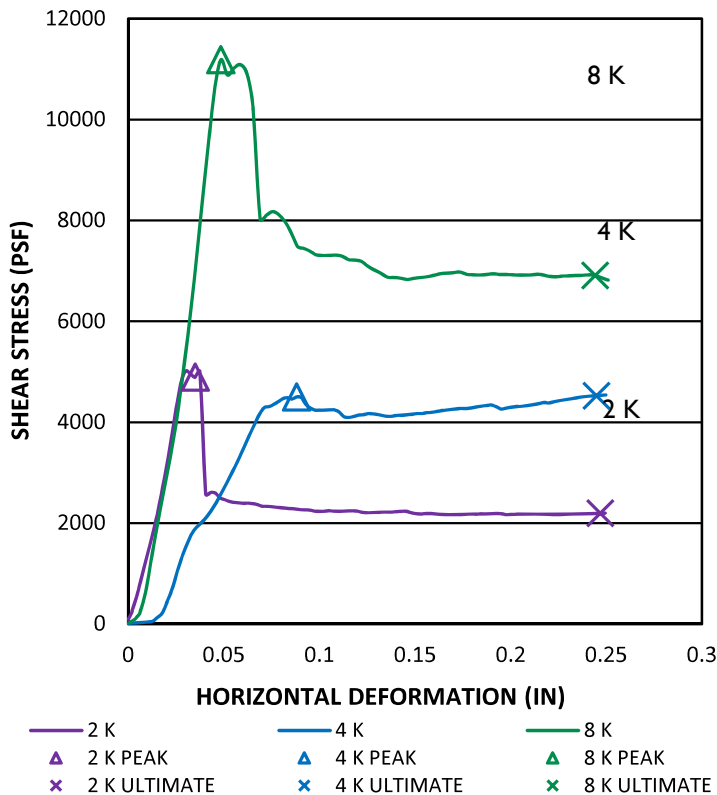
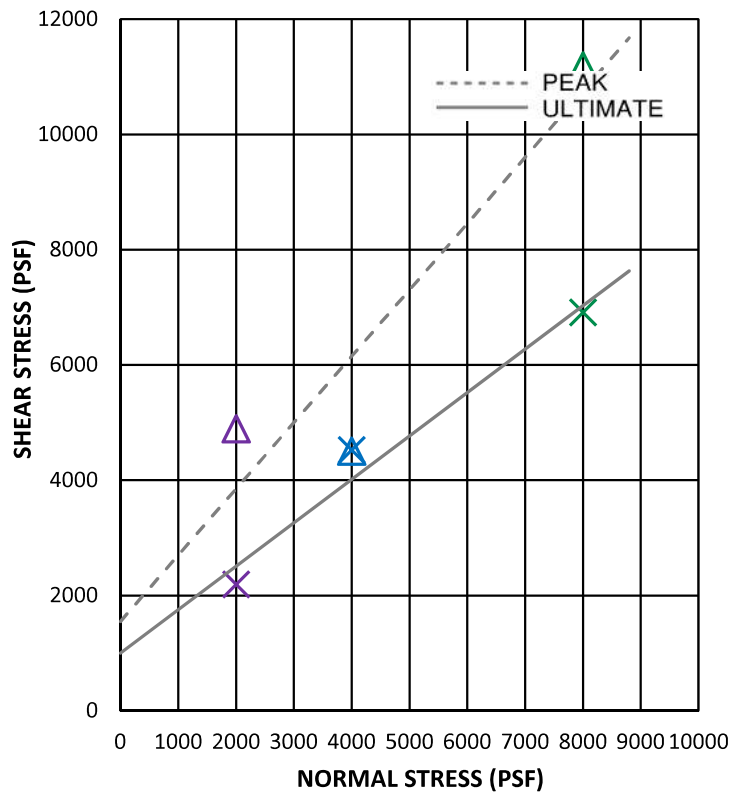
INITIAL CONDITIONS				
NORMAL STRESS TEST LOAD	2 K	4 K	8 K	AVERAGE
ACTUAL NORMAL STRESS (PSF):	2000	4000	8000	--
WATER CONTENT (%):	8.0	9.7	9.1	8.9
DRY DENSITY (PCF):	113.4	113.2	113.9	113.5

AFTER TEST CONDITIONS				
NORMAL STRESS TEST LOAD	2 K	4 K	8 K	AVERAGE
WATER CONTENT (%):	15.5	16.0	15.5	15.7
PEAK SHEAR STRESS (PSF):	4892	4502	11186	--
ULT.-E.O.T. SHEAR STRESS (PSF):	2194	4525	6913	--

RESULTS		
PEAK	COHESION, C (PSF)	1550
	FRICTION ANGLE (DEGREES)	49
ULTIMATE	COHESION, C (PSF)	1000
	FRICTION ANGLE (DEGREES)	37

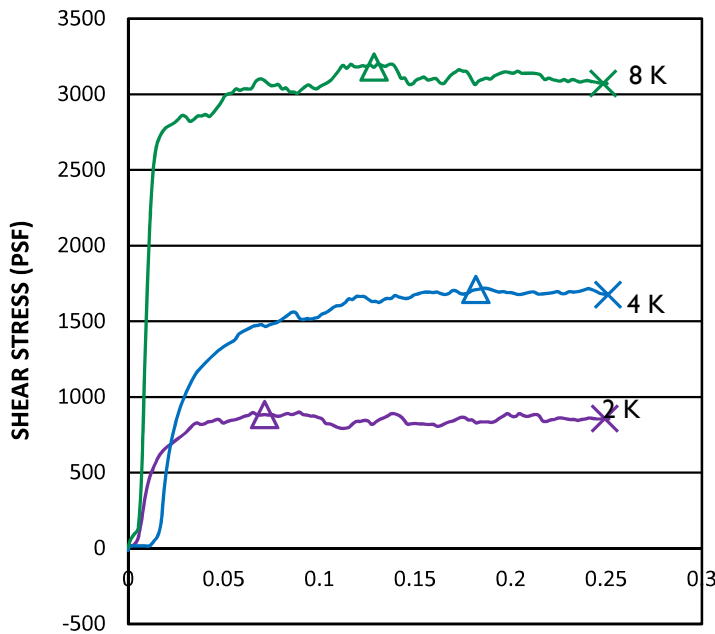
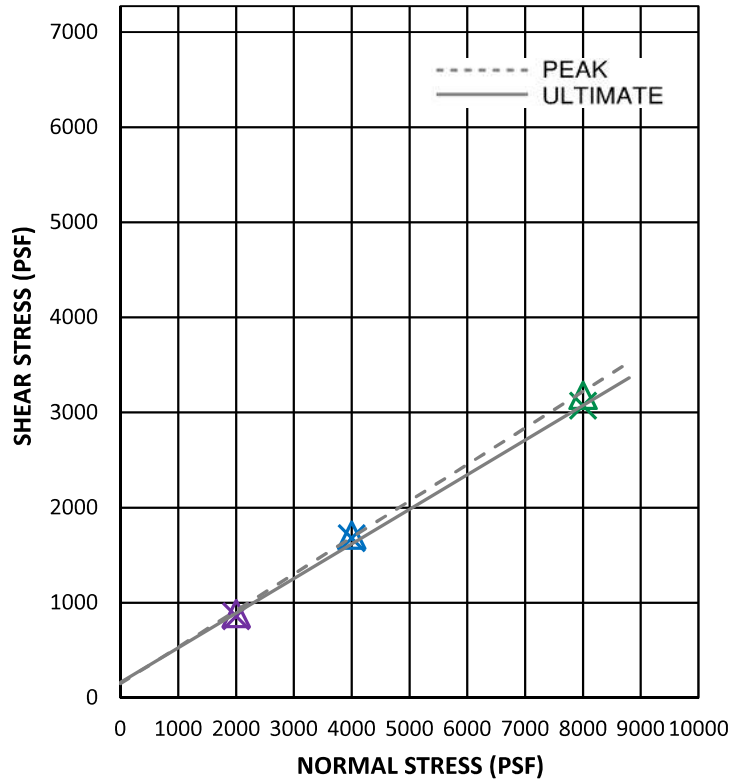
INITIAL CONDITIONS				
NORMAL STRESS TEST LOAD	2 K	4 K	8 K	AVERAGE
ACTUAL NORMAL STRESS (PSF):	2000	4000	8000	--
WATER CONTENT (%):	18.3	18.3	18.3	18.3
DRY DENSITY (PCF):	107.4	107.4	107.4	107.4

AFTER TEST CONDITIONS				
NORMAL STRESS TEST LOAD	2 K	4 K	8 K	AVERAGE
WATER CONTENT (%):	23.3	23.3	23.3	23.3
PEAK SHEAR STRESS (PSF):	884	1710	3179	--
ULT.-E.O.T. SHEAR STRESS (PSF):	858	1677	3072	--

RESULTS		
PEAK	COHESION, C (PSF)	150
	FRICTION ANGLE (DEGREES)	21
ULTIMATE	COHESION, C (PSF)	160
	FRICTION ANGLE (DEGREES)	20

Sample No.	Geologic Unit	Dry Density (pcf)	Moisture Content (%)	Angle of Shear Resistance (degrees)	Unit Cohesion (psf)
LB3-3 ^{†*}	Otay Formation	93.4	19.0	32	500
LB1-3 ^{**}	Landslide Debris	101.0	25.9	31	135
LB4-9 ^{†**}	Remolded Shear Plane	--	--	27	180
B1@215 ft	Otay Formation	121.2	6.1	45 (peak) 39 (ultimate)	3,260 (peak) 960 (ultimate)
B2@289 ft	Otay Formation	116.4	6.4	38 (peak) 29 (ultimate)	1,720 (peak) 600 (ultimate)
B3@394 ft	Otay Formation	113.5	8.9	49 (peak) 37 (ultimate)	1,550 (peak) 1,000 (ultimate)
B3@328-330 ft	Basal Shear Zone (Remolded)	107.4	18.3	21 (peak) 20 (ultimate)	150 (peak) 160 (ultimate)

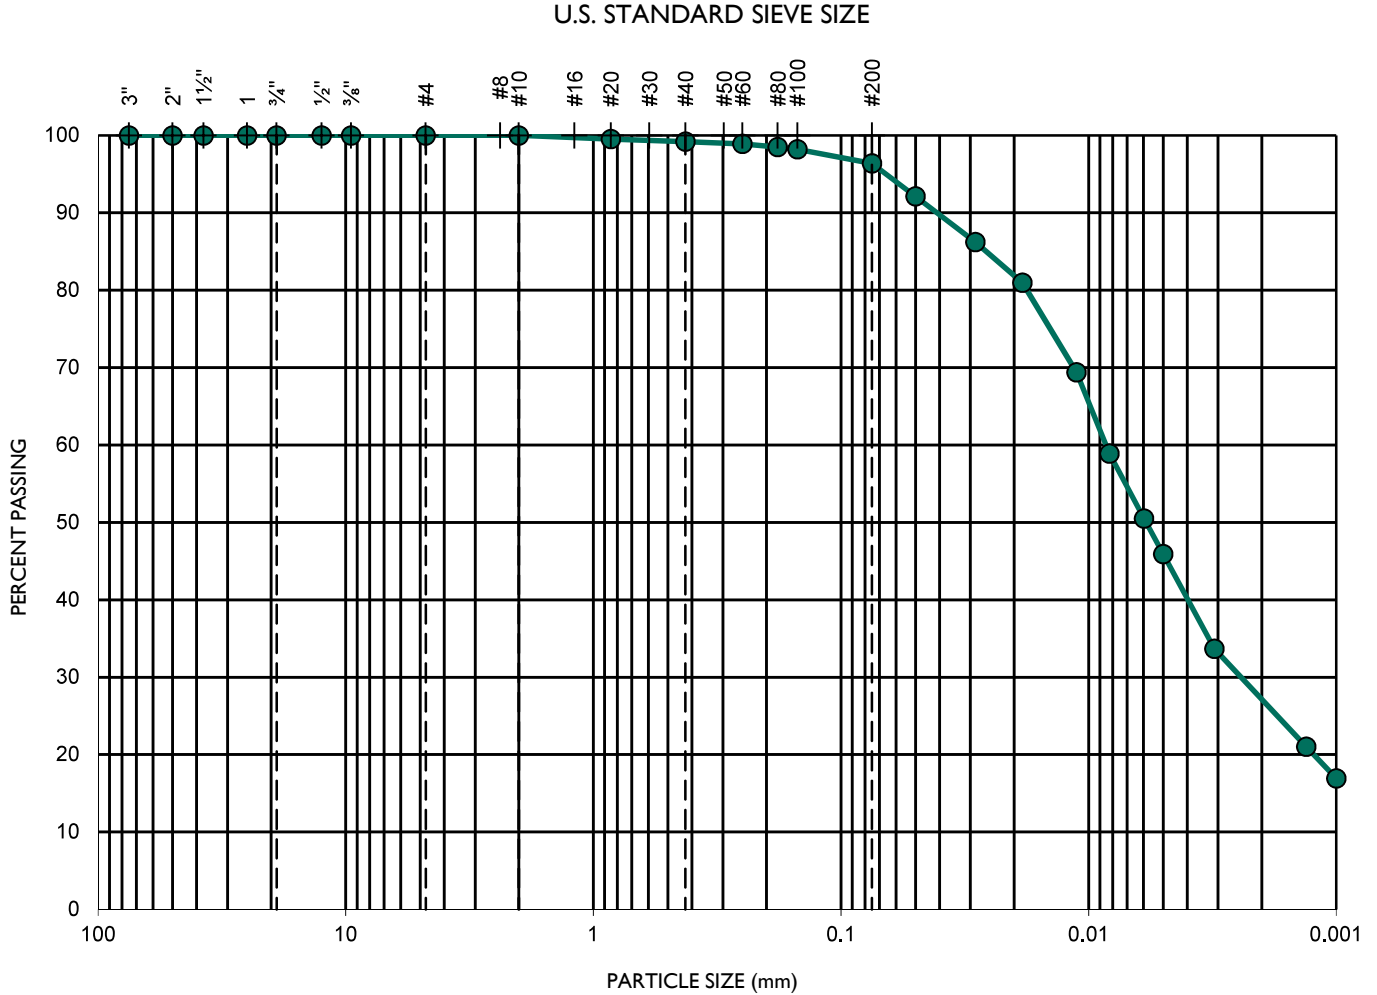
GEOLOGIC UNIT: **Shear Zone**

TEST DATA					
D ₁₀ (mm)	D ₃₀ (mm)	D ₆₀ (mm)	C _c	C _u	SOIL DESCRIPTION
0.00046	0.00259	0.00854	1.7	18.6	Silty CLAY

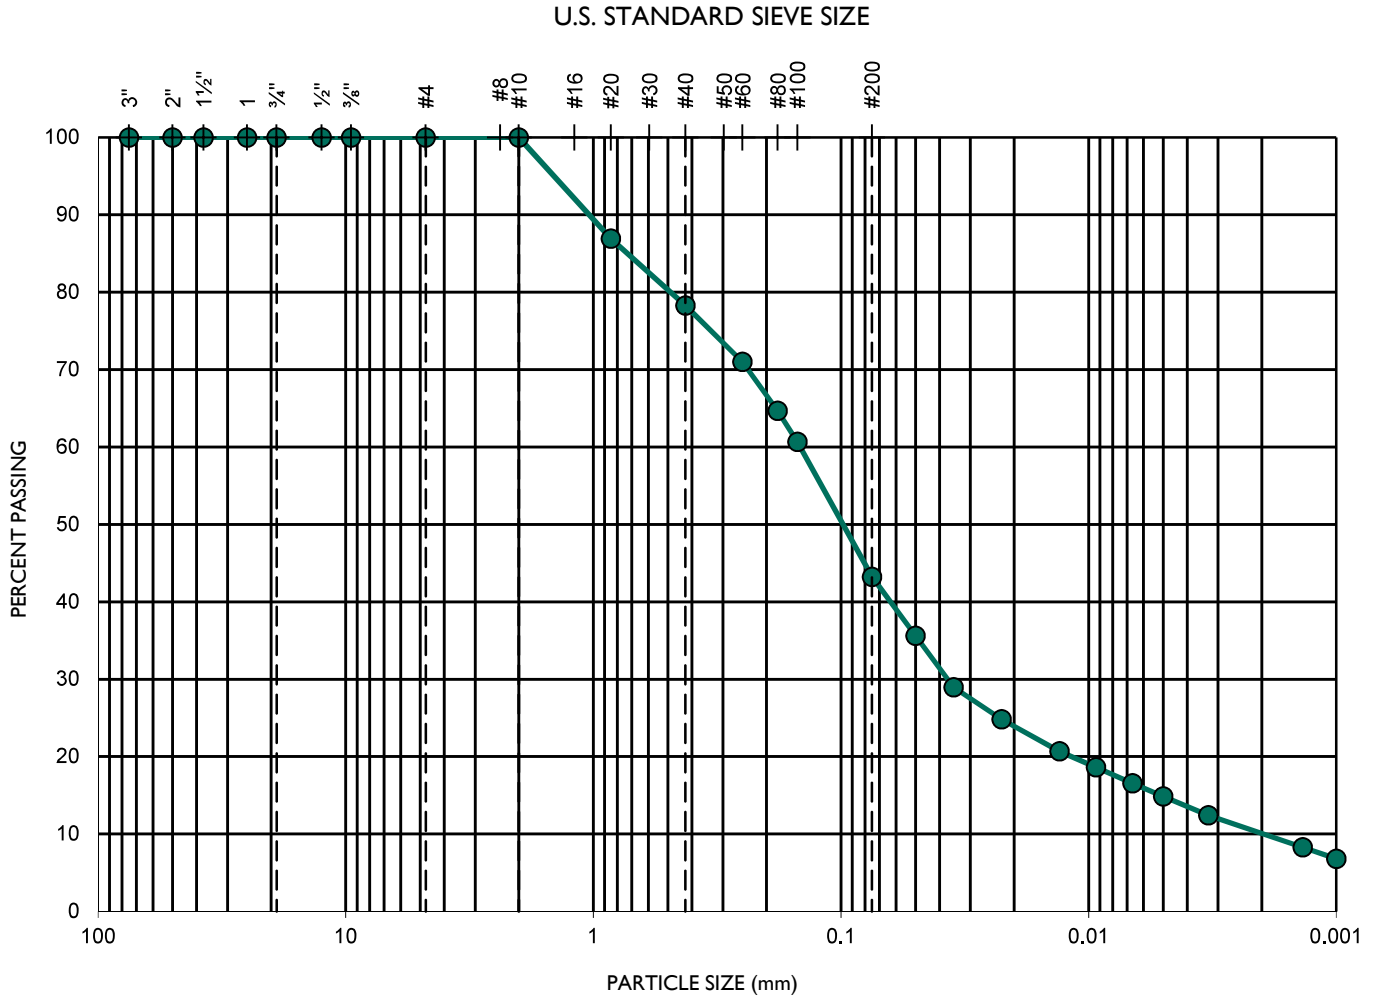
GEOLOGIC UNIT: **Shear Zone**

TEST DATA					
D ₁₀ (mm)	D ₃₀ (mm)	D ₆₀ (mm)	C _c	C _u	SOIL DESCRIPTION
0.00217	0.03745	0.14714	4.4	67.8	Silty SAND

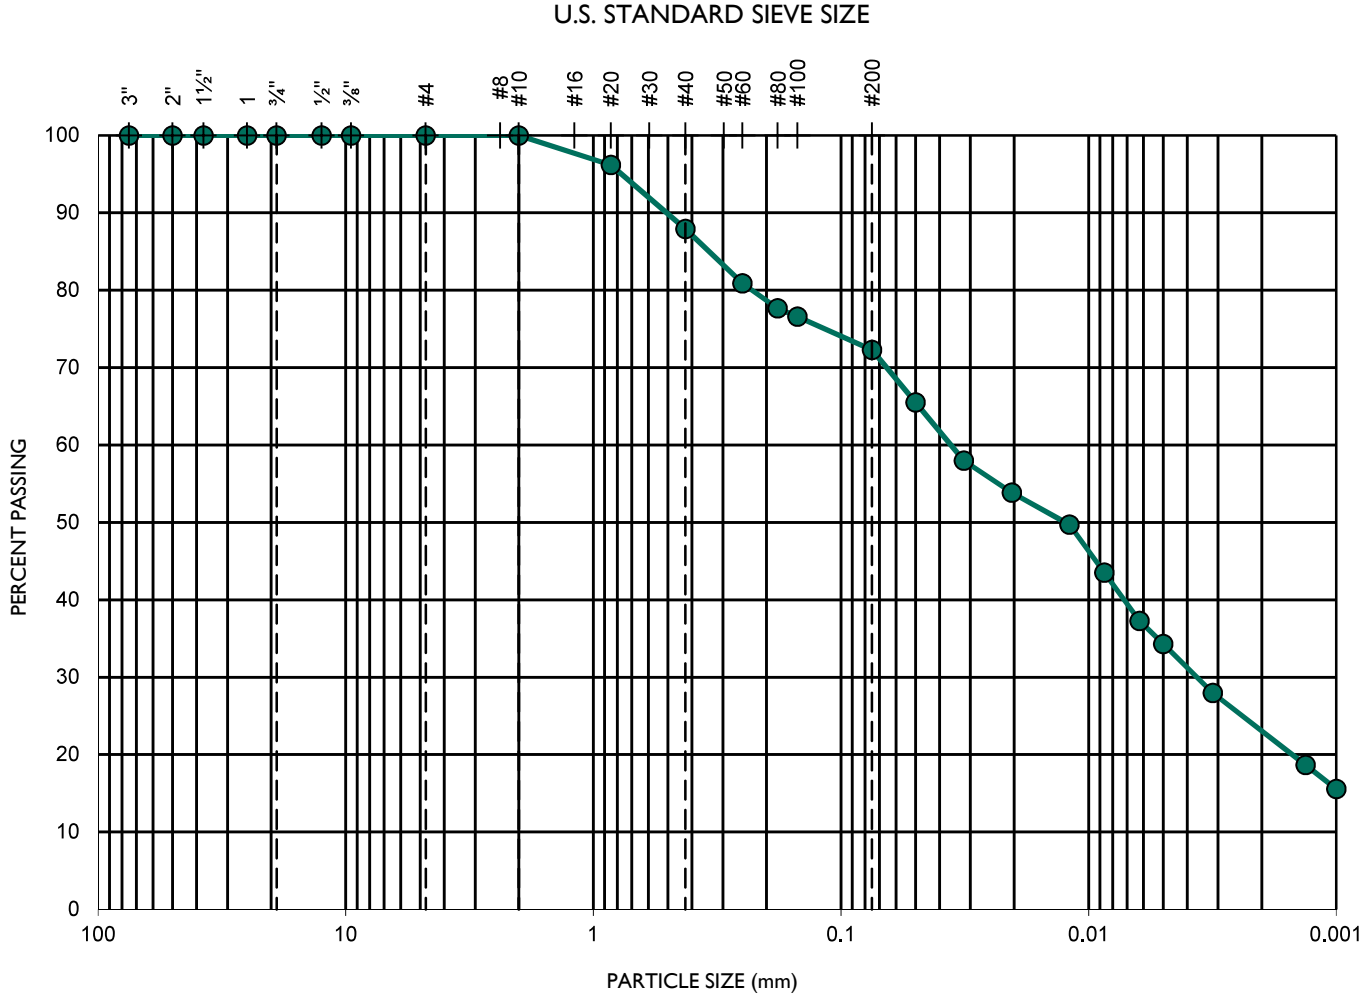
GEOLOGIC UNIT: **Shear Zone**

TEST DATA					
D ₁₀ (mm)	D ₃₀ (mm)	D ₆₀ (mm)	C _c	C _u	SOIL DESCRIPTION
0.00040	0.00375	0.03673	0.9	90.8	Silty CLAY with sand

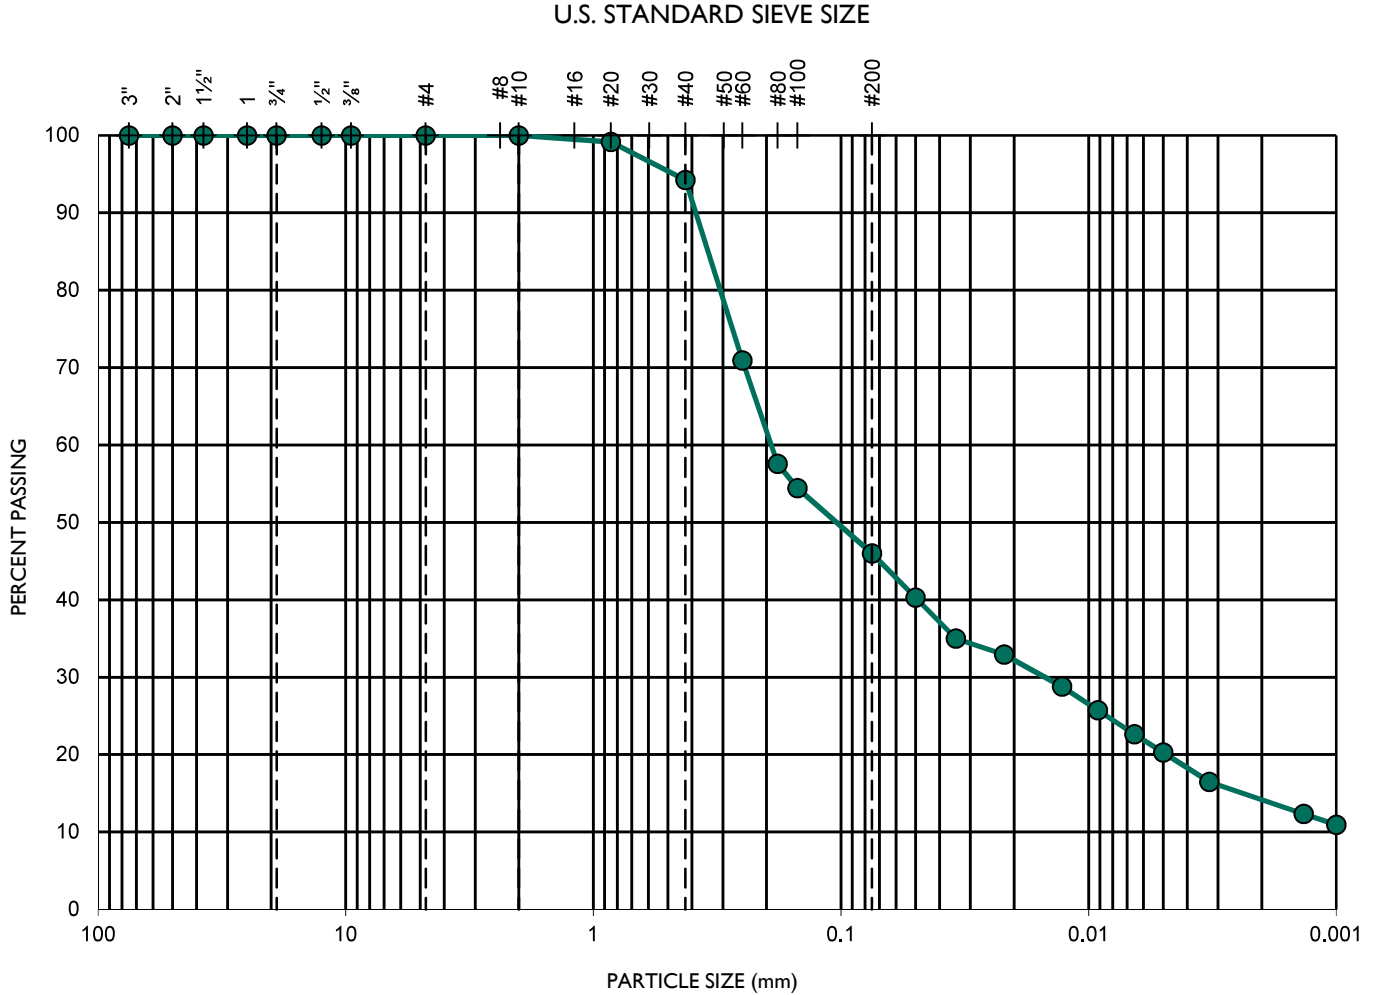
GEOLOGIC UNIT: **Shear Zone**

TEST DATA					
D ₁₀ (mm)	D ₃₀ (mm)	D ₆₀ (mm)	C _c	C _u	SOIL DESCRIPTION
0.00077	0.01546	0.19277	1.6	250.6	Silty Clayey SAND

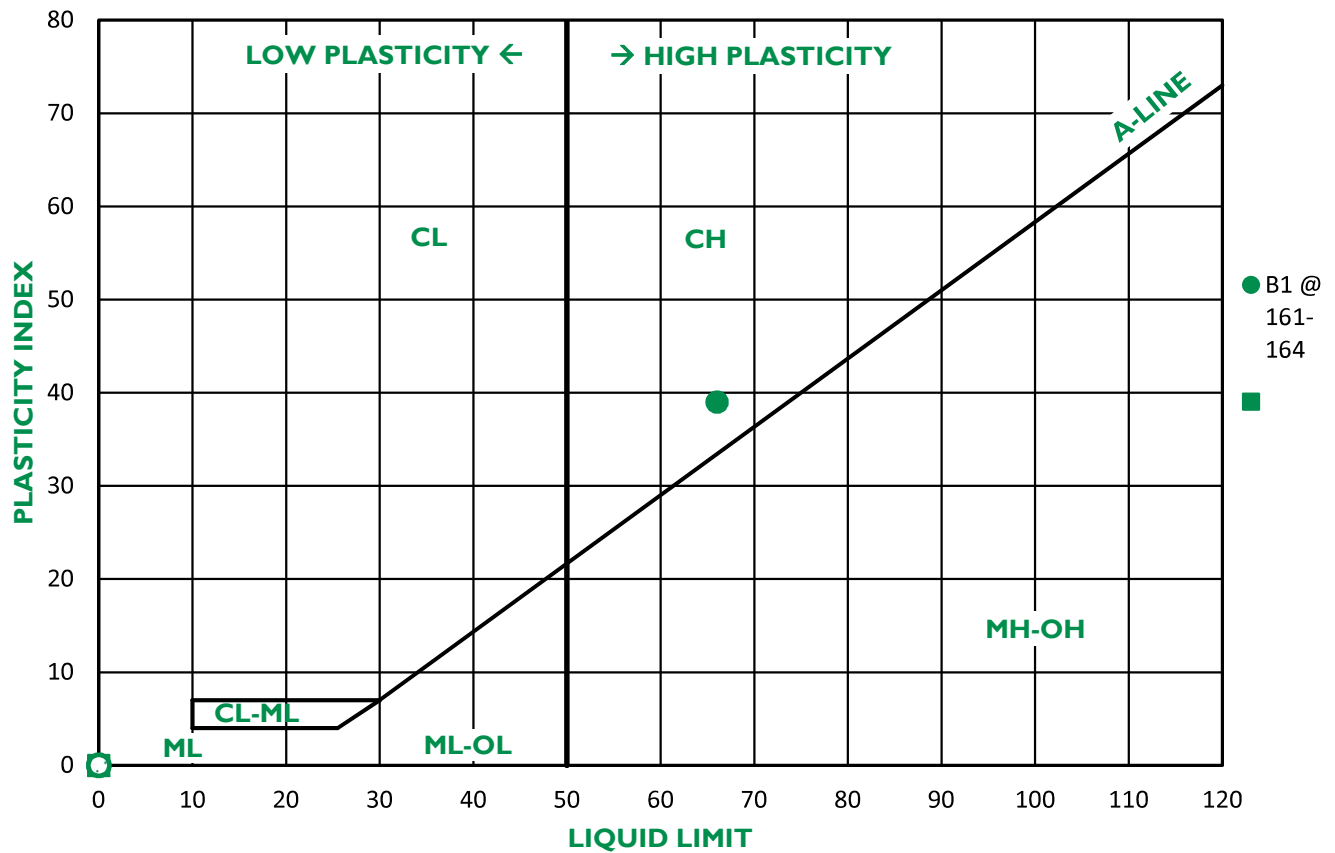
TEST RESULTS					
SAMPLE NO.	GEOLOGIC UNIT	LIQUID LIMIT	PLASTIC LIMIT	PLASTICITY INDEX	SOIL TYPE
B1 @ 161-164	Shear Zone	66	27	39	CH

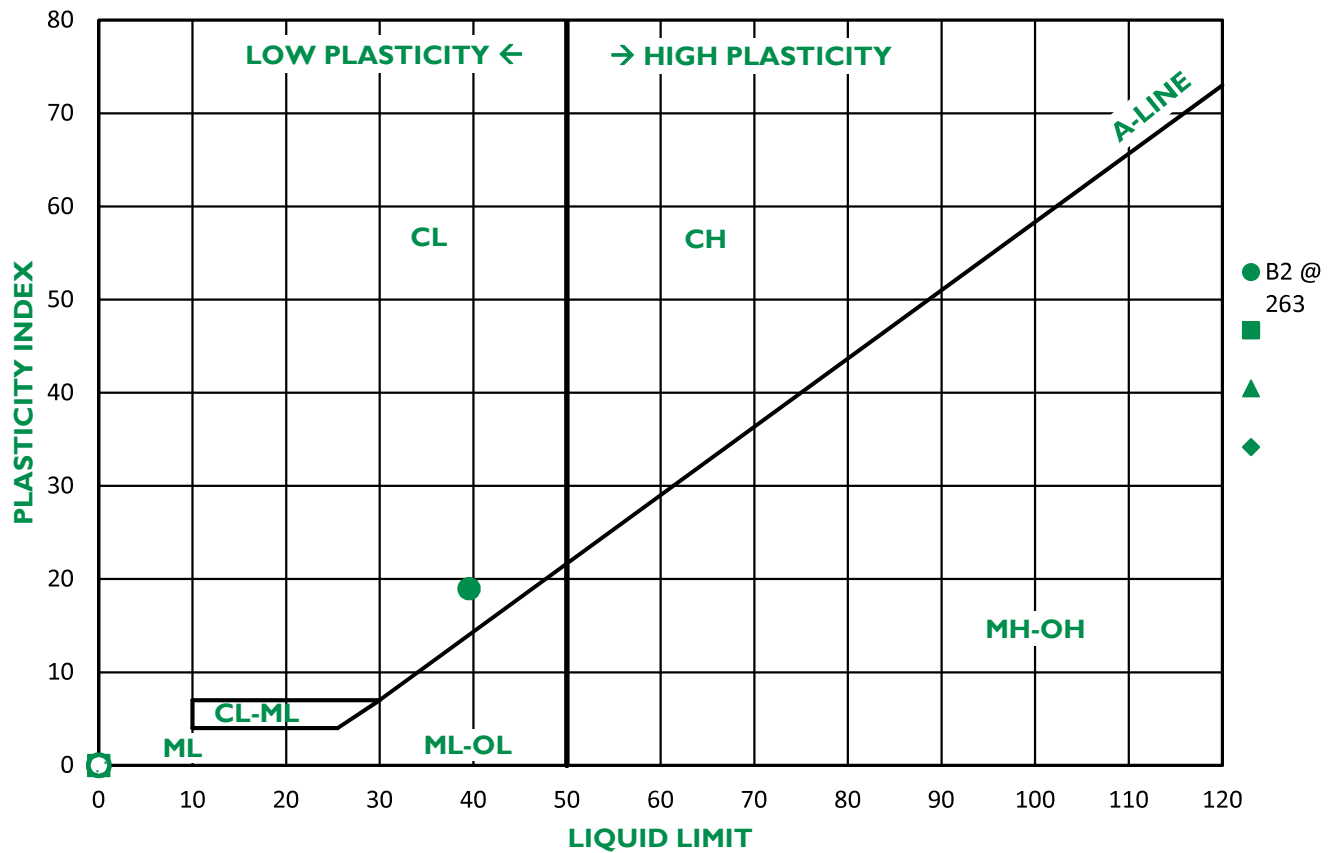
TEST RESULTS					
SAMPLE NO.	GEOLOGIC UNIT	LIQUID LIMIT	PLASTIC LIMIT	PLASTICITY INDEX	SOIL TYPE
B2 @ 263	Shear Zone	40	21	19	CL

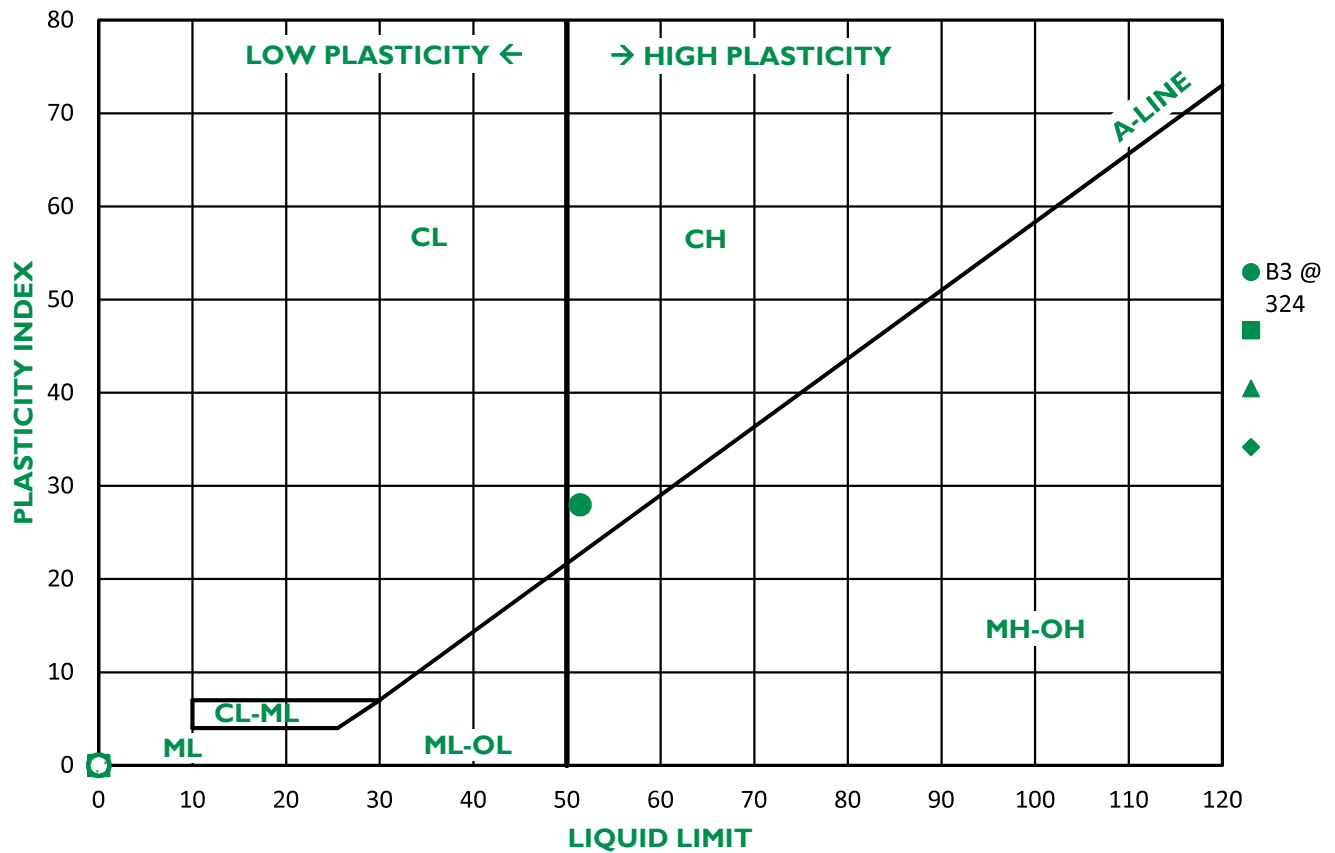
TEST RESULTS					
SAMPLE NO.	GEOLOGIC UNIT	LIQUID LIMIT	PLASTIC LIMIT	PLASTICITY INDEX	SOIL TYPE
B3 @ 324	SHEAR ZONE	51	23	28	CH

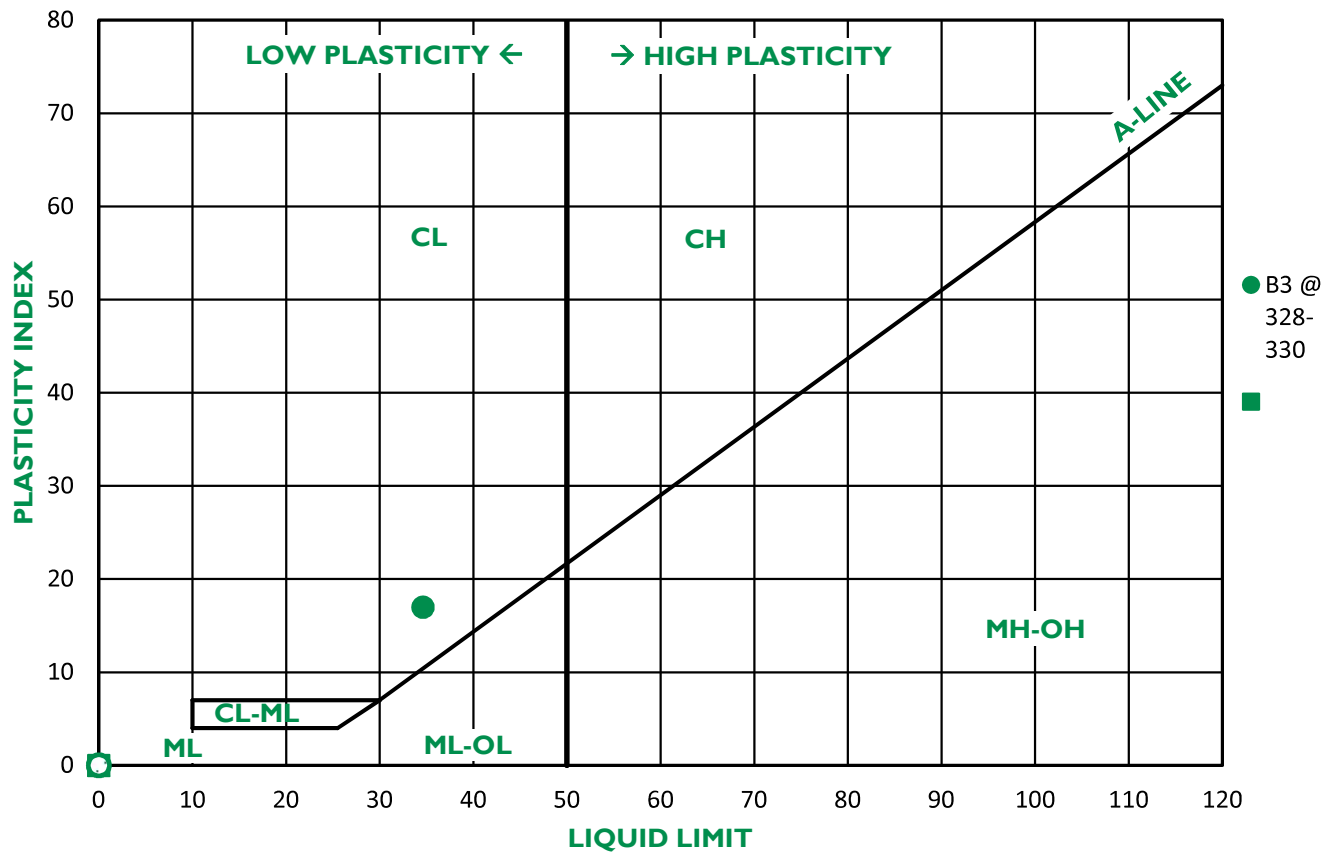
TEST RESULTS					
SAMPLE NO.	GEOLOGIC UNIT	LIQUID LIMIT	PLASTIC LIMIT	PLASTICITY INDEX	SOIL TYPE
B3 @ 328-330	Shear Zone	35	18	17	CL

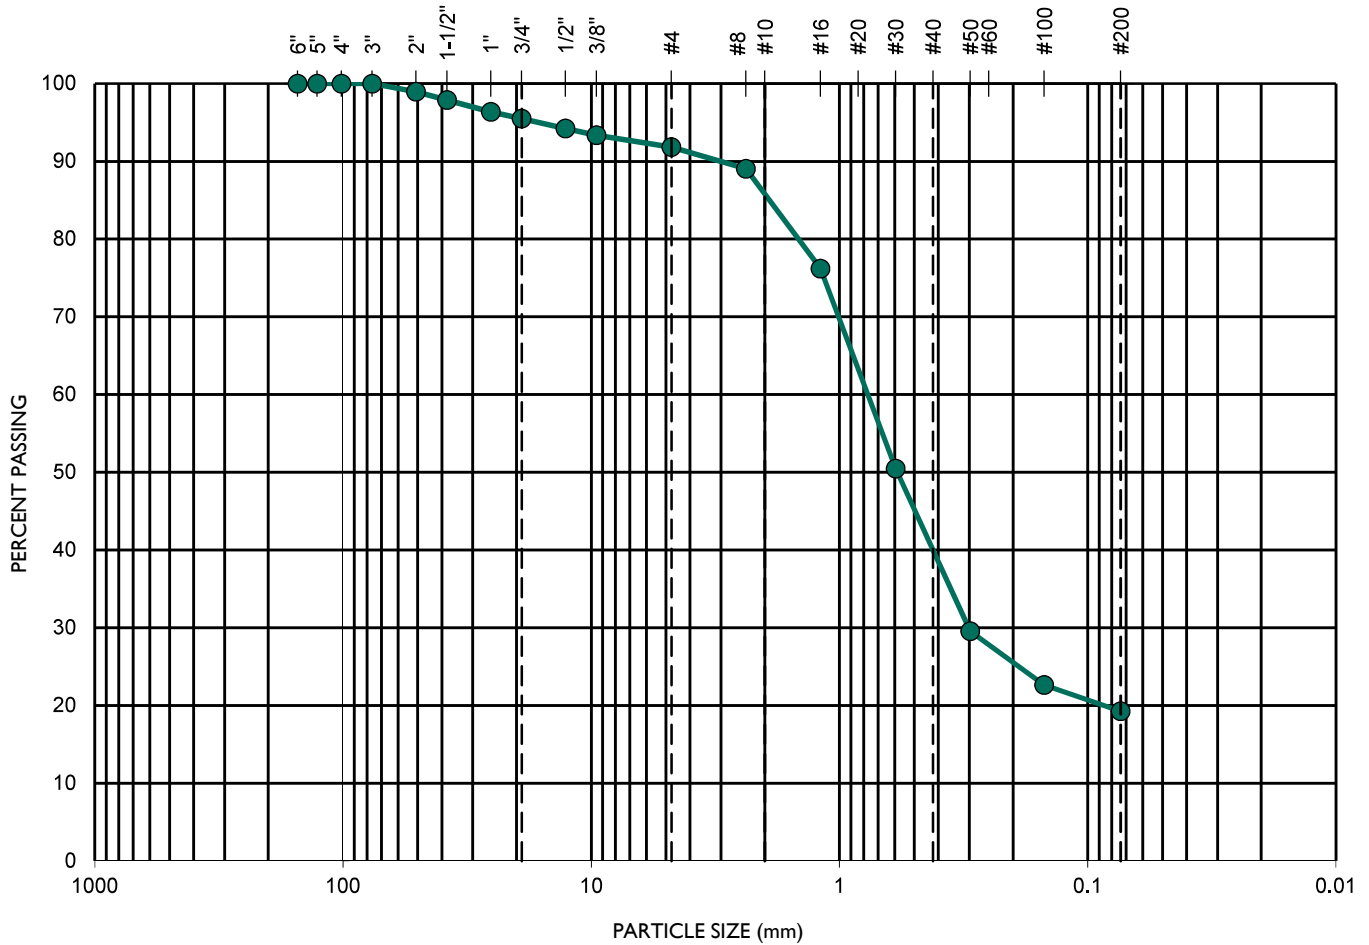
TEST DATA					SOIL DESCRIPTION
D ₁₀ (mm)	D ₃₀ (mm)	D ₆₀ (mm)	C _c	C _u	
0.038	0.303	0.816	2.9	21.3	SM - Silty SAND

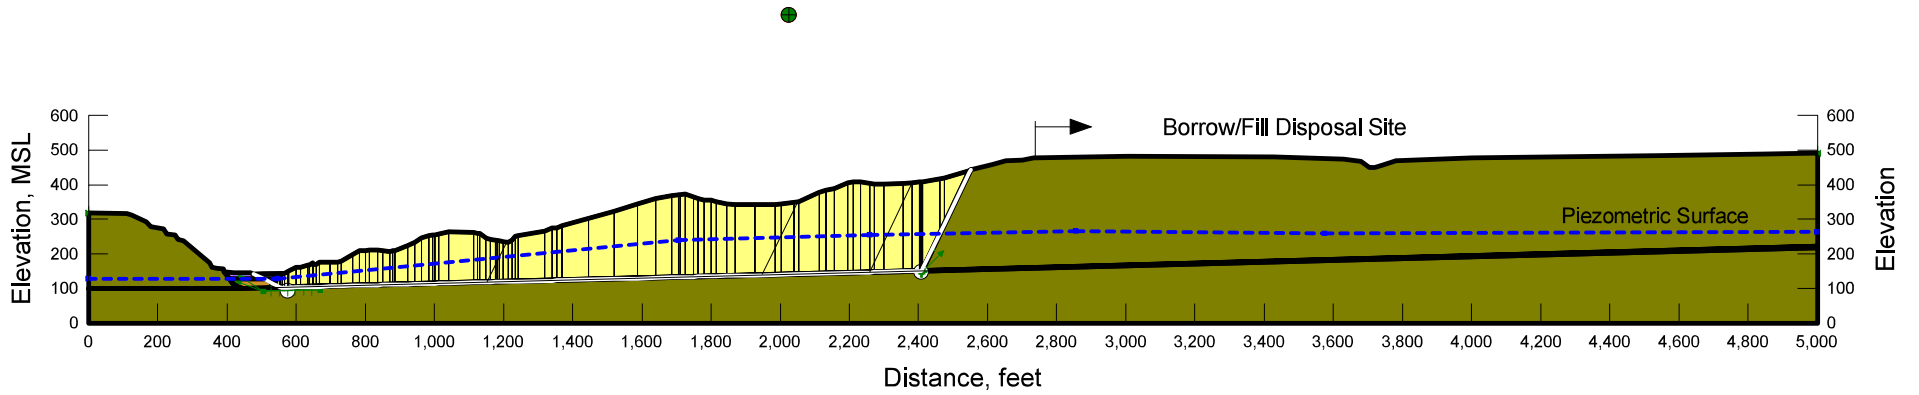
Analysis:
 – Failure Up Headscarp

Color	Name	Unit Weight (pcf)	Cohesion' (psf)	Phi' (°)	Piezometric Line
Orange	Qal	125	100	28	1
Purple	Qcf	130	300	30	1
Yellow	Qls	130	300	30	1
Red	Shear Zone	120	50	8	1
Olive Green	To	130	450	34	1
Olive Green	To (2)				1

We analyzed three failure locations. The first location was along the basal slide plane and up the assumed landslide headscarp. The strength parameters used for the basal surface was also used along the landslide headscarp. The result of this analysis is shown on Figure C-1 which indicates a factor of safety of 1.21. For the second location we allowed the computer to search for the failure surface with the lowest factor of safety assuming that a bedding plane shear with the same strength parameters as the basal shear zone extends behind the landslide headscarp and beneath the mesa. The results of this analysis is shown on Figure C-2 and indicates a factor of safety greater than 1.5. The third failure location was set at the edge of the borrow/fill disposal limits (see Figure C-3). The factor of safety at the edge of the borrow/disposal limits is 1.5.

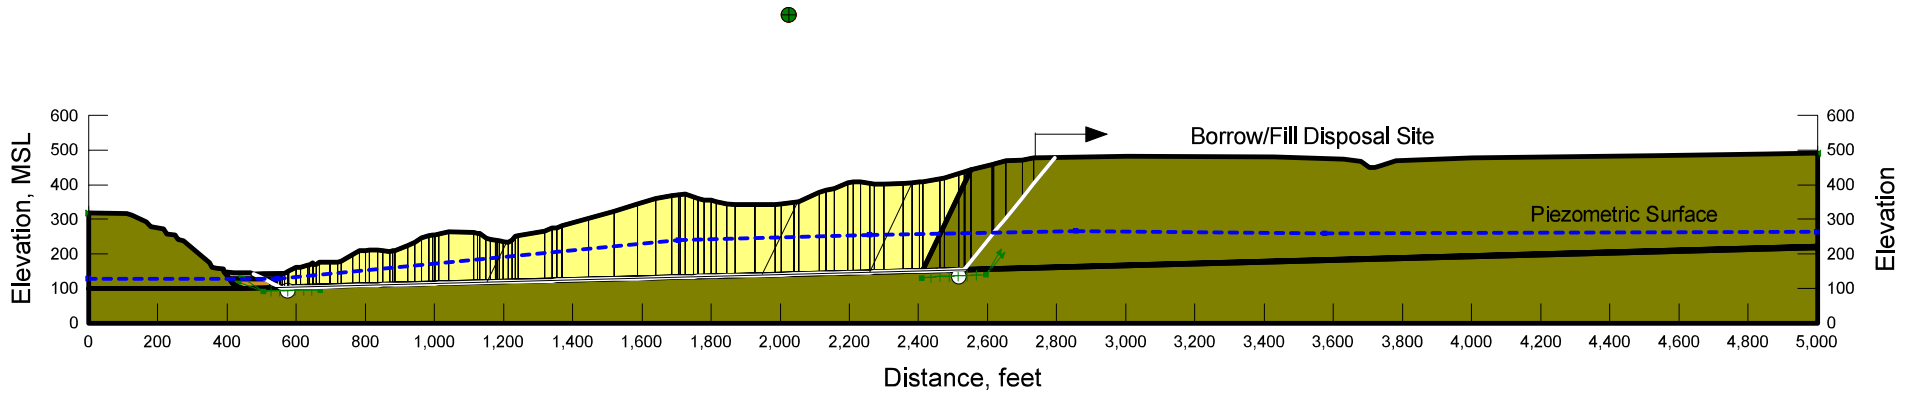
Analysis:
 – Failure along Extended Shear Plane

Color	Name	Unit Weight (pcf)	Cohesion' (psf)	Phi' (°)	Piezometric Line
Orange	Qal	125	100	28	1
Purple	Qcf	130	300	30	1
Yellow	Qls	130	300	30	1
Red	Shear Zone	120	50	8	1
Olive Green	To	130	450	34	1
Olive Green	To (2)				1

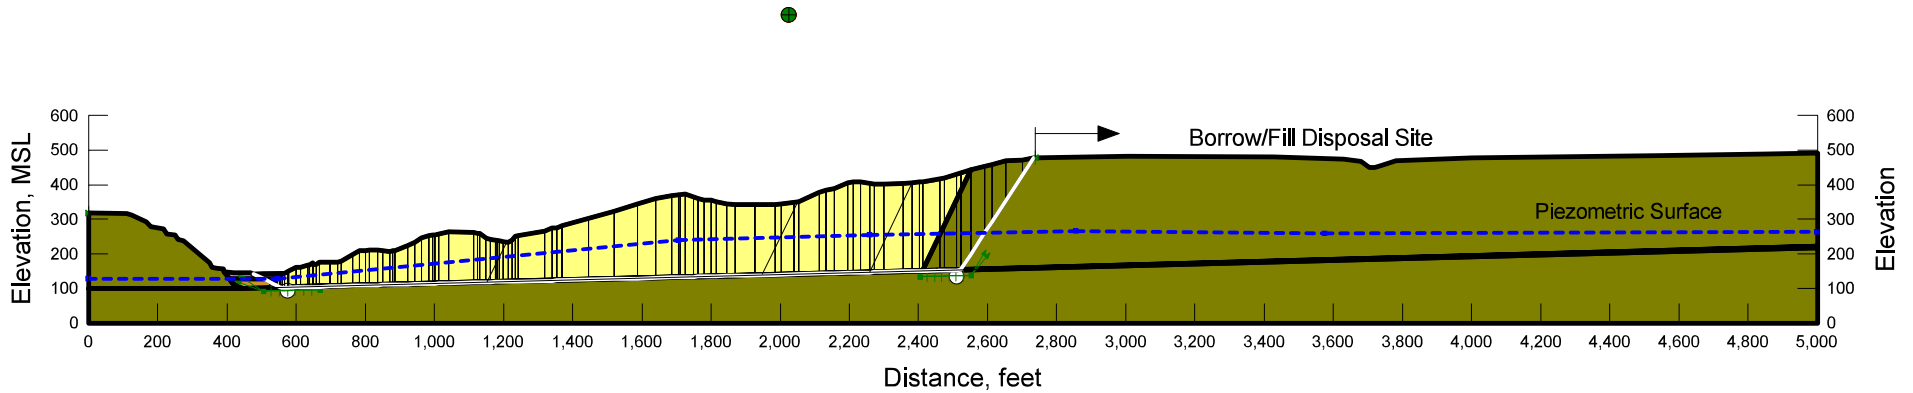
Analysis:
 – Failure at Edge of Borrow/Disposal Site

Color	Name	Unit Weight (pcf)	Cohesion' (psf)	Phi' (°)	Piezometric Line
Orange	Qal	125	100	28	1
Purple	Qcf	130	300	30	1
Yellow	Qls	130	300	30	1
Red	Shear Zone	120	50	8	1
Olive Green	To	130	450	34	1
Olive Green	To (2)				1
