**PRELIMINARY GEOTECHNICAL
EVALUATION AND SLOPE STABILITY
ANALYSIS**

**SOUTHWEST VILLAGE VTM-2
(BORROW/FILL SITE)
SAN DIEGO, CALIFORNIA**

**JULY 2, 2021
PROJECT NO. 06847-42-04**

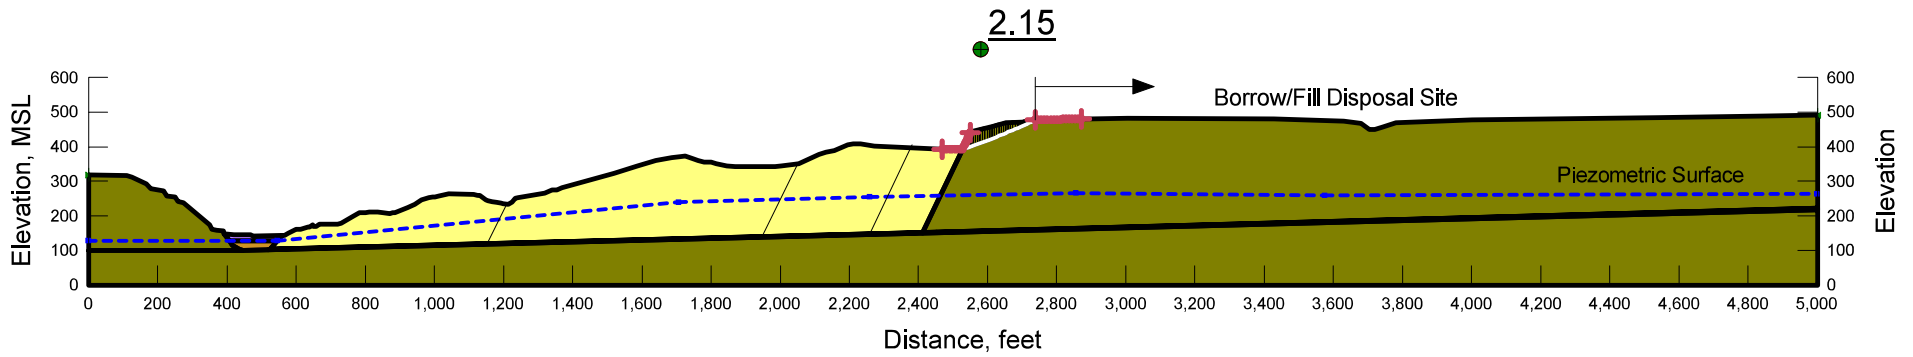
Analysis:
 – 50 foot drop in landslide

Color	Name	Unit Weight (pcf)	Cohesion' (psf)	Phi' (°)	Piezometric Line
Orange	Qal	125	100	28	1
Purple	Qcf	130	300	30	1
Yellow	Qls	130	300	30	1
Red	Shear Zone	120	50	8	1
Olive Green	To	130	450	34	1
Olive Green	To (2)				1

We also analyzed the cross section assuming landslide movement causes the ground surface in front of the landslide headscarp to drop thereby creating a higher exposed headscarp slope. Assuming a 50-foot elevation change in front of the headscarp, a factor of safety of at least 1.5 exists at or in front of the edge of the borrow/disposal limit (see Figure C-4).

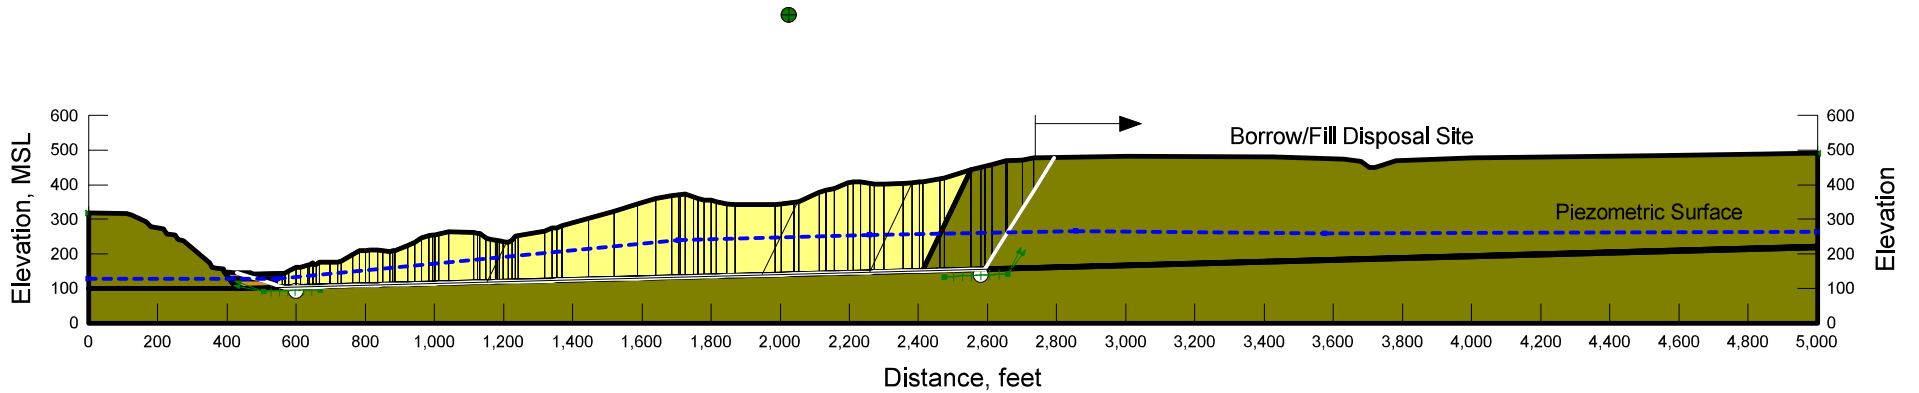
Analysis:
 – Seismic Analysis: Horz Seismic Coef.: 0.101

Color	Name	Unit Weight (pcf)	Cohesion' (psf)	Phi' (°)	Piezometric Line
Orange	Qal	125	100	28	1
Purple	Qcf	130	300	30	1
Yellow	Qls	130	300	30	1
Red	Shear Zone	120	50	8	1
Olive Green	To	130	450	34	1
Olive Green	To (2)				1

- 5.4 With respect to seismic slope stability, the section analyzed did not pass the screening evaluation, therefore, we performed a deformation analysis utilizing procedures in Special Publication 117A. Using the overall landslide slope height (336 feet), our analysis indicates 0 cm of deformation. If we use the landslide headscarp slope height (approximately 80 feet), our analysis indicates a deformation of 12 cm. According to Special Publication 117A, displacements up to 15 centimeters are unlikely to correspond to serious landside movement and damage. Using the steeper landslide headscarp slope height in the seismic analysis rather than the overall more gentle landslide slope is a conservative approach. Additionally, the 12 centimeters deformation would occur over the length of the slide area (2,000 lineal feet) resulting in negligible deformations throughout the slide area.

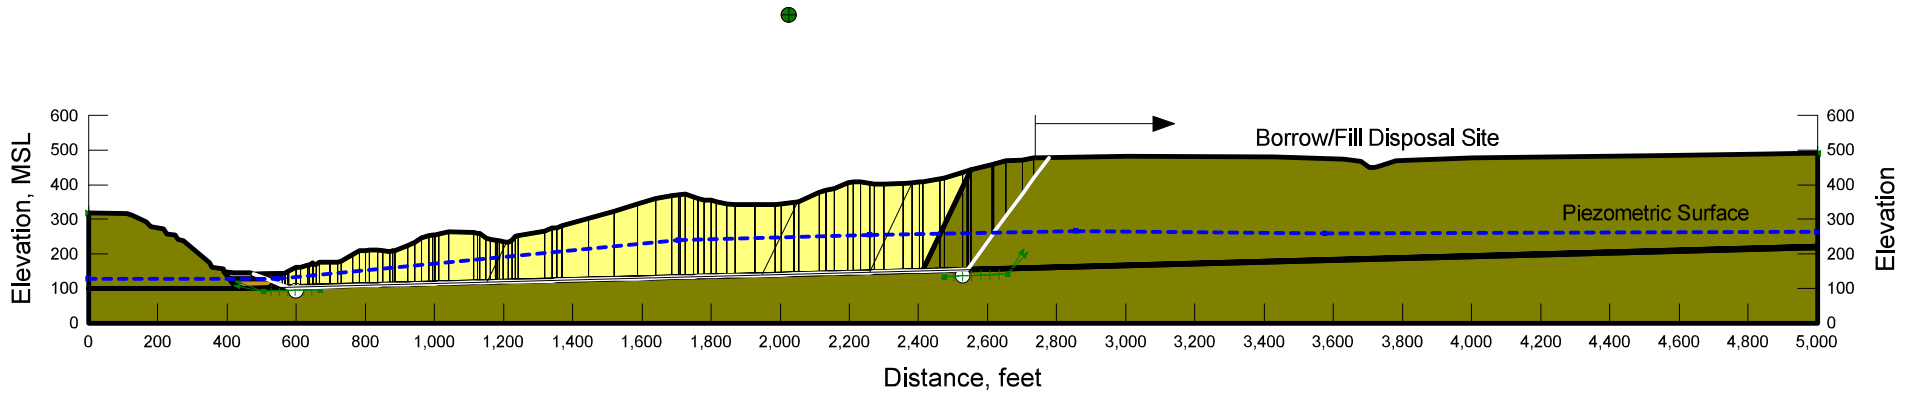
Analysis:

- Seismic for FS=1.0
- Horz Seismic Coef.: 0.05

Color	Name	Unit Weight (pcf)	Cohesion' (psf)	Phi' (°)	Piezometric Line
Orange	Qal	125	100	28	1
Purple	Qcf	130	300	30	1
Yellow	Qls	130	300	30	1
Red	Shear Zone	120	50	8	1
Olive Green	To	130	450	34	1
Olive Green	To (2)				1

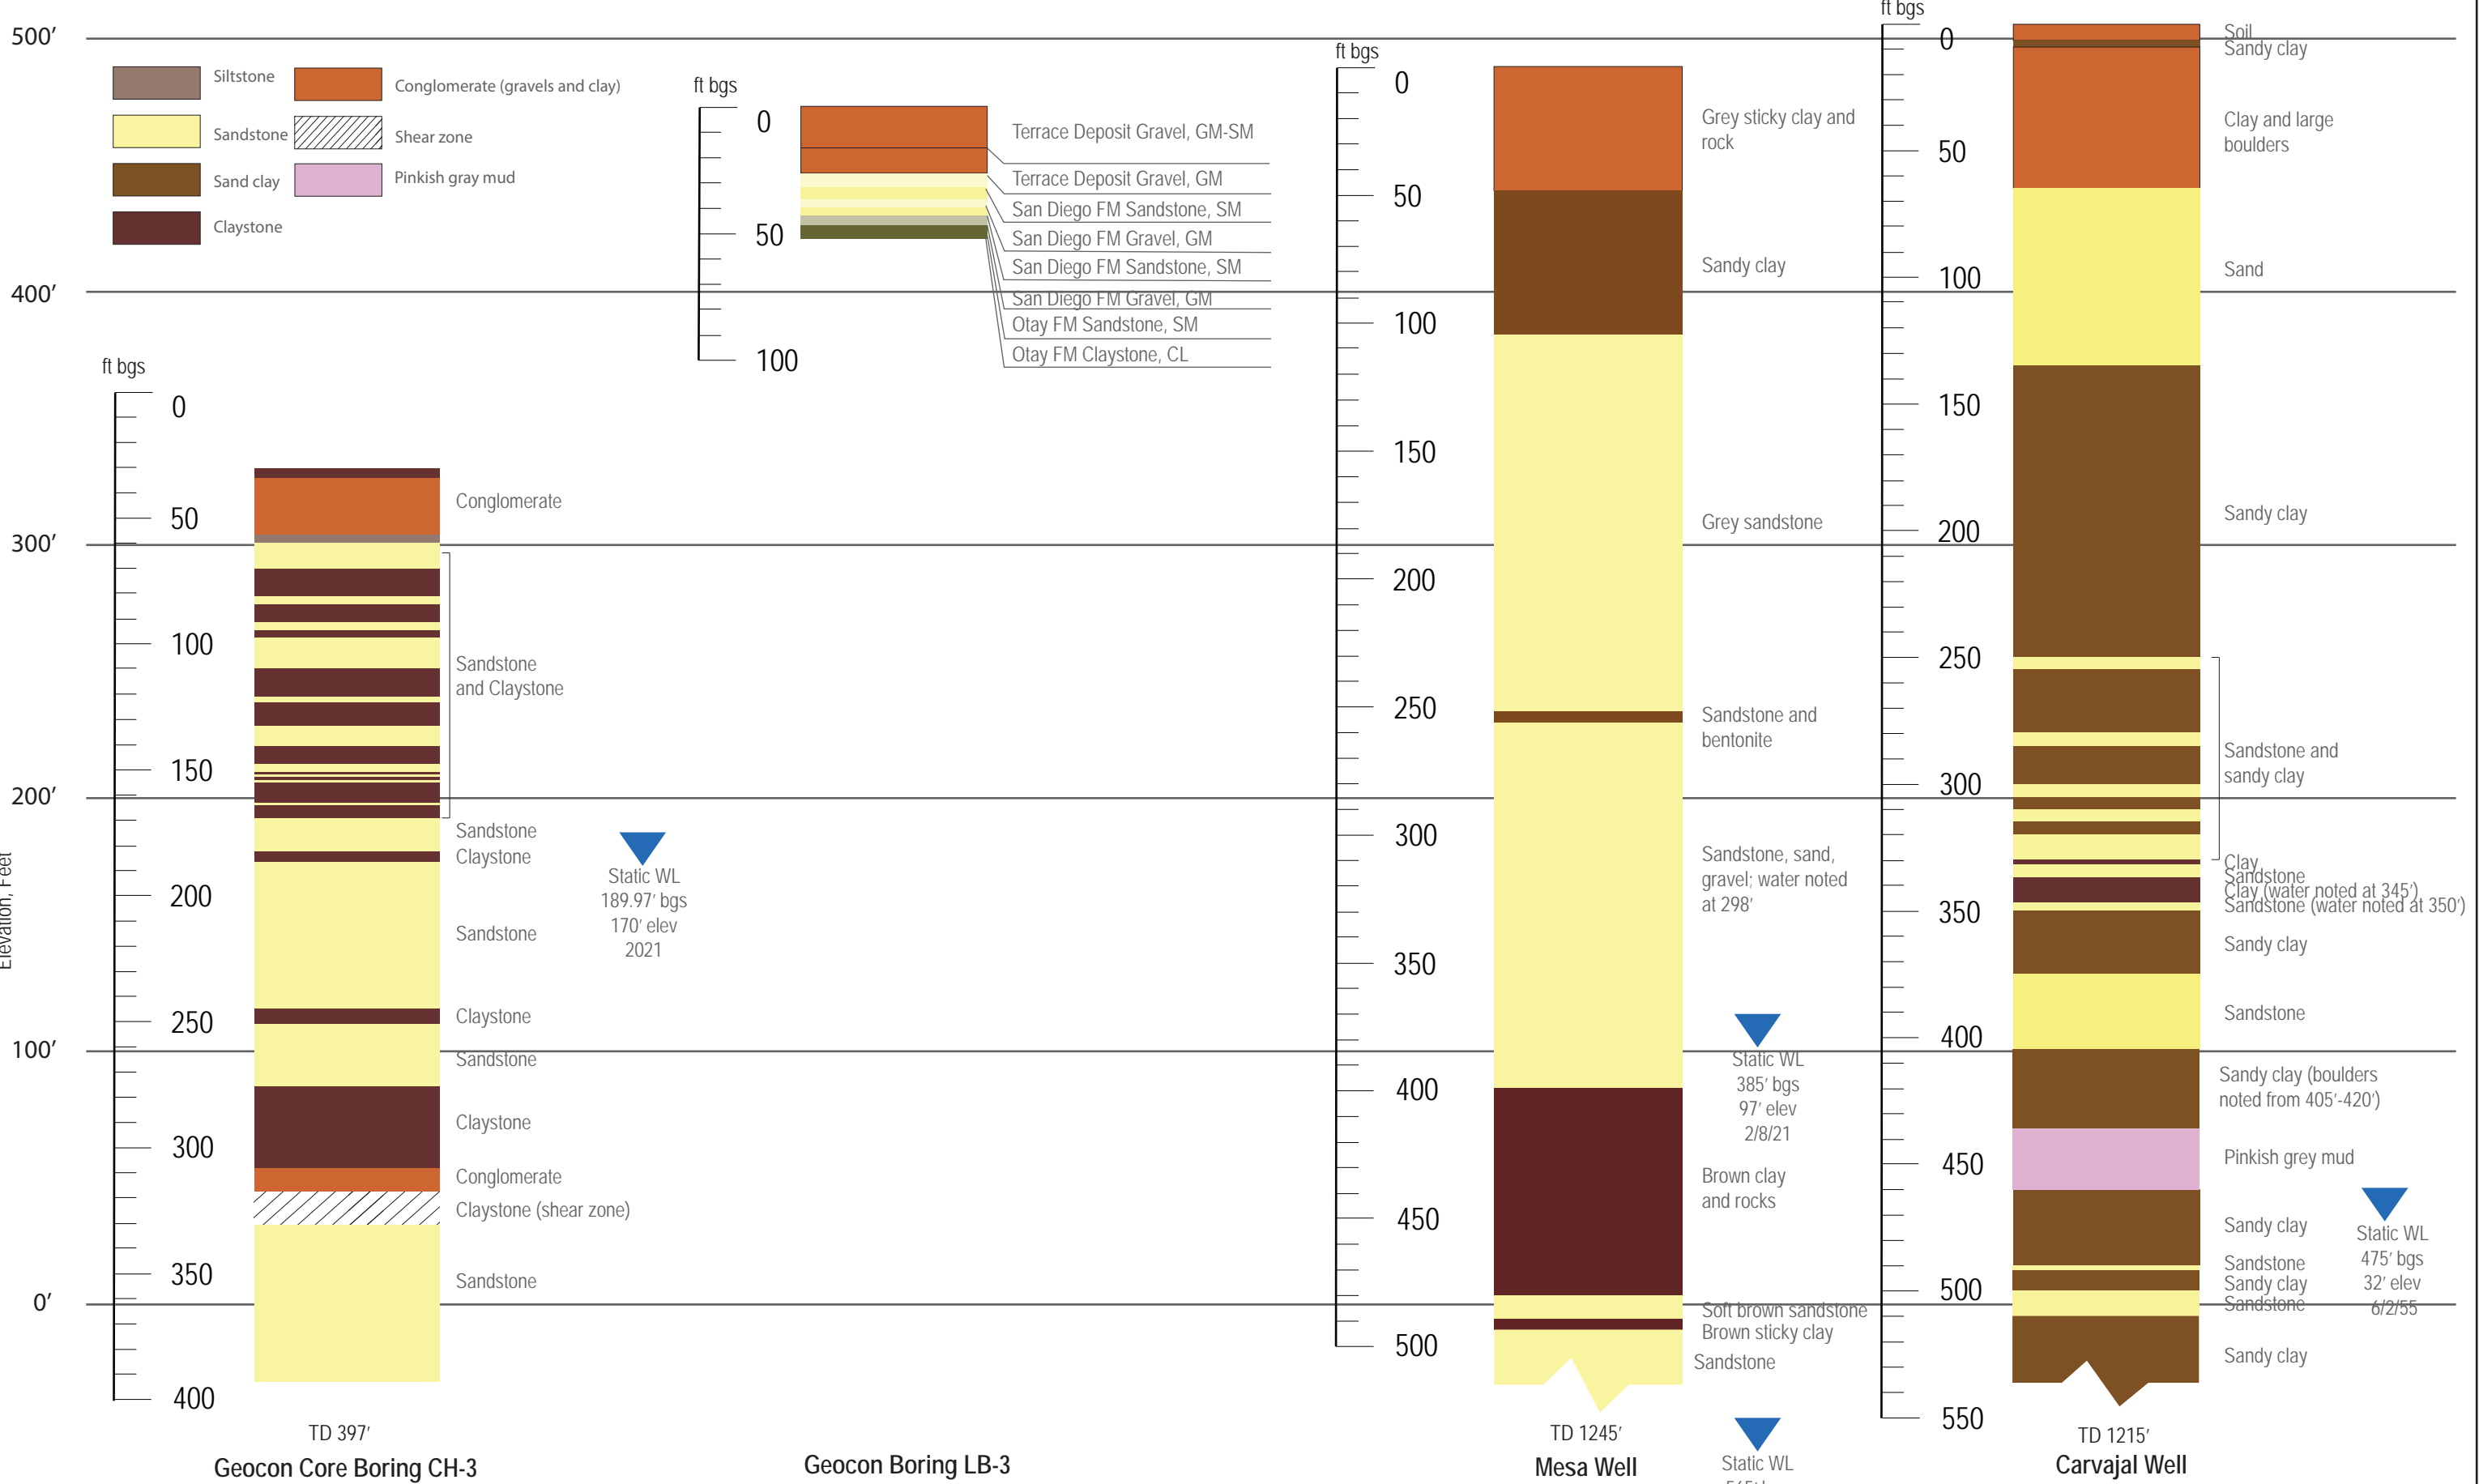
Figure 2
Otay Mesa Geotech Boring and Water Wells

Note: Dark brown colors indicate clay bearing lithology
 Figure shows generalized geology
 Elevation Datum NAVD88

Figure 2 provides a cross section constructed from the Mesa and Carvajal driller's logs, along with Geocon boring and corehole logs. The Carvajal well log indicates "pinkish gray mud" from depth 435-460 ft, at elevation slightly higher than the basal shear bentonite bed encountered on the Project side of the Mesa in Geocon Corehole 3.

Although not current or the most reliable data, we regard the “first water” notation on the Mesa Well driller’s log as the best available indication of groundwater depth beneath the Project area, subject to verification. The Mesa Well driller’s log is presented in the Figure 2 cross section.

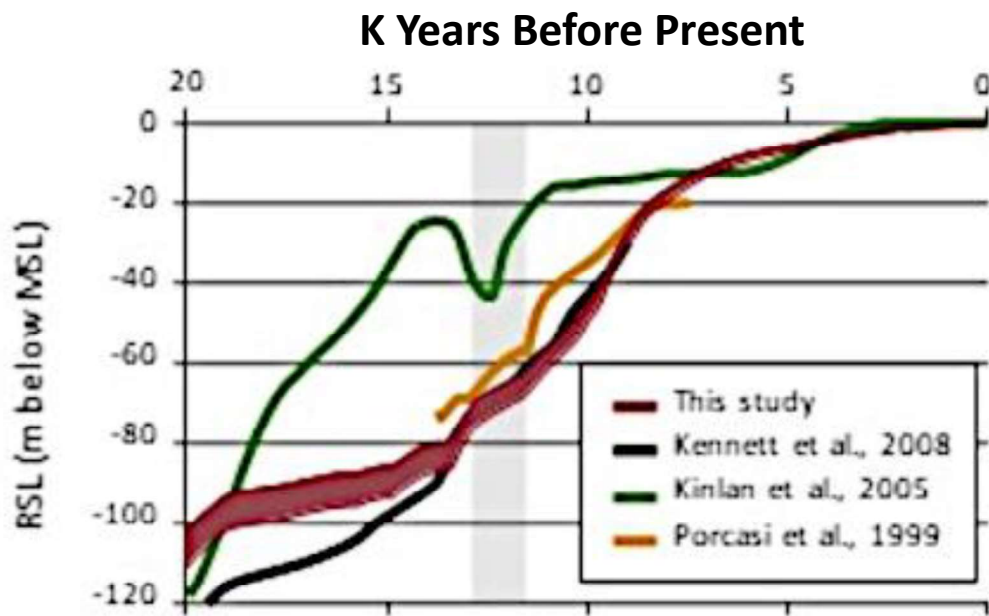
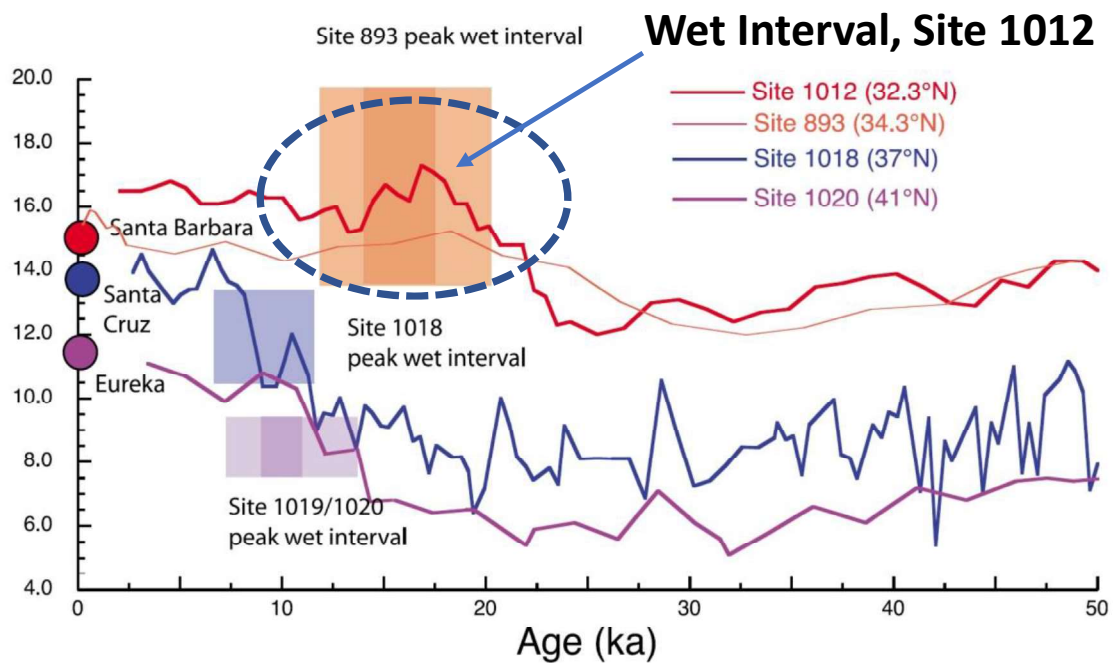
FIGURE 3
 Pleistocene Sea Level Curve
 And Ocean Core Paleo
 Environment Analysis

Sea Level Curve, reproduced from Reeder, et al, 2015

Wet Climate Interval, inferred from pollen analysis
 Of ocean bottom sediment cores, CA Borderland.
 Reproduced from Lyle, et al, 2010

Figure 3 provides an estimated sea level curve from 20,000 years BP to present, along with a summary graph of ocean core pollen analyses indicating a prolonged wet climate interval during the Pleistocene epoch from 12,000 to 20,000 years BP for the California Borderland at latitude 32.3 degrees north.

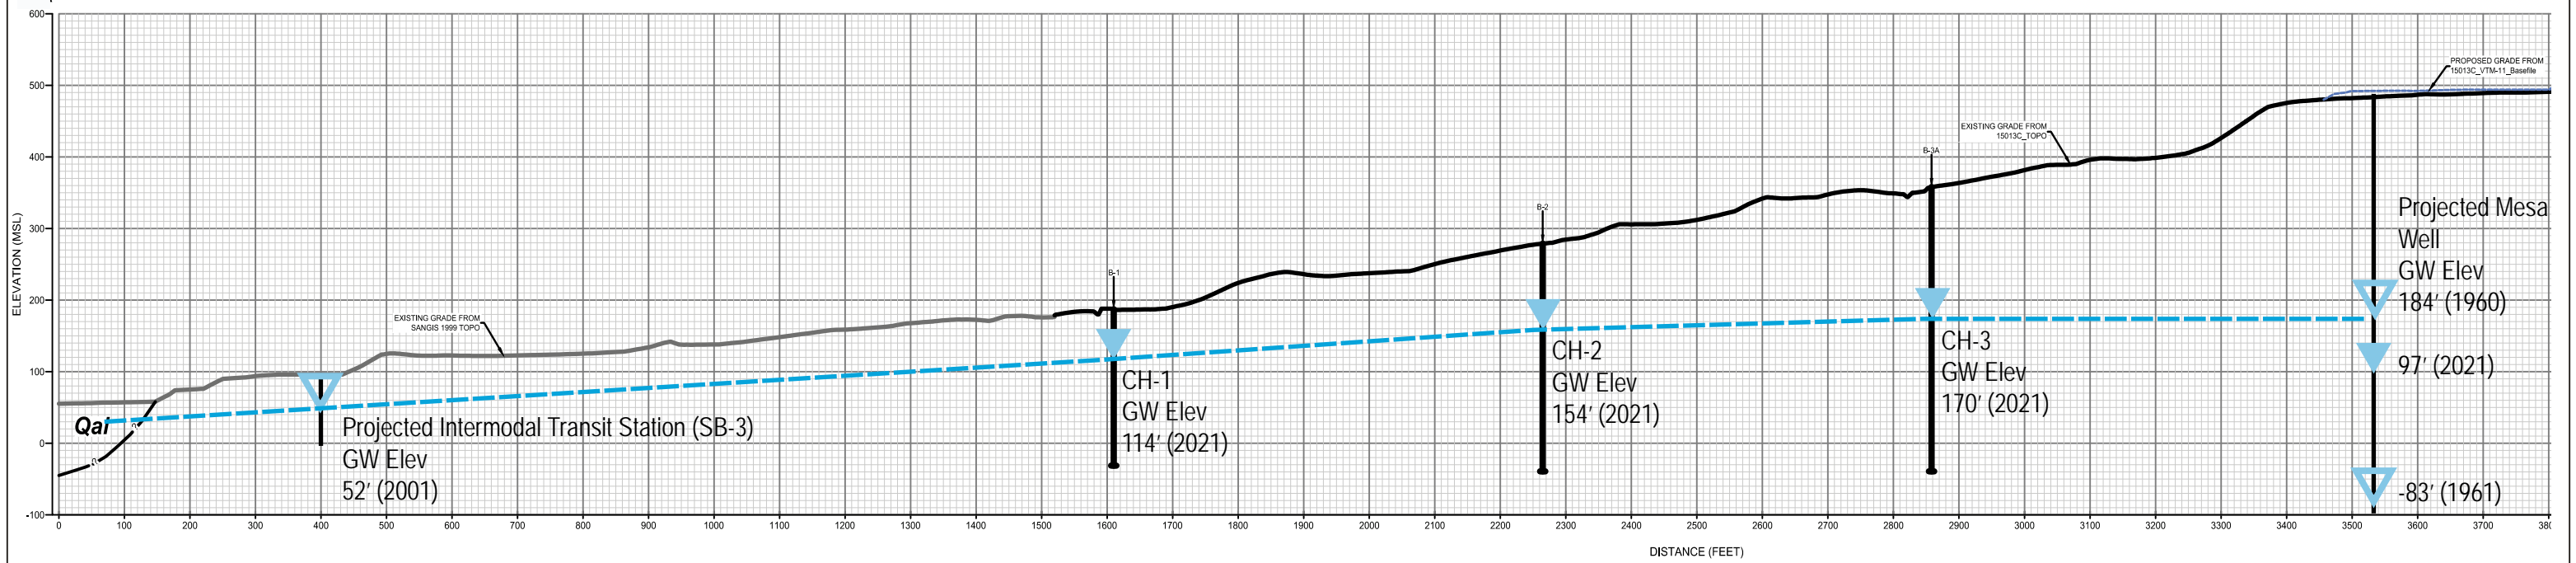
FIGURE 4

Groundwater cross section through Geocon Landslide A
 Figure adapted from Draft Geocon cross section
 Groundwater elevations shown for borings are NAVD88

Plate 2 is a cropped portion of Plate 1, which enlarges the proposed Southwest Village development area. A cross section line through Landslide A is presented in Figure 4. The groundwater depth/elevation cross section shows depth to water and elevation from the three Geocon core holes, the Mesa irrigation well (depth to "first water" in 1960), and Boring SB-3 drilled at the Intermodal Transportation Center in 2001. Groundwater levels for the Mesa Well and the SB-3 exploration boring have been projected northwest into the Figure 4 cross section.

As part of this investigation, Corehole 3 was equipped with a PVC casing and well screen extending to 270 foot depth, and equipped with a water level recording pressure transducer. The groundwater levels shown in Figure 4 for Coreholes 1 and 2 were measured very shortly after drilling with a borehole seismic survey conducted by Geovision, and the borings have since been abandoned. Boring SB-3 was abandoned in 2001 shortly after logging.

It should not be assumed that the groundwater conditions shown in Figure 4 and Plate 2 are static and invariant with respect to seasonal storms or unusual series of precipitation events, should they occur. Because the core borings indicate the bulk of the Otay formation slide mass is composed of claystone, siltstone, and sandstone, a conservative assumption would be that groundwater flow within Landslide A occurs primarily via fracture flow, and a much lesser degree porous media flow. Therefore groundwater level response of the slope to heavy rainfall could be greater and also more rapid than would occur in more porous, unconsolidated basin aquifer sediments such as sand.

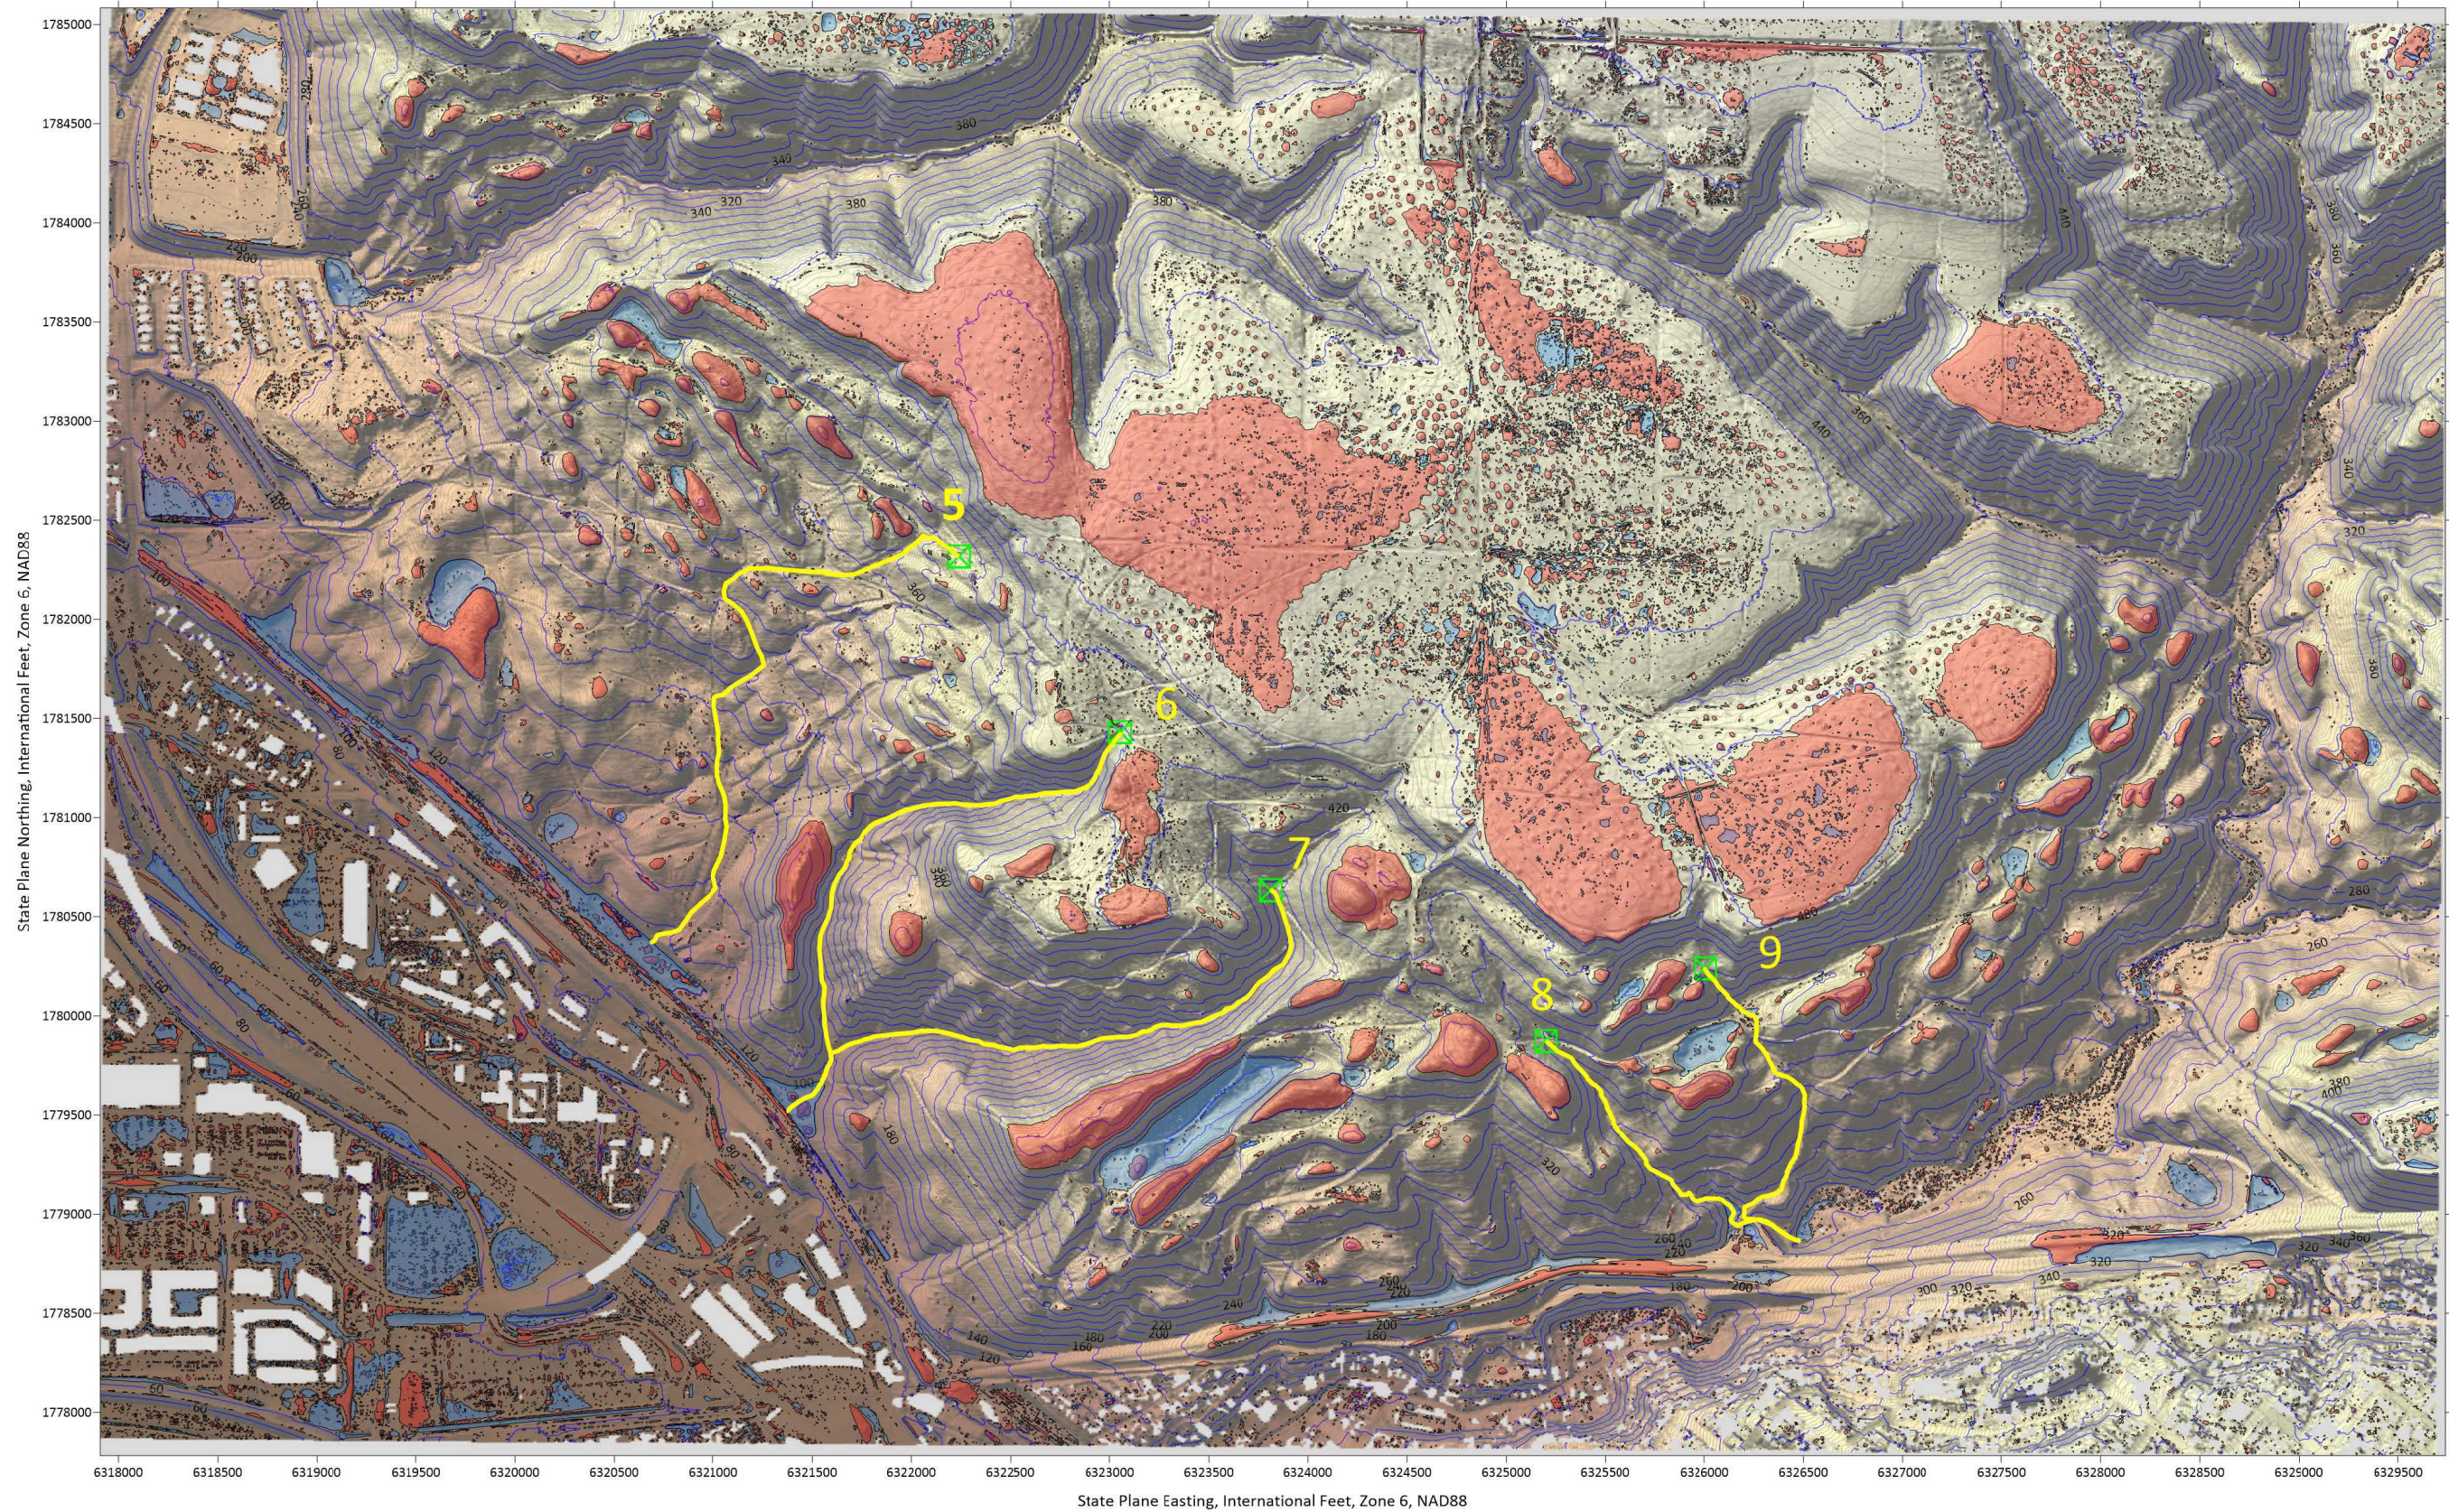
FIGURE 5
Stormwater Outfalls and
Outfall Flow Paths

NOTES: Blue Topo Shading Indicates Closed Contour Depression
Salmon Topo Shading Indicates Closed Contour Hilltops
Yellow Lines are Outfall Flowpaths

The project as proposed includes five outfalls to manage the Project stormwater flows. Figure 5 shows the location of proposed stormwater outlet structures which are intended to convey project stormwater and excess irrigation water to existing bare earth drainages which will then convey the stormwater to the base of the slope and existing San Ysidro stormwater infrastructure. The outfalls are numbered 5, 6, 7, and 8 as indicated in Figure 4.

The existing drainage pathways that traverse from the proposed outfalls through the slide areas are shown in Figure 5 as yellow lines. The drainage pathways were digitized and are graphed as profiles in Figure 6. The cross sections for these bare earth drainages have been unfolded from their curved path routes into the flat plane of Figure 6. Thus the true drainage path lengths and slopes are retained in the figure.

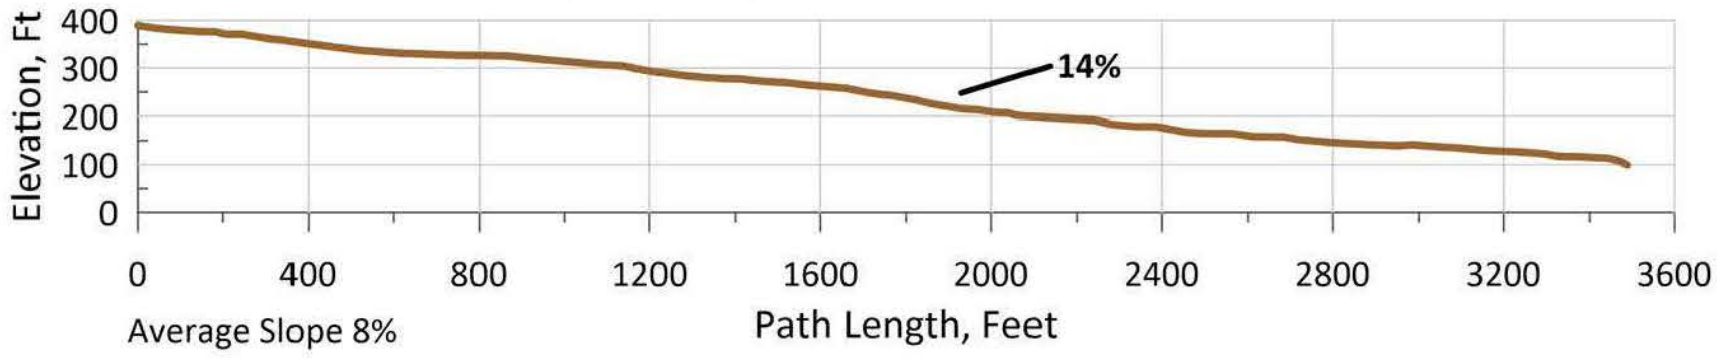
Slope of Gully Bottom From Outfall 5

Elevation profiles digitized from 2 foot contour map of USGS/San Diego County
2014 Lidar data downloaded from NOAA Digital Coast access server.

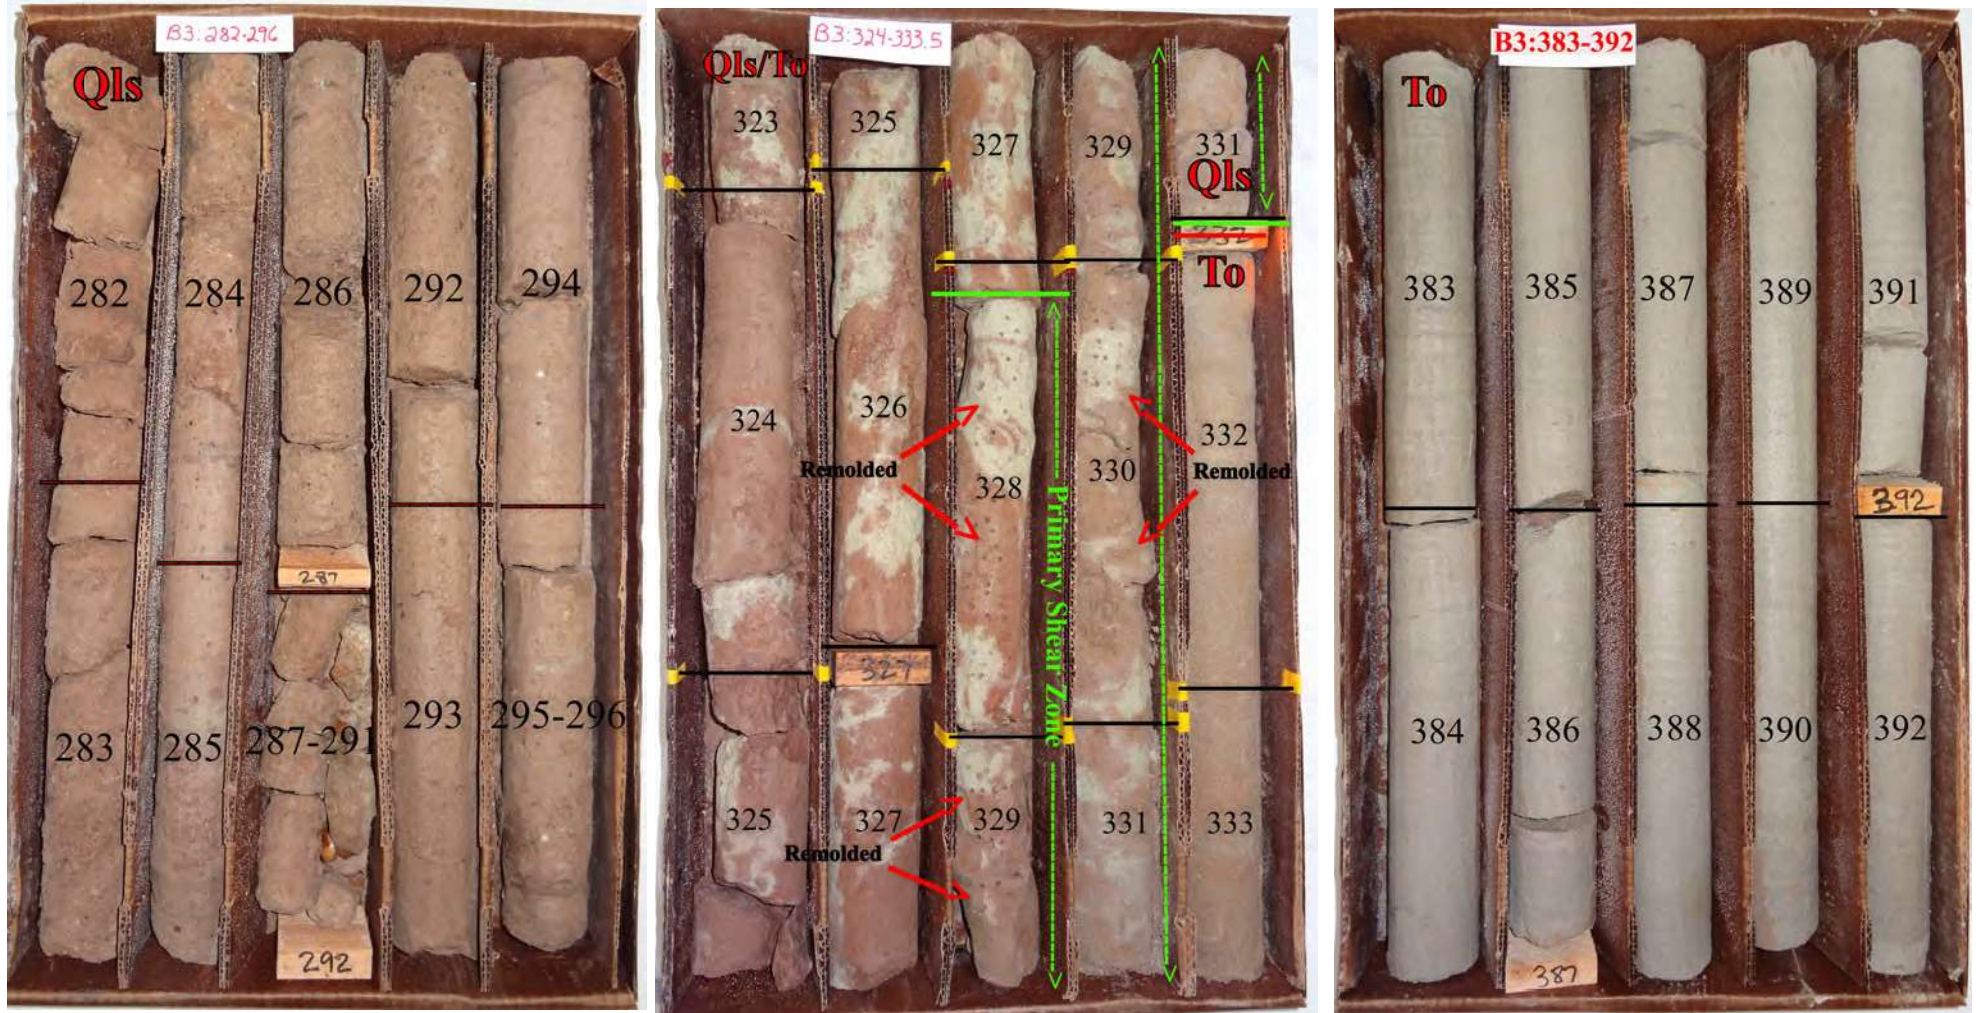
Figure 7
Lithology photographs of Borehole CB-3

Sandstone (324' - 333.5' bgs)

Sandstone (382' - 392' bgs)
