# **RESPONSE TO CITY REVIEW COMMENTS**

## **SOUTHWEST VILLAGE SAN DIEGO, CALIFORNIA**

**SEPTEMBER 14, 2023  
PROJECT NO. 06847-42-04A**

Subject: ADDENDUM REPORT AND RESPONSE TO CITY REVIEW COMMENTS  
SOUTHWEST VILLAGE  
SAN DIEGO, CALIFORNIA

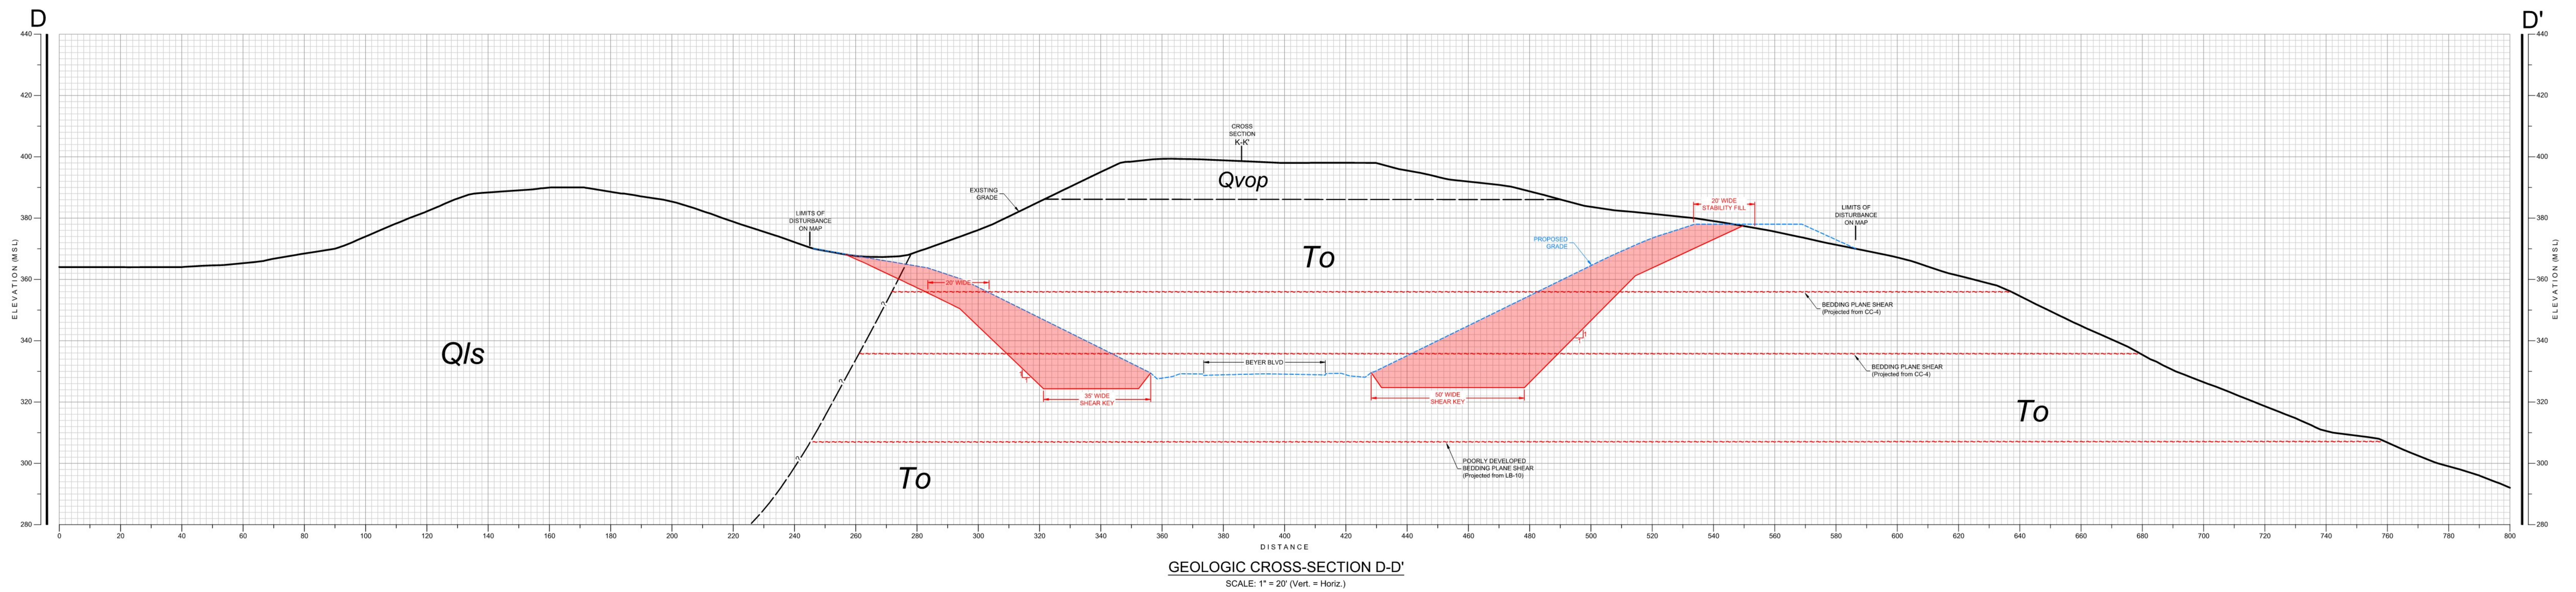
The County property is highlighted on the geologic map (Figure 1). Cross section D-D' (Figure 2) represents geologic conditions in the area. The cross section includes proposed grades and buttress construction widths determined from the "worst case" analysis.

The appended figures show the current project disturbance limits. As depicted on Figure 2, grading to construct the buttresses under "worst case" conditions remains within the previously established disturbance limits.

To achieve a 1.5 factor of safety under assumed "worst case" conditions, the buttress widths need to be widened approximately 8 feet on the southern cut slope and 15 feet on the northern cut slope from previously designed buttress widths. Figure 2 reflects the increased buttress widths determined for the "worst case" analysis.
