THE CITY OF SAN DIEGO

Report to the Historical Resources Board

SUBJECT: **ITEM #2 – 4804 BIONA DRIVE**

DESCRIPTION: Consider the designation of the property located at 4804 Biona Drive as a historical resource.

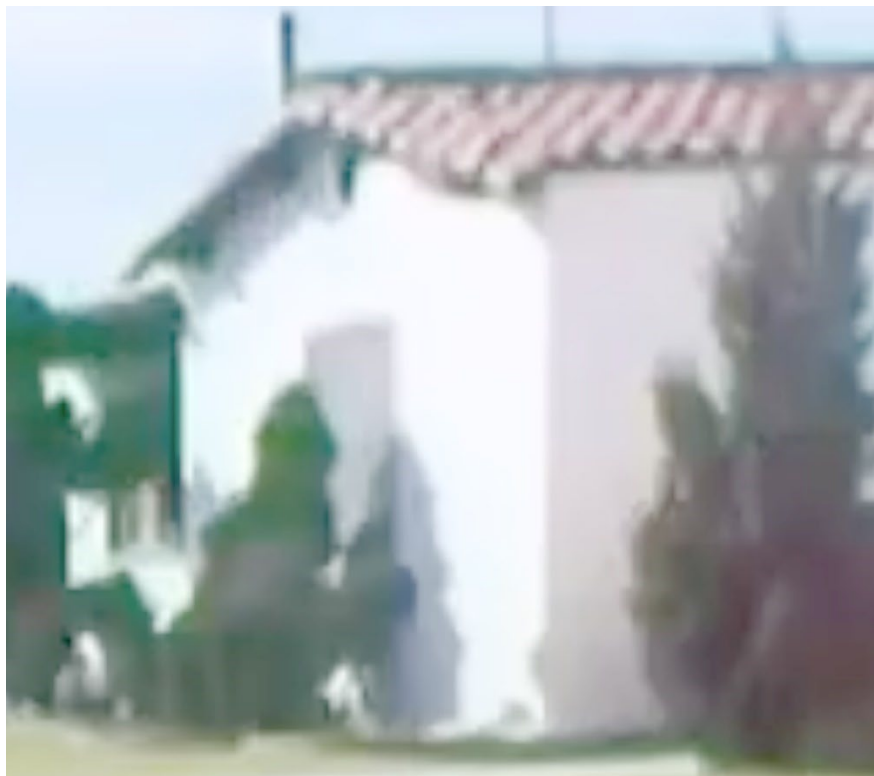
Frame, cropped and gamma-adjusted, showing no window grille at this time

Since its construction in 1933, the property has been modified as follows: In 1960, a patio cover and concrete slab were installed at the west elevation, but they were later removed. After 1970, a metal grille with scrollwork was added to the primary façade double-hung window (see Attachment 1). Between 1980 and 2004, the front door's glazing was replaced with a grilles-between-the-glass unit. In 1998, a remodel project replaced an original window at the south elevation with a pair of casement windows in a modified opening, removed an existing door and a window opening at the west elevation, and installed a pair of new French doors in their place. In 2005, a one-story attached addition was constructed on the west elevation. As part of this project, the south-elevation courtyard stucco wall was raised, the tile roof was replaced in kind, and modern bird blockers were added. The original detached garage was demolished, and a new garage and pool were constructed. Between 2005 and 2018, a north elevation single-hung window opening was enlarged and replaced with a vinyl sliding window. Between 2014 and 2016, solar panels were added to the roof. Between 2018 and 2019, a cast-iron railing was added at the entry path. In May of 2026, the owner removed the non-original metal window grille from the primary elevation (see Attachment 2). Heritage Preservation staff did not review any of the aforementioned projects for consistency with the [Secretary of the Interior Standards for Rehabilitation](#).

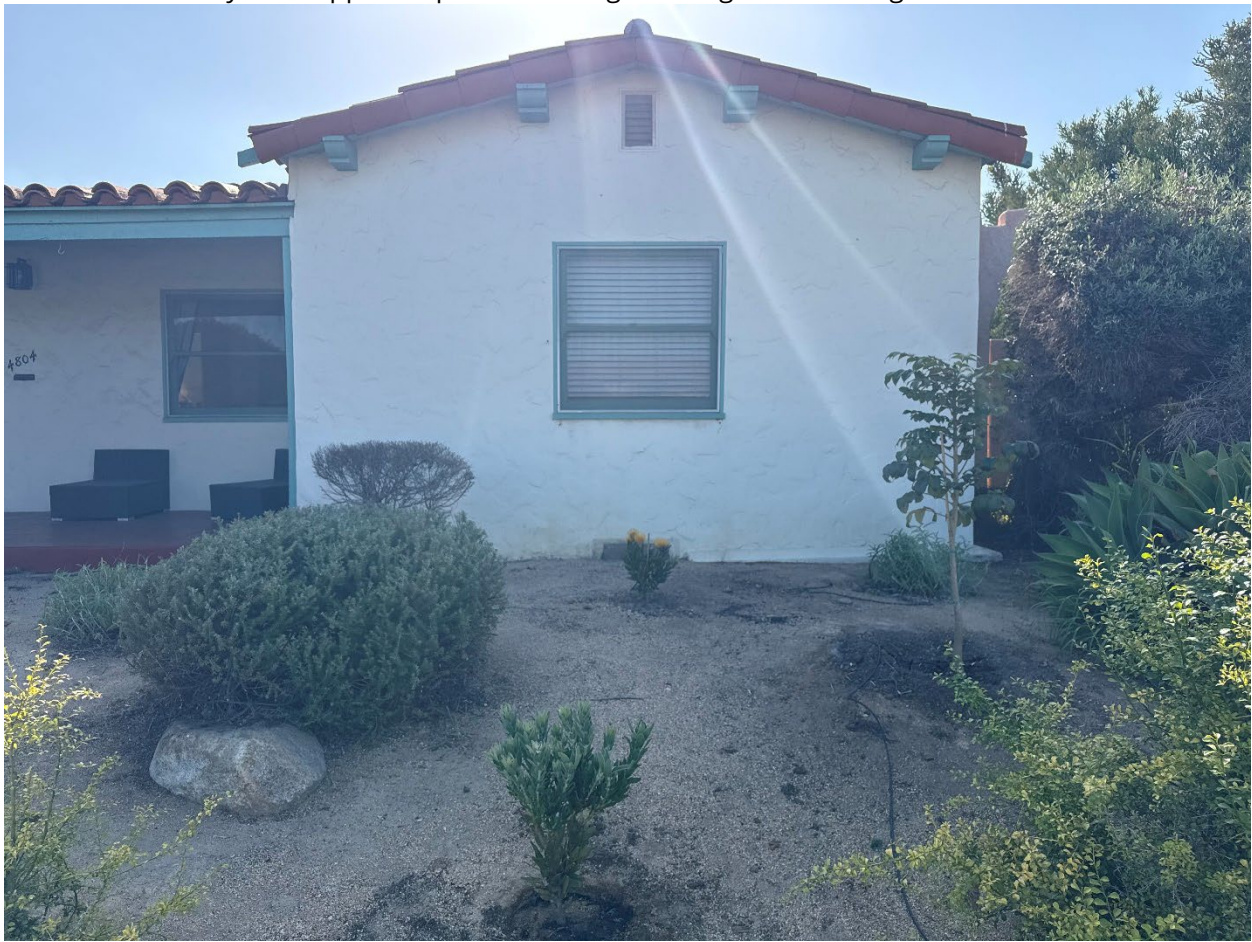
4804 Biona Drive, East Elevation

May 2026 applicant photo showing non-original window grille removed
