MORADI RESIDENCE

1835 SPINDRIFT DRIVE, LA JOLLA, CA 92037

SITE PLAN

A-001

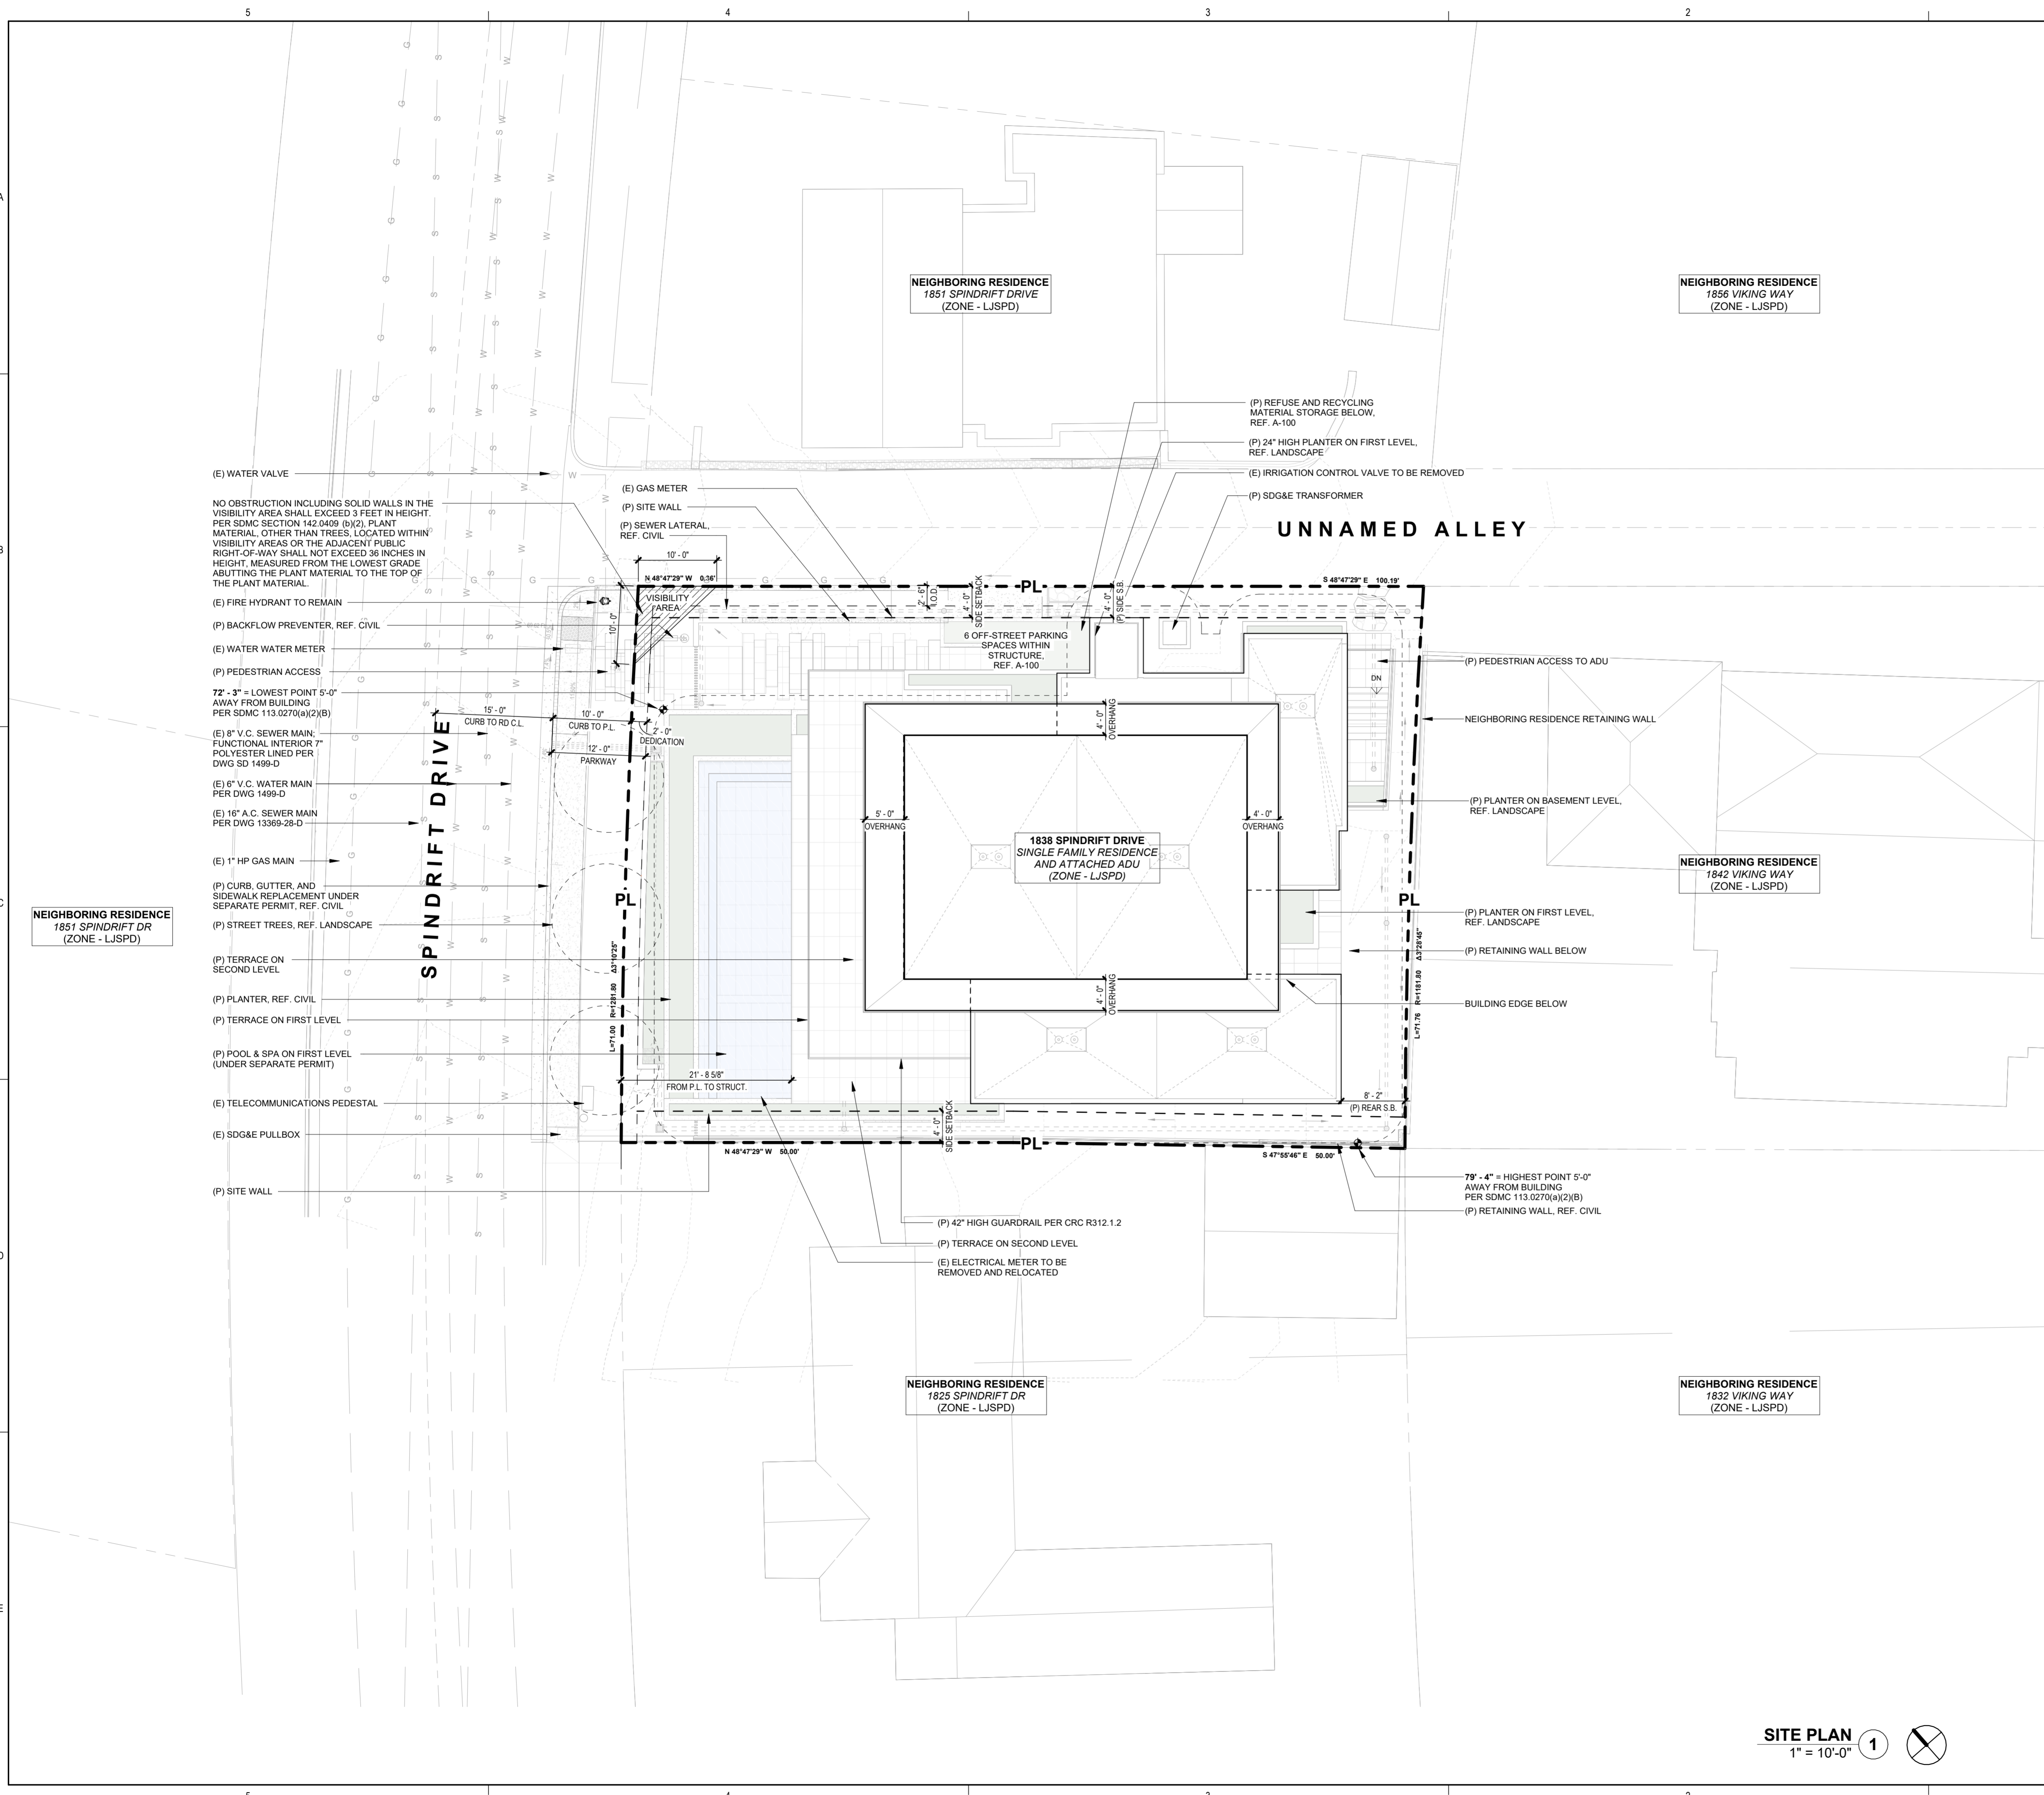
SITE PLAN 1
1" = 10'-0"

- PROVIDE BUILDING ADDRESS NUMBERS VISIBLE AND LEGIBLE FROM THE STREET OR ROAD FRONTING THE PROPERTY PER FHPS POLICY P-00-06 (LFC 901.4.4)
- CONTRACTOR TO ENSURE THAT SPRINKLERS REMAIN OPERATIONAL THROUGHOUT CONSTRUCTION.
- NO INVASIVE PLANT SPECIES ARE TO BE PLANTED IN LANDSCAPED / PLANTING AREAS.

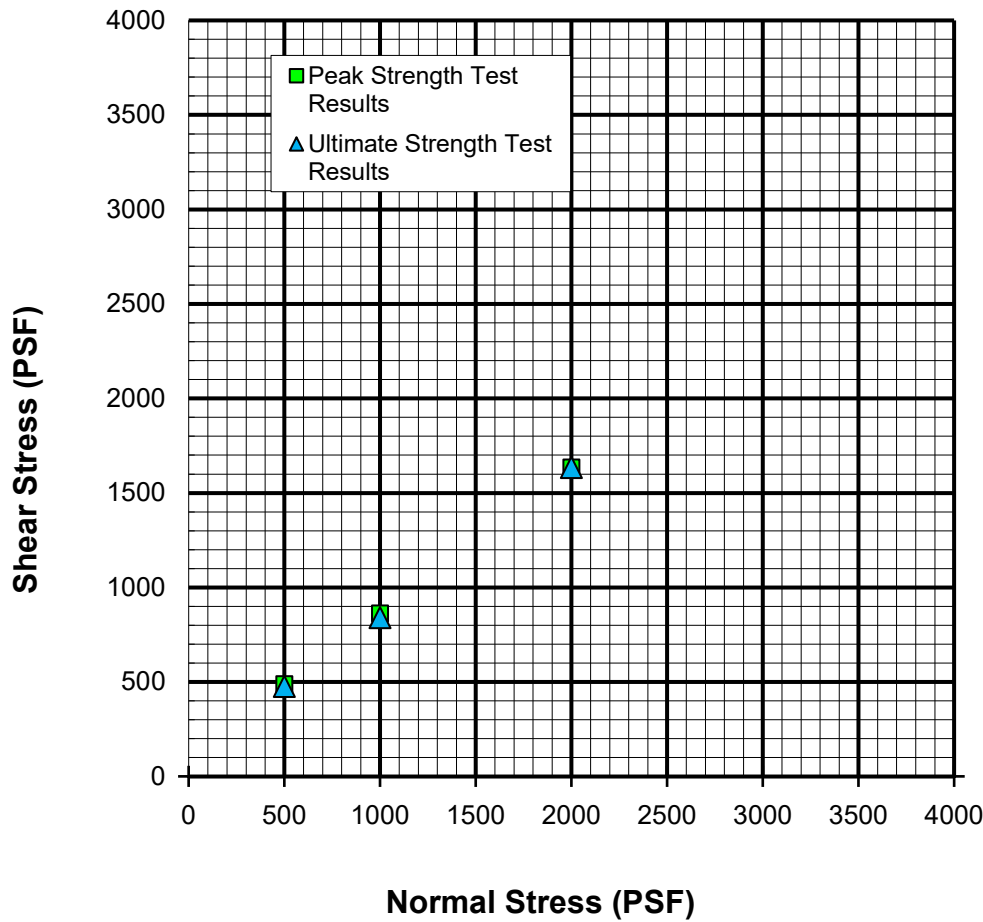
DIRECT SHEAR TEST
Laboratory Report

Sample No. & Location:	B-2 @ 0-10.0'
Soil Description:	Dark Brown Sand
Sample Type:	Remolded
Specimen Preparation:	Inundated

Peak	Ultimate
Friction Angle Φ' (deg)	37	37
Cohesion C' (psf)	110	100

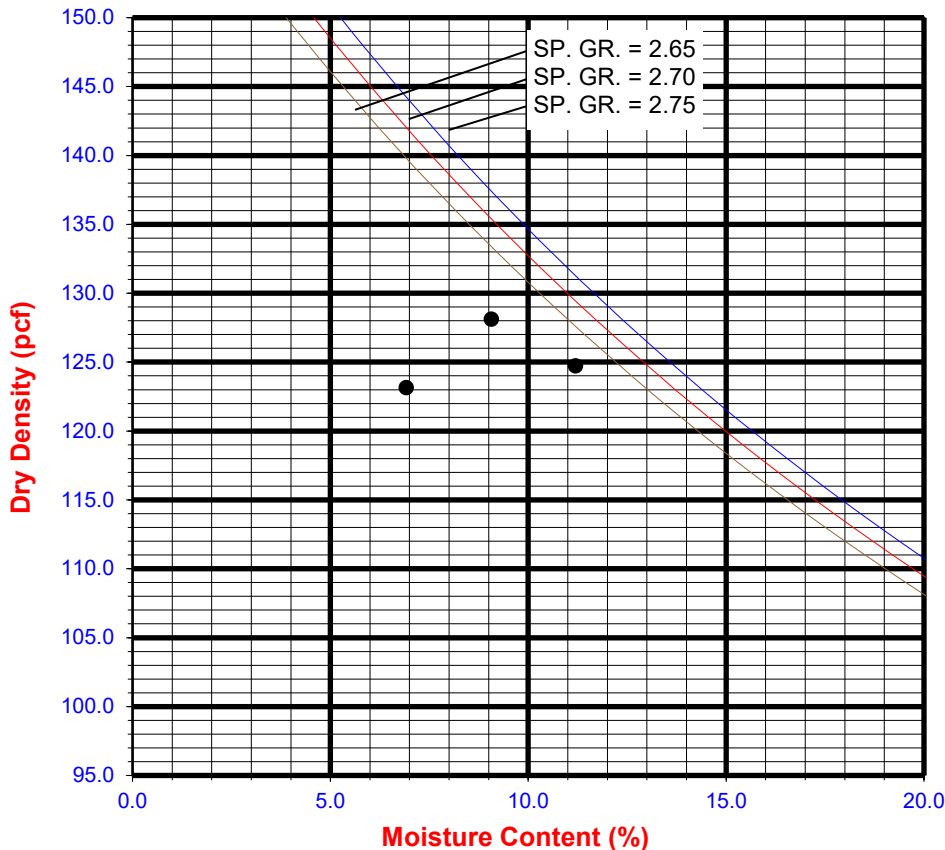
Maximum Dry Density (pcf) **128.1**

Optimum Moisture Content (%) **9.0**

PROCEDURE USED

Procedure A

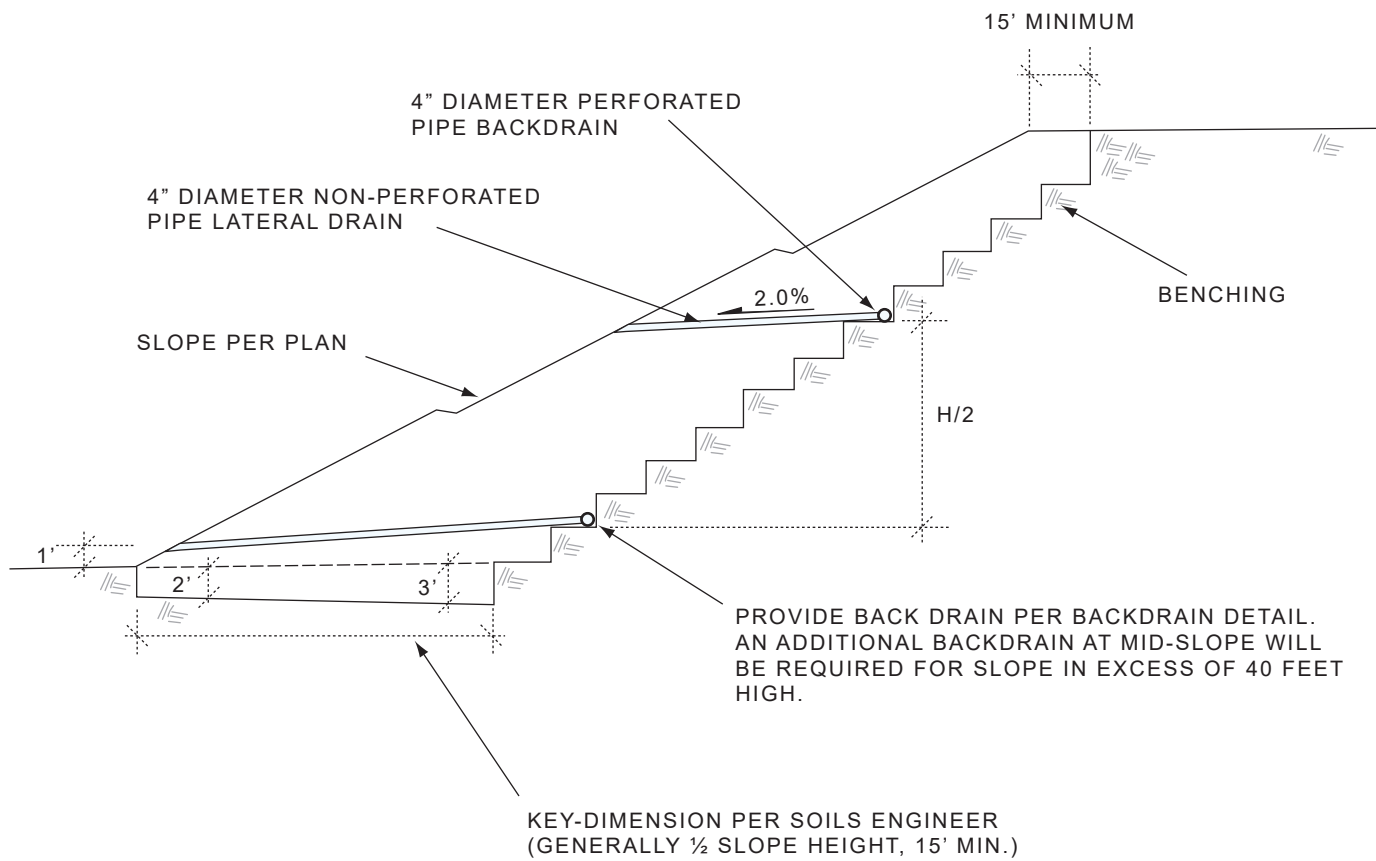
FIGURE 1

TYPICAL STABILIZATION FILL DETAIL

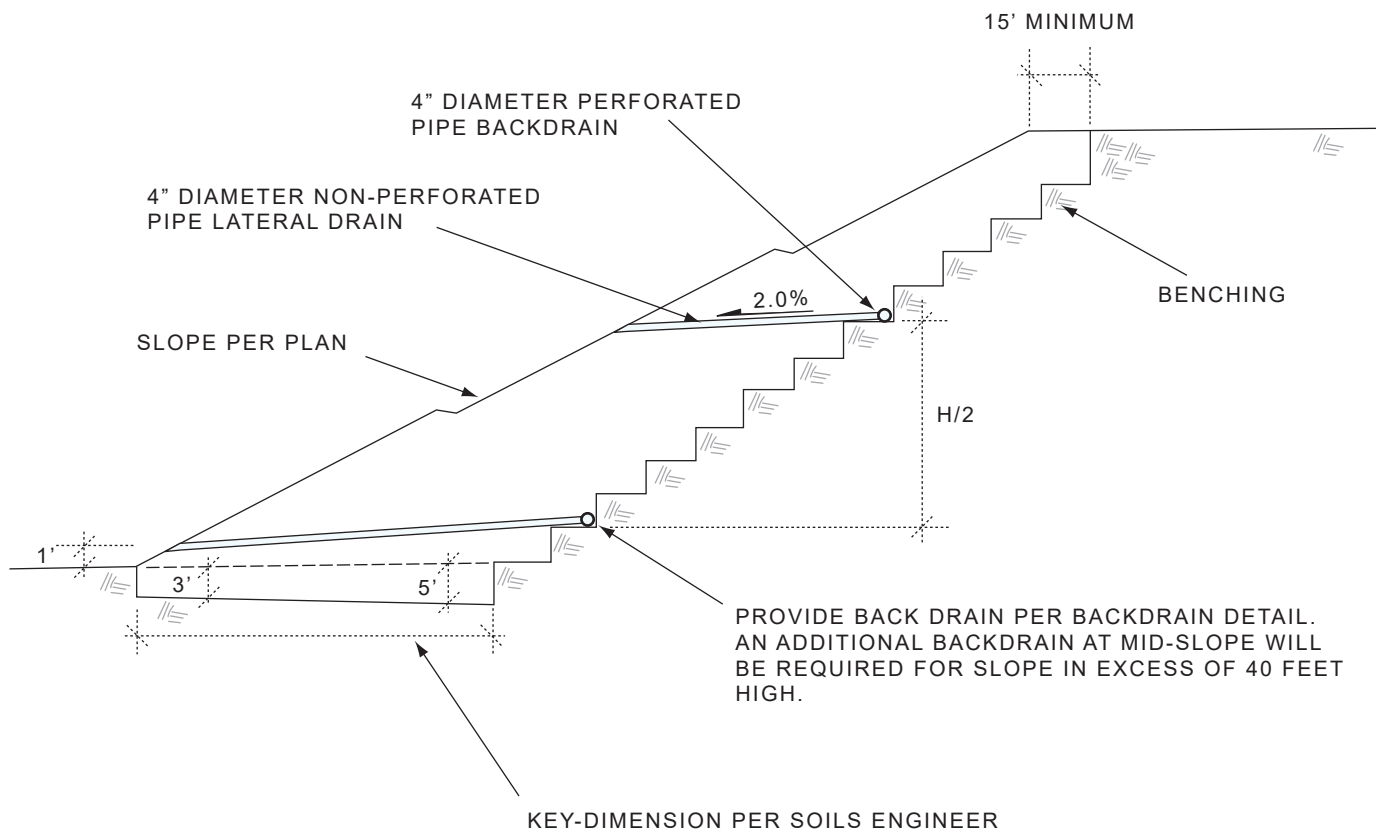
TYPICAL BUTTRESS FILL DETAIL

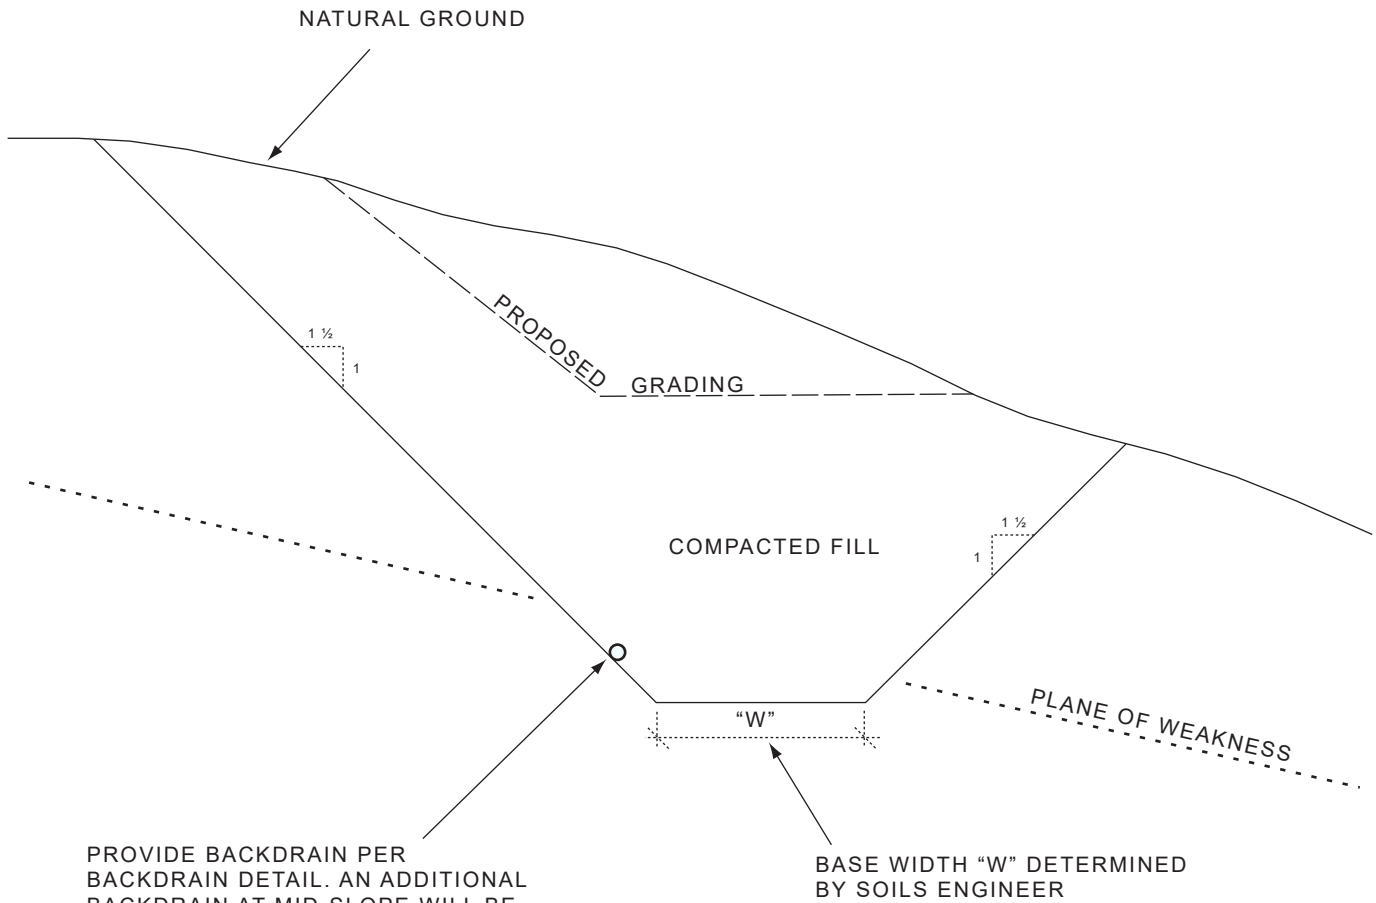
FIGURE 3

TYPICAL SHEAR KEY DETAIL

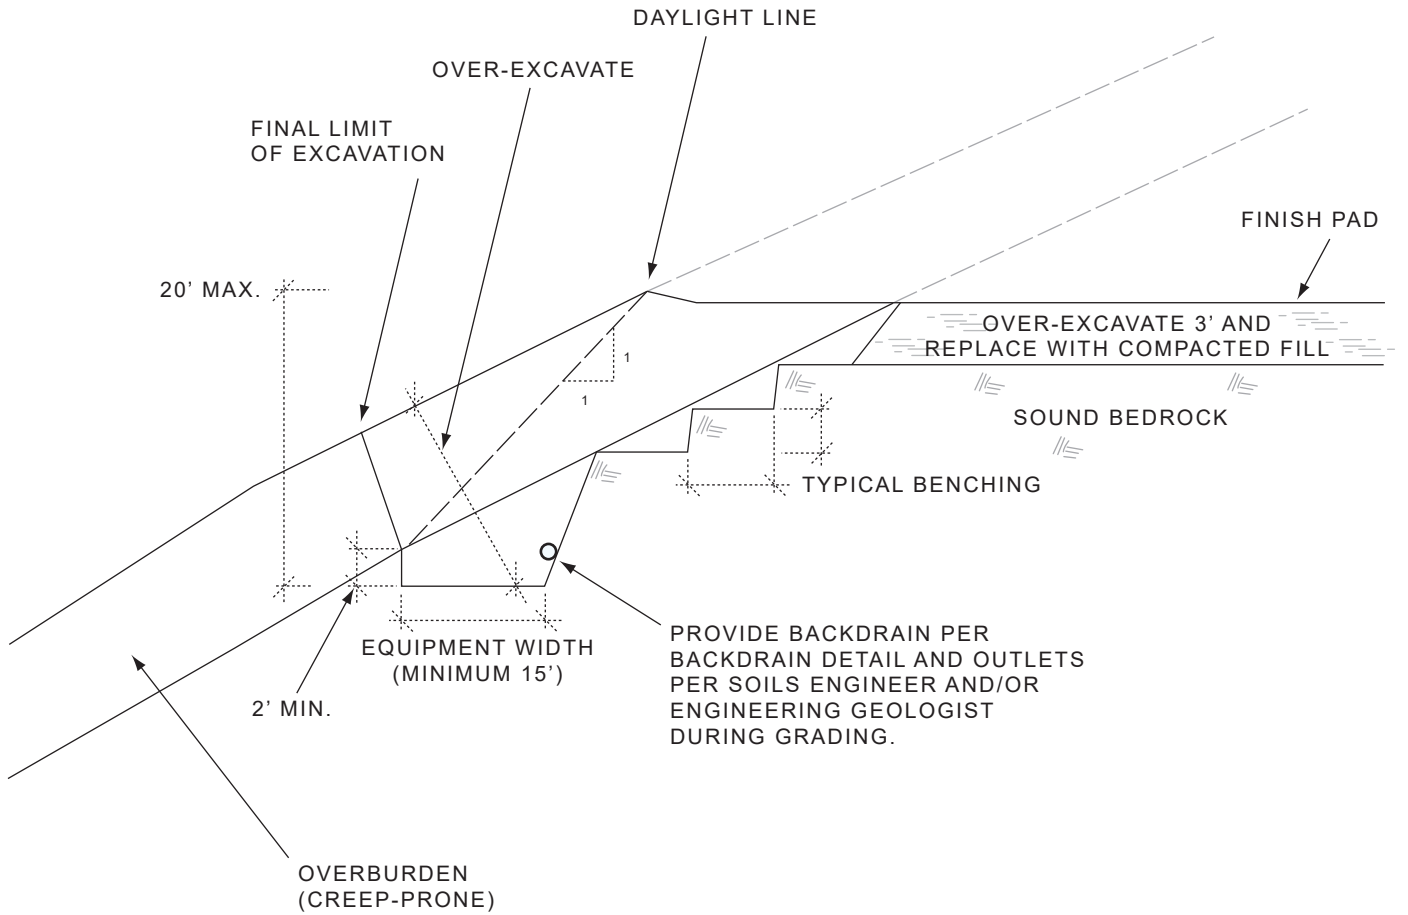
FIGURE 4

DAYLIGHT SHEAR KEY DETAIL

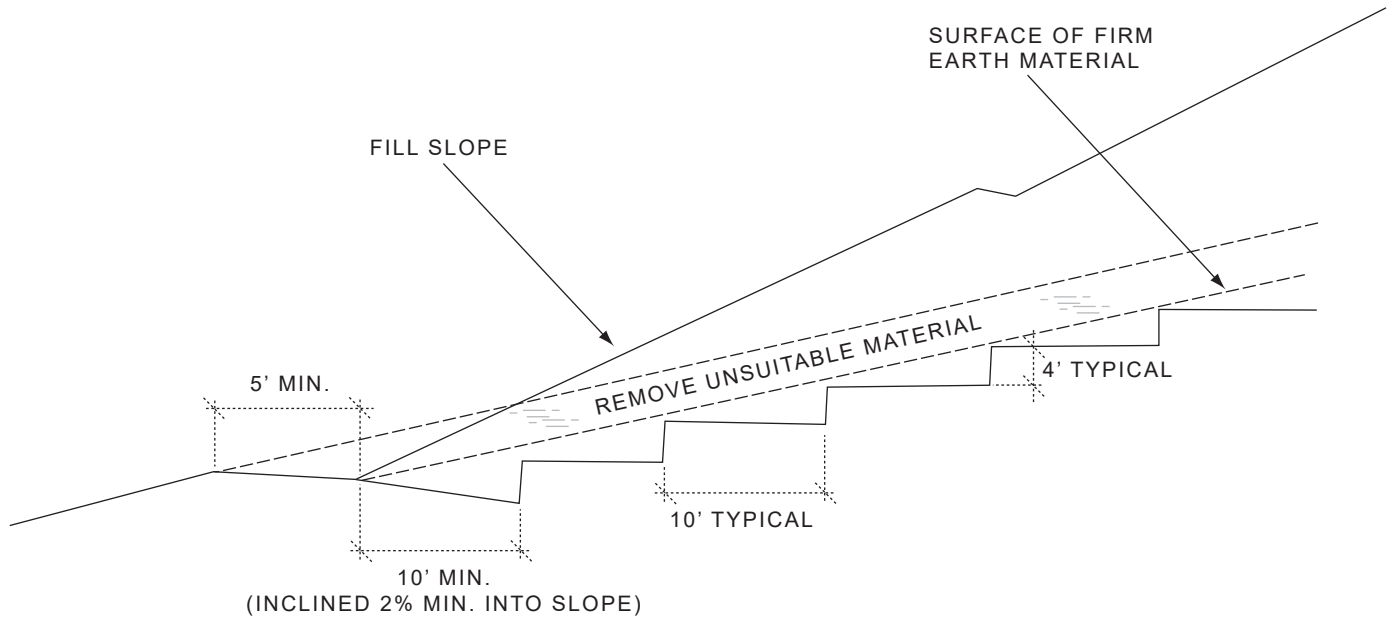
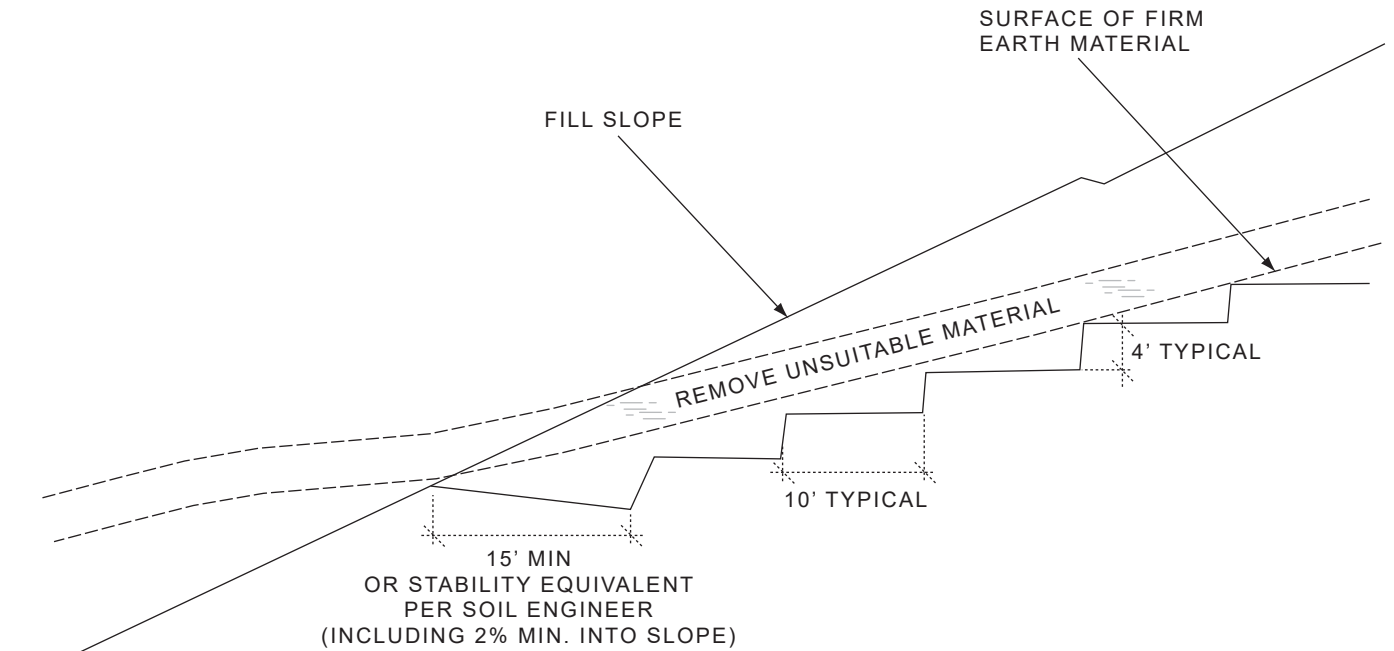
FIGURE 5

BENCHING FILL OVER NATURAL

BENCHING FILL OVER CUT

BENCHING FOR COMPACTED FILL DETAIL

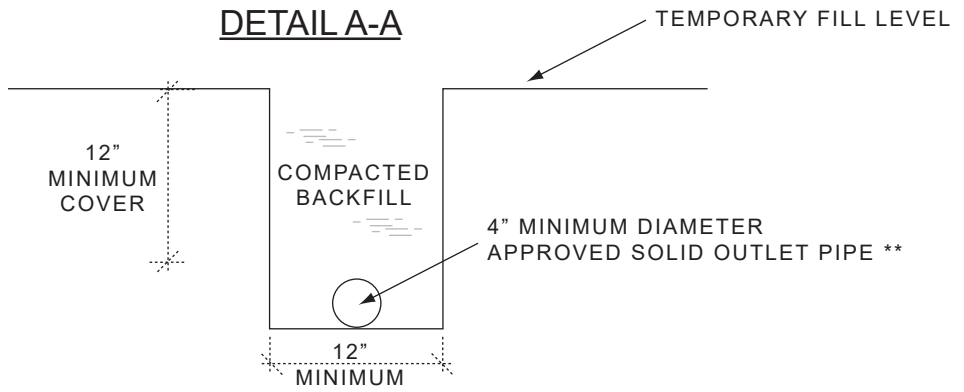
DETAIL A-A

* Filter rock to meet following specifications or approved equal.

Sieve	% Passing
1"	100
3/4"	90-100
3/8"	40-100
No.4	25-40
No.30	5-15
No.50	0-7
No.200	0-3

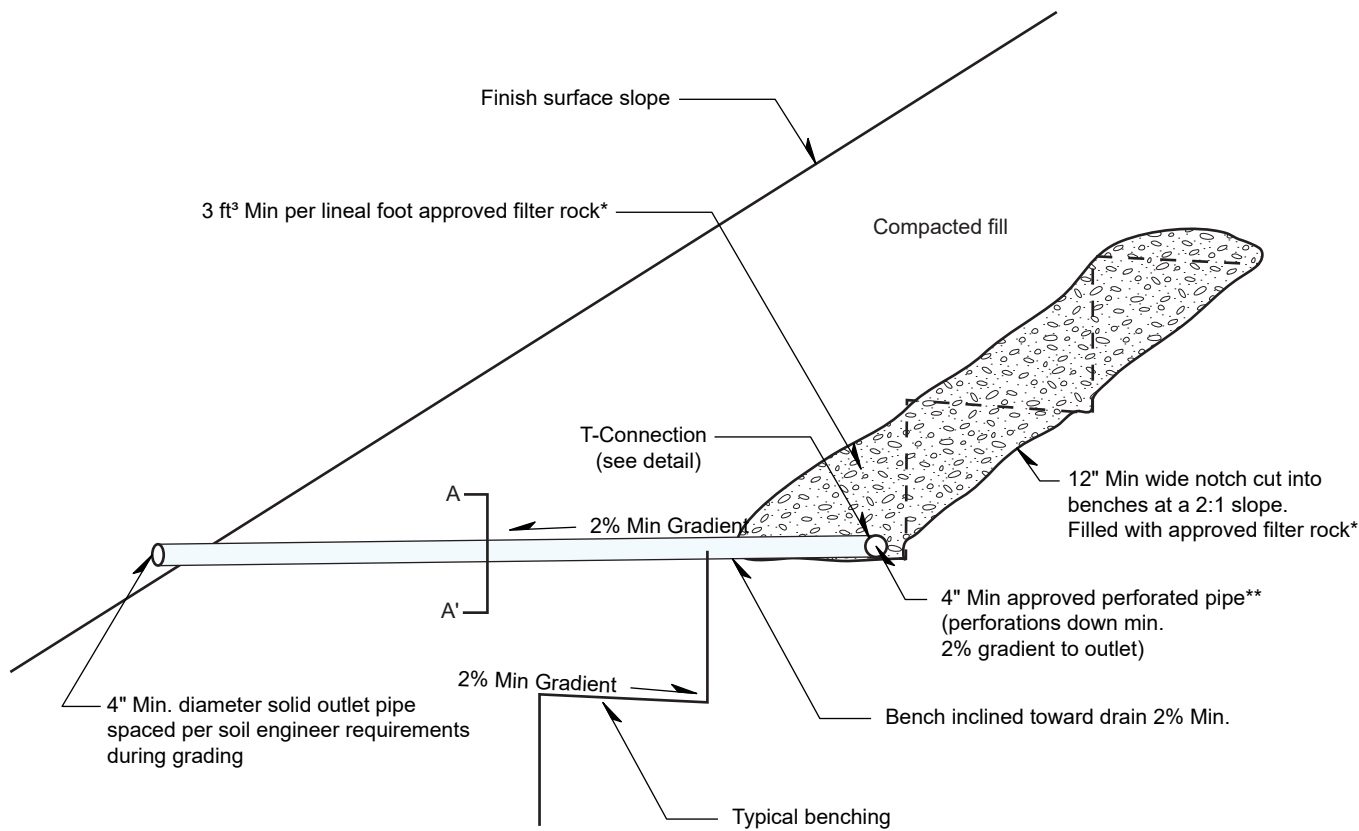
TYPICAL BACKDRAIN DETAIL

* Filter rock to meet following specifications or approved equal.

Sieve	% Passing
1"	100
3/4"	90-100
3/8"	40-100
No.4	25-40
No.30	5-15
No.50	0-7
No.200	0-3

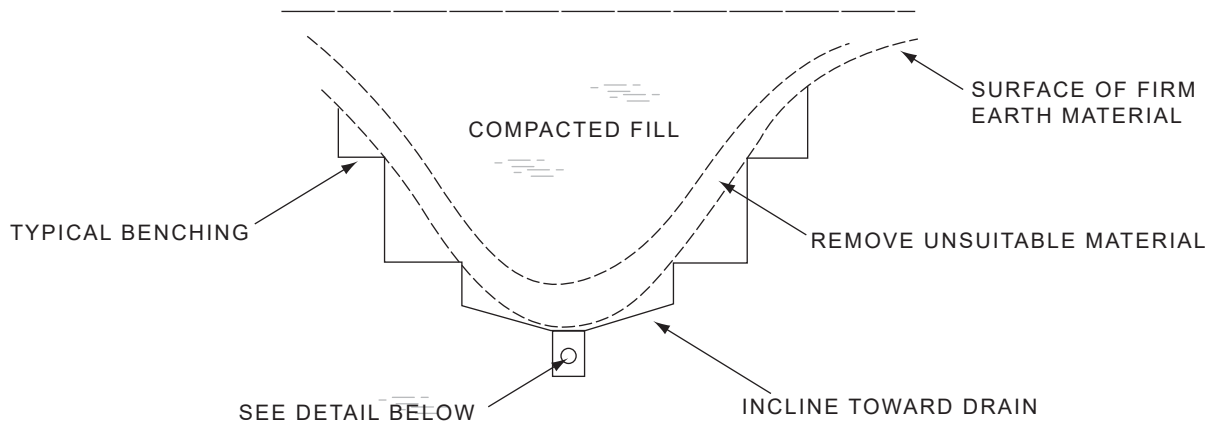
BACKDRAIN DETAIL (GEOFABRIC)

Schedule 40 polyvinyl chloride (P.V.C.) or approved equal.
Min. crush strength 1000 PSI.

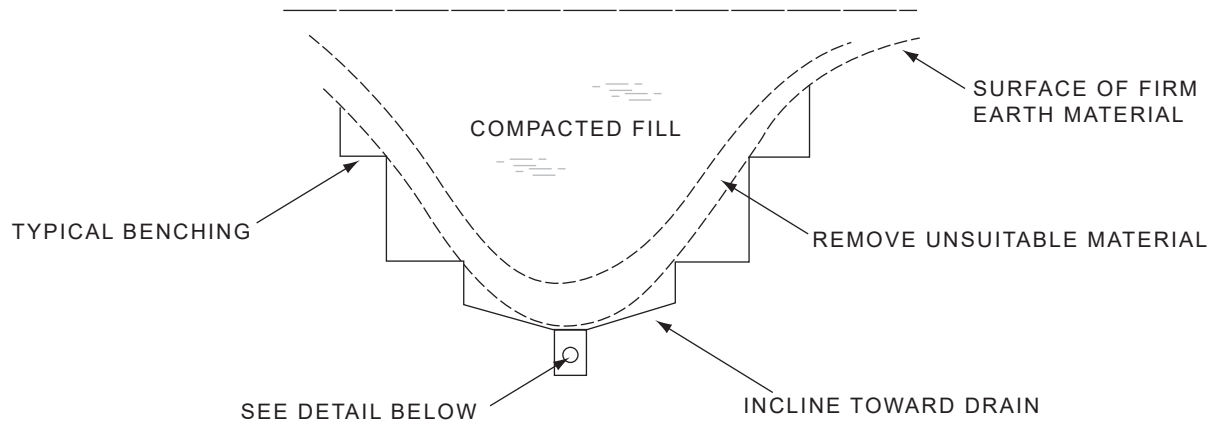
TYPICAL CANYON SUBDRAIN DETAIL

Pipe diameter to meet the following criteria. Subject to field review based on actual geotechnical conditions encountered during grading.

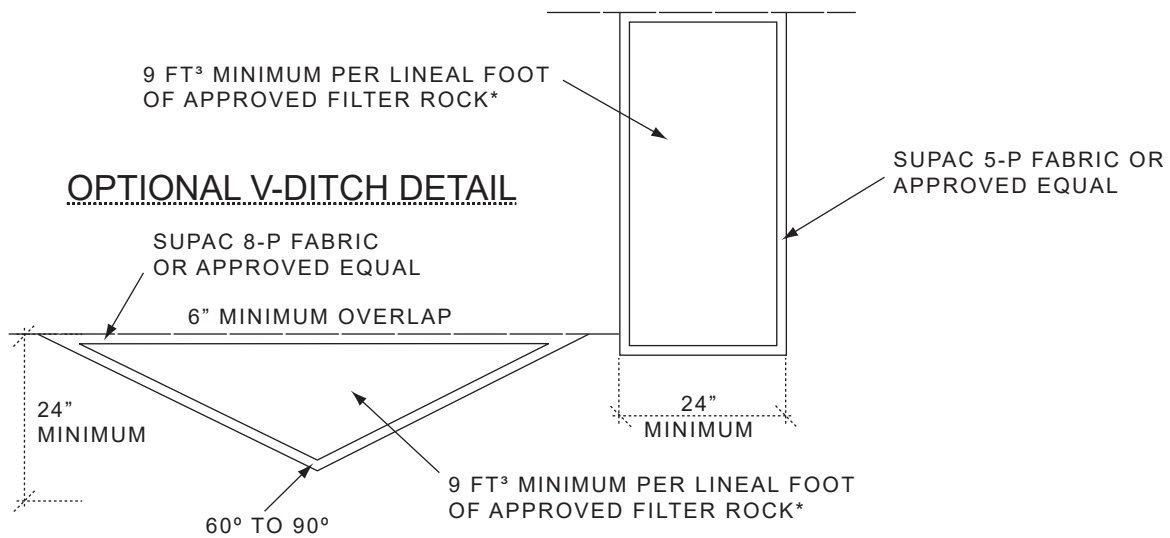
TRENCH DETAIL

* Drainage material to meet following specifications or approved equal.

Sieve	% Passing
1 1/2"	88-100
1"	5-40
3/4"	0-17
3/8"	0-7
No.200	0-3

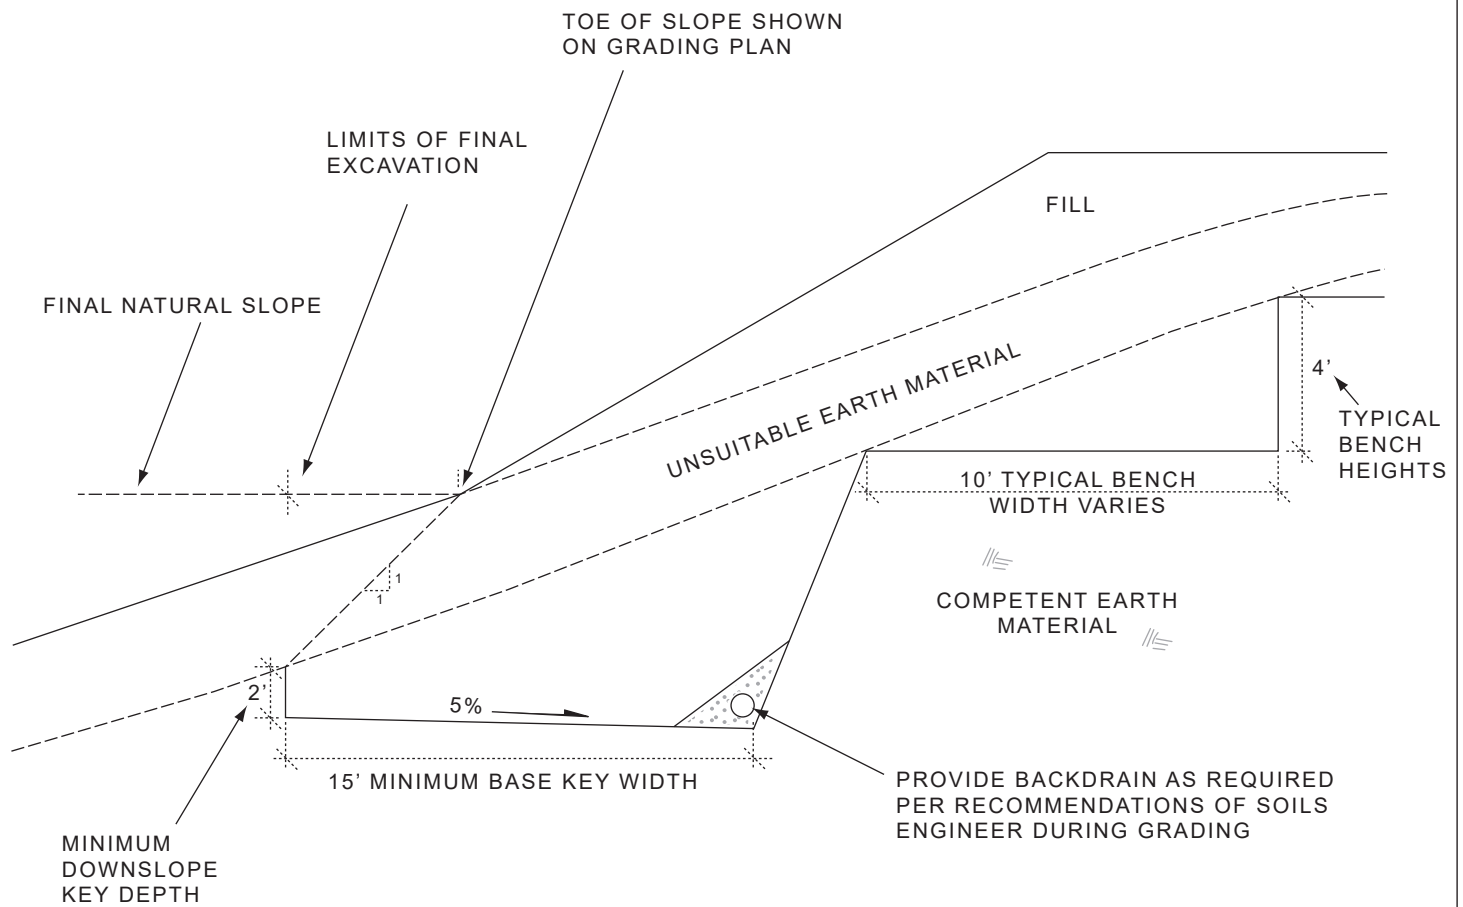
FILL SLOPE ABOVE NATURAL GROUND DETAIL

WHERE NATURAL SLOPE GRADIENT IS 5:1 OR LESS, BENCHING IS NOT NECESSARY. HOWEVER, FILL IS NOT TO BE PLACED ON COMPRESSIBLE OR UNSUITABLE MATERIAL.

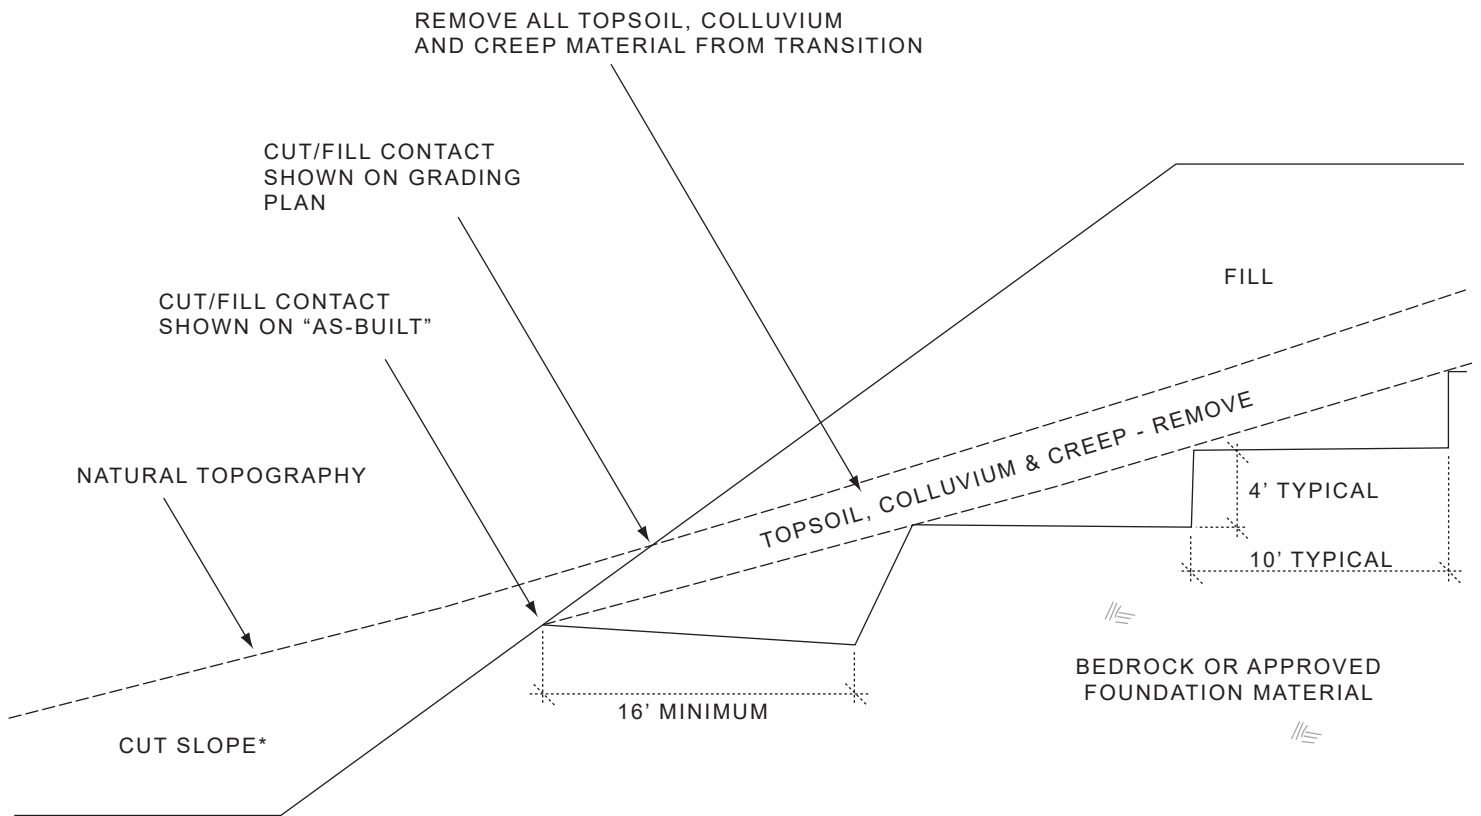
FILL SLOPE ABOVE CUT SLOPE DETAIL

NOTE:
CUT SLOPE PORTION SHALL BE MADE
PRIOR TO PLACEMENT OF FILL

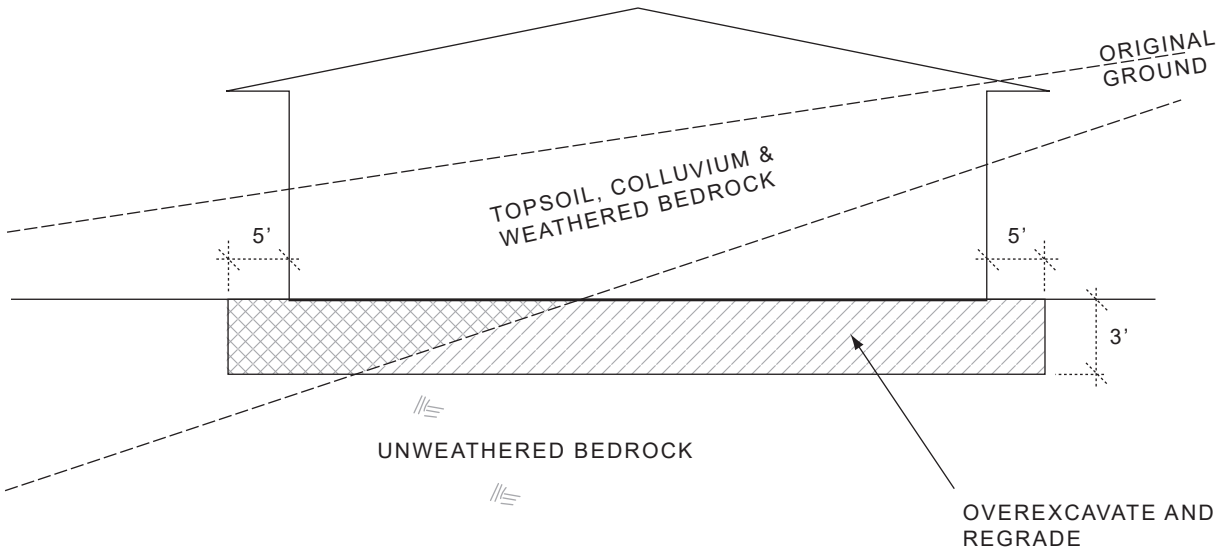
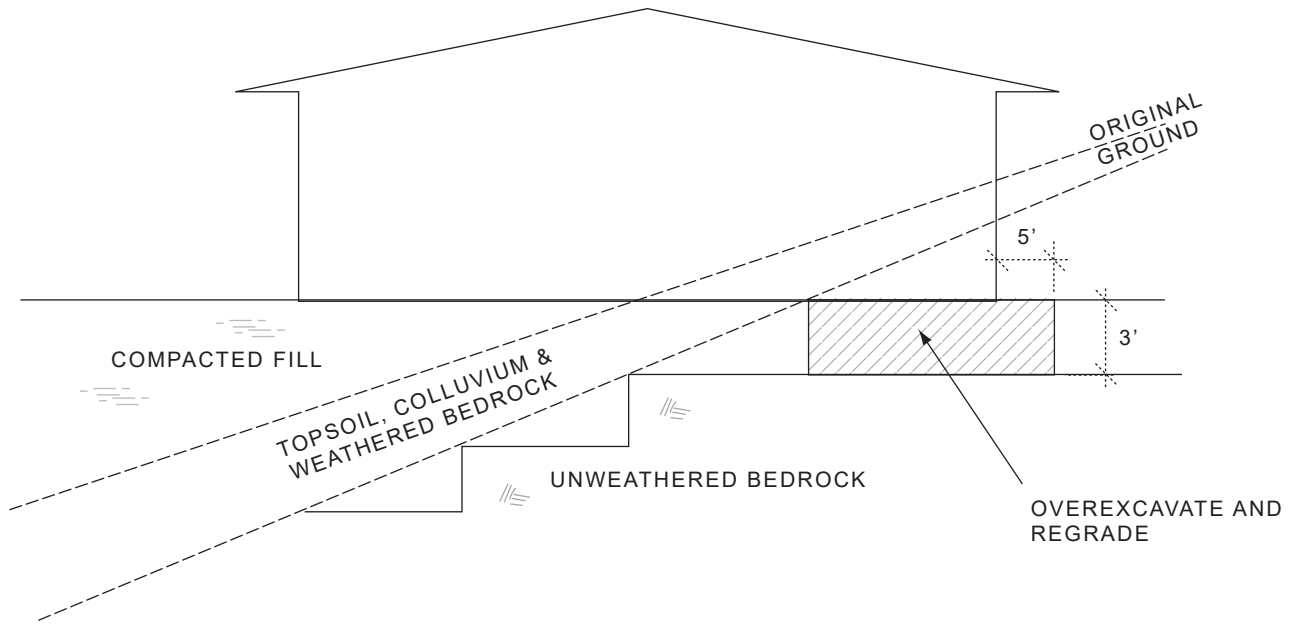
TRANSITION LOT DETAIL

CUT LOT

CUT/FILL LOT (TRANSITION)

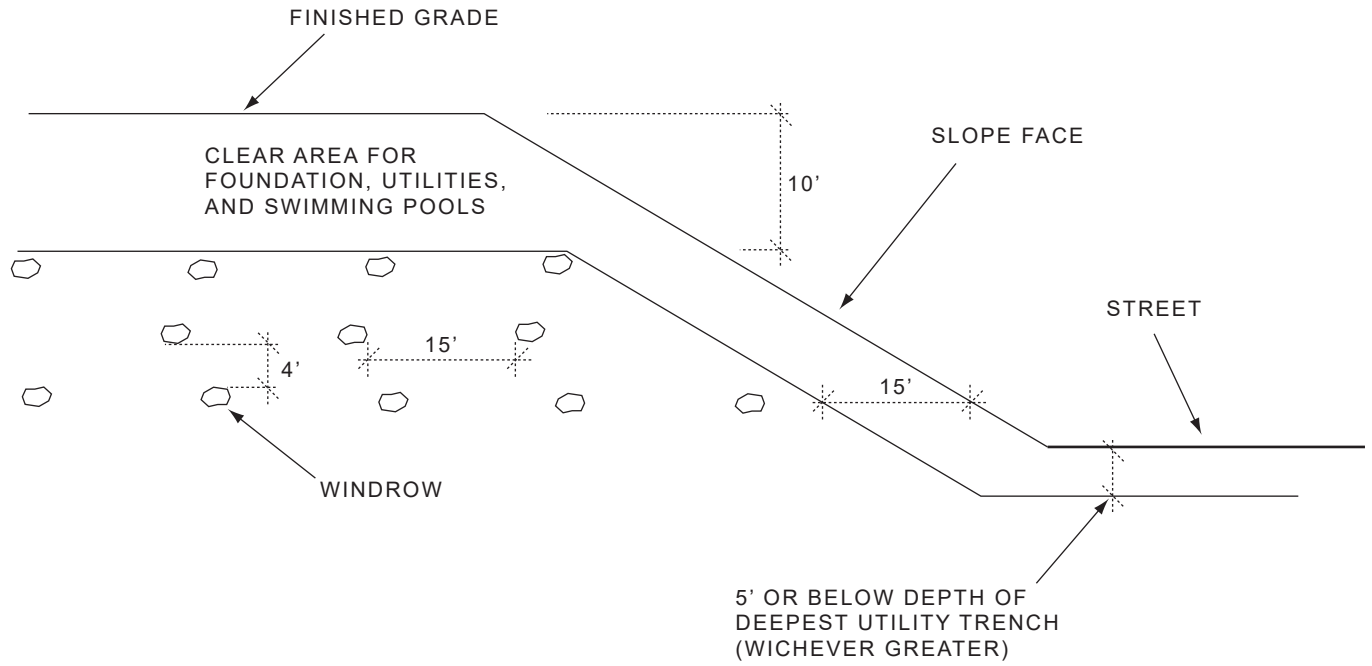
TYPICAL WINDROW DETAIL (EDGE VIEW)

BUILDING

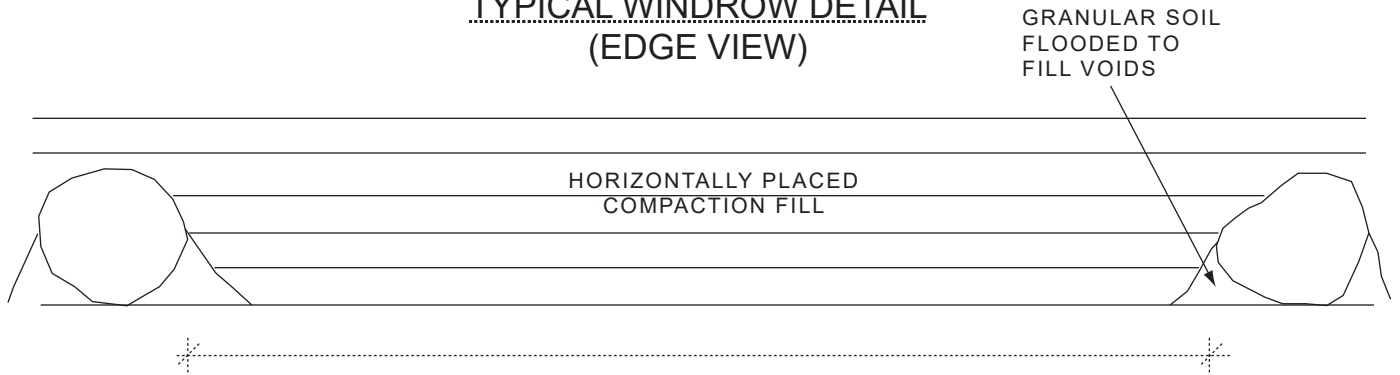
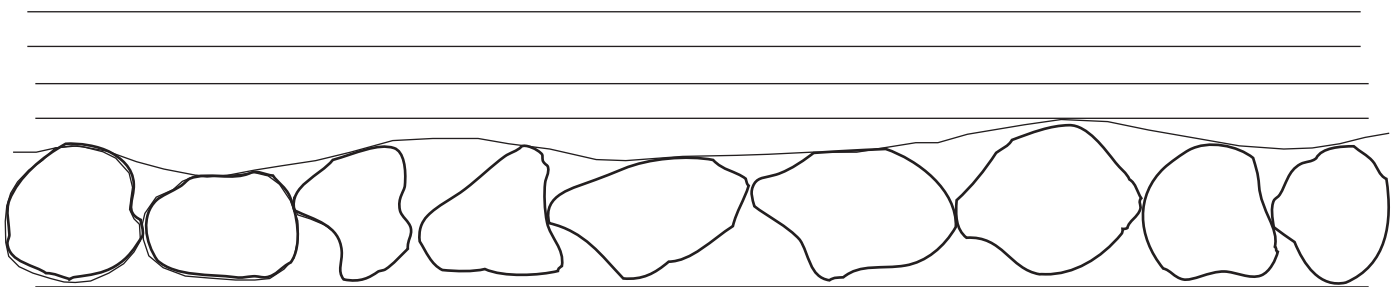
ROCK DISPOSAL DETAIL

(PROFILE VIEW)

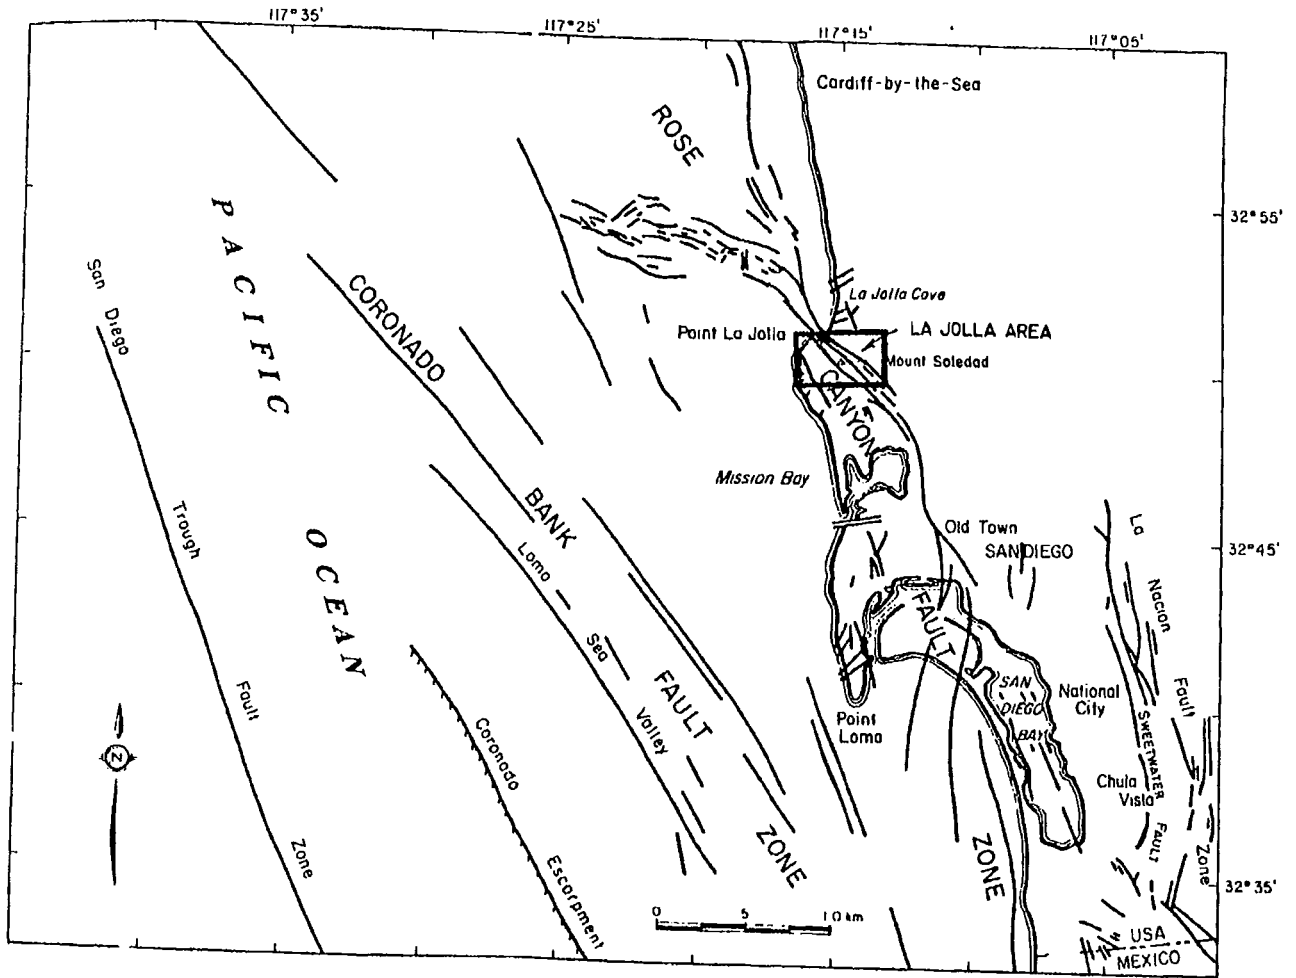
FIGURE 1. FAULT LOCATION AND AREA MAP, SAN DIEGO, CALIFORNIA

MODIFIED FROM KENNEDY, CLARK, GREENE & LEGG, 1980.

This Final Technical Report of a study carried out under U.S. Geological Survey Contract No. 14-09-0001-1924 documents and describes the results of logging a trench in an area mapped as the location of the Rose Canyon Fault zone. The trench was located in the La Jolla area of San Diego, California (Figure 1).

The roughly-defined San Diego Bay graben, a structurally depressed block, is bounded on the east by the La Nacion Fault zone, on the west by the San Diego Bay Faults and offshore faults, and on the north by the Rose Canyon Fault (Figure 1).

The Rose Canyon Fault zone comprises a number of closely spaced subparallel faults that displace Cretaceous and Tertiary strata near Mount Soledad. The fault zone, as mapped, continues offshore to the north, and it has been suggested that the fault continues to the south under San Diego Bay and offshore of Coronado. The Rose Canyon Fault zone has been shown on land to extend for approximately 15 km south of the La Jolla Cove and Shores area (Kern, 1973a; Ziony, 1973; Kennedy, 1975) (Figure 1).
