REPORT OF PRELIMINARY GEOTECHNICAL INVESTIGATION

Proposed Lee-DeGuzman Residence
1855 Spindrift Drive
La Jolla, California

JOB NO. 22-13755

13 July 2023

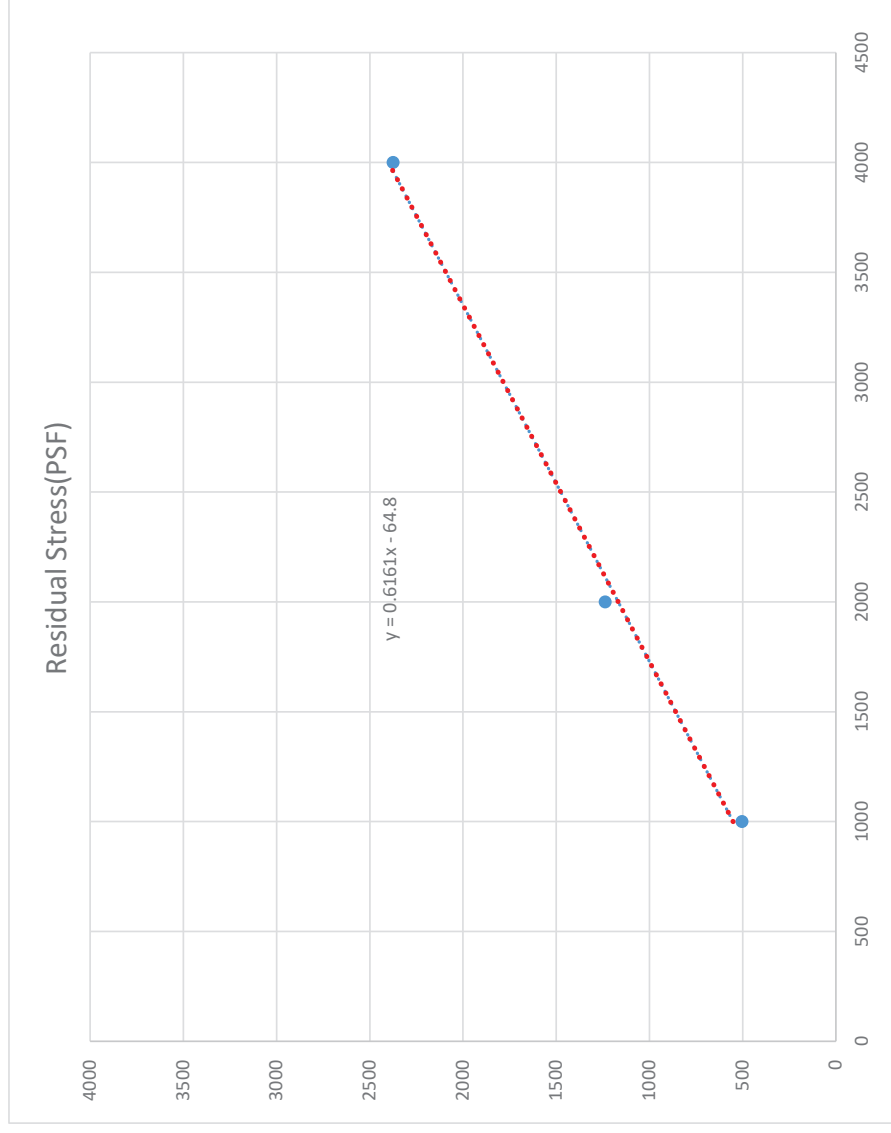
DIRECT SHEAR TEST
 Lee-DeGuzman Residence
 1855 Spindrift Drive, La Jolla CA
 Job No. 22-13755
 Figure No. IVb

Slope	0.6161
Phi in Radians	0.552173701

Phi in Degrees	31.6
Cohesion(PSF)	0
