**REPORT OF PRELIMINARY GEOTECHNICAL INVESTIGATION**

**MORROW RESIDENCE  
8460 EL PASEO GRANDE  
LA JOLLA, CALIFORNIA**

CWE 2230041.01

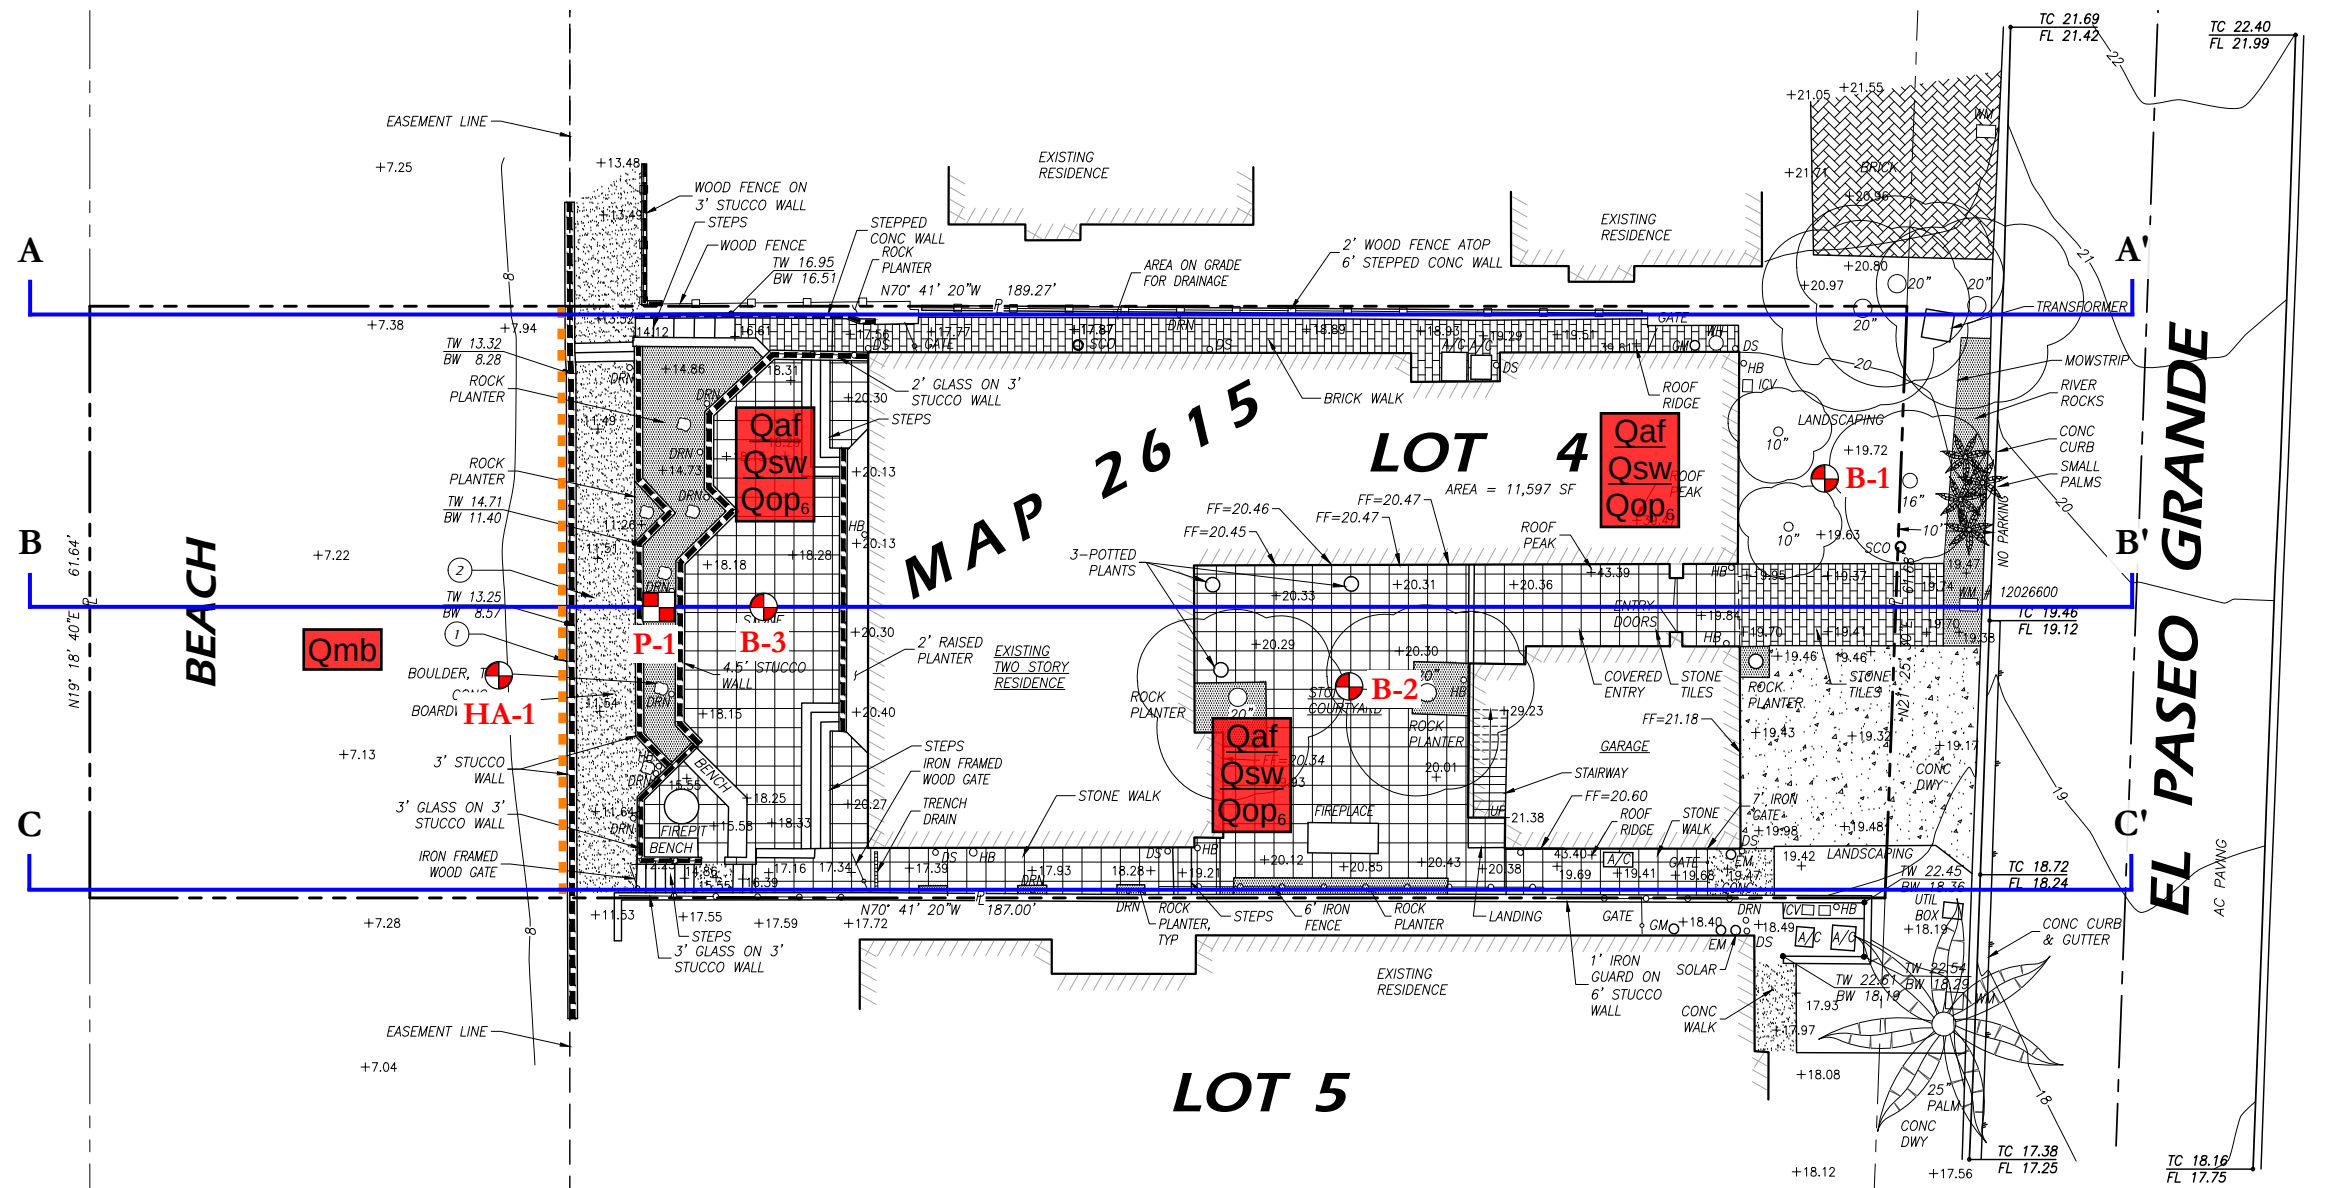
| CWE LEGEND | | |
| | <b>B-3</b> | APPROXIMATE BORING LOCATION |

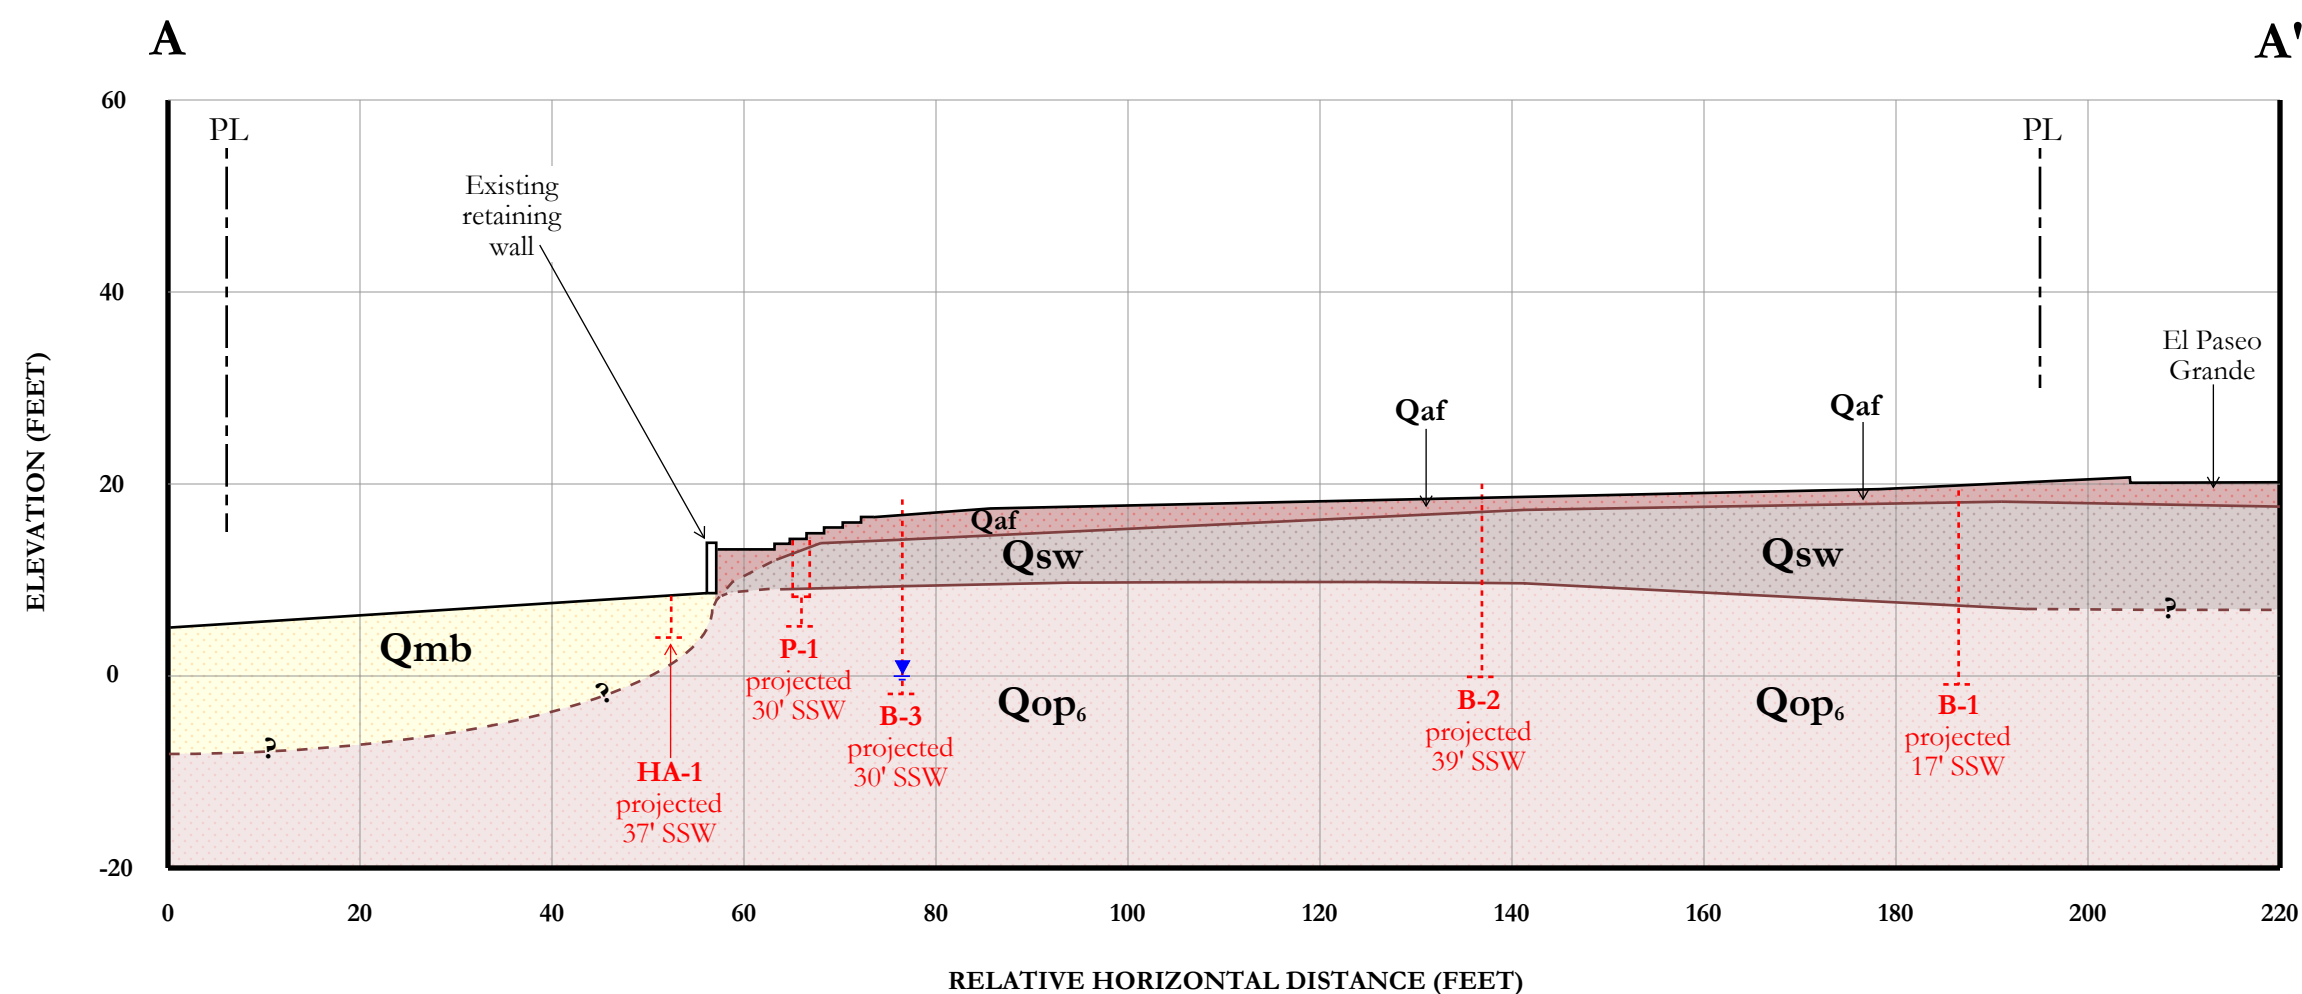
| BY: JMM | PLATE NO.: 2 |

**CWE LEGEND**

- Qaf** ARTIFICIAL FILL
- Qsw** SLOPEWASH
- Qmb** MARINE BEACH DEPOSITS
- Qop<sub>6</sub>** OLD PARALIC DEPOSITS, UNIT 6
- **?** **---** GEOLOGIC CONTACT - QUERIED WHERE INFERRED
- ▼** GROUNDWATER ELEVATION IN BORING

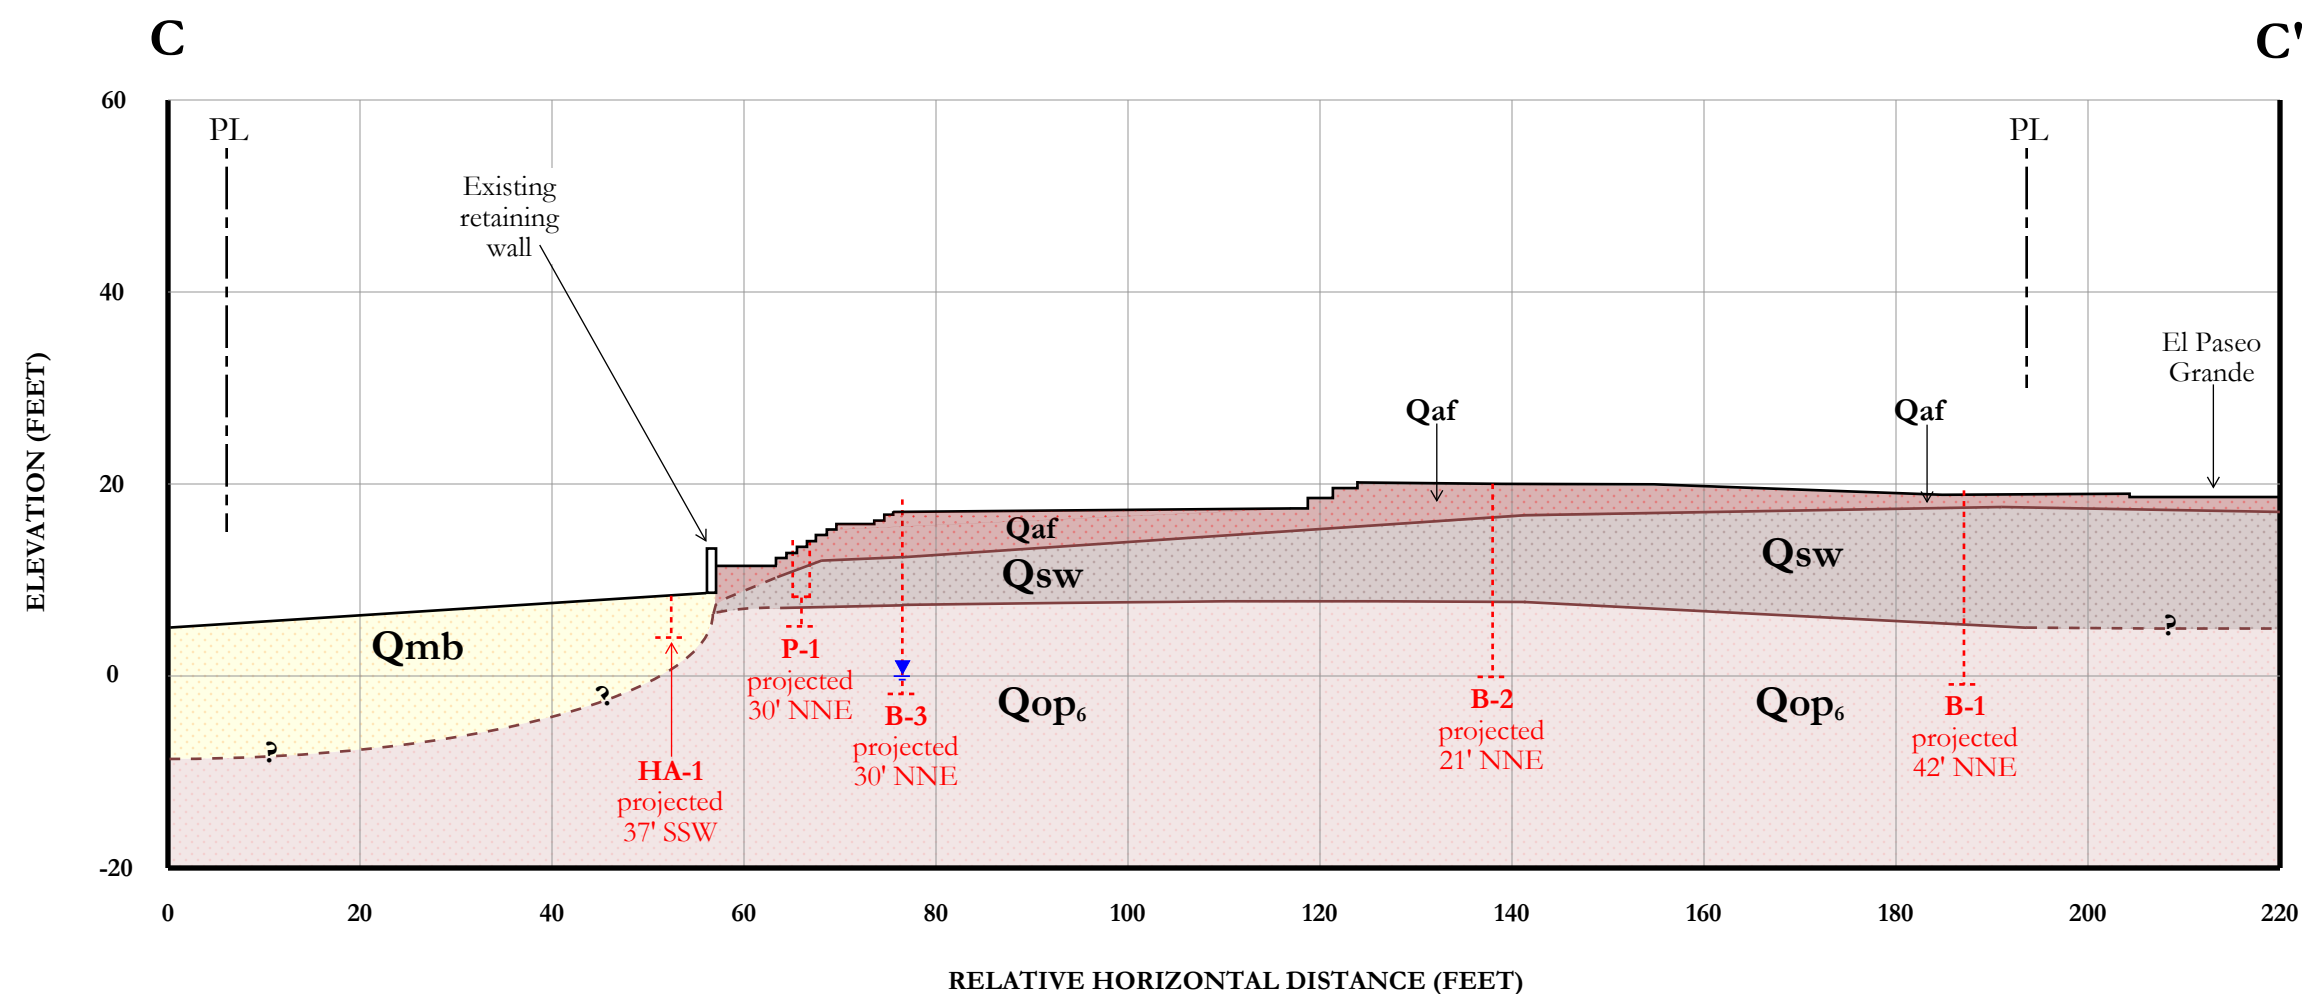
| BY: | JMM | PLATE NO.: 4 |

**CWE LEGEND**

- Qaf** ARTIFICIAL FILL
- Qsw** SLOPEWASH
- Qmb** MARINE BEACH DEPOSITS
- Qop<sub>6</sub>** OLD PARALIC DEPOSITS, UNIT 6
- GEOLOGIC CONTACT - QUERIED WHERE INFERRED
- ▼** GROUNDWATER ELEVATION IN BORING

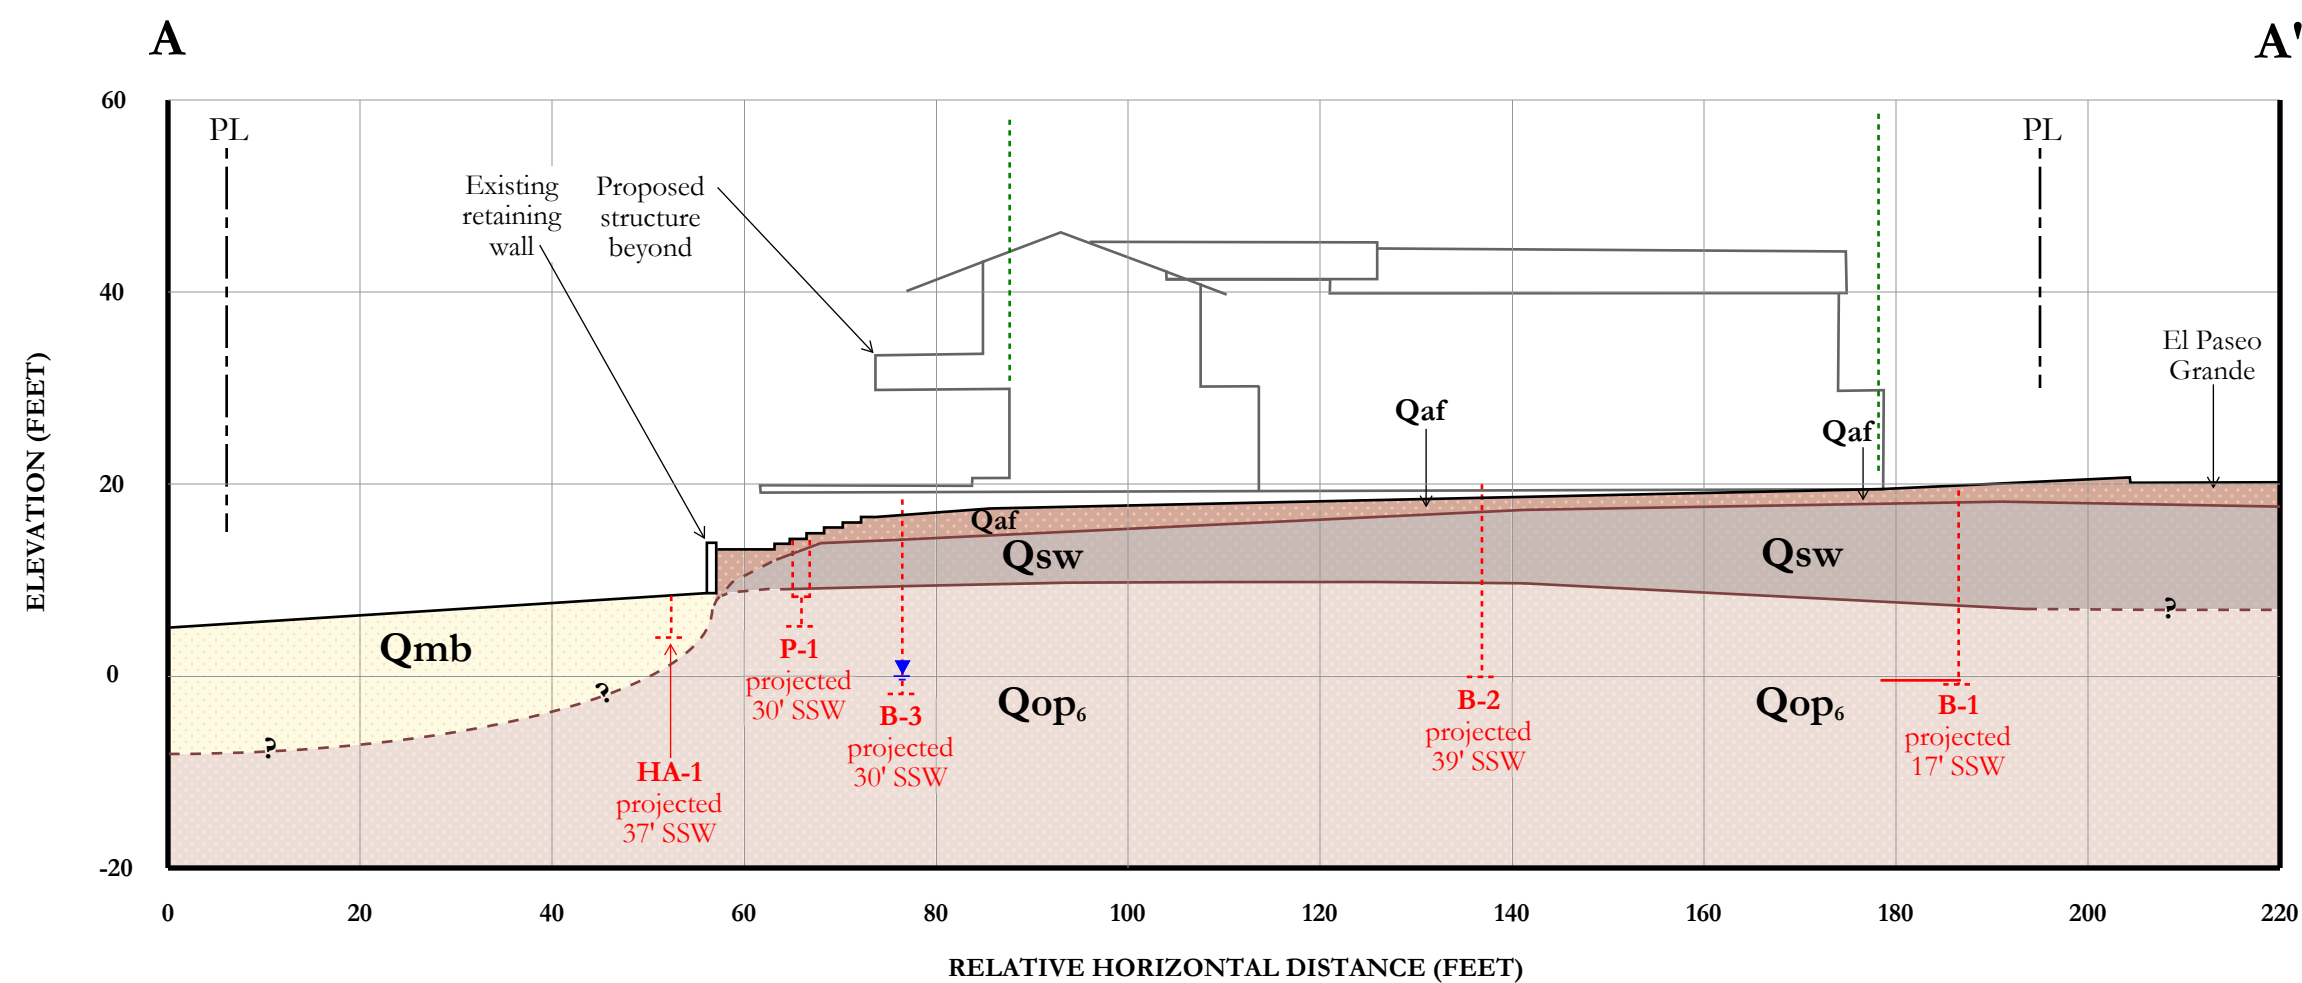
| BY: | JMM/SD | PLATE NO.: | 2 |

**CWE LEGEND**

- Qaf** ARTIFICIAL FILL
- Qsw** SLOPEWASH
- Qmb** MARINE BEACH DEPOSITS
- Qop<sub>6</sub>** OLD PARALIC DEPOSITS, UNIT 6
- **?** **---** GEOLOGIC CONTACT - QUERIED WHERE INFERRED
- ▼** GROUNDWATER ELEVATION IN BORING
- **---** LINE OF EXISTING STRUCTURE

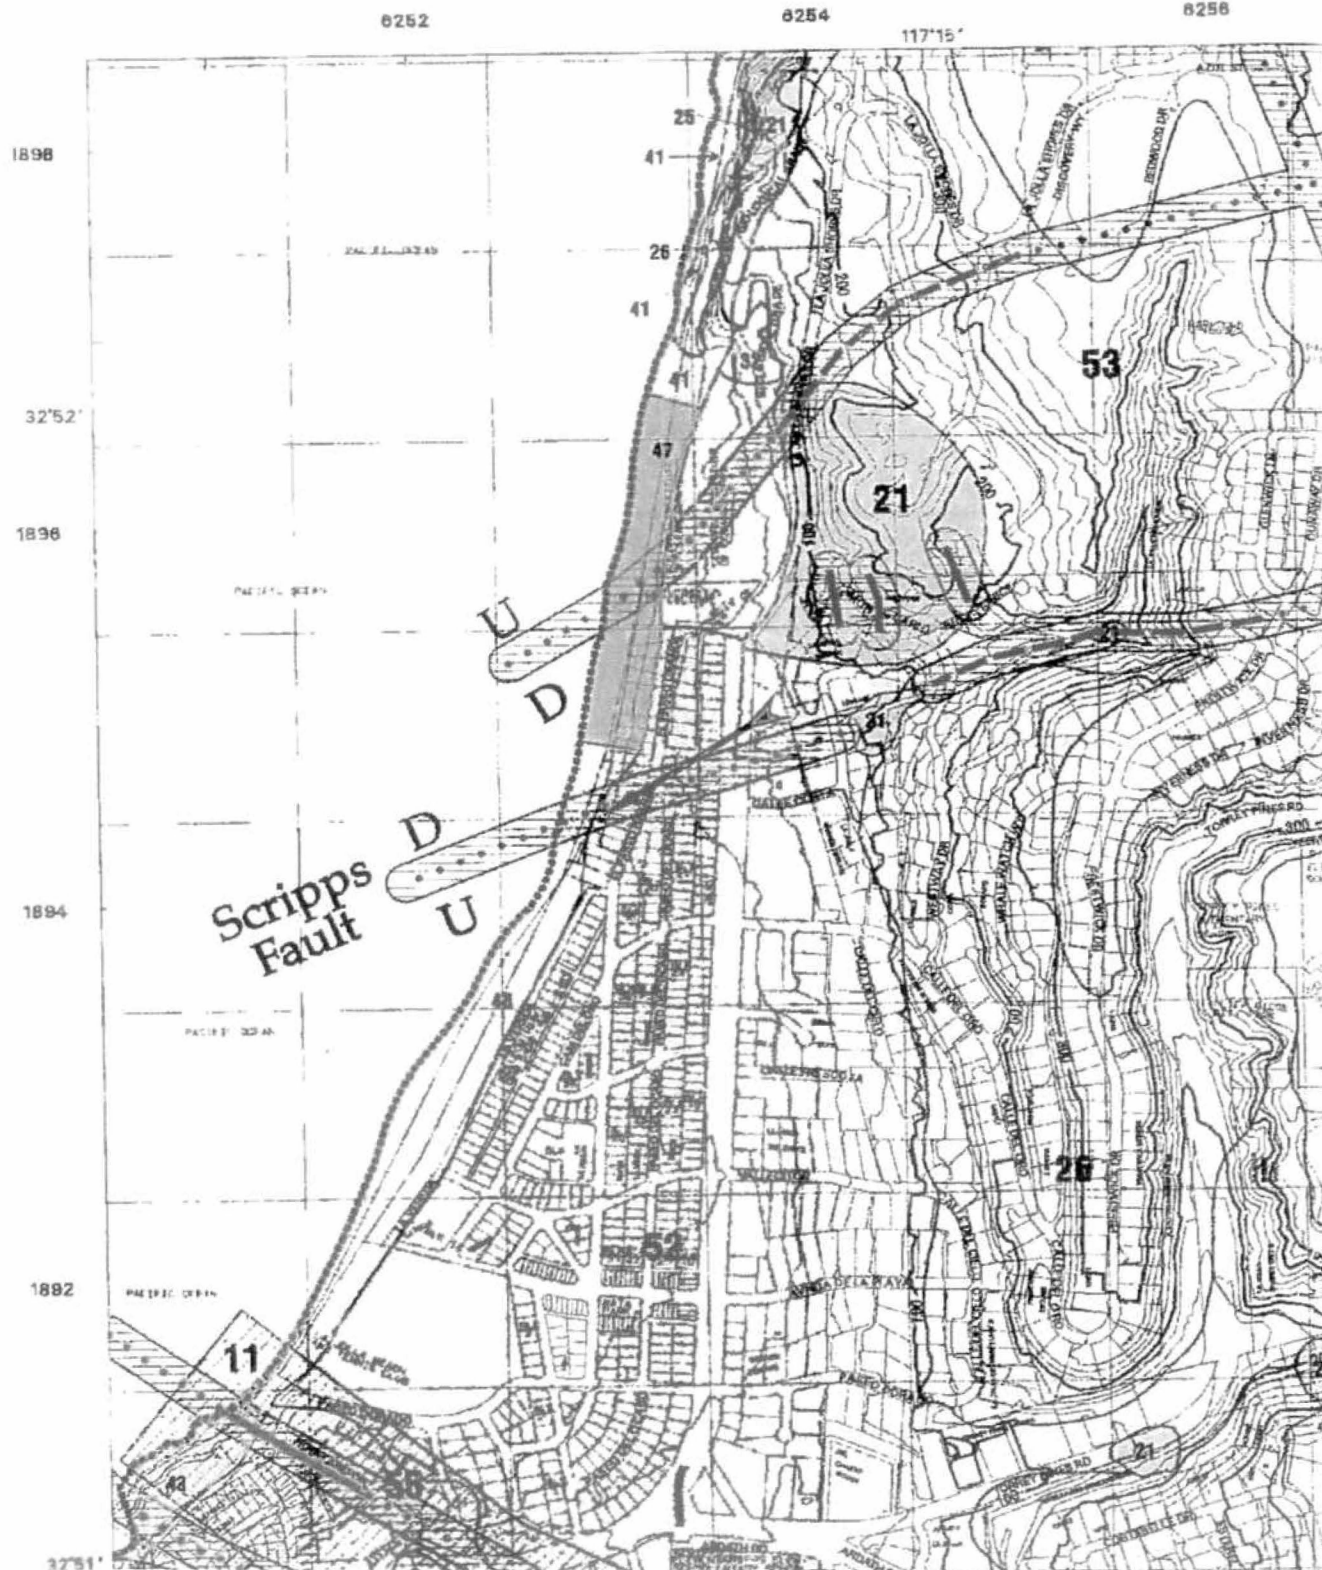
CTE JOB NO. 10-8264G  
 SCALE NO SCALE  
 DATE 1/07 FIGURE 2

**SEISMIC SAFETY STUDY MAP**  
 LUSARDI RESIDENCE  
 LA JOLLA, CALIFORNIA

A portion of the subject site is situated within the City of San Diego Seismic Safety Study, Hazard Category 12 for fault zones, and Category 48 for Coastal Bluffs. The remaining portion of the site is zoned as other terrain, Category 52. Figure 2 shows the location of the site and associated zone boundaries. The Category 12 zones are for faults considered potentially active, inactive, or activity level unknown, and a zone has been established around the interpreted location of the Scripps Fault that transects the northwestern corner of the site (Figure 2). A surface rupture hazard evaluation was requested by the City of San Diego for the subject site in their cycle review comments dated, July, 19, 2006.

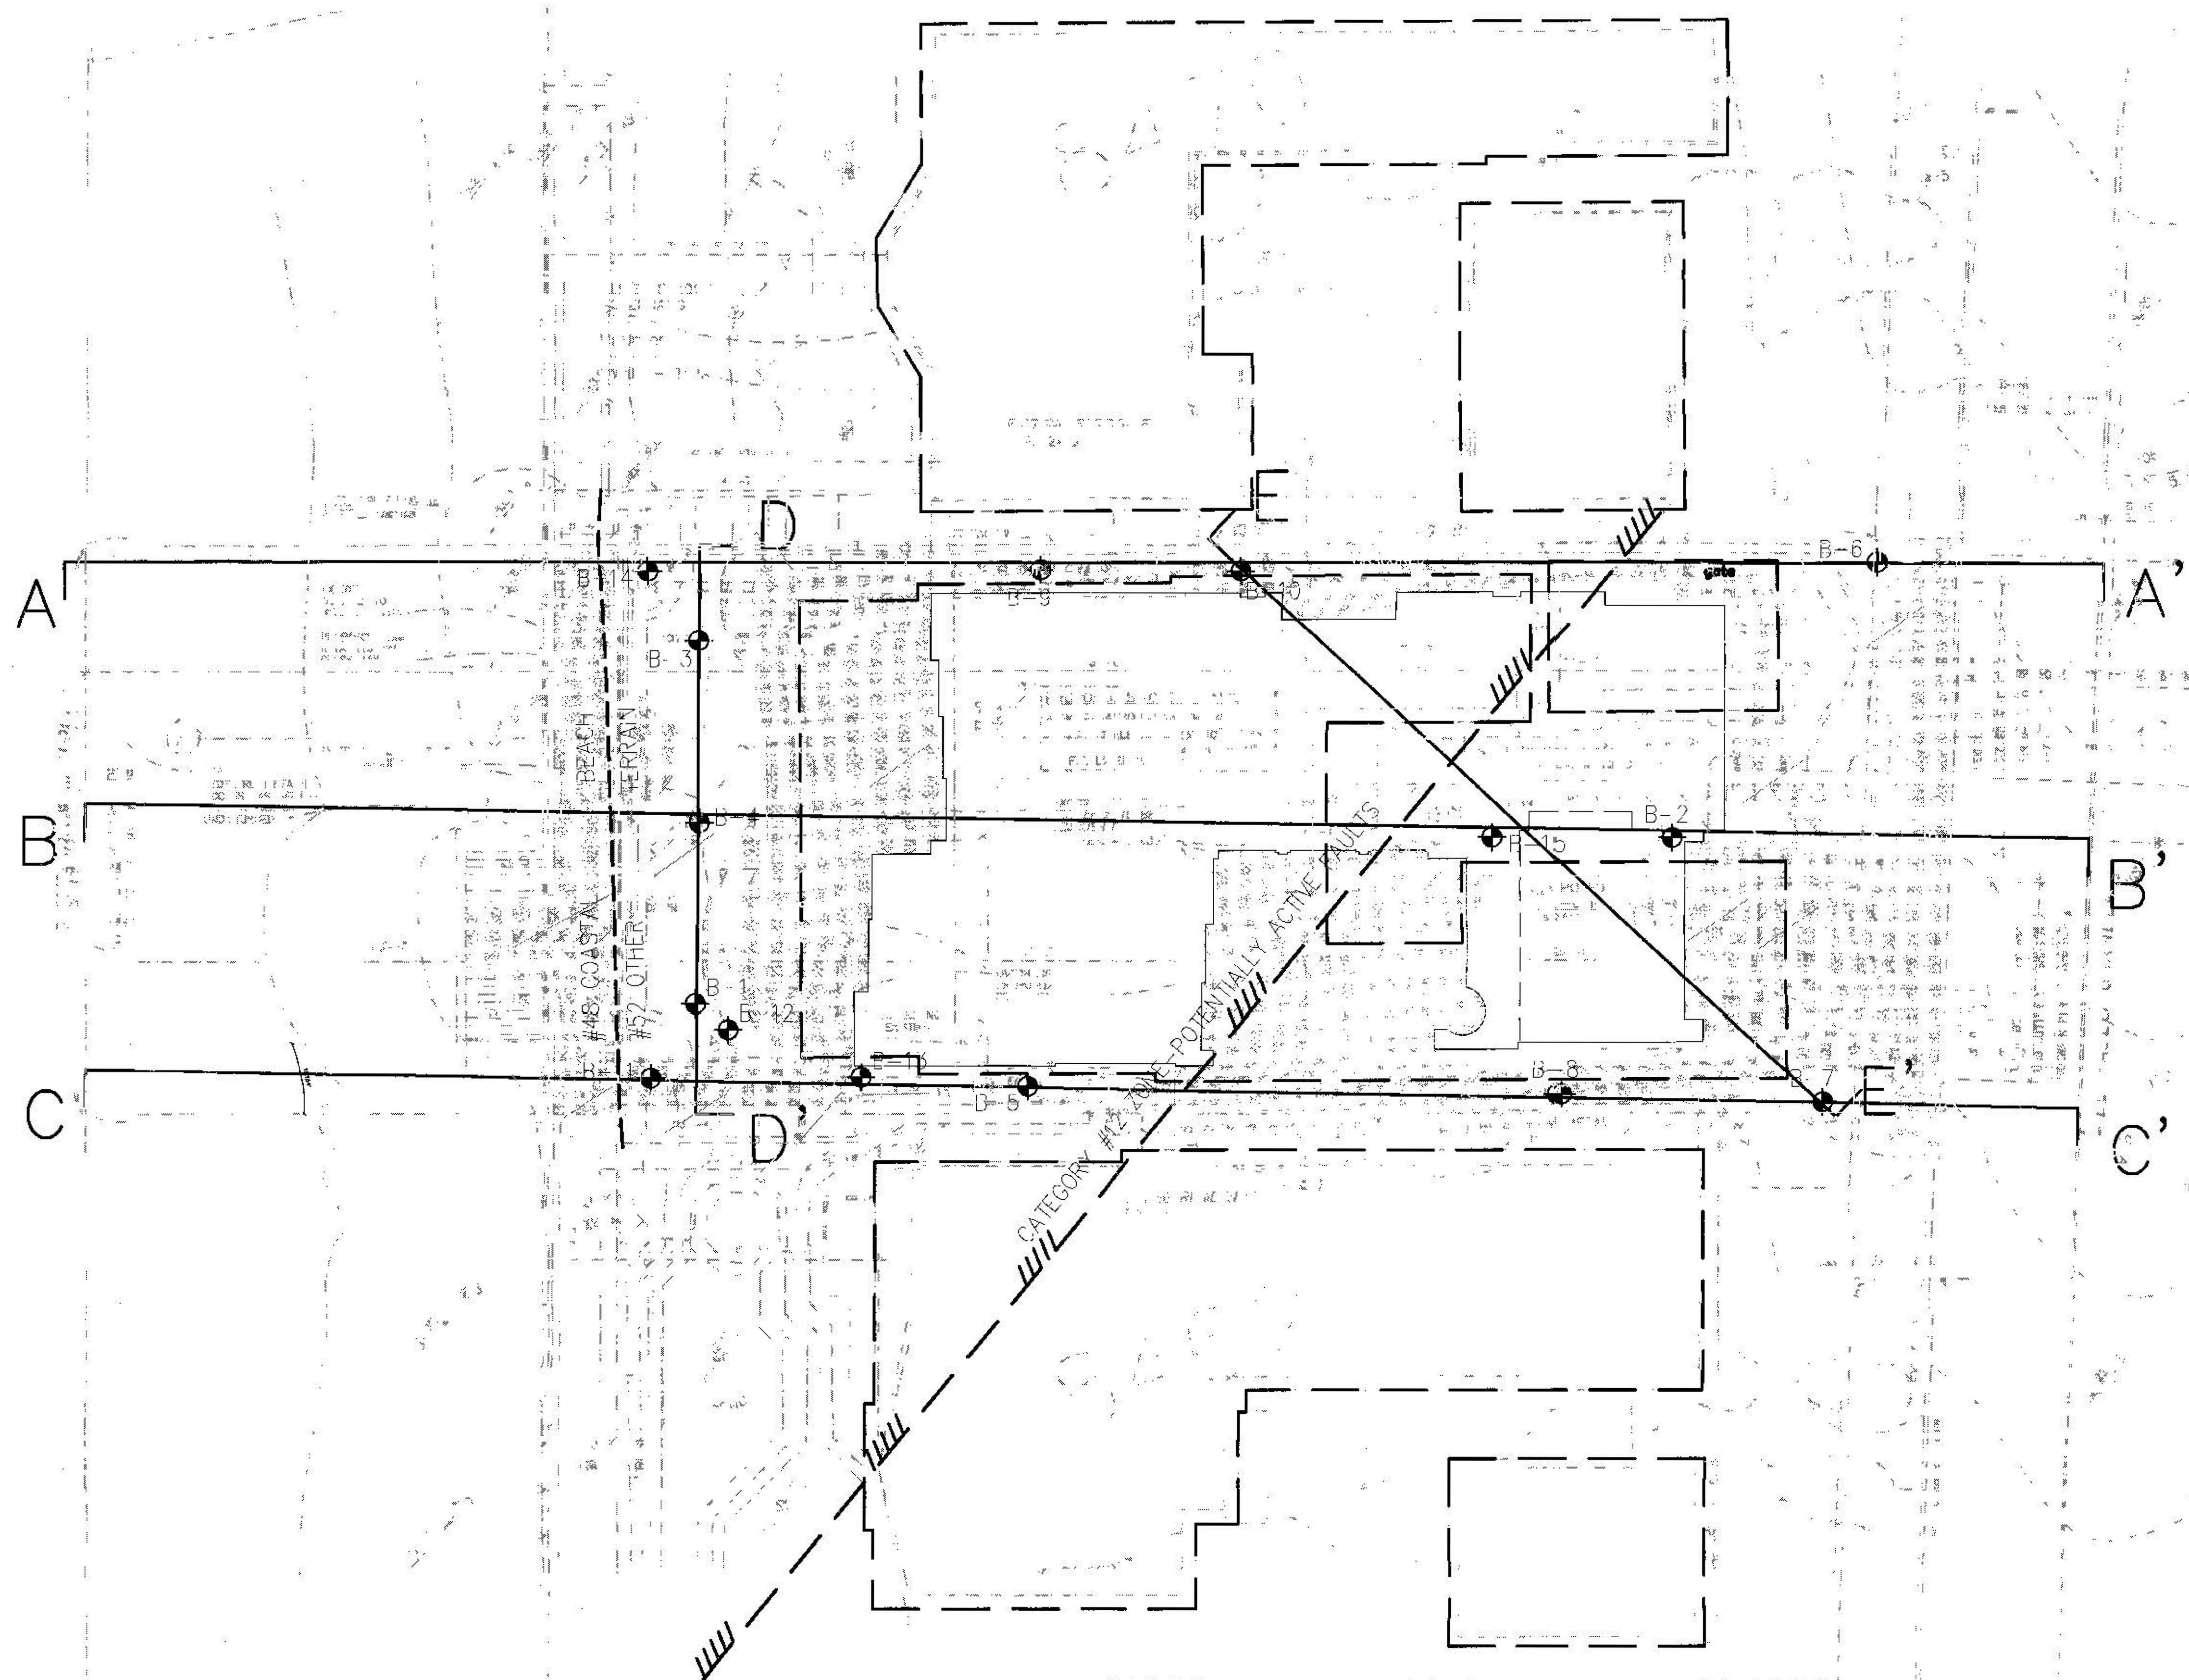
| CTE Job No.:<br>10-8264G | FIGURE:<br>3 |

**LEGEND**

The field descriptions have been modified, where appropriate, to reflect laboratory test results. Exploration logs, including descriptions of the soil, are included in Appendix B. Approximate exploration locations are shown on Figure 2.

As shown on Figure 2, the borings were located around the perimeter of the existing structures with a distribution that provided the correlation of subsurface stratigraphy along three east-west oriented cross-section lines, A-A', B-B', and C-C' (Figures, 3, 4, and 5 respectively), and two additional cross-sections, D-D', along a north-south orientation, and E-E' along a northwest-southeast orientation ( Figures 6 and 7, respectively).

A total of 15 borings were advanced at the site (B-1 through B-15) to depths ranging from 11 to 41 feet below existing grades. As shown on Figure 2, the borings were located around the perimeter of the existing structures with a distribution that provided the correlation of subsurface stratigraphy along three east-west oriented cross-section lines, A-A', B-B', and C-C' (Figures 3, 4, and 5, respectively), and two additional cross-sections, D-D', along a north-south orientation, and E-E' along a northwest-southeast oriented ( Figures 6 and 7, respectively). Lithostratigraphic (similar lithology) and a chronostratigraphic (time boundary) horizon could be correlated across the entire site. The cross-sections were correlated at there intersection points to provide internal consistency of the geologic interpretations. The lithostratigraphic horizons include the contact between map units Qsw and Qsw/Bp1, Bp-2 and Bp-3, Bp-3 and Bp-4. The chronostratigraphic horizon is the contact between map units Qsw/Bp-1 and Bp-2. This is based on the buried soil profile (paleosol) that represents the top of unit Bp-2. The correlations of these units are depicted on the Geologic cross-section A-A' through E-E' (Figures 3 through 7, respectively).

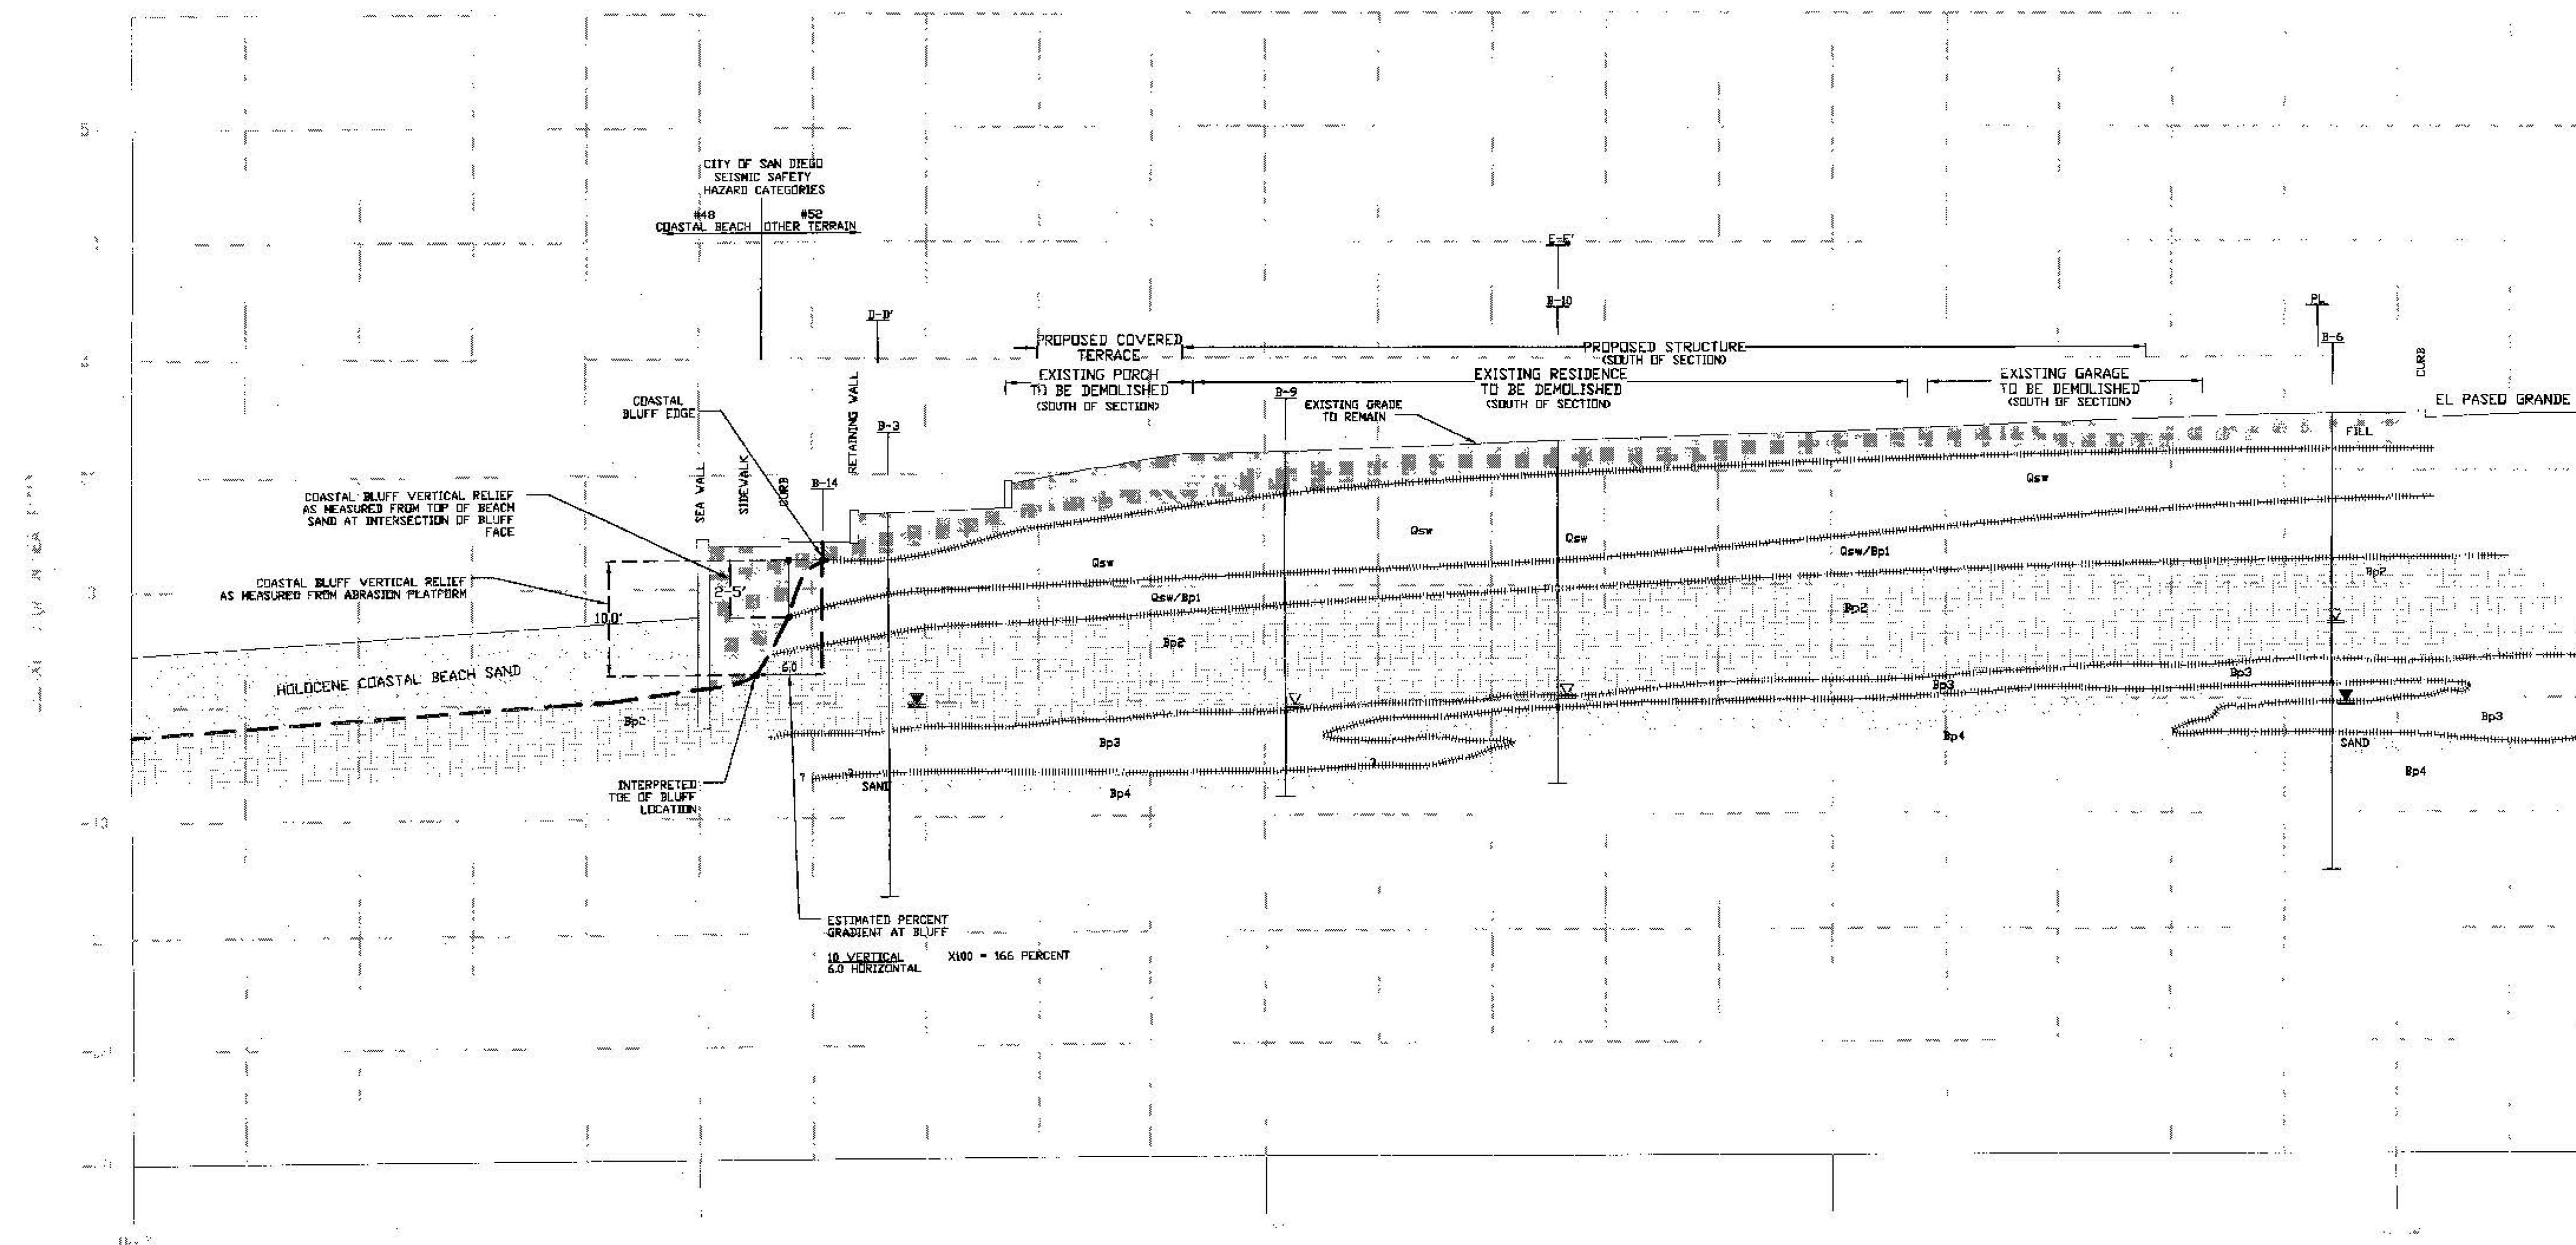
| CIS Job No.:<br>10-8264G | FIGURE:<br>4 |

# VIFW LOOKING NORTH

## Explanation

**Fill:** Consists of loose to medium stiff, reworked Quaternary Slope Wash as described below, with loose, silty sand, abundant organics, roots, topsoil from turf and planter areas, minor debris.

Quaternary-aged sedimentary deposits identified as the Bay Point Formation were encountered within our subsurface explorations beneath the slopewash. These soils were divided into three, map units based on lithologic differences, and degree of soil development. Contacts were gradational with overlying and underlying units. The units are described below and depicted on the geologic-cross-sections (Figures 3 through 7).

Based on the lateral and vertical stratigraphic and structural continuity of the deposits across the site, as depicted in Figures 3 through 7, and the age-constraints discussed above, it is clear that active faults do not cross the site. The existence of potentially active faults (faults older than 10,000 years and younger than 1.6 million years) could be present at depths below the limits of our investigation. However, there is no indication of faulting within the depths explored and it is
