**REPORT OF PRELIMINARY GEOTECHNICAL INVESTIGATION**

**MORROW RESIDENCE  
8460 EL PASEO GRANDE  
LA JOLLA, CALIFORNIA**

CWE 2230041.01

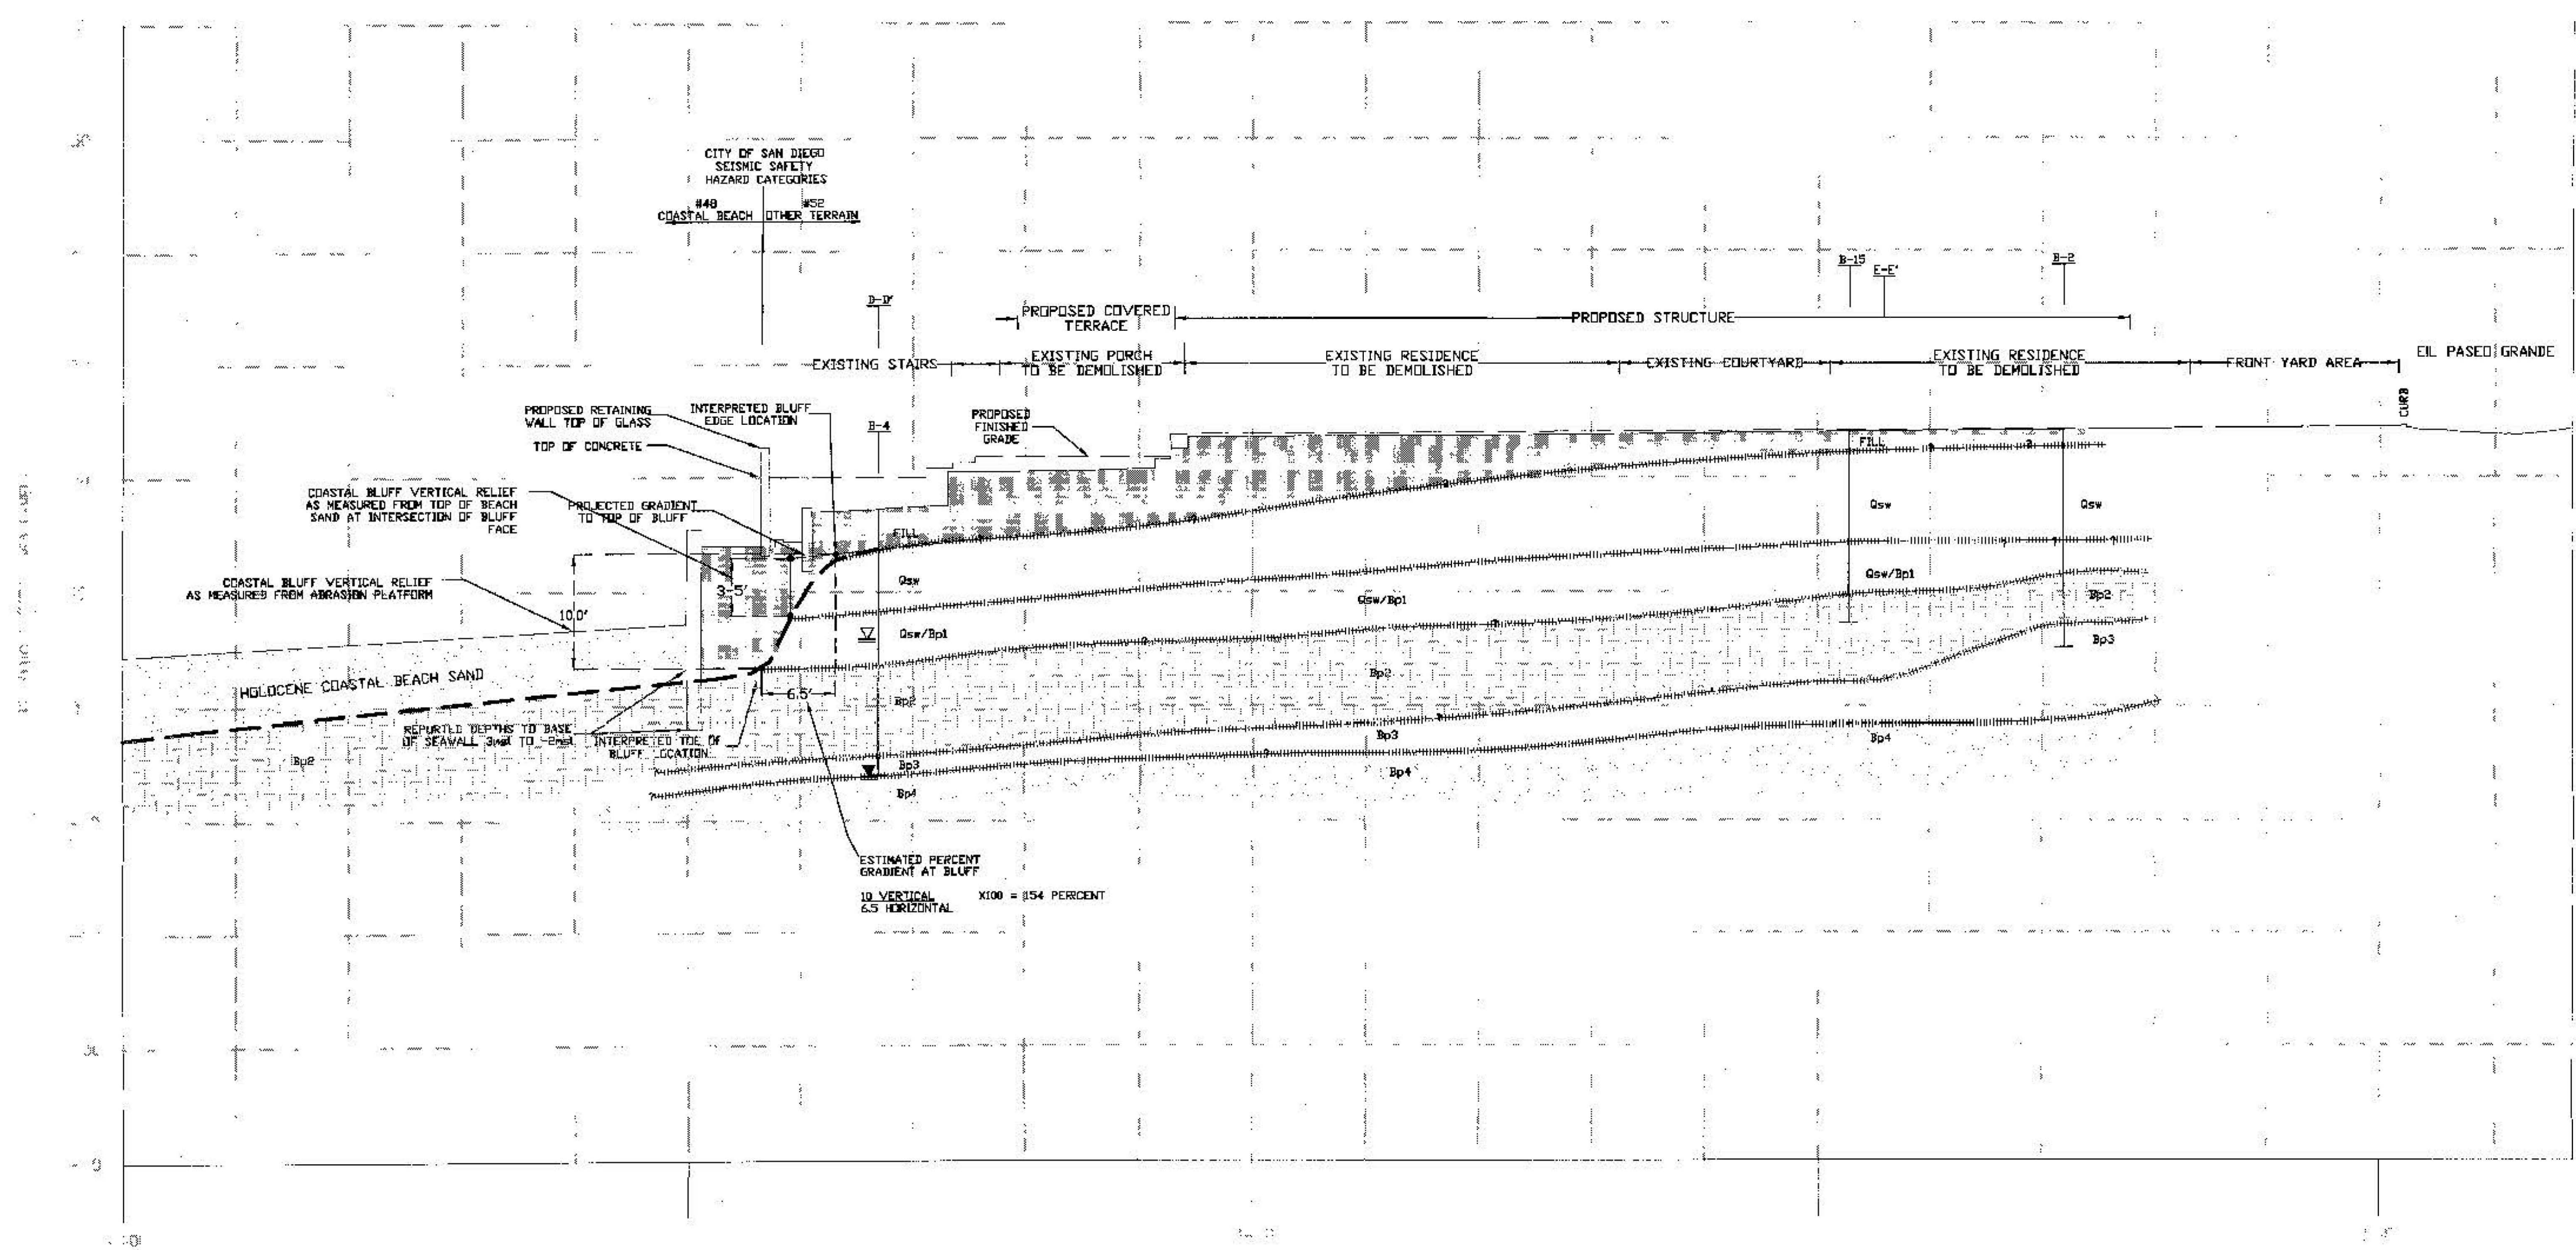
VIEW LOOKING NORTH

Explanation

**Fill:** Consists of loose to medium stiff, reworked Quaternary Slope Wash as described below, with loose, silty sand, abundant organics, roots, topsoil from turf and planter areas, minor debris.

- Gradation contact between mapped units.
- Approximate location or inferred (?) location of geologic contacts
- Zones of carbonate accumulation
- Existing Grade
- Proposed Final grade
- Perched groundwater observed
- Groundwater at time of drilling

\\Cte\_server\projects\10-8264\cross section C.dwg 1/24/2007 2:59:17 PM PST

Quaternary-aged sedimentary deposits identified as the Bay Point Formation were encountered within our subsurface explorations beneath the slopewash. These soils were divided into three, map units based on lithologic differences, and degree of soil development. Contacts were gradational with overlying and underlying units. The units are described below and depicted on the geologic-cross-sections (Figures 3 through 7).

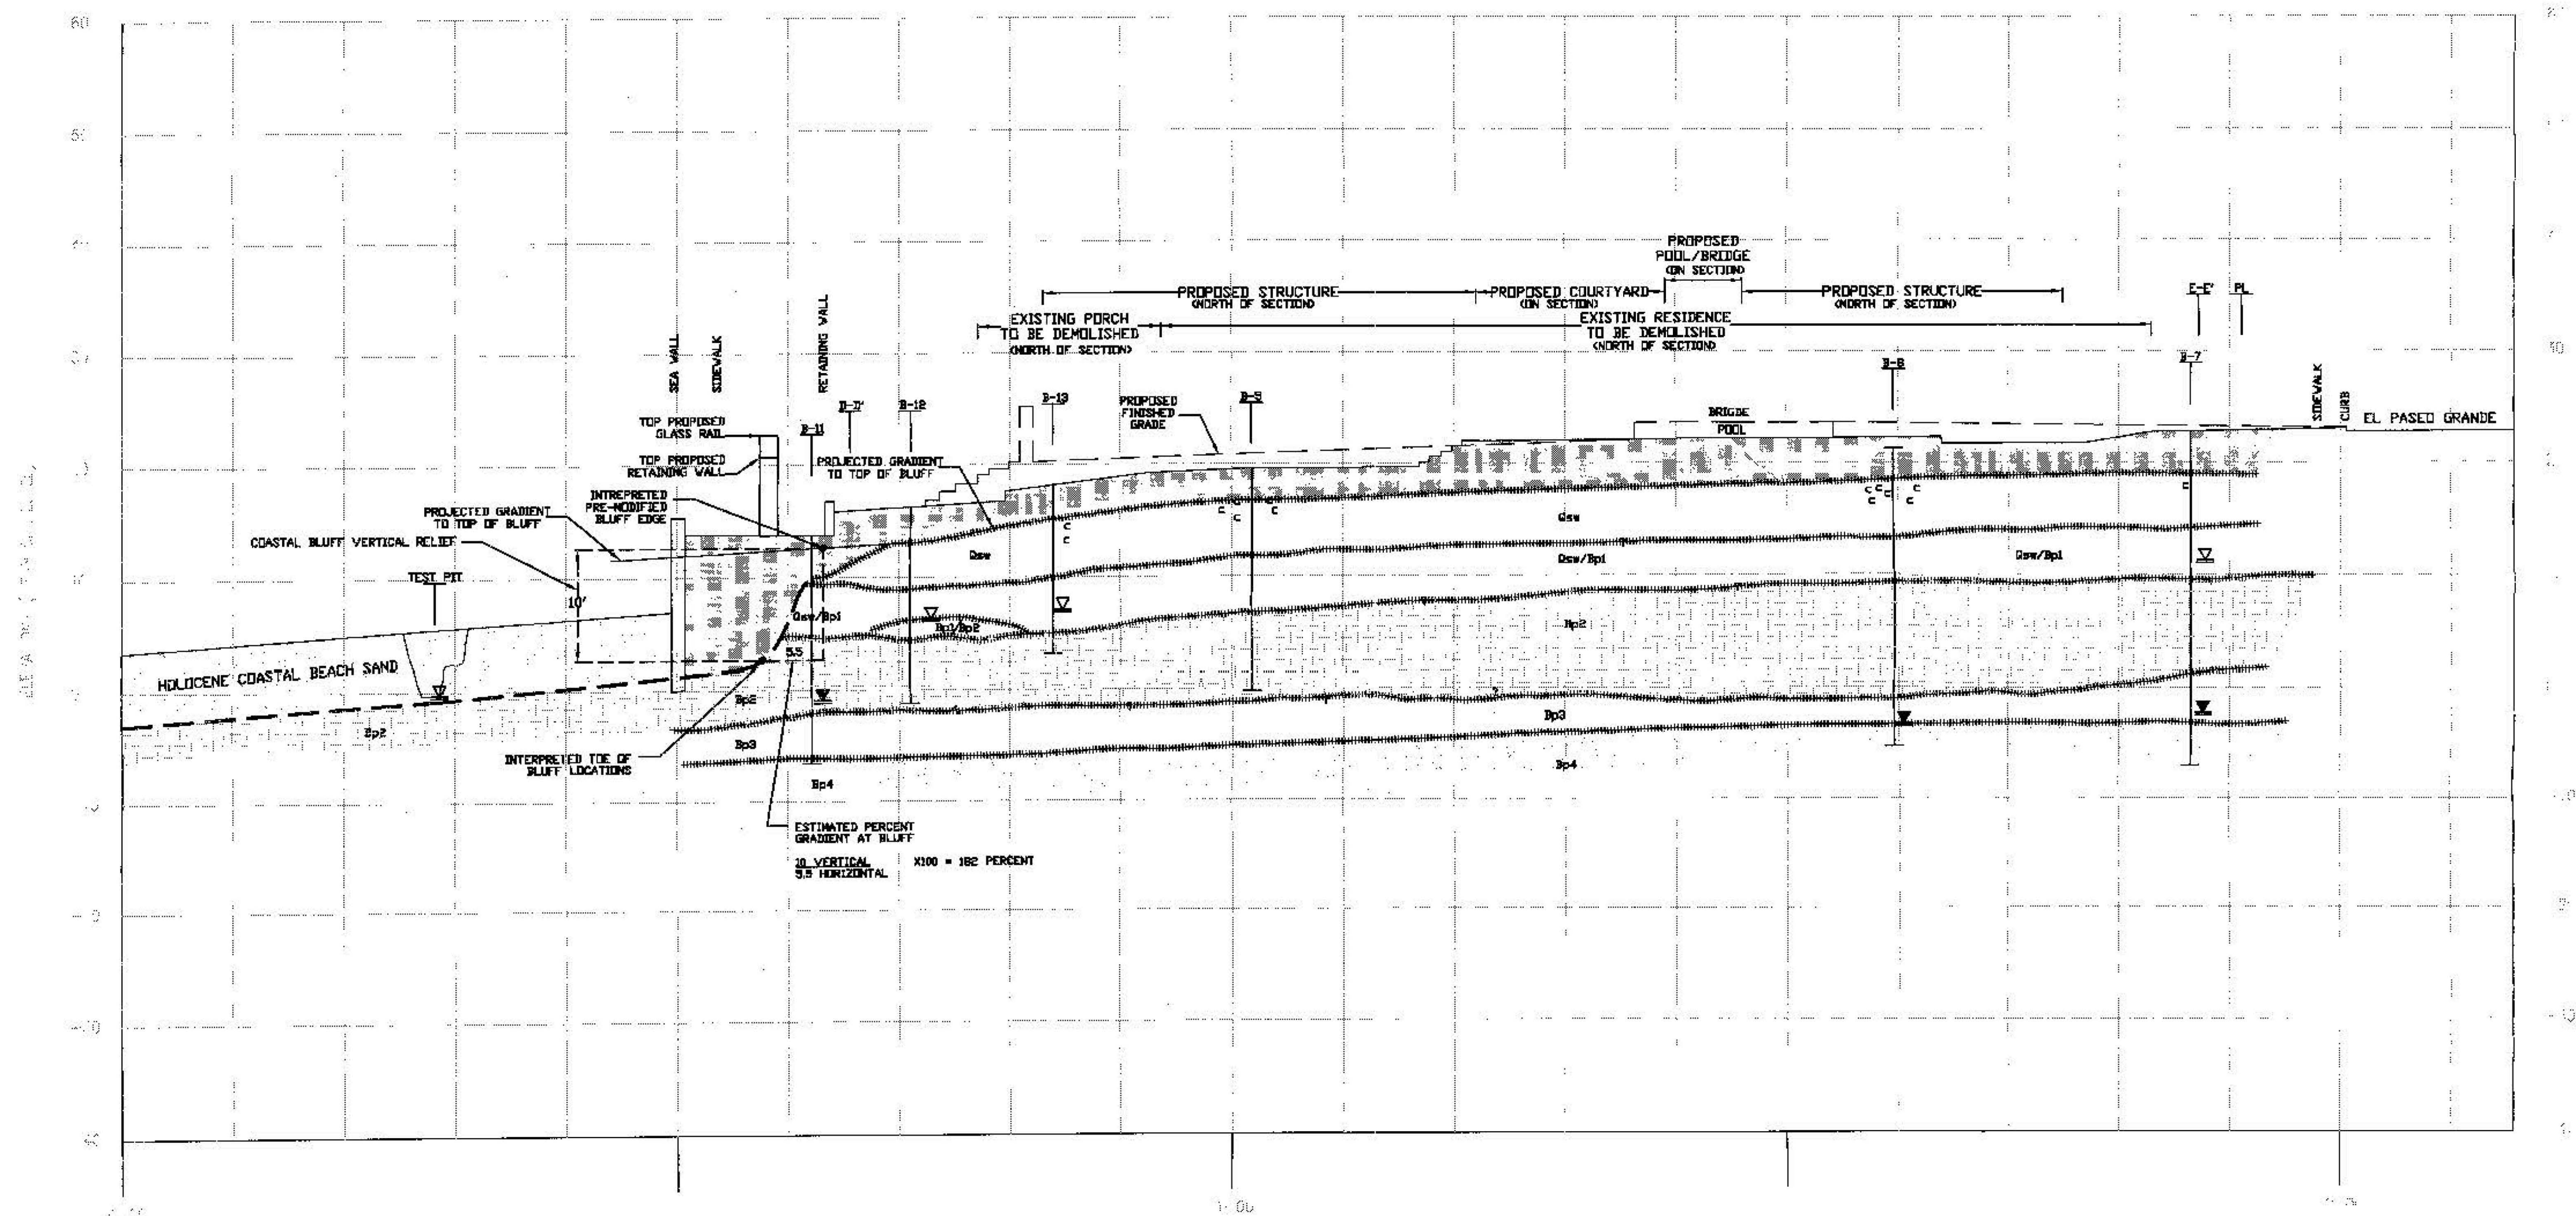
| CTE Job No.:<br>10-8264G | FIGURE:<br>6 |

#### Explanation

**Bp1:** Consists of loose to medium stiff, reworked Quaternary Slope Wash as described below, with loose, silty sand, abundant organics, roots, topsoil from turf and planter areas, minor debris.

Based on the lateral and vertical stratigraphic and structural continuity of the deposits across the site, as depicted in Figures 3 through 7, and the age-constraints discussed above, it is clear that active faults do not cross the site. The existence of potentially active faults (faults older than 10,000 years and younger than 1.6 million years) could be present at depths below the limits of our investigation. However, there is no indication of faulting within the depths explored and it is

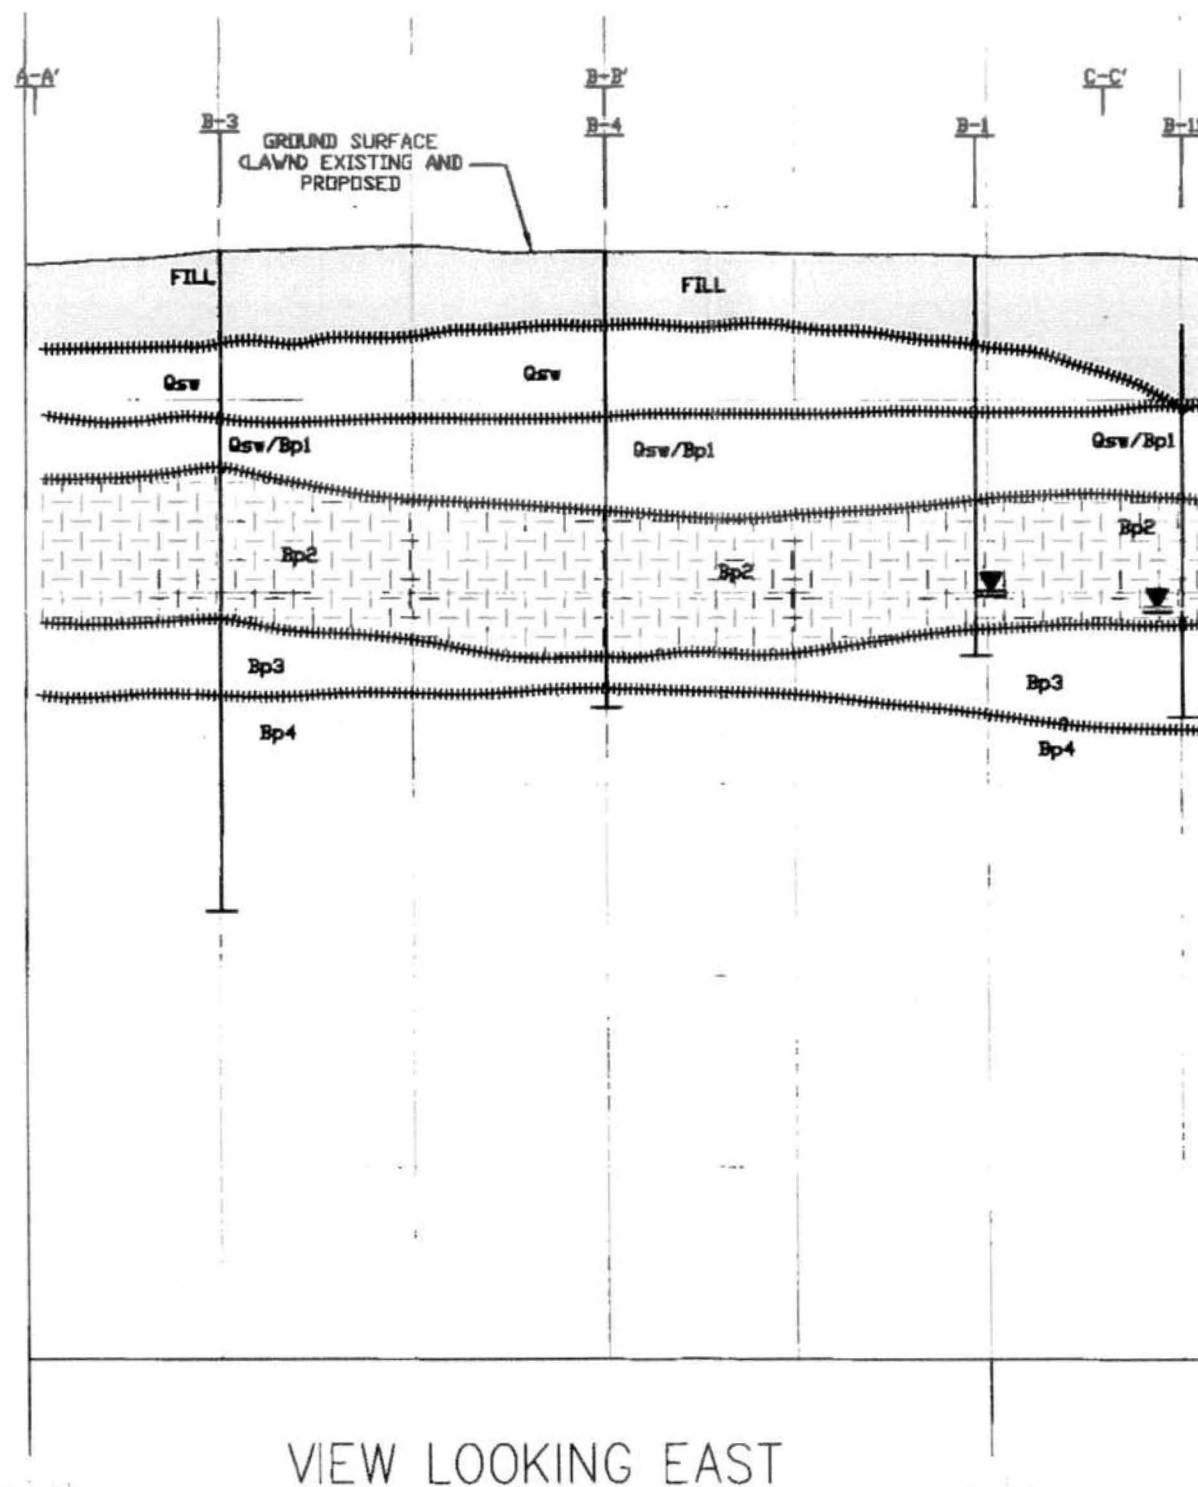
| 01/07 | 7 |

SEE FIGURE 3 FOR EXPLANATION

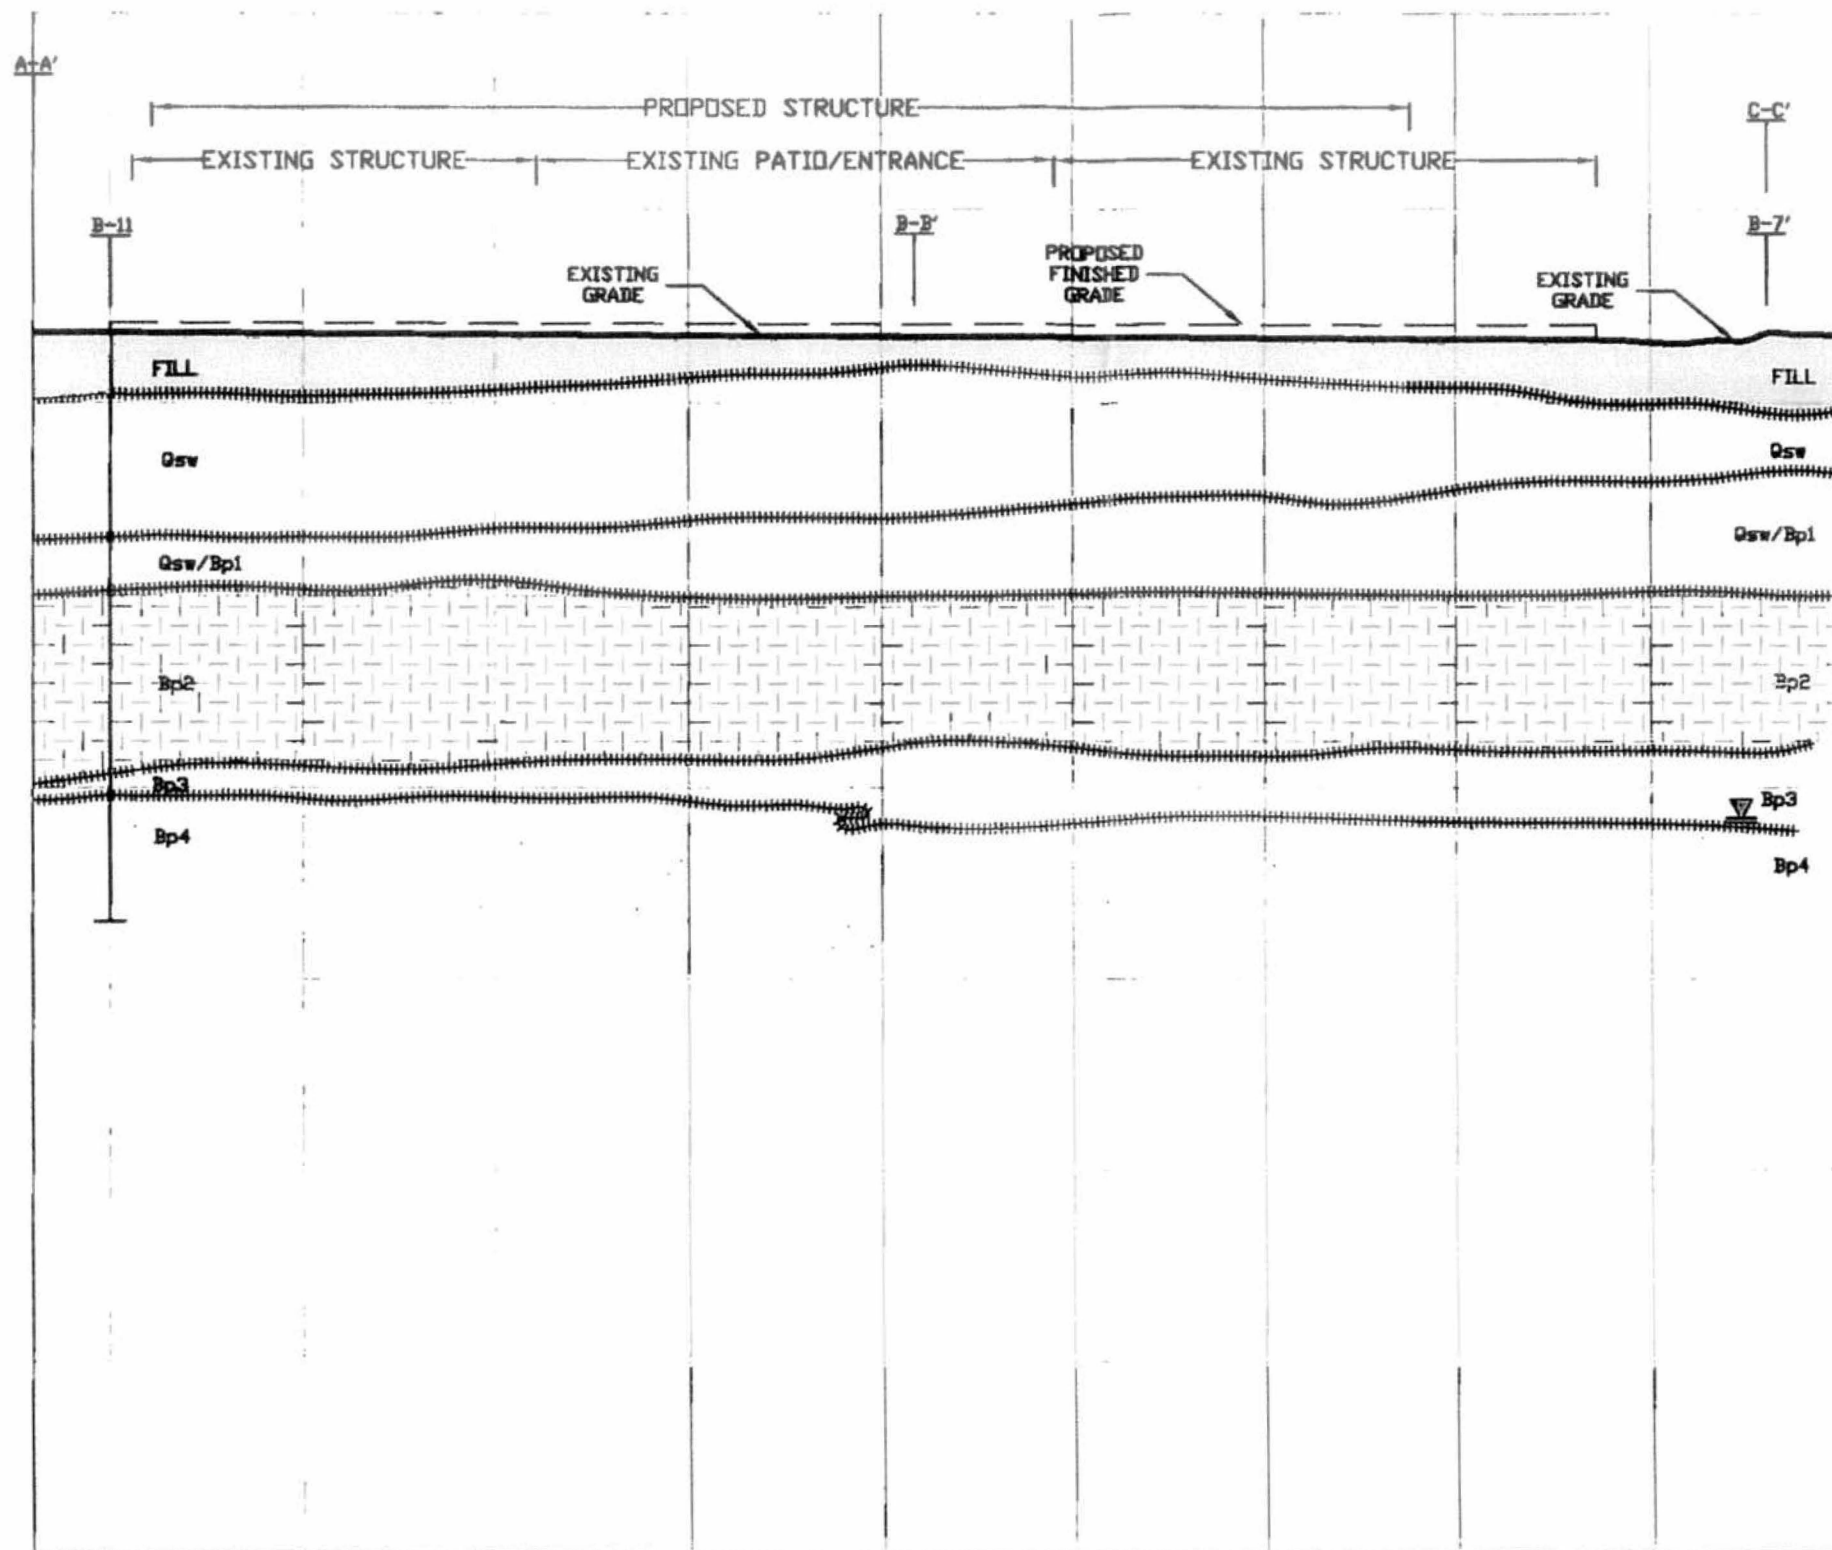
VIEW LOOKING NORTHEAST

**CROSS SECTION E-E'**  
 LUSARDI RESIDENCE  
 8466 EL PASEO GRANDE  
 LA JOLLA, CALIFORNIA

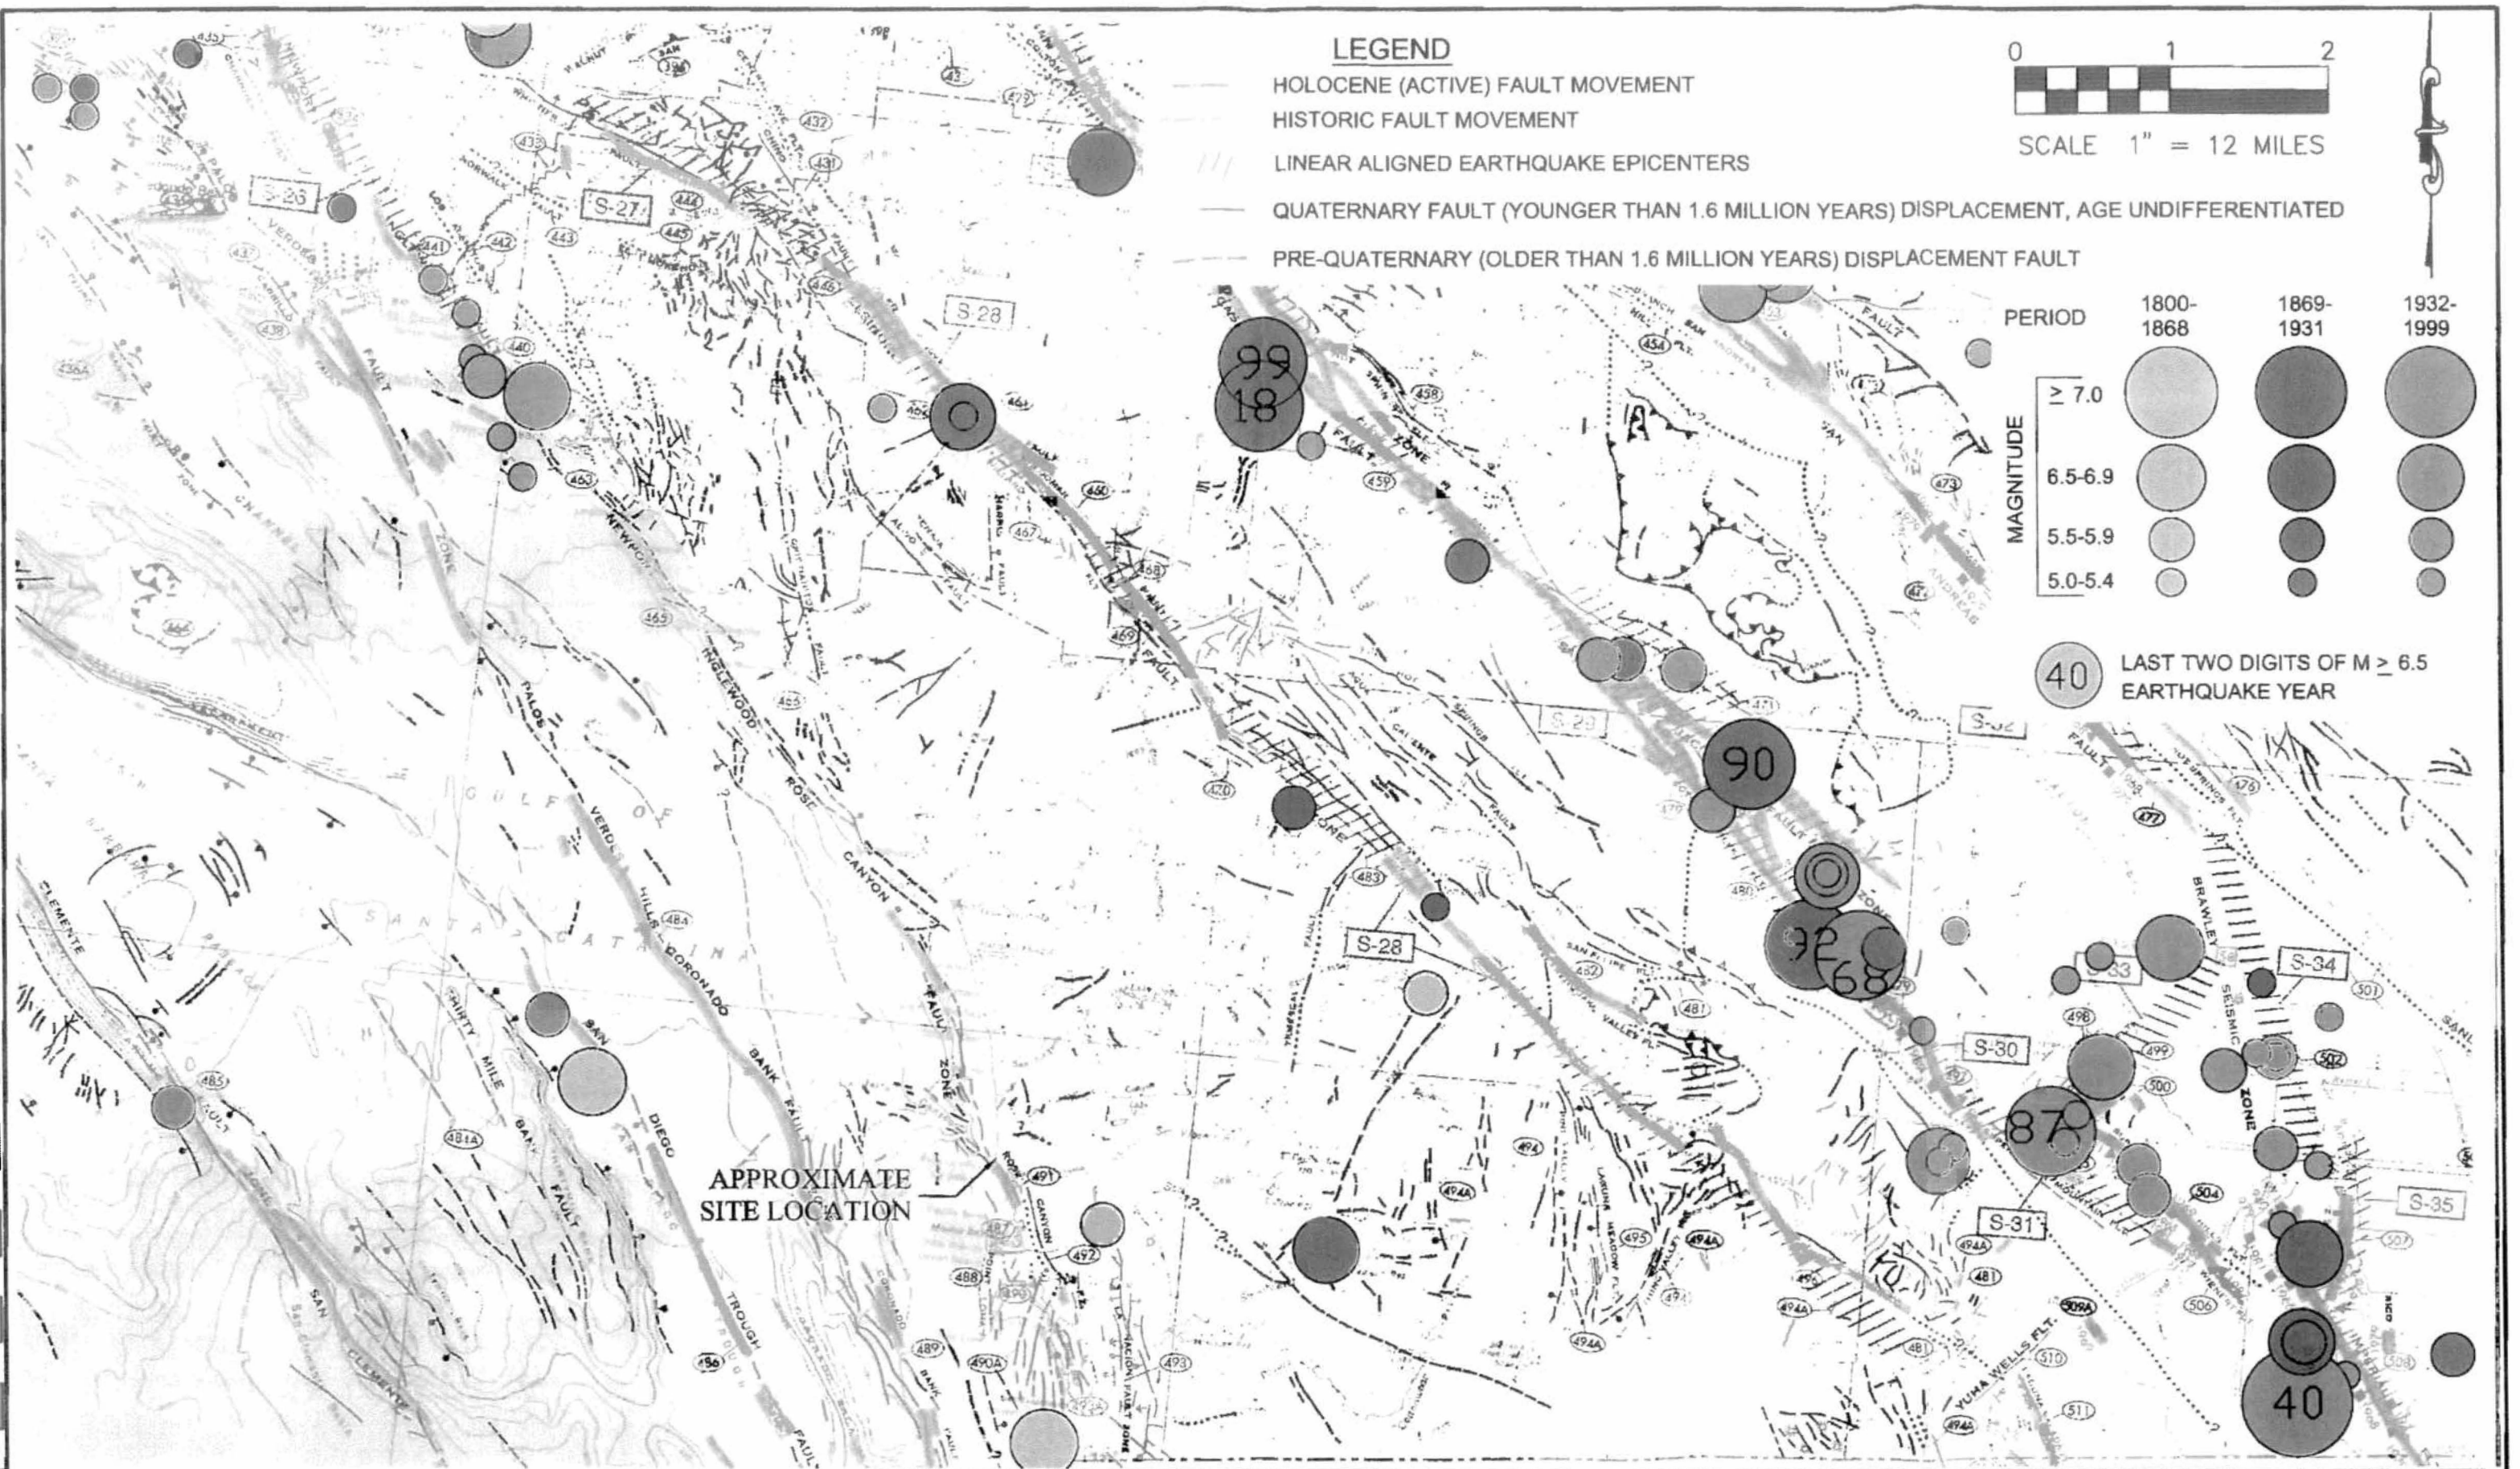
# LEGEND

- HOLOCENE (ACTIVE) FAULT MOVEMENT
- HISTORIC FAULT MOVEMENT
- LINEAR ALIGNED EARTHQUAKE EPICENTERS
- QUATERNARY FAULT (YOUNGER THAN 1.6 MILLION YEARS) DISPLACEMENT, AGE UNDIFFERENTIATED
- PRE-QUATERNARY (OLDER THAN 1.6 MILLION YEARS) DISPLACEMENT FAULT

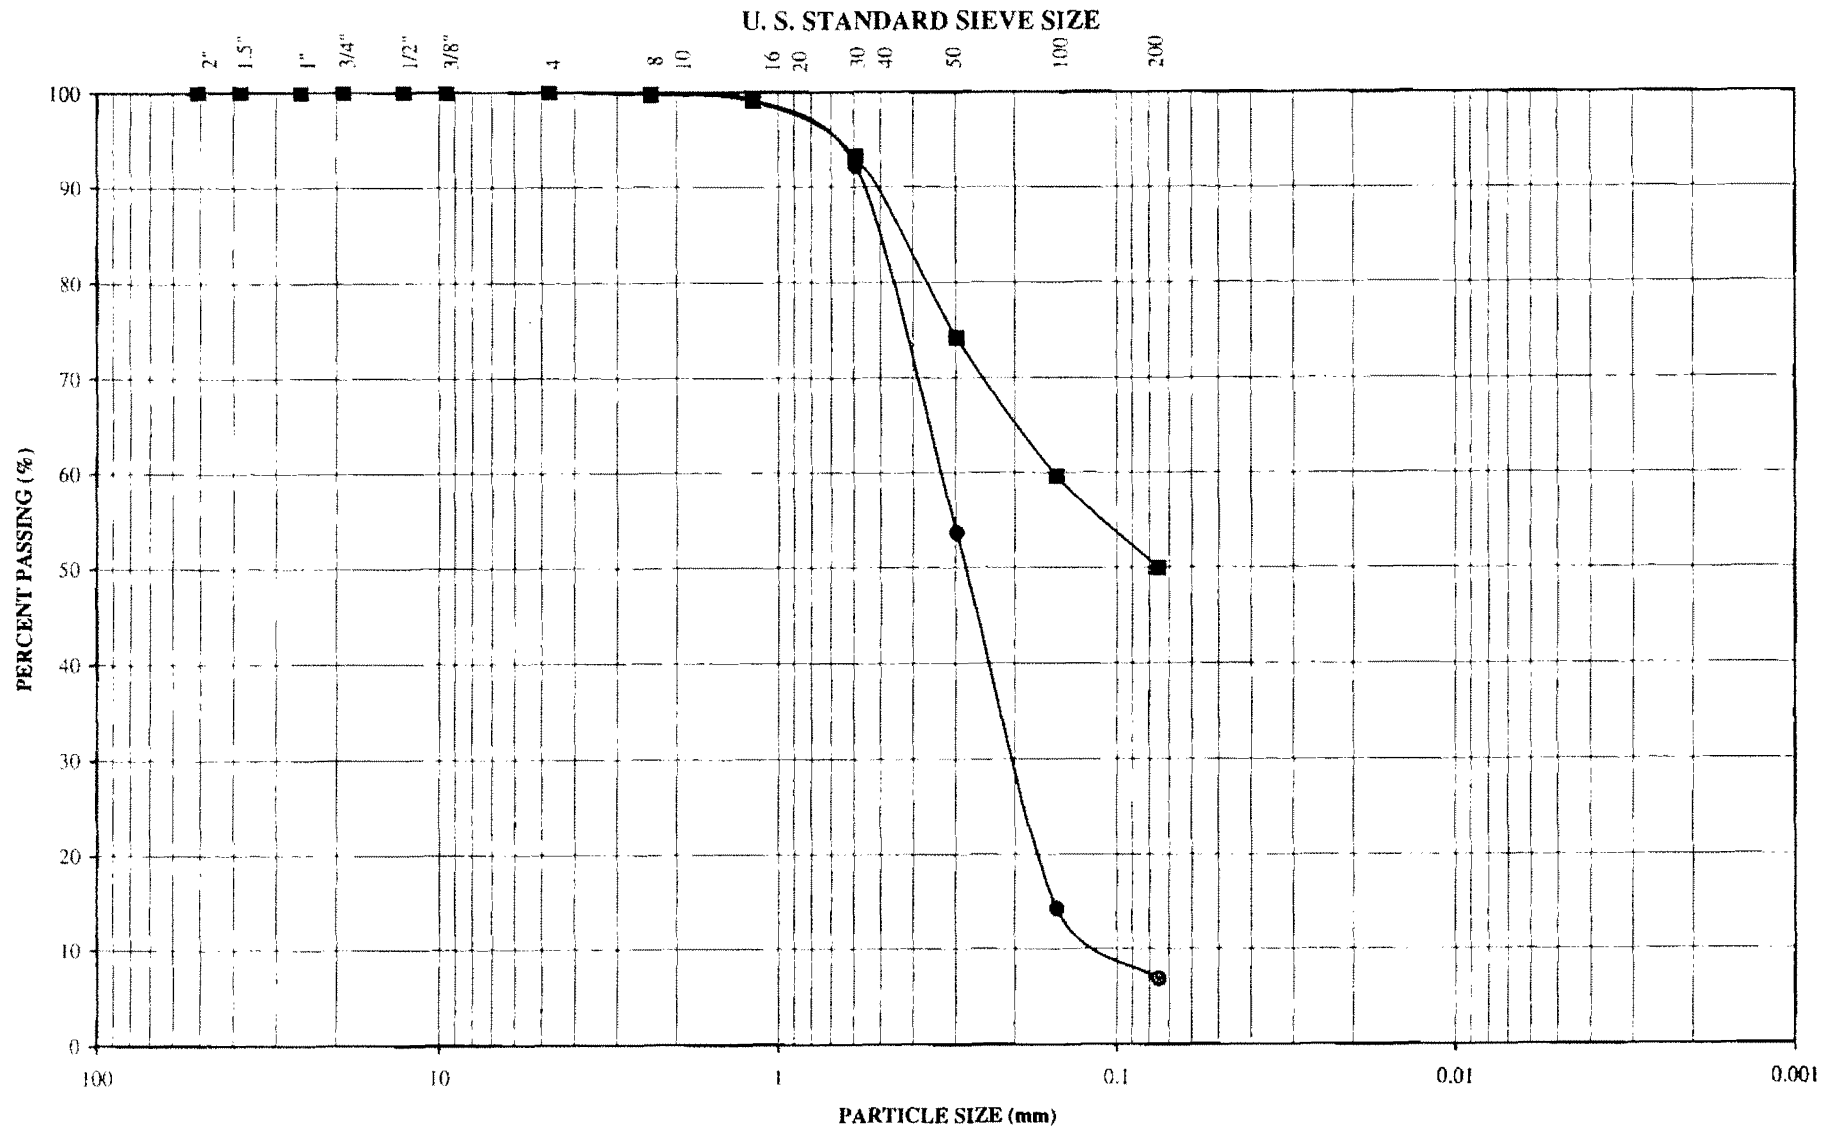
| Sample Designation | Sample Depth (feet) | Symbol | Liquid Limit (%) | Plasticity Index | Classification |
|---|---|---|---|---|---|
| CTE JOB NUMBER: | | | 10-8264G | | FIGURE: C-1 |

### PARTICLE SIZE ANALYSIS

| Sample Designation | Sample Depth (feet) | Symbol | Liquid Limit (%) | Plasticity Index | Classification |
|---|---|---|---|---|---|
| B-3 | 20-21.5 | ■ | - | - | CL-SC |

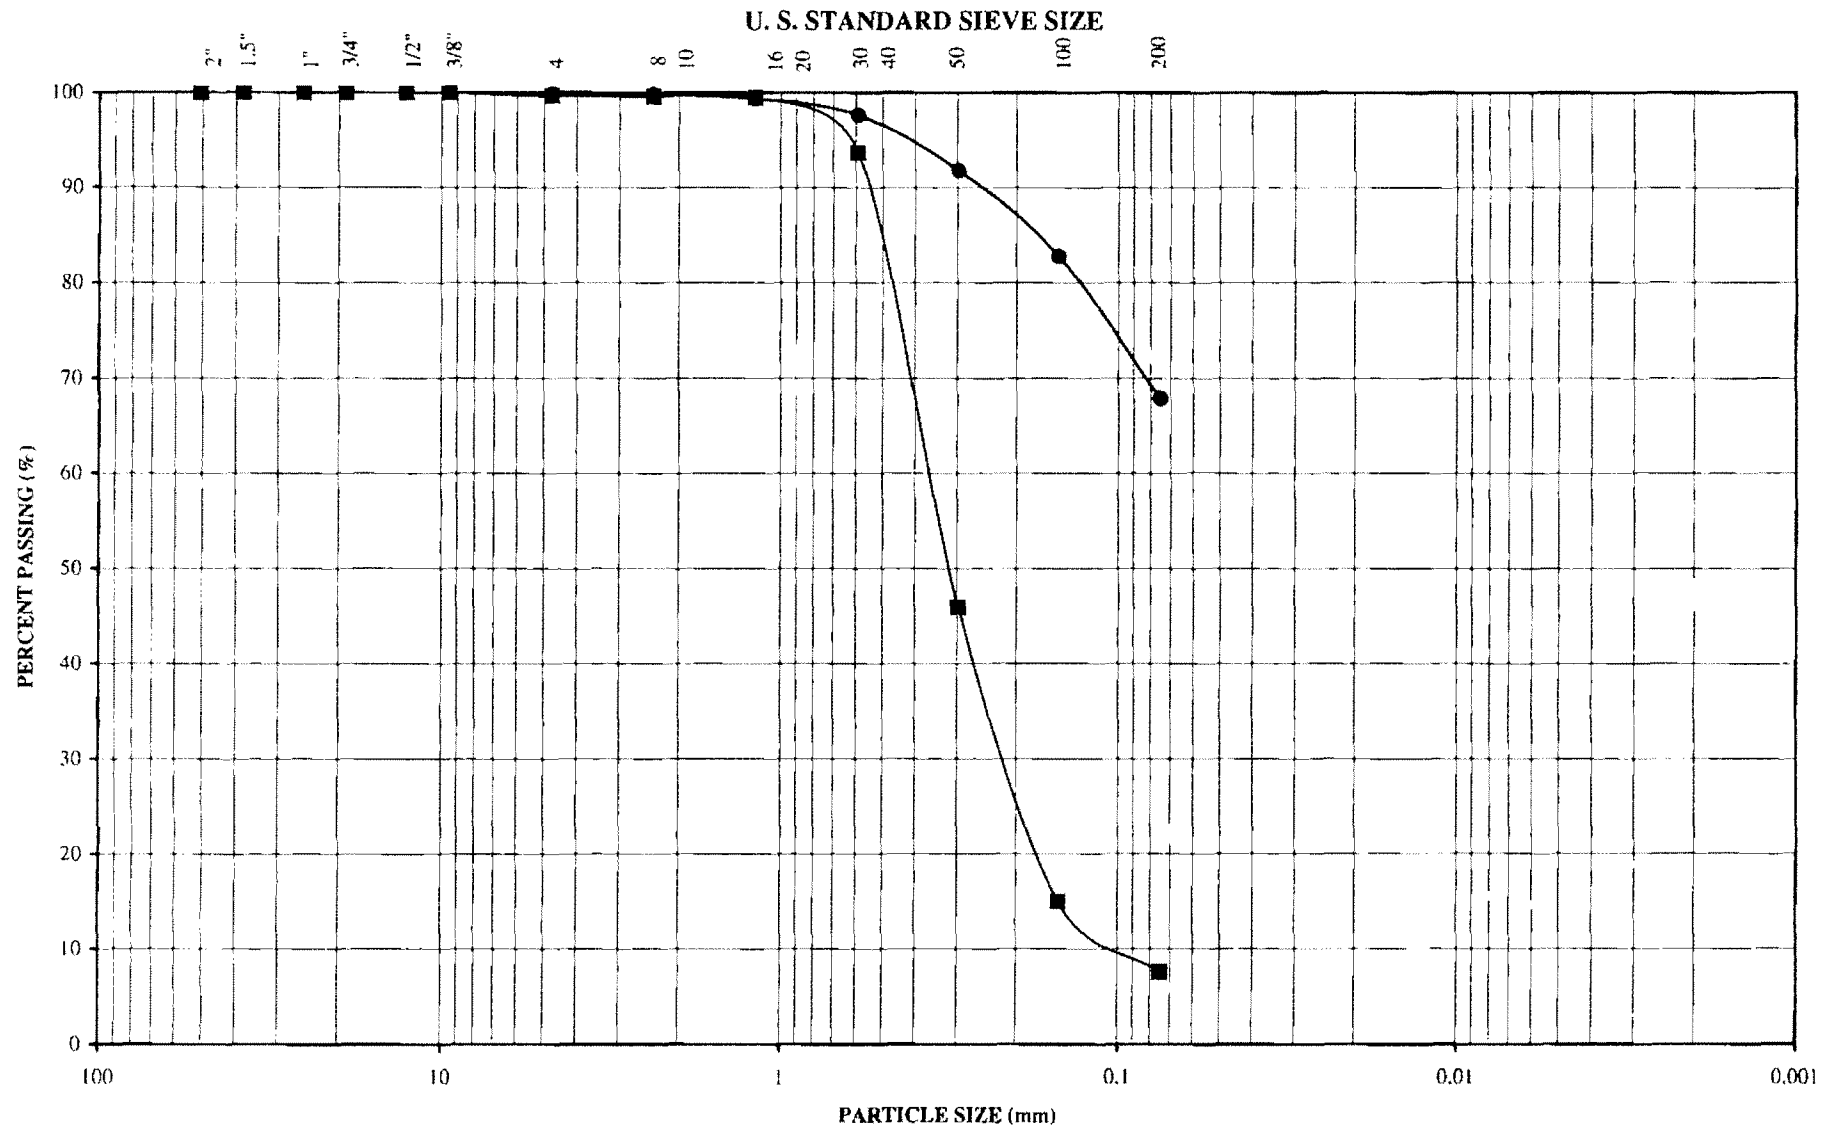
| Sample Designation | Sample Depth (feet) | Symbol | Liquid Limit (%) | Plasticity Index | Classification |
|---|---|---|---|---|---|
| CTE JOB NUMBER: | | | 10-8264G | | FIGURE: C-2 |

### PARTICLE SIZE ANALYSIS

| Sample Designation | Sample Depth (feet) | Symbol | Liquid Limit (%) | Plasticity Index | Classification |
|---|---|---|---|---|---|
| B-6 | 29.5-31.5 | ■ | - | - | SP-SM |

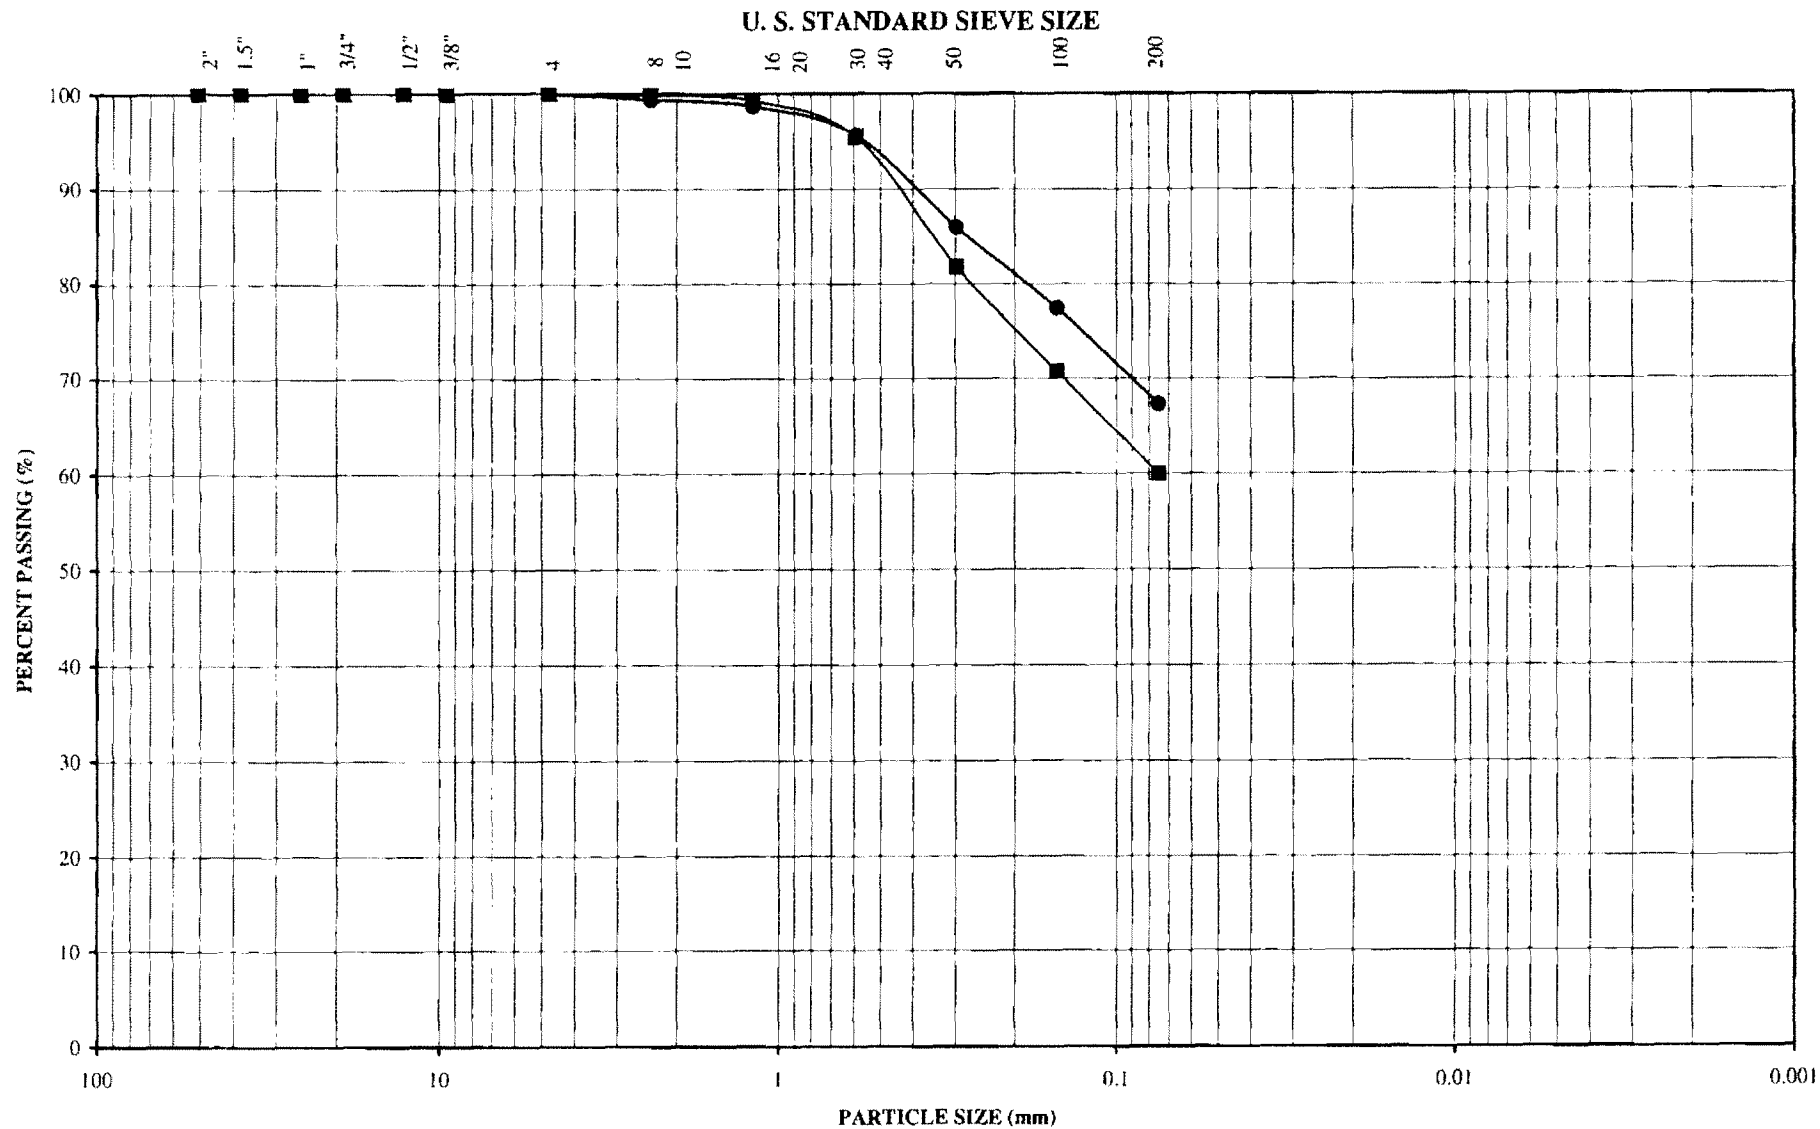
| Sample Designation | Sample Depth (feet) | Symbol | Liquid Limit (%) | Plasticity Index | Classification |
|---|---|---|---|---|---|
| CTE JOB NUMBER: | | | 10-8264G | FIGURE: | C-3 |

### PARTICLE SIZE ANALYSIS
