**REPORT OF PRELIMINARY GEOTECHNICAL INVESTIGATION**

**MORROW RESIDENCE  
8460 EL PASEO GRANDE  
LA JOLLA, CALIFORNIA**

CWE 2230041.01

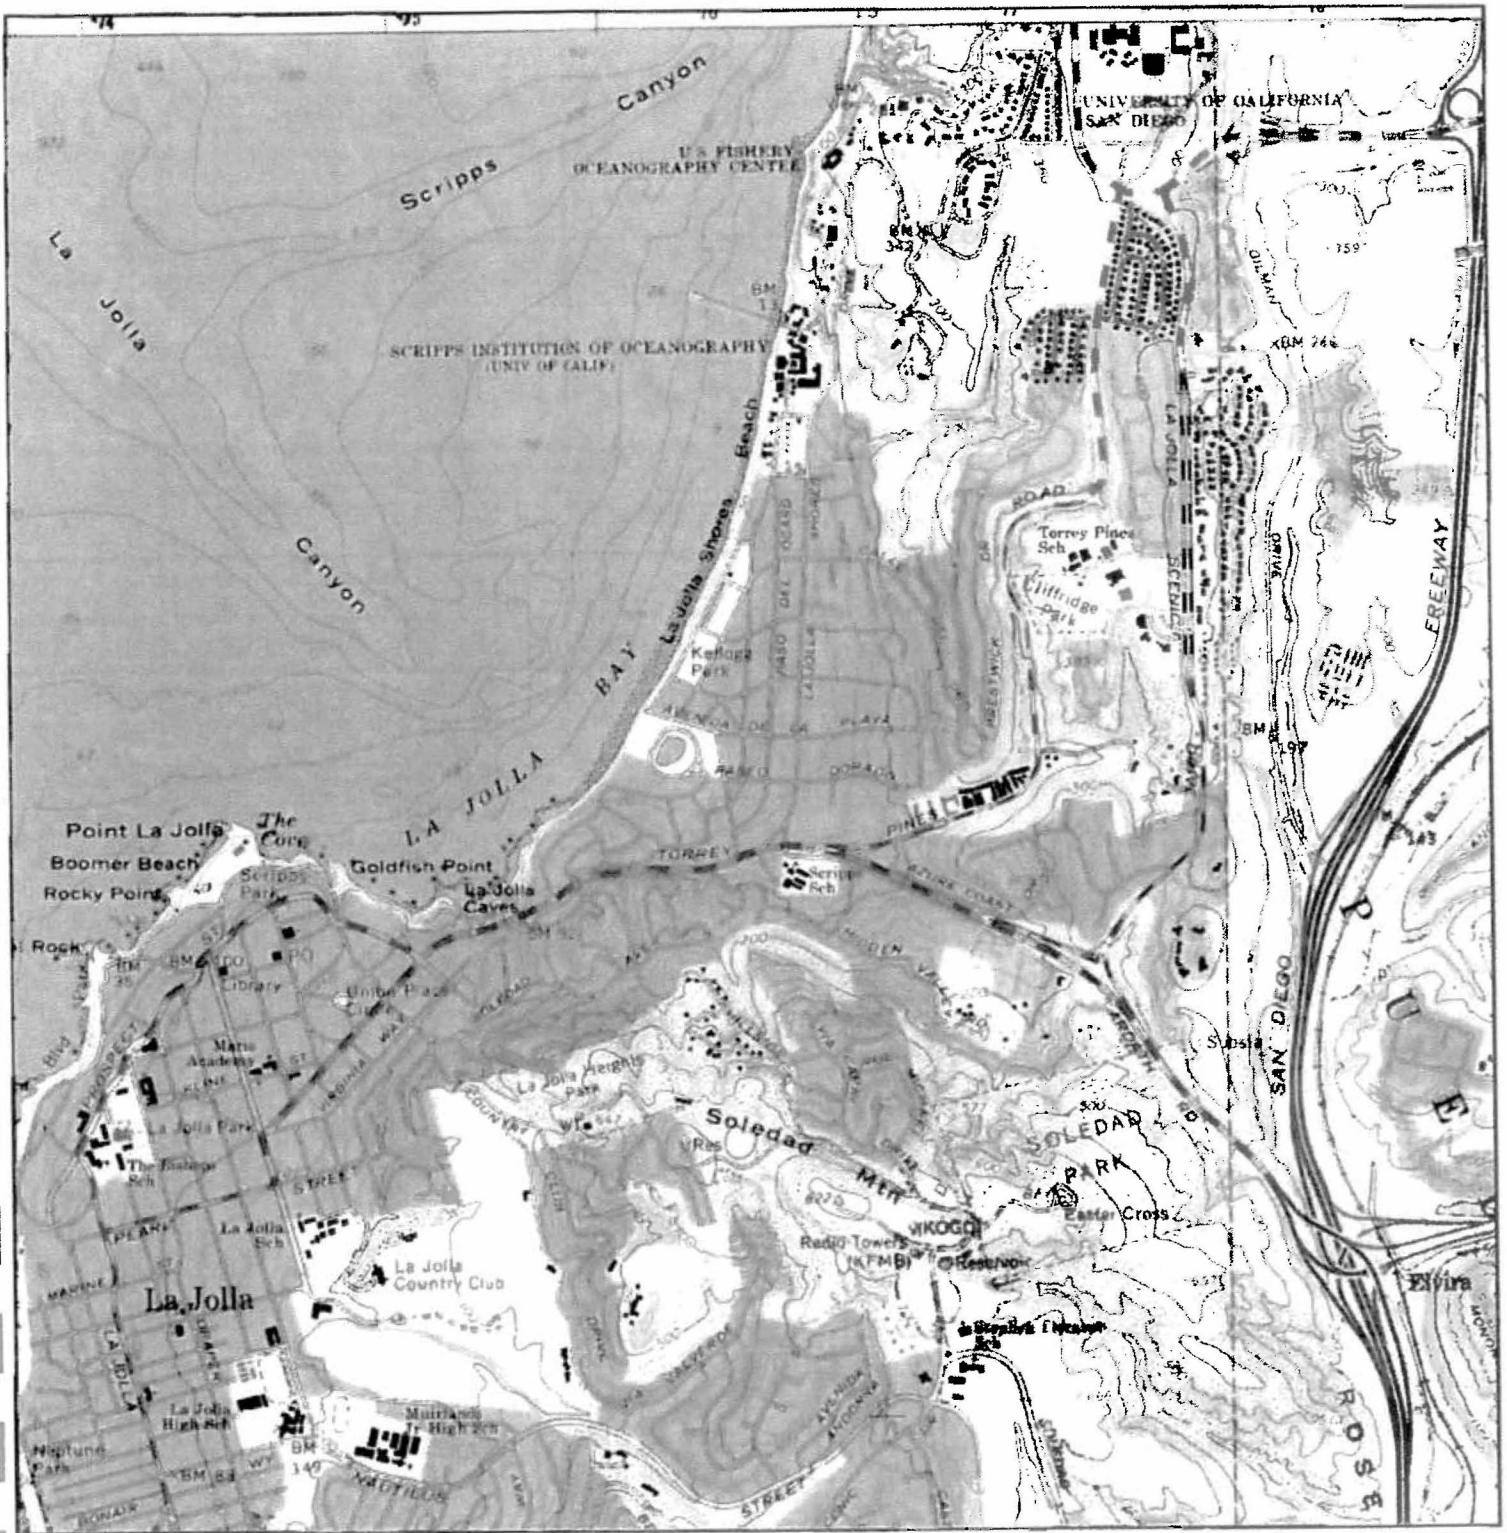
| FIGURE | D-4 |

**LA JOLLA 7.5' QUAD. 1975**  
**LUSARDI RESIDENCE**  
**LA JOLLA, CALIFORNIA**

Based on our review, it appears that the site surface elevation was lower than 25 feet msl, and possibly lower than 20 feet msl on the 1930 and 1953 maps. The 1967, 1975, and 1996 maps indicate the surface elevation was between 20 to 25 feet msl. The 1977 map at a smaller scale than the other maps reviewed, indicated the surface elevation was between 15 to 25 feet from west to east across the site. The present surface elevations, as shown on Figure 2, range from 14 feet on the sidewalk behind the seawall, then approximately 17 feet msl from behind the retaining wall to 24 feet msl at the eastern end of the existing structures. Copies of the topographic maps are presented in Appendix D.

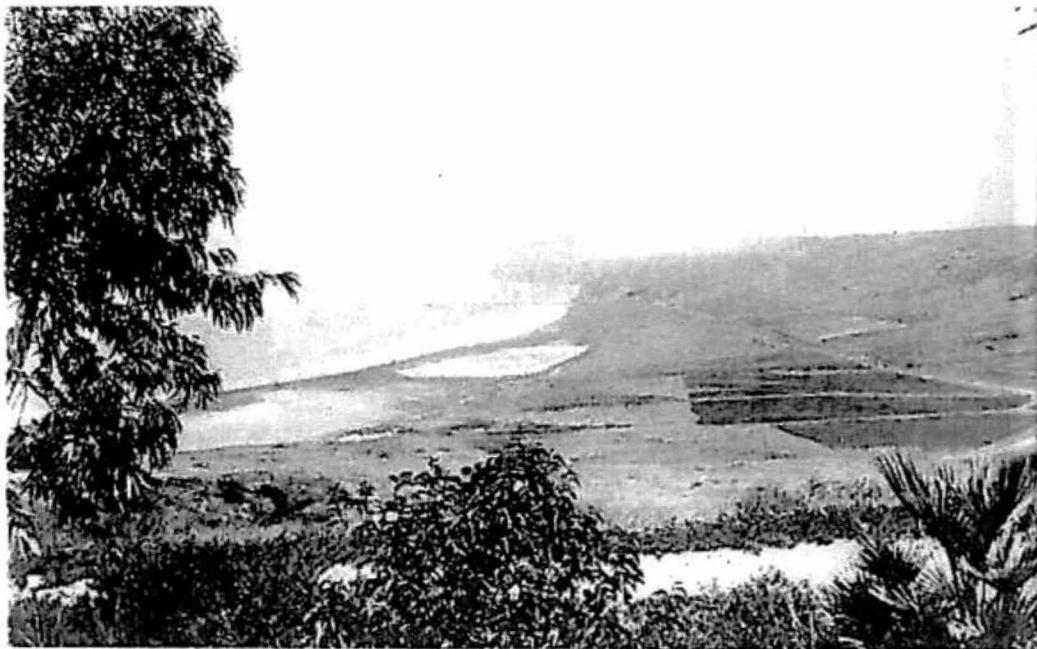
Photo #1: La Jolla Shores 1930 (T. Shepard Collection; in Kuhn, 1984)

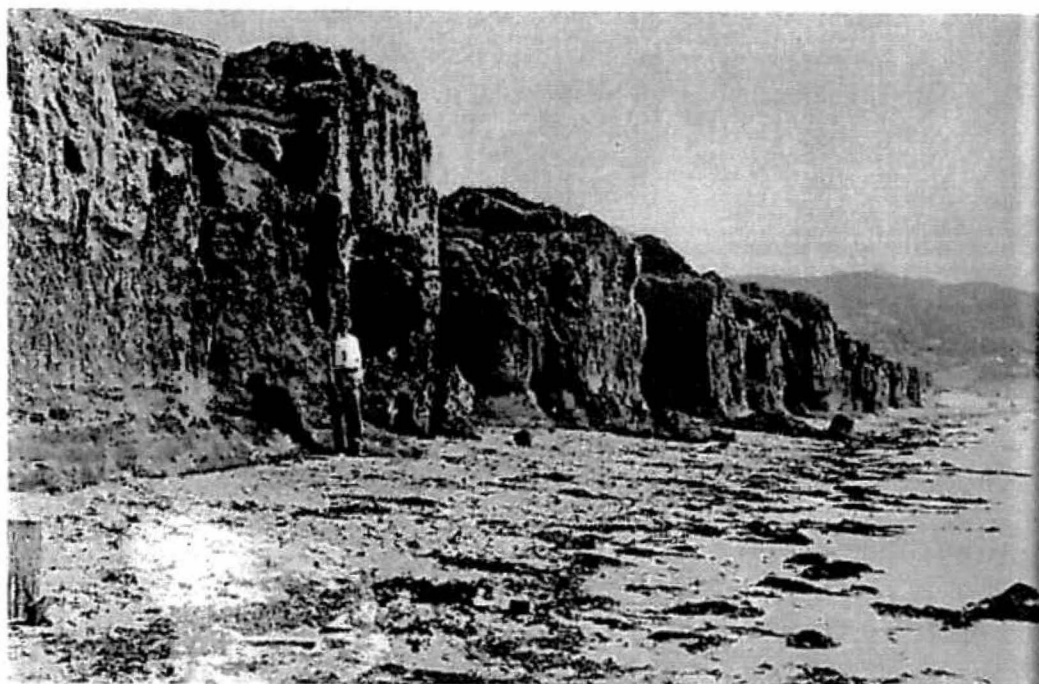
Photo #2: View of low-lying alluvial cliffs 1936 (approximate location at 8516 El Paseo Grande  
Cliff erosion rate at that time estimated at one foot per year (photo from U.S. Grant View Kuhu, 1984)

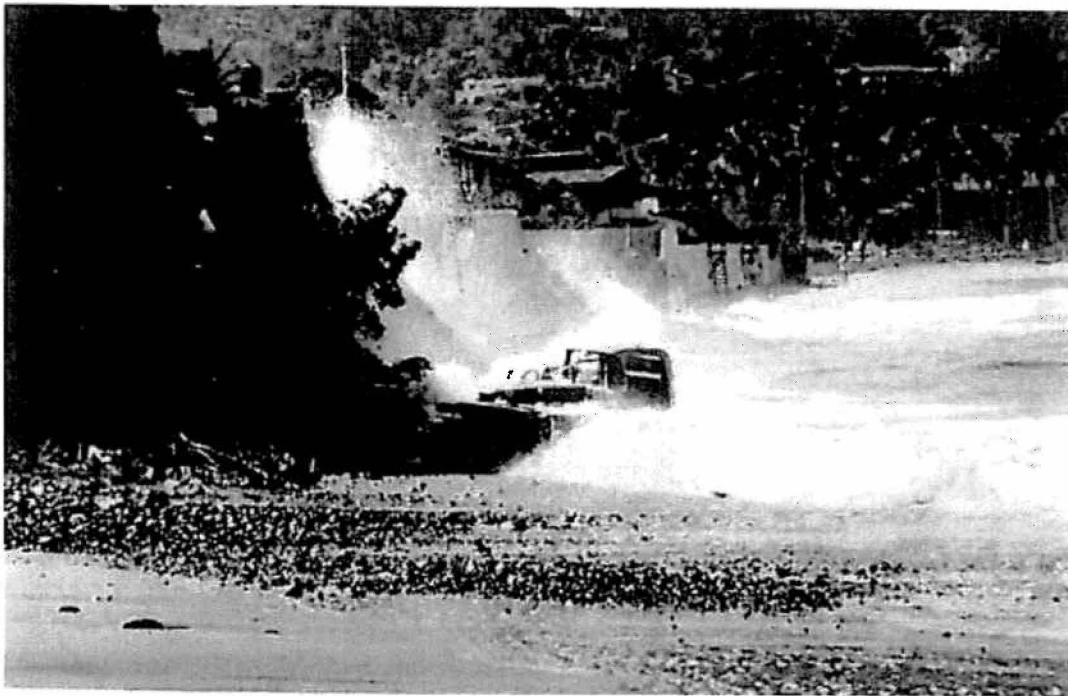
Photo #3: View at same location as Photo #2 during heavy storms of 1978 (Kuhn, 1984)

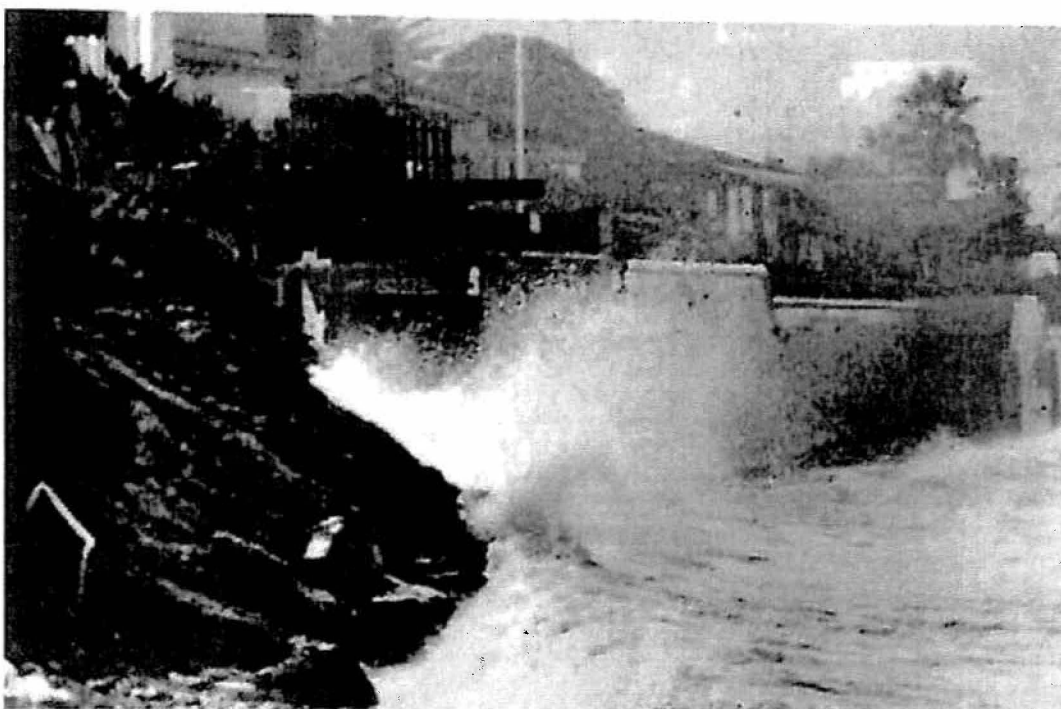
Photo #4: Same Location as Photo #3 1978 (Kuhn, 1984)

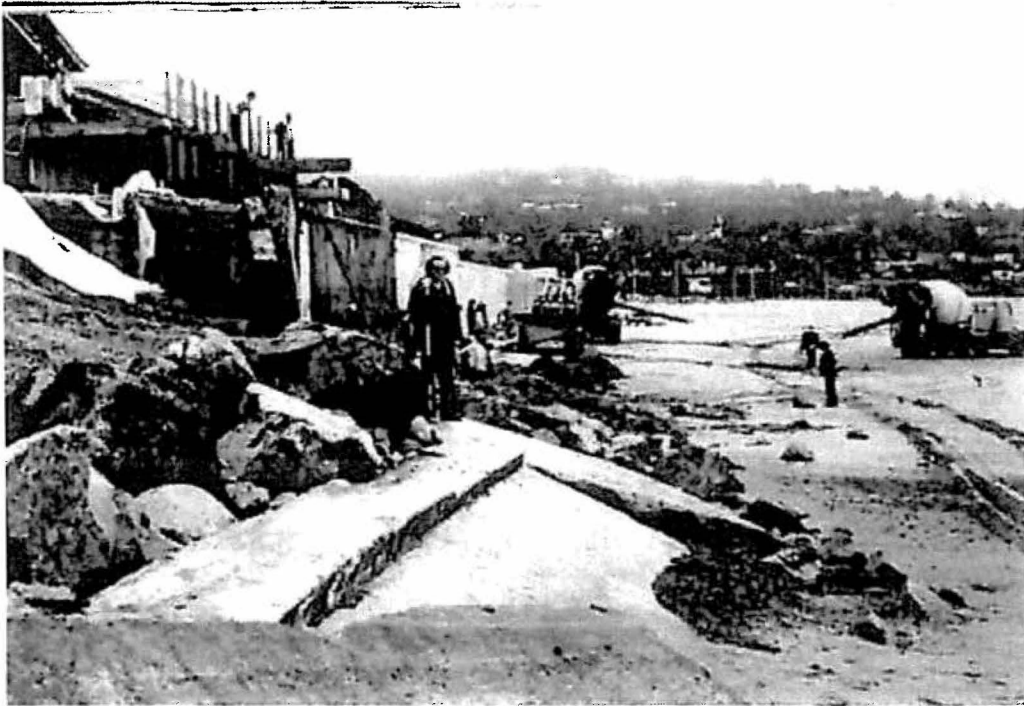
Photo #5: Same location as Photo #2-#5, showing partial collapse of seawall in 1978 (Kuhn, 1984)

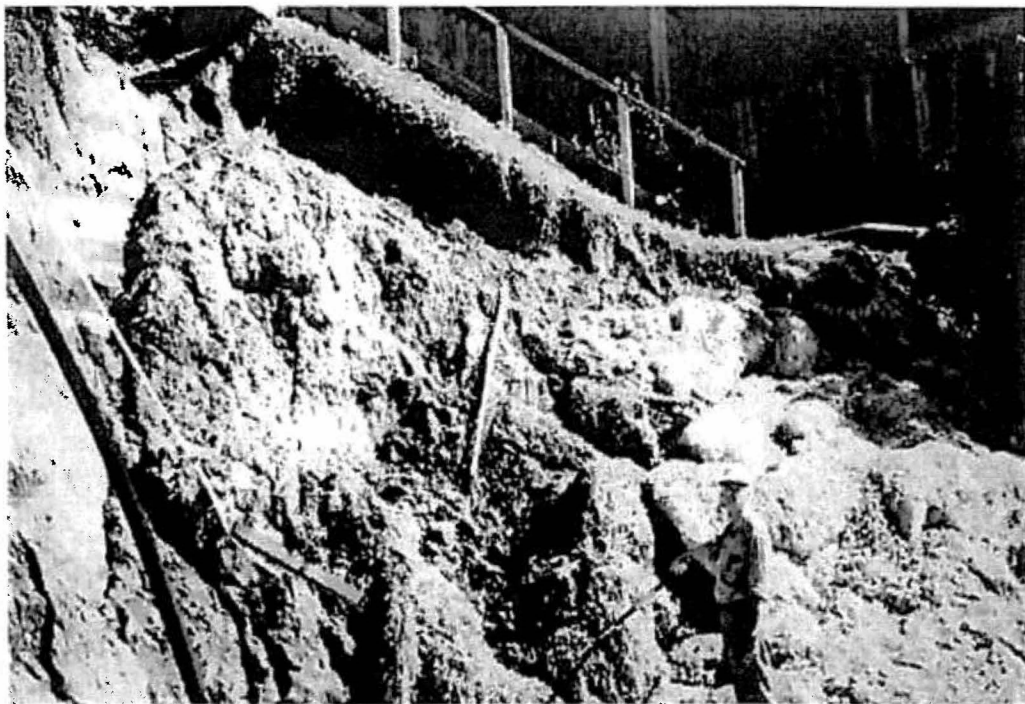
Photo #6: Up to 15 feet local retreat in general area as Photo #5 (Kuhn, 1984)

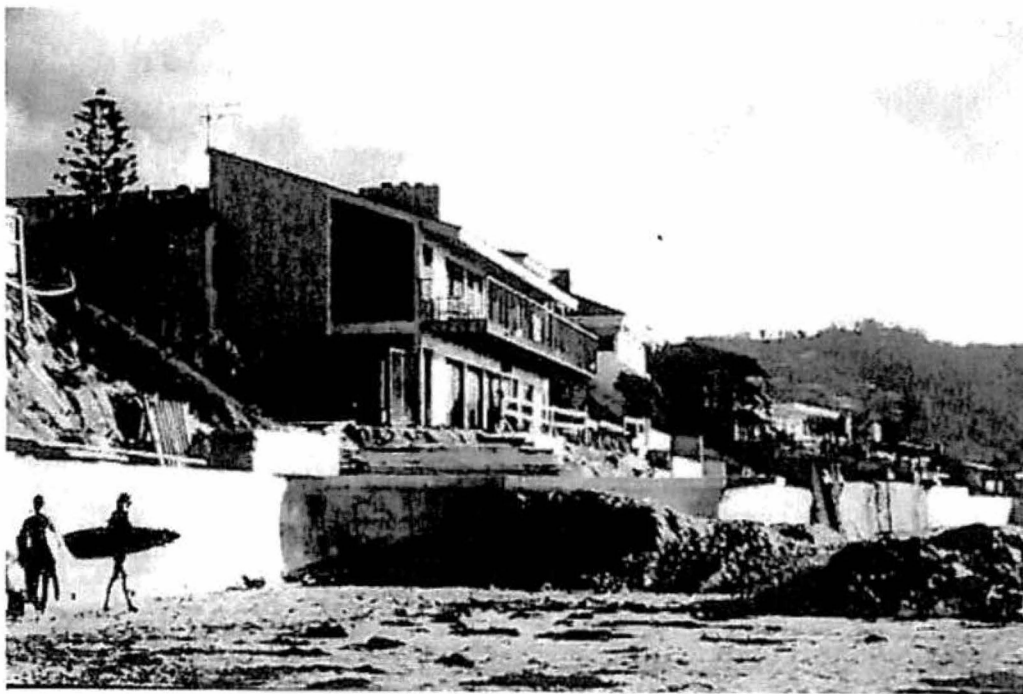
Photo #7: 1979 view at 8516 El Paseo Grande with new seawall constructed (Kuhn, 1984)

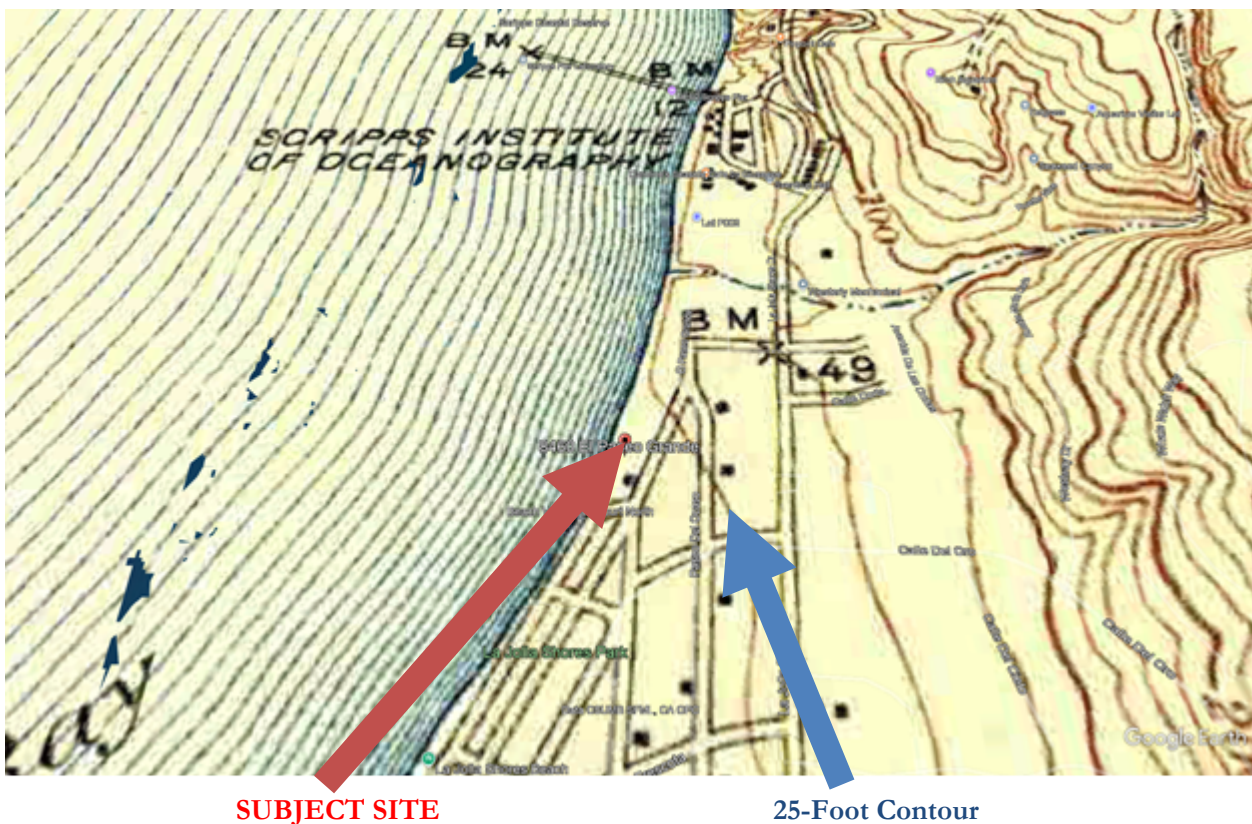
The Following Figure No. 1 shows the location of the subject site plotted on the USGS 1943 edition of the La Jolla Topographic Quadrangle. The pre-development topography of the site presented on Figure No. 1 is consistent with our determination that the subject site does not contain a coastal bluff and that the western portion of the site is indeed located on a broad, stable beach. The natural coastal bluff to the north of the site is clearly expressed along that portion of the 25-foot contour line that closely parallels the shoreline. Along those areas, the elevations of the natural ground surface are as much as 15 feet above the maximum elevation of the subject lot.

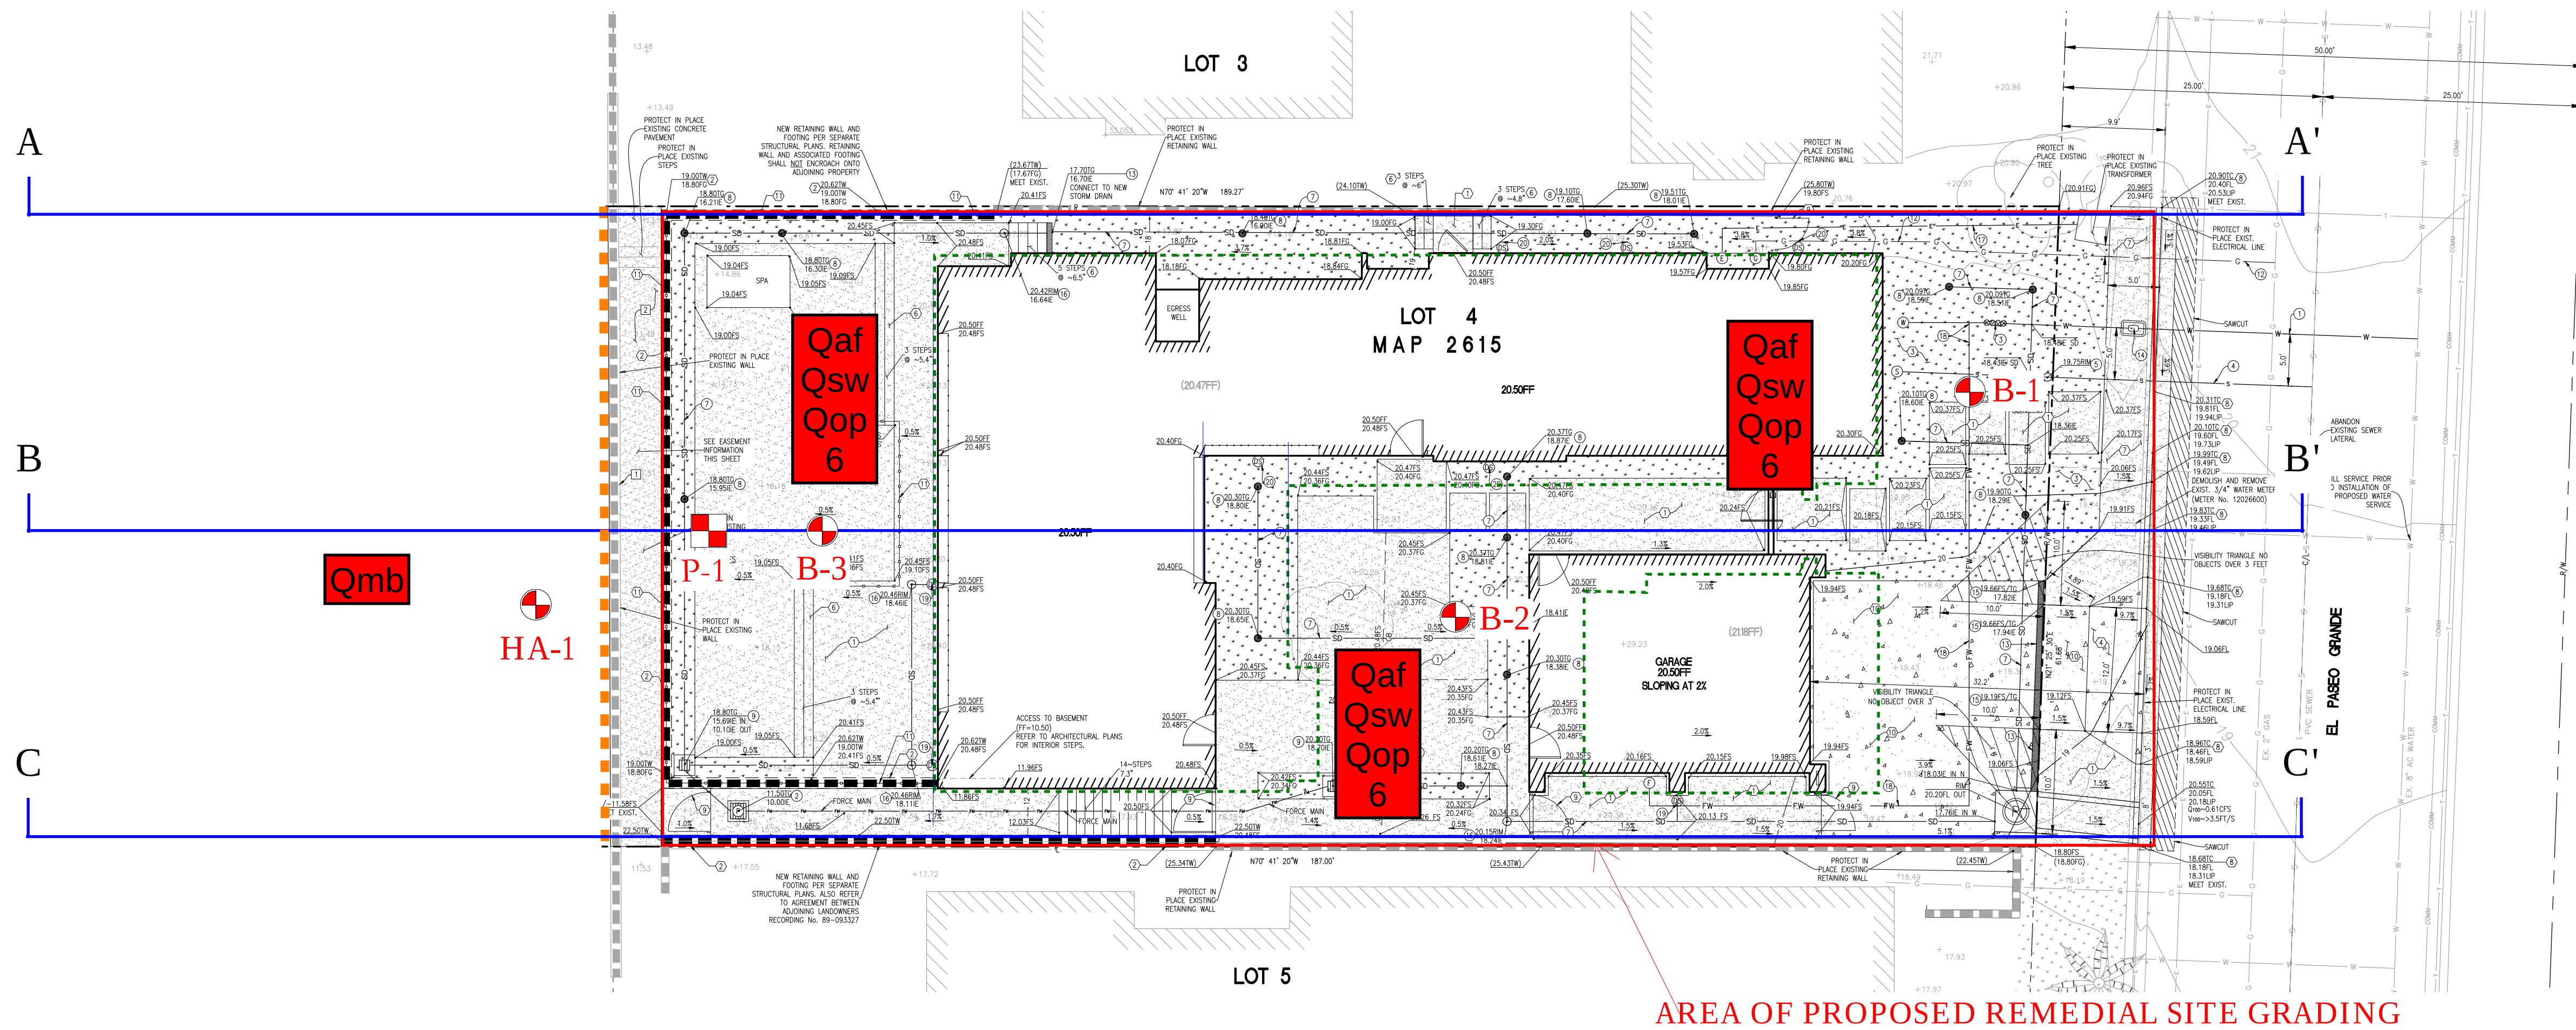
| MORROW RESIDENCE<br>8460 EL PASEO GRANDE, LA JOLLA, CA | |
|---|---|
| BY: JMM | PLATE NO.: 2 |

| CWE LEGEND | |

**CWE Response:** An Updated Site Plan and Geotechnical Map is included on Plate No. 1 of this report and updated geologic cross sections are presented on Plate Nos. 2-4 of this report. The Site Plan and Geotechnical Map is on a topographic base map of suitable scale to show details of the coastal landforms, existing improvements, and proposed development. As described in our response to City Comment 00104 above, we have determined that a bluff edge is not present at the site. Rather, the geologic and geomorphic conditions of the site are considered consistent with definition of a Coastal Beach within Section I.C of the City's Coastal bluffs and beaches Guidelines.
